**NATIONAL TRANSPORTATION SAFETY BOARD  
OFFICE OF AVIATION SAFETY  
WASHINGTON, D.C. 20594**

**ENGINE INSPECTION FACTUAL REPORT  
NTSB ID: CEN17IA094**

Location: Sioux Falls, South Dakota  
Date: January 26, 2017  
Time: 2148 central standard time (CST)  
Aircraft: Eurocopter Deutschland GMBH MBB-BK 117 C-2, N911MK,  
operated by Avera McKennan Careflight

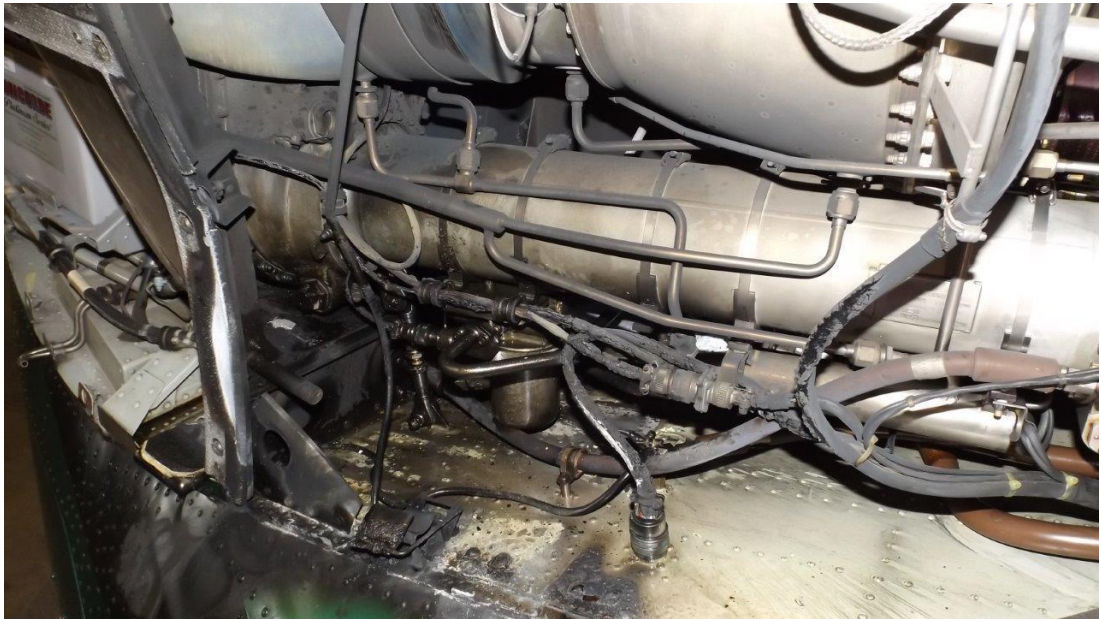
Figure 1. Thermal damage to engine deck and externals

A post-incident aircraft inspection found minor fire damage and oil on the engine deck and fuselage.

The airframe fire damage was limited to the aft outboard section of the No. 2 engine deck and the outboard section of the engine cowling. The damage included local blistering to the

deck paint. The viton sheath of a wiring harness was split and burned where it faced the cowling but the underlying wires were undamaged. There was no evidence of a pool fire. See Figure 1.

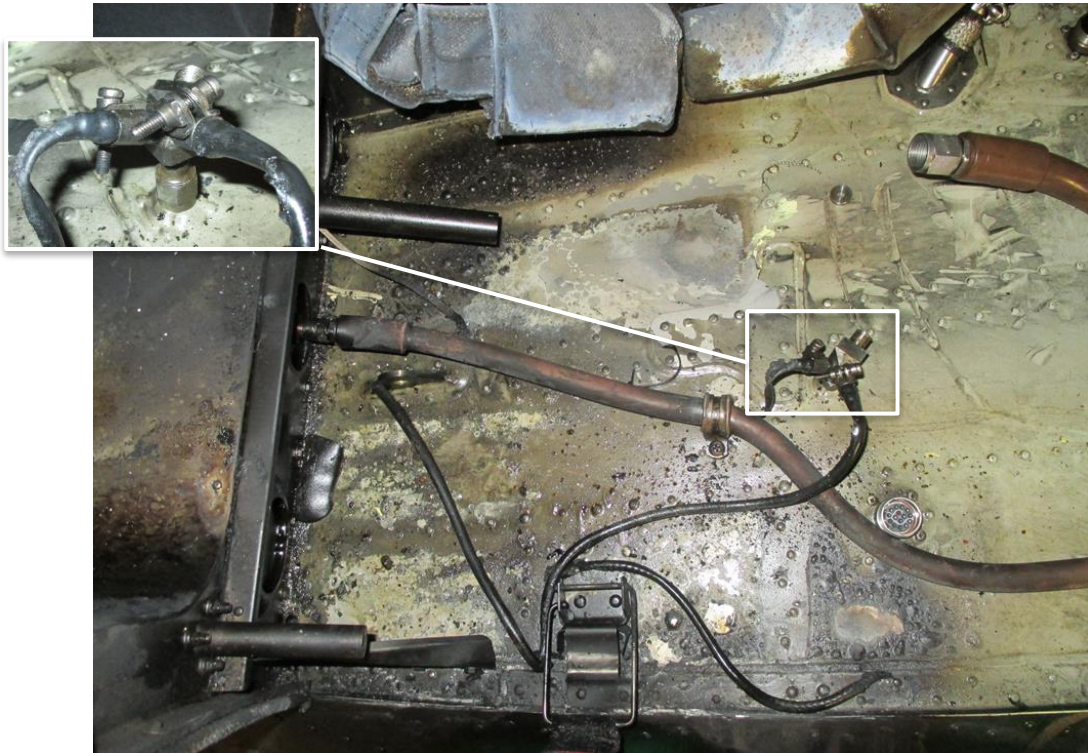
Figure 2. Engine deck after engine removal

Axially-oriented holes were noted at two locations in the airframe-supplied elastomer tube that connects the engine vent pipe<sup>2</sup> to the 3-way union deck drain fitting. The 3-way union deck drain fitting (see Figure 2) was clogged with coke.<sup>3</sup> A section of another elastomer drain tube, identified as part of an airframe collector drain line, was found lying on the engine deck and was separated/melted at both ends. The outside surfaces of the elastomer tubing were heat damaged but the insides appeared smooth. Oil and some debris, but no obvious coking, could be observed inside them.

Raw oil was noted on the bottom of the engine. There were black deposits on the the rear bearing chip detector tip. The oil scavenge pipe between the rear bearing housing and the in-line strainer/chip detector contained an oily black substance. The rear bearing strainer housing union was partially obstructed by oily soot/coke where the rear bearing scavenge line attaches. The rear bearing chip detector housing and strainer were obstructed by coke.

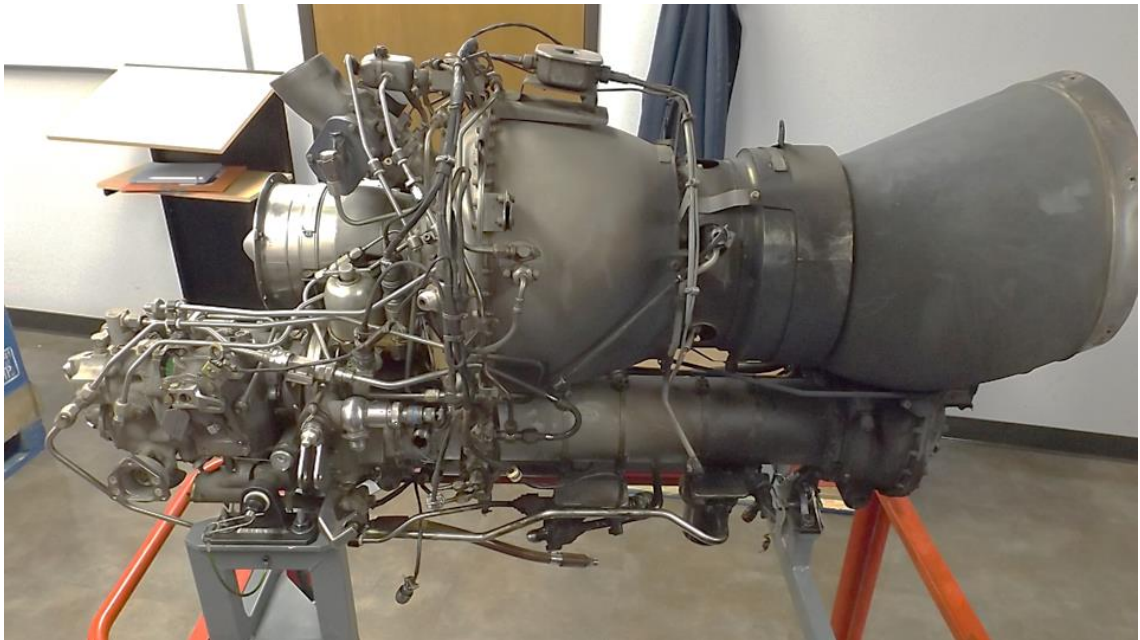
Figure 3. View of left side of the engine

The engine displayed a light coat of soot aft of the combustor section. There was light thermal damage to hose and harness insulation and to attachment hardware along the lower right side and bottom of the engine. The gas generator rotor was seized. No other external discrepancies were noted. See Figure 3.

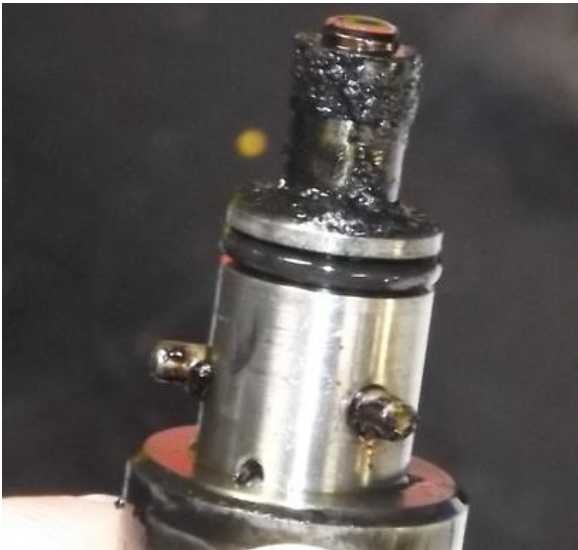
Figure 4. Rear bearing chip detector

The MO3 (high pressure gas generator module) rear bearing chip detector end was coated with a black substance. See Figure 4. No significant ferrous material was observed. The gas generator rear bearing oil scavenge pipe was clear at the housing end and heavily contaminated with oily carbon material at the rear bearing strainer end. See Figure 5.

The gas generator rear bearing chip detector was operationally tested using an engine installed on a Safran HE test cell. The test indicated that the black debris on the detector tip impeded the detector function:

Signal integrity was verified by bridging the engine's chip detector circuit and confirming a chip detector signal indication at the test cell control display. The test cell engine chip detector was then replaced with the incident gas generator rear bearing chip detector. There was no indication.

The incident chip detector circuit was mechanically bridged. There was no indication.

The debris coating the magnetic tip of the incident chip detector was wiped with a dry rag and the circuit was bridged again. This produced an indication.

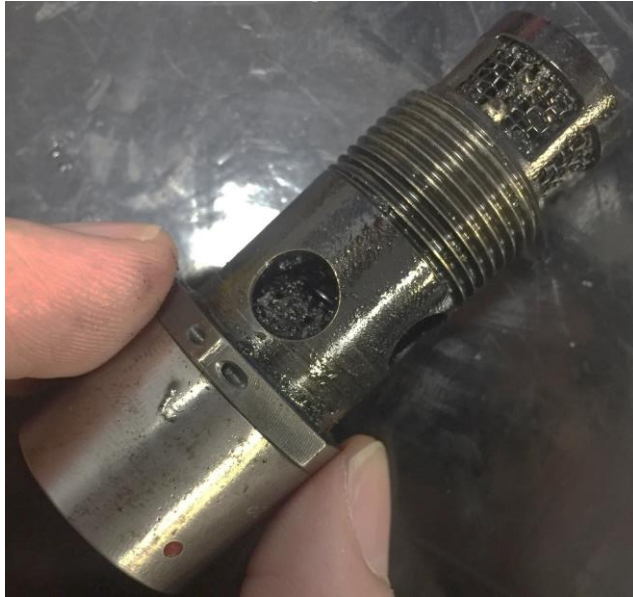
Figure 6. Rear bearing strainer and magnetic chip detector housing

The rear bearing strainer housing union was obstructed by coke. The rear bearing scavenge strainer and magnetic chip detector housing were full of coke particles. See Figure 6.

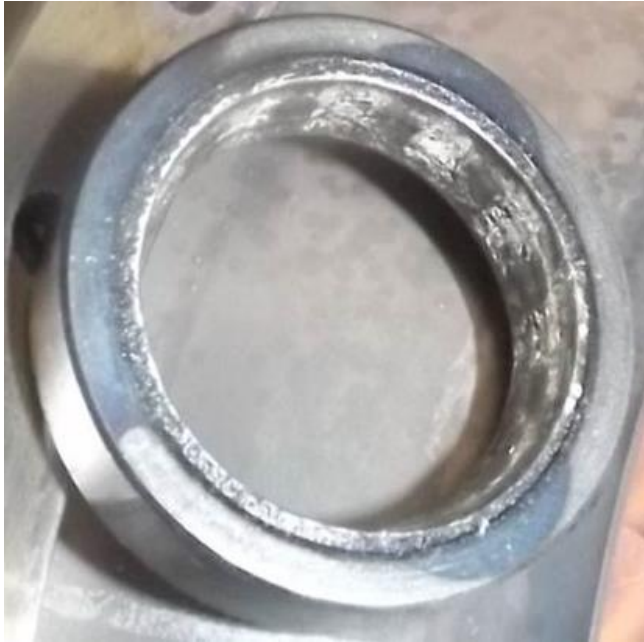
Figure 7. Gas generator rear bearing

The rear bearing was displaced on the turbine bolt. The retaining ring circlip was broken. A small amount of oil was present at the bearing. The bearing inner race was fragmented. The bearing color and texture were consistent with adhesion damage. The roller assembly exhibited extreme rotational scoring with only a small amount of material remaining. The scored surface was battered. See Figure 7.

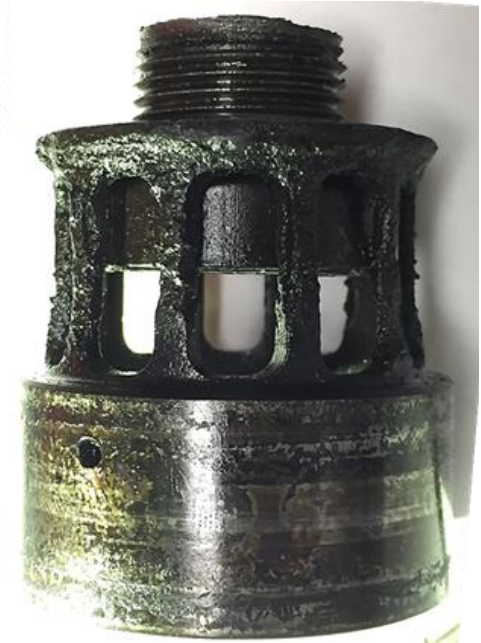
Figure 8. Bearing support assembly

There were carbon deposits on the inner surfaces of the bearing support assembly cage outer race and vibration dampeners. All of the cage dampeners were damaged and a number were missing material. See Figure 8.

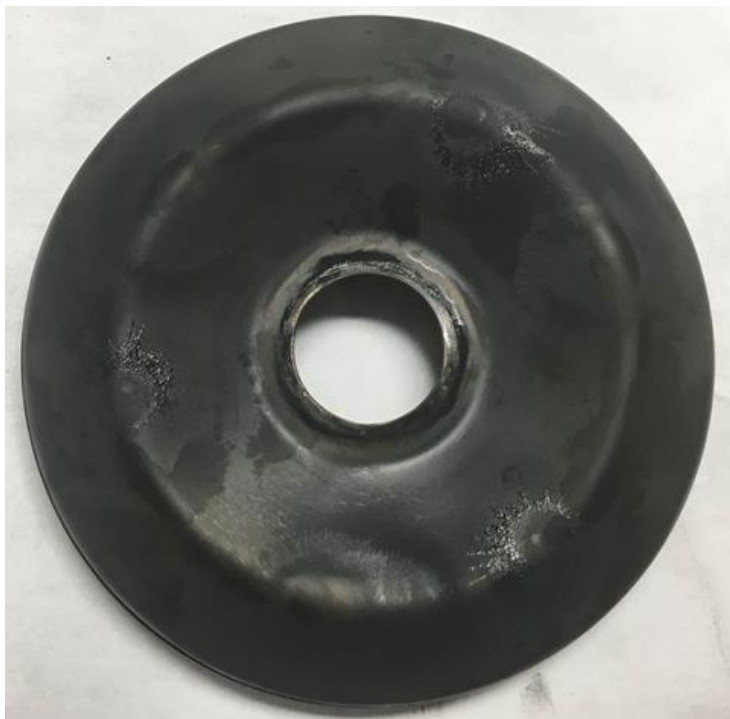
Figure 9. Cover showing splash marks

The forward face of the cover exhibited oil staining and splash marks axially coincident with the outlet ends of the three air supply tubes. The aft face exhibited coking 360° around and additional coking between 4 and 8 o'clock. See Figure 9. The aft side of the deflector exhibited splash marks coincident with the air tube exits.

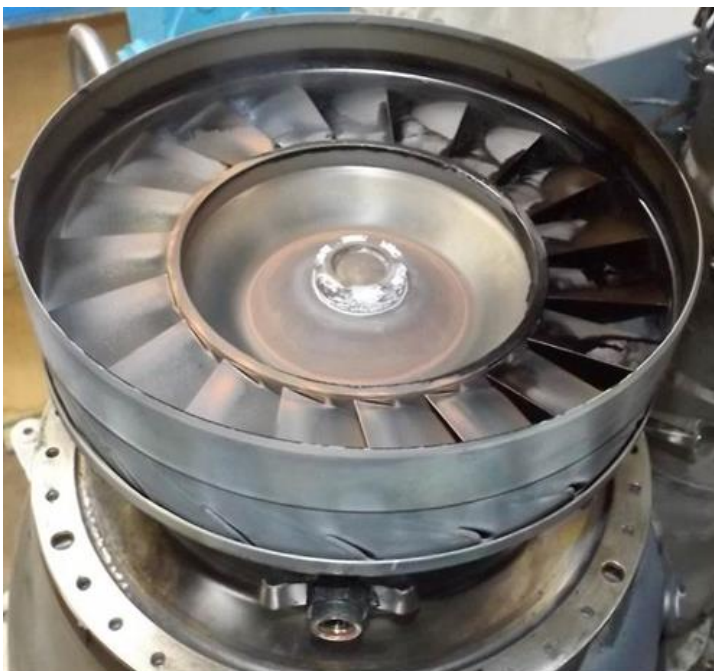
Figure 10. Oil on power turbine nozzle guide vane at 6 o'clock

The power turbine nozzle guide vanes were coked with oil at 6 o'clock. See Figure 10.
