# NATIONAL TRANSPORTATION SAFETY BOARD

## Investigation Summary and Findings

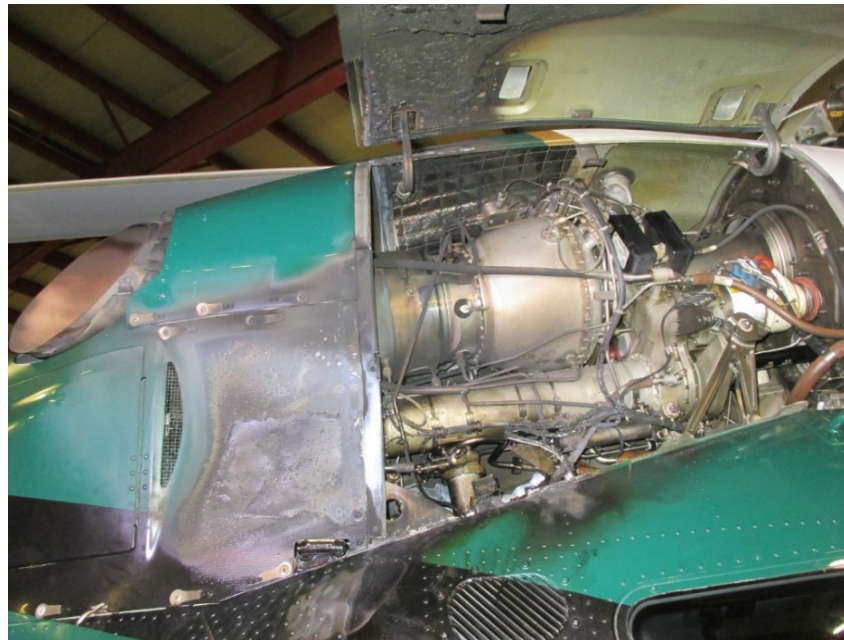
Figure 1 – No. 2 engine compartment damaged by fire

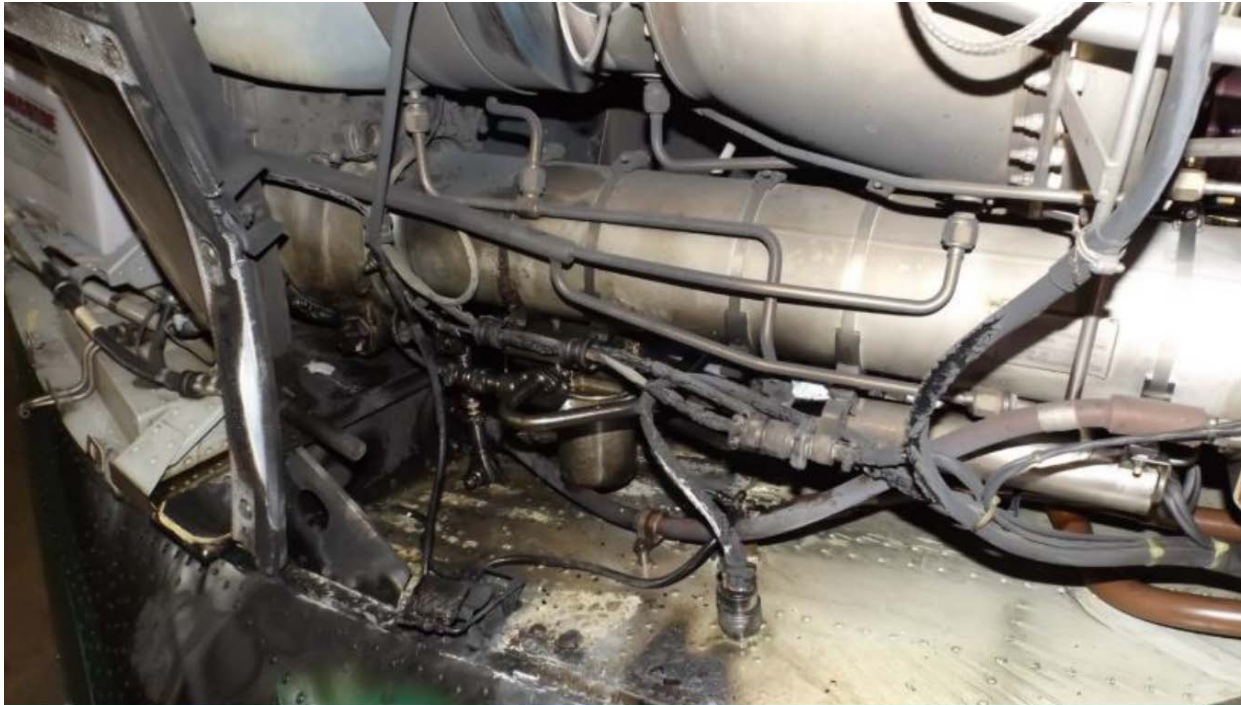
Heat/fire damage was limited to rear end of No. 2 engine. Soot examination confirmed an oil based fire. Stains of liquid splatter were noted in the lower engine area. Heat/fire marks were noted on the lower part of hot section of No. 2 engine (see photo below).

Figure 3 – No. 2 engine deck fire damage

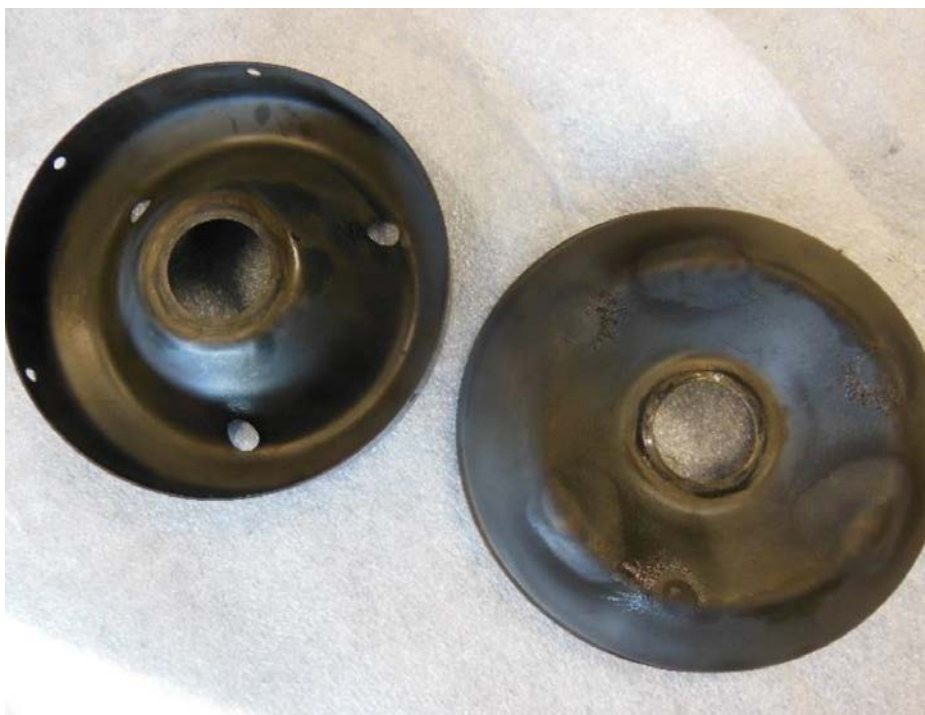
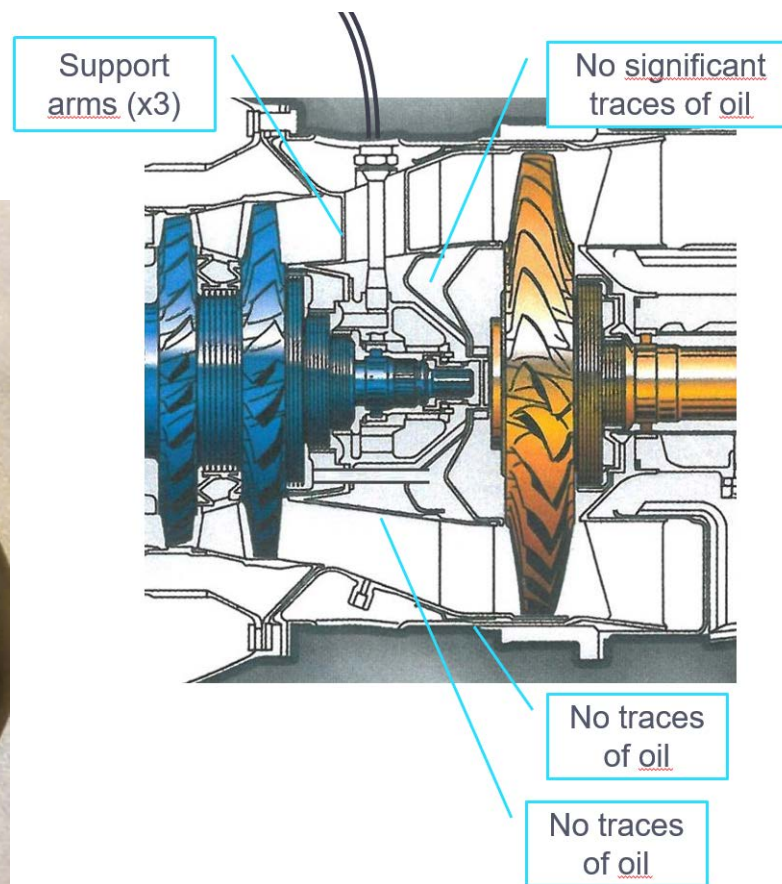
The back plate displayed 3 distinct area of oil/coke splatter which lined up with the 3 horizontal tubes.

Figure 7/8 – Back plate with oil splatter from 3 horizontal tubes (L) and locations on diagram (R)

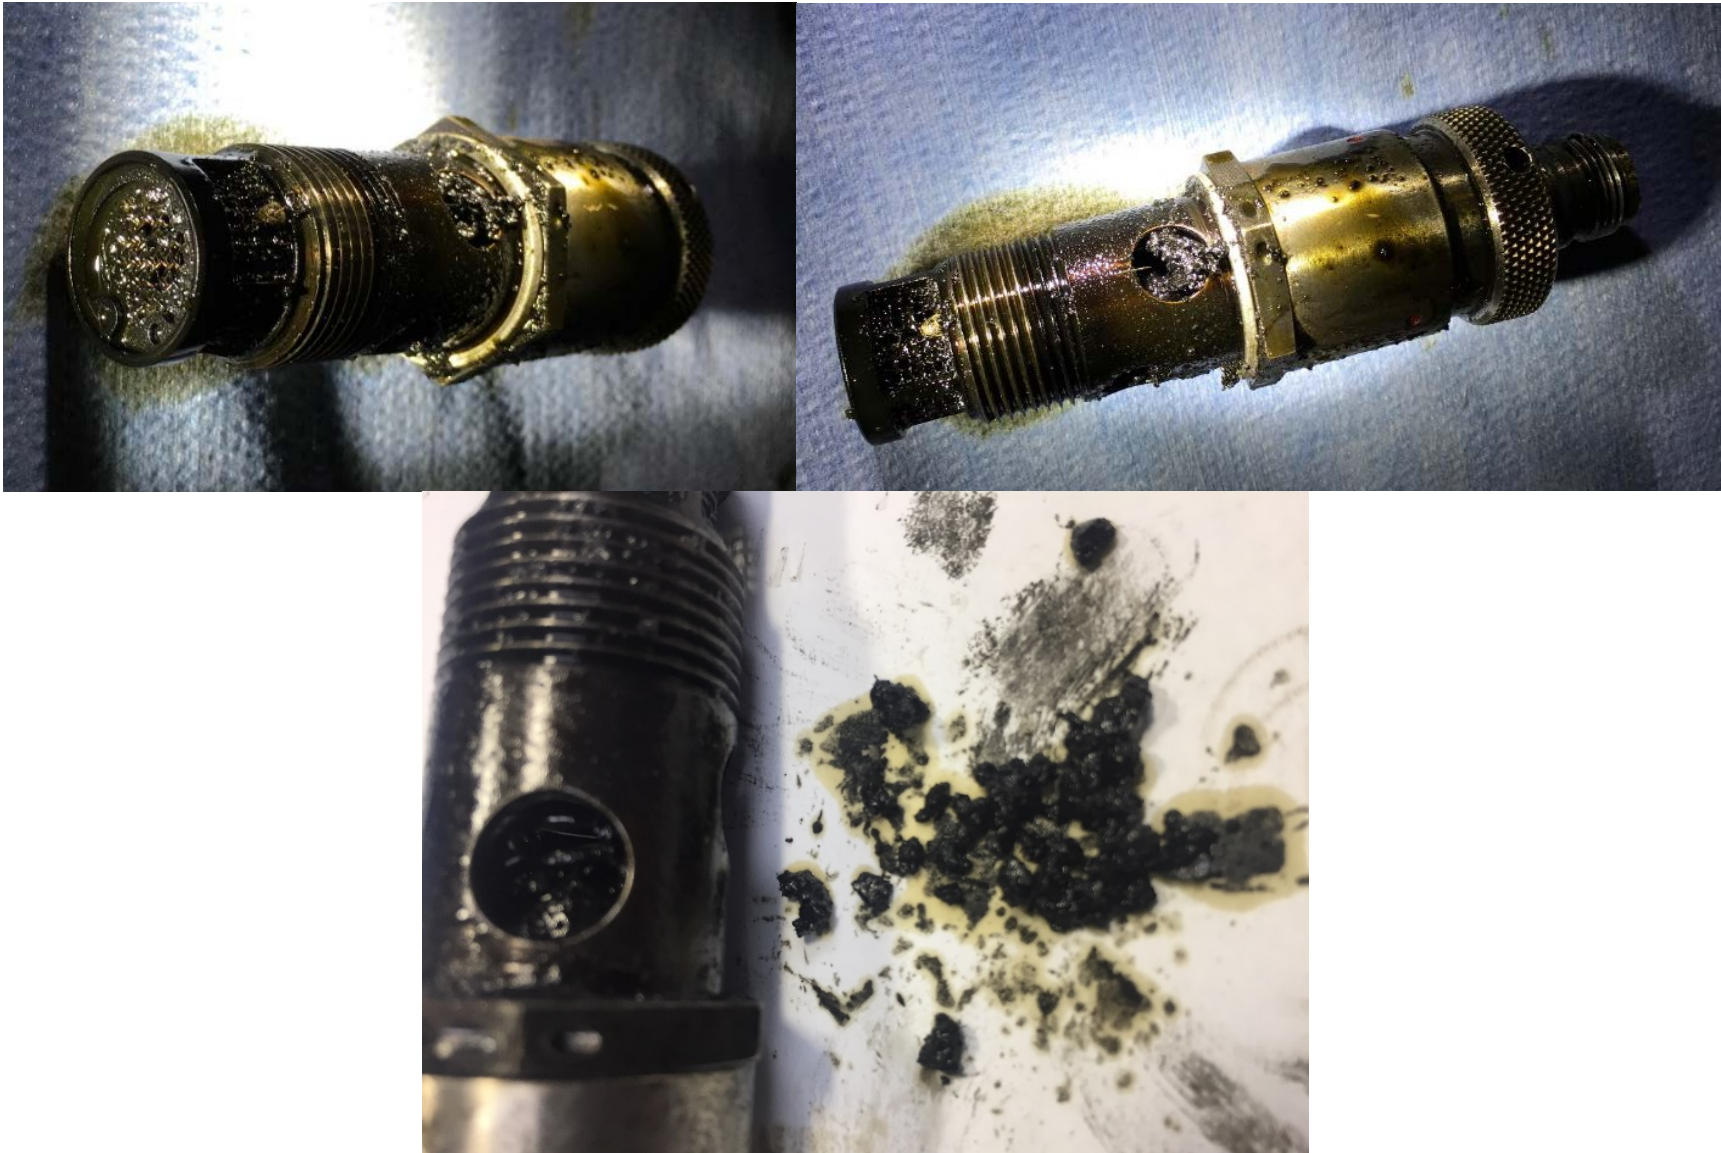
Figure 9/10/11 – Rear bearing strainer with coke buildup

- Coke material in the scavenge tube. Coke typically forms due to the degradation of the oil.
- Coke material in the strainer. Coke typically forms due to the degradation of the oil.

- o Note: there was no metallic debris found. Therefore, the coke accumulated before the degradation of the rear bearing.
- Coke in the three-way union. Coke typically forms due to the degradation of the oil.

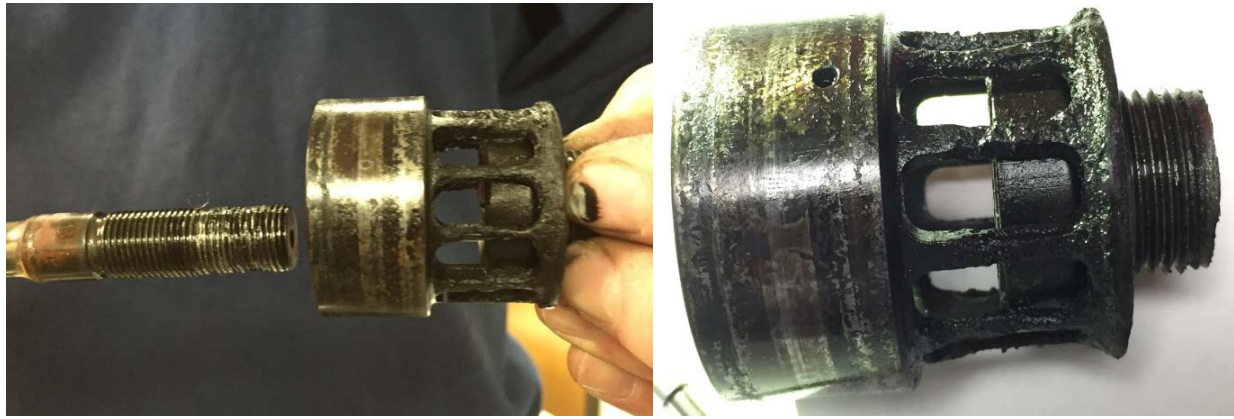
The rear bearing's flexible cage shows corrosion on several arms. Cases of cage corrosion are very rare and are not systematically associated with bearing failures. Examination and comparison with the No. 1 engine flexible cage showed that dispersion with the surface treatment made the No. 2 cage more sensitive to corrosion. The bearing's lubrication hole was clear of obstruction.

Figure 12/13 – Flexible cage damage

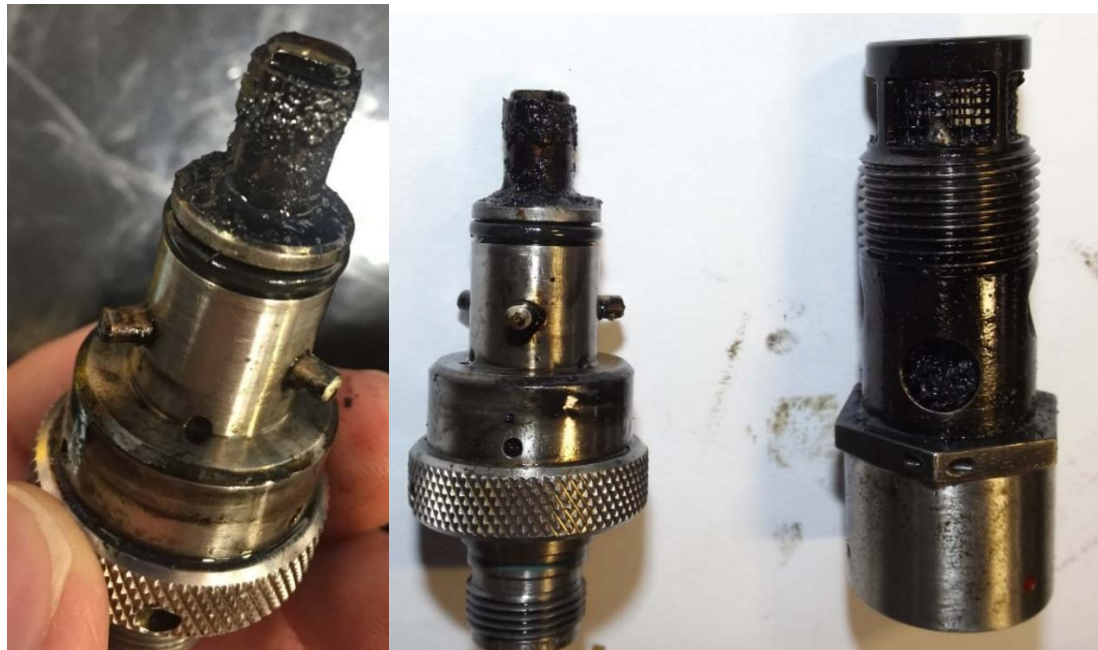
Figure 14/15 – Coke on chip plug and strainer

- Significant coking material was found in the rear bearing casing.
- The scavenge line was blocked with coke at the magnetic plug level. Significant coking was in the vent tube and contained no metallic debris.

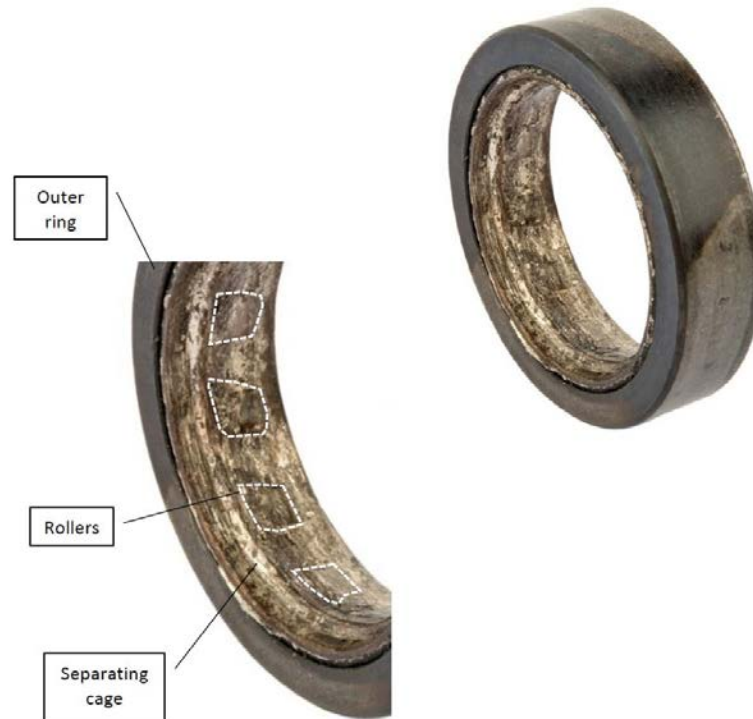
The bearing was totally seized and could not rotate. All of the rollers, the cage, and the outer ring were stuck together. The rollers were flattened and did not protrude from the separating cage as they would normally. The separating cage and the flattened rollers showed circular scoring marks consistent with rubbing against the rotating inner race. The cage also exhibited numerous impact marks and indentations consistent with contact with other debris while rubbing with the rollers; the damage was also consistent with the rubbing and separation into several fragments of the inner race. The bearing's outer ring showed no indication of movement (rotation or displacement) against its support and was in good condition on the external surface. The fragments of the inner ring exhibited traces of rotational scoring and metal ripping at the race's surface, which was indicative of friction under a significant radial load. Several fragments showed rectangular imprints left by the flattening rollers. These imprints indicated that a significant sudden radial load was applied to the inner ring while it was still mounted on the shaft. The fragments exhibited blunted and rounded edges due to contact with surrounding parts or debris after the rupture of the bearing ring.

Figure 16 – No. 2 engine rear bearing damage

- Excess of oil in chamber
  - The investigation revealed that oil had overflowed from the bearing chamber once the scavenge line was clogged. The bearing is designed to operate in an oil mist and not in an oil bath. The presence of liquid in the bearing chamber will provoke a resistance to the movement of the rollers. Prior to the clogging of the vent line, the bearing was still in satisfactory condition as no metallic debris were found in the scavenge line's strainer / magnetic plug assembly. The pilot did not report any change in engine parameters until he activated the fire pushbutton which in turn led to the activation of the fuel shut-off valve and to the engine shutdown. Therefore, the bearing operated satisfactorily until its final moments of operation in an excess of oil following the scavenge line's clogging and until the pilot shut-down the engine.

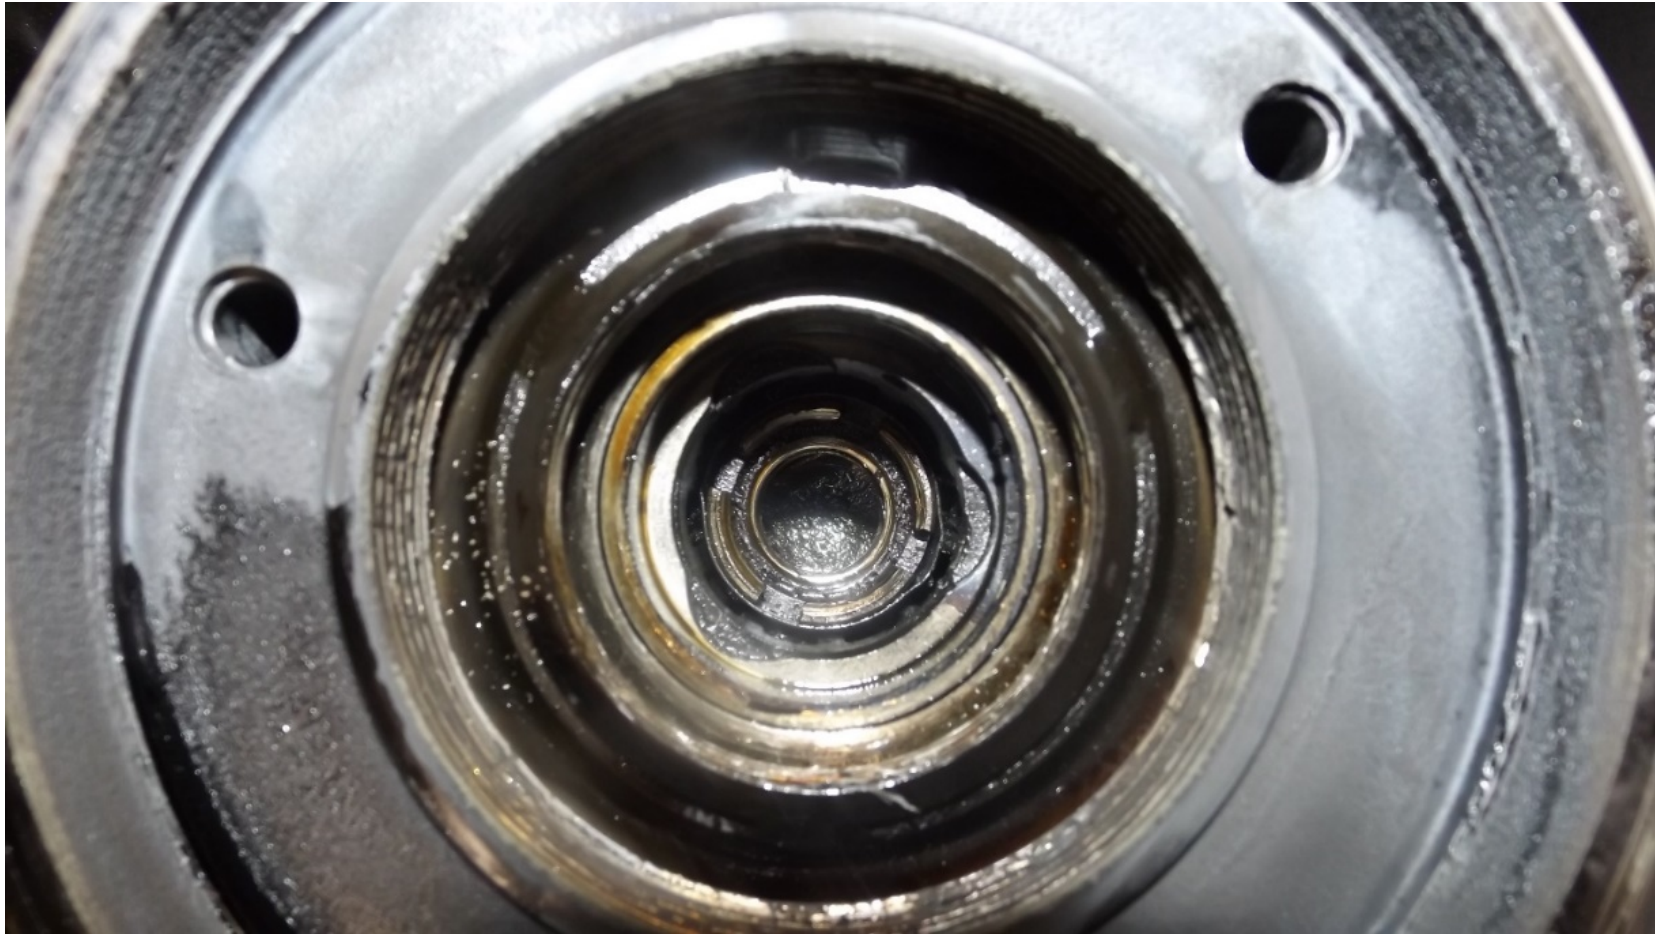
Figure 17 – Coke buildup in rear bearing casing

- Coke material and metallic debris in the rear bearing chamber. Coke typically forms due to the degradation of the oil. The large metallic debris is from the rear bearing material. Smaller debris was likely due to wear of other parts in the rear bearing assembly such as the rear bearing casing.

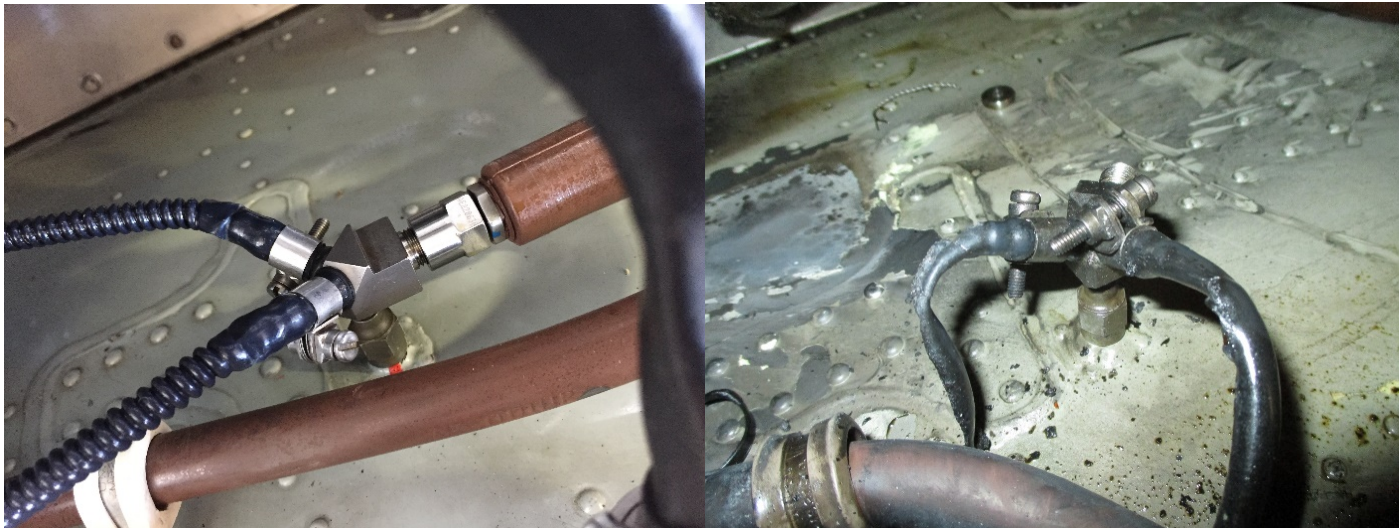
Total obstruction  
Coke only

Figure 18/19 – Exemplar Deck Fitting / 3-way union (L) - No. 2 deck fitting / 3-way union (R)

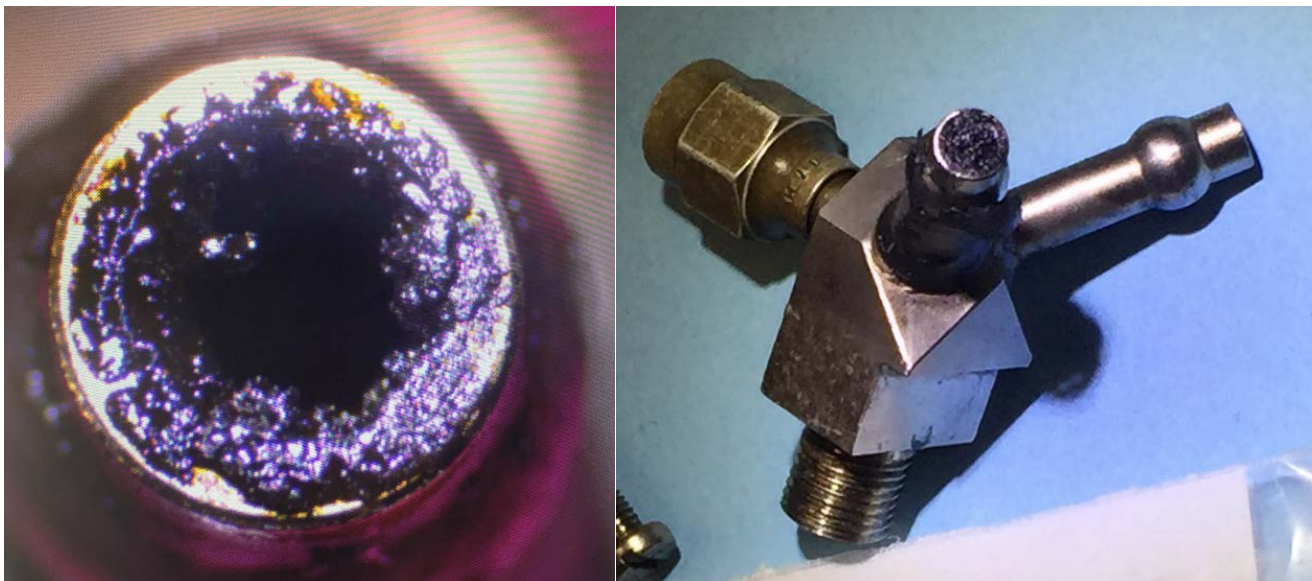
Figure 20/21 – No. 2 deck fitting opening for vent tube clogged with coke

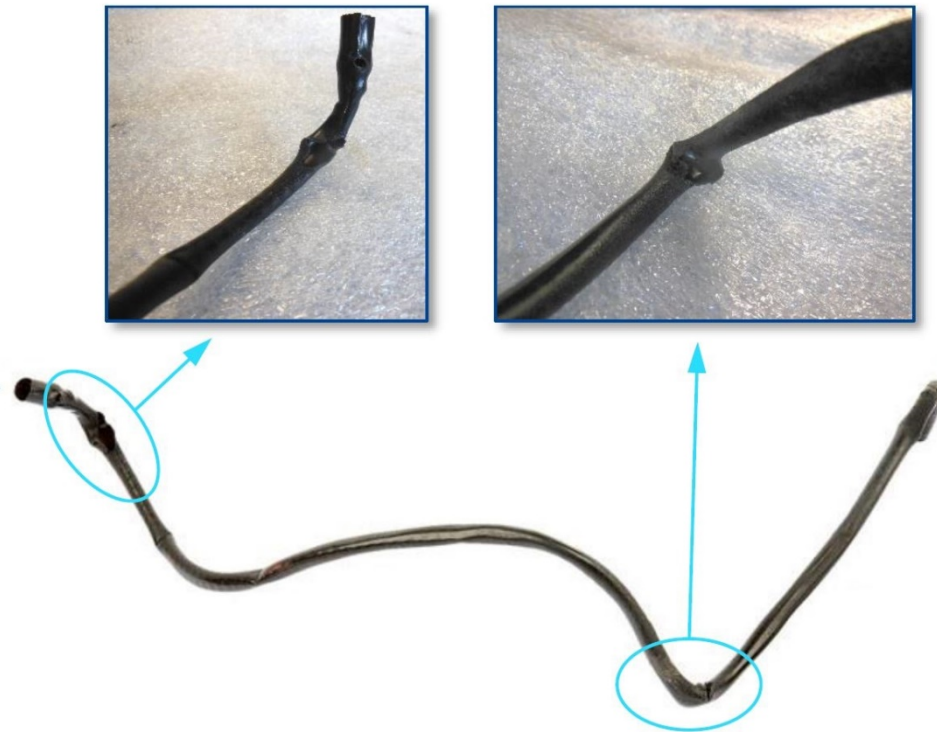
- The vent line was found split open in two positions and the splits were from inside going out. The vent line contained liquid oil and coking residues, and metallic debris. No significant amount of coking.
- Vent line's 3-way union was clogged with coking. Coking material was found hard and compacted in the union's orifice and contained no metallic debris.
- AHD performed extensive testing of exemplar flexible vent lines. The performed tests showed that the damage to the vent line is most likely a result of low pressure and high heat when compared to different setups of pressure and temperature failure modes of sample tubes.

Figure 22 – No. 2 engine flexible vent line with heat damage and elongation

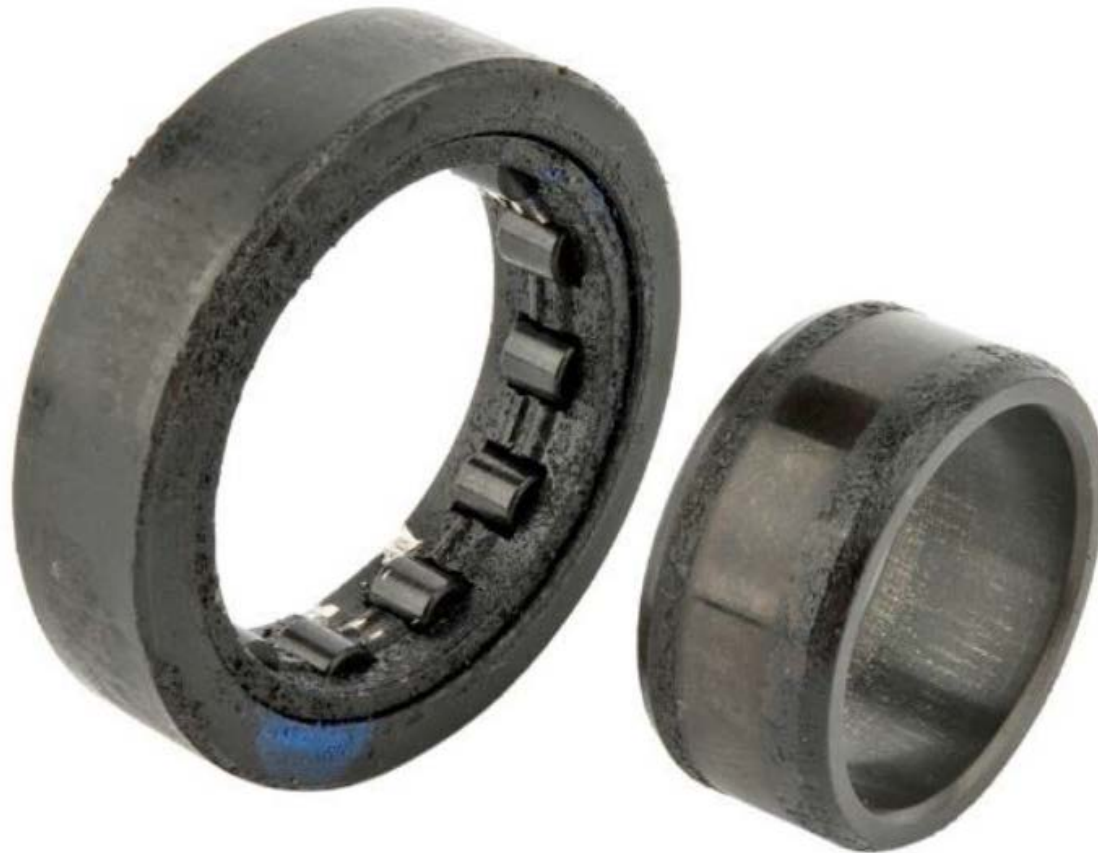
Figure 23 – No. 1 engine rear bearing

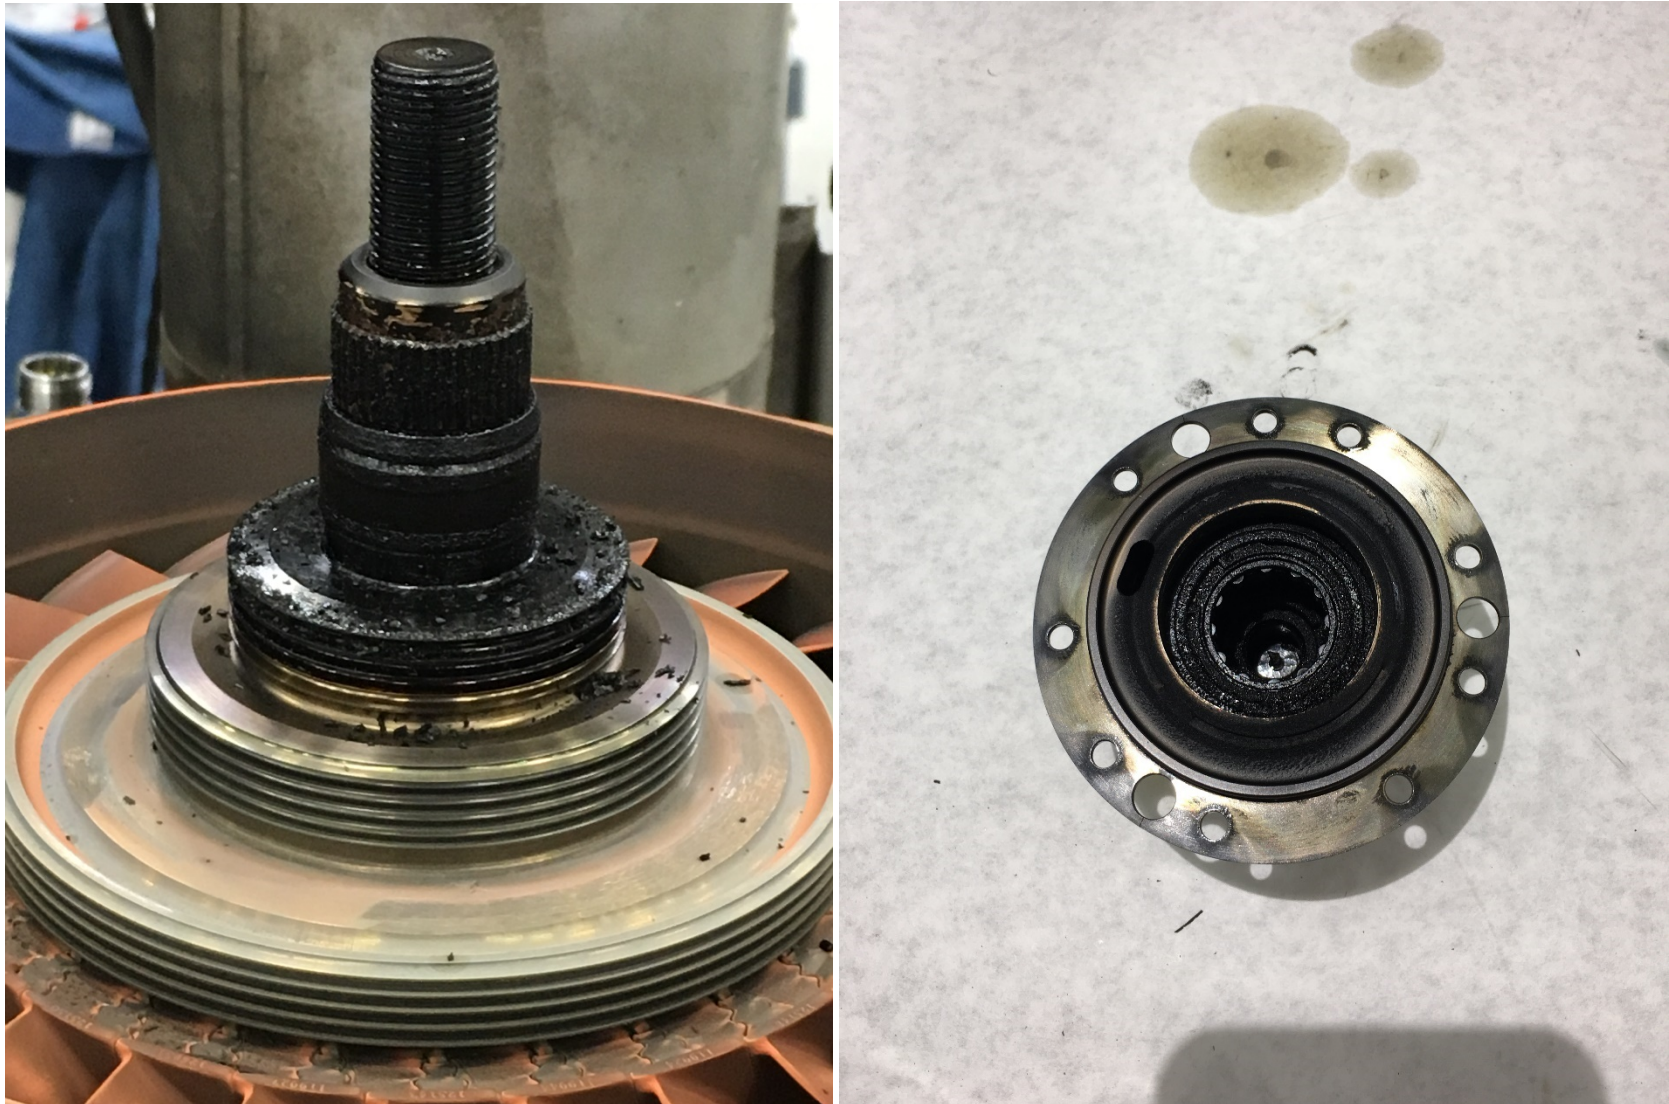
Figure 24/25 – No. 1 shaft with coking (L) and rear bearing in casing (R)

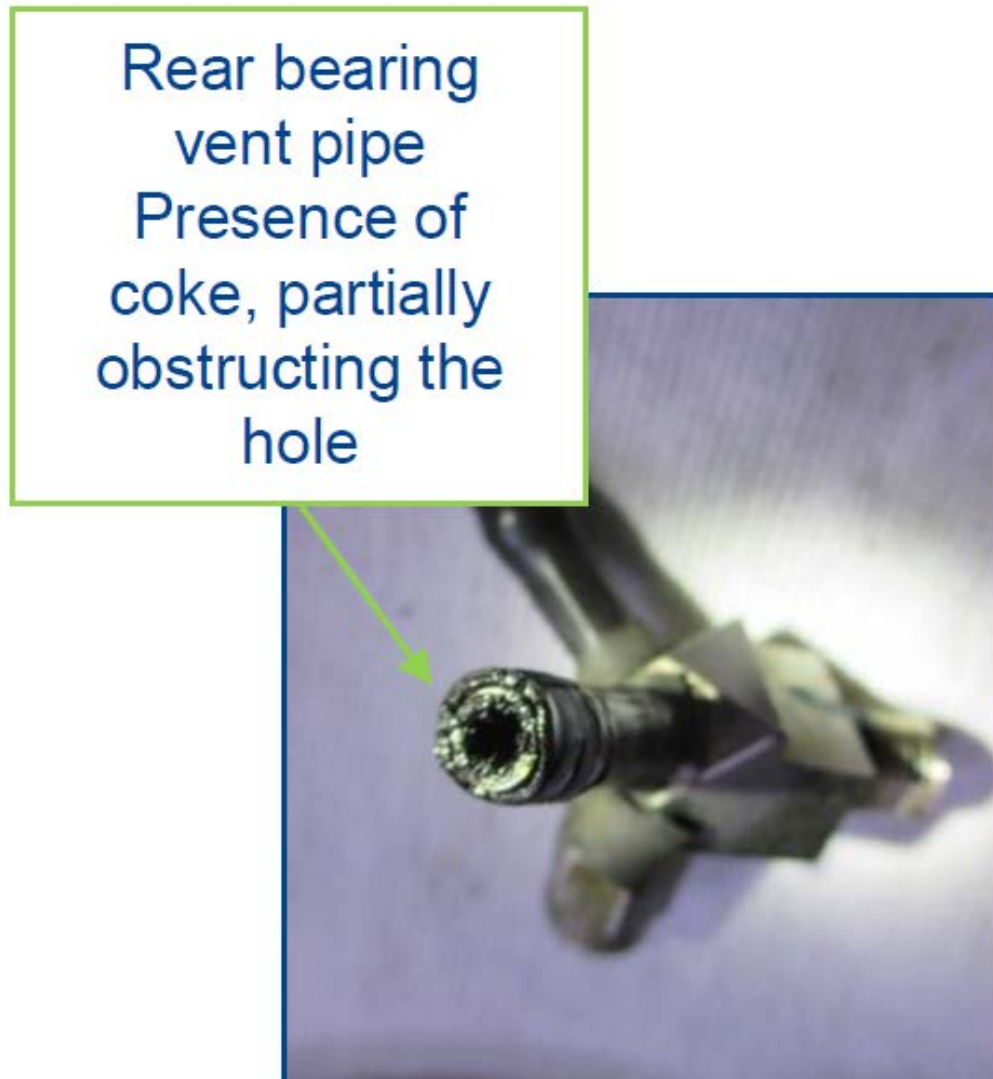
The No. 1 engine was utilized by the pilot during the OEI emergency procedures to return to the airport. The No. 1 Engine was not damaged during the incident but it was decided to examine the engine to look for any commonalities from the No. 2 engine examination. The examination of the No. 1 engine's rear bearing assembly showed it contained significant coking. The bearing was found covered with coke but otherwise in good condition and moved smoothly. The 3-way union was partially blocked with coke.

Figure 26 – No. 1 engine deck fitting / 3-way union, vent line orifice partially obstructed with coking
