# Serious Incident Investigation EC145 (BK117 C-2), N911MK S/N 9218

Christian BERNHARDT, Aviation Safety  
09 November 2017

## Part 1 – Considerations - Inflight Fire

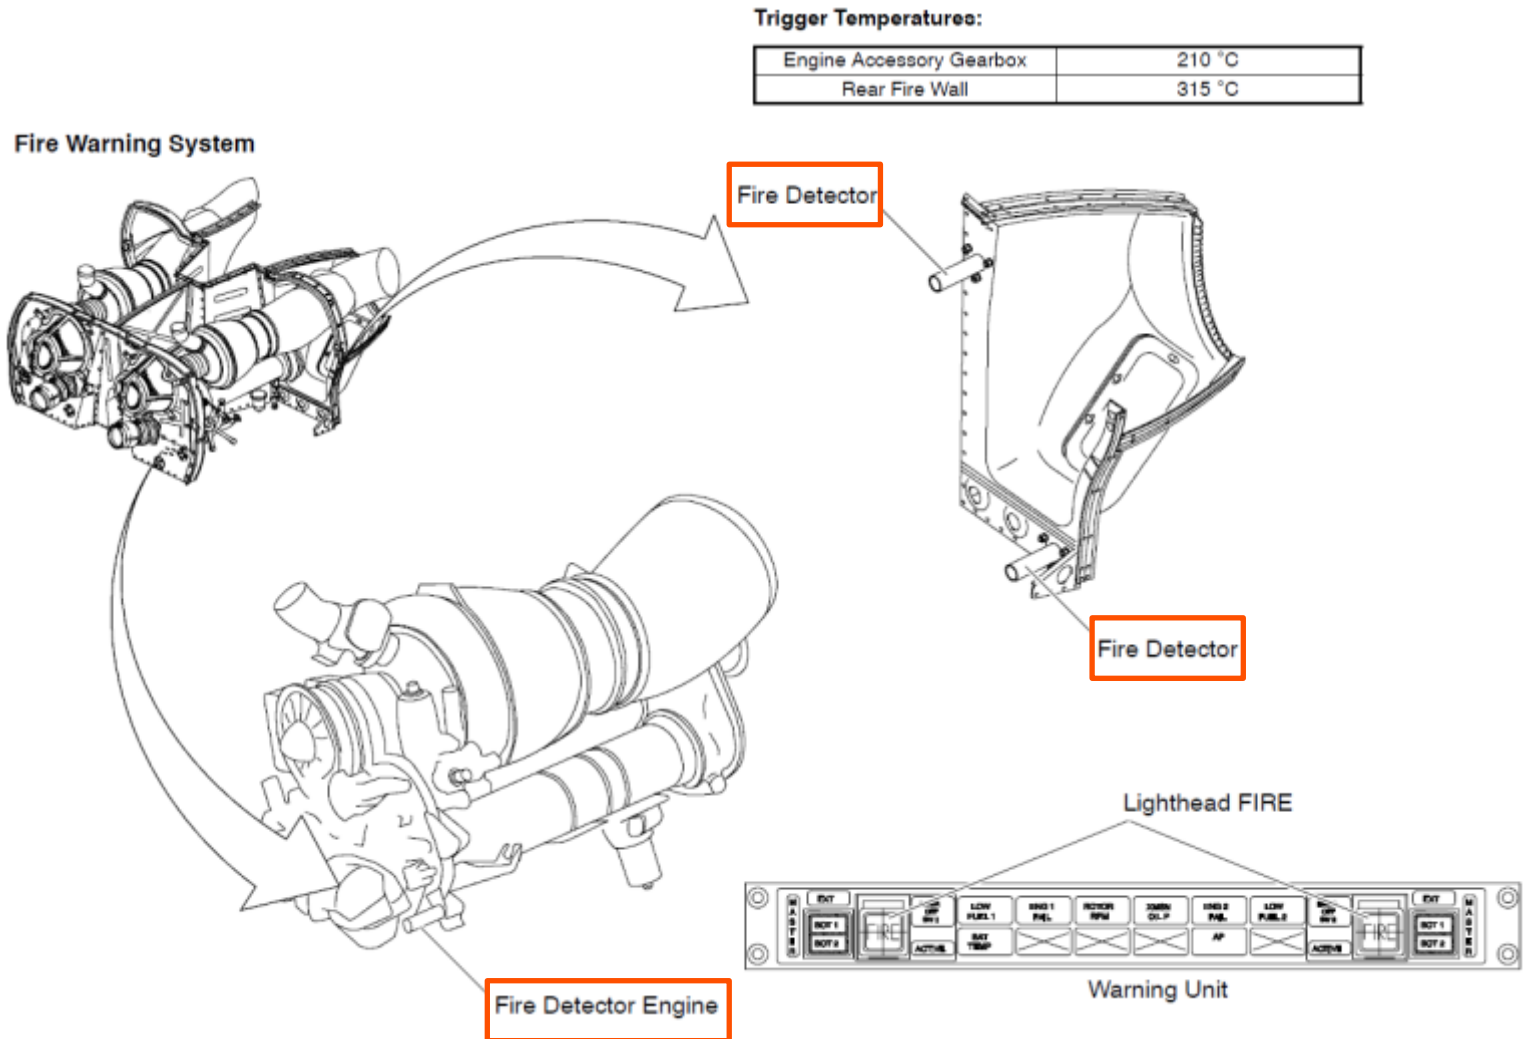
# Fire Detection System AC 29-2C

- The EC145 has 3 fire detectors for each engine.
- They are bi-metal type detectors that close an electrical circuit when they are exposed to heat.
- AC 29-2C: (4) The detector system should:
  - (i) Indicate fire within 15 seconds after ignition, and show which engine compartment in which the fire is located.

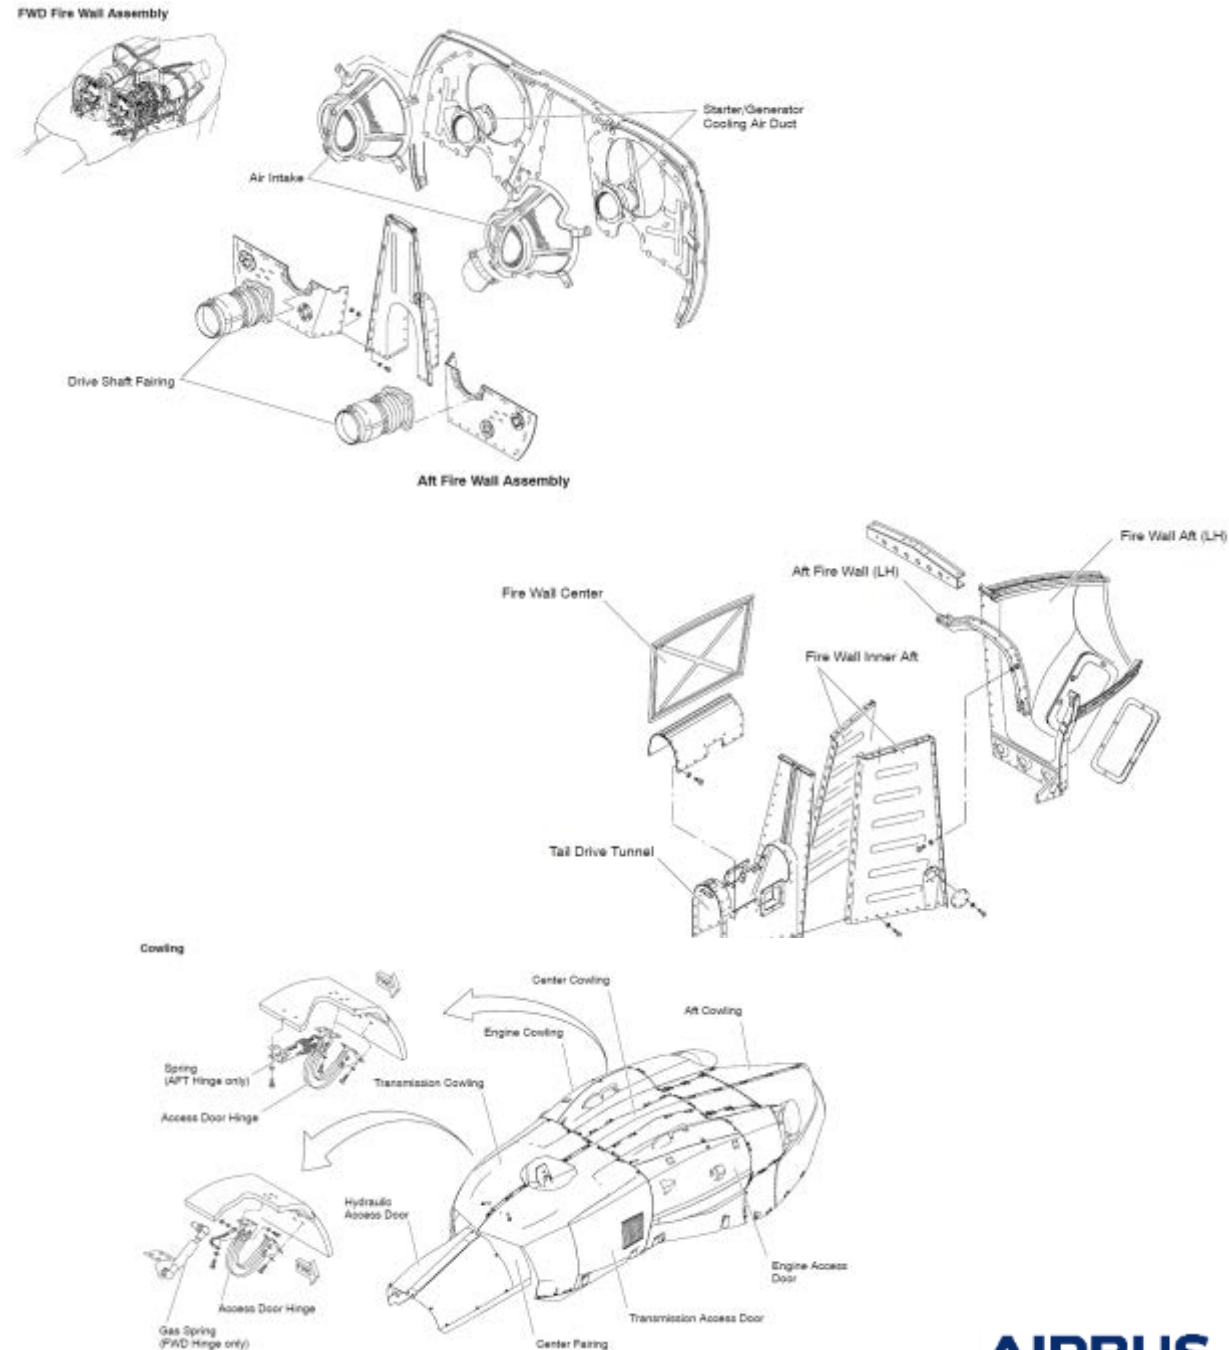
# Fire Containment AC 20-135

- Fire should be contained for 15 min
- The engine deck carries both engines. The deck is built from aluminium frames and stringers, the sheeting is made of titanium.
- Fire Walls are made of Titanium
- Required thickness for Titanium sheet as given in AC 20-135:

- The cowlings are made of Kevlar. The hot section of the cowlings interior is protected with fire retarding paint.
- Engine Cowling fire resistance was demonstrated by testing.

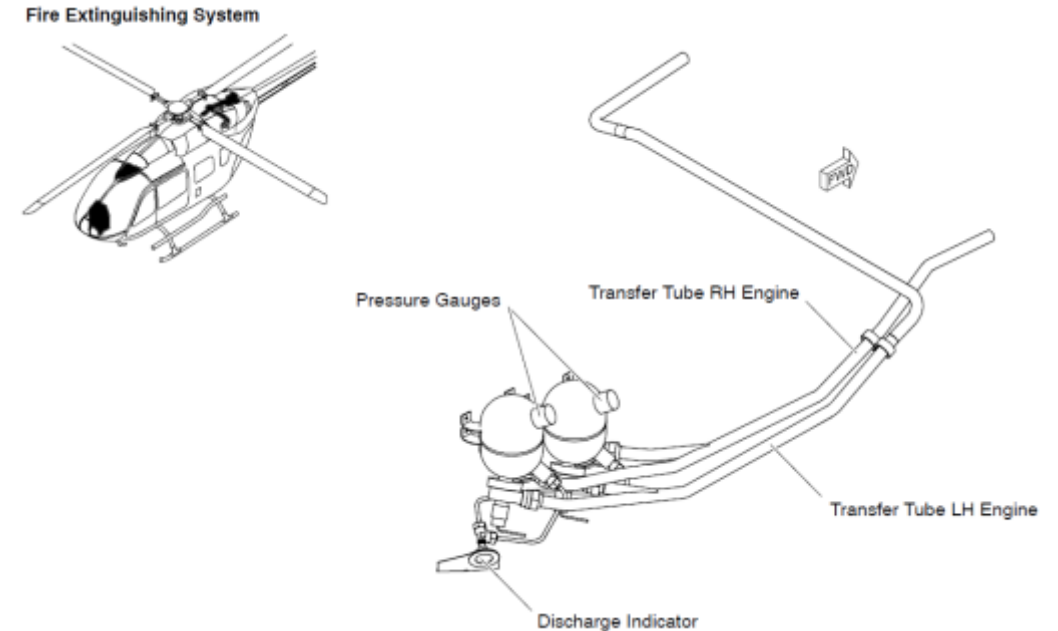
# Fire Extinguishing System AC 20-100

- The fire extinguishing system is a semi automatic system with a extinguishing logic, integrated into the warning unit. Two extinguishing bottles are installed to the right hand side of the aft deck. The bottles have two outlet ports each, guarded by explosive cartridges. From these outlet ports tubes are routed to the engine compartments.
- AC 20-100 gives a value of 6% volumetric concentration for Halon for 0,5 sec at all sampling points to extinguish a fire.
