**SAIB:** CE-17-16

**Date:** June 9, 2017

**SUBJ:** Main Landing Gear – Actuator Inspection

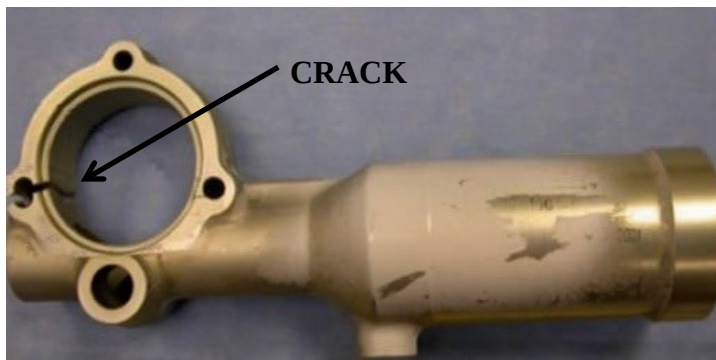
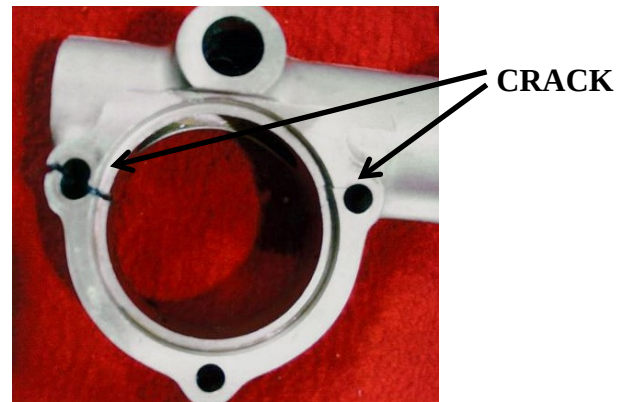
The FAA recently investigated an accident involving a Model 172RG airplane that had performed a gear up landing when the pilot was unsuccessful in getting the left main gear down and locked. During review of the landing gear system, investigators found the left main gear actuator (part number 9882015-2) housing cracked across the forward attach bolt hole. The crack allowed the actuator bore to open enough such that the piston would not engage the landing gear pivot sector sufficiently to move the gear. This failure will result in the affected side not being able to fully retract or extend through normal method or prevent use of the emergency hand pump.

Figures 1 and 2 reflect two actuators with the crack location most commonly noted that contributes to the gear malfunction.

The FAA recommends performing the inspections detailed in Textron SID 32-10-01 appropriate for the applicable airplane model. These inspections incorporate a combination of visual, fluorescent penetrant, and eddy current depending on the airplane model.

Initial inspection of the actuator is recommended at 3,000 hours time-in-service (TIS) or 10 years of age, whichever occurs first, for all models except the 210/T210 series airplanes produced from 1962 to 1968. Repetitive inspections are recommended every 500 hours (TIS) or 5 years, whichever occurs first.

Initial inspection of the actuator is recommended at 6,000 hours (TIS) or 10 years of age, whichever occurs first, for 210/T210 series airplanes produced from 1962 to 1968 with repetitive inspections at 1,000 hours TIS or 3 years, whichever occurs first.

Additionally, an inspection is recommended following any unplanned event such as a hard landing to ensure cracks have not developed.
