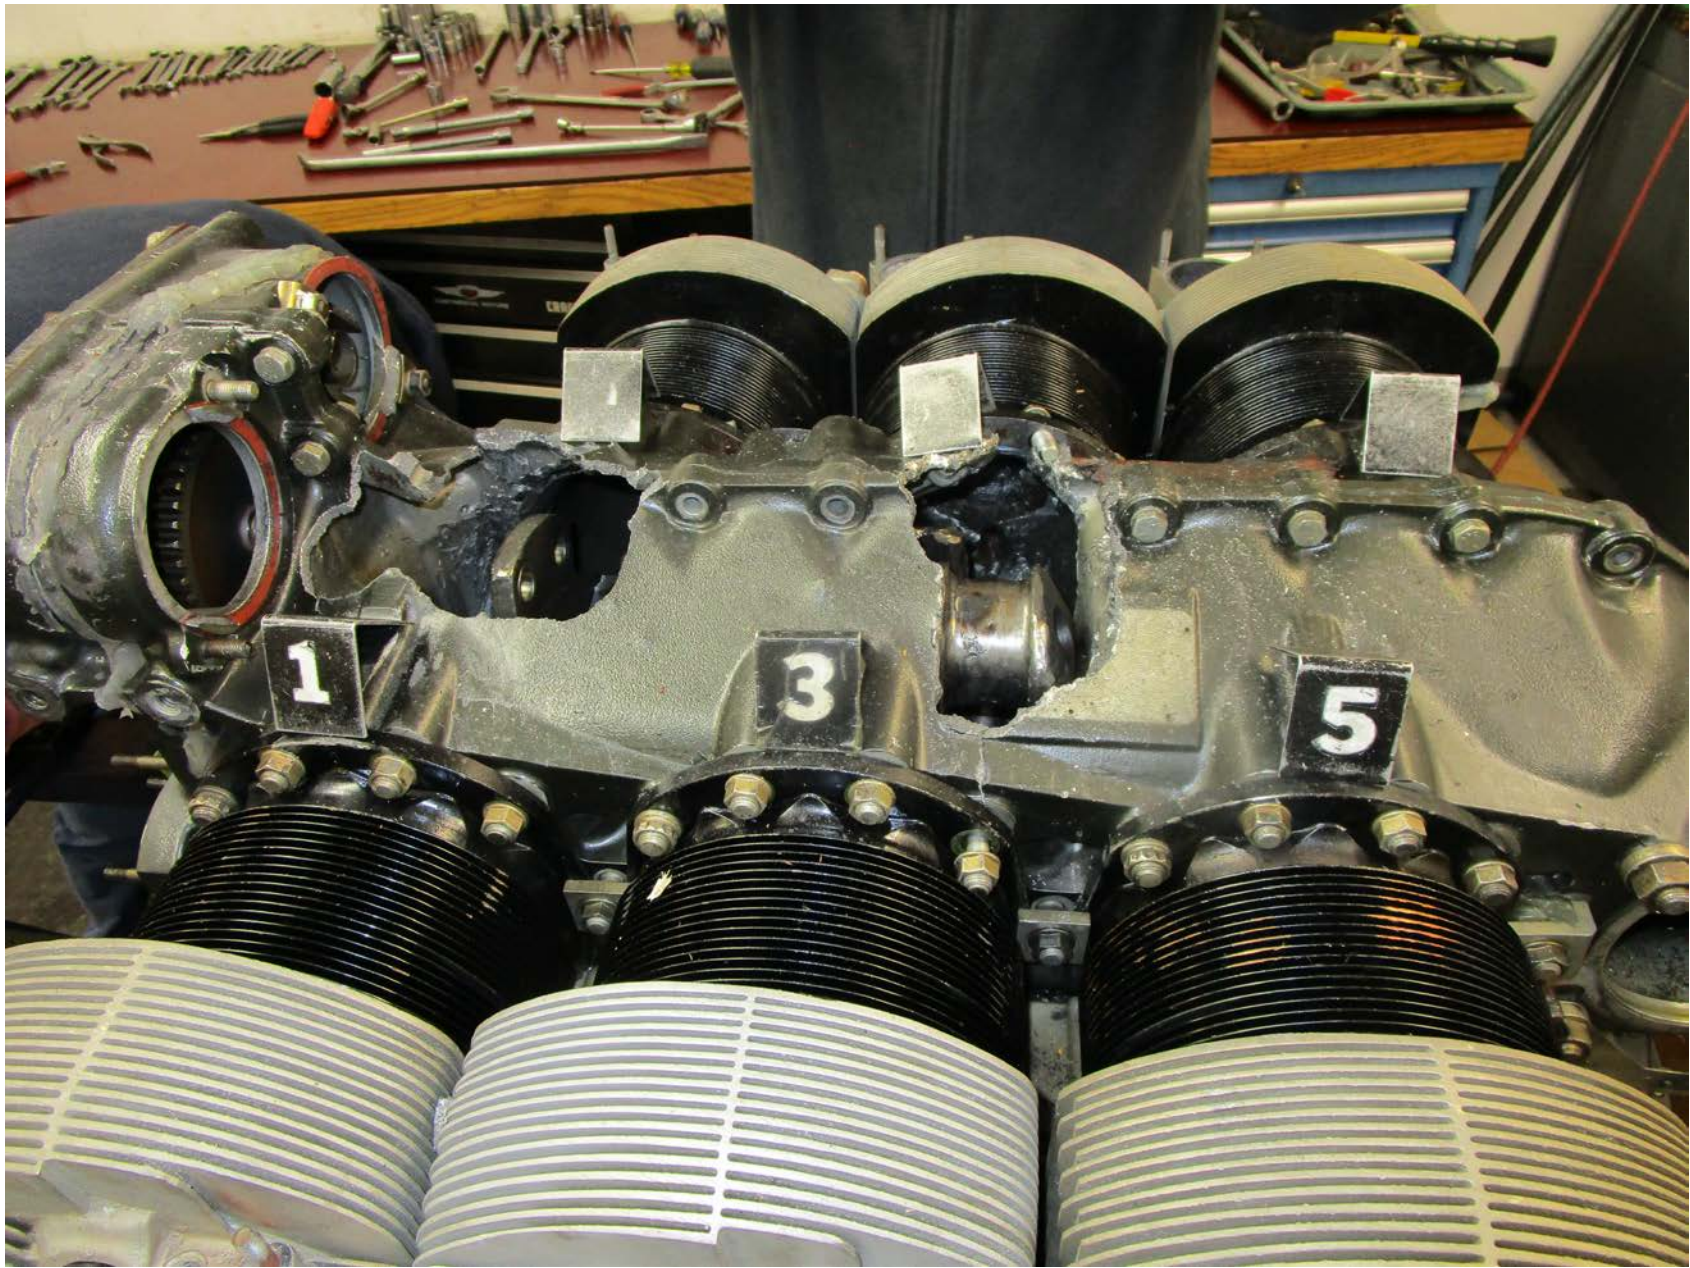
**Photo 1 – Engine with multiple breaches in crankcase**

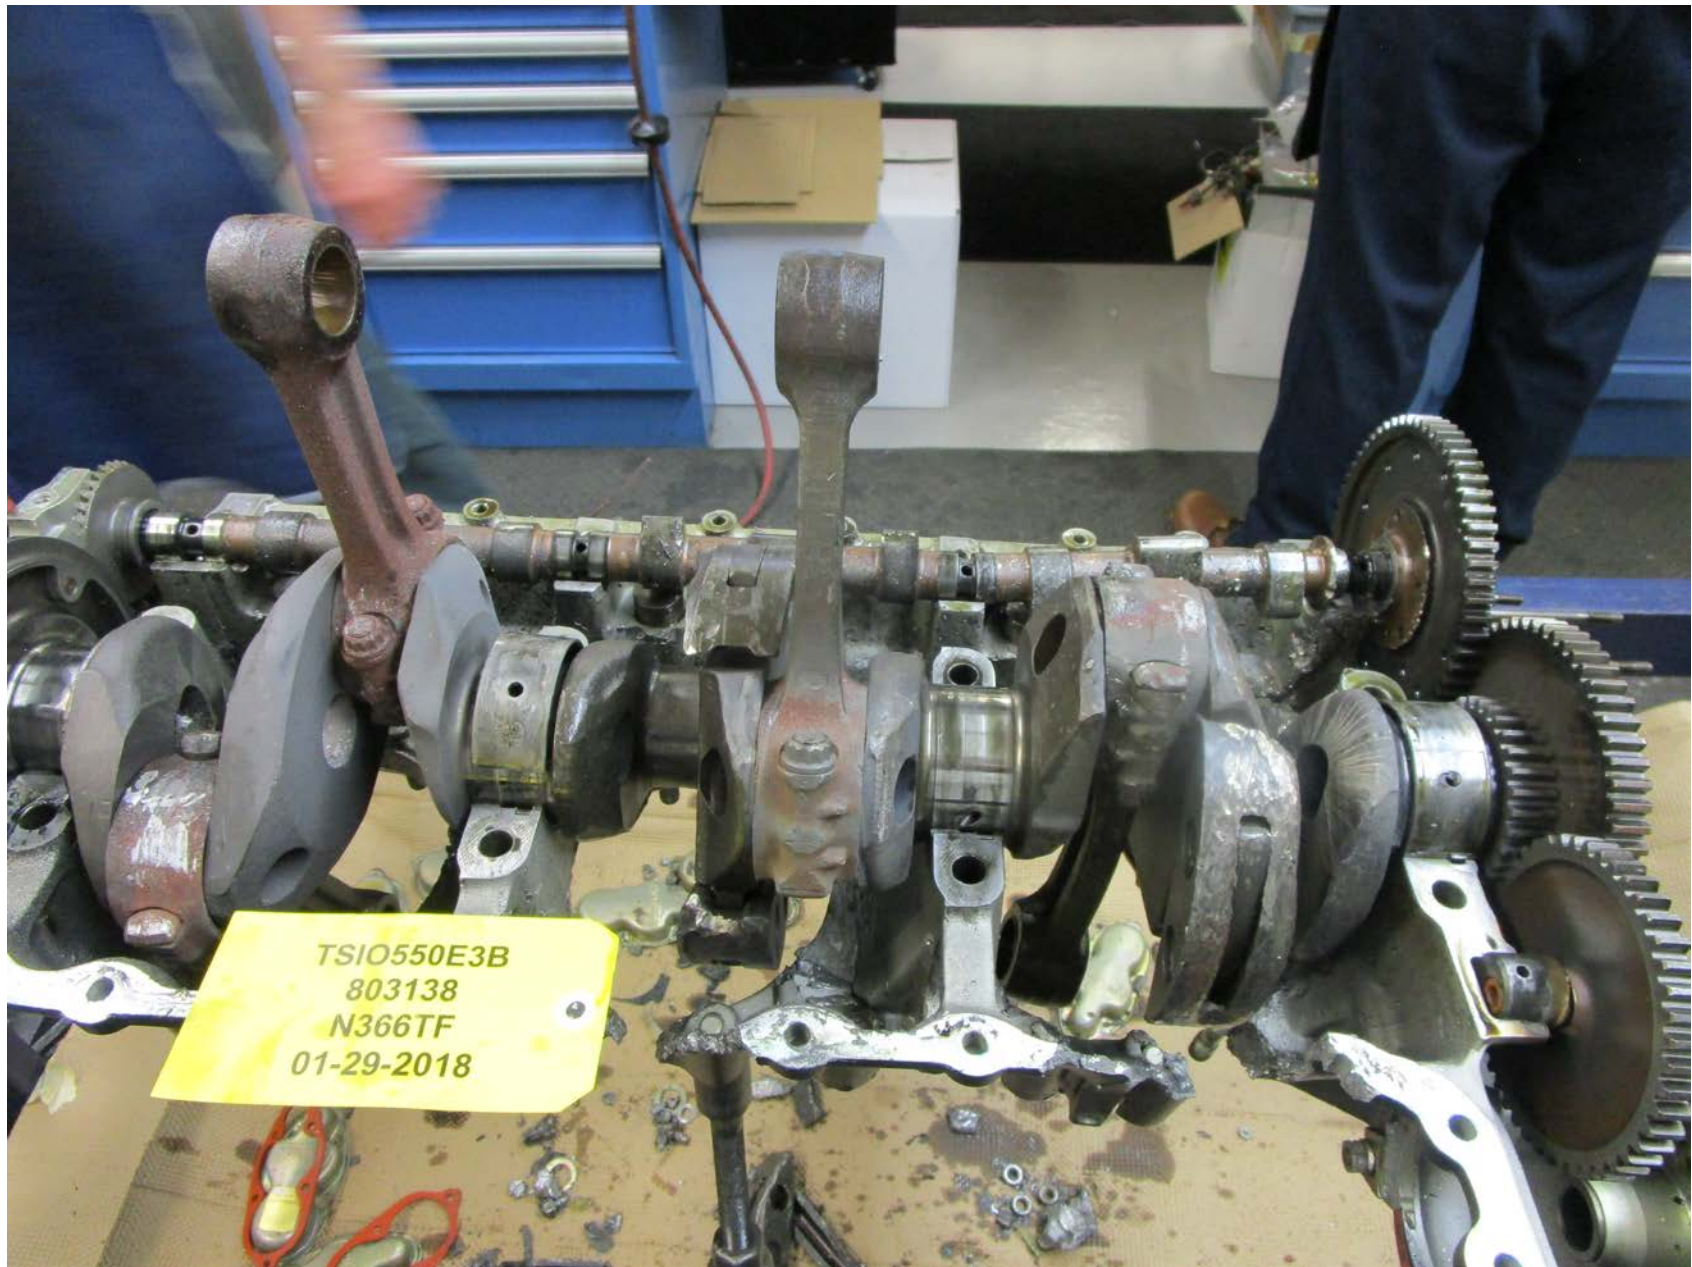
**Photo 2 – Crankshaft with discolored connecting rods and bearings**

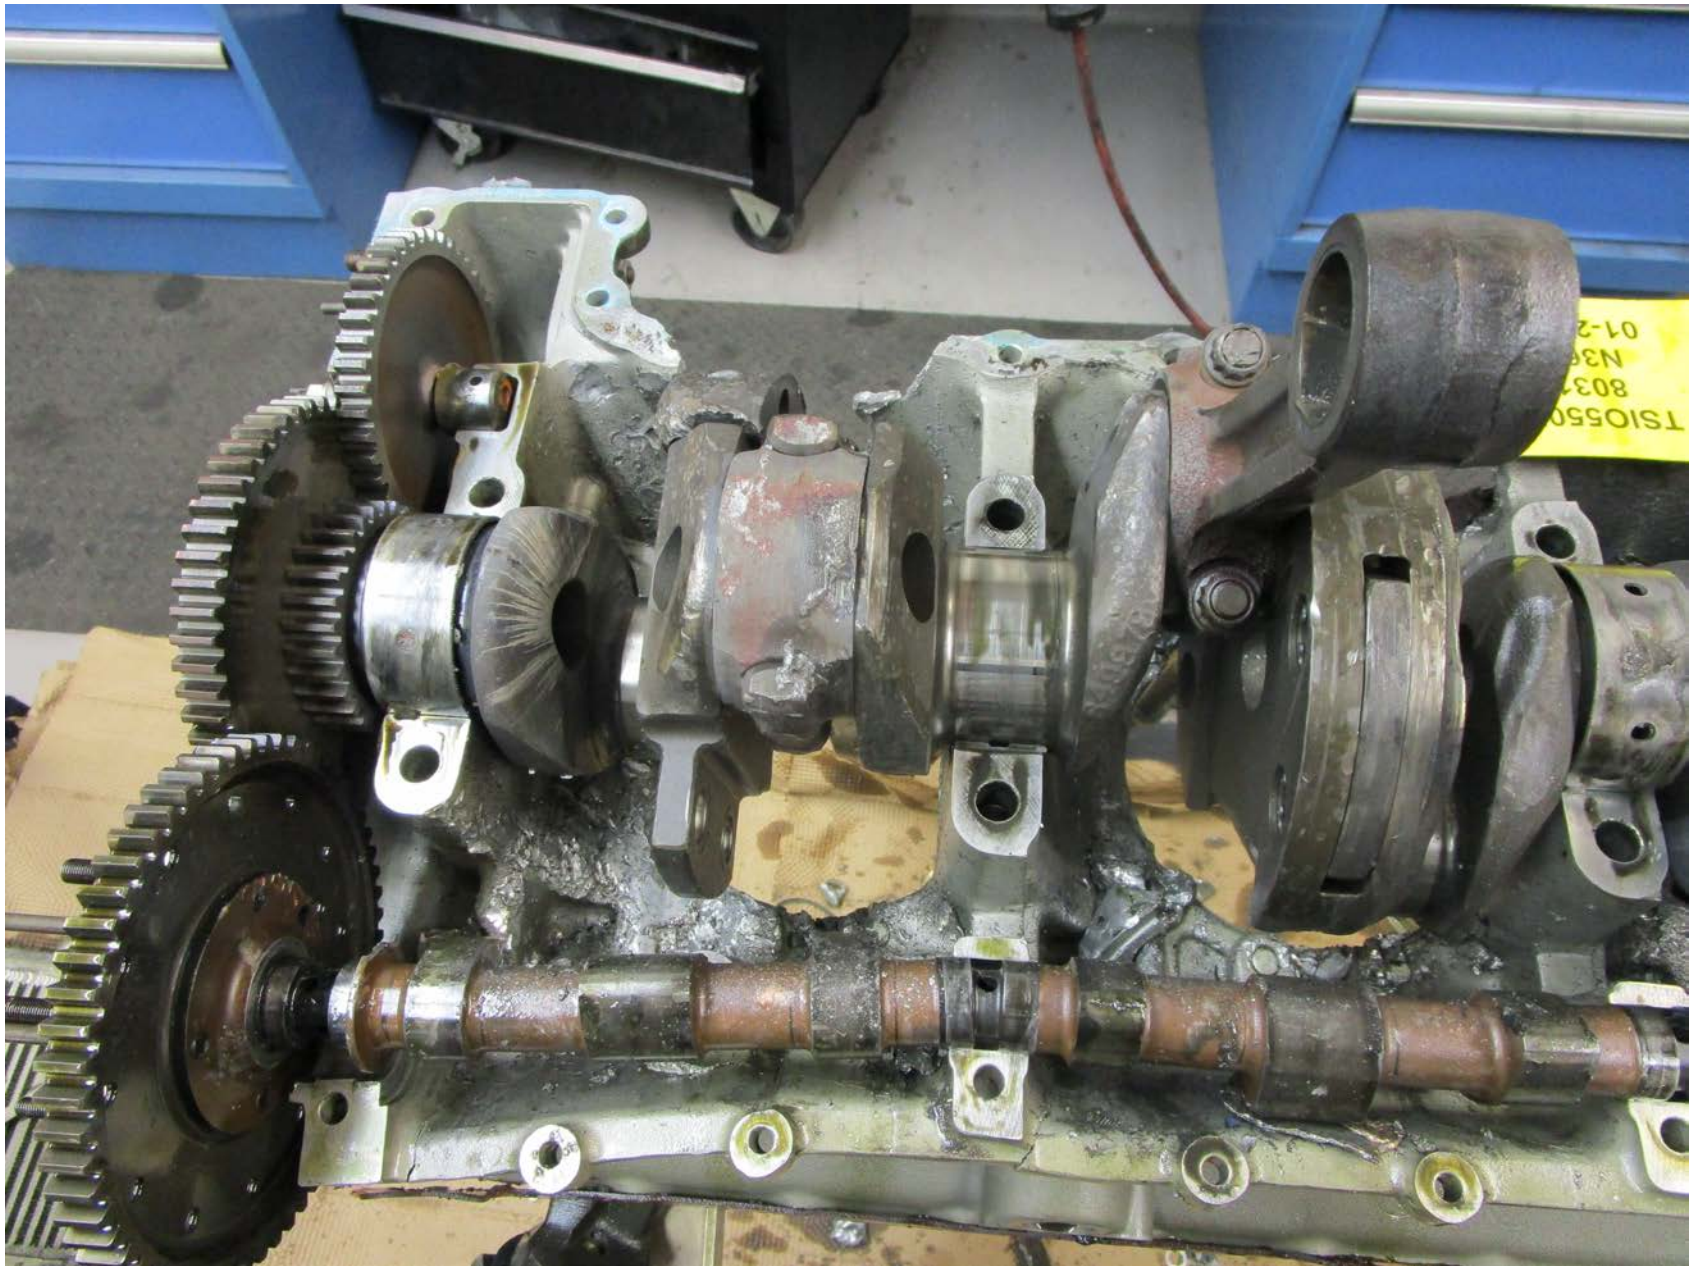
**Photo 3 – Camshaft displaced from crankshaft**

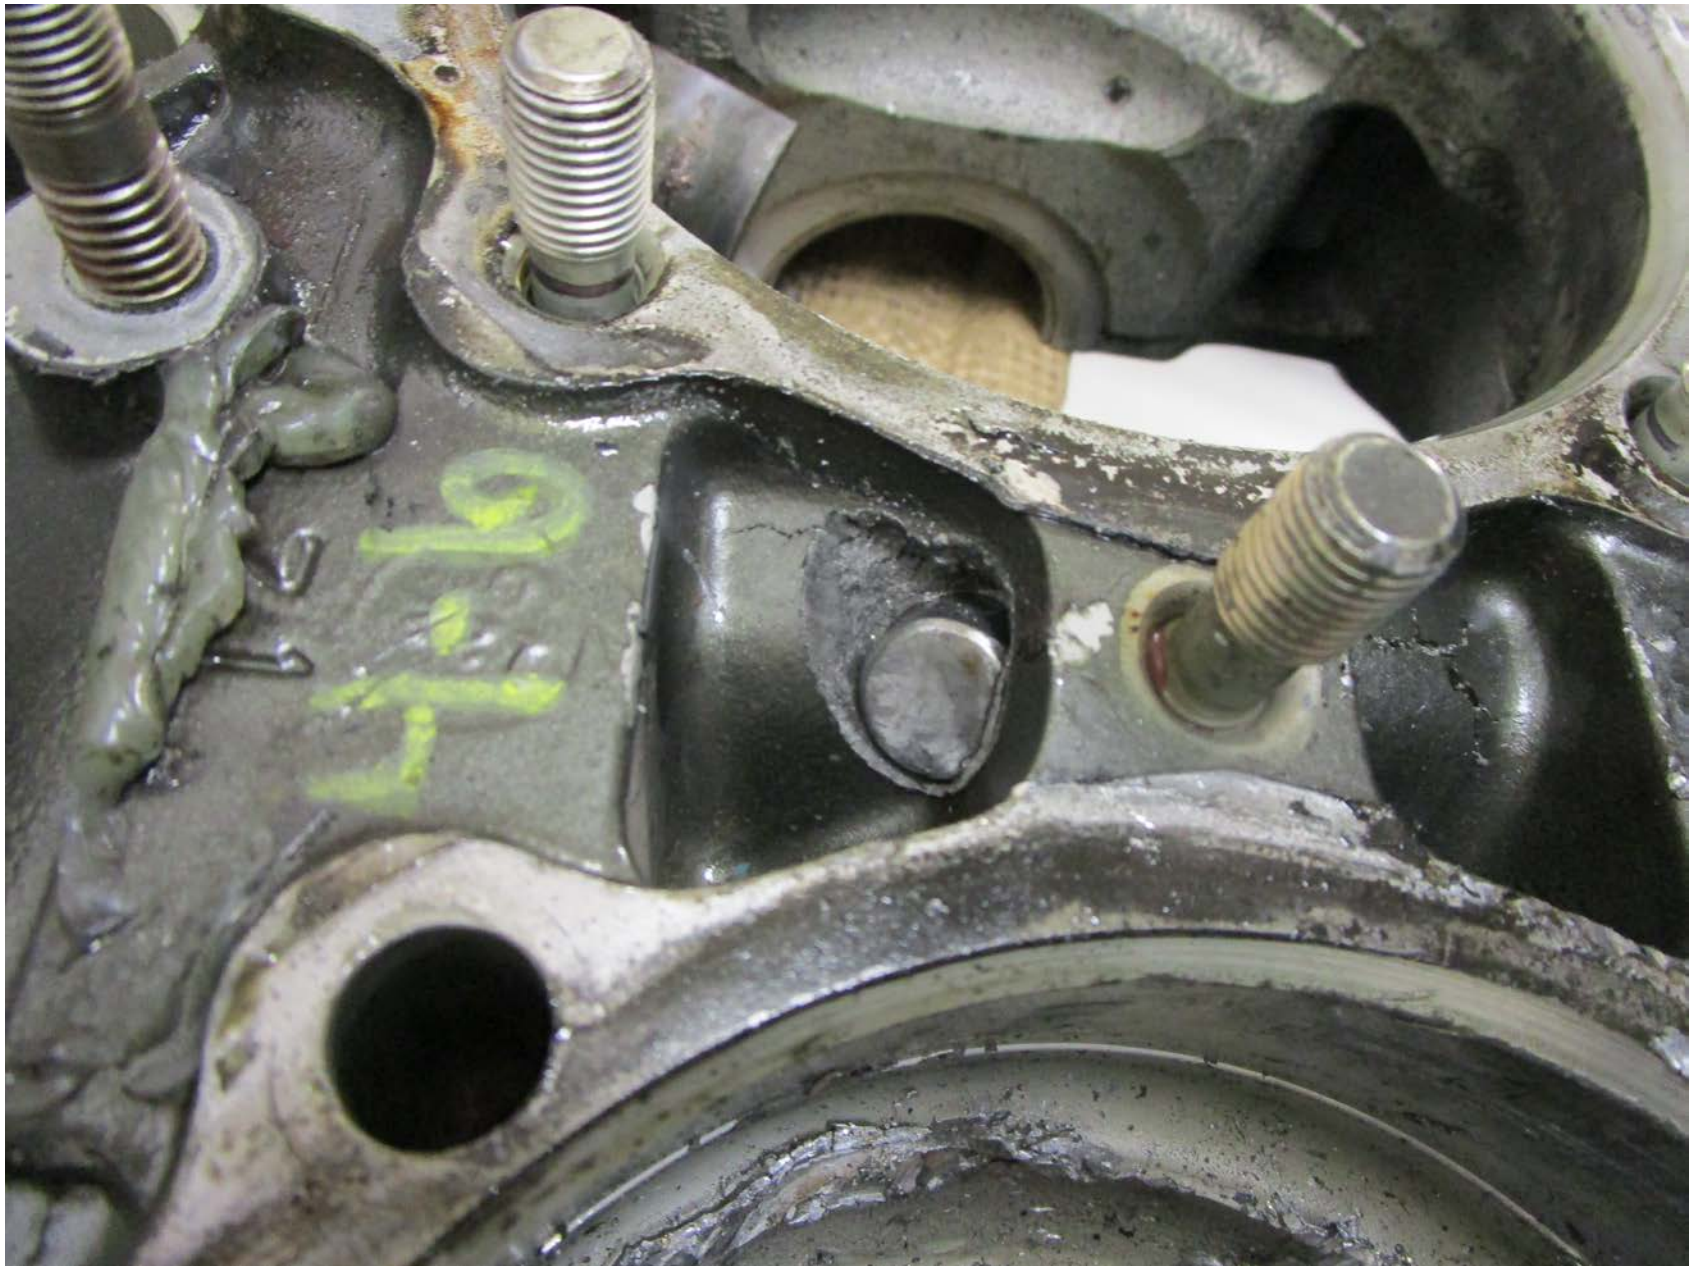
**Photo 4 - 6th order counterweight connecting pin lodged in crankcase**

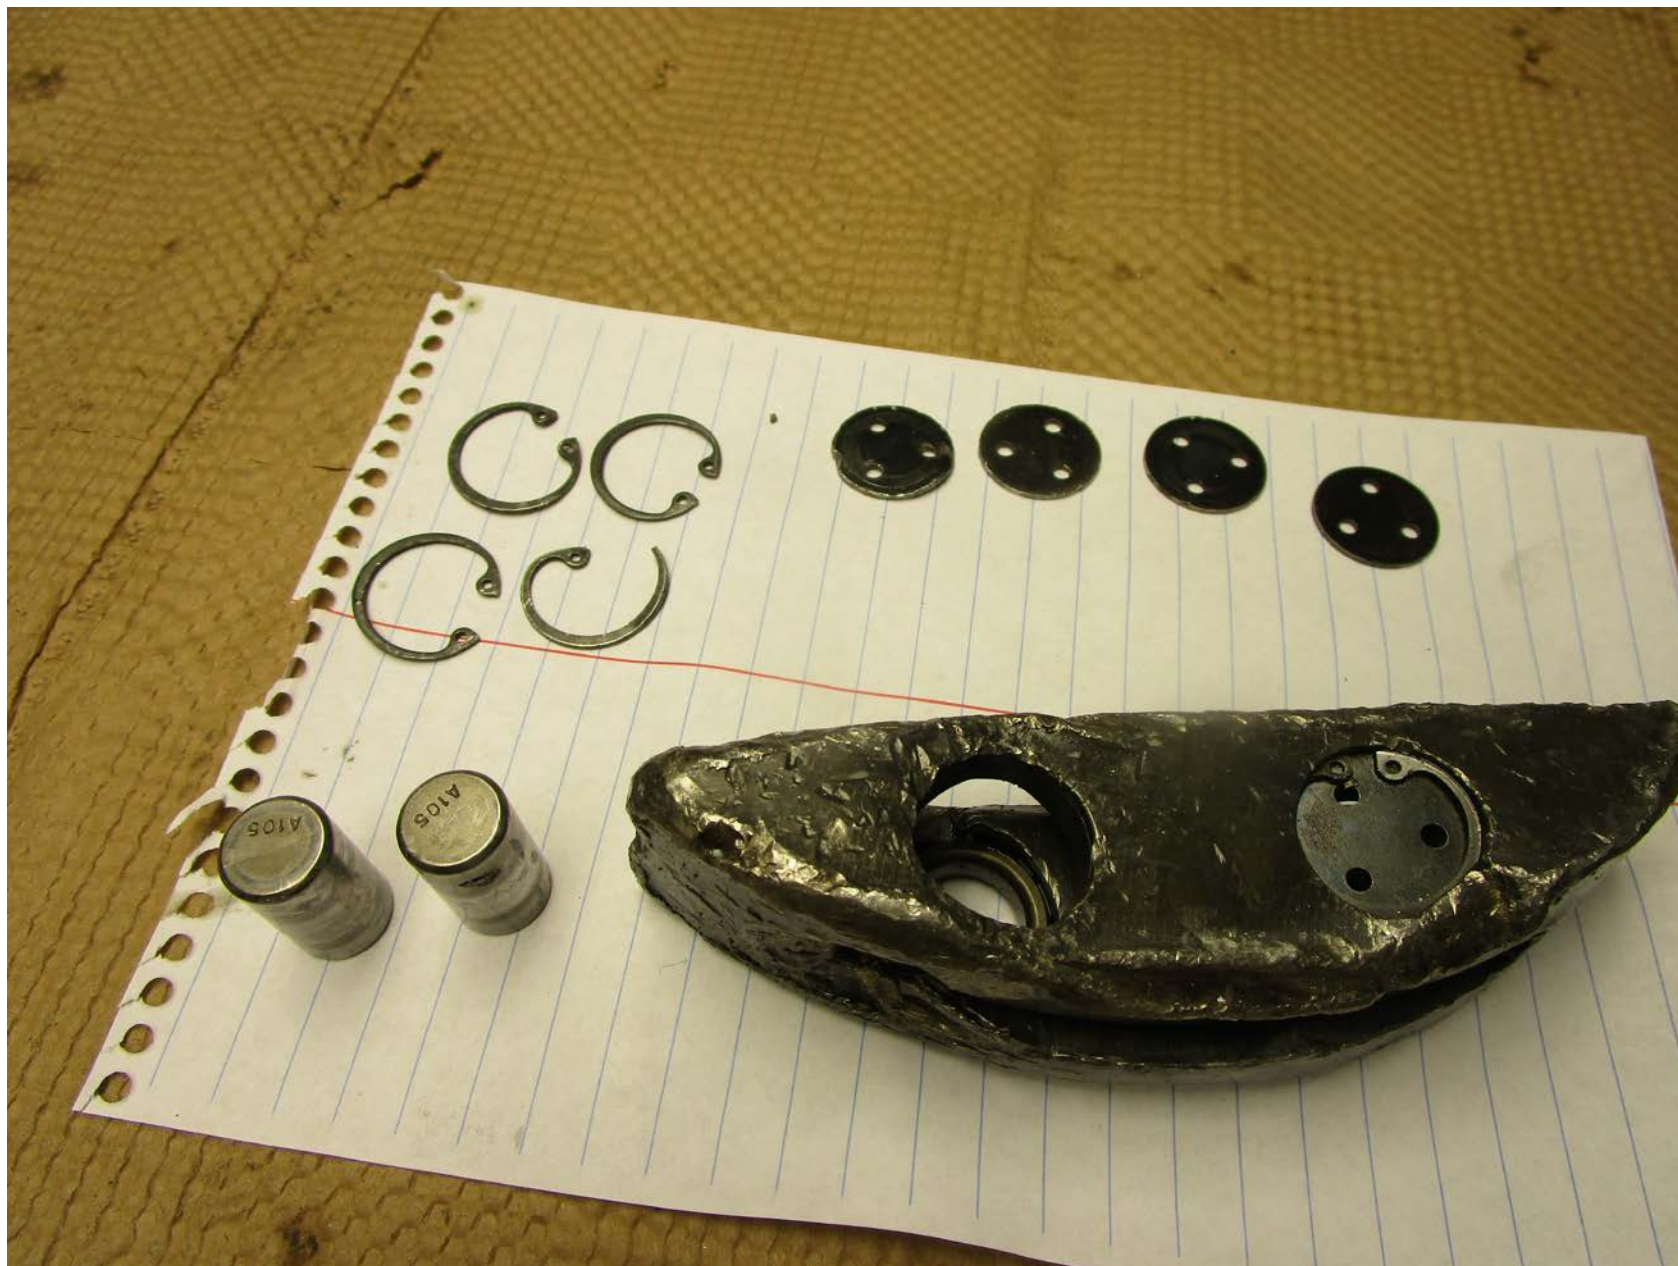
**Photo 5 – 6th order counterweight and debris from oil pan**
