## **NATIONAL TRANSPORTATION SAFETY BOARD**

# **MAGNETO EXAMINATION**

**CEN17LA015**

Location: Select Aircraft Services, (KLNC) Lancaster, Texas  
Date: June 1, 2017  
Aircraft: N/A  
NTSB IIC: Jennifer Rodi

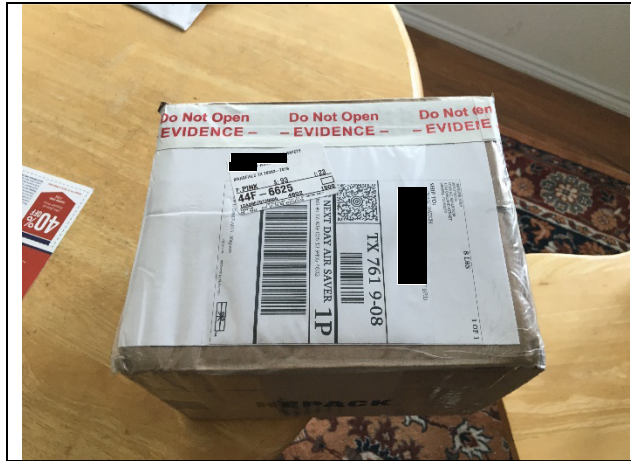
Magneto Shipment

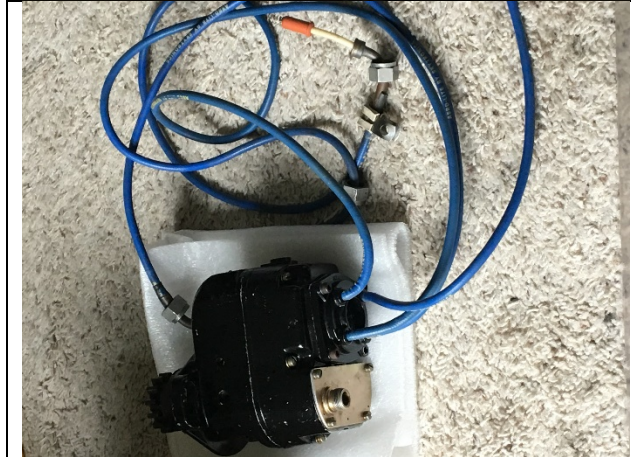
The wire harness was reconnected to the magneto, the wire terminals were noted as being long; however, the terminal cover was screwed back in place. The magneto was then placed in the test machine, and brought to operating speed. Each of the four-ignition leads produced “spark” however, at times the spark would skip or miss intermittently.

Magneto and wire harness

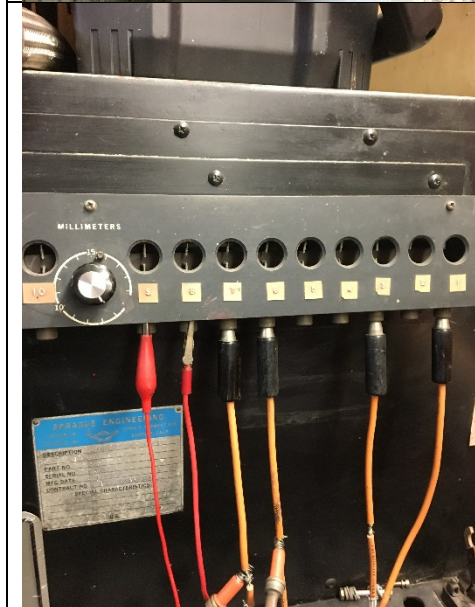
Magneto wire harness, connected to test machine

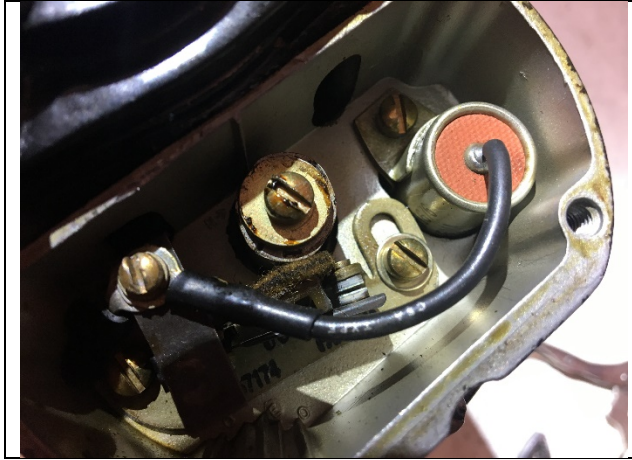
The magneto was removed from the test machine and the access plate removed to allow access to the points and capacitor. Electrical connections appeared tight; a visual inspection of the points noted that they were greyish in color. The technician noted that this is consistent with the capacitor failing. He also stated that the capacitor might test good, however, it could also fail once the magneto (engine) got hot during normal engine operation.

Inside magneto: note greyish coloring on points
