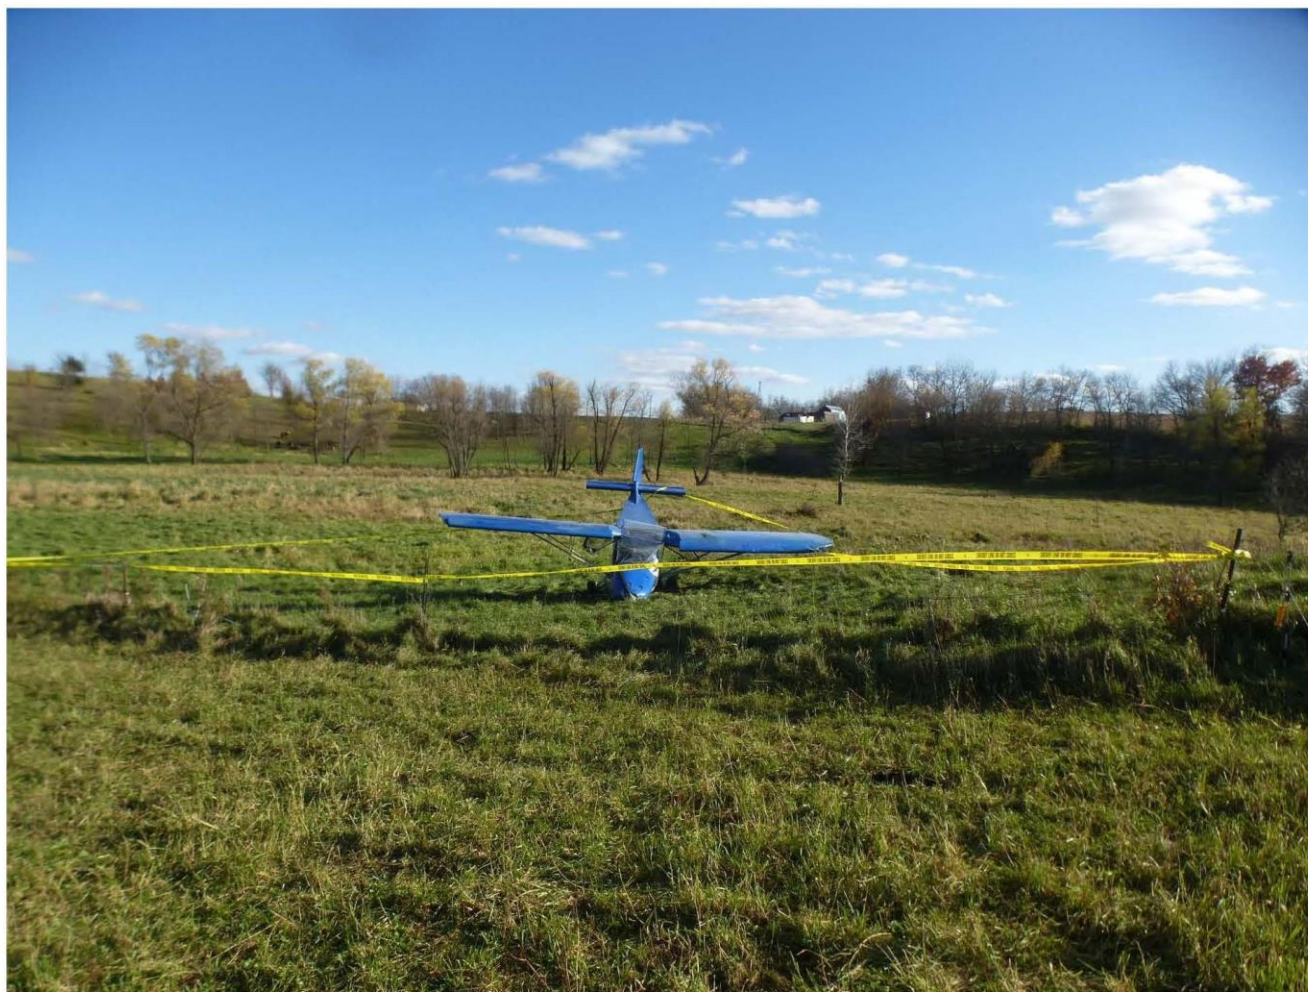
**Photo 1 – Front view of N8681 at the accident site.**

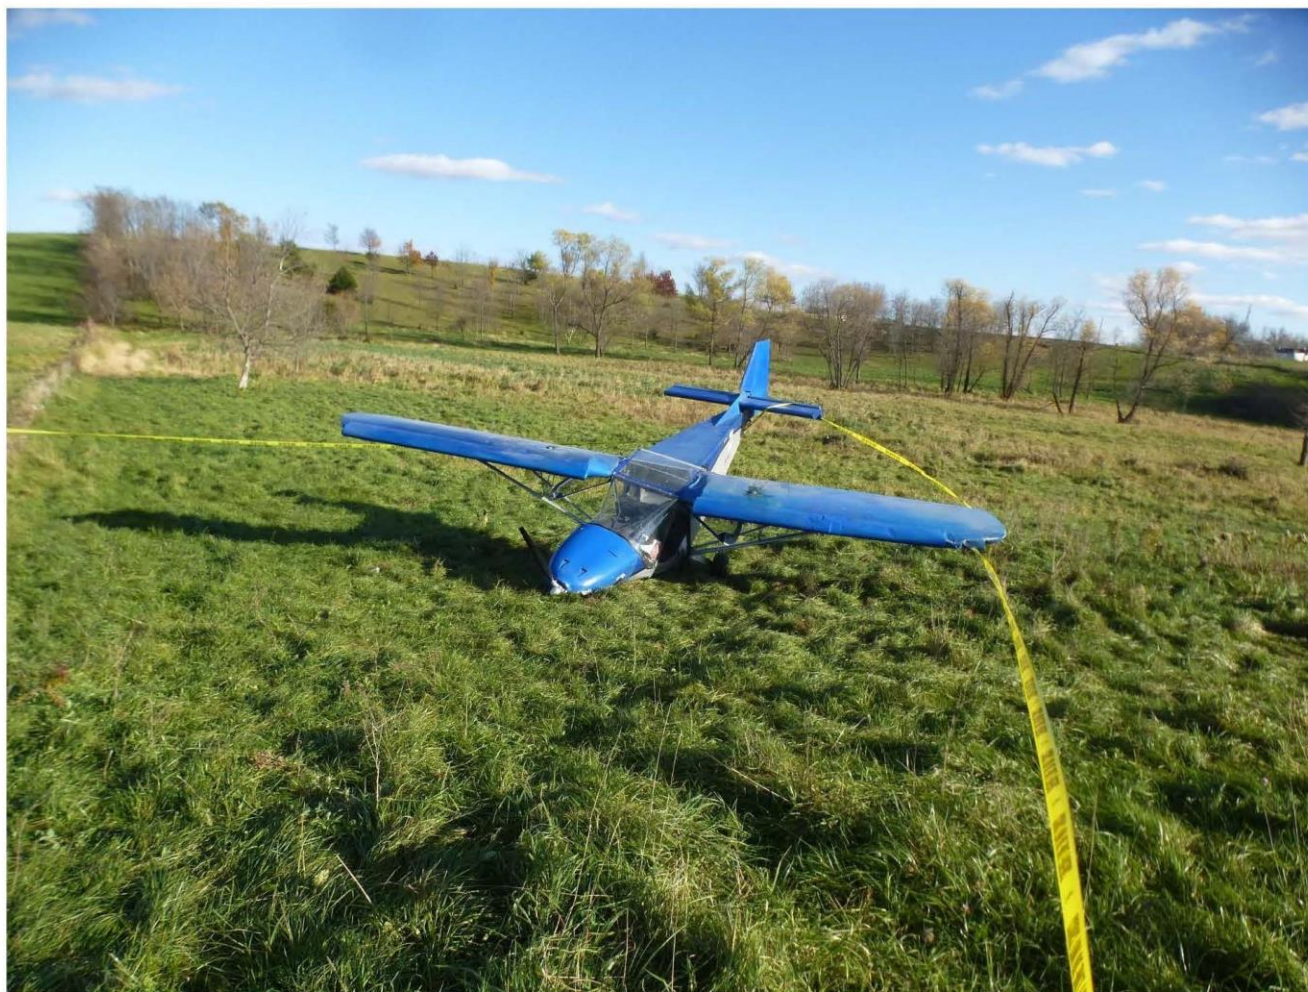
**Photo 2 – Left front view of N8681. Note the drag marks through the grass.**

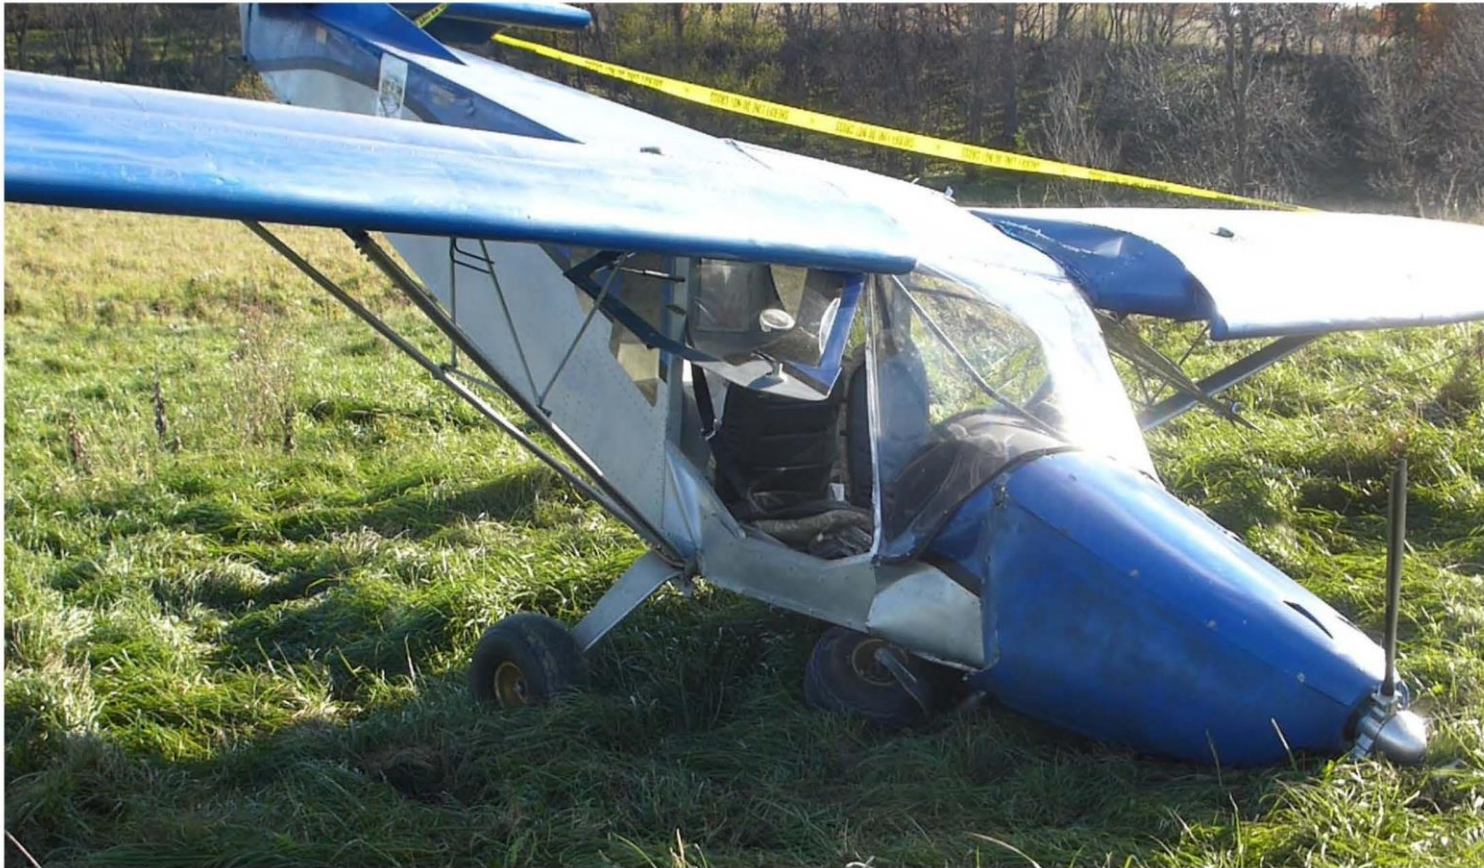
**Photo 3 – Right front view of N8681, showing collapsed nose gear and buckled forward section.**

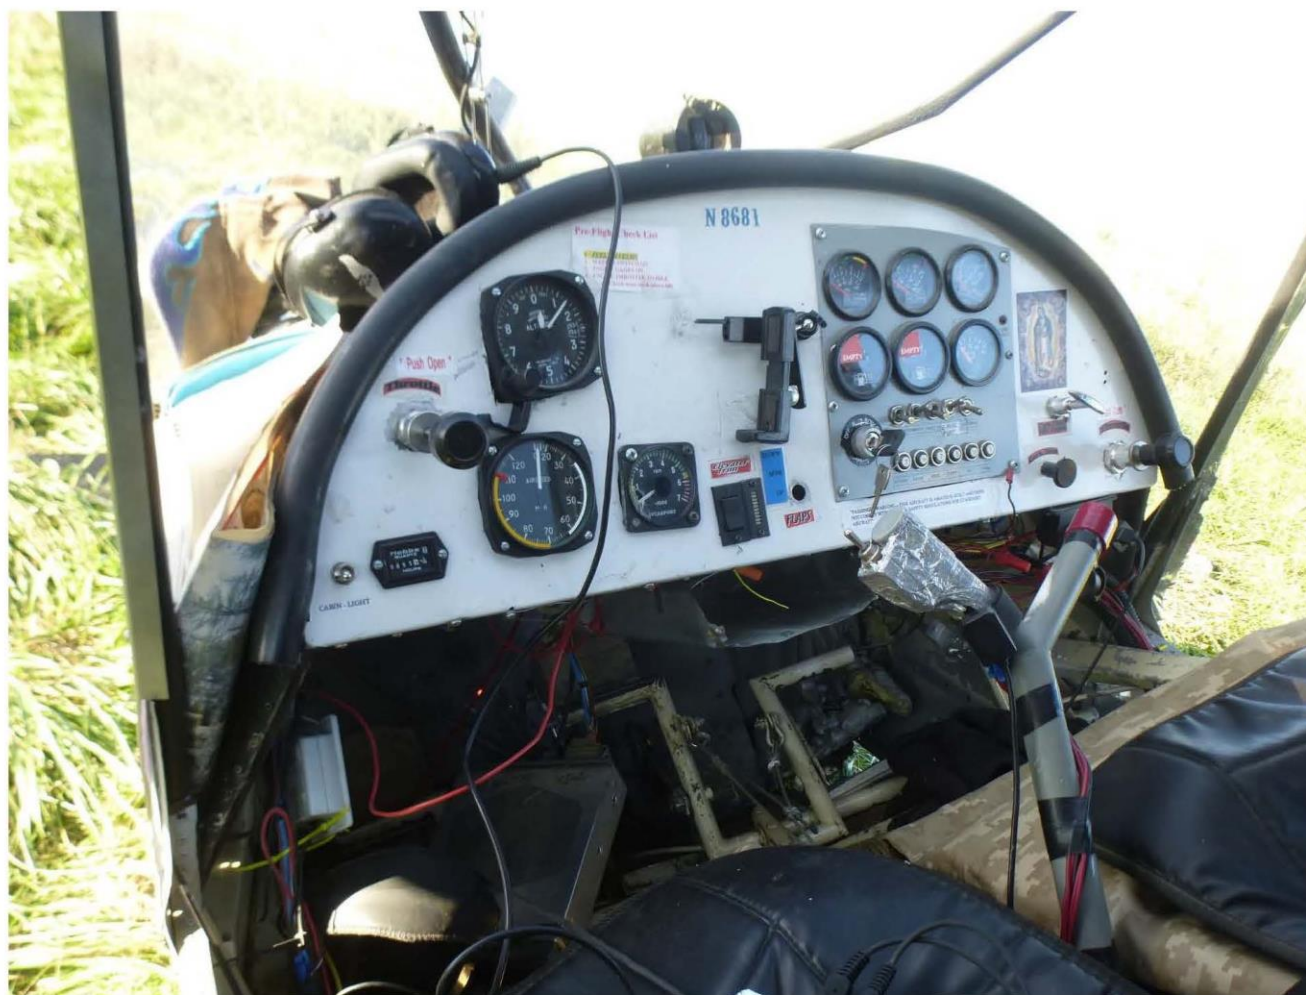
**Photo 4 – The cockpit. Note fuel pump is ON, throttle is FULL FORWARD, carburetor heat is COLD, magnetos are on BOTH, Hobbs meter indicates 0655.1 altimeter reads 140 feet, and Kollsman window is set to 29.36" Hg.**

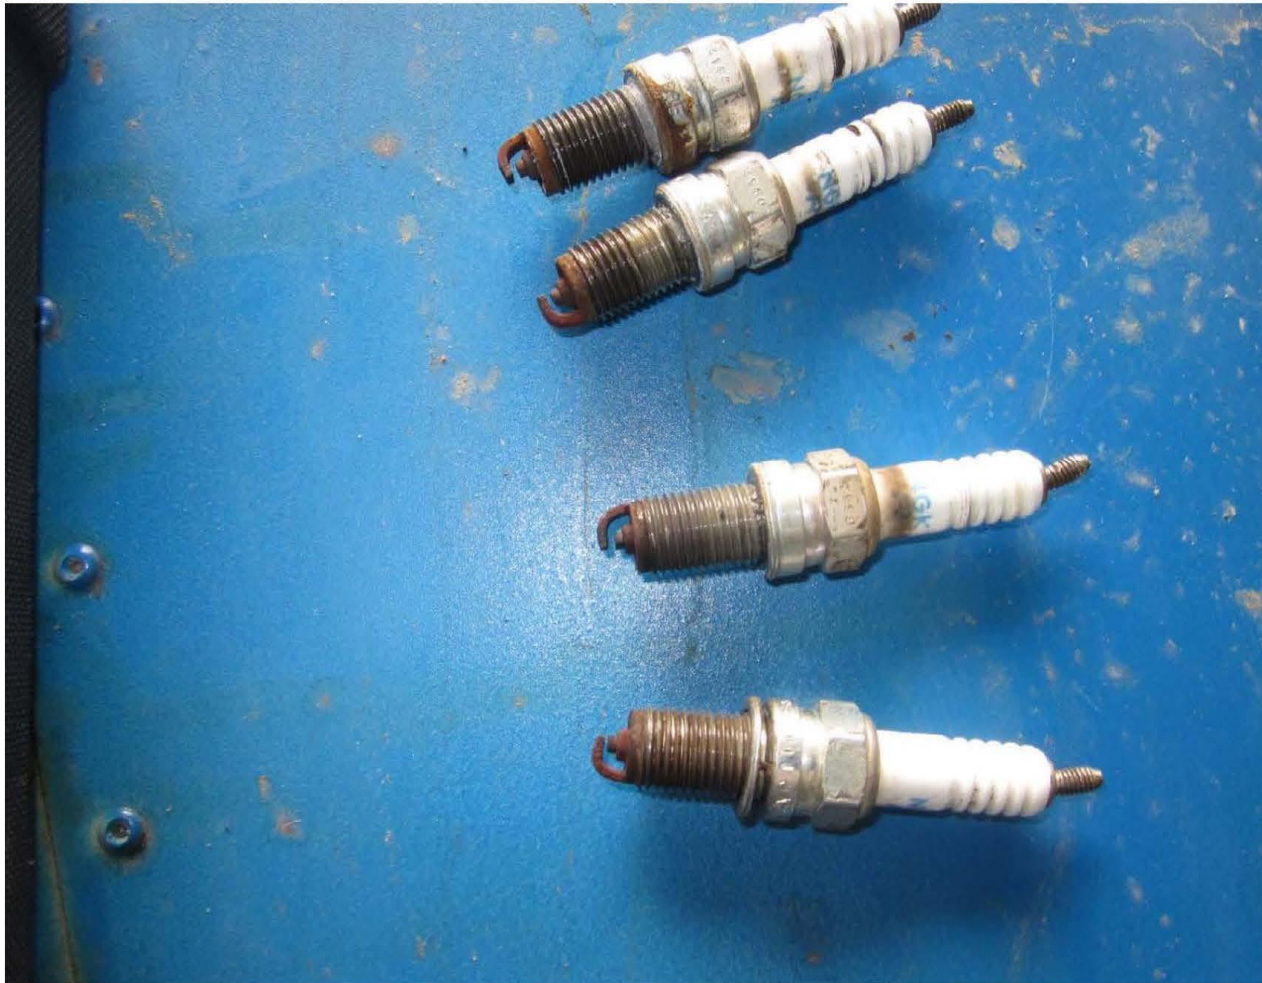
**Photo 5 – Top spark plugs after removal. The plugs are old and the electrodes are corroded. The number 1 spark plug has a narrow gap, and the number 3 spark plug has a wide gap.**
