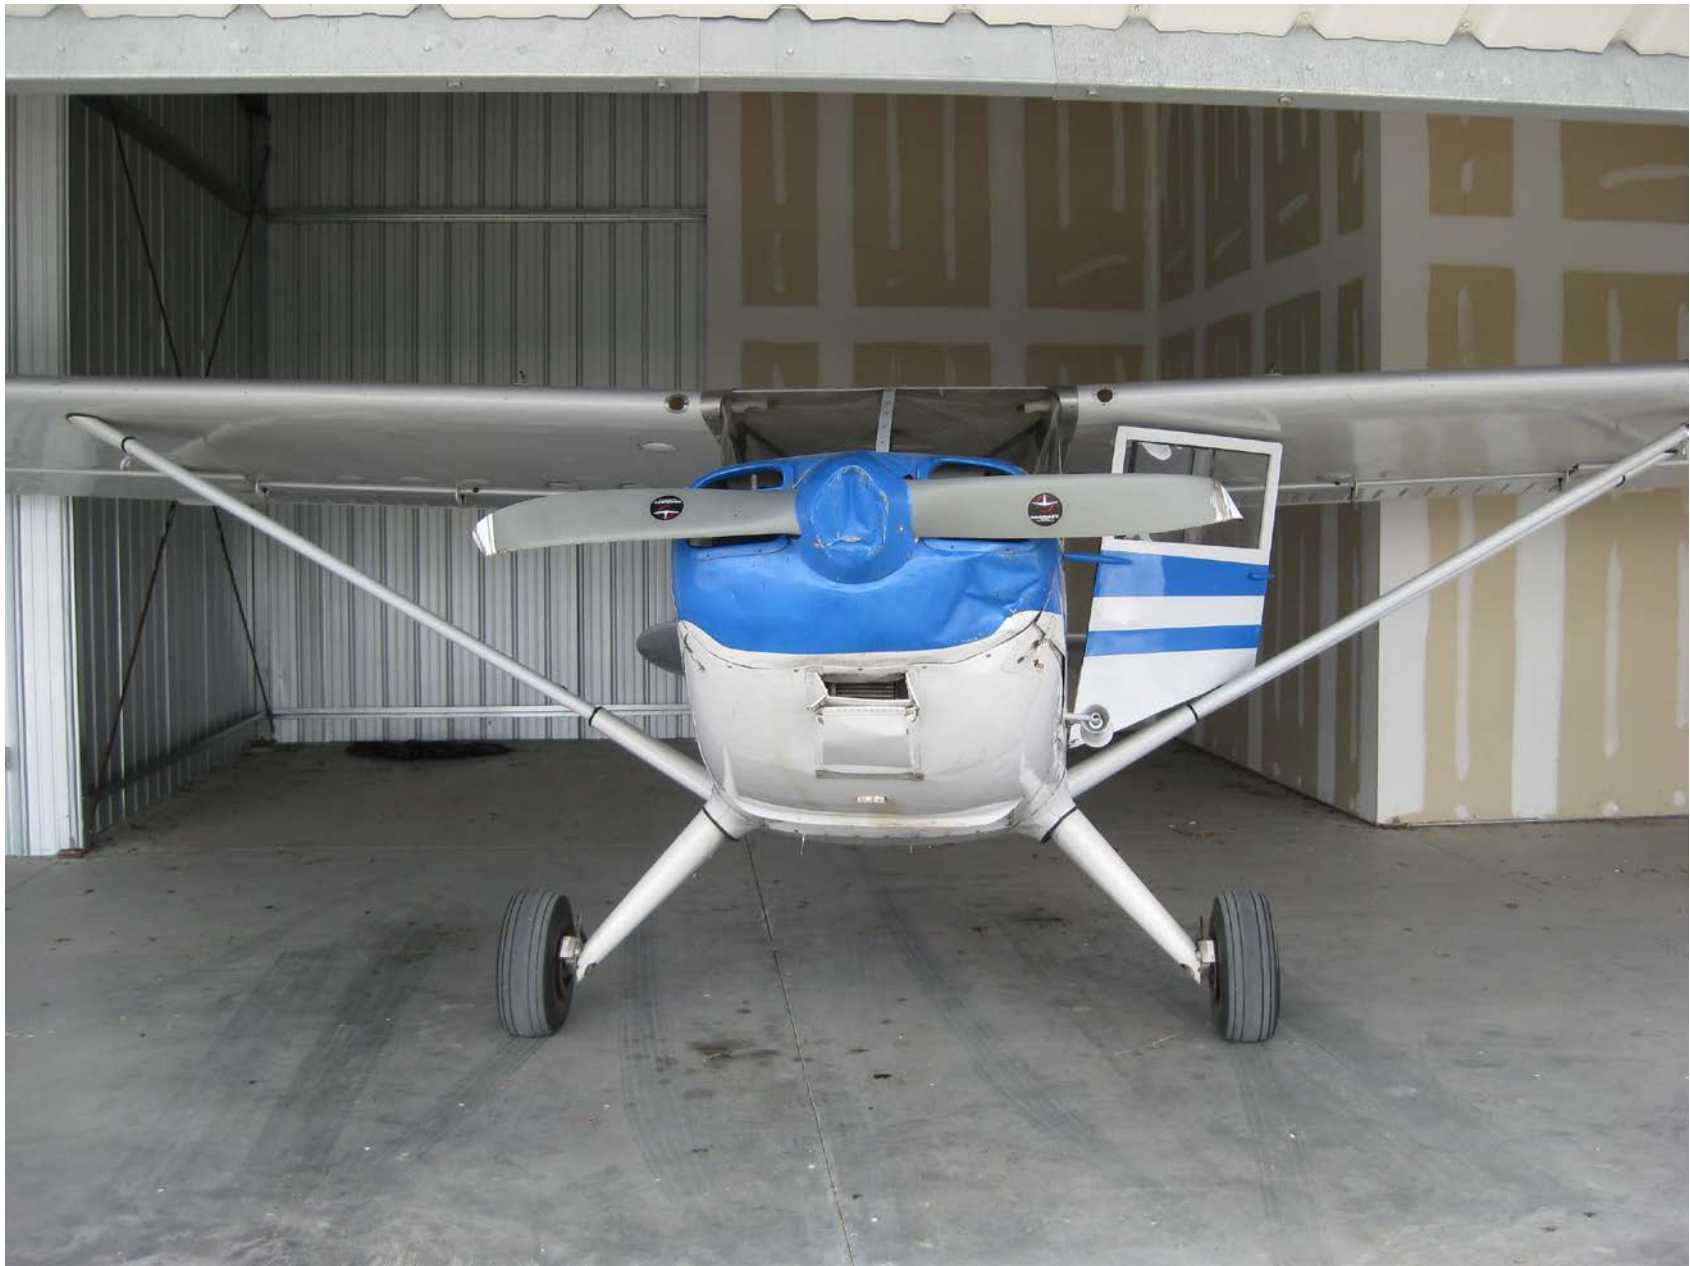
**Photo 1 – Supplied photo looking at the front of the airplane. Propeller tips are bent rearward and the spinner is crushed.**

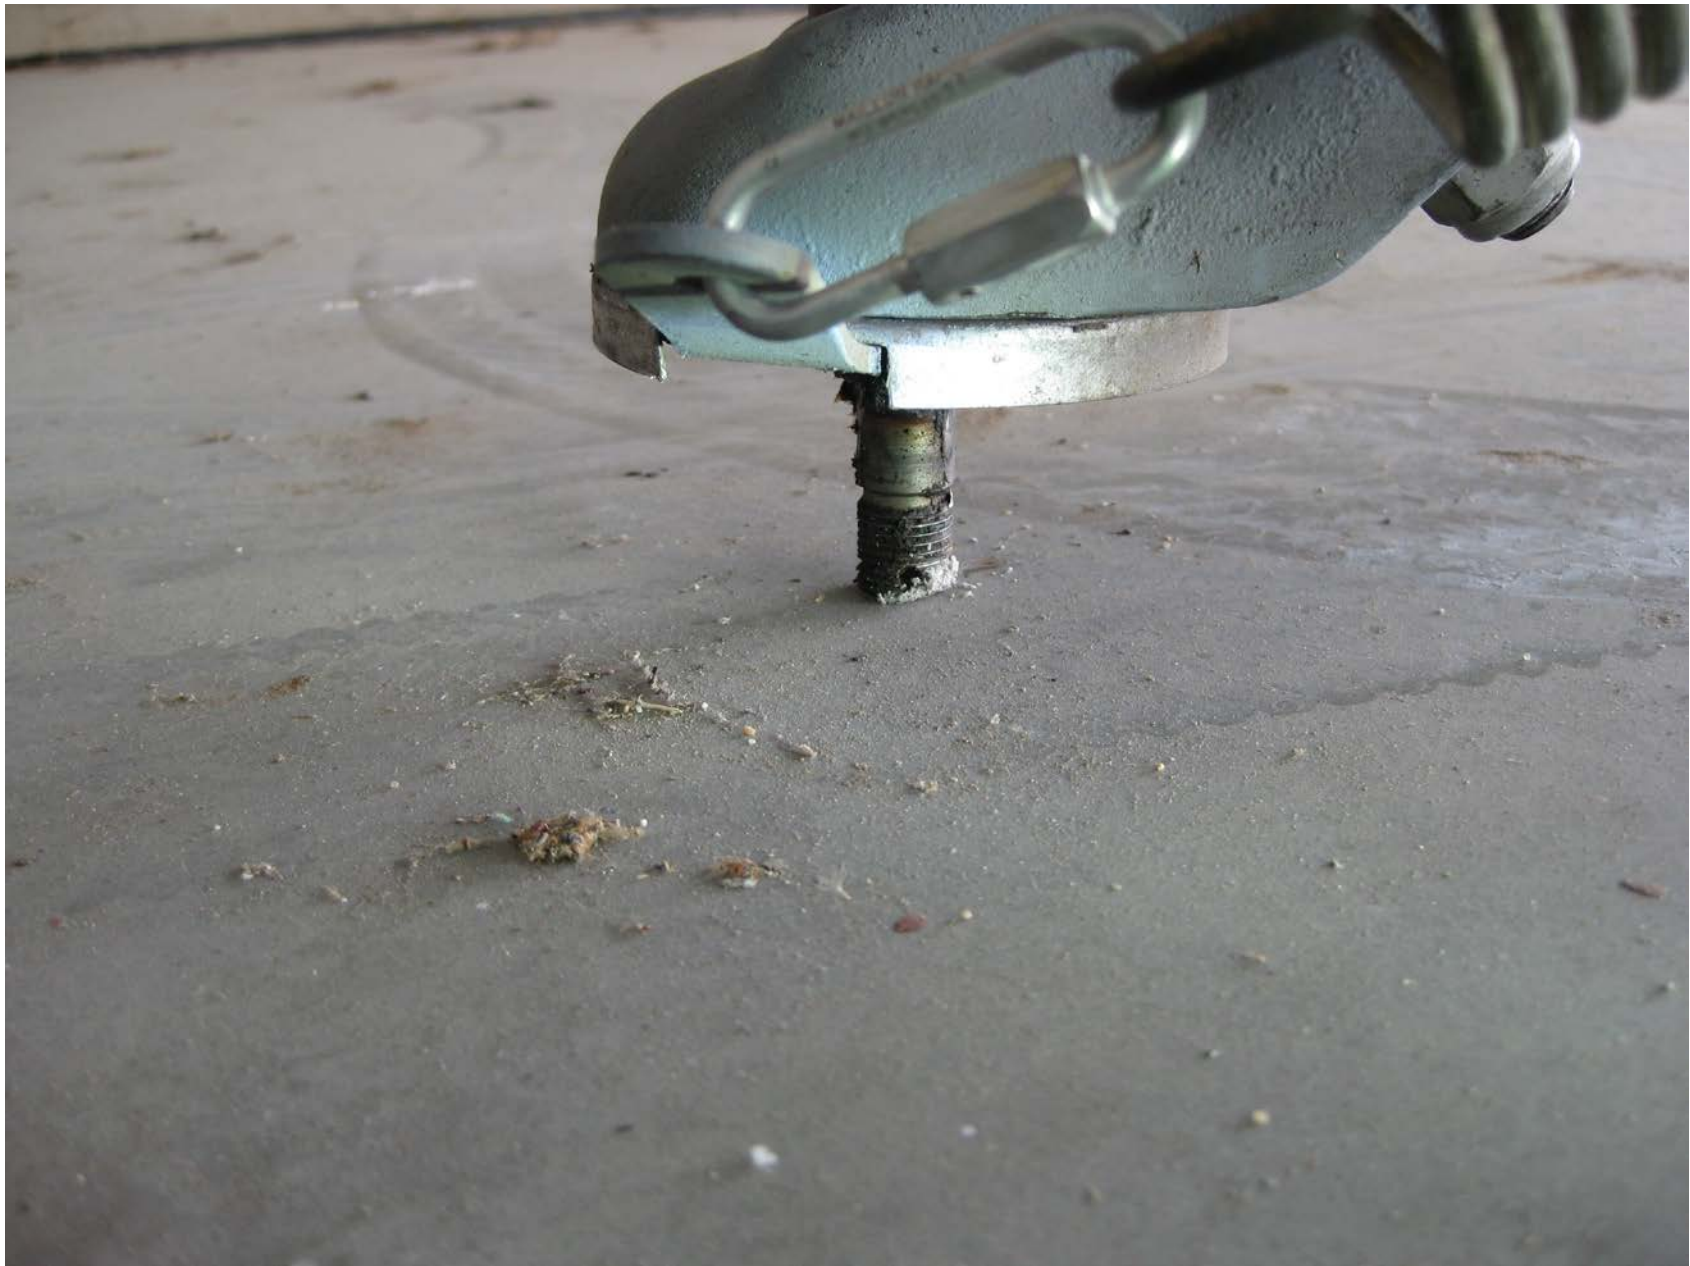
**Photo 2 - Supplied close-up photo looking at the tailwheel assembly. The tailwheel is not present.**

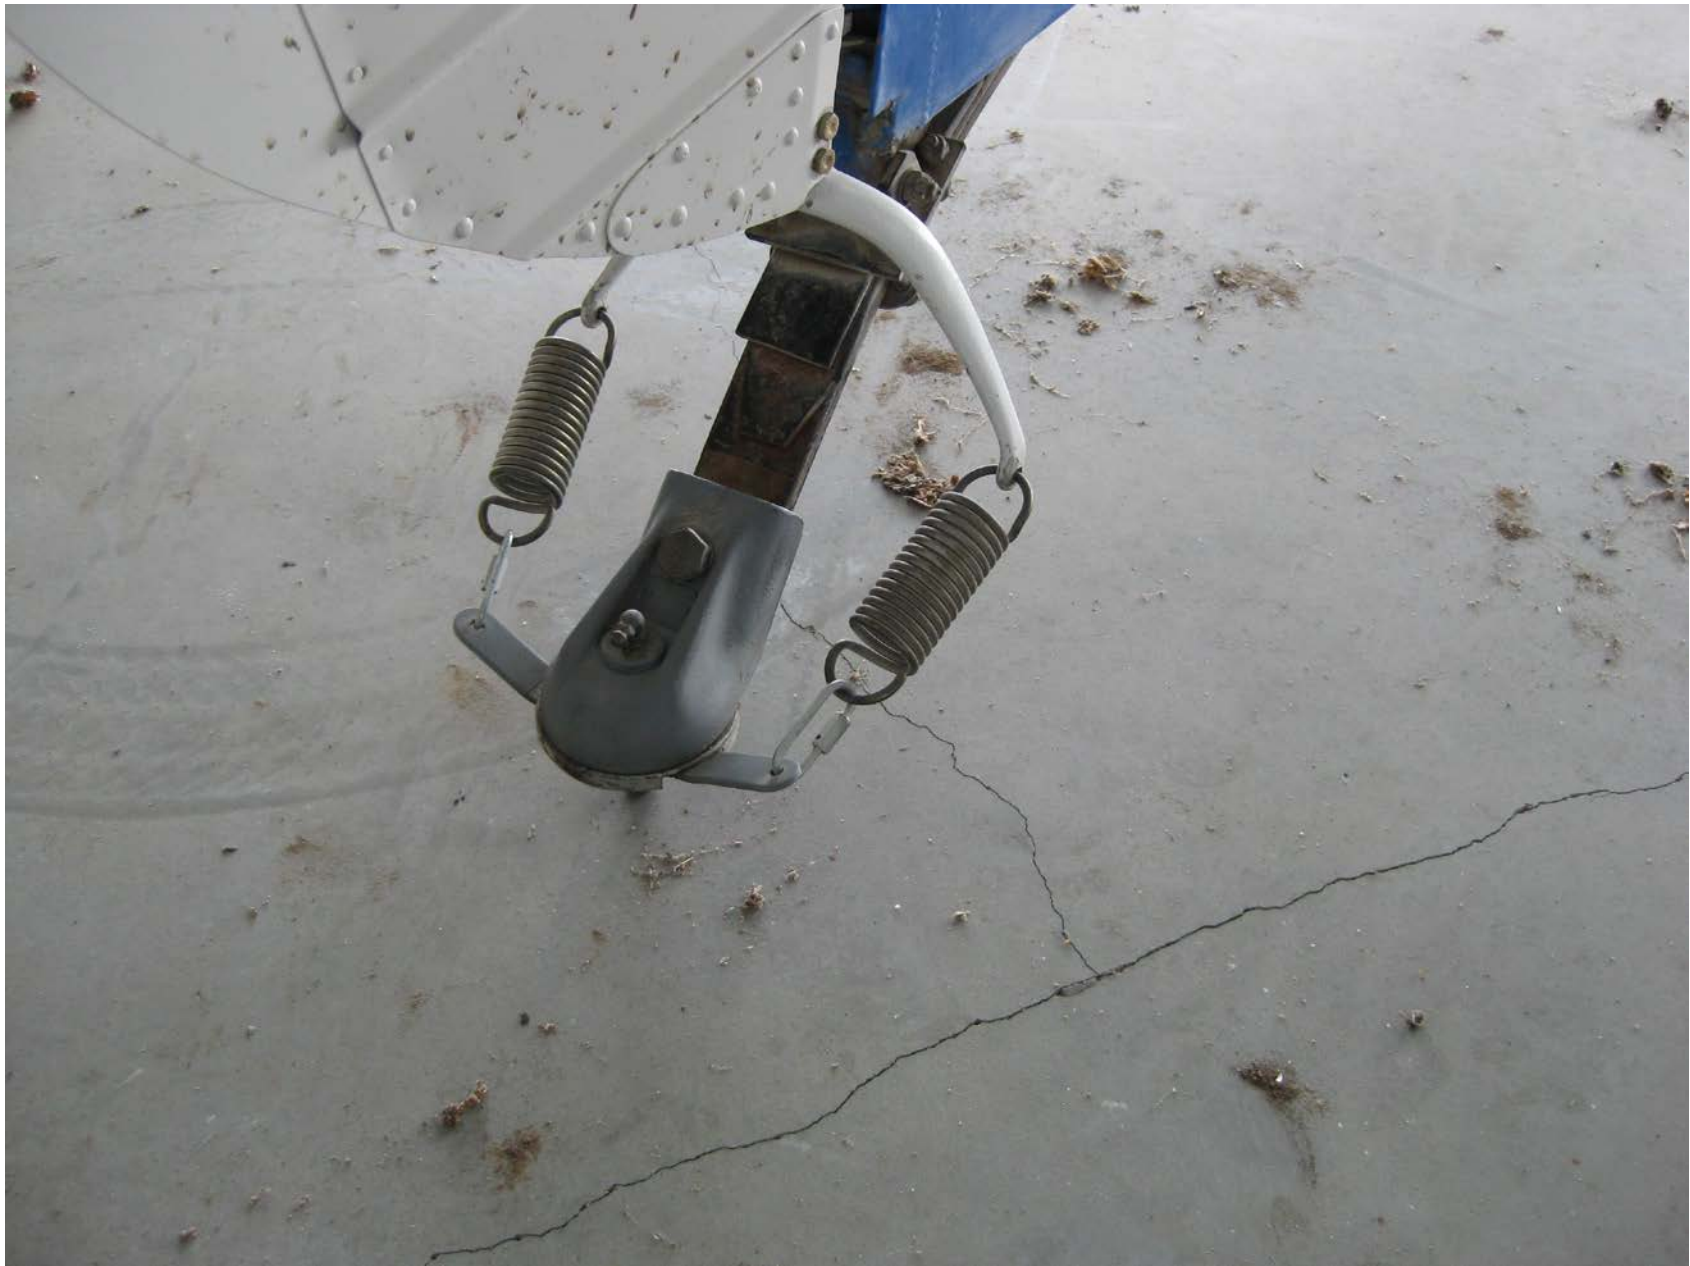
**Photo 3 - Supplied close-up photo looking at the tailwheel assembly. The tailwheel is not present.**

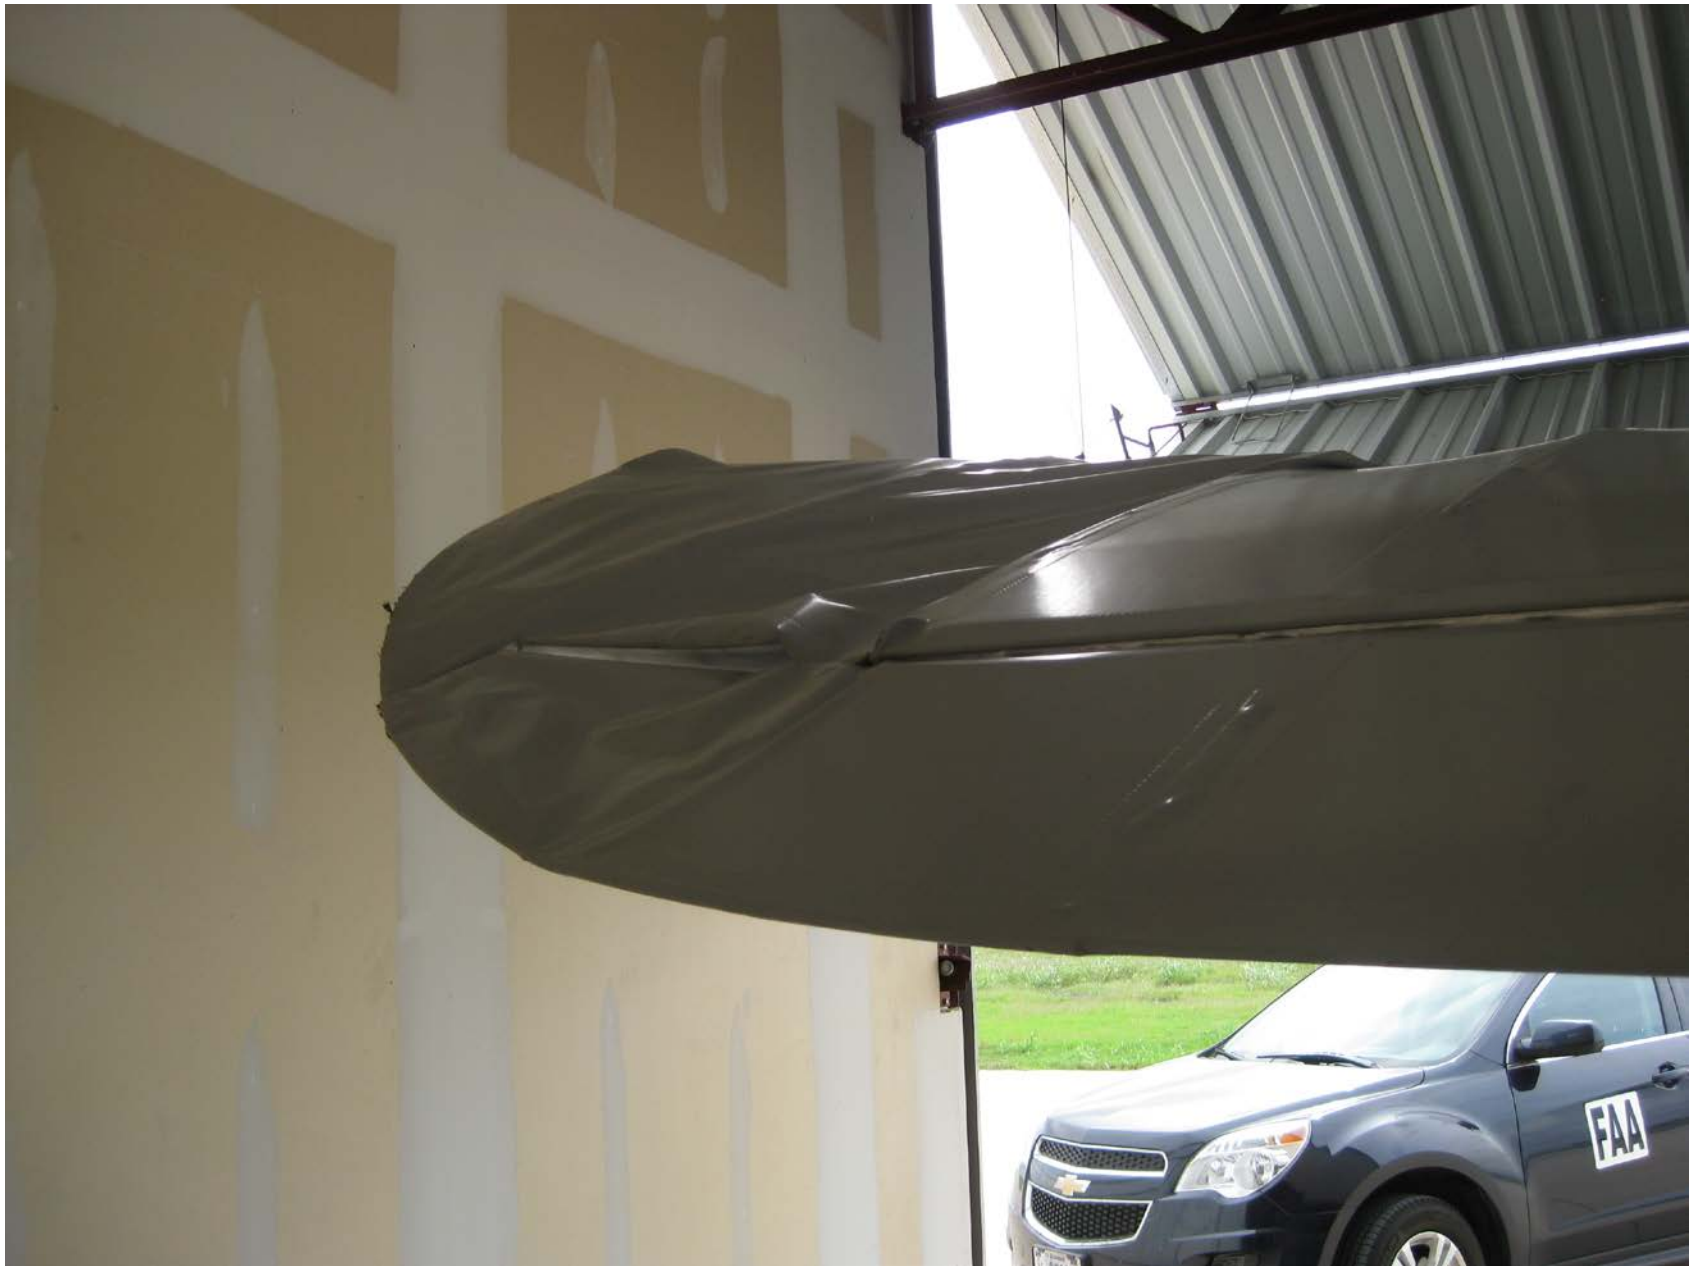
**Photo 4 - Supplied photo looking at left wing tip. The outboard wing section exhibits upward deformation.**

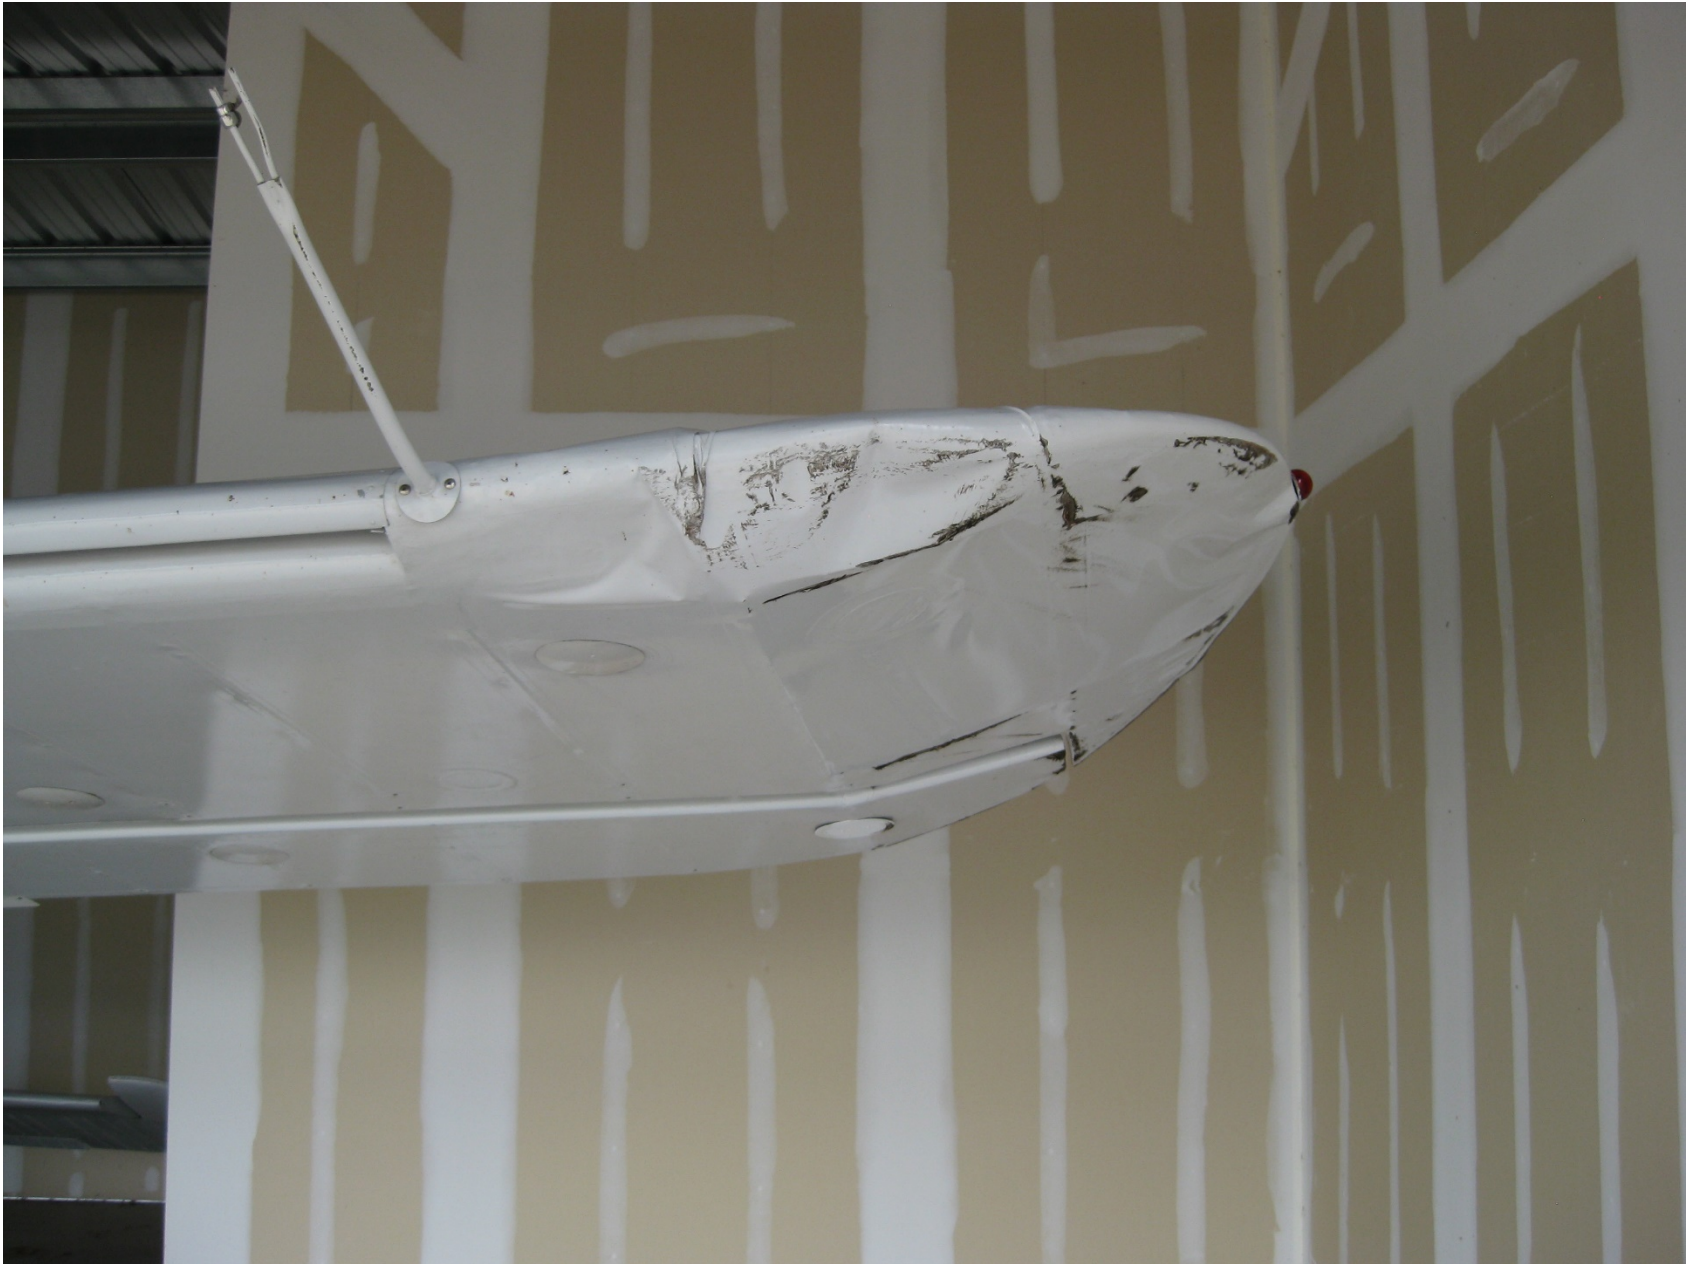
**Photo 5 - Supplied photo looking at left wing tip. The outboard wing section exhibits upward deformation.**

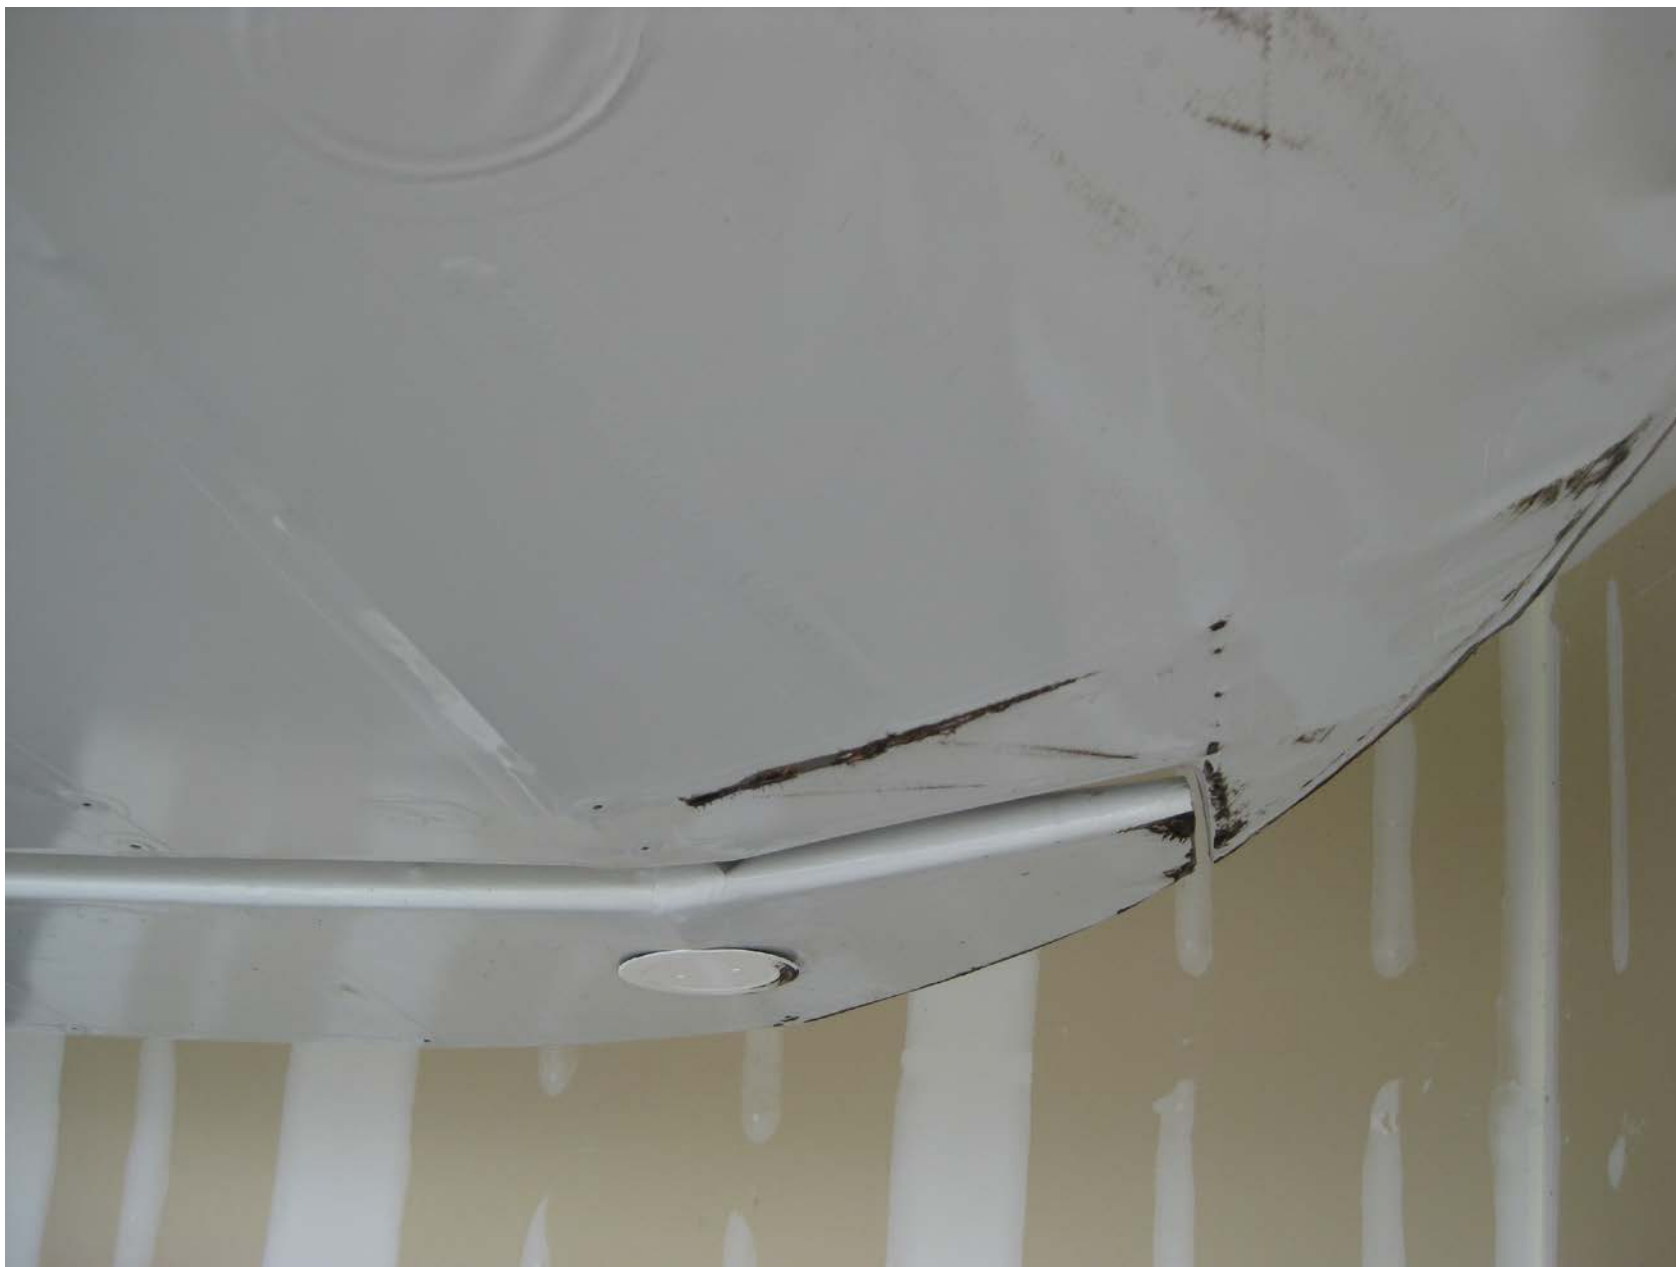
**Photo 6 - Supplied close-up photo looking at left wing tip. The outboard wing section exhibits upward deformation.**
