# NATIONAL TRANSPORTATION SAFETY BOARD

MATERIALS LABORATORY FACTUAL REPORT

Report No. 17-051

Place : Ingleside, Texas  
Date : October 25, 2016  
Vehicle : Boeing A75N1 (PT-17), N48182  
NTSB No. : CEN17LA032  
Investigator : Andrew Todd Fox, ASI-CEN

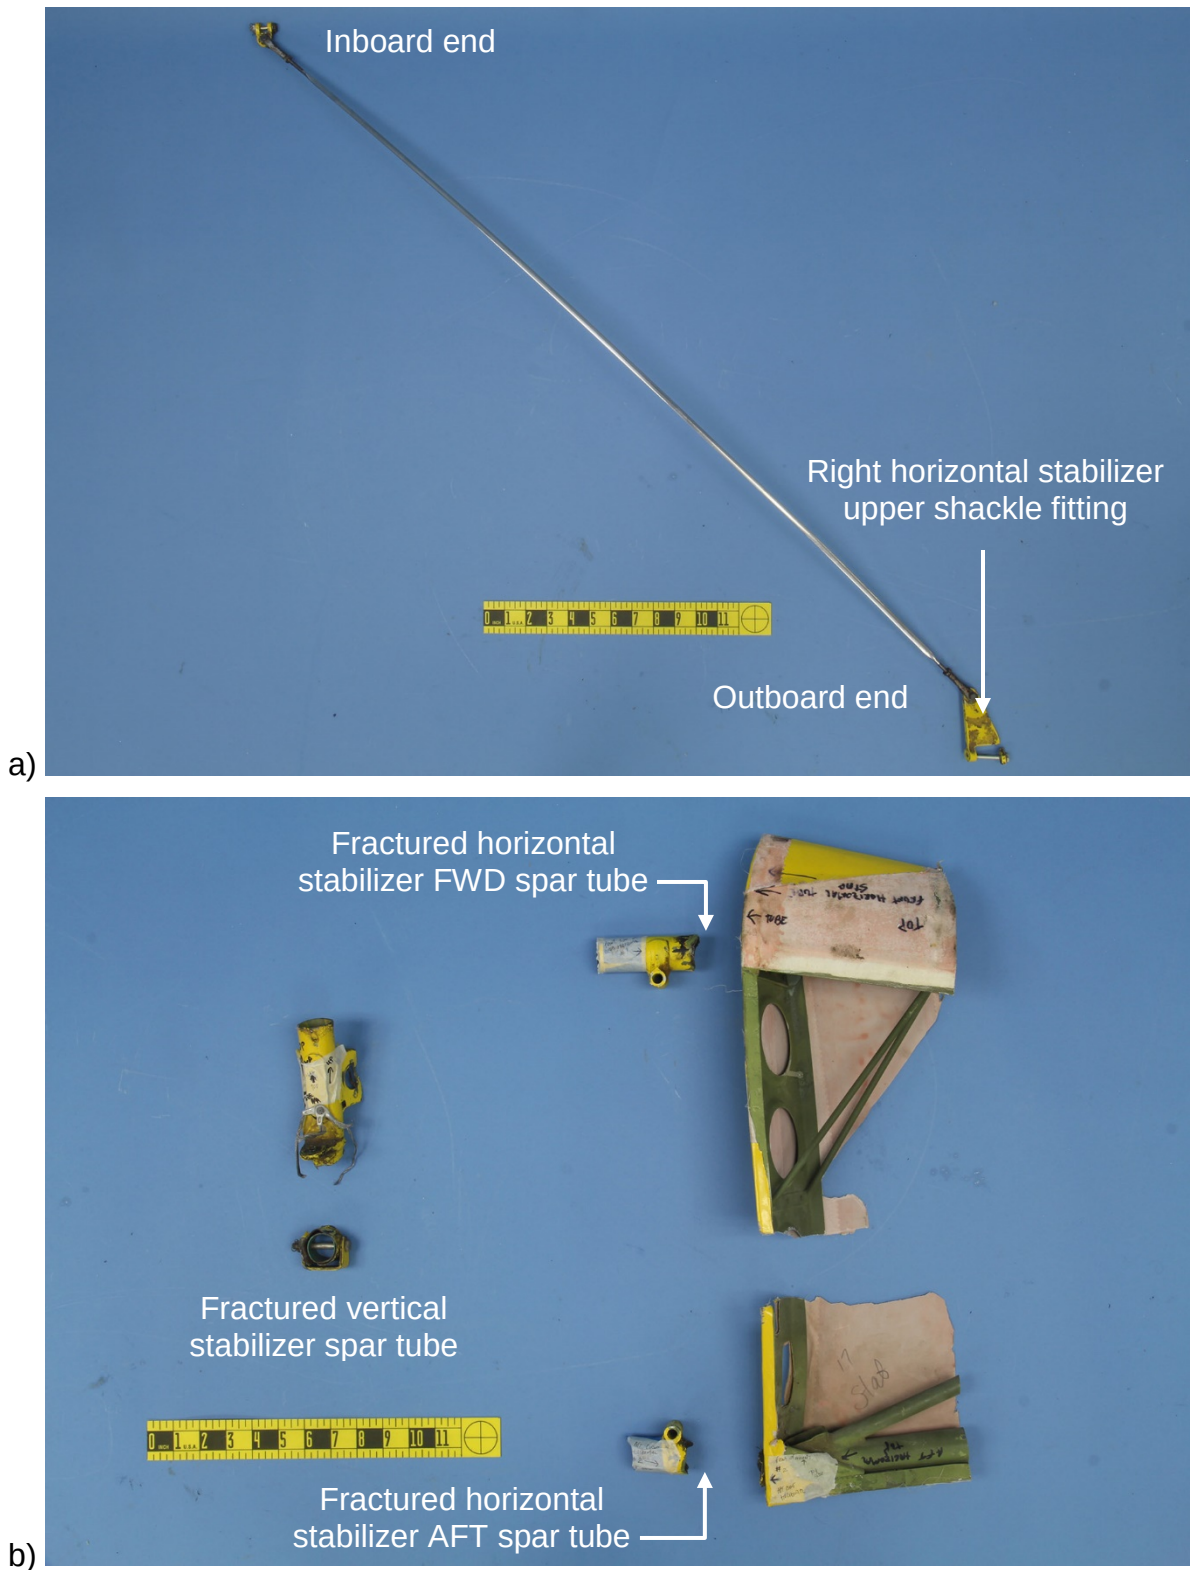
Pieces of a Boeing A75N1 (PT-17) involved in the accident referenced above were sent to the NTSB Materials Laboratory for examination. The pieces included a right horizontal stabilizer bracing wire with a fractured shackle fitting and fractured attachment bolt at the outboard end (figure 1a), fractured forward and aft spar tubes pieces from the right horizontal stabilizer (figure 1b), and fractured spar tube pieces from the vertical stabilizer (figure 1b).

**Figure 1:** a) Image of the as-received right horizontal stabilizer upper bracing wire with the fractured shackle fitting and attachment bolt at the outboard end; b) image of the as-received fractured horizontal stabilizer forward spar tube, horizontal stabilizer aft spar tube, and vertical stabilizer spar tube.

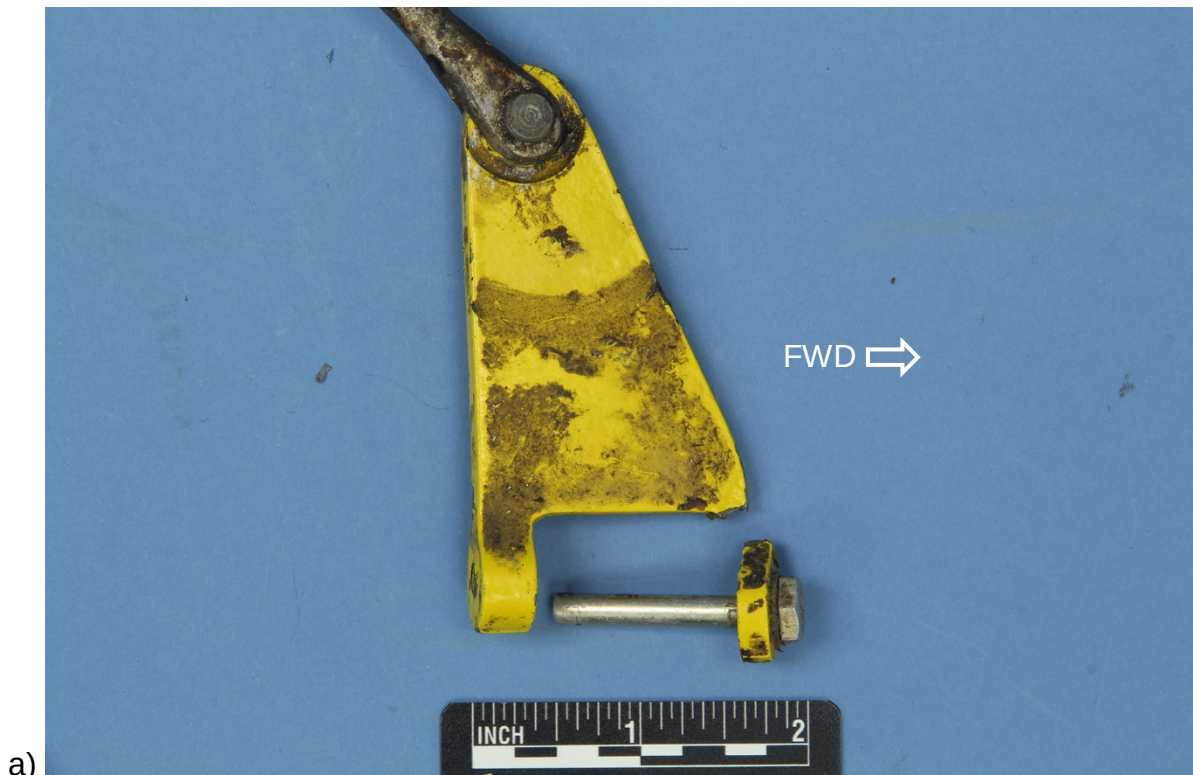
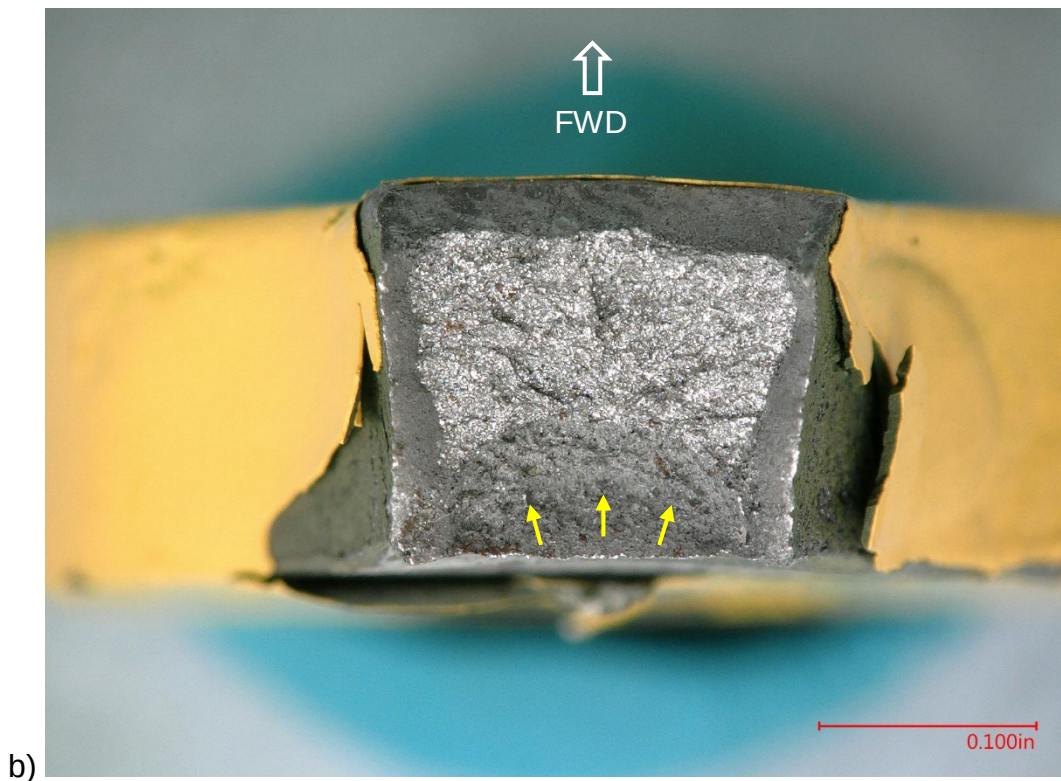
The airplane had a braced tail structure with the bracing wire connecting the right horizontal stabilizer's forward spar tube to the vertical stabilizer's leading edge. The fractured shackle fitting and the fractured attachment bolt pieces from the bracing wire assembly were examined visually to determine their respective modes of failure. The bracing wire outboard shackle fitting consisted of a clevis (figures 2a and 2b) that was joined to a knuckle-type fitting on the horizontal stabilizer spar tube by means of a bolt (figures 3a and 3b) that was inserted through both clevis arms and the knuckle. The bolt was fractured through the grip toward its threaded (aft) end at the interface between the knuckle and the aft clevis arm and the shackle fitting was fractured through its forward arm.

The forward clevis arm was fractured starting at the fillet and progressing forward as indicated in figure 2b. The fracture surface exhibited a rough appearance with a darker thumbnail-shaped region near the fillet, 45° shear lips along the other three edges, and a comparatively specular appearance elsewhere. The observations were consistent with an overstress fracture starting in bending and transitioning to tensile overstress.

**Figure 2:** a) Image of the fractured upper right shackle fitting and b) image of the shackle fitting forward arm fracture surface. Yellow arrows indicate the direction of crack progression from the fillet.

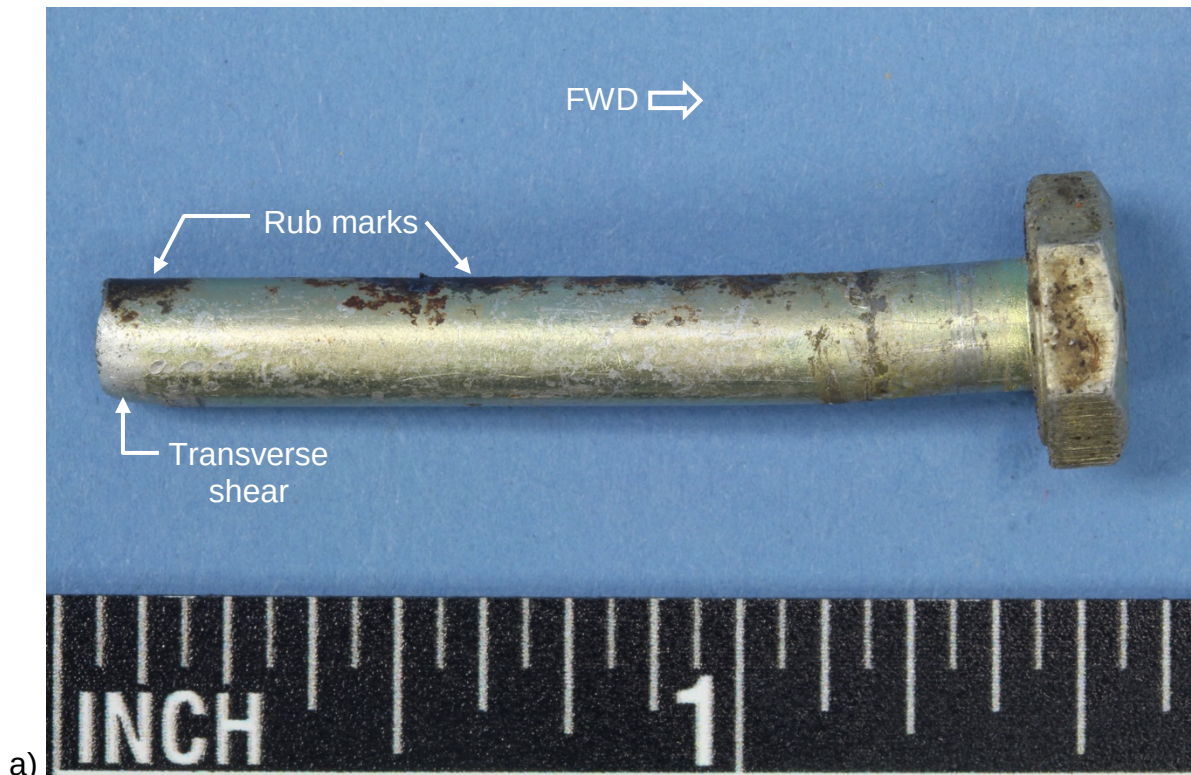
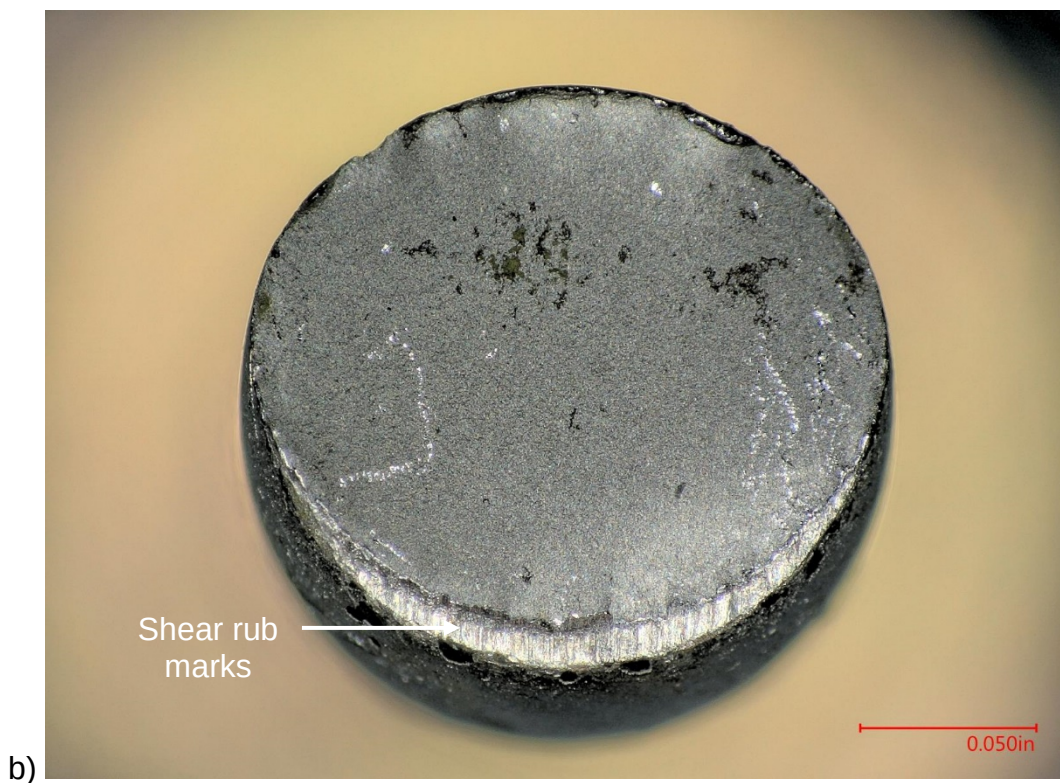
The bolt shank exhibited transverse shear deformation adjacent to the fracture surface (figure 3a). The fracture surface was planar and perpendicular to the axial direction of the bolt (transverse plane). Shear rub marks were observed along its lower edge, as pictured in figure 3b, which was adjacent to the transverse shear deformation across the shank. The fracture surface was comparatively featureless elsewhere. Considered together, the features were consistent with a shear overstress fracture.

The hardness of the bolt was measured using a Rockwell hardness tester to compare with the strength requirement for the bolt. According to the aircraft illustrated parts catalog (IPC), the specified attachment bolt was of type AN3-20<sup>1</sup> (see Appendix A of this report for the relevant pages from the IPC). The AN specification does not directly list a required material strength or hardness for the bolt. However, the specification lists an ultimate breaking strength (load) at the thread root. For a 10-32 UNF-3A AN3 bolt like the fractured bolt, the listed ultimate tensile strength (load) at root diameter was 2,210 lbs. According to the specification for UNF-type threads,<sup>2</sup> the section at the minor diameter at  $D - 2h_b$  is 0.0175 inch<sup>2</sup> and the tensile stress area is 0.0200 inch<sup>2</sup>. Using the smaller of the two area values, the approximate minimum tensile strength requirement is 126 ksi, which correlates with a hardness of approximately 26 HRC in accordance with ASTM E140.<sup>3</sup> The bolt head was sectioned from the shank and two opposing faces of the bolt head were ground flat using abrasive grinding paper. The hardness, measured on the bolt piece in accordance with ASTM E18,<sup>4</sup> was 28.4 HRC, meeting the minimum strength requirement of the bolt.

**Figure 3:** a) Image of the fractured shackle fitting attachment bolt showing transverse shear across the shank adjacent to the fracture and b) image of the bolt fracture surface showing rub marks on the lower part of the image and a flat featureless fracture elsewhere.

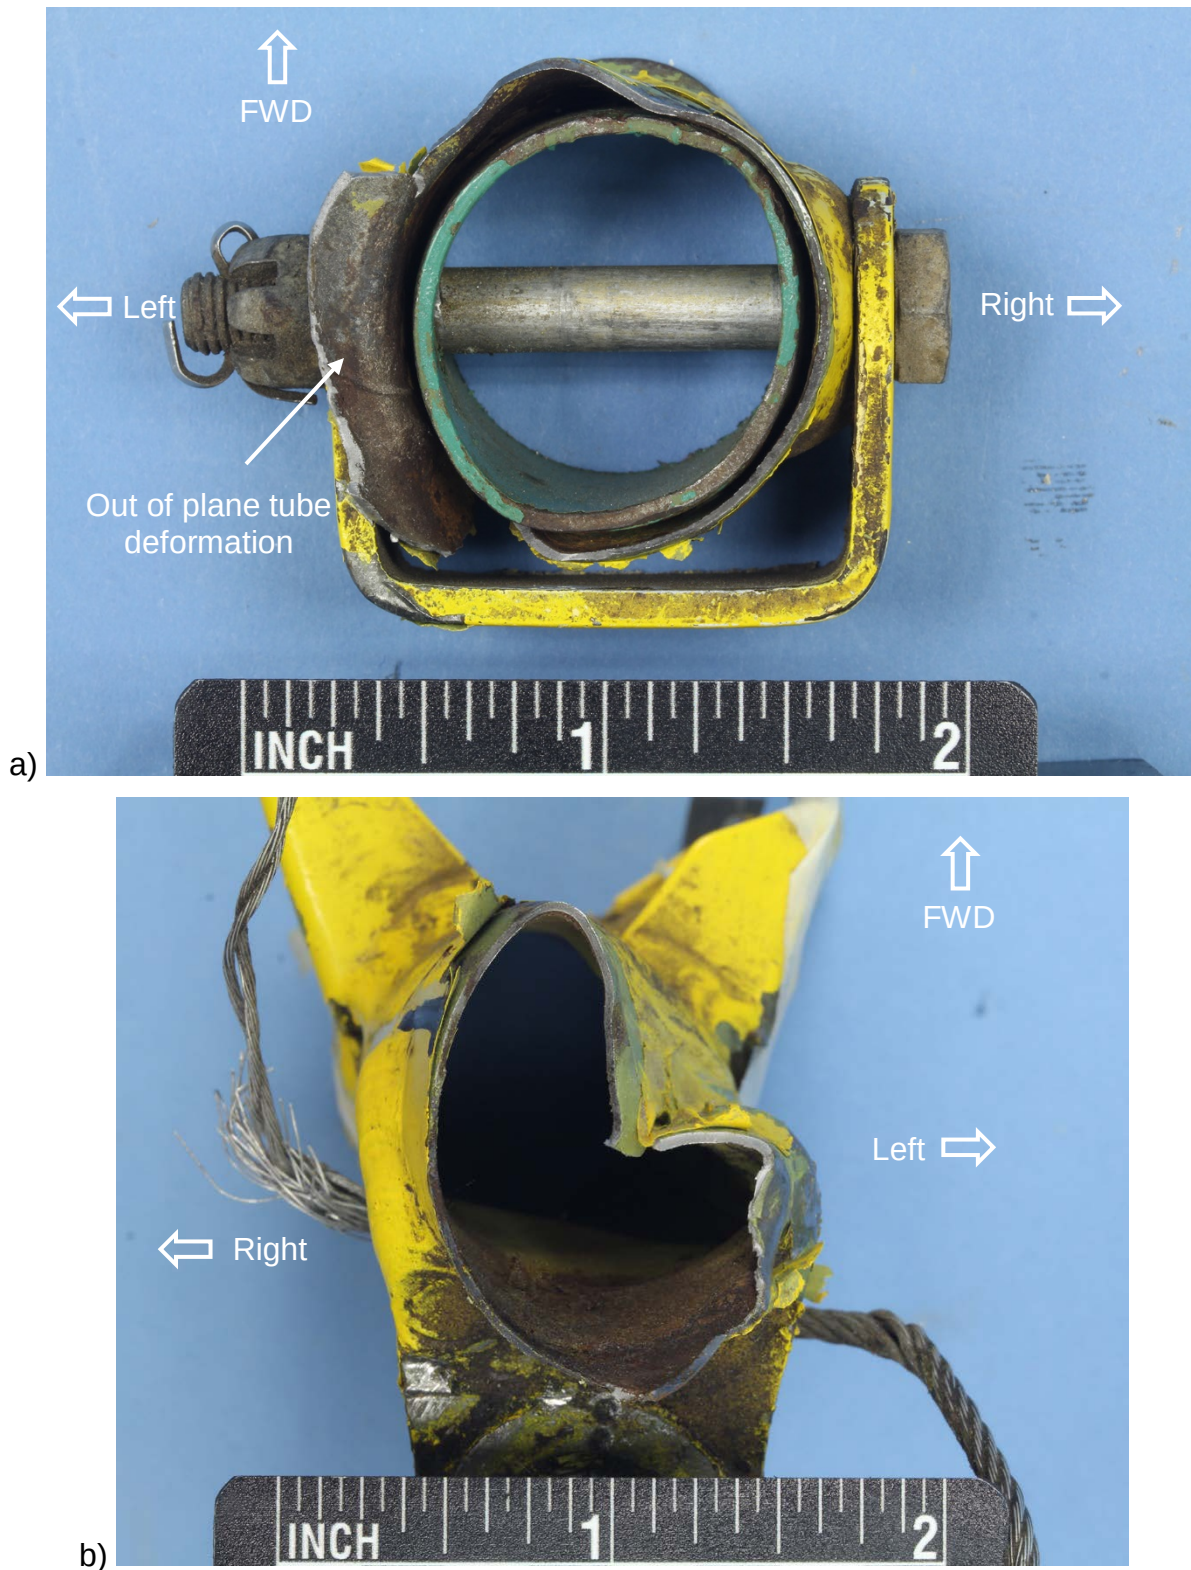
The vertical stabilizer spar tube was examined visually to determine its mode of failure. The lower and upper fractured vertical stabilizer spar tube pieces are shown in figures 4a and 4b, respectively. Along the right, forward, and aft sides of the tube, the fracture surfaces were inclined at 45° to the transverse plane of the tube, consistent with a ductile overstress fracture. Towards the left side of the tube, the fracture path deviated from the radial/circumferential plane and the tube exhibited out-of-plane bending deformation. The features were consistent with a ductile overstress fracture in bending from the right to left sides of the aircraft as viewed aft looking forward.

**Figure 4:** Images of fractured vertical stabilizer tube pieces. The appearance of the the tube pieces was consistent with a ductile overstress fracture in bending from right to left; a) lower fractured piece viewed from above looking down; and b) upper fractured piece viewed from below looking up.

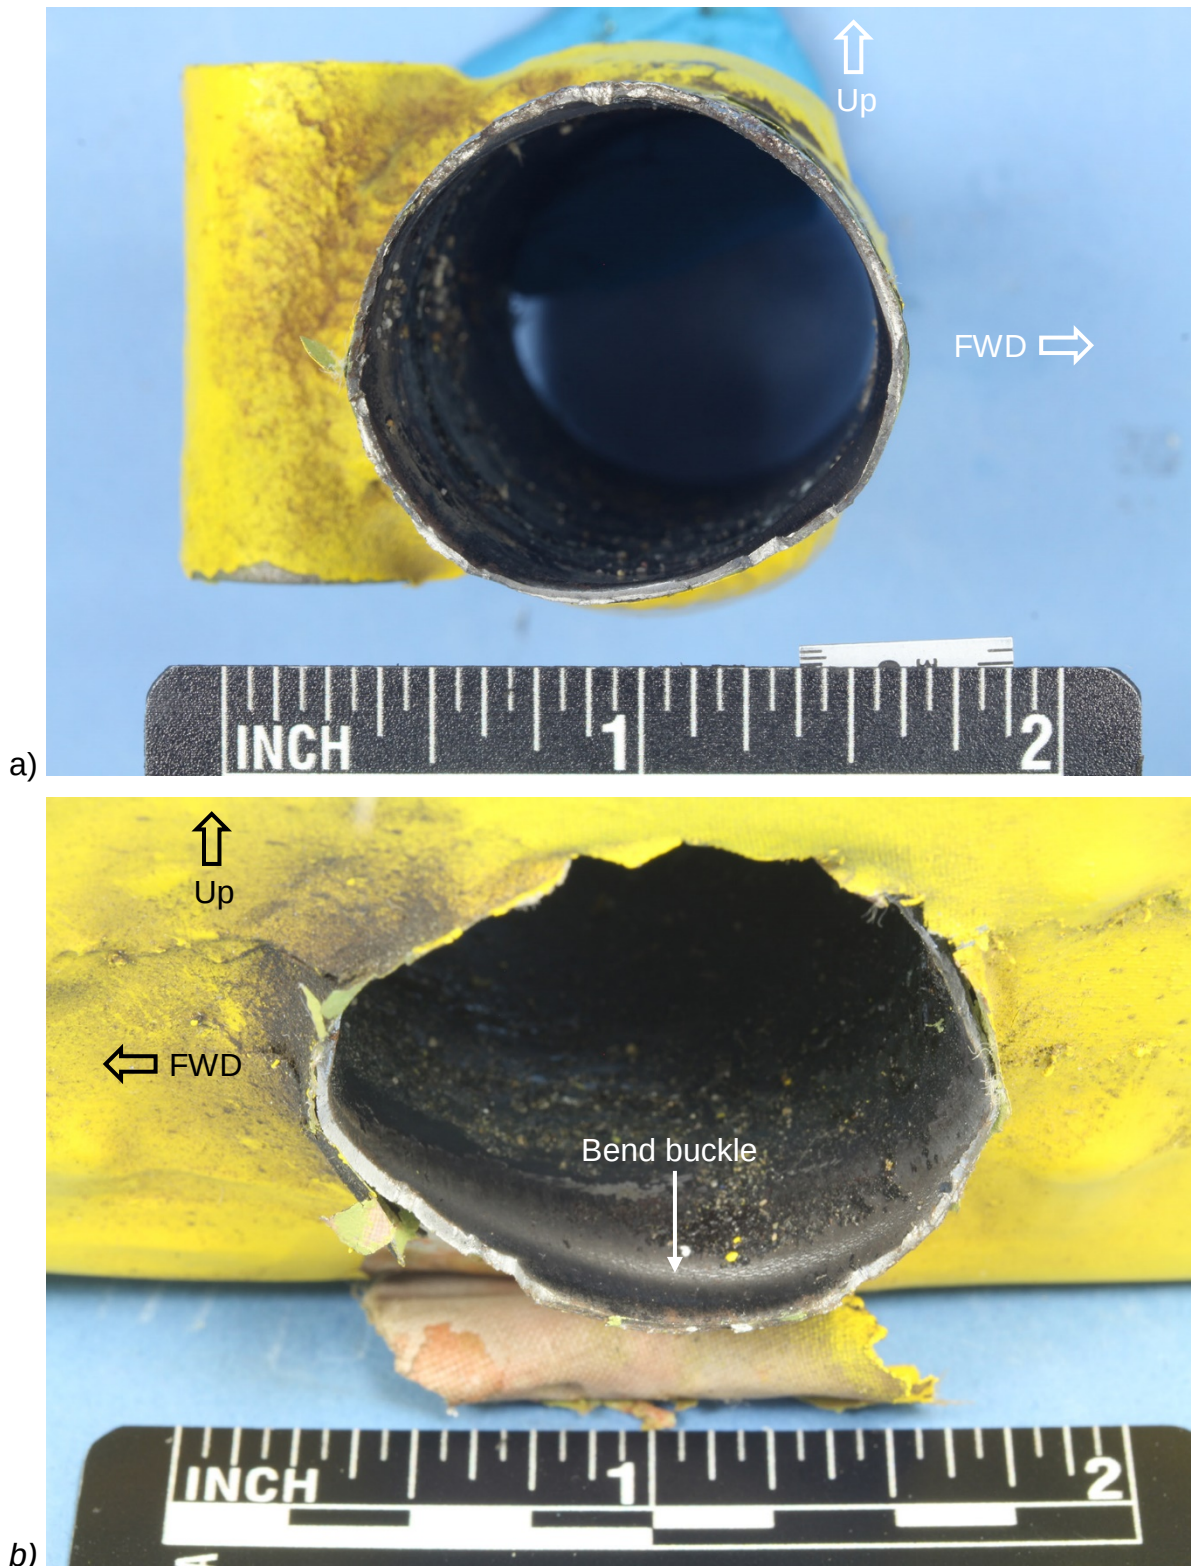
The forward and aft right horizontal stabilizer spar tubes were examined visually to determine their mode of failure. The inboard and outboard fractured horizontal stabilizer forward spar tube pieces are shown in figures 5a and 5b, respectively, and the inboard and outboard fractured horizontal stabilizer aft spar tube pieces are shown in figures 6a and 6b, respectively. Along the top of the forward tube, the fracture followed the toe of a weld where the tube passed through an inboard rib and exhibited a specular appearance. Elsewhere, the top, forward, and aft sides of the two tubes exhibited fracture surfaces that were inclined at 45° to the radial/circumferential plane of each tube, consistent with ductile overstress fractures. Towards the bottom of the two tubes, each fracture path deviated from the transverse plane and each tube exhibited regions of double-sigmoidal bending deformation, each consistent with a bend buckle, as indicated in figures 5b and 6b. Taken together, the features were consistent with ductile overstress fractures in tip-downward bending.

**Figure 5:** Images of fractured horizontal stabilizer forward spar tube pieces. The appearance of the the tube pieces was consistent with a ductile overstress fracture in tip-downward bending; a) inboard fractured piece viewed outboard looking inboard; and b) outboard fractured piece viewed inboard looking outboard.

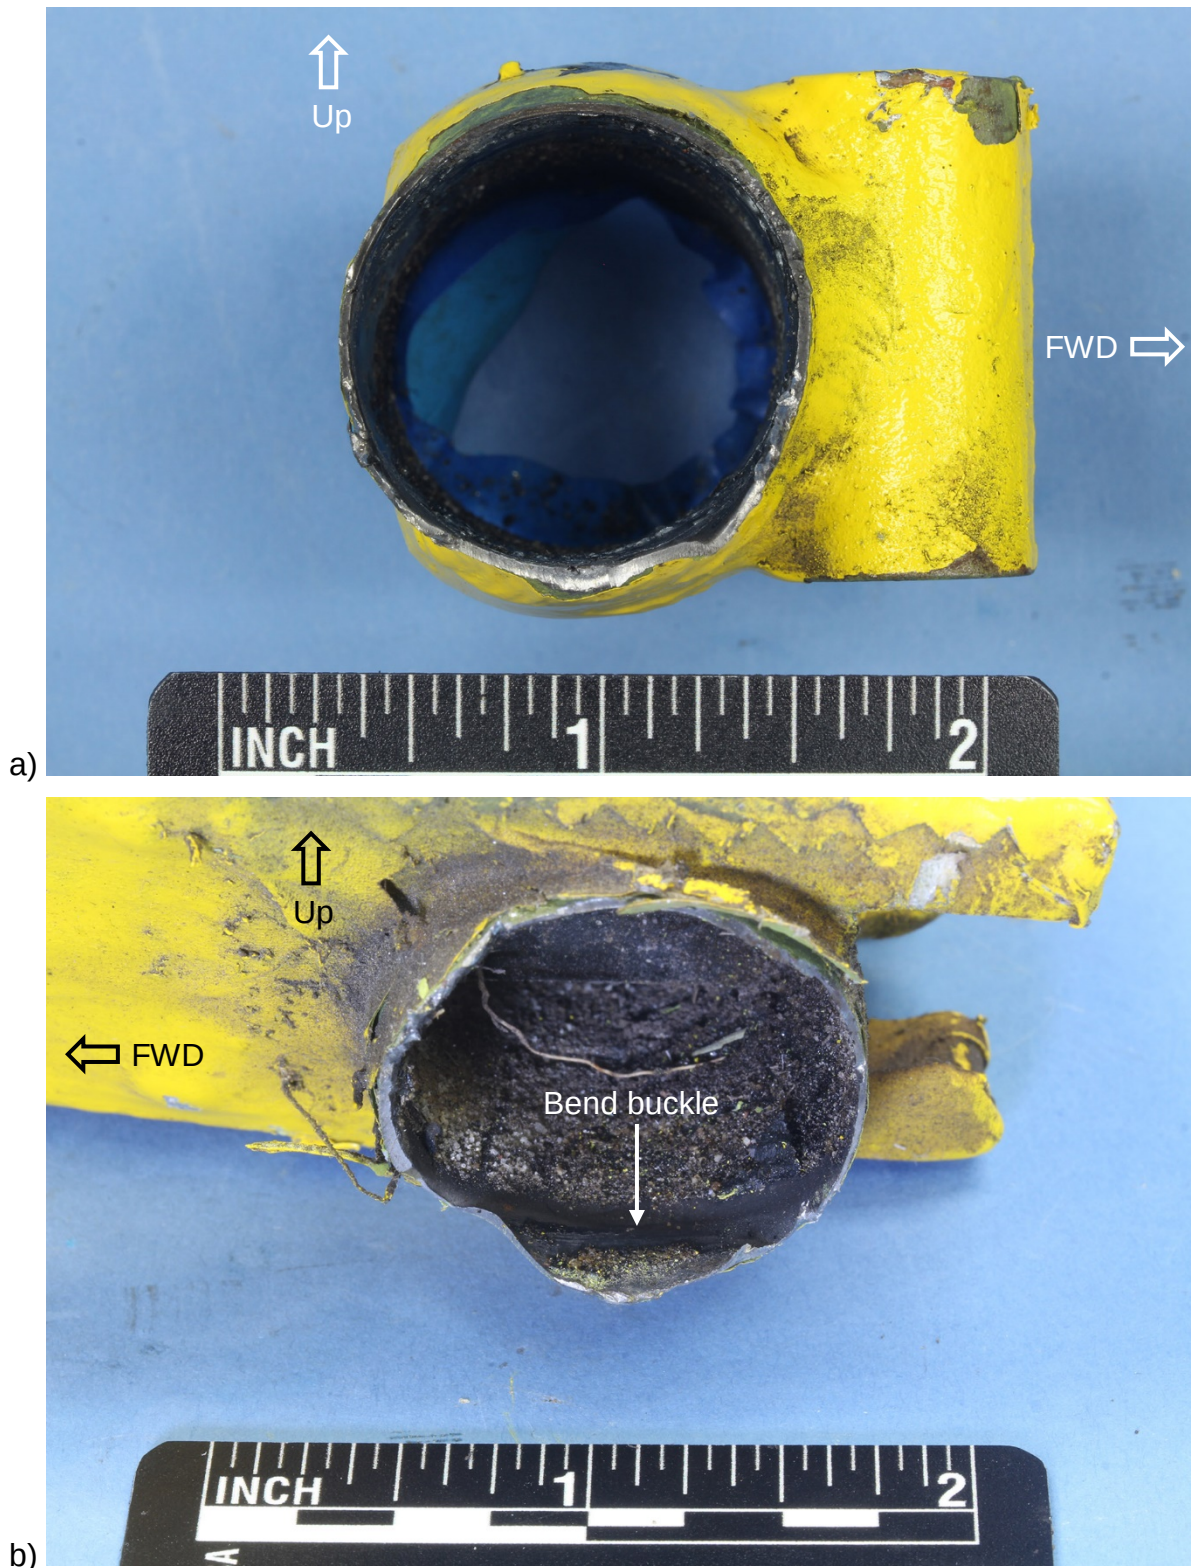
**Figure 6:** Images of fractured horizontal stabilizer aft spar tube pieces. The appearance of the the tube pieces was consistent with a ductile overstress fracture in tip-downward bending; a) inboard fractured piece viewed outboard looking inboard; and b) outboard fractured piece viewed inboard looking outboard.
