# NATIONAL TRANSPORTATION SAFETY BOARD

MATERIALS LABORATORY FACTUAL REPORT

Report No. 16-111

Place : Dallas, Texas  
Date : October 29, 2016  
Vehicle : North American TB-25N, N25YR  
NTSB No. : CEN17LA033  
Investigator : Joshua Lindberg, ASI-CEN

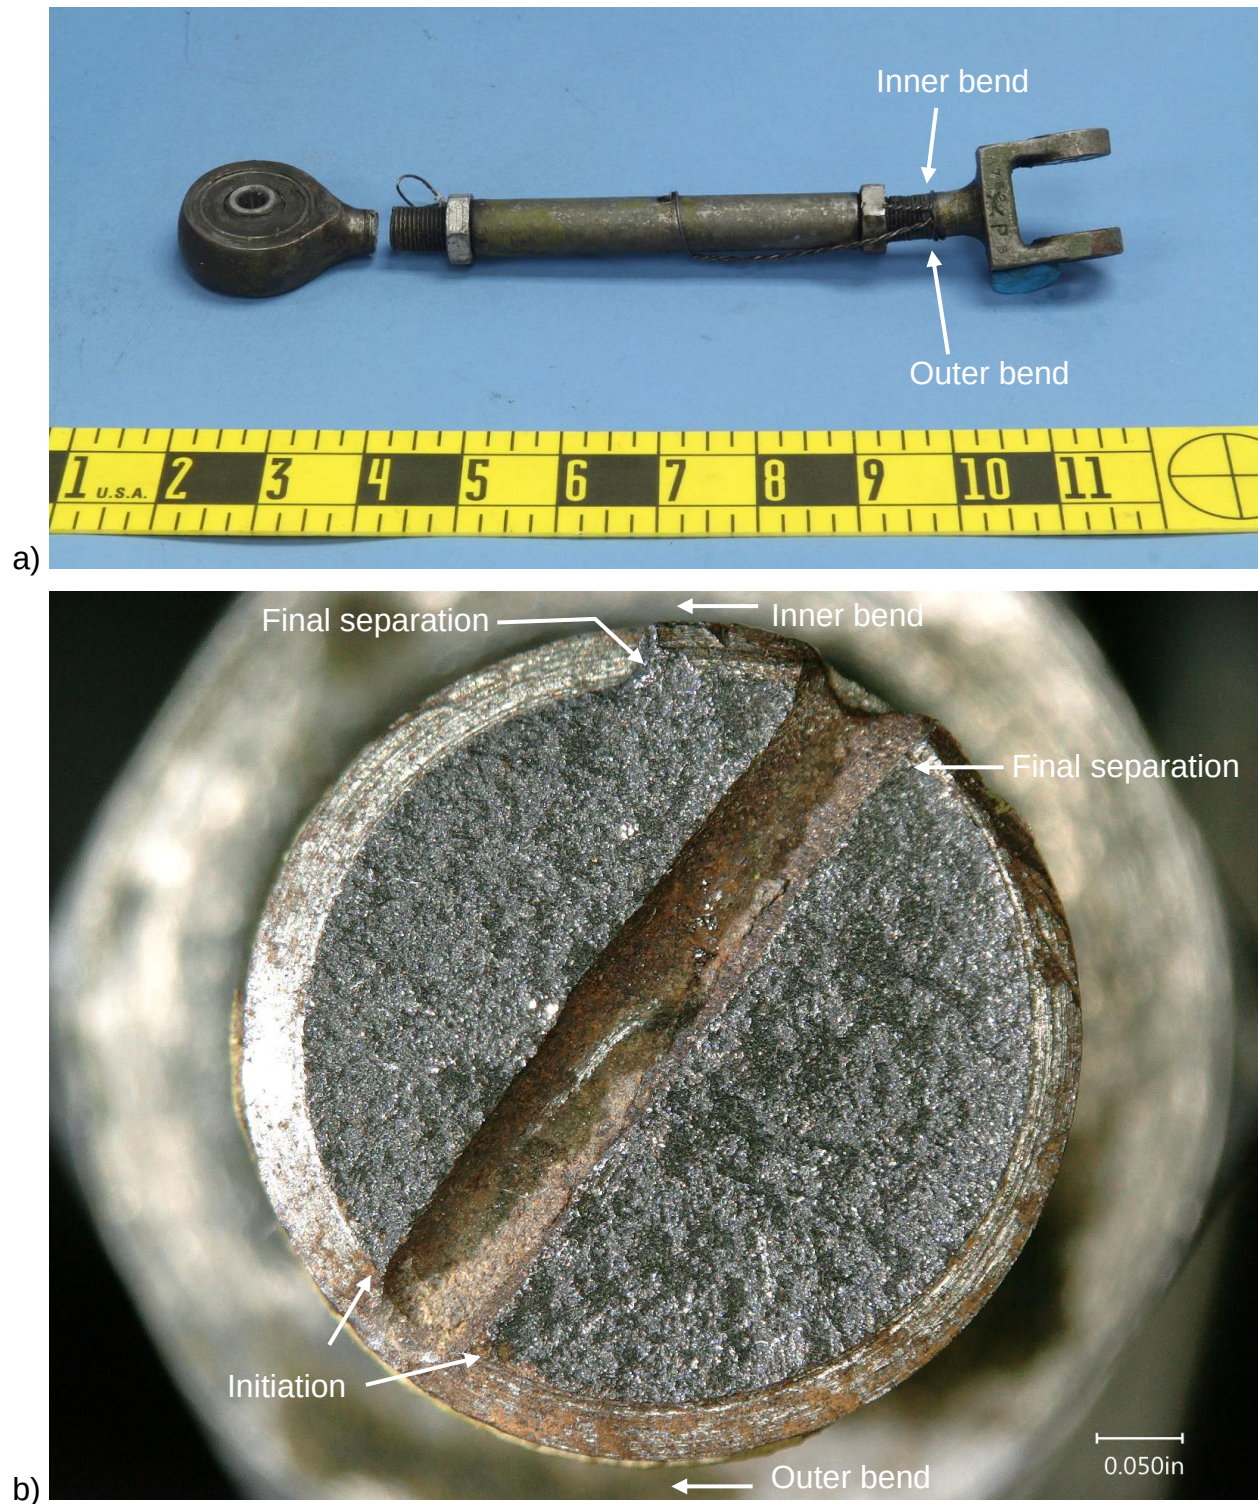
The clevis end was bent along the shank. For convenience one side of the bend is referred to as the inner bend and the opposite side is referred to as the outer bend, as indicated in figure 1a. The bend axis was perpendicular to the clevis hinge.

The spherical bearing rod end was fractured in the threaded portion of the shank in the same plane as a drill hole for safety wire, as shown in figure 1b. The fracture surface was examined and exhibited a rough appearance consistent with an overstress fracture. There were no features indicative of a preexisting crack. Microscopic examination of the fracture surface revealed tear lines radiating away from the safety wire drill hole on the outer bend side of the fracture. Near the inner bend side, the fracture progressed longitudinally across one of the threads, consistent with a point of final separation. Taken as a whole the features observed on the connecting rod assembly were consistent with an overstress failure in bending.

**Figure 1:** a) Image of the fractured connecting rod assembly showing the fractured spherical bearing rod end and bend along the shank of the clevis rod end; b) image of the fracture surface. The fracture surface exhibited rough features consistent with overstress.
