## SUMMARY OF FINDINGS

**Thomas J. Latson, Jr.**  
**Air Safety Investigator**  
**Central Region**

**NTSB Accident Number: CEN17LA041 – N329CT at Port Allen, Louisiana**

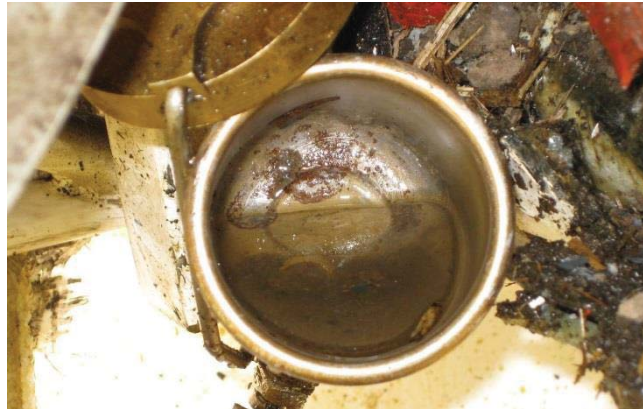
11. The student pilot, who was also the airplane's registered owner, removed the wreckage from the sugar cane field and took it to another location.
12. The student pilot reported that his pilot logbook was lost during the impact, and the slash on the recently harvested sugar cane field was burned several days after the wreckage was removed.
13. The FAA Inspectors examined the fuel can used to refuel the airplane and observed that it appeared to be clean and non-contaminated.
14. The FAA Inspectors examined the inside surface of the airplane's gascolator bowl and observed that it was rusty and corroded.

*Figure 1 – showing a rusty and corroded gascolator bowl (FAA Photo)*

"Gascolator. Open gascolator, remove filter and check for cleanliness..."

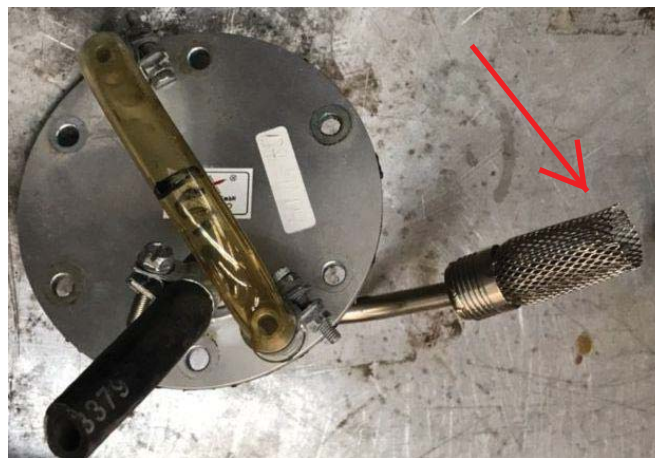
*Figure 2 – showing steel mesh finger screen with a missing end cap (Aircraft Owner Photo)*

17. The airplane's registered owner observed that the end cap was present on the undamaged fuel intake filter (*finger screen*) in the right wing.
18. The airplane's registered owner disassembled and examined the fuel line and discovered a soft dirt ball lodged in the inlet side of the fuel shutoff valve, which is upstream from the in-line fuel filter.

"Fuel Intake Filter. Check intake filter every 1000 hours or after negative fuel flow test."

The instructions in paragraph 6.6.3 show that the procedure to check the fuel intake filters on each wing requires that the fuel must be drained from the tank; the wing uninstalled from the fuselage; and the fuel tank access panel must be removed from the end of the wing root. The intake filter mesh should then be examined for integrity and to insure there are no foreign objects inside and on the surface of the mesh.

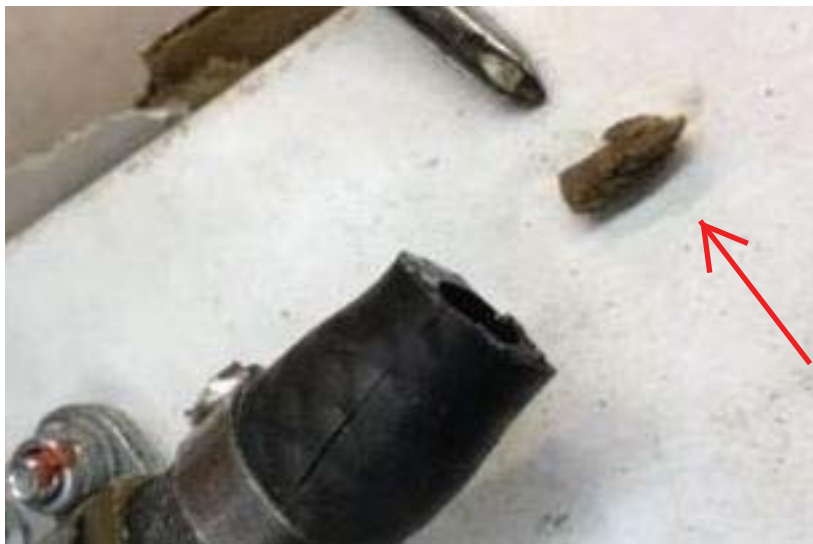
*Figure 3 – showing a dirt ball removed from the fuel line (Aircraft Owner Photo)*
