# Continental Motors

## ENGINE EXAMINATION REPORT

| ENGINE MODEL | IO520K (1A) |
| FILE NUMBER | 16-327 |

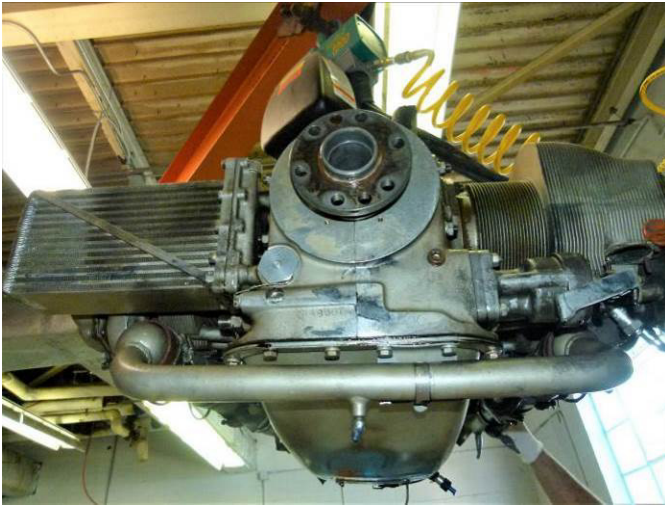
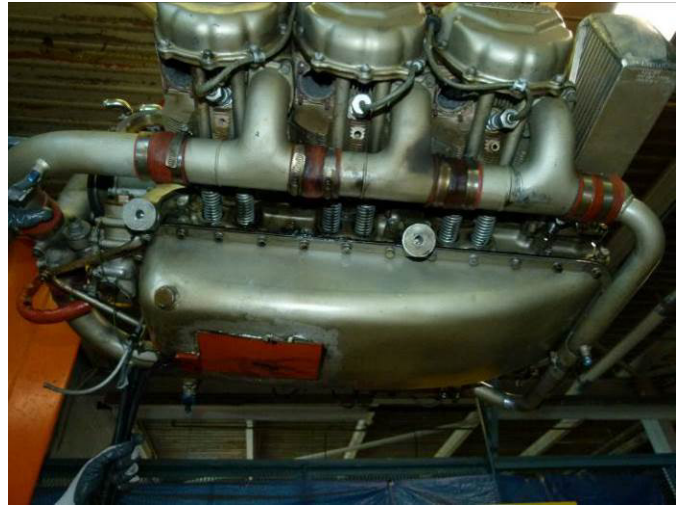
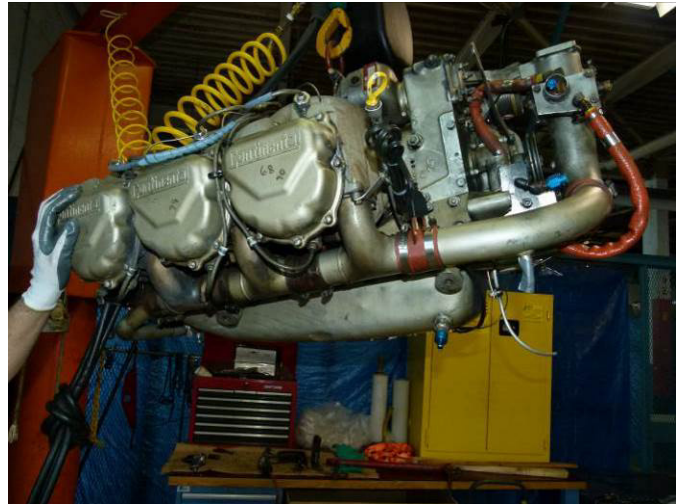
#### INDUCTION SYSTEM

All induction components were intact and did not exhibit damage

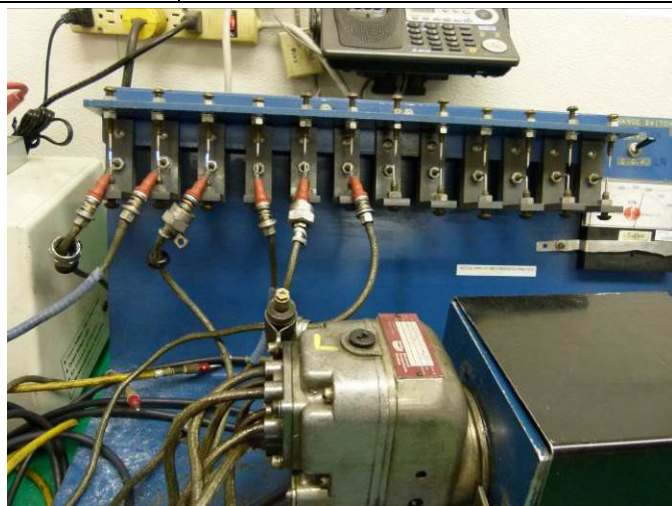
### LEFT MAGNETO

The magneto was bench tested and performed satisfactorily

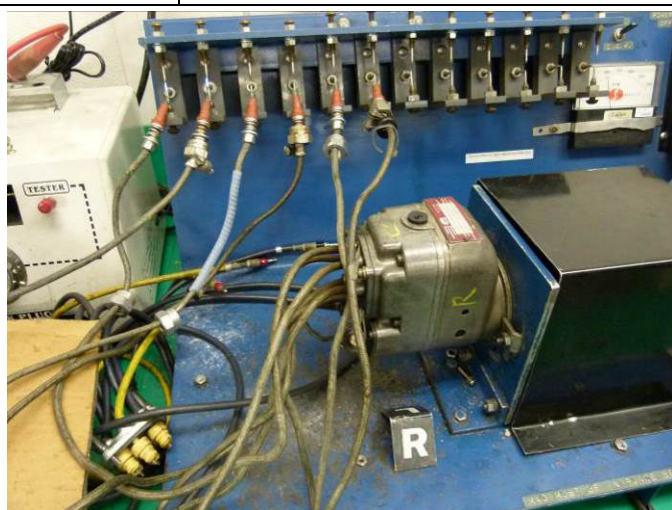
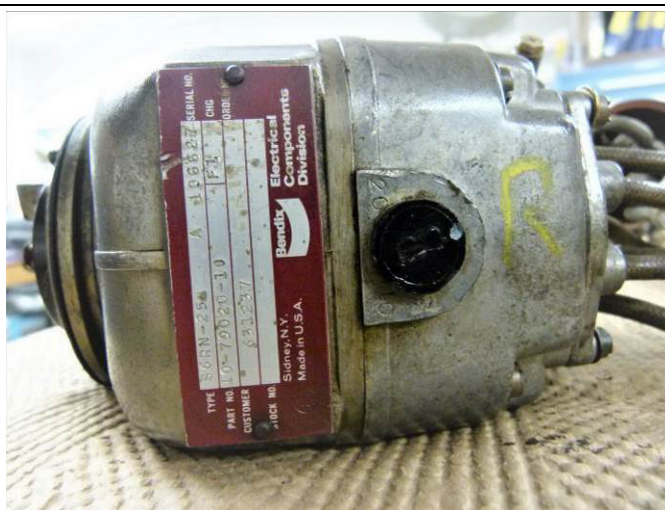
### RIGHT MAGNETO

The magneto was bench tested and performed satisfactorily

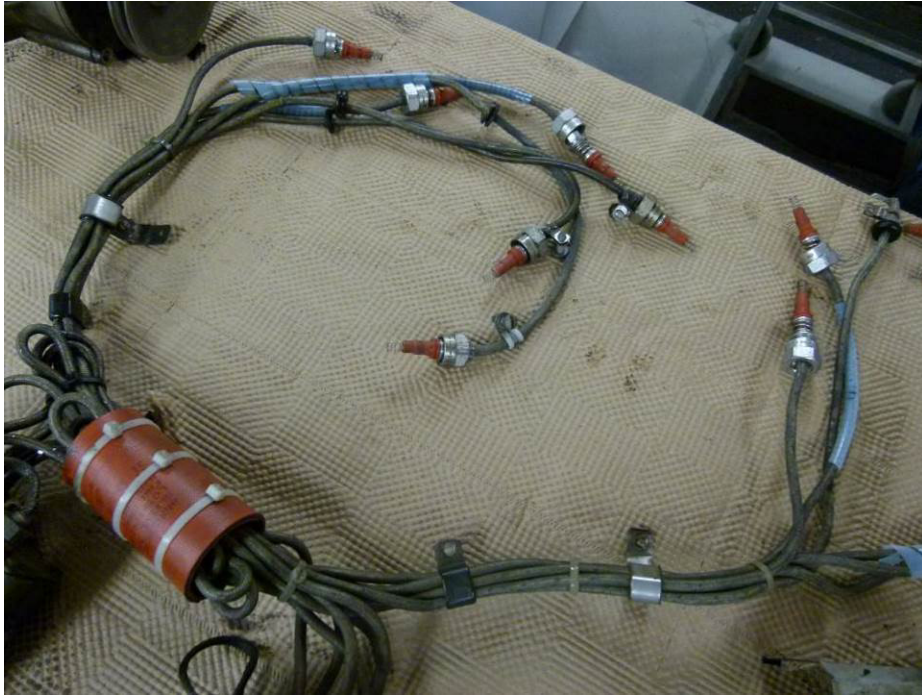
| Condition: | The ignition harness did not exhibit damage. | | |

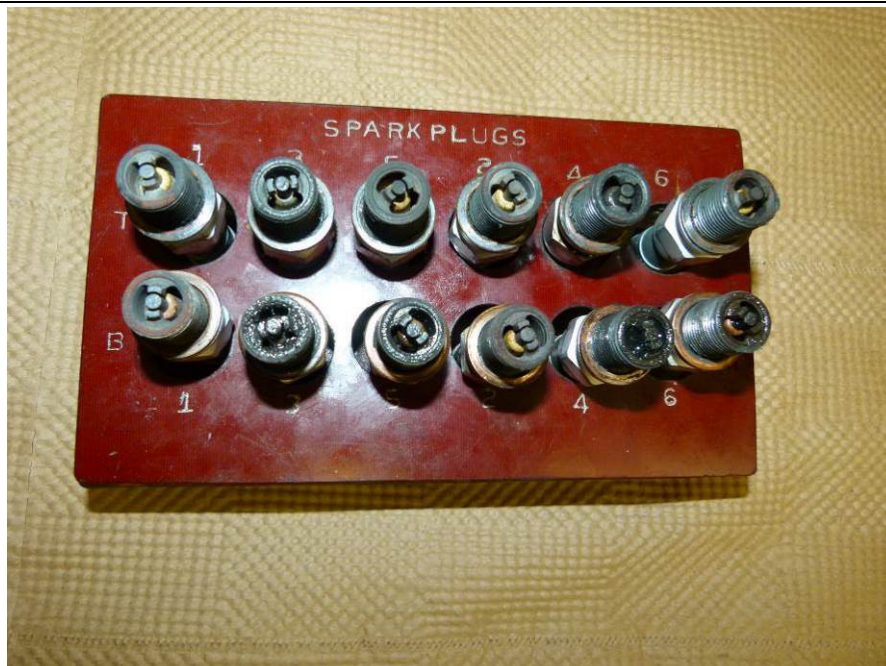
| Condition: | Top sparkplugs were normal in coloration and <i>normal</i> to <i>worn-out normal</i> condition. Bottom sparkplugs from cylinders 2, 3, 4, and 6 were oil contaminated. | |

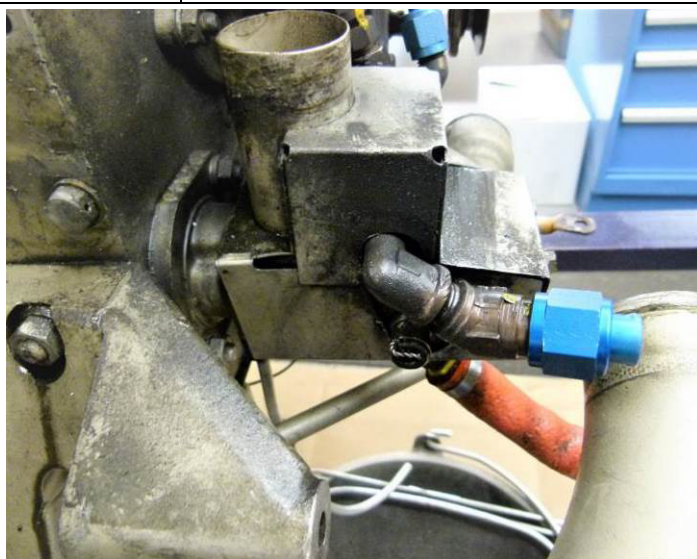
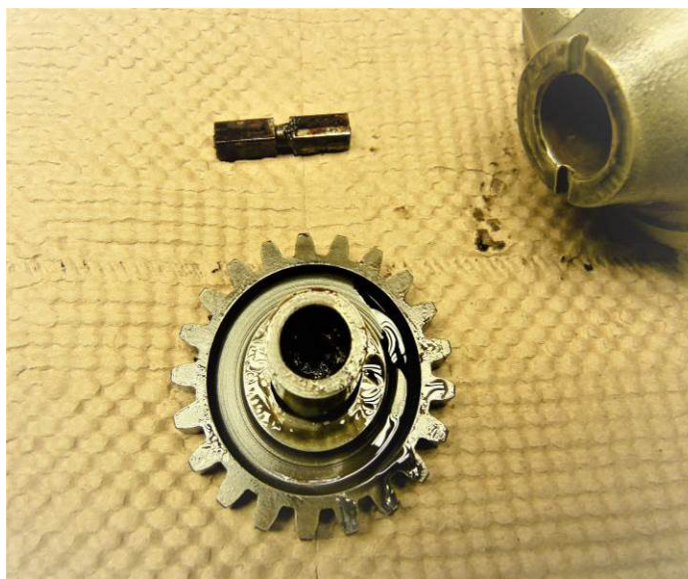
| Condition: | The fuel pump was not damaged. The pump operated smoothly when manually rotated. The drive coupling and gear were intact. The fuel pump was bench tested "as received" and flow results are listed below. | | |

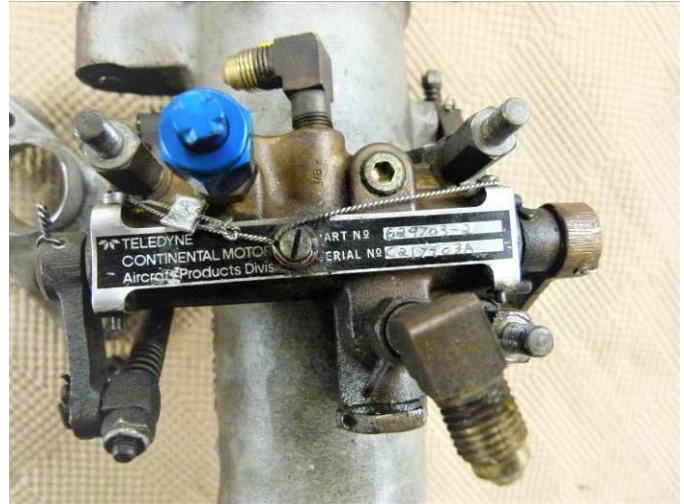
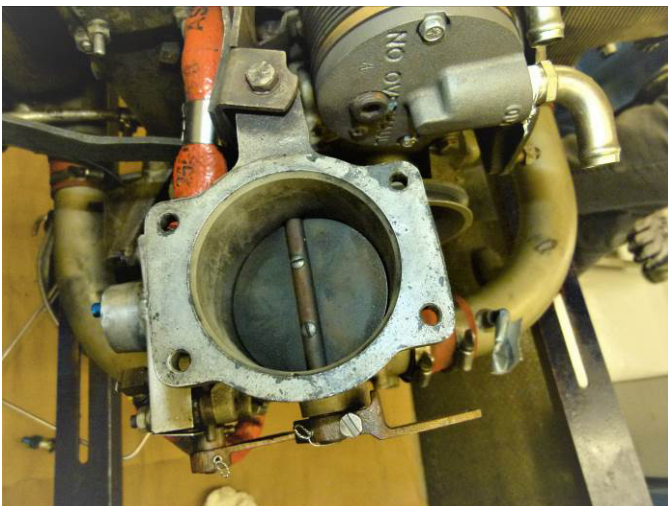
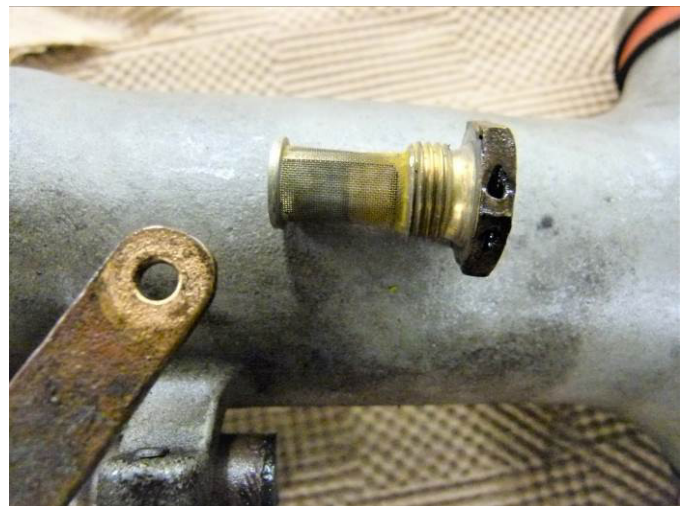
## THROTTLE BODY METERING UNIT

Condition: Control arms were secured correctly. The throttle plate operated correctly. The fuel screen was uncontaminated. A small amount of fuel drained from metering unit when storage caps were removed.

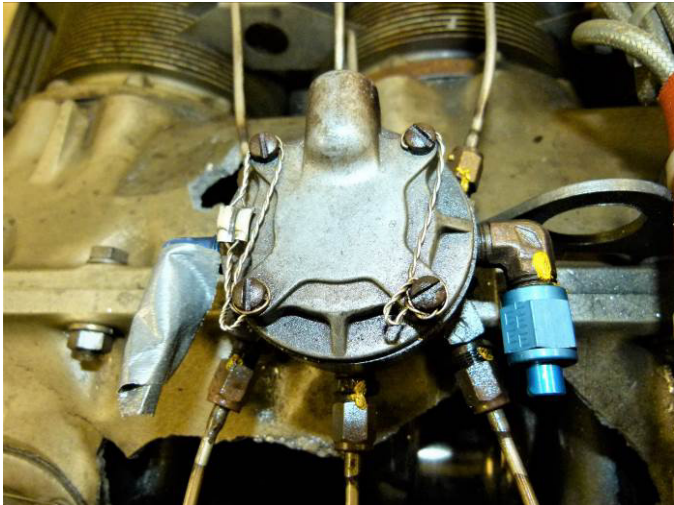
| Condition: | Assembly screws were secured and a lead seal was in place. Data plate missing. | | |

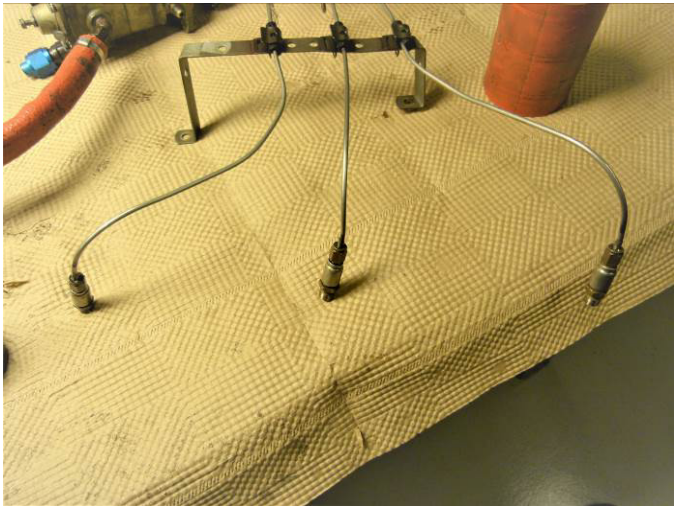
| Condition: | All fuel injector nozzles were open | | | | | |

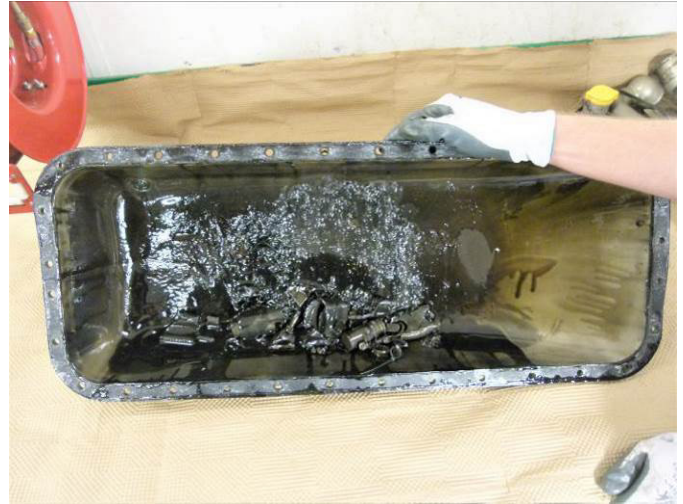
#### OIL SUMP

Condition: The oil sump was undamaged. Metal contamination was exhibited when the oil sump was removed. **NOTE:** The oil sump heat pad was tested and found operational. Red arrow points to installed oil sump heat pad.

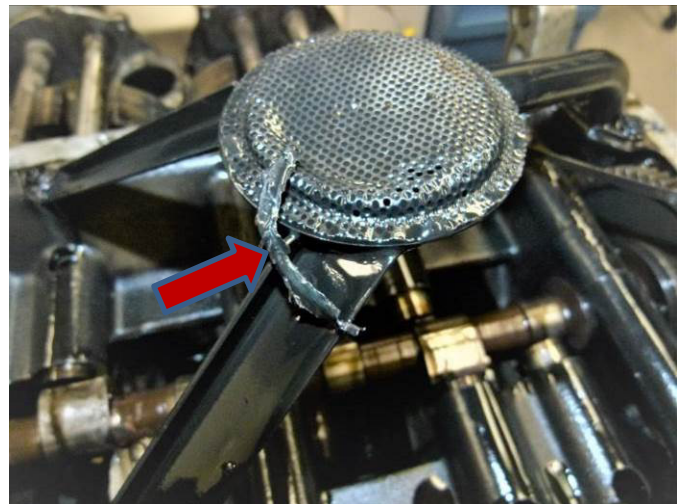
#### OIL PICK-UP TUBE & SCREEN

Condition: A small quantity of metal debris was present on the pick-up screen. Red arrow points to debris.

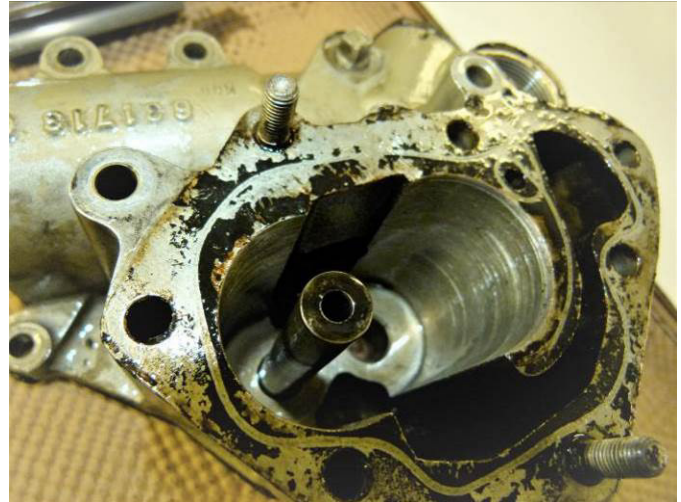
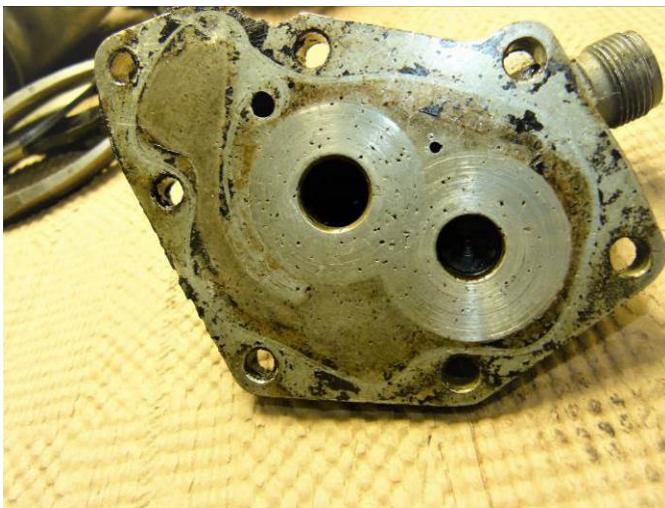
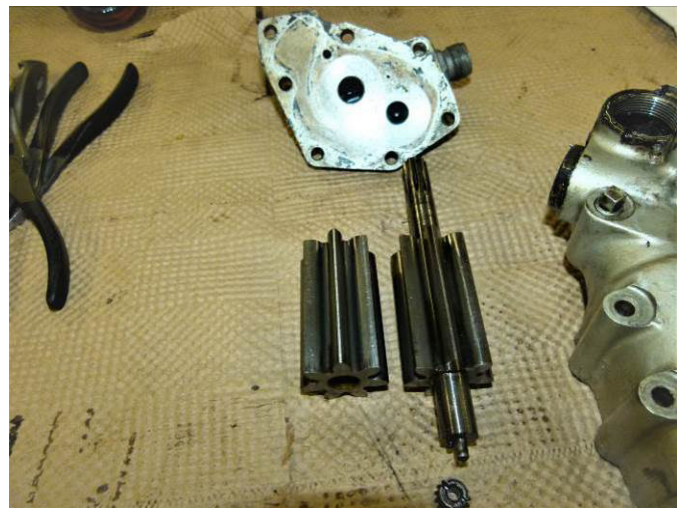
### OIL PUMP

The oil pump was disassembled and inspected. The sealant on the parting surface does not appear to be sealant used by CMI at this location. The pump chamber and cover plate exhibits evidence of hard partial passage and pitting. Pump gears indicated wear and light scratches from metal contamination.

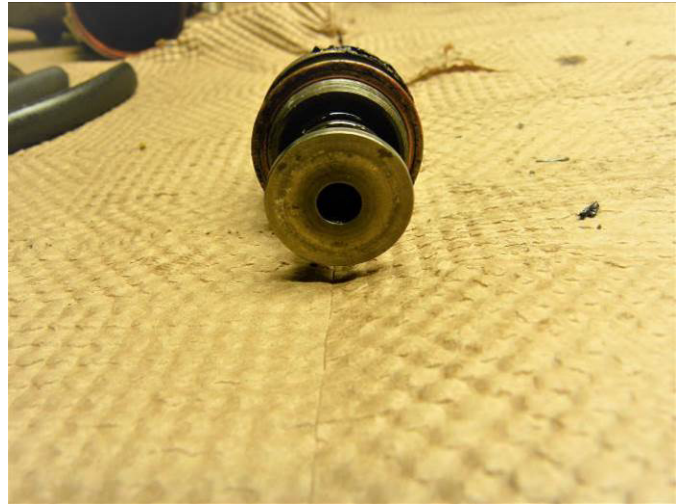
### OIL PRESSURE RELIEF VALVE

**Condition:** The oil pressure relief valve had evidence of sealant on the oil pressure relief valve body. A copper gasket (crush washer) part number MS35769-26 is the proper interface for this component. A red arrow points to sealant.

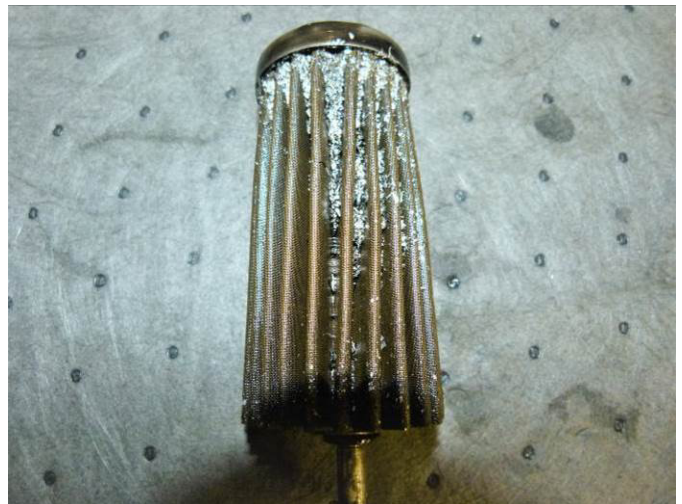
### OIL SCREEN

**Condition:** The reusable oil screen contained ferrous and non-ferrous metal contamination.

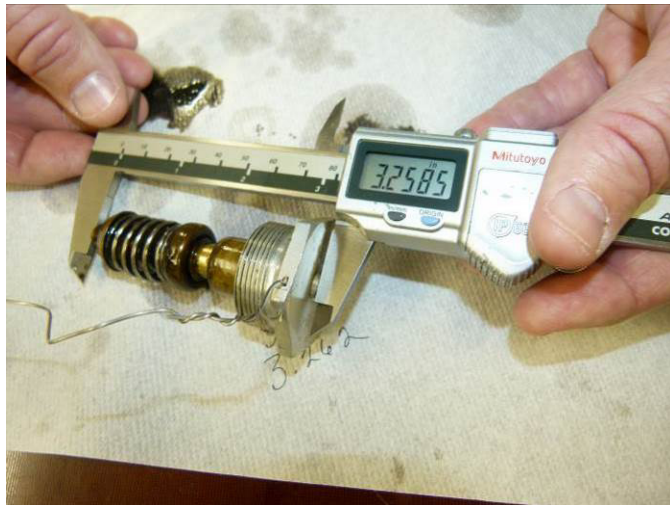
## VERNATHERM

Condition: The vernitherm was removed and functionally tested. When heated in liquid, the spring extends fully at 178 °F. Specified travel range is from 3 inches to 3.262 inches. This component met specifications during the functional test.

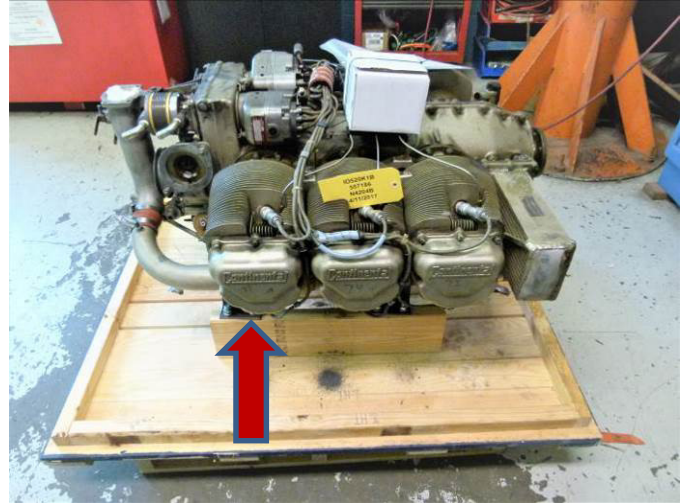
| Condition: | Externally, cylinder 1 did not exhibit impact damage. | | |

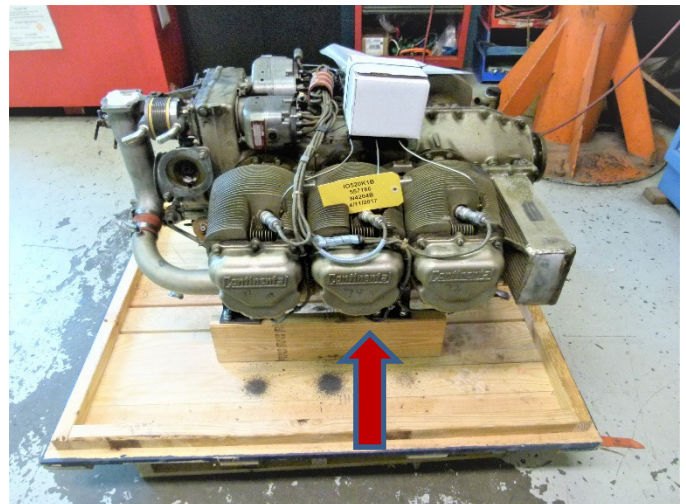
| Condition: | Externally, cylinder 3 did not exhibit impact damage. Internally, the cylinder skirt was damaged by released rotating components. | | |

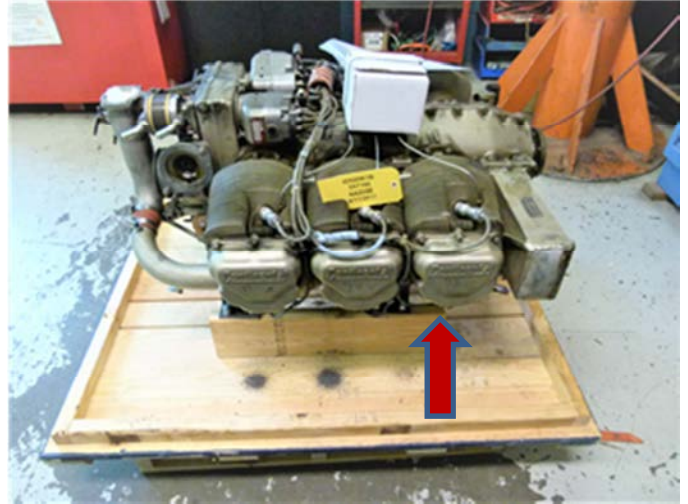
| Condition: | Externally, cylinder 5 did not exhibit impact damage. | | |

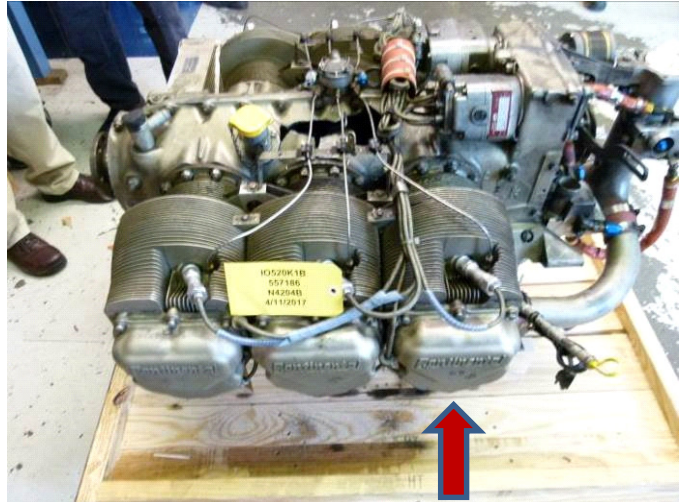
| Condition: | Externally, cylinder 2 did not exhibit impact damage. | | |

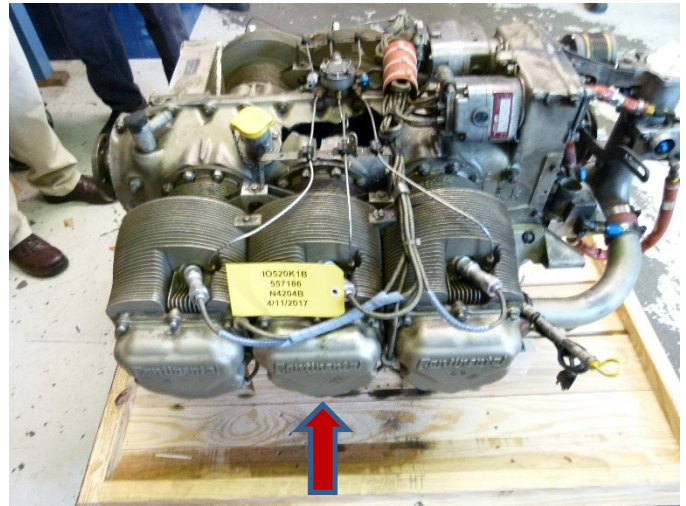
## CYLINDER #4

Externally, cylinder 4 did not exhibit impact damage. Internally, the cylinder skirt was damaged by released rotating components.

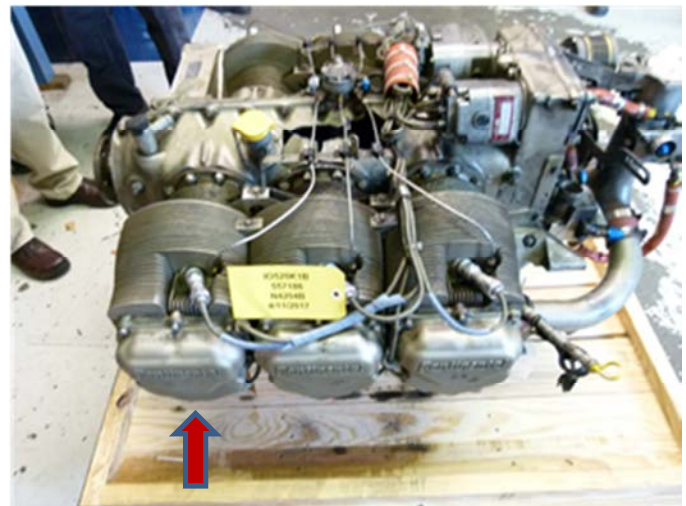
## CYLINDER #6

Externally, cylinder 6 did not exhibit impact damage.

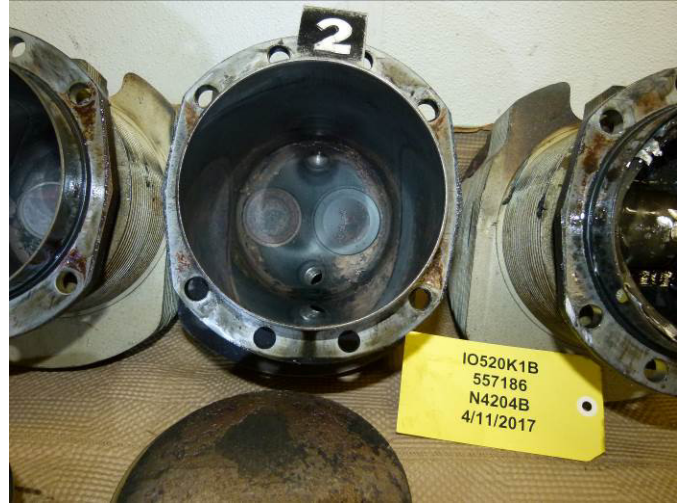
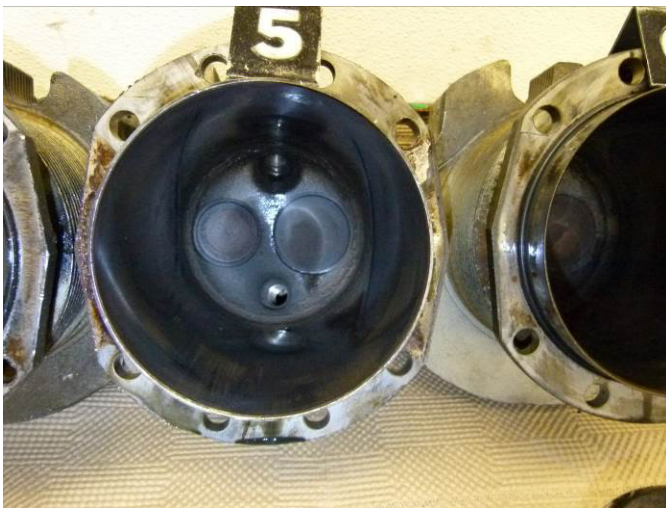
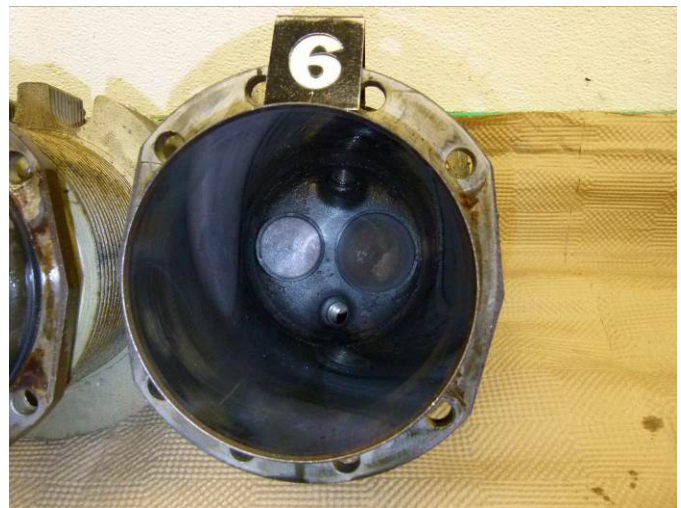
All valves were intact with normal combustion signatures. No photo available for cylinders 3 or 4

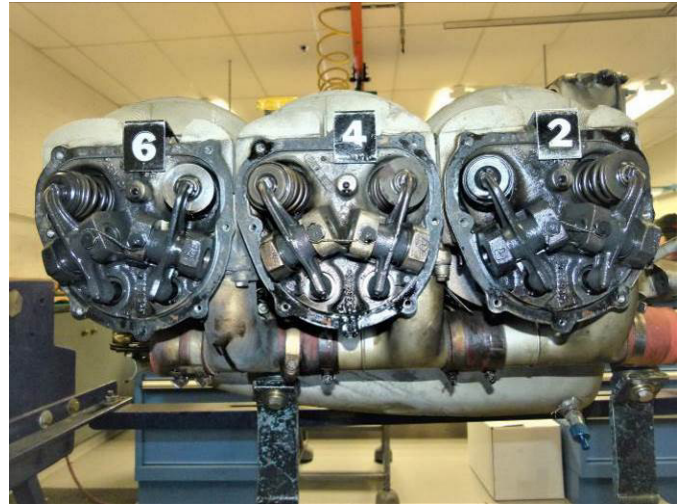
All rocker arms and shafts were intact and did not exhibit damage.

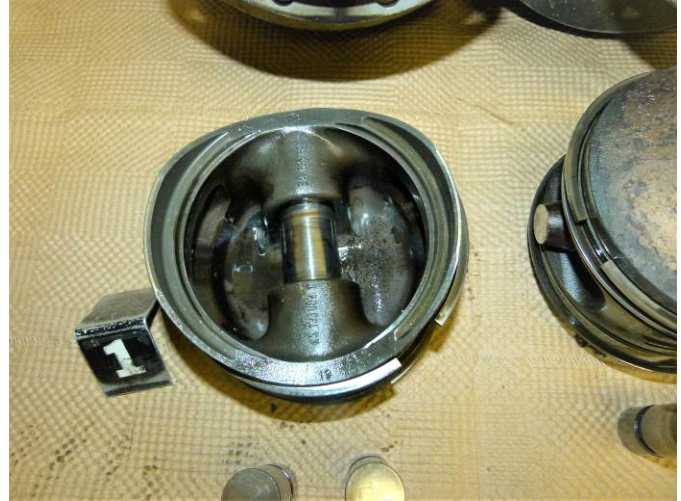
The piston dome exhibited normal combustion signatures. Rings and piston pin were normal.

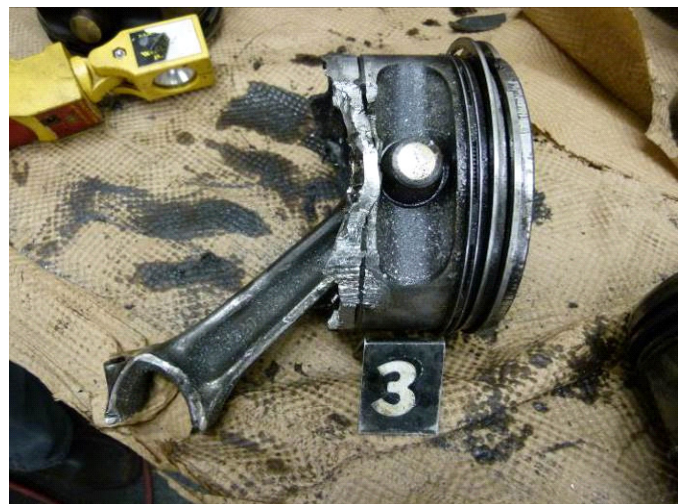
## #3 PISTON, RINGS AND PIN

The piston skirt was mechanically damaged. The piston had to be cut from the damaged cylinder.

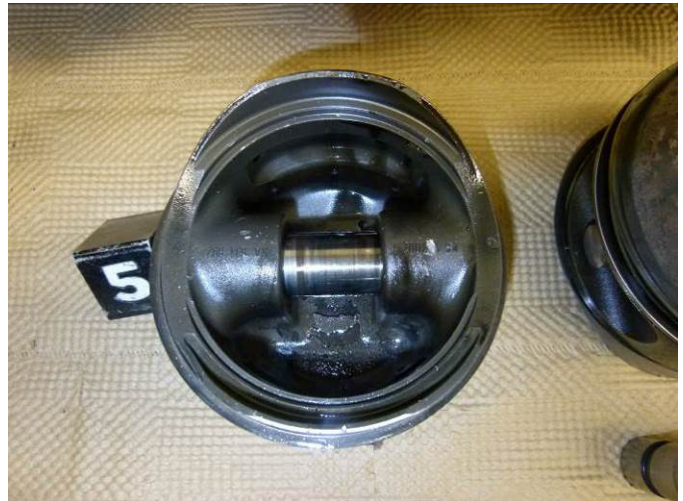
**Condition:** The piston dome exhibited normal combustion signatures. Rings and piston pin were normal.

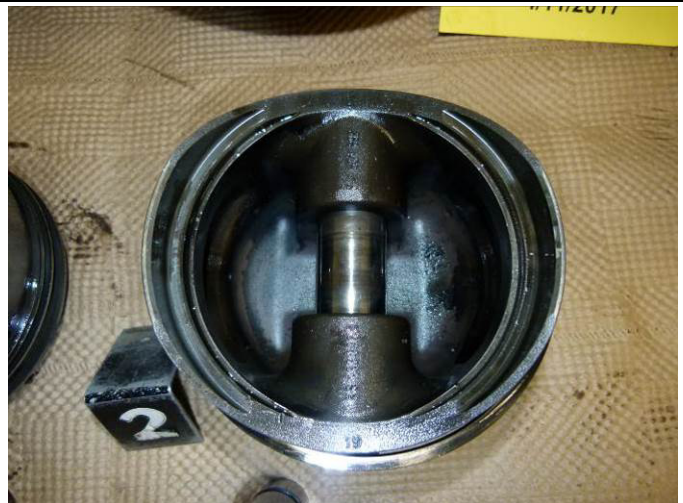
## #2 PISTON, RINGS AND PIN

**Condition:** The piston dome exhibited normal combustion signatures. Rings and piston pin were normal.

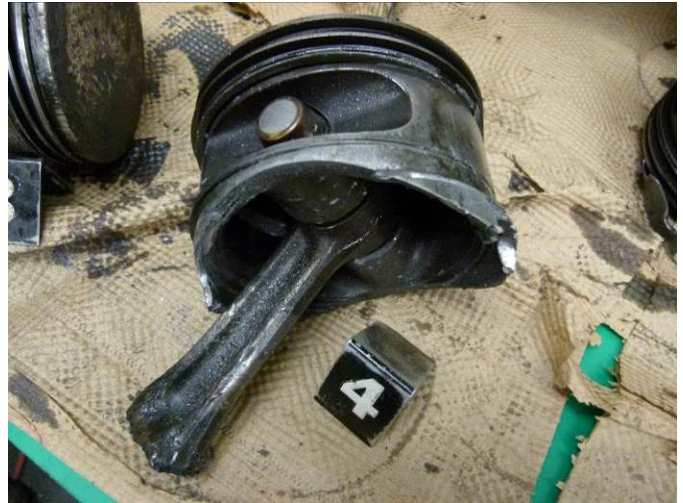
The piston skirt was mechanically damaged and the piston was cut from the damaged cylinder. Piston rings and pin were intact.

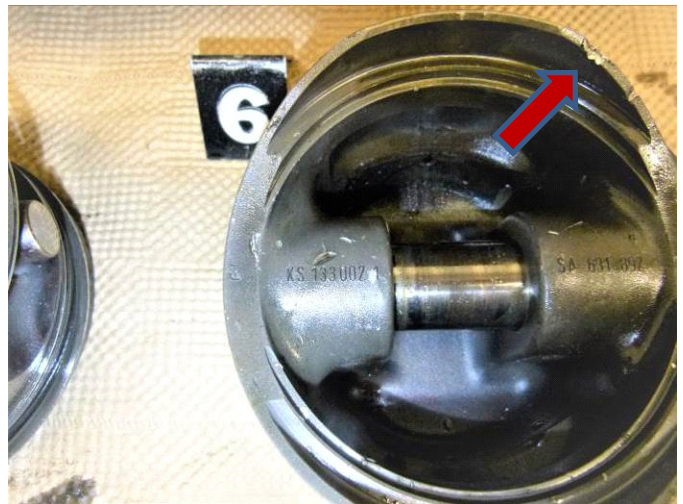
### #6 PISTON, RINGS AND PIN

The piston dome exhibited normal combustion signatures. Rings and piston pin were normal. The piston skirt was mechanically damaged. Red arrow points to skirt damage.

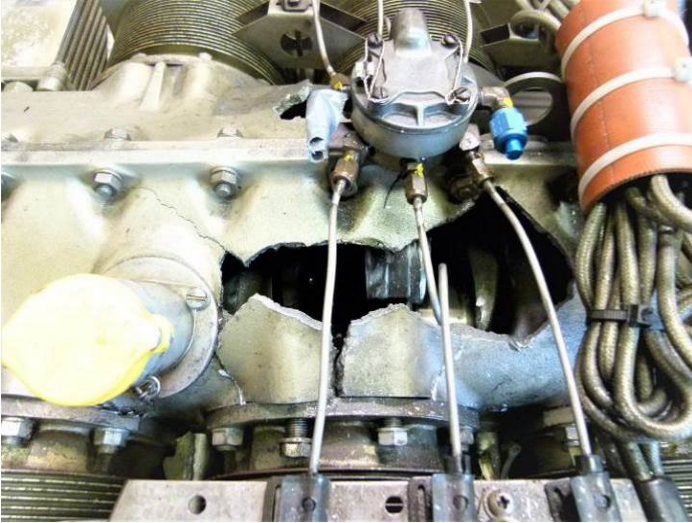
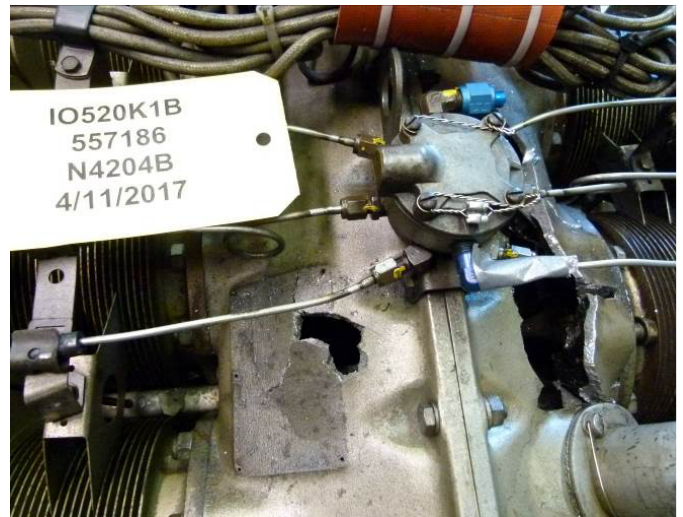
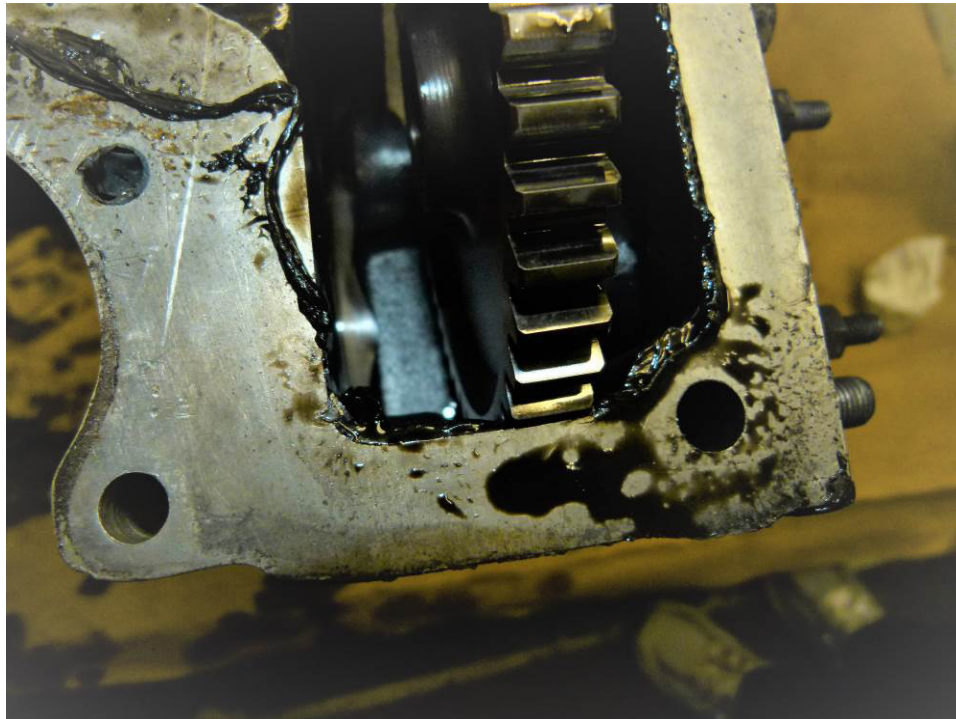
| Condition: | Both crankcase halves received damage due to uncontained rotational component issues. Non-CMI sealant was used on case-half parting surfaces. | | | |

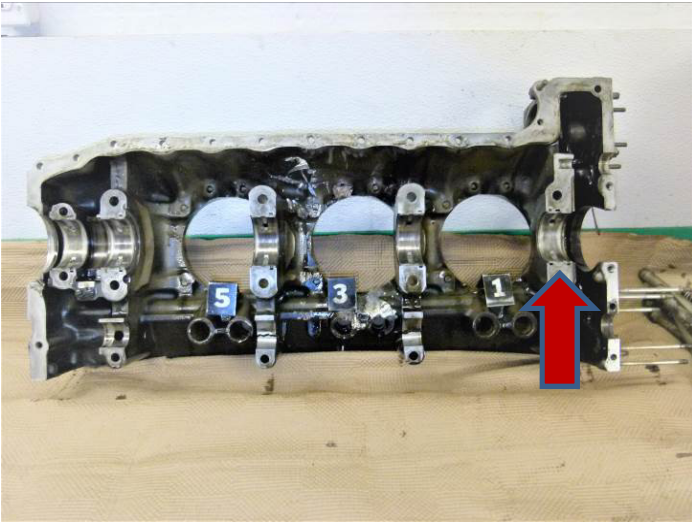
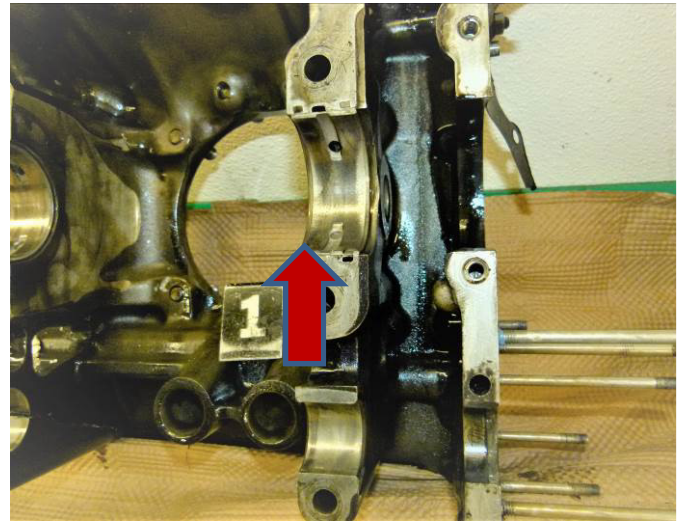
Red arrow points to # 1 main bearing. The bearings were intact and exhibited an insignificant amount of contamination and hard particle passage

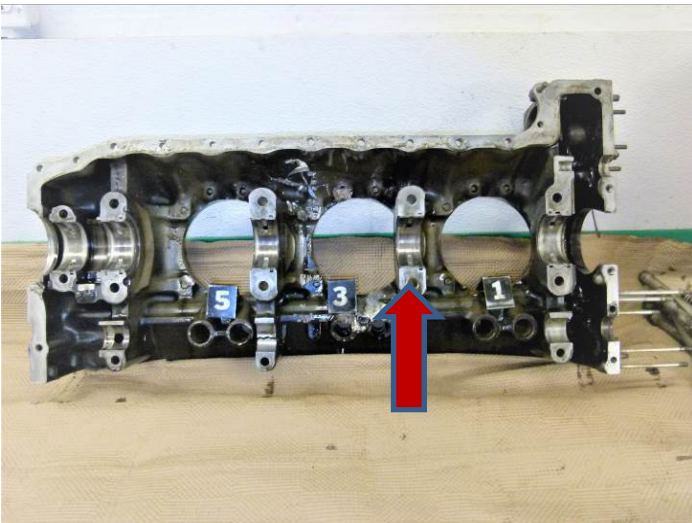
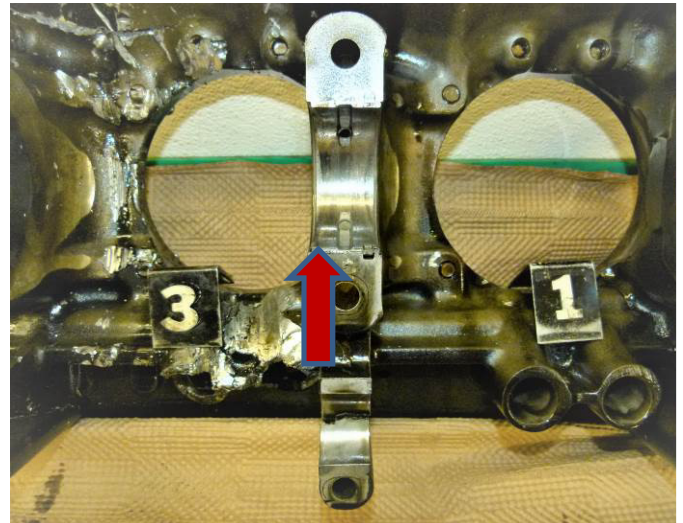
## #2 MAIN BEARINGS

Red arrow points to # 2 main bearing. The bearings were intact and exhibited an insignificant amount of contamination and hard particle passage

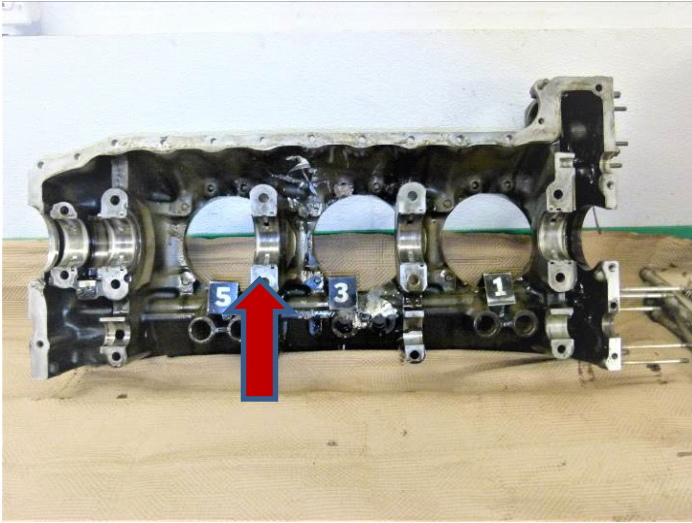
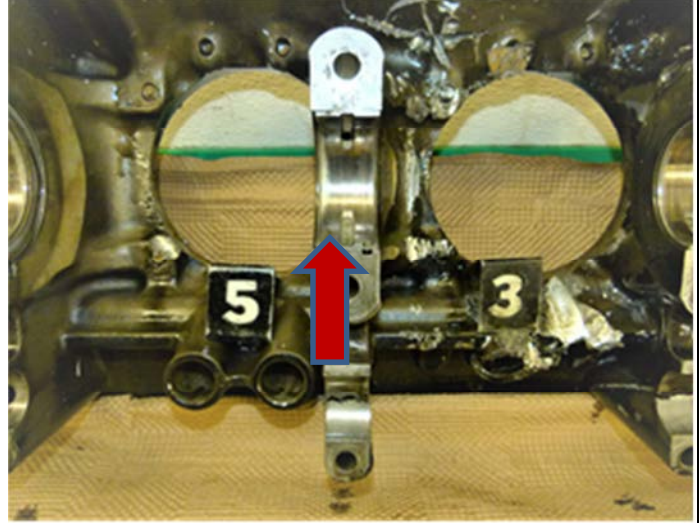
Red arrow points to # 3 main bearing. The bearings were intact and exhibited an insignificant amount of contamination and hard particle passage

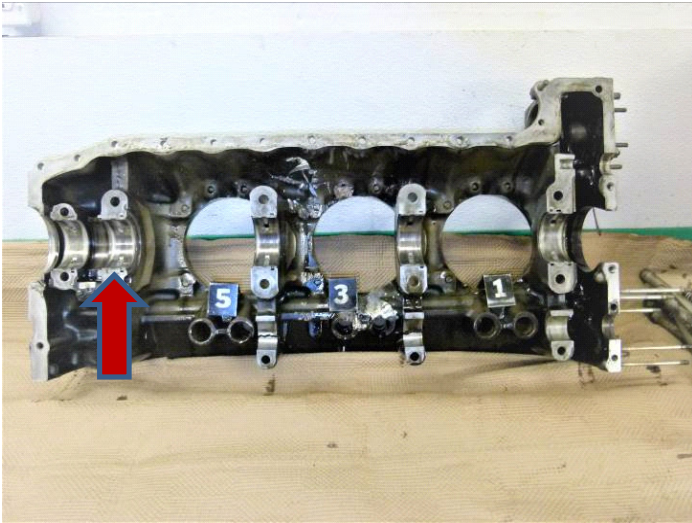
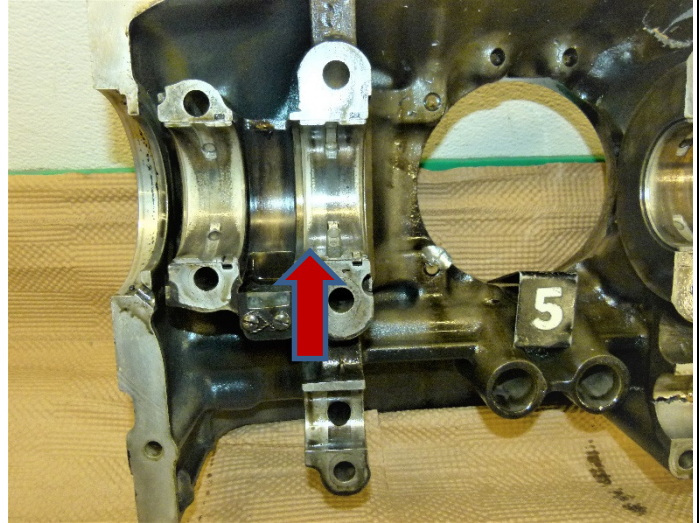
### #4 MAIN BEARINGS

Red arrow points to # 4 main bearing. The bearings were intact and exhibited an insignificant amount of contamination and hard particle passage

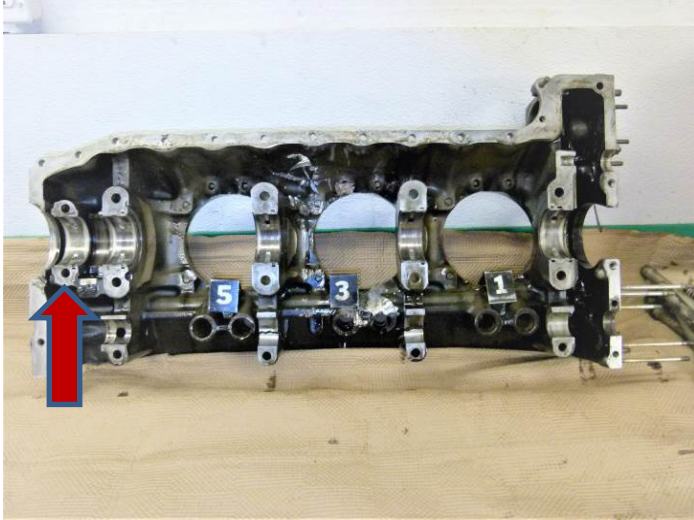
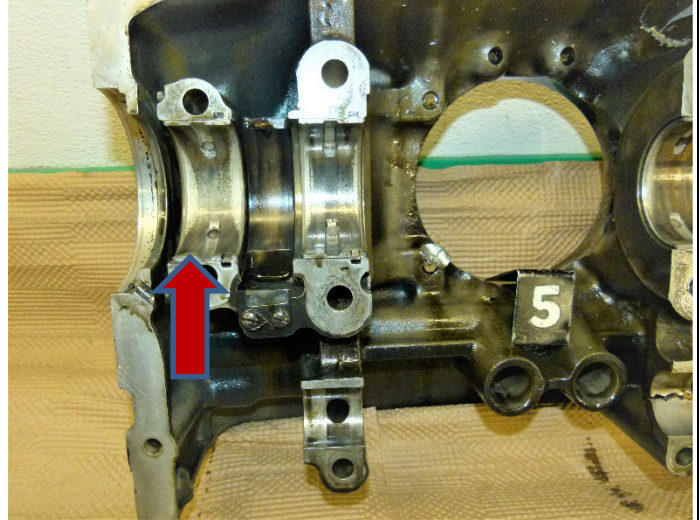
Condition: Red arrow points to # 5 main bearing. The bearings were intact and exhibited an insignificant amount of contamination and hard particle passage

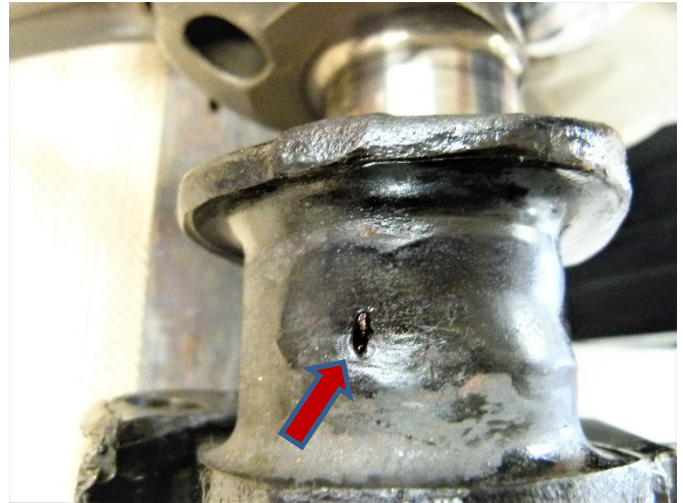
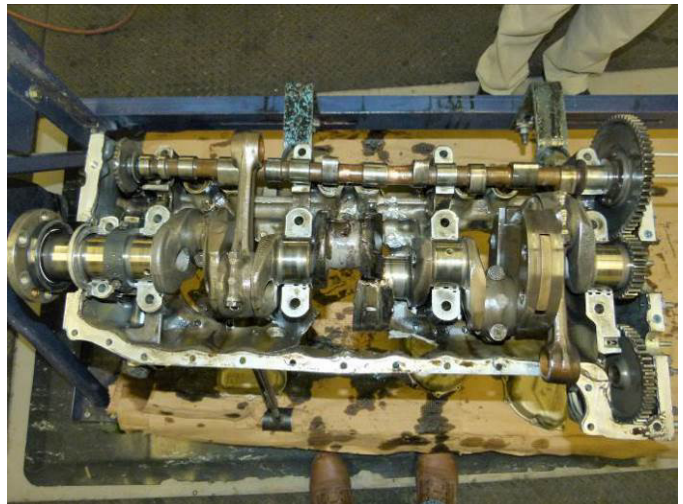
The engine suffered an oil starvation event for unknown reasons. The engine was being operated in an extremely cold environment on the day of the engine failure.

Condition: Crankshaft # 4 connecting-rod journal suffered catastrophic oil starvation damage. The red arrow points to light visible through the oil transfer tube to the journal oil orifice in #4 rod journal. No oil blockage was discovered in the oil galleys or transfer tubes. The nose seal assembly was protruding from the crankcase. The oil seal retainer plates and attaching hardware were not installed as received.

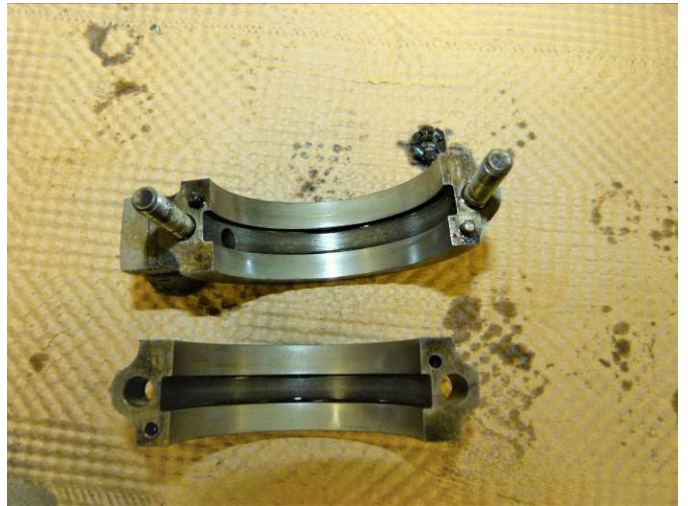
## TRANSFER COLLAR

The transfer collar exhibited normal wear patterns.

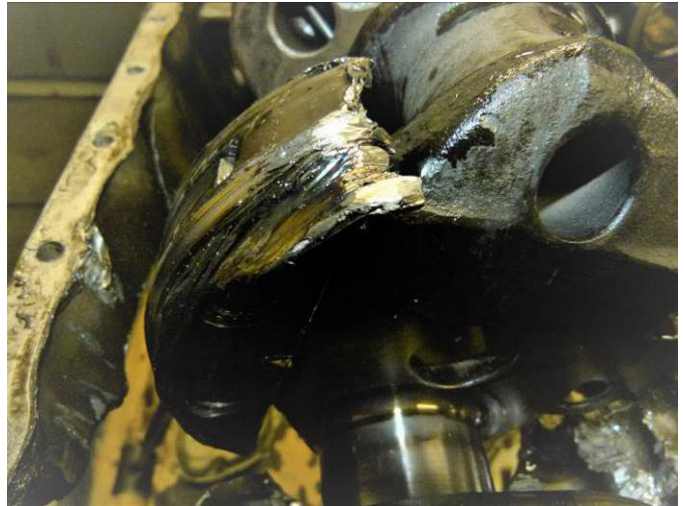
The rear counter weights were intact and free to move on pins. One of the forward counter weights released for undetermined reasons. The opposing forward counterweight remained attached to pins but was damaged.

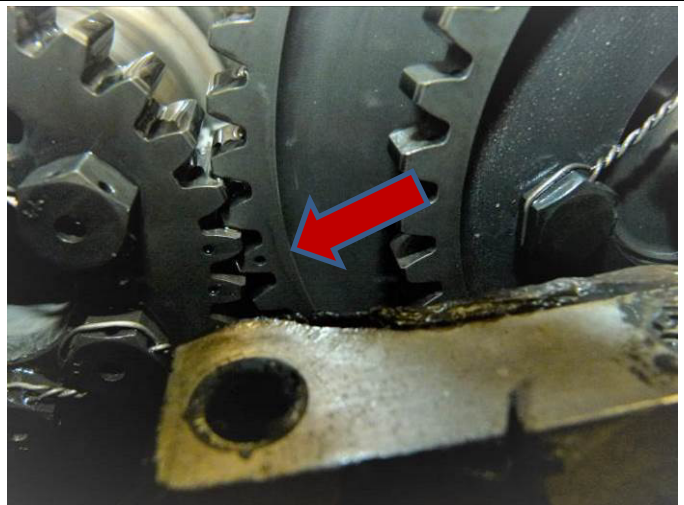
### INTERNAL TIMING

The internal timing marks aligned when piston 1 was positioned at top dead center

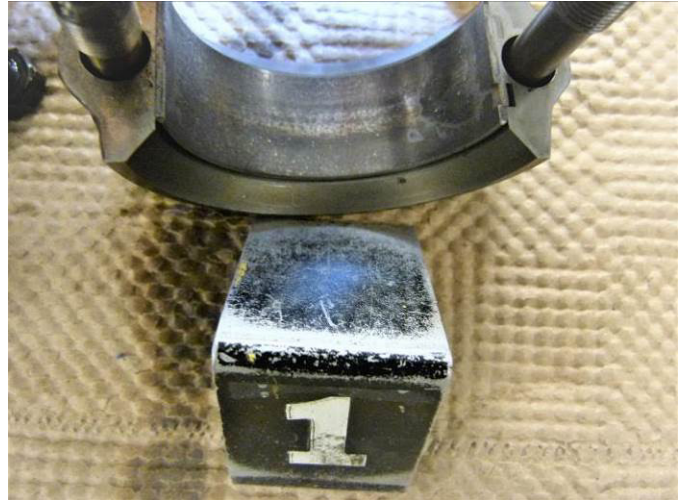
Condition: The connecting rod did not exhibit damage.

Condition: The bearing exhibited hard particle passage and contamination embedded in the Babbitt layer.

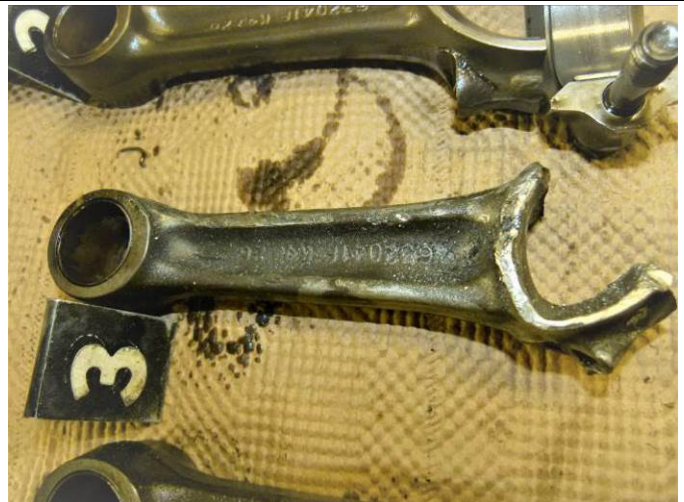
## #3 CONNECTING ROD

Condition: #3 rod was damaged and the rod cap separated.

Condition: #3 rod bearing was extruded and destroyed from mechanical damage.
