# Continental Motors

## ENGINE EXAMINATION REPORT

| ENGINE MODEL | IO520K (1A) |
| FILE NUMBER | 16-327 |

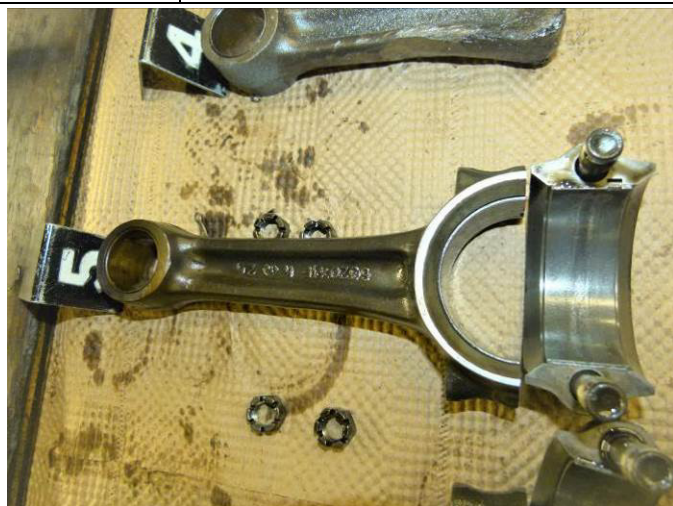
Condition: The connecting rod did not exhibit damage.

Condition: The bearing exhibited hard particle passage and contamination embedded in the Babbitt layer.

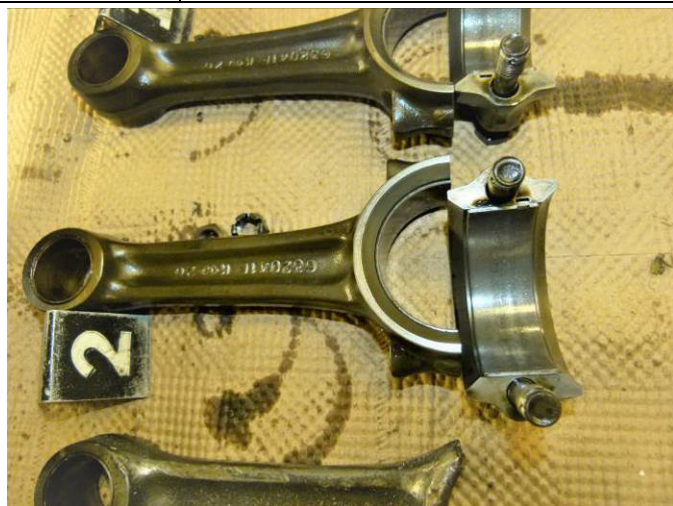
## #2 CONNECTING ROD

Condition: The connecting rod did not exhibit damage.

Condition: The bearing exhibited hard particle passage and contamination embedded in the Babbitt layer.

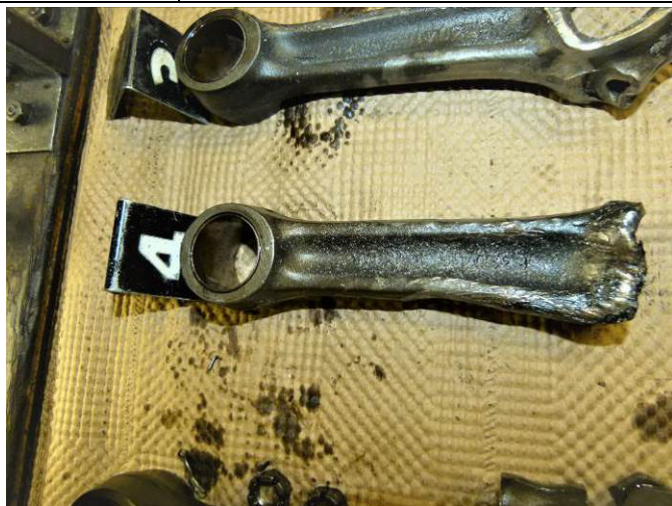
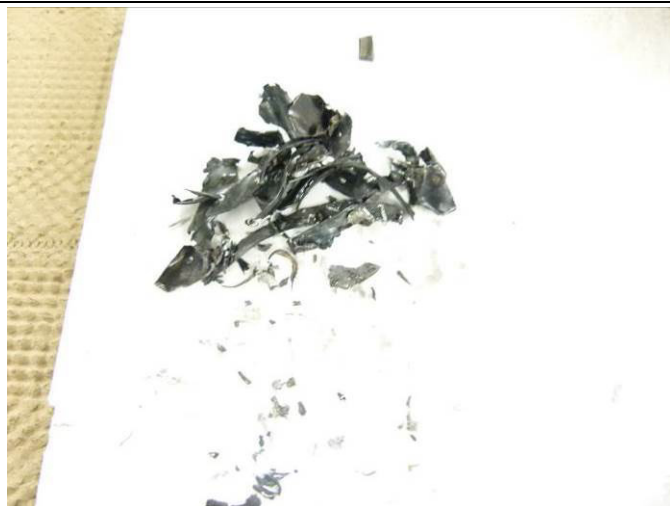
Condition: #4 rod was damaged and the rod cap separated.

Condition: #4 rod separated at the rod cap due to oil starvation.

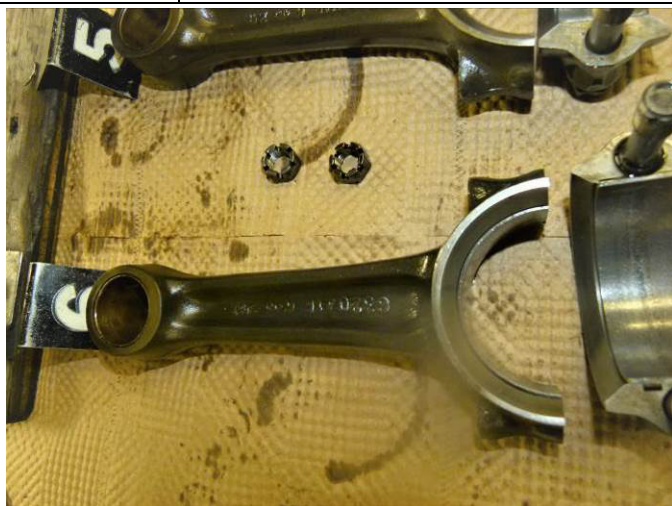
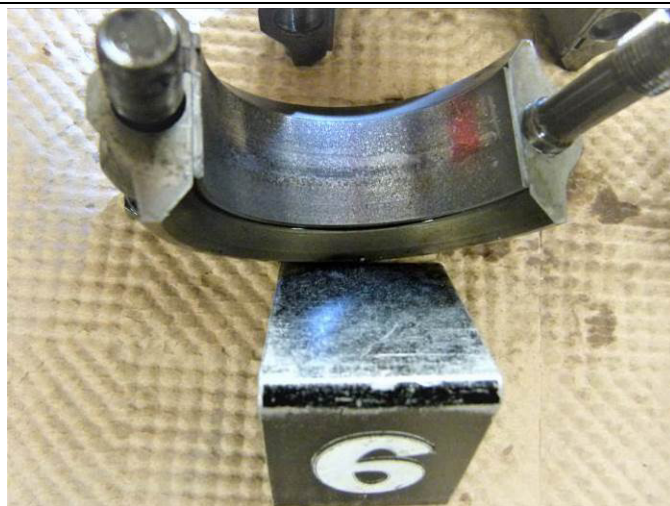
## #6 CONNECTING ROD

Condition: The connecting rod did not exhibit damage.

Condition: The bearing exhibited hard particle passage and contamination embedded in the Babbitt layer.

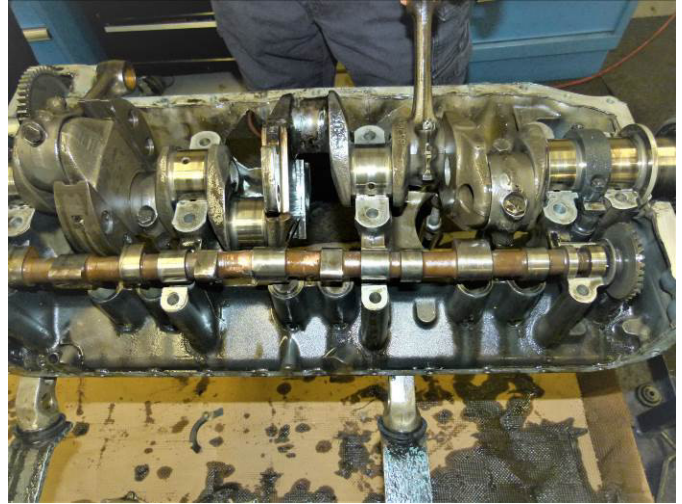
| <b>Condition:</b> | The camshaft received impact damage from released counter weight. |

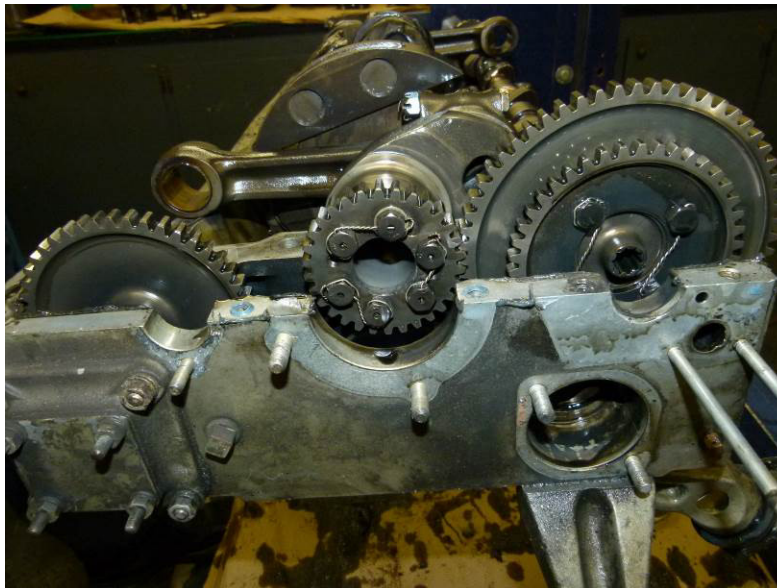
### ACCESSORY GEARS

| <b>Condition:</b> | Normal wear patterns were exhibited. Assembly bolts were secured correctly. |

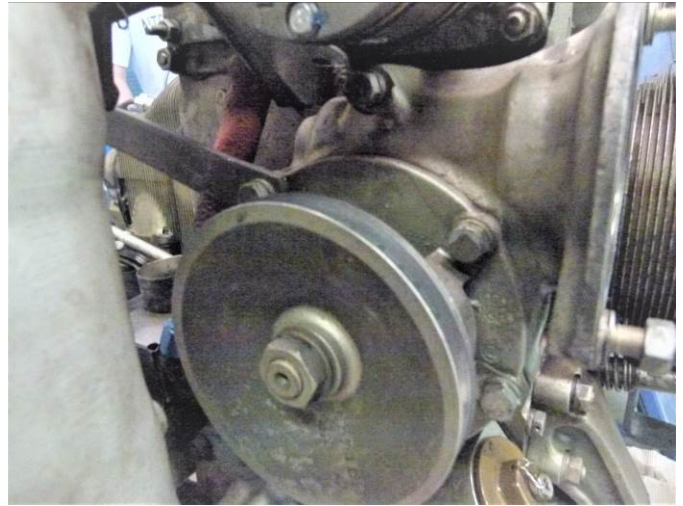
| Condition: | No damage was exhibited. The pulley was turned freely when the starter adapter was rotated manually. Note: starter motor missing as received. | | |

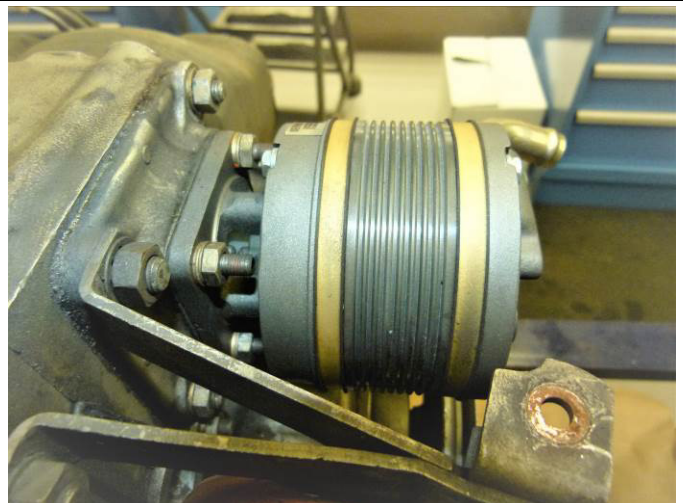
| Condition: | The vacuum pump rotated freely and appeared to be undamaged. | | |
