## **NATIONAL TRANSPORTATION SAFETY BOARD**

# **ENGINE EXAMINATION**

**CEN17LA068**

Location: Air Salvage of Dallas (ASOD)  
Date: January 12, 2017  
Aircraft: Mooney M20K: N1159G,  
NTSB IIC: Jason Aguilera

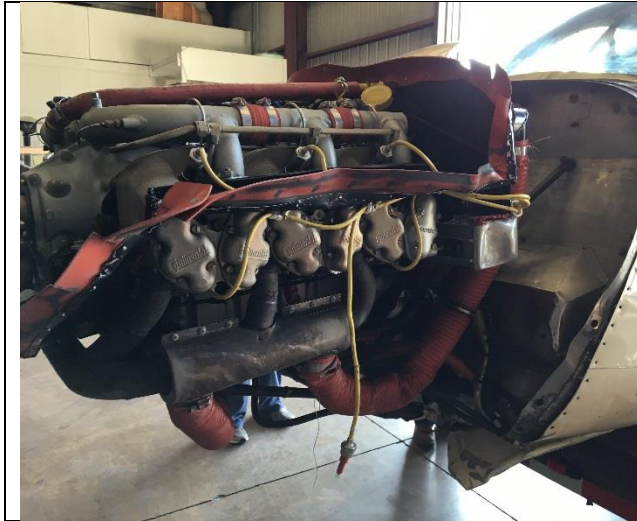
Engine with #4 cylinder, ignition lead repaired and rocker cover replaced.

Damage to oil cooler is noted

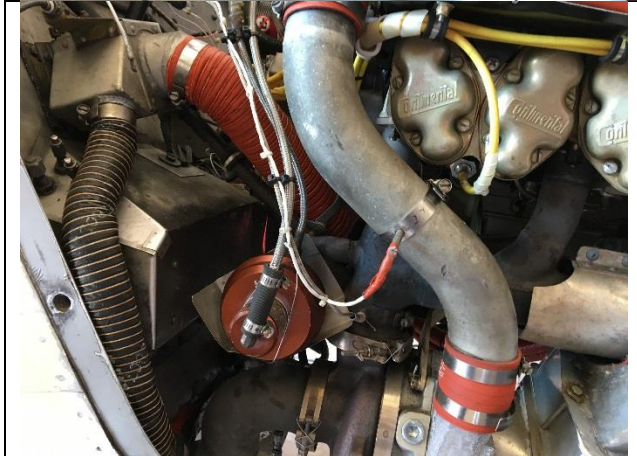
Waste gate controller, repaired and attached (safety wired) to the engine/mount.

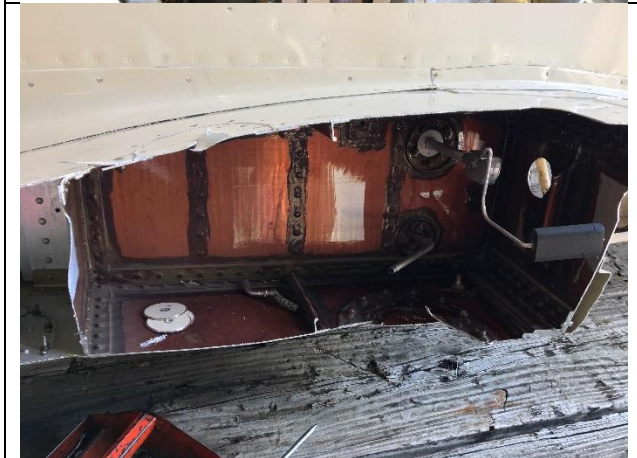
Wing fuel tank, and fuel pickup point.

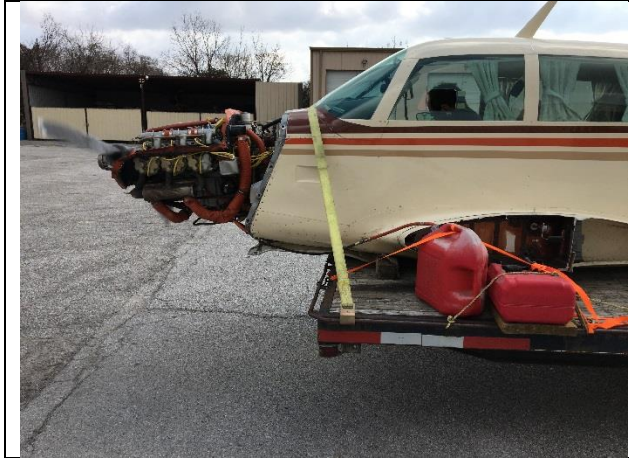
Fuel cans connect to fuel pickup points;  
Airplane on trailer ready for engine run.

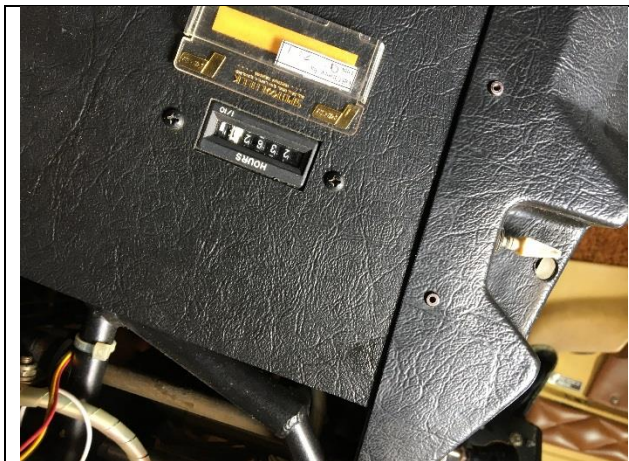
Hobbs meter: 2362.1

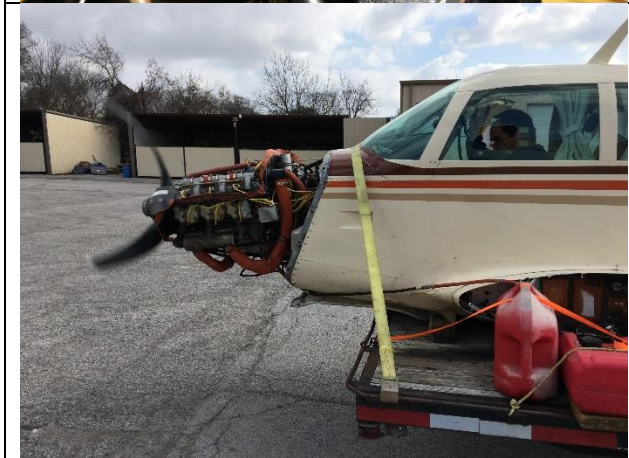
Engine run, during testing

Run #1- The engine was started and allowed to warm up (~6 minutes). With the engine running (with power) the fuel selector was switched from the right fuel tank, to the left tank. After a brief moment the engine started to lose power, the fuel selector was quickly switched back to the right side. The engine shuddered a couple times, but continued to run and resumed power.

Run #2 – The fuel lines were disconnected and shop air introduced to the fuel lines on both left and right sides, in order to drain the fuel lines completely. The fuel lines were then reconnected to the fuel respective fuel cans. With the right side tank selected, the engine boost/prime pump was able to deliver fuel to the engine. The engine was then started and run to power. The fuel selector was then moved to the left tank position. Again after a brief moment, the engine started to lose power; no operator/pilot action was conducted, and the engine continued to lose power until it stopped.

Run #3 - Without disconnecting the fuel lines, another run was conducted. Again the engine was started on the right side fuel tank. After the engine was brought to power, the fuel selector was switched to the left tank. Observation from outside the airframe, did not detect any noticeable differences. However, the operator inside the airframe, noted a drop in fuel pressure, and a slight decrease in engine manifold pressure, before recovering. It was presumed that the previous engine run and purged most of the air left side fuel line.

Run #4 and #5 – For the last two runs, the same procedure was conducted. Before the engine test started, the fuel lines were disconnected, and shop air was used to drain the fuel lines. The fuel lines were reconnected, the engine was primed by the boost/prime pump. With the right side fuel tank selected the engine was started and run to power. The fuel selector was then switched to the left side. After a brief moment, the engine would lose power, and without operator intervention, the engine would come to a complete stop.
