# Continental Motors

## ENGINE FIELD RUN REPORT

| ENGINE MODEL | IO-550-N7B |
| FILE NUMBER | 16-356 |

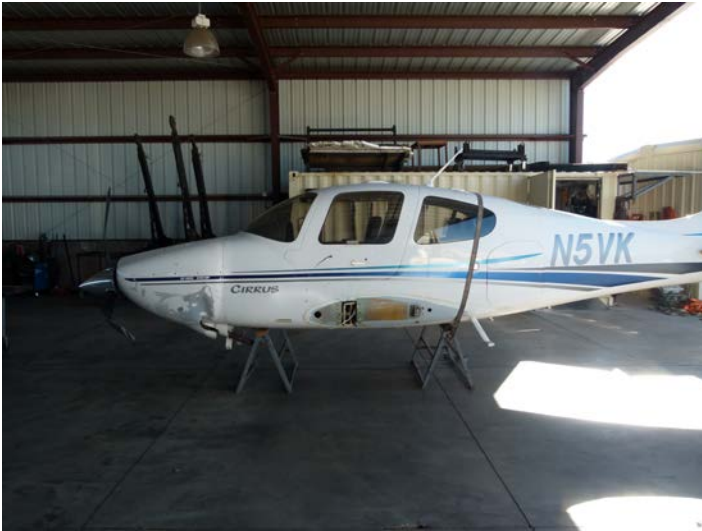
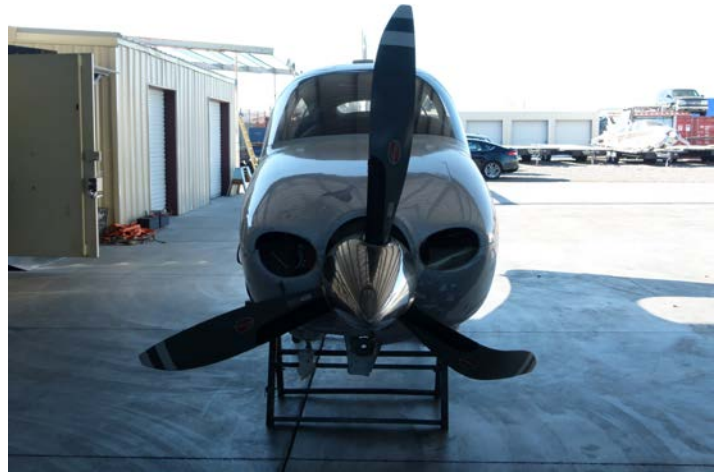
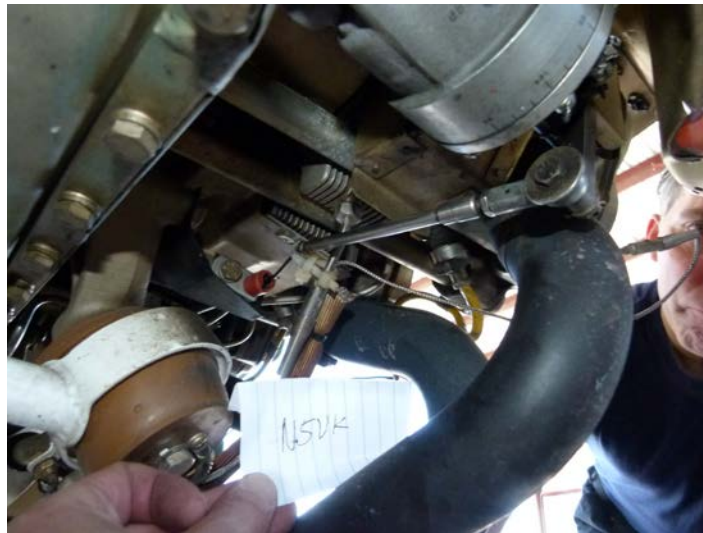
The engine remained attached to the airframe. All three blades of the propeller were bent aft. The propeller governor cable exhibited damage, the end of the conduit was pushed forward exposing the actual cable.

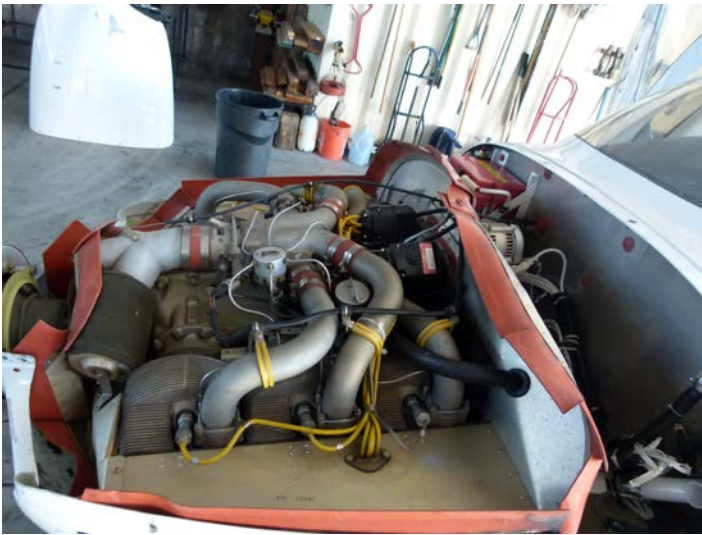
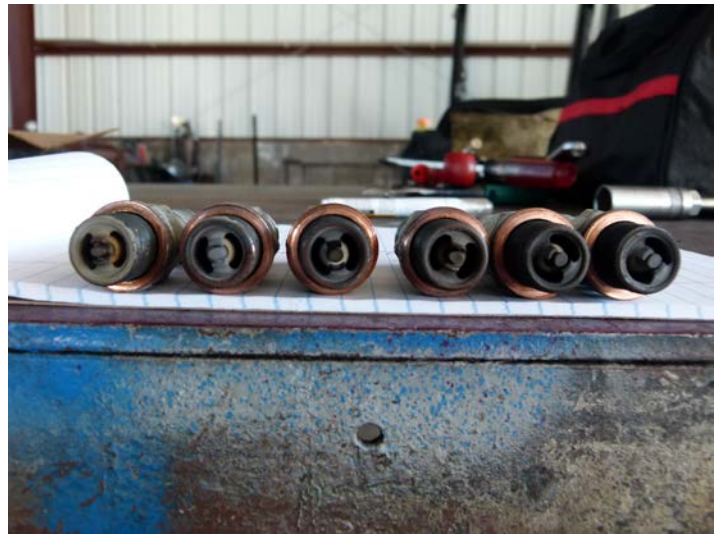
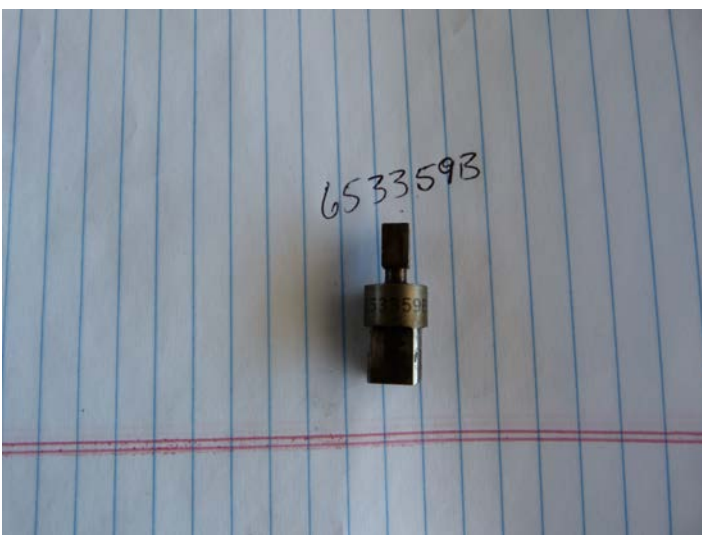
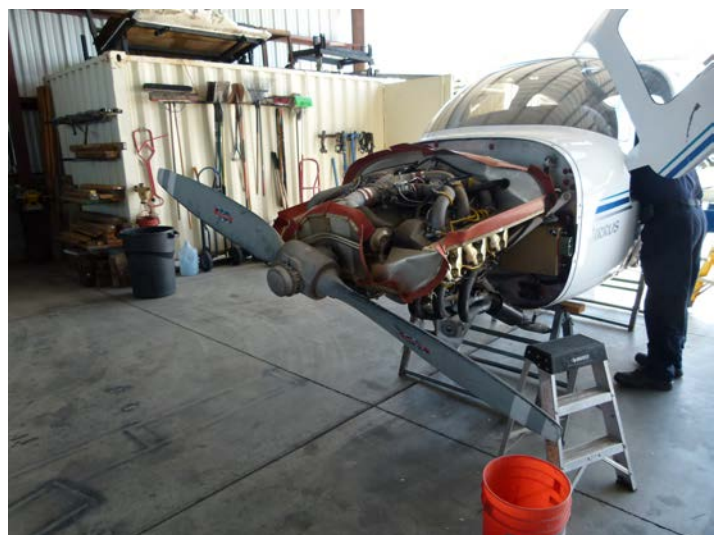
The top spark plugs were removed and had normal wear and light colored combustion deposits. The cylinder combustion chambers were examined with a lighted bore scope and no anomalies were noted. The engine driven fuel pump was removed and the drive coupling was intact. The fuel pump drive turned freely by hand. The crankshaft was rotated by hand using the propeller. Continuity to the accessory section was confirmed, spark was obtained on all six top spark plug leads and thumb compression was observed on all six cylinders.

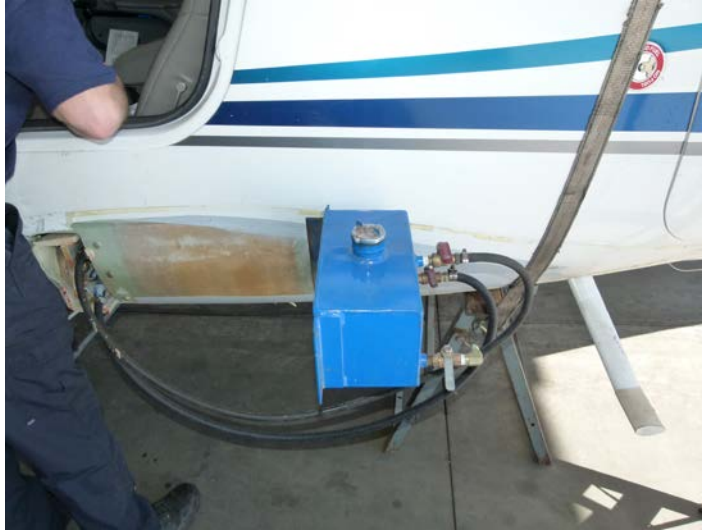
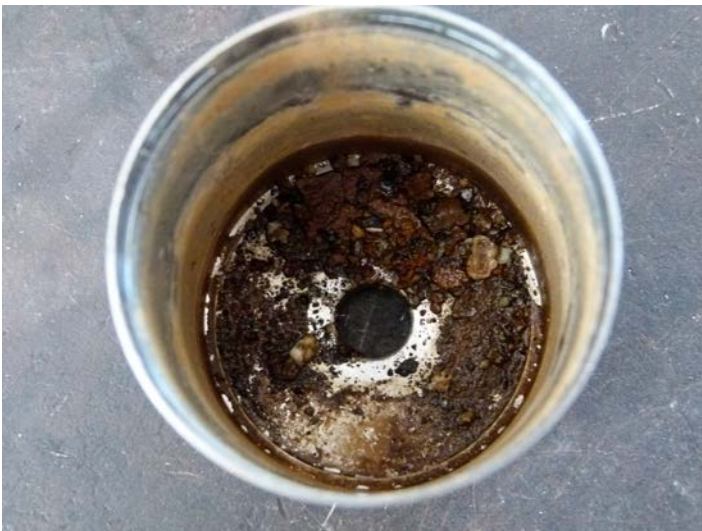
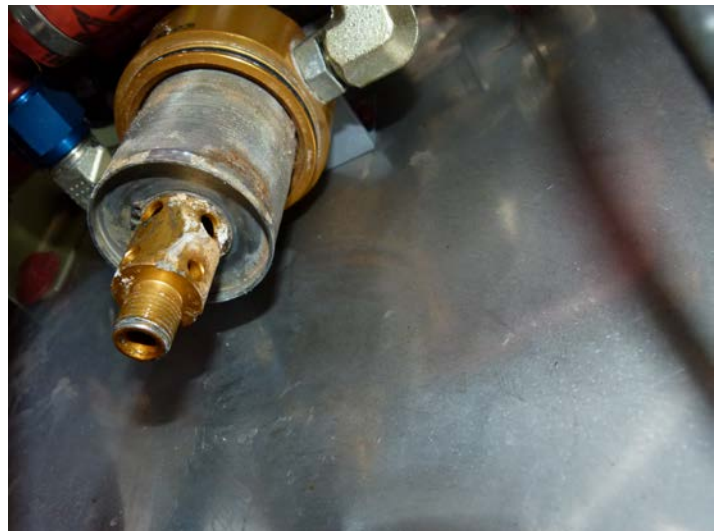
When the engine was primed with the electric fuel boost pump, fuel was observed draining from the fuel gasculator. The gasculator was removed and disassembled and debris and rust were noted in the bowl. A replacement gasculator was installed along with a sump drain. The engine was started normally by recovery company personnel who reported the throttle was gradually advanced to 2300 RPM and approximately 10" Hg. The engine ran smoothly with no interruptions or hesitations. The engine was shut down normally with the mixture control.
