## Introduction

This report includes analyses of PFD flight log data and MFD engine log data from the accident flight of N5VK on January 7, 2017. The analyses are limited to the time period from the start of the takeoff roll at approximately 15:21 UTC to the end of the flight at approximately 16:52 UTC.

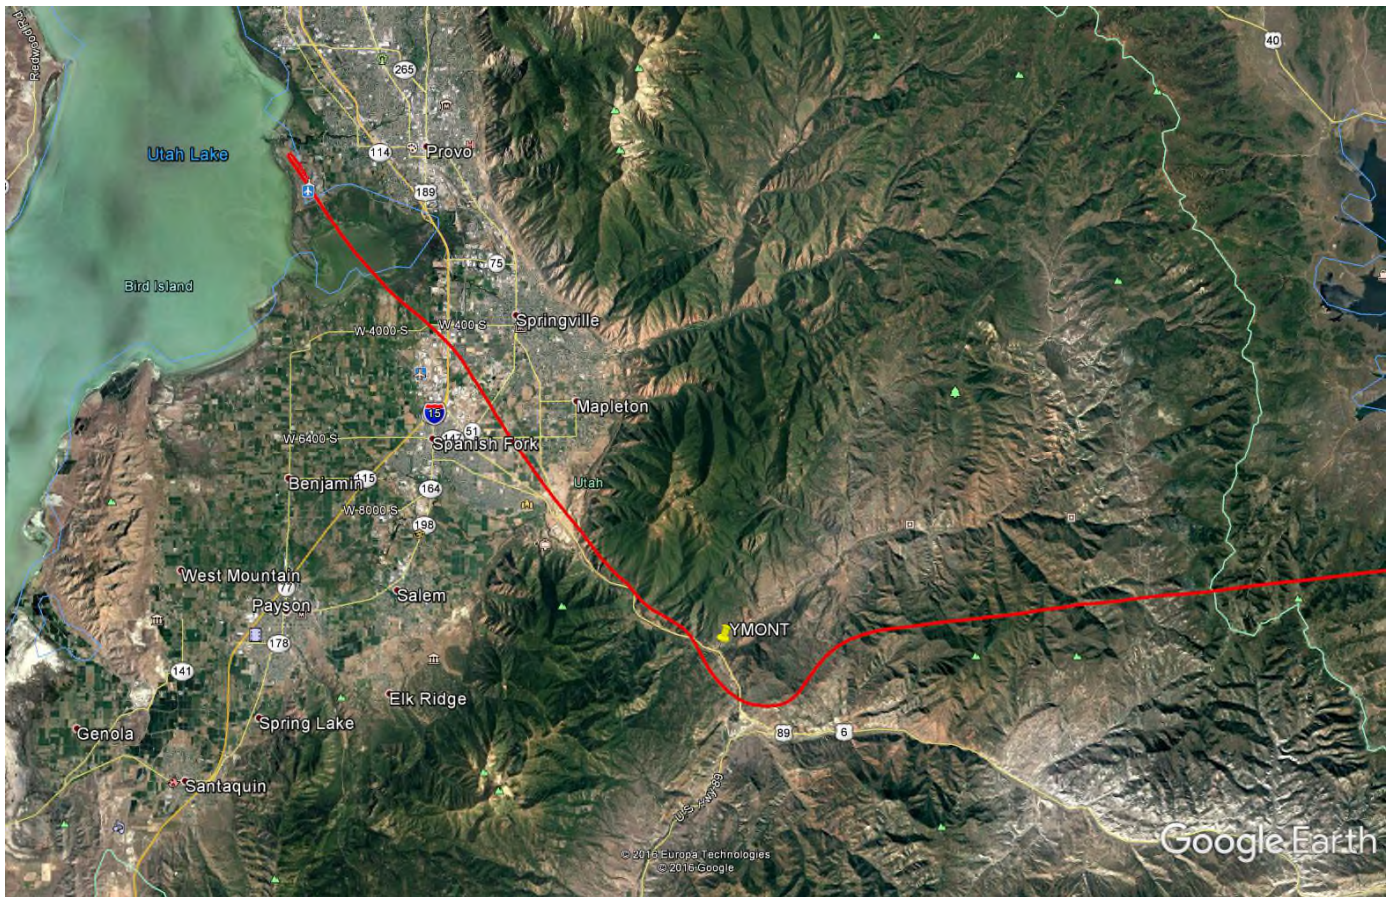
**Figure 1: Route of flight, takeoff and initial climb**

The airplane departed straight out (Figure 1).

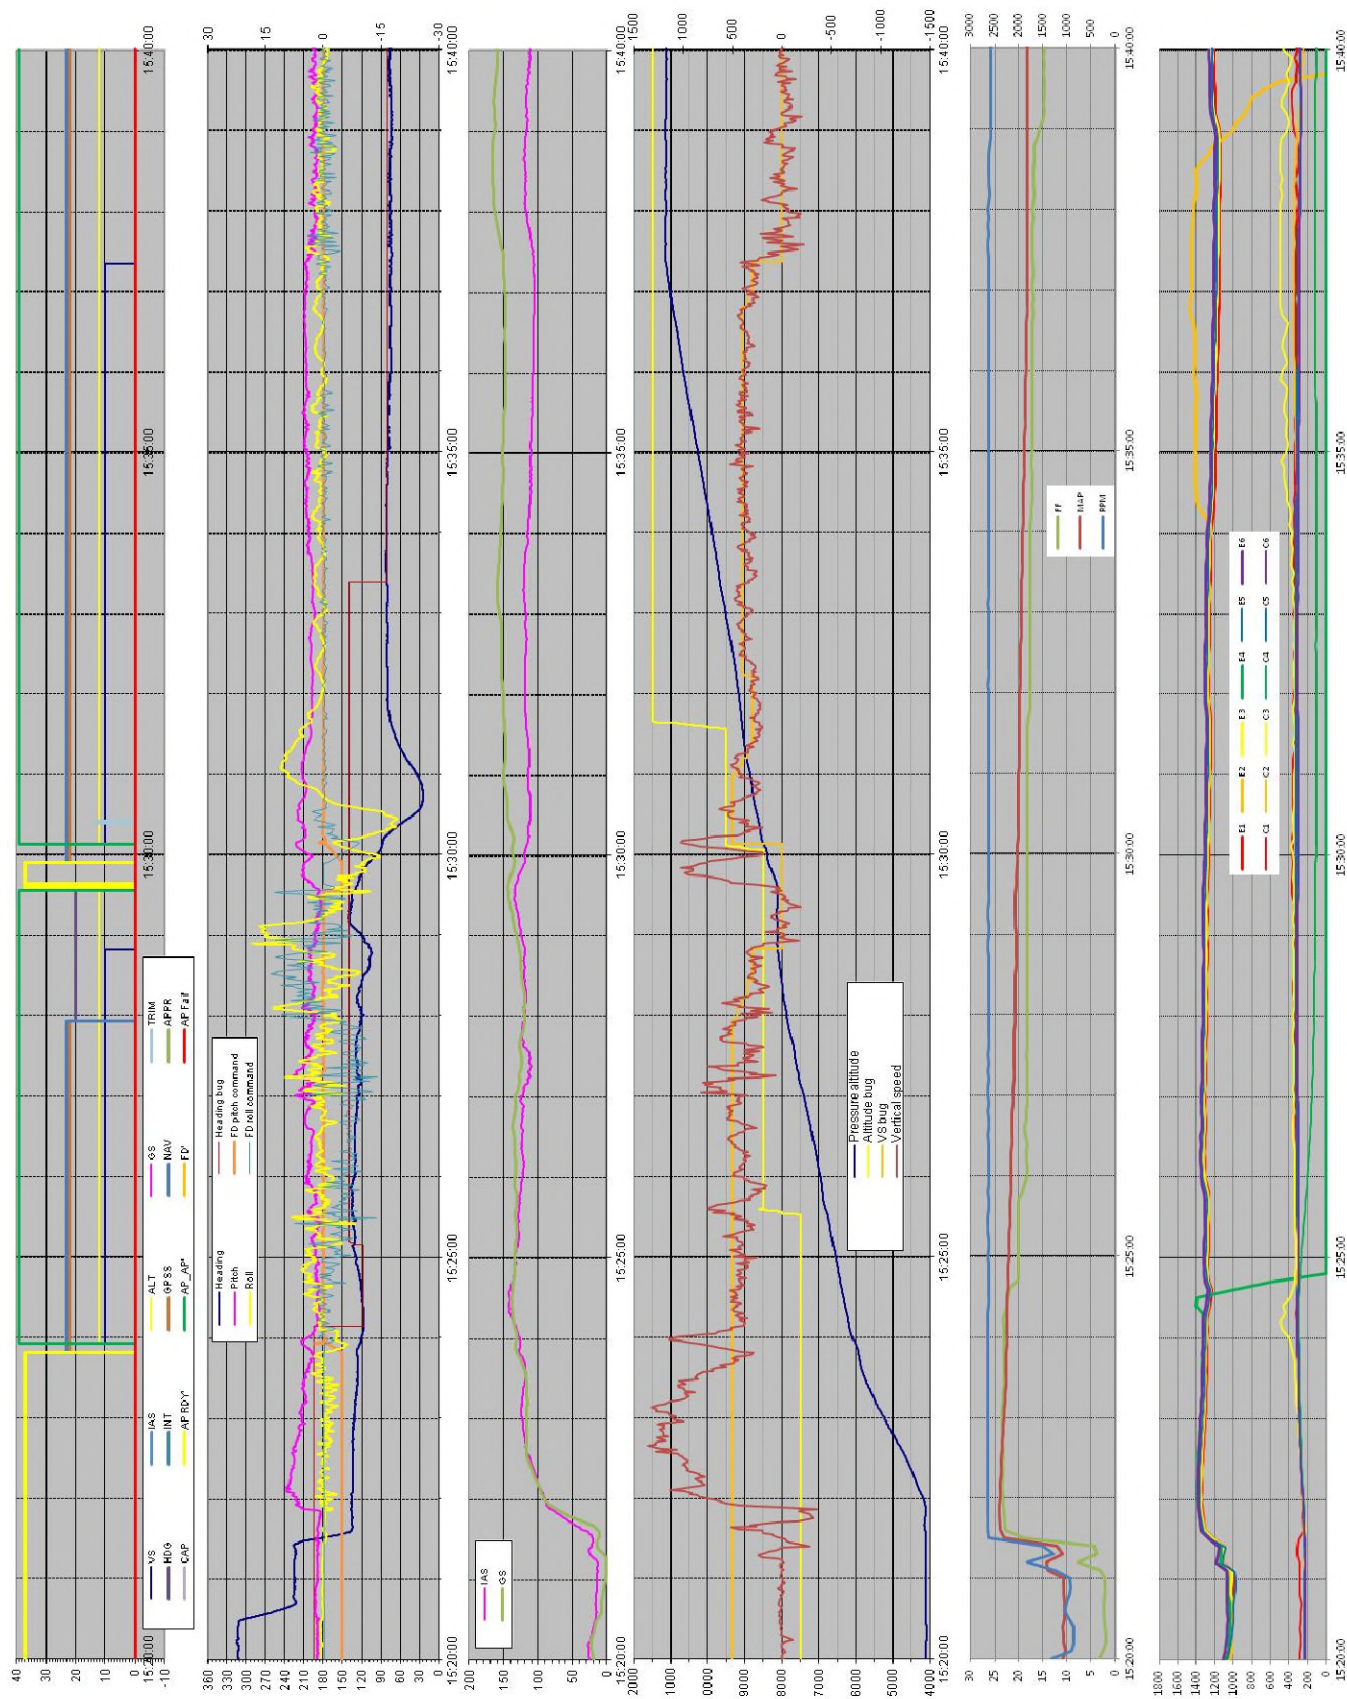
Figure 2: Flight and engine data, takeoff and initial climb

Beginning shortly after takeoff, cylinder three began to register higher CHTs than the other five cylinders (Figure 2). Within about two minutes after takeoff, C3 read  $400^{\circ}$  and was increasing rapidly, while the other five cylinders were all at around  $300^{\circ}$ . C3 peaked shortly thereafter at nearly  $500^{\circ}$ , then fell, but continued to show readings  $25^{\circ}$  to  $50^{\circ}$  higher than the others for a period of time.

In the meantime, fuel flow had been falling slowly but steadily in the climb. At 15:24:00, however, FF appears to have briefly increased slightly, then fell briefly at an increased rate, settling at about 20 GPH at 15:25, then stepping down to about 21.5 GPH at 15:26. Following this step, it resumed its gradual decrease with altitude.

At 15:24:36, cylinder four's EGT abruptly rose from  $1325^{\circ}$  to  $1400^{\circ}$ , then fell rapidly below the SIU's minimum of  $500^{\circ}$ . It remained below this threshold for the remainder of the flight. The cylinder's CHT, which had been around  $300^{\circ}$  before the drop in EGT, also began to drop. Within a minute and a half, it fell below  $200^{\circ}$ . Within another minute and a half, it fell below  $120^{\circ}$  and it maintained values around  $100^{\circ}$  for the remainder of the flight.

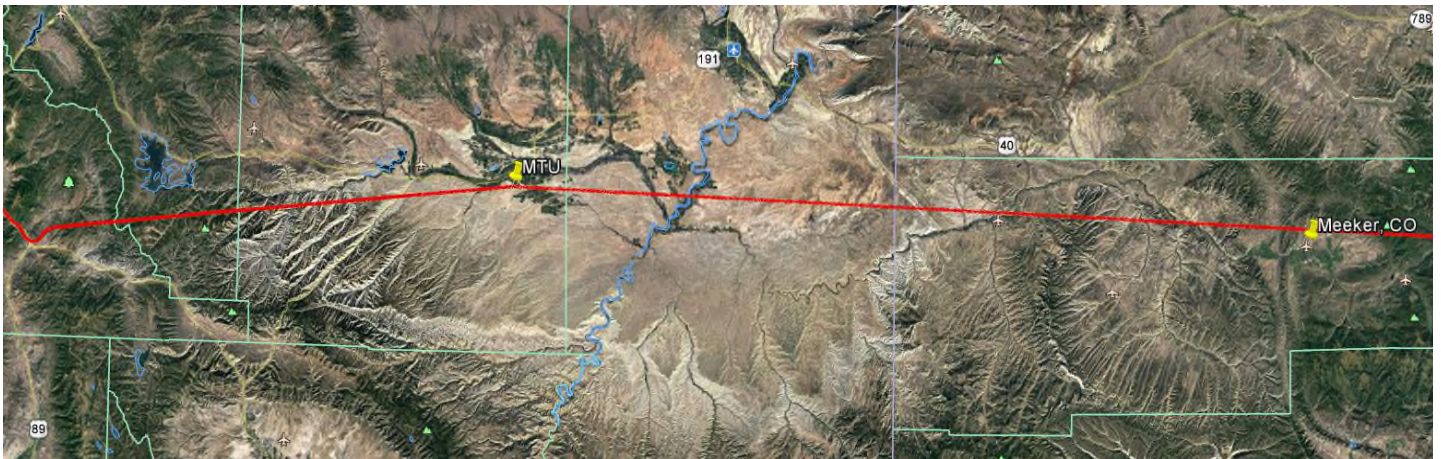
Figure 3: Route of flight, cruise

At 15:40 (2143.6), the airplane was established in cruise (Figure 3) at 11100 ft PA, which is taken to be 11500 ft MSL, the altitude bug value. The autopilot was engaged in ALT NAV GPSS mode. The current GPS waypoint was MTU, 38 nm to the ENE. The airplane's heading was 76°, its airspeed was 112 KIAS and its groundspeed was 160 kts (Figure 4). The engine was operating at 18.2" MP and 2580 RPM, drawing 14.7 GPH. EGTs for cylinders one, three, five and six were between 1200° and 1260°. CHTs for one, five and six were stable between 275° and 320°. CHT for cylinder three was fluctuating between about 400° and 500°. EGTs for two and four were off-scale low. CHT for two was below 250° and dropping. EGT for four was just over 100° and stable.

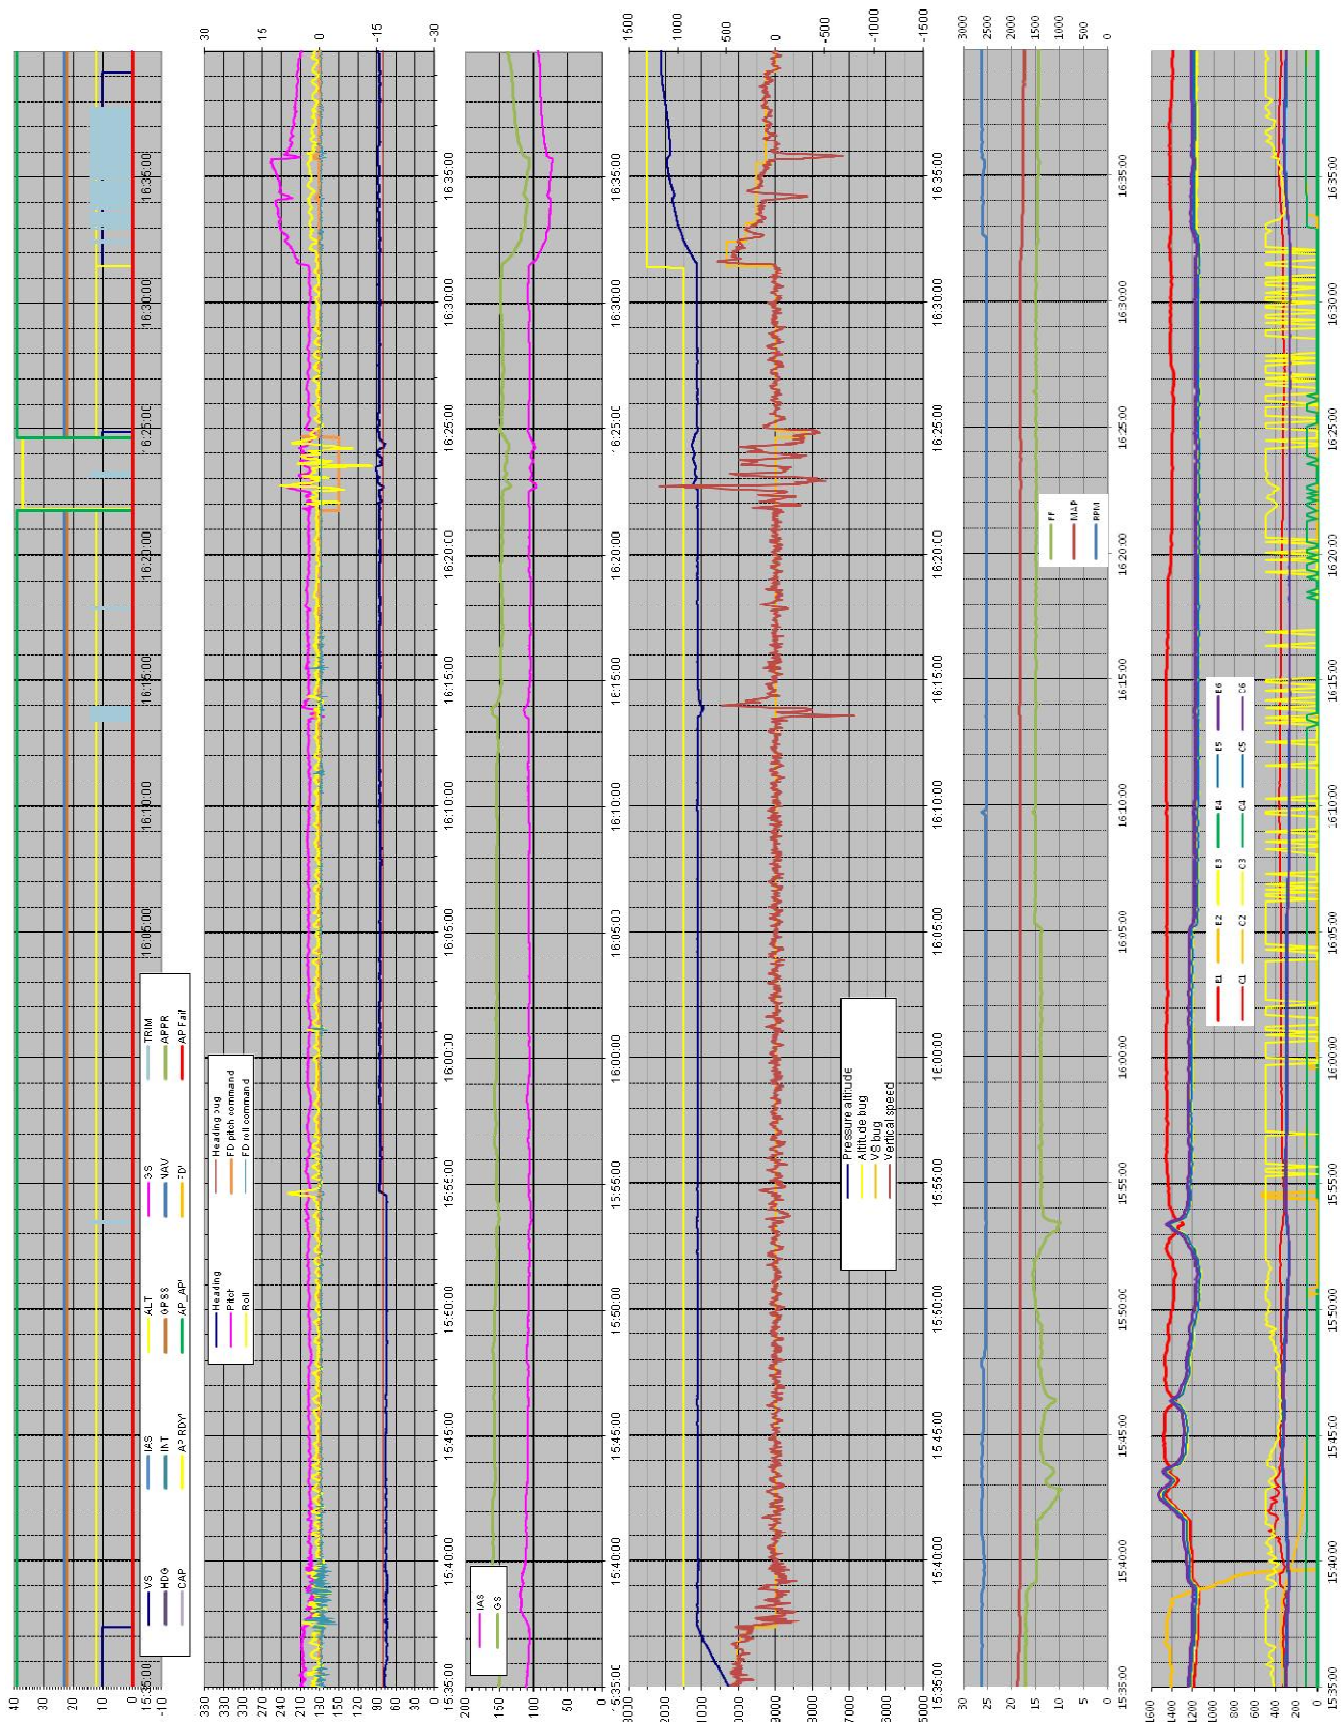
#### Figure 4: Flight and engine data, cruise

Over the next 15 minutes, there were fluctuations in fuel flow with corresponding fluctuations in EGT and some variation in CHT. E1, E3, E5 and E6 were strongly correlated initially, but after a few minutes E1 began to show a negative correlation with respect to the others.

At 15:54:40 (3024), as the airplane passed MTU, the GPS waypoint changed to PENEY, in the general vicinity of Fraser and Tabernash, CO, or about 200 nm east of the aircraft's position at the time. Flight and engine operating conditions

were generally similar to those reported above. The autopilot was still engaged, as before, and made a brief turn on course.

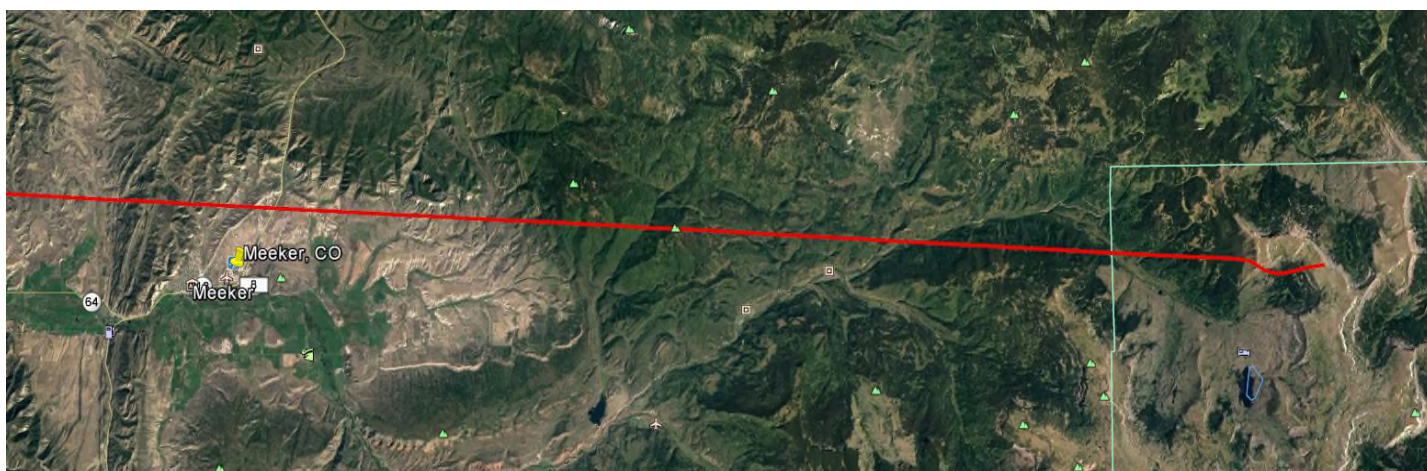
Figure 5: Route of flight, descent and landing

At 16:44, the airplane was stable in cruise (Figure 5). The autopilot was in ALT NAV GPSS mode, maintaining 12110 ft PA (taken to be 12500 MSL) on course to PENEY at 105 KIAS (Figure 6). The engine condition readings, as before, showed EGTs in the normal range for cylinders one, three, five and six. (Though in the normal range, E1 was several hundred degrees above E3, E5 and E6, as had been the case since the changes noted in the previous section.) CHTs for cylinders one, five and six were in the normal range. C3 read approximately 450°. EGTs and CHTs for cylinders two and four were near or below the SIU's sensing range.

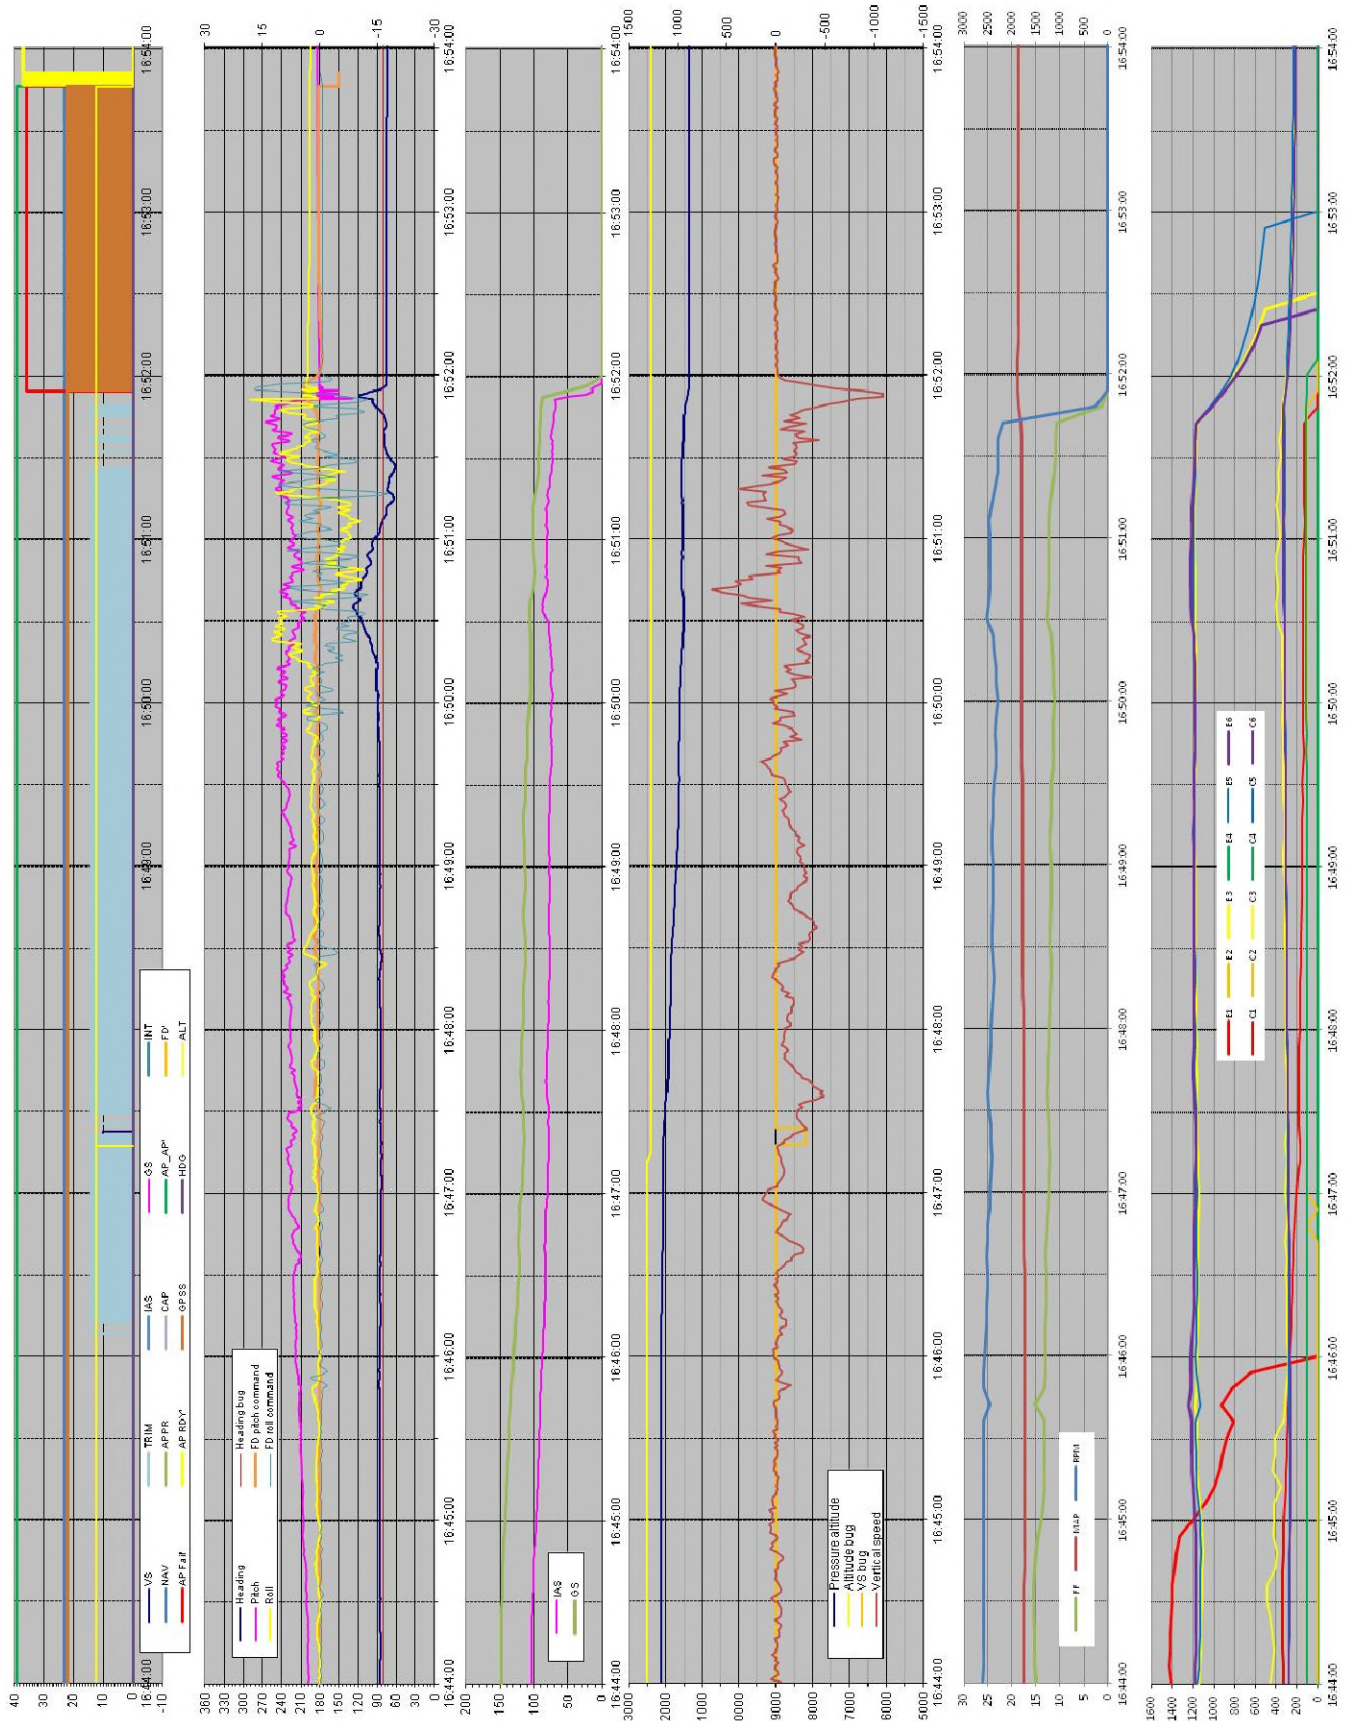
Figure 6: Flight and engine data, descent and landing

Immediately thereafter, E1 began to drop – slowly at first, then rapidly, reaching 1000° in a little more than a minute and falling below the SIU's sensing range less than a minute later. It never returned to the normal range. As with cylinders two and four, C1 dropped following the reduction in E1.

Fuel flow dropped concurrent with the drop in E1, from 15 GPH to 13 GPH. MP and RPM remained constant.

Simultaneously, the airplane's airspeed fell off. The autopilot began trimming almost constantly in an unsuccessful attempt to maintain altitude. By 16:48 (6224), the airspeed had fallen from 105 KIAS to 80 KIAS and altitude from 12110 ft PA to 11900 ft PA (and falling).

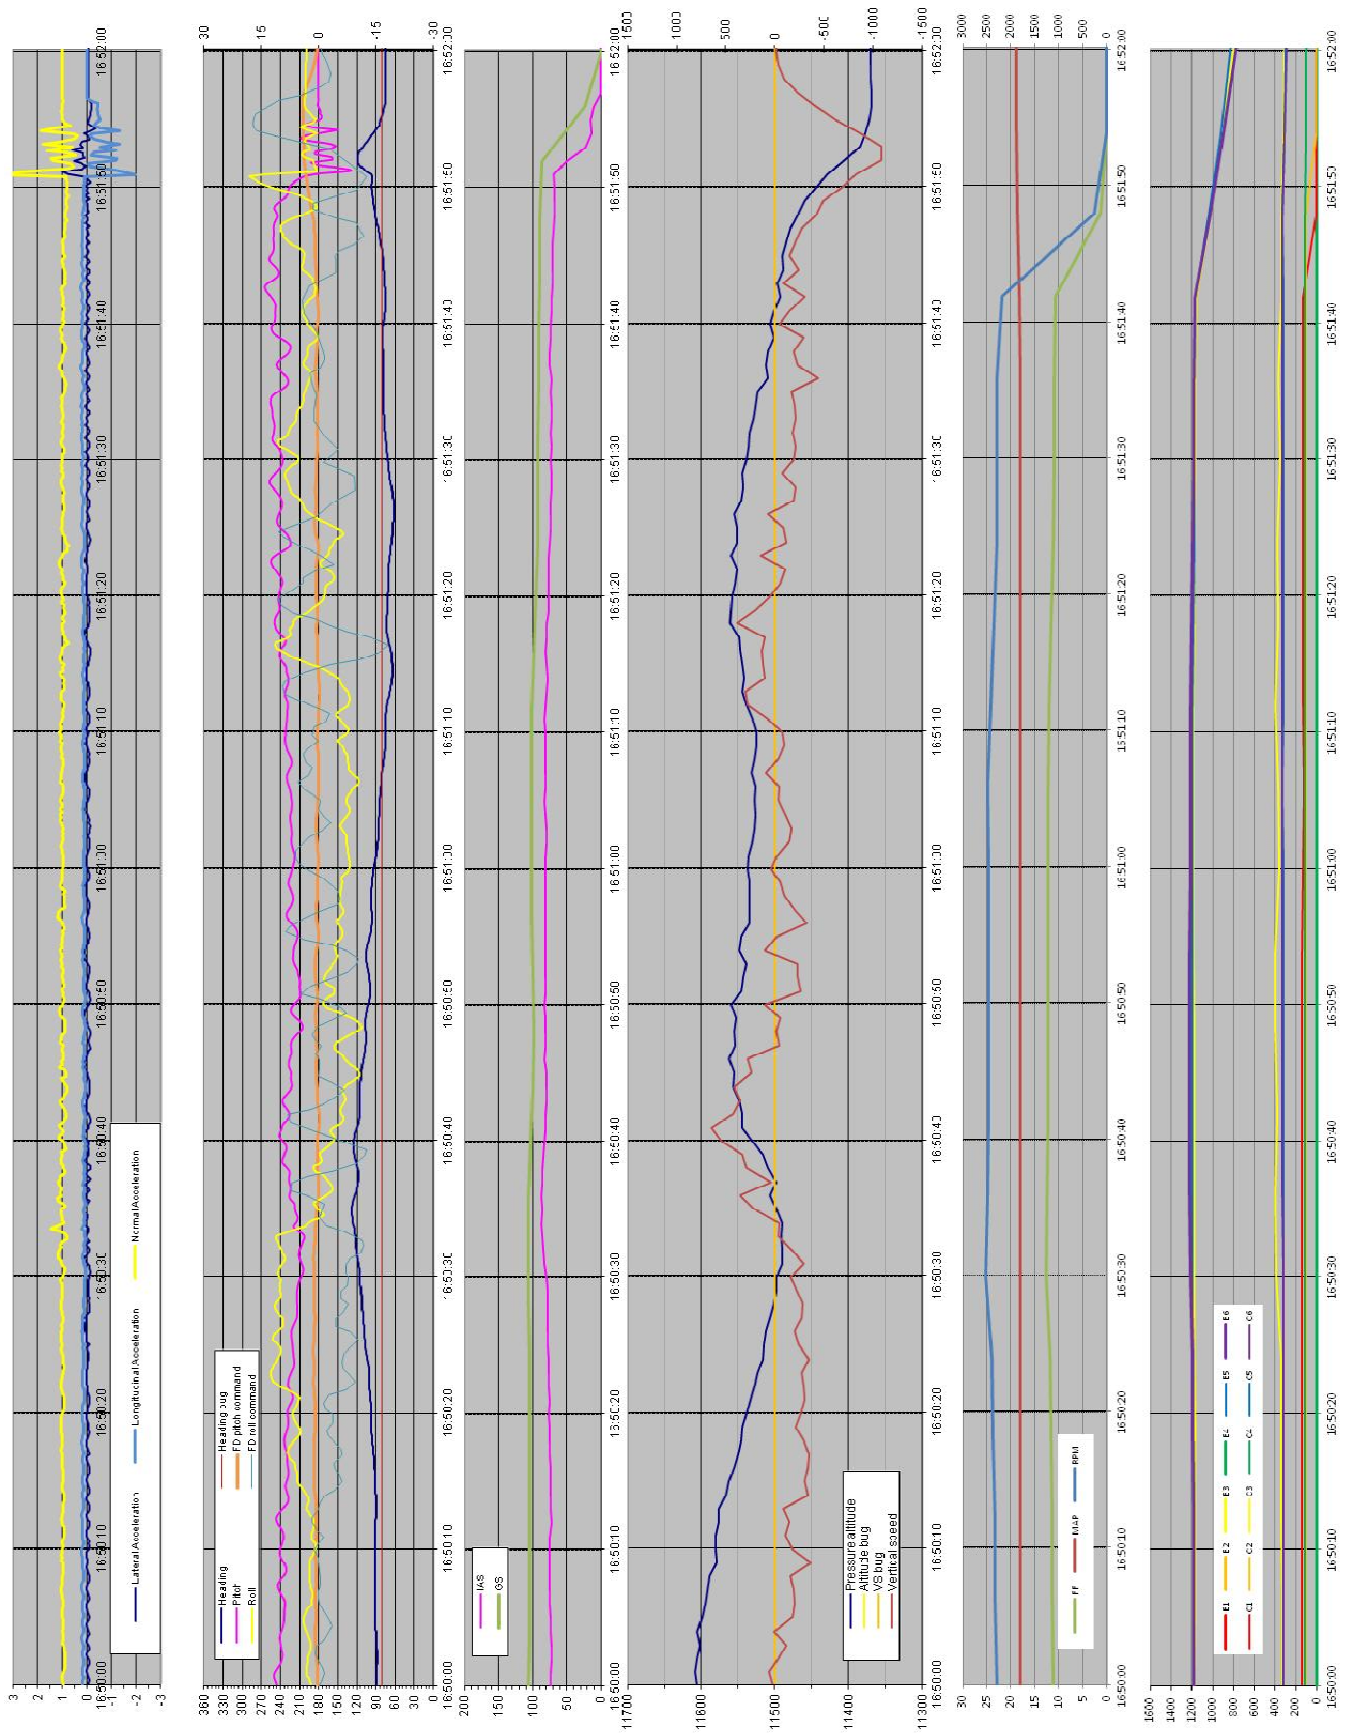
Figure 7: Flight and engine data, landing

Beginning at approximately 16:50:20 (6364), the airplane began a series of pitch and roll excursions (Figure 7). The autopilot was still engaged at the time and the flight director commanded corrections opposite to these excursions. This often indicates that the pilot is on the stick, overpowering the autopilot. This condition remained until the end of the flight.

The airplane experienced no more than about 3g vertical and 2g longitudinal at touchdown, with significant accelerations only over about a five second period.

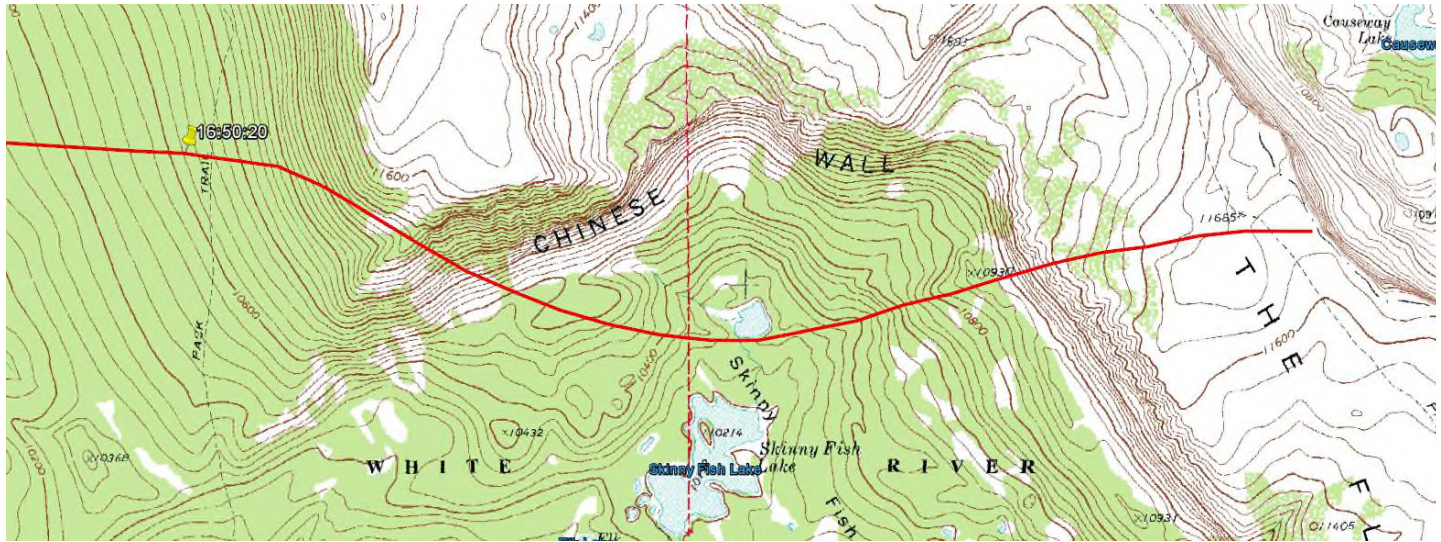
Figure 8: Route of flight, landing

The airplane appears to have crossed the edge of the plateau (elevation 11400 ft MSL; Figure 8) at 16:51:32 (6436). At the time, it was at 11530 ft PA. The final resting altitude of the airplane was 11370 ft PA, which is, based on the topographical map, 11660 ft MSL. Using the same correction from PA to MSL (290 ft), the corrected altitude crossing the edge of the plateau was approximately 11820 ft MSL, or about 400 ft AGL.

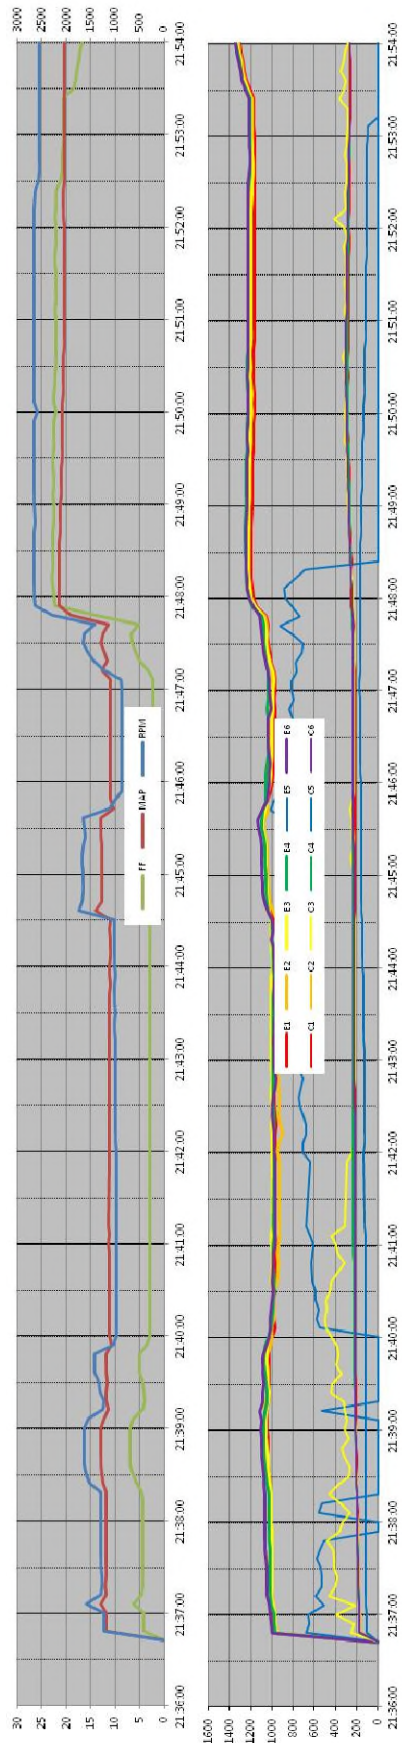
Figure 9: Engine data, start of 1/6 flight

On January 6, 2017, during a flight from Meadow Lake Airport to Provo on the day before the accident flight, cylinder five fails to reach a normal EGT after engine start. Its EGT falls out of the SIU's measurement range at power-up for takeoff, the CHT falling thereafter (Figure 9). In addition, unusually high CHTs are recorded for cylinder three. The unusually low values for E5 and C5 persist until late in the flight, just under three hours after the start of the log. During the airplane's descent toward Provo, as the power is reduced, E5 climbs into the normal range after which C5 does the same (Figure 10). Readings for the cylinder remain within the normal range for the remainder of the log.
