**Pratt & Whitney Canada**

# Materials Investigation

### ME16964FS

| Part Name: BLADE-LOW COMPRESSOR<br>ROTOR / FAN BLADE, SHAFT ASSY-LOW<br>COMPRESSOR / LOW COMPRESSOR<br>SHAFT | Date Received: 2017-07-28 | Page 3 of 18 |

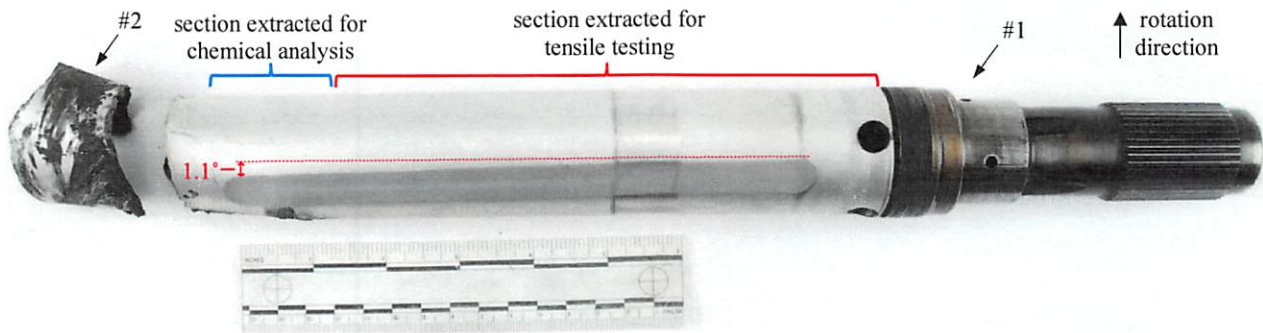
Figure 1. General view of the Low Compressor Shaft Assy (P/N: 3114594-01) which fractured in two locations. The fragments were arbitrarily numbered as #1 (fractured shaft assy) and #2 (small separated fragment from the shaft) as shown. The Low Compressor Rotor assembly with the other portion of the Low Compressor Shaft fracture (arbitrarily numbered as #3) was also submitted for examination (see fig. 26).

Visual examination showed that the downstream portion of the shaft is permanently twisted approximately  $1.1^\circ$  in the direction opposite to the rotation direction. Moreover the shaft fragment #1 exhibits evidence of necking near the fracture plane.

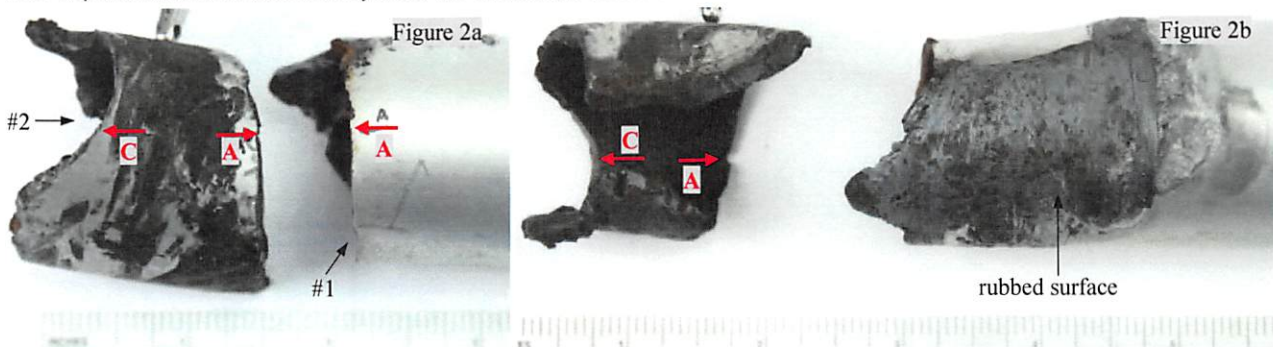
Figure 2. Fig. 2a: View of shaft fragment #1 with the adjacent matching fragment #2. Fig. 2b: View of the same configuration, rotated  $\approx 180$  degrees in respect to Figure 2a, showing visible rubbing on the outside diameter (OD) surface.

Macroscopic fractographic features allowed to match the mating fracture surfaces of all three shaft fragments. Reference points are marked with capital letters "A" and "C" and serve throughout the report for orientation purpose.

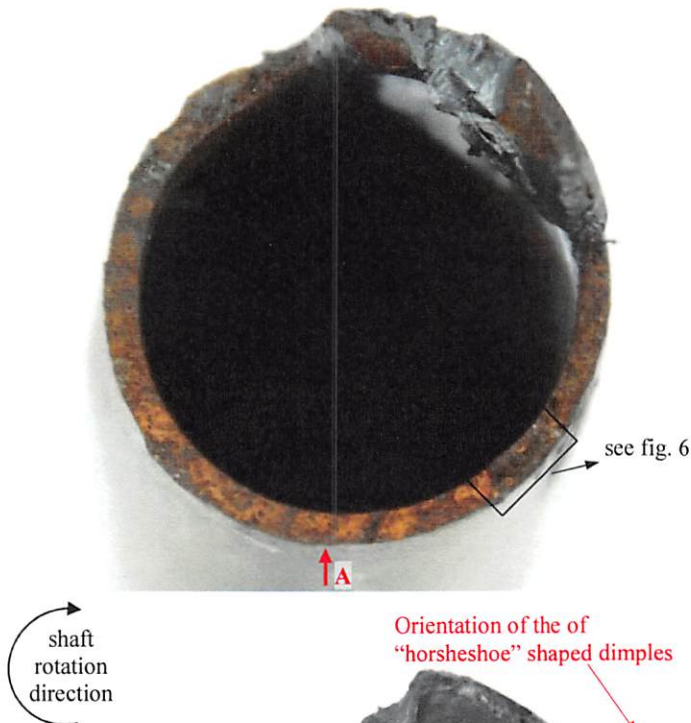
Figure 3.

View of the fracture surface on the shaft fragment #1 with reference marking point "A".

The fracture surface was rusted and obscured any underlying fractographic features.

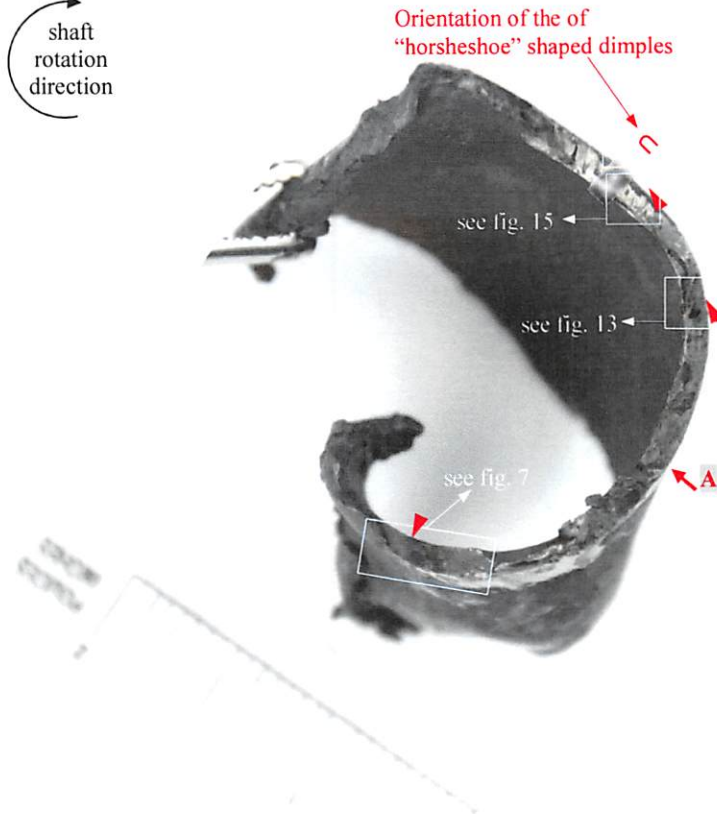
Figure 4.

General view of the fracture surface on the shaft fragment #2 with reference marking point "A".

Although this fracture surface exhibited some rusting and that some regions of the fracture surface suffered secondary damage, several areas remained in relatively good condition, see Figures 7-16.

Characterisation of the fracture surface, carried out using the Scanning Electron Microscope (SEM), showed the presence of both tensile and torsional shear dimples suggesting that the shaft fractured in torsion and tension. Based on the torsional shear dimples "horseshoe" shape, this fracture occurred in the opposite direction to the shaft rotation. This indicates that this side of the sample was decelerated in respect to the downstream portion of the shaft which is driving.

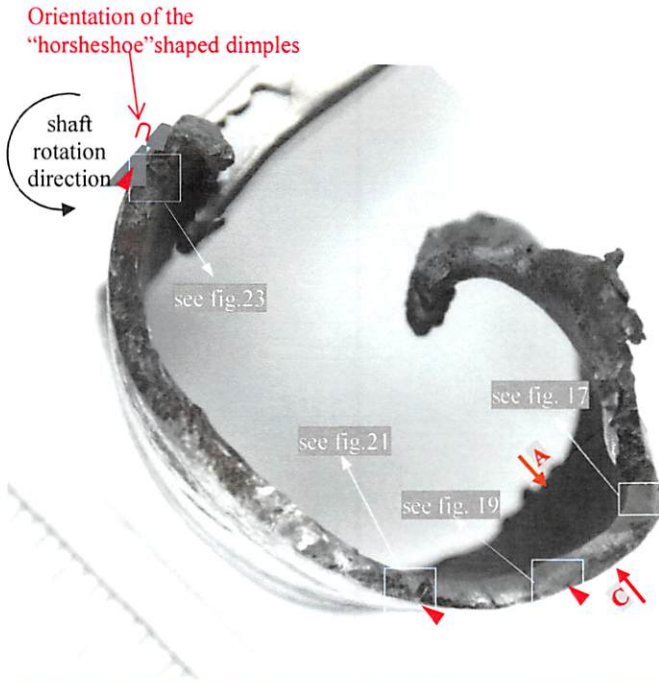
Figure 5.

General view of the fracture surface on the shaft fragment #2 with reference marking point "C".

Examination of the fracture surface, similarly to what was observed on the other side of this fragment (side "A"), showed the presence of both tensile and torsional shear dimples suggesting that the shaft fractured in torsion and tension. Based on the torsional shear dimples "horseshoe" shape, this fracture occurred in the opposite direction to the shaft rotation. This indicates that this side of the sample was decelerated in respect to the upstream portion of the shaft (attached to the fan) still rotating likely as a result of the fan assembly inertia.

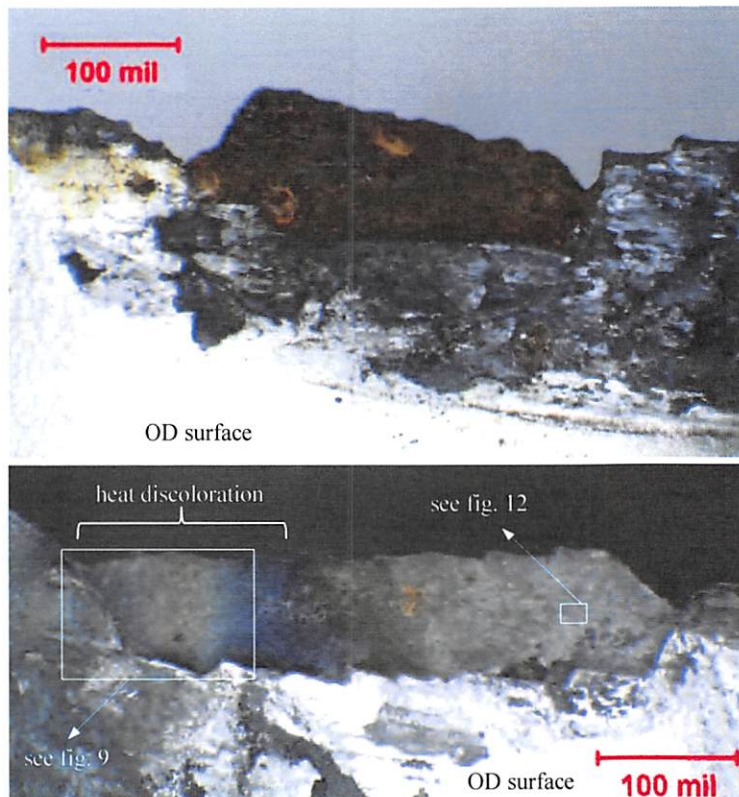
Figure 6.

Side view of the shaft fragment #1 fracture surface close to reference marking point "A".

Shaft fractured at approximately 45° in reference to the shaft longitudinal axis in this location, which is typical for an overload fracture.

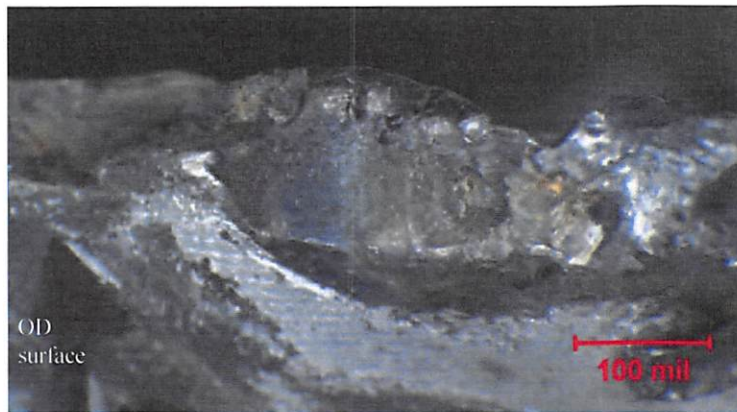
Figure 7.

Side view of the shaft fragment #2 fracture surface with reference marking point "A".

Heat discoloration on the fracture surface was observed which suggest that heat was generated by the shat rubbing observed on the OD against a mating element. Note that the fracture surface in this location has a 45° slant, as for the shaft fragment #1 (see fig. 6). Fracture surface was further examined, see Figures 9-12.

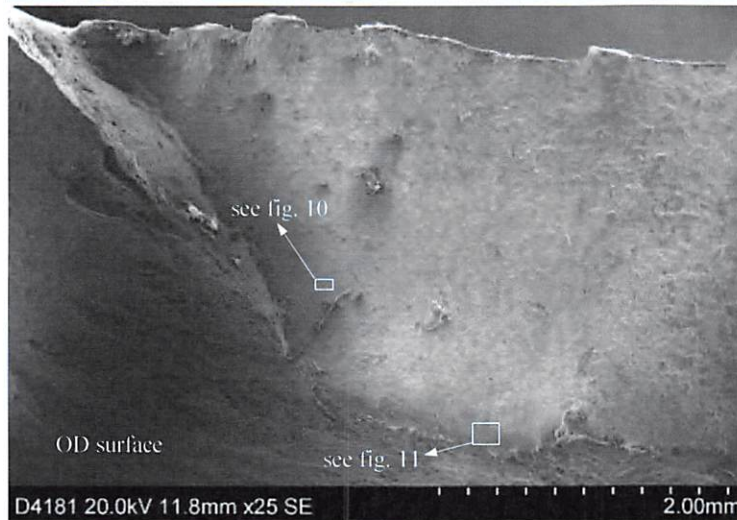
Figure 8.

Magnified view of the fracture surface on the shaft fragment #2 from reference marking point "A" side.

Heat discoloration and similar aspect of fracture surface were observed as in Figures 6 and 7.

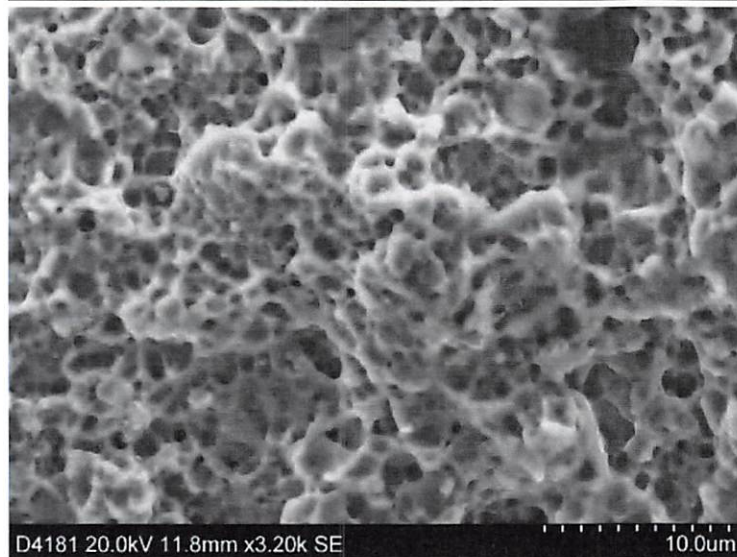
Figure 9.

SEM low magnification view of the fracture surface on the shaft fragment #2 from reference marking point "A" side.

Transgranular ductile mode of overload fracture was observed. Marked areas were further examined, see Figures 10 and 11.

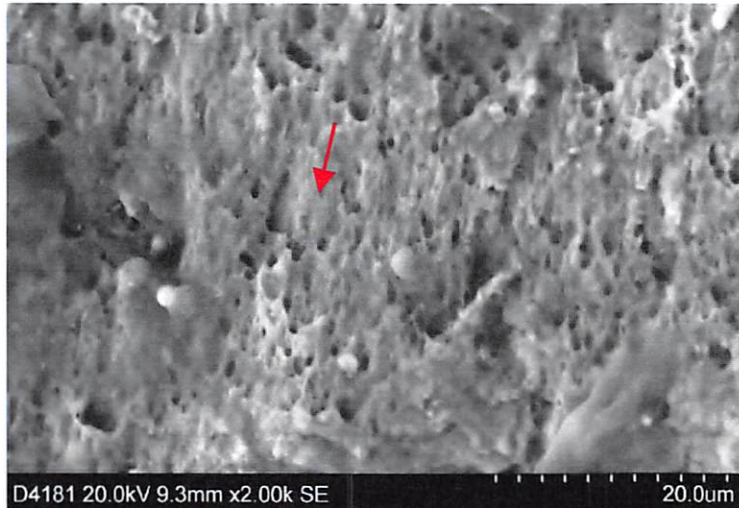
Figure 10.

SEM magnified view of the fracture surface on the shaft fragment #2 from reference marking point "A" side.

Ductile dimples suggestive of overload ductile fracture were observed. Slight oxidation of the fracture surface was observed, likely as a result of the heat generated by the shaft OD rubbing.

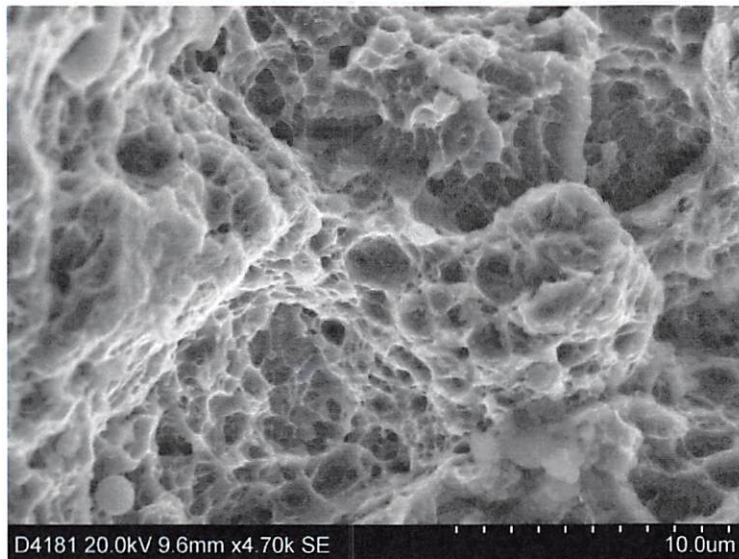
Figure 11.

SEM low magnification view of the fracture surface on the shaft fragment #2 from reference marking point "A" side.

Shear dimples were observed suggestive of shear overload ductile fracture. The red arrow shows the direction of shear.

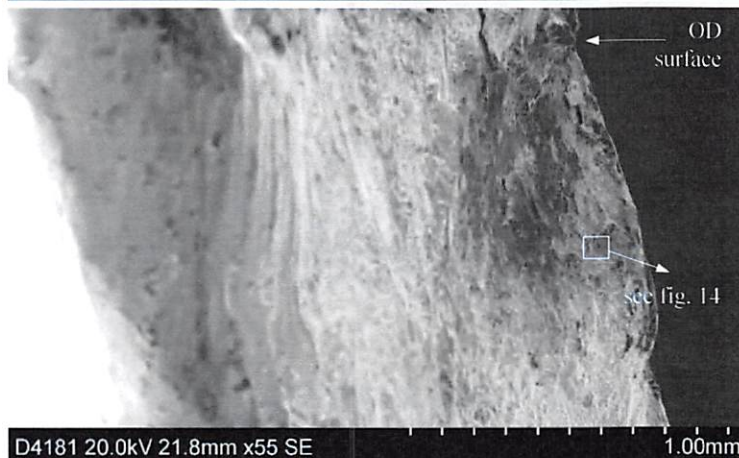
Figure 12.

SEM magnified view of the fracture surface on the shaft fragment #2 from reference marking point "A" side.

Presence of tensile ductile dimples suggestive of overload fracture was noted.

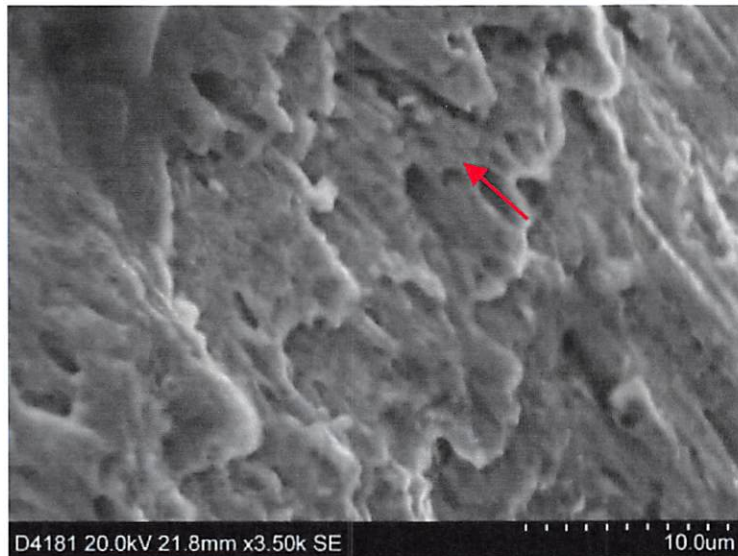
Figure 14.

SEM low magnification view of the fracture surface on the shaft fragment #2 from reference marking point "A" side.

Shear dimples were observed. The red arrow shows the direction of shear.

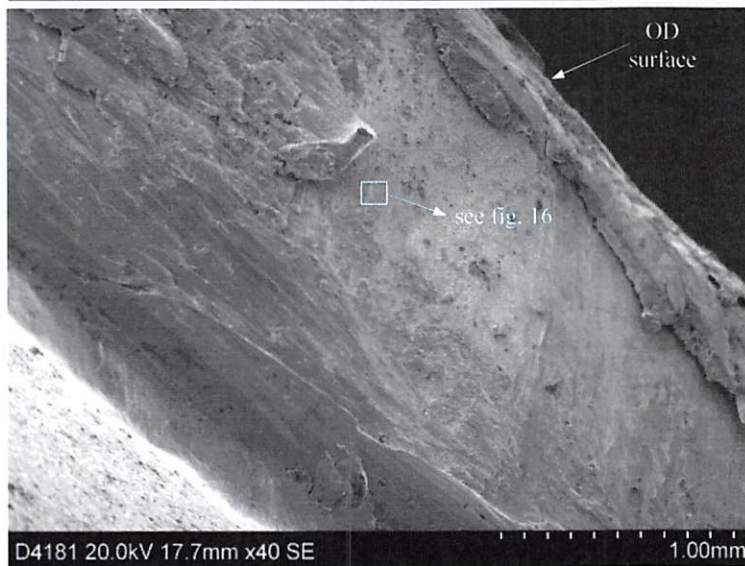
Figure 15.

SEM low magnification view of the fracture surface on the shaft fragment #2 from reference marking point "A" side.

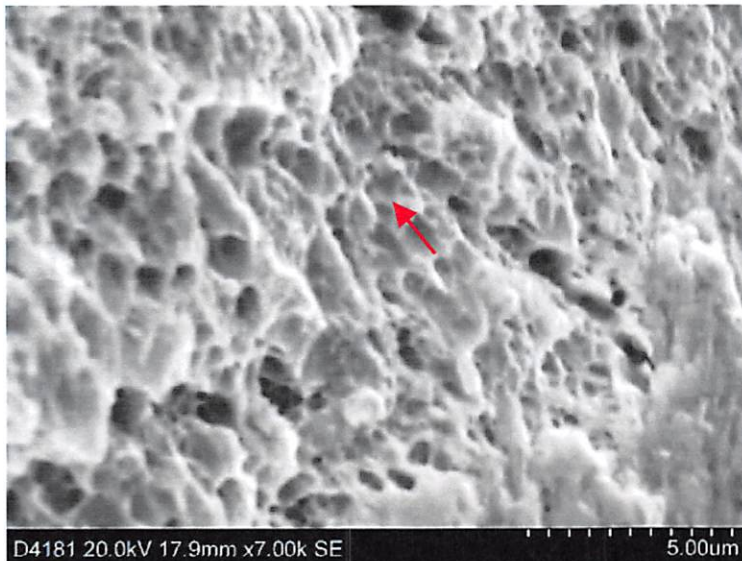
Figure 16.

SEM magnified view of the fracture surface on the shaft fragment #2 from reference marking point "A" side.

Shear dimples were observed. The red arrow shows the direction of shear.

Observations of fracture surface from reference marking point "A" side, in all examined areas examined, showed presence of overload transgranular tensile ductile/shear ductile fractures.

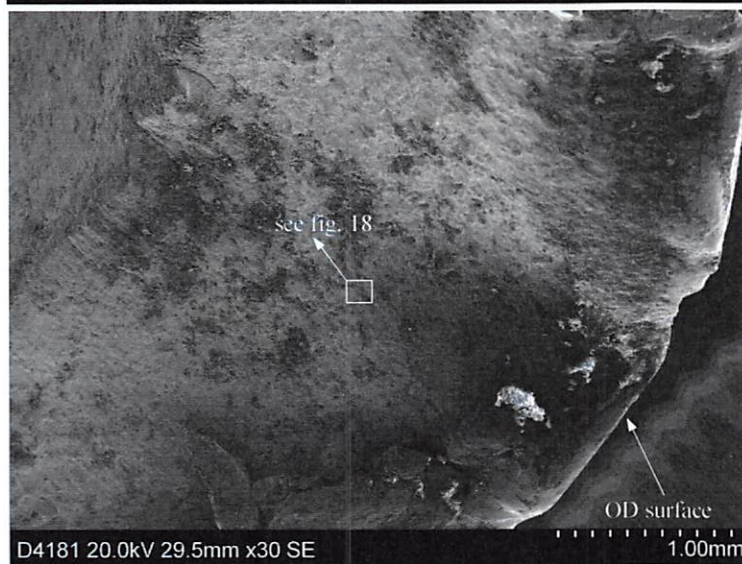
Figure 17.

SEM low magnification view of the fracture surface on the shaft fragment #2 from reference marking point "C" side.

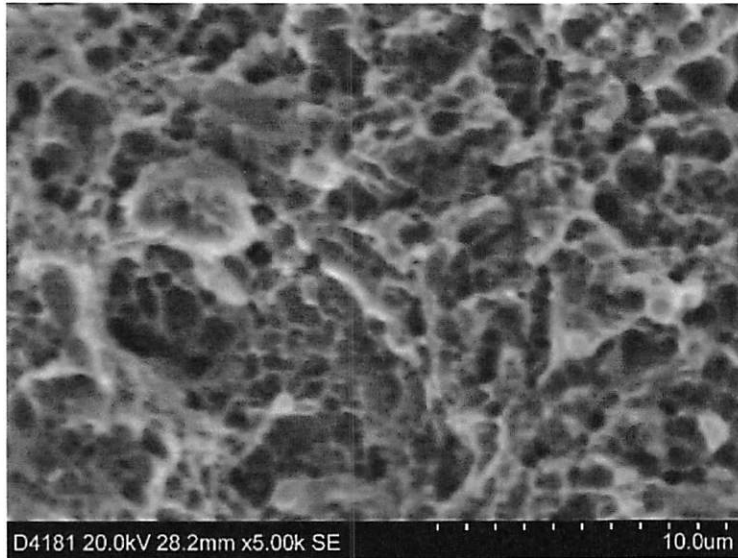
Figure 18.

SEM low magnification view of the fracture surface on the shaft fragment #2 from reference marking point "C" side.

Presence of tensile ductile dimples suggestive of overload fracture was noted.

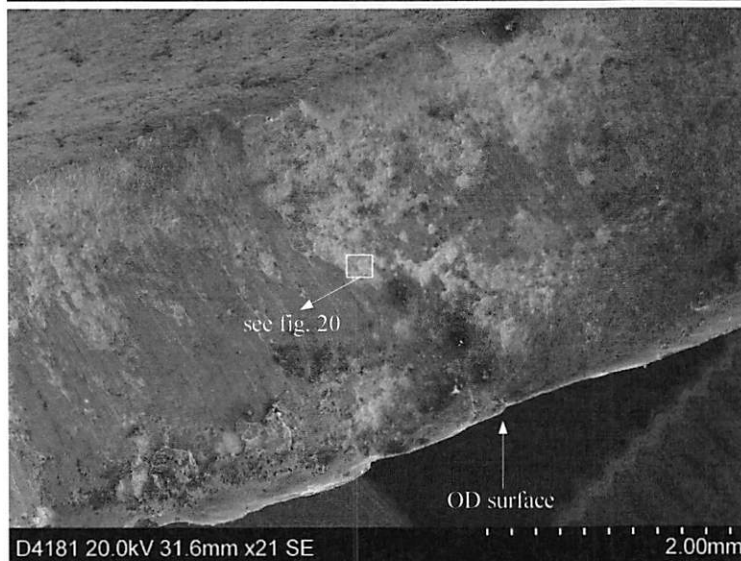
Figure 19.

SEM low magnification view of the fracture surface on the shaft fragment #2 from reference marking point "C" side.

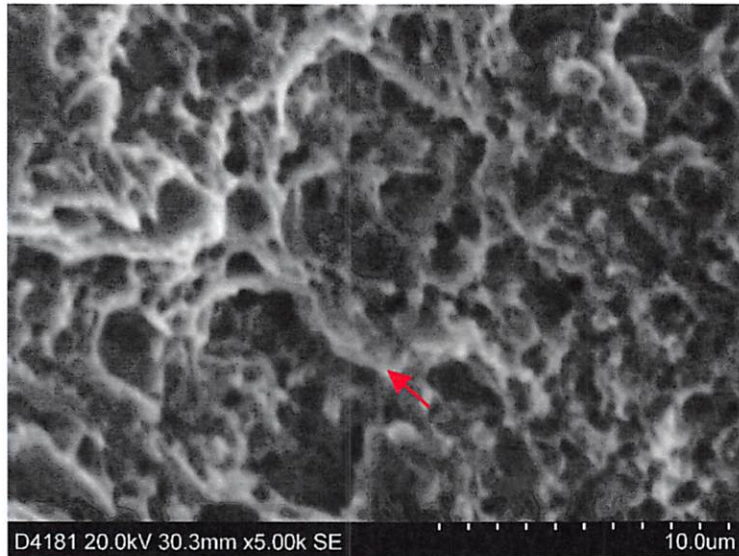
Figure 20.

SEM low magnification view of the fracture surface on the shaft fragment #2 from reference marking point "C" side.

Shear dimples were observed, suggestive of shear overload ductile fracture. The red arrow shows the direction of shear.

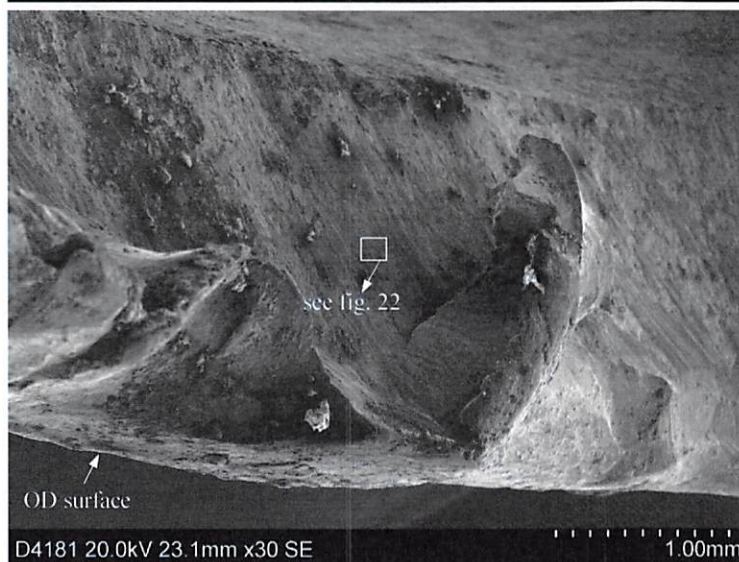
Figure 21.

SEM low magnification view of the fracture surface on the shaft fragment #2 from reference marking point "C" side.

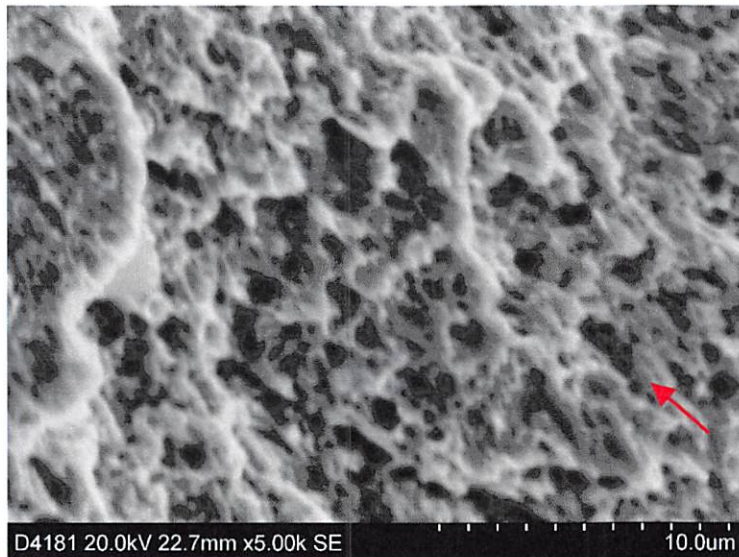
Figure 22.

SEM low magnification view of the fracture surface on the shaft fragment #2 from reference marking point "C" side.

Shear dimples were observed. The red arrow shows the direction of shear.

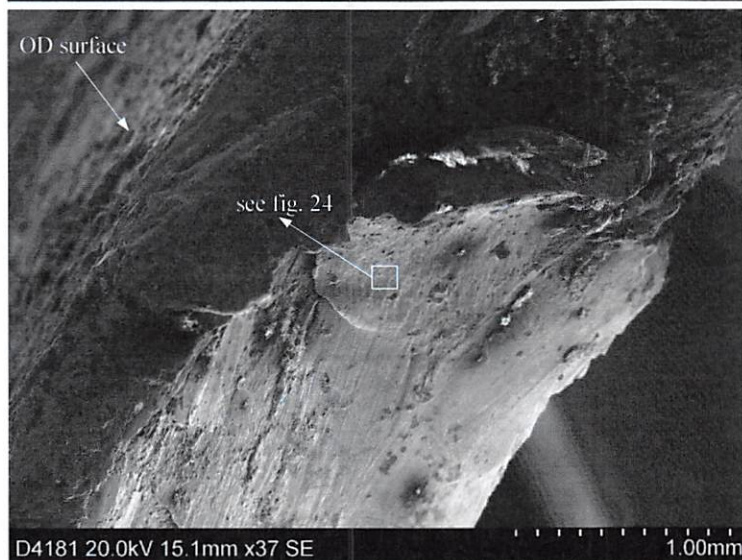
Figure 23.

SEM low magnification view of the fracture surface on the shaft fragment #2 from reference marking point "C" side.

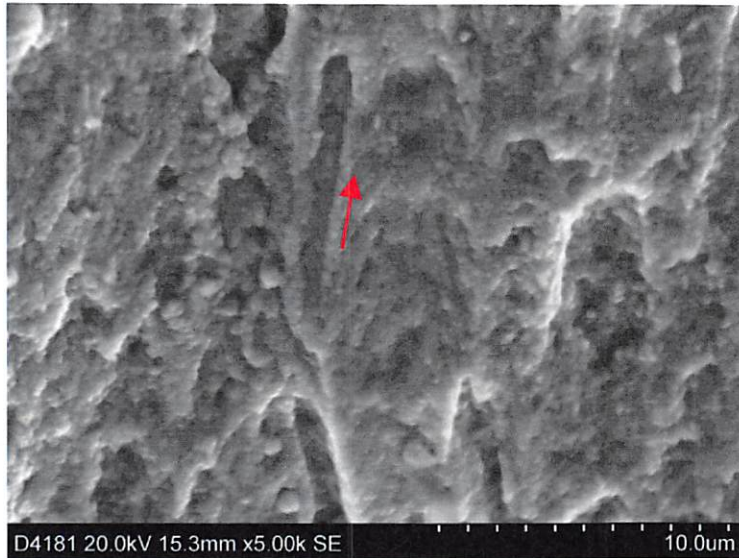
Figure 24.

SEM low magnification view of the fracture surface on the shaft fragment #2 from reference marking point "C" side.

Shear dimples were observed and the red arrow shows the direction of shear.

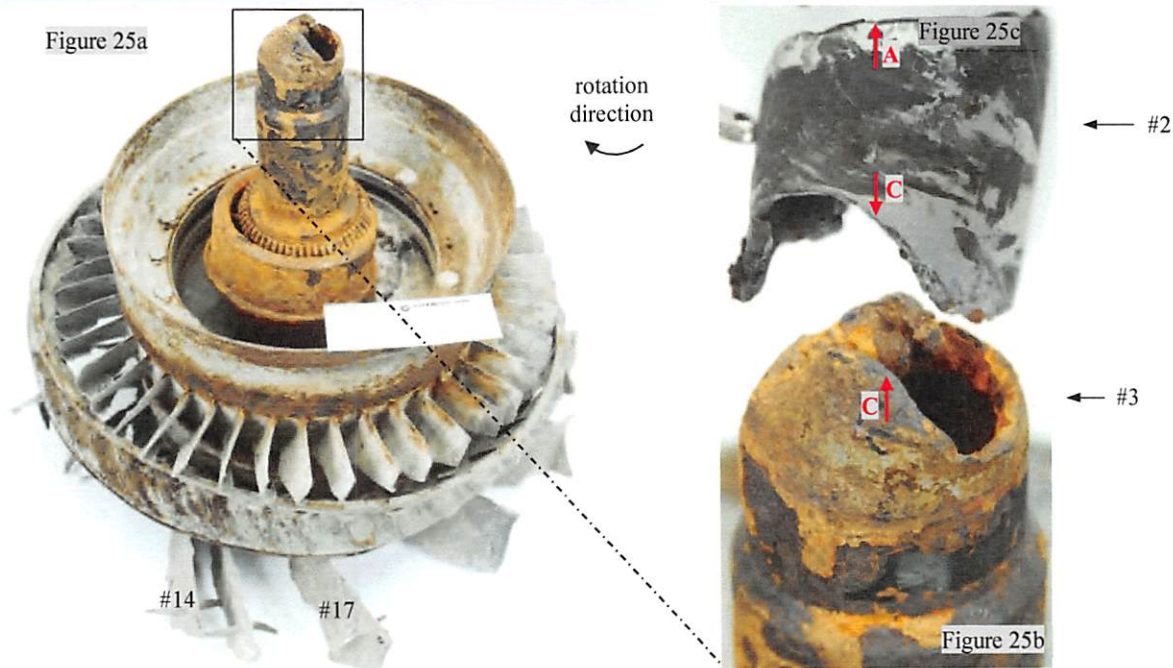
Figure 25. Fig. 25a: General view of downstream side of bladed-Low Compressor Rotor in as received condition.

Fig. 25b: Magnified view of fractured and significantly rusted Low Compressor Shaft fragment marked as #3.

Note that the observed shaft corroded fracture was likely the result of secondary damage due to immersion and/or atmospheric exposure for one month in the marsh. This matching fracture was not examined due to the presence of corrosion products obscuring any possible underlying fractographic details. Note that the matching fracture with fragment #2 (fig. 25c), which was not as significantly corroded, was examined in details and identified as an overload fracture.

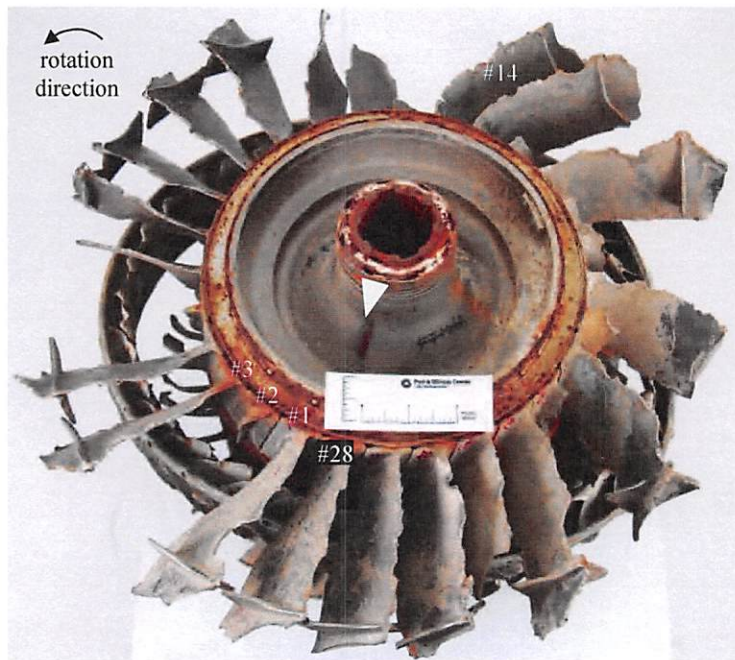
Figure 26.

General view of upstream side of the bladed Low Compressor Rotor assembly.

The red marking (indicated with white arrowhead) on the fan ring indicates the TDC position (12 o'clock position) of the engine. Fan blades were numbered from #1 to #28 in the opposite direction of rotation as shown.

Fan blades exhibited significant damage and bending from the airfoil's pressure side towards the suction side. Blades #2, #5, #13, #16, #18, #19, #21, #23 were fractured close to the platform and their fracture surfaces are shown in Figure 27. Blades #6, #11, #12 and #20 were fractured away from the platform.

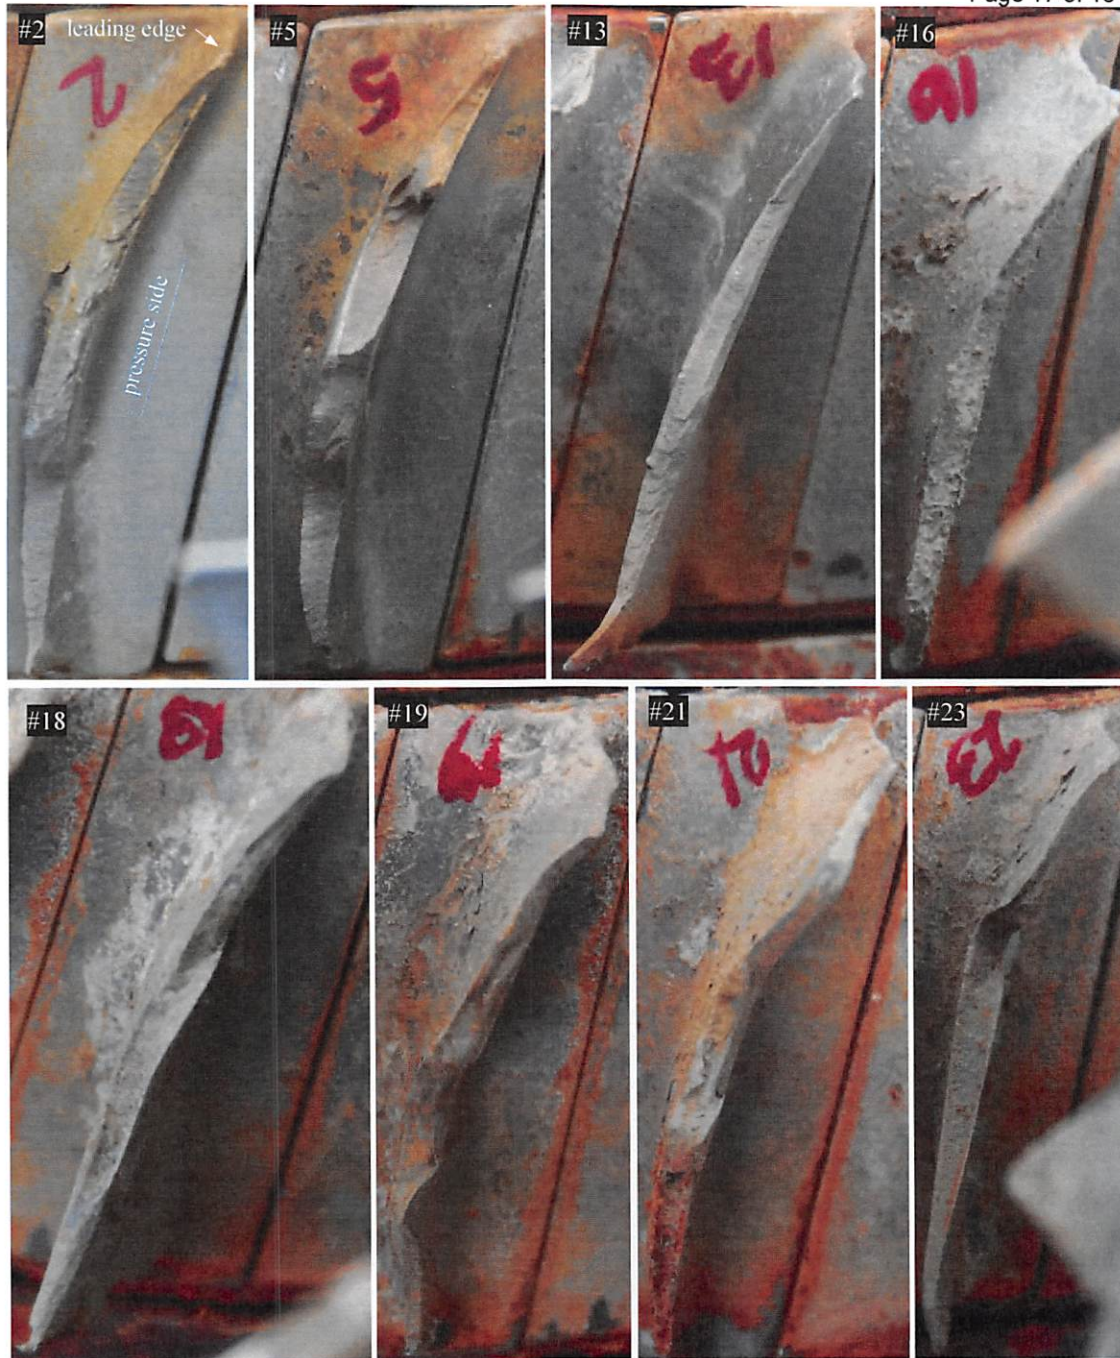
- 2- Visual examinations of the eight (8) fractured blades from the Low Compressor Rotor were consistent with bending (from the airfoil pressure side to the suction side) ductile overload fractures. No evidence of fatigue was observed.

Figure 27. View of the fracture surfaces of eight (8) fractured fan blades close to the platform in the "as received" condition.

No evidence of fatigue fracture features was found. All these blades fractured by overload in a similar manner, and no anomalies were observed.

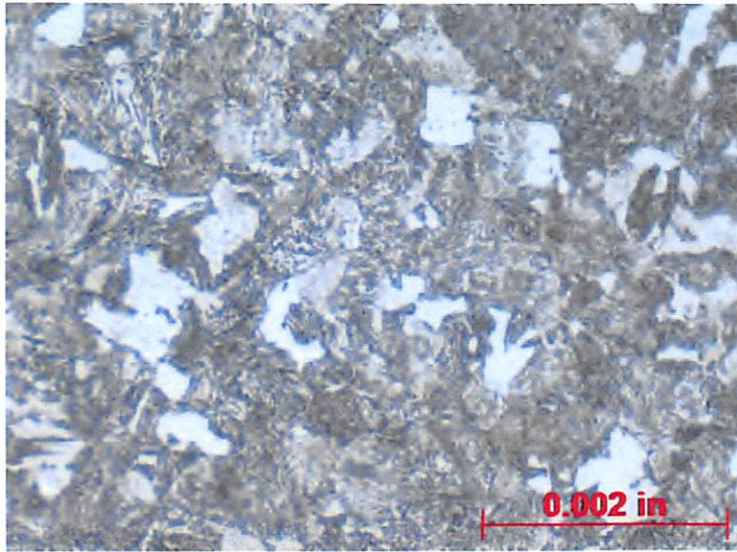
Figure 28.

- 5- Microstructure of the shaft meet drawing requirements of CPW 300J standard. No anomalies were observed.

Shaft, metallographic cross-section, etched: Nital 2%.

Microstructure of the shaft is consistent with tempered martensite of CPW 245M steel, according to CPW 300J standard.
