**Photo 1 – View of gyroplane on the side of a ditch at the accident site**

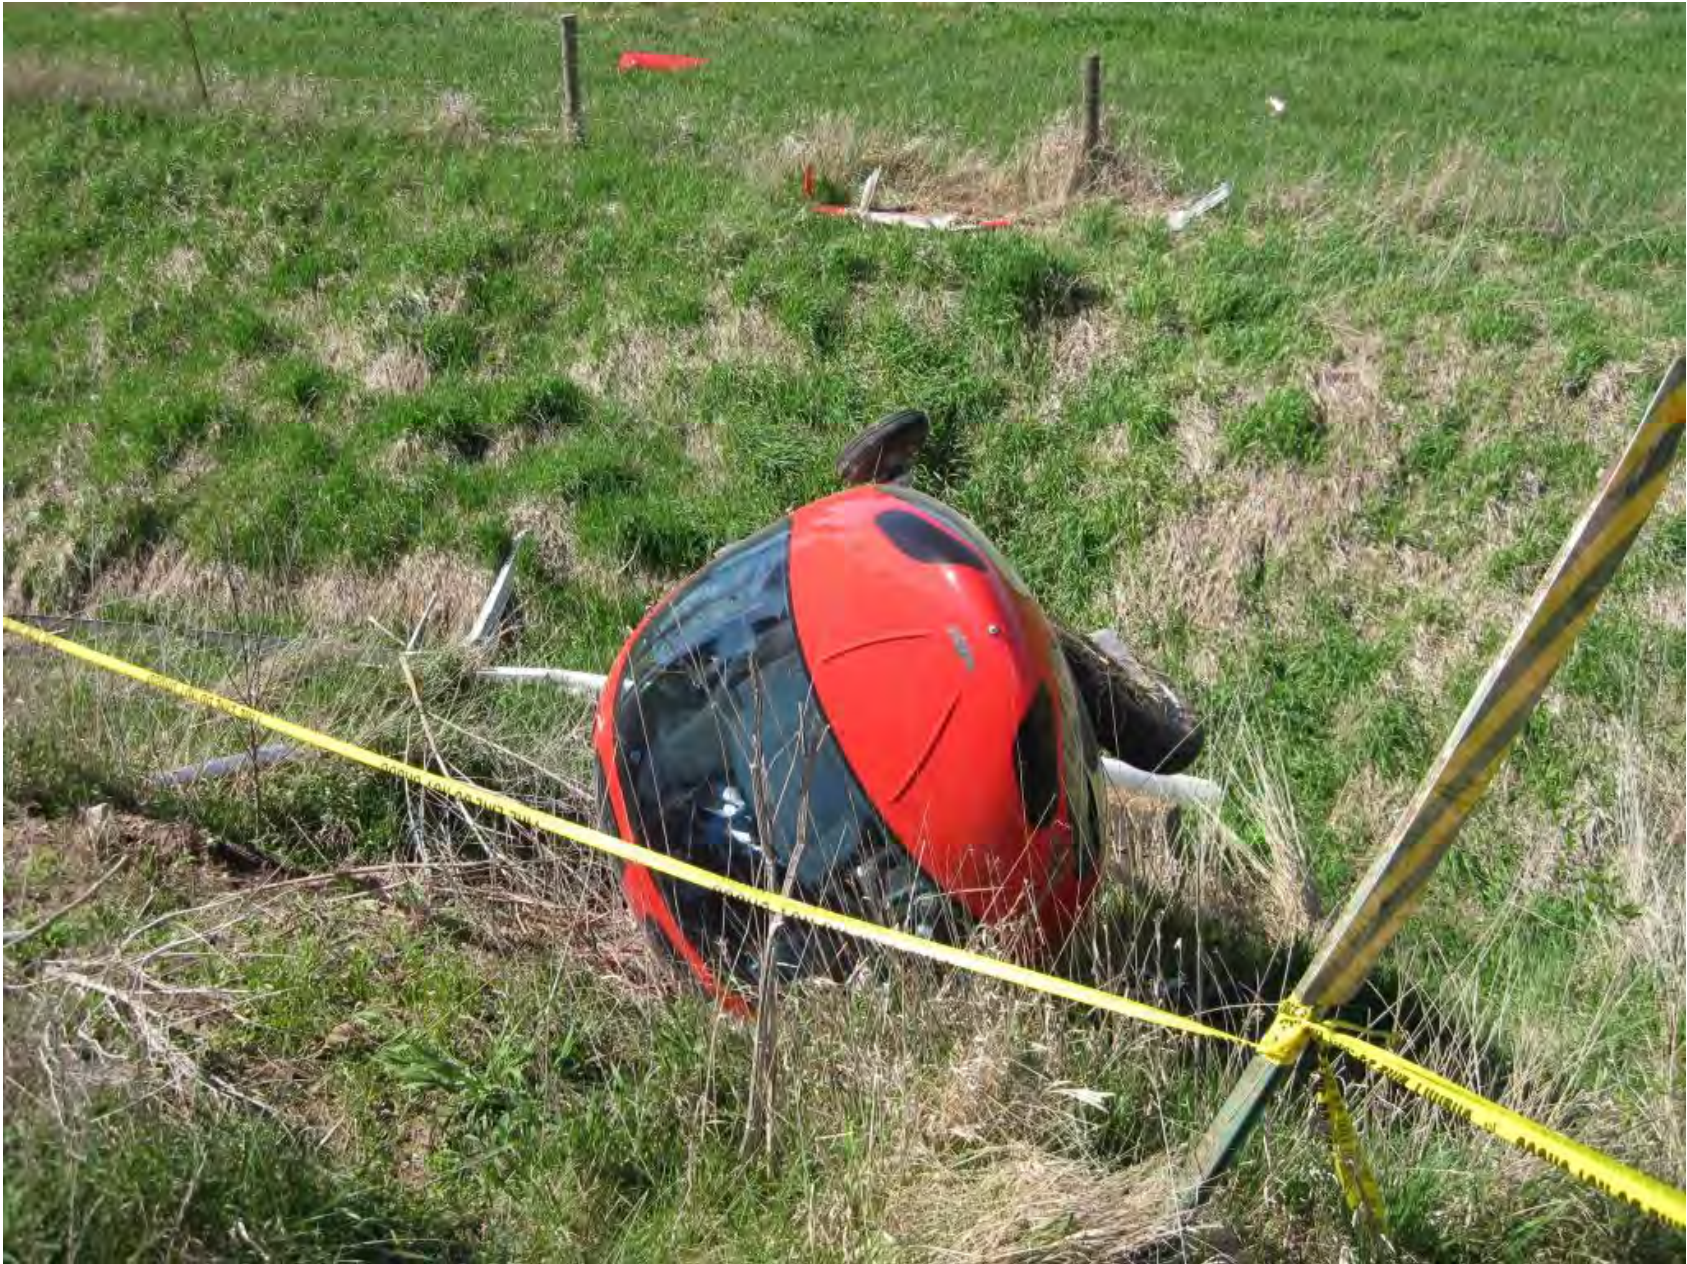
**Photo 2 – View of the front of the gyroplane.**

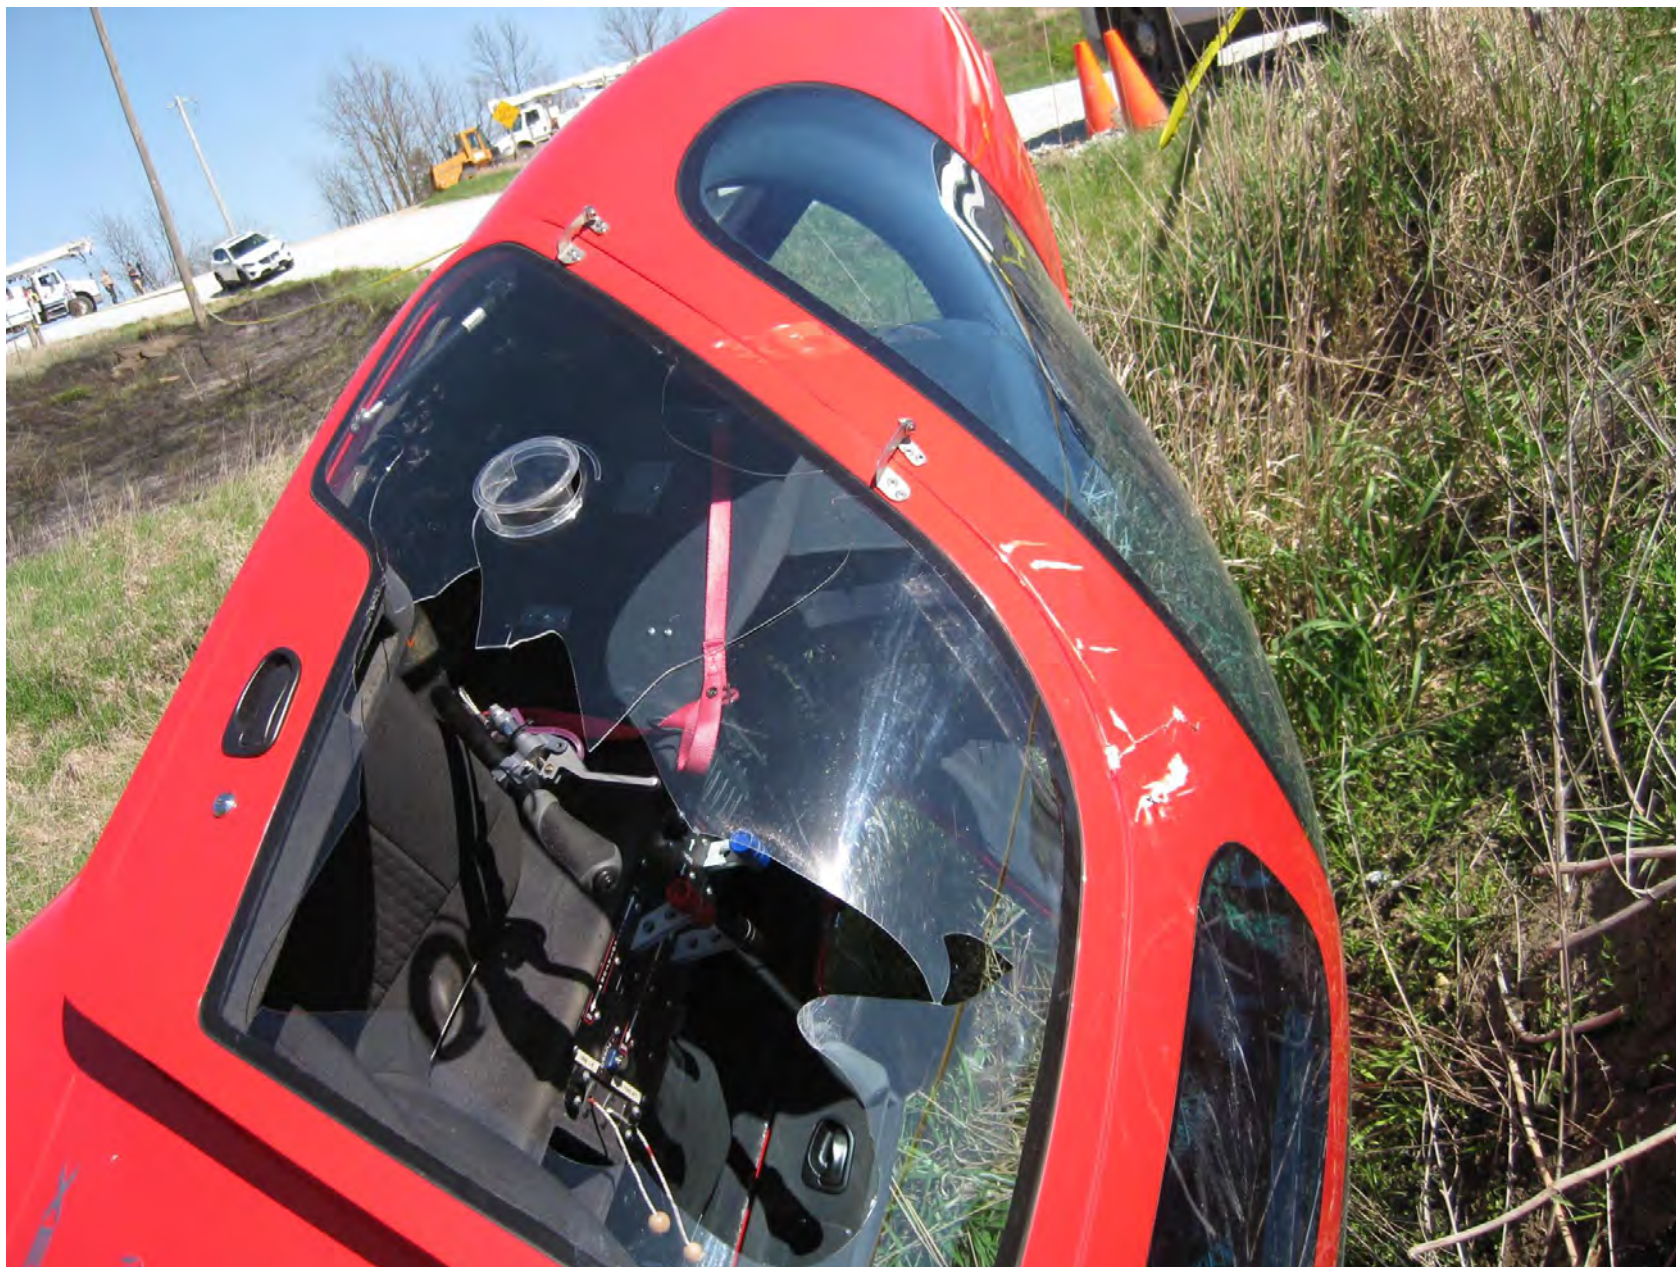
**Photo 3 - View of the left cockpit/cabin door of the gyroplane**

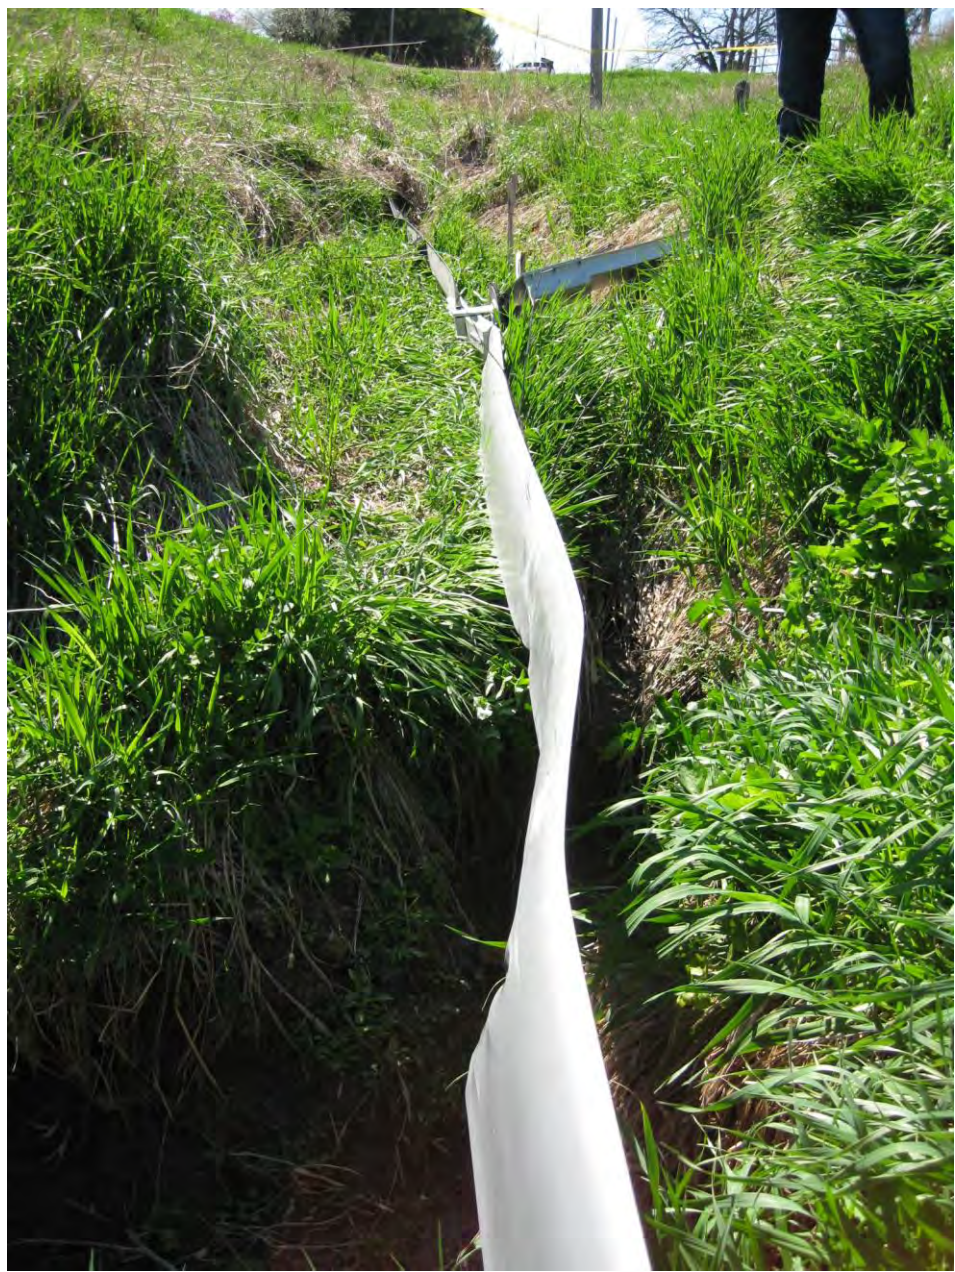
**Photo 4 - View of the main rotor blade which separated from the mast**

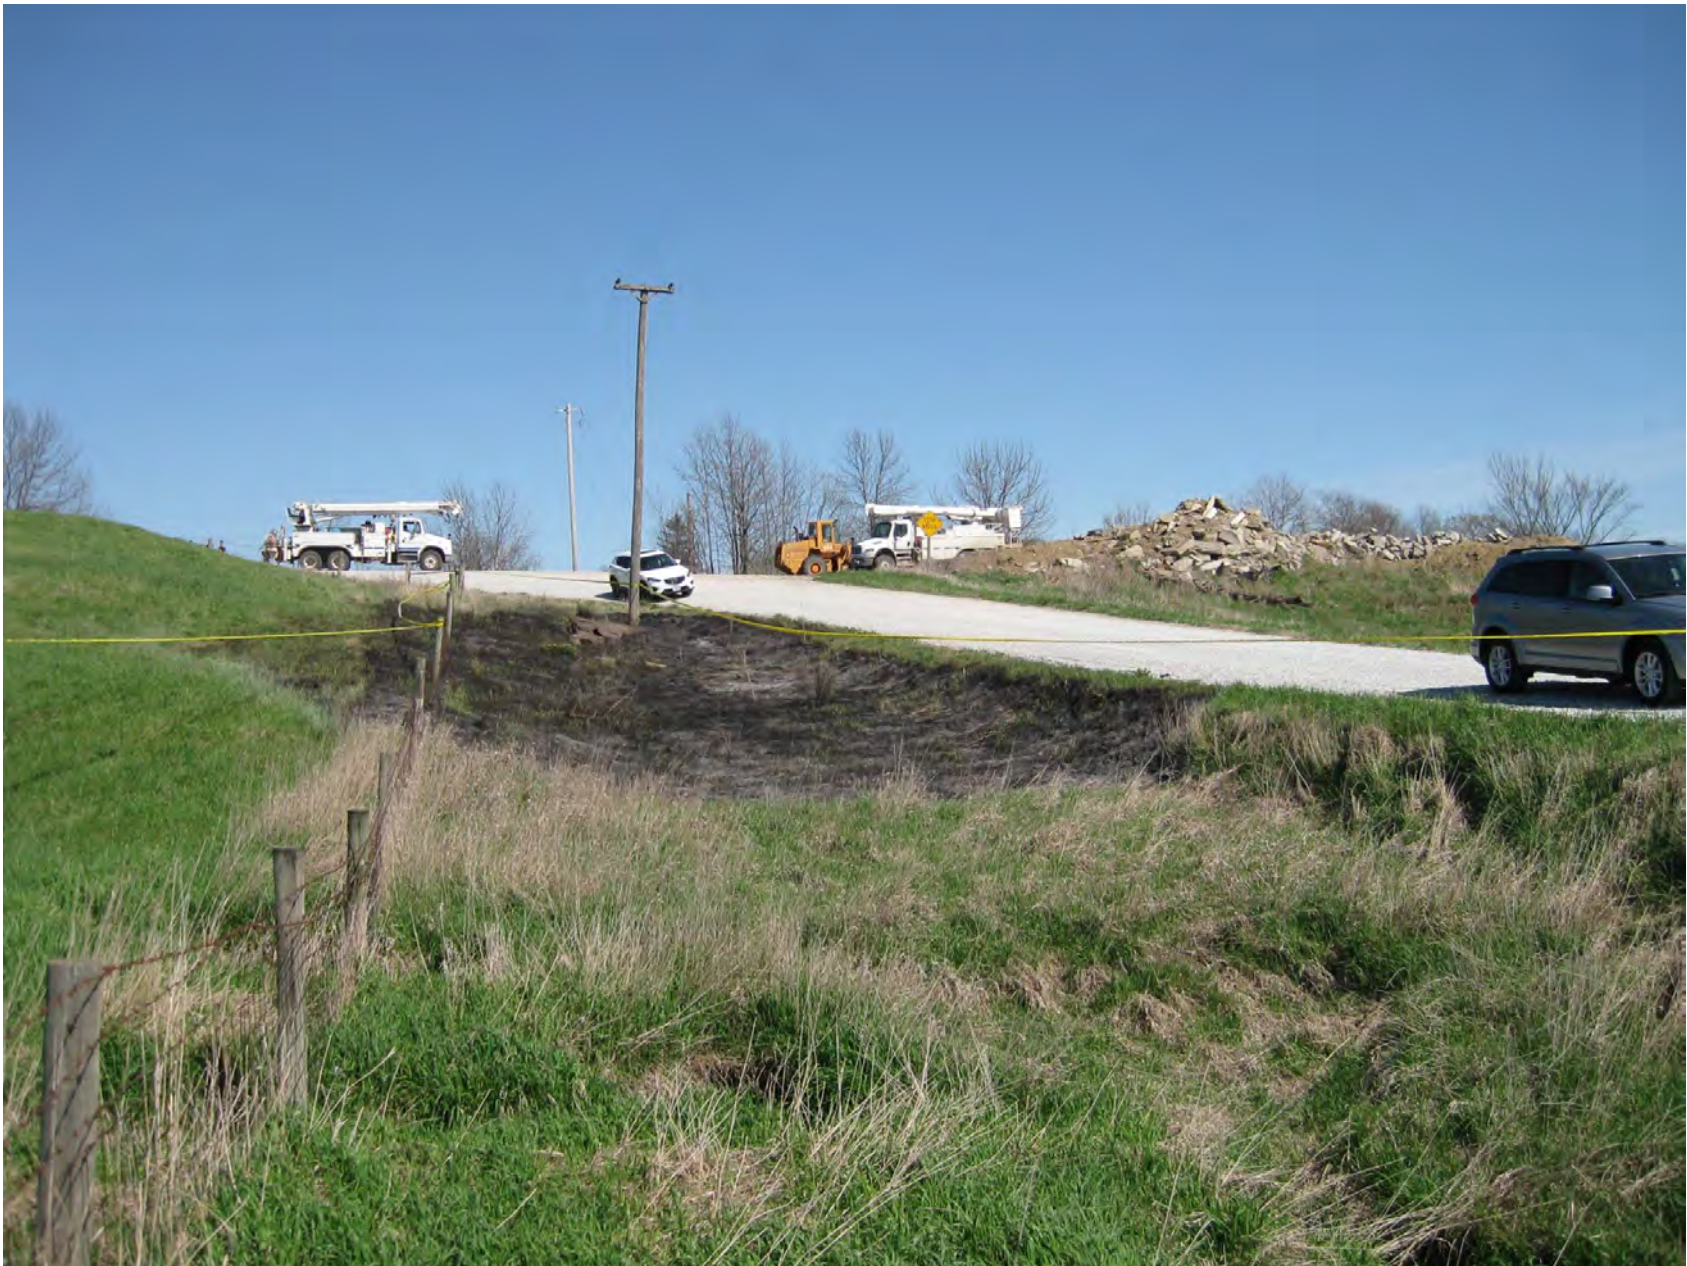
**Photo 5 - View of the power line that was hit by the gyroplane**

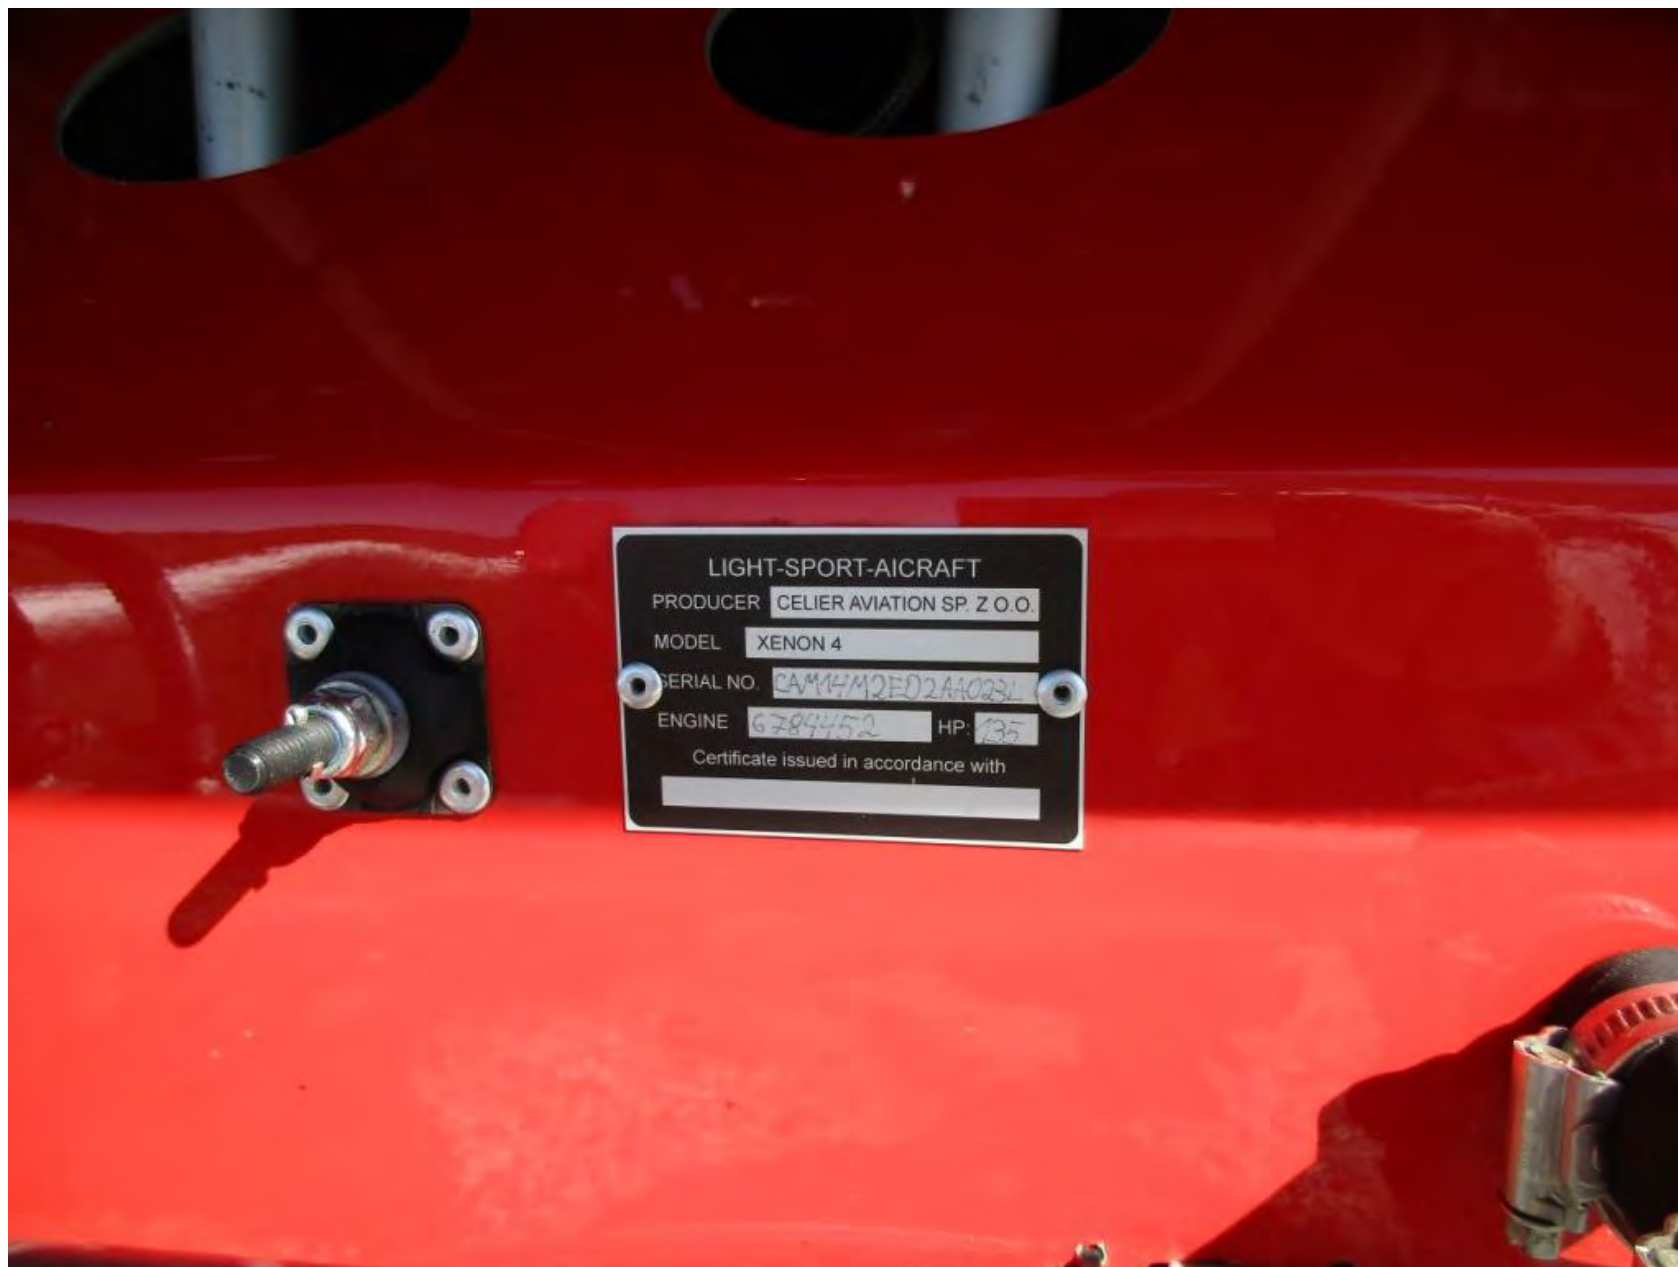
**Photo 6 - View of the gyroplane's data plate**

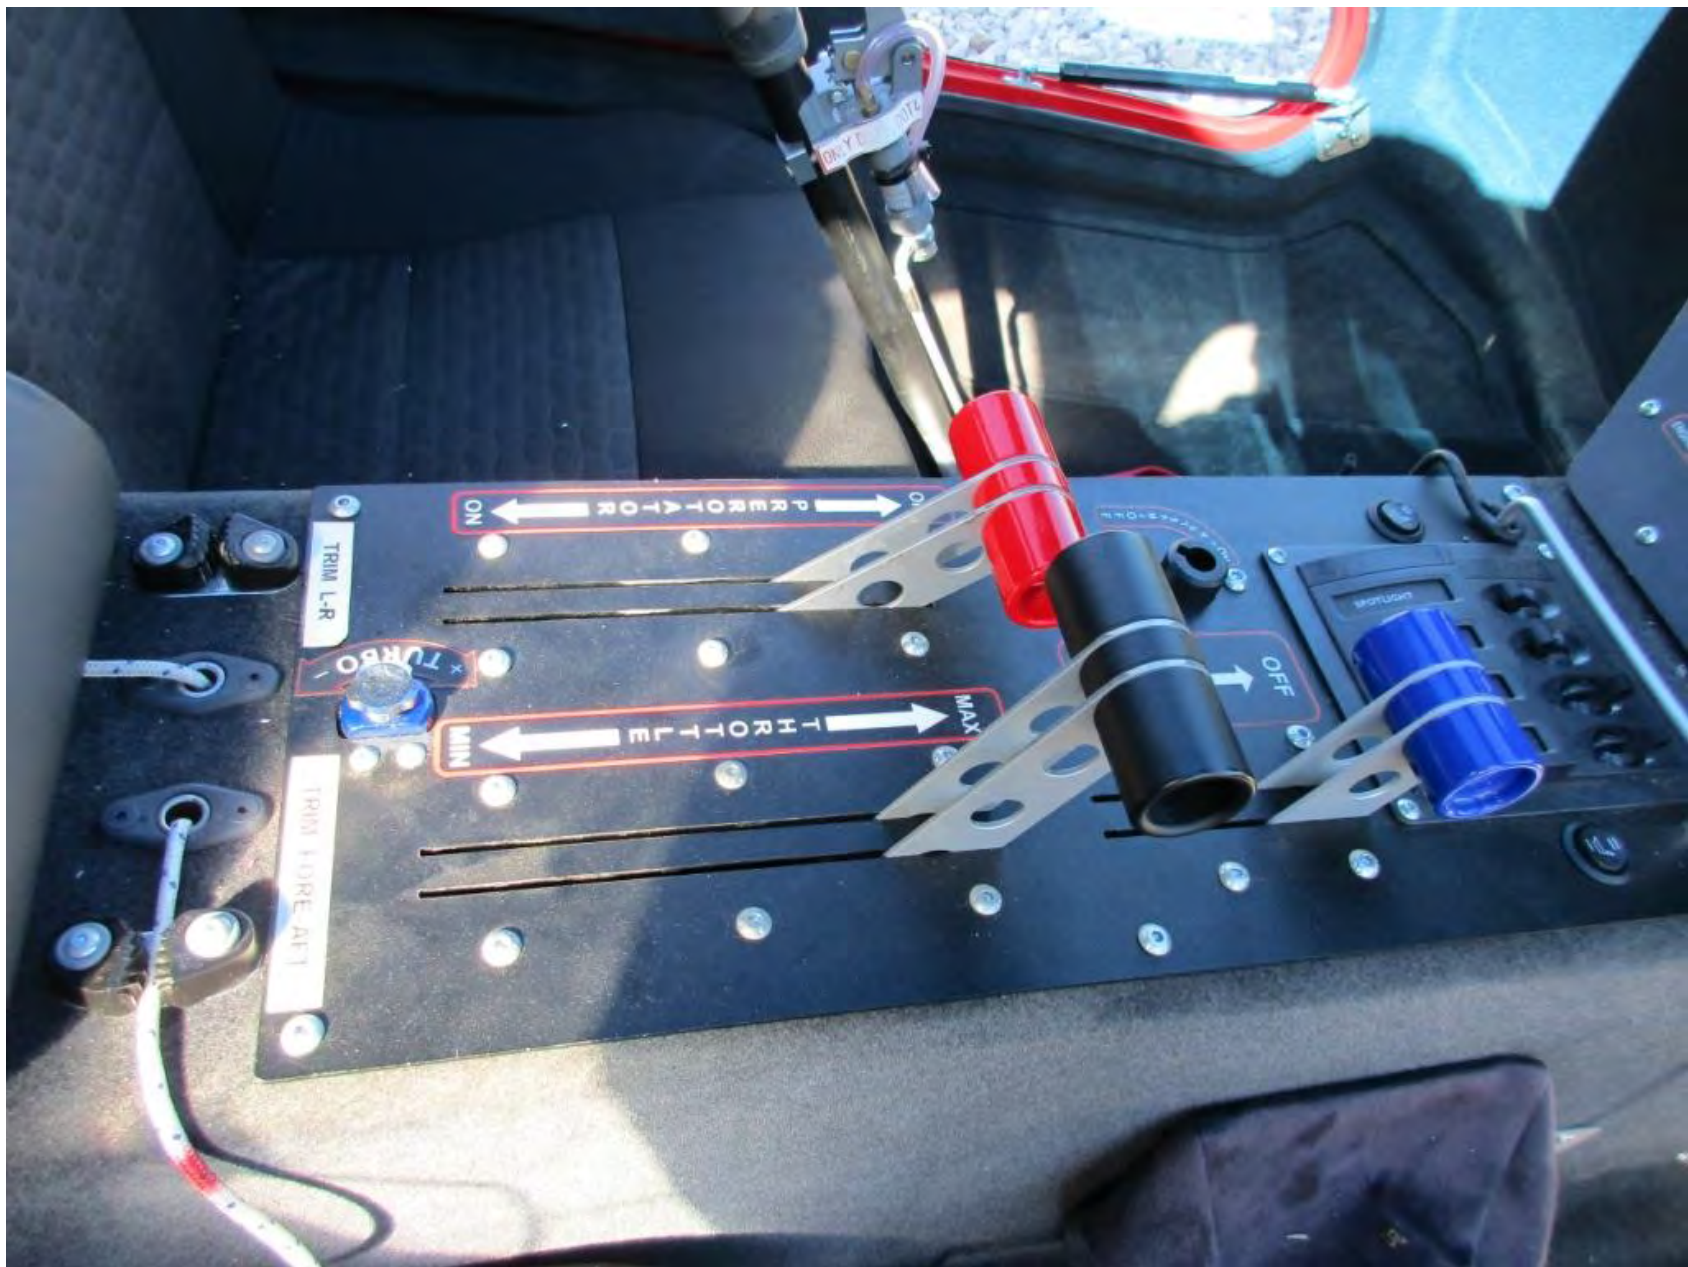
Photo 7 - View of the cockpit's power quadrant

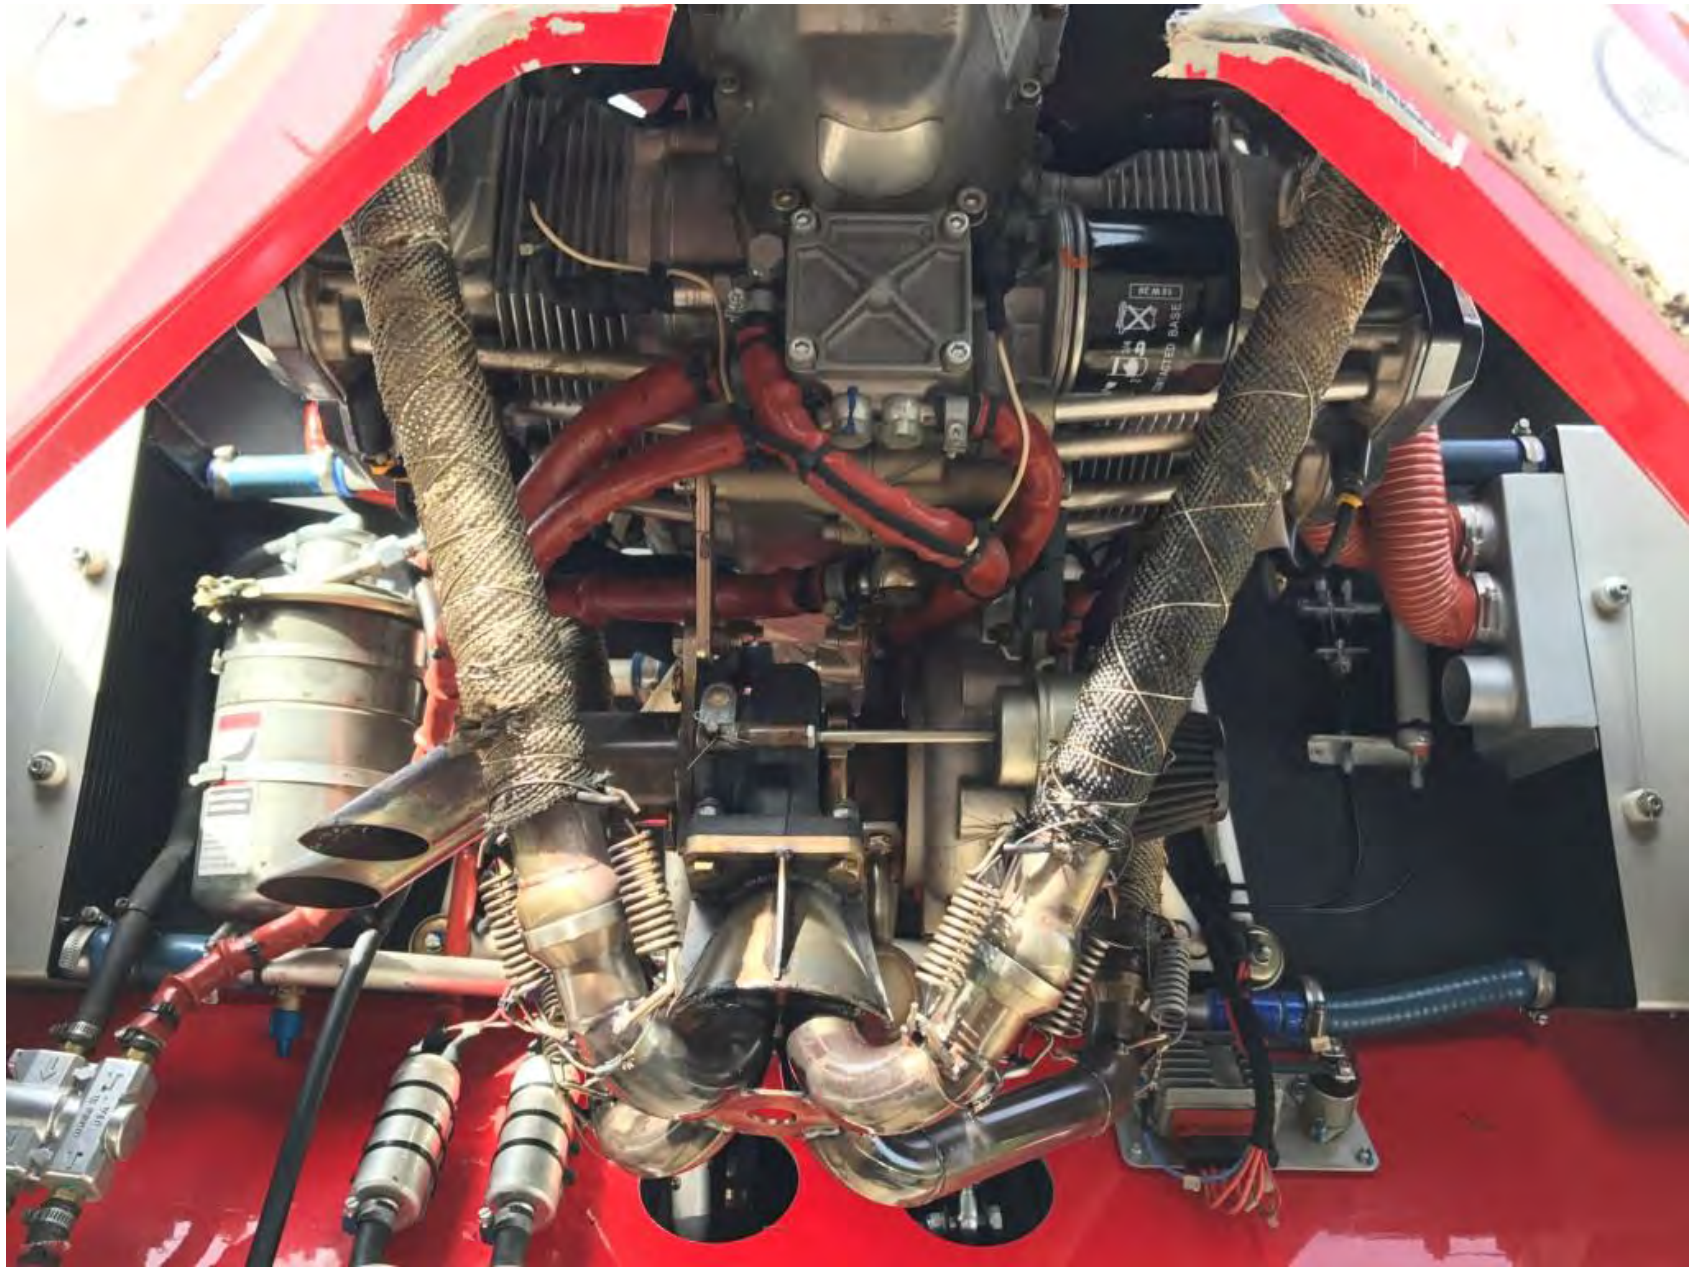
**Photo 8 - View of the bottom of the engine**

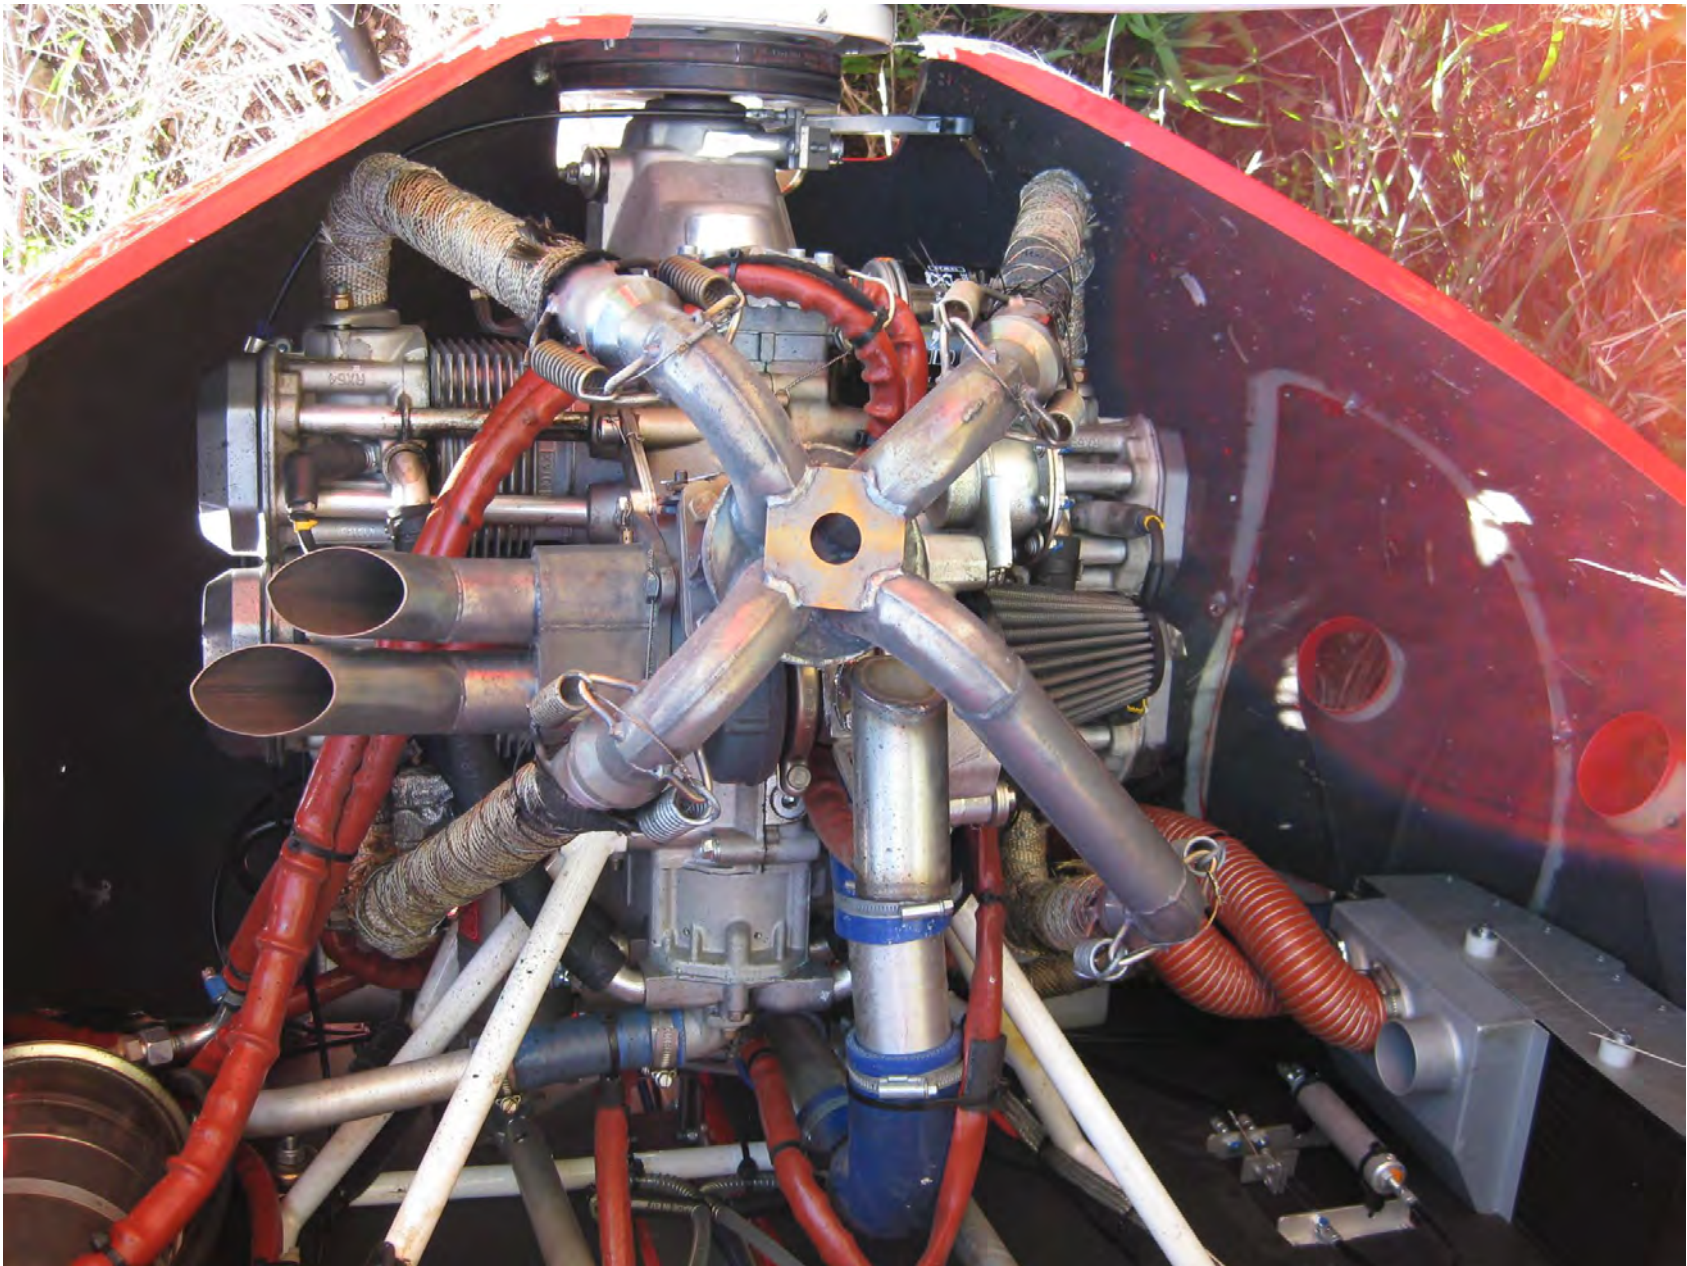
**Photo 9 - View of the bottom of the engine**

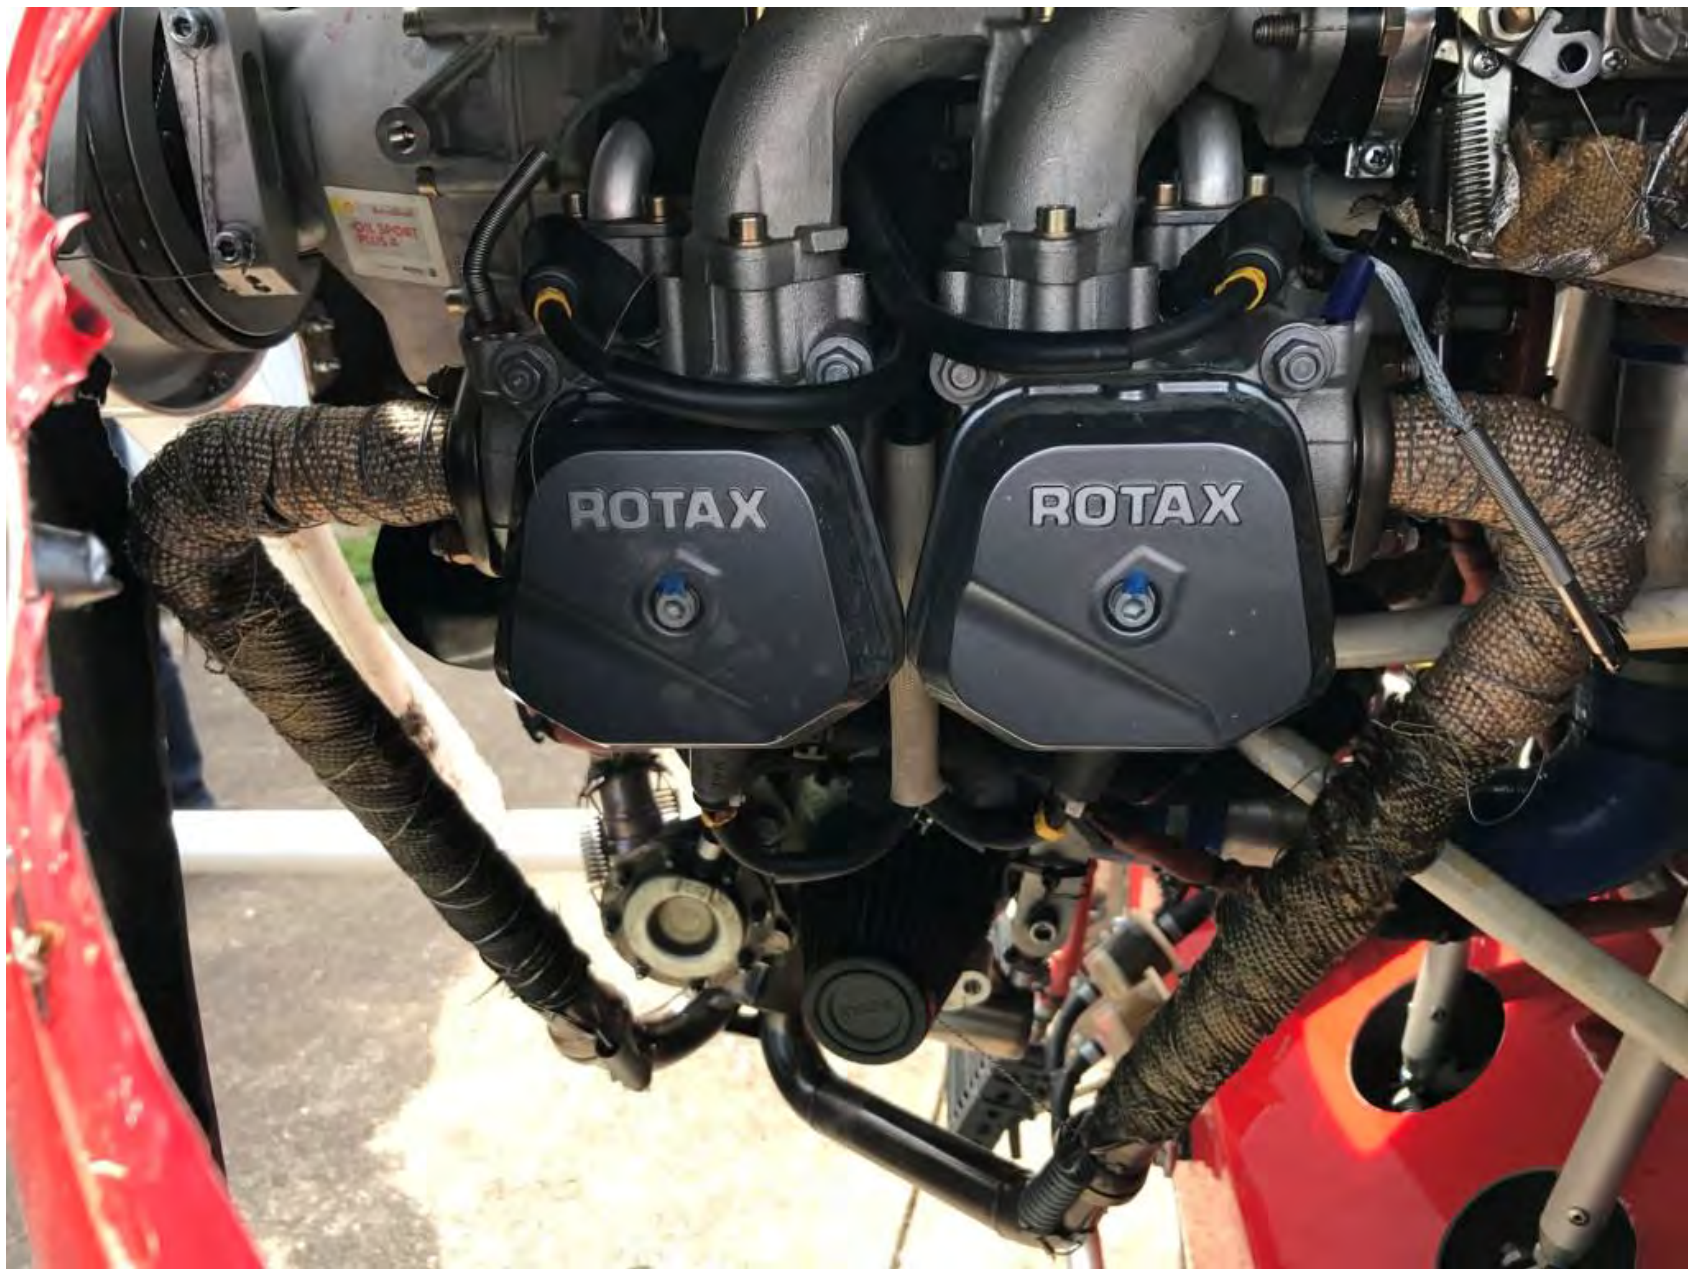
**Photo 10 - View of the right side of the engine (looking aircraft forward)**

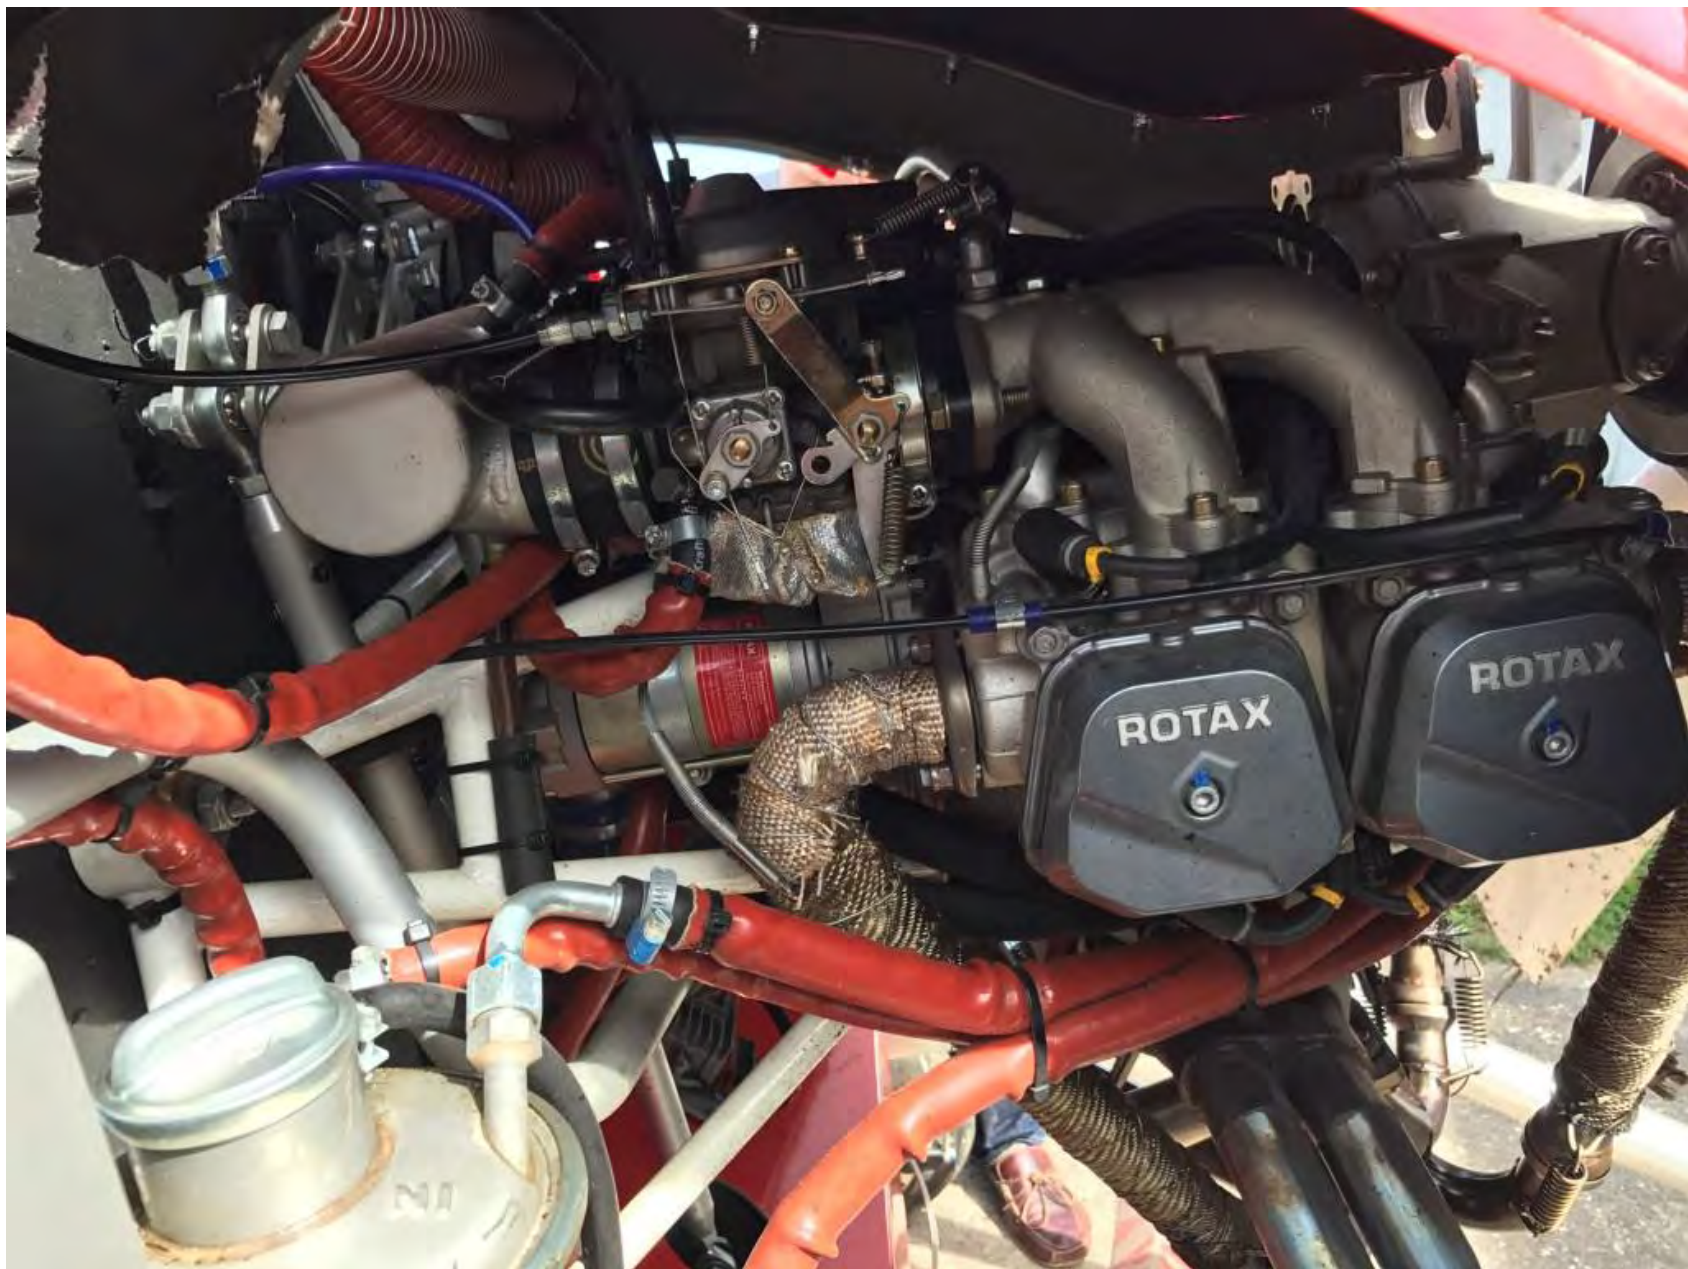
**Photo 11 – View of the left side of the engine (looking aircraft forward)**

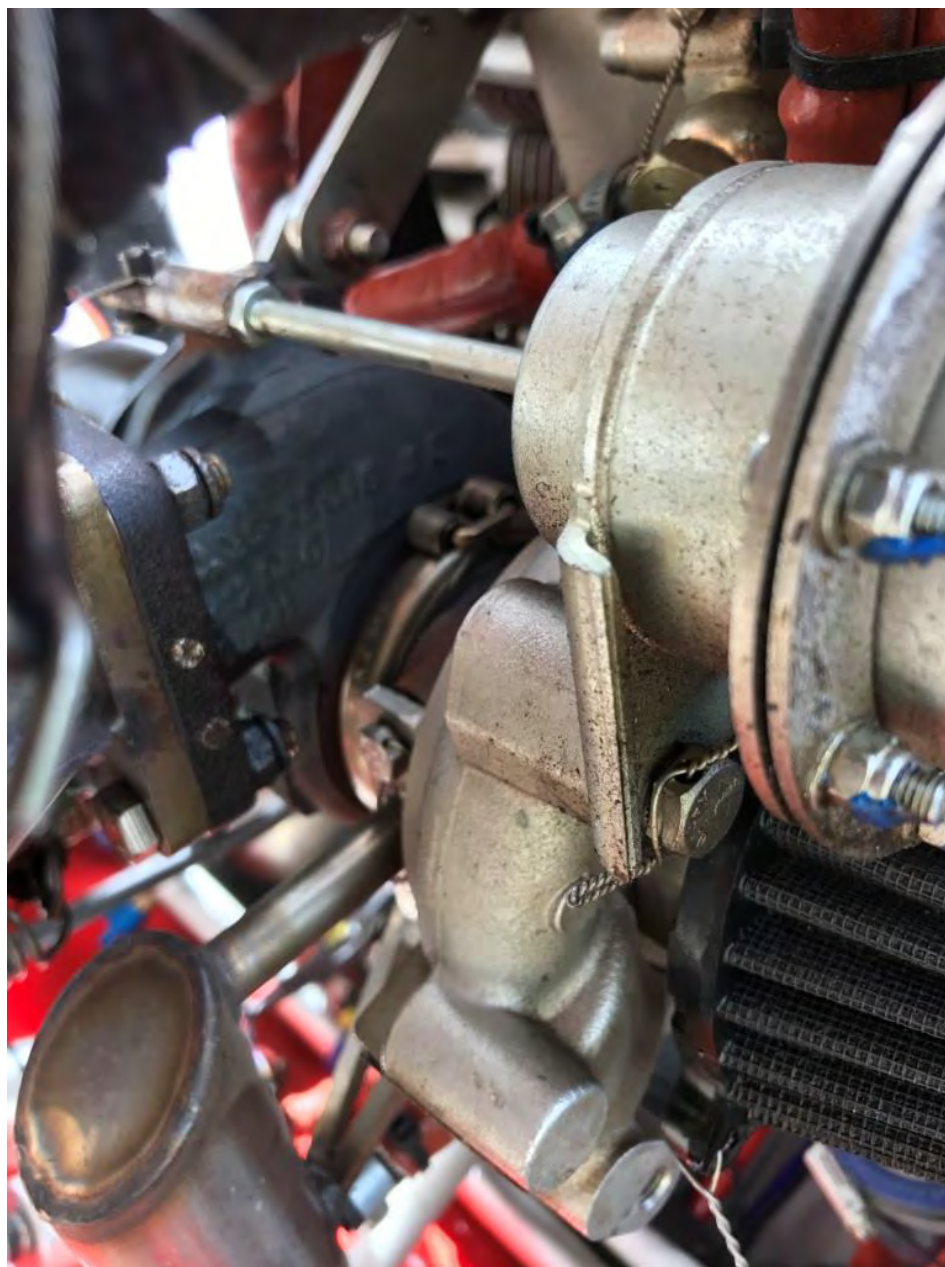
**Photo 12 – View of the Wastegate Actuator**
