**Photo 1 – View of gyroplane on the side of a ditch at the accident site**

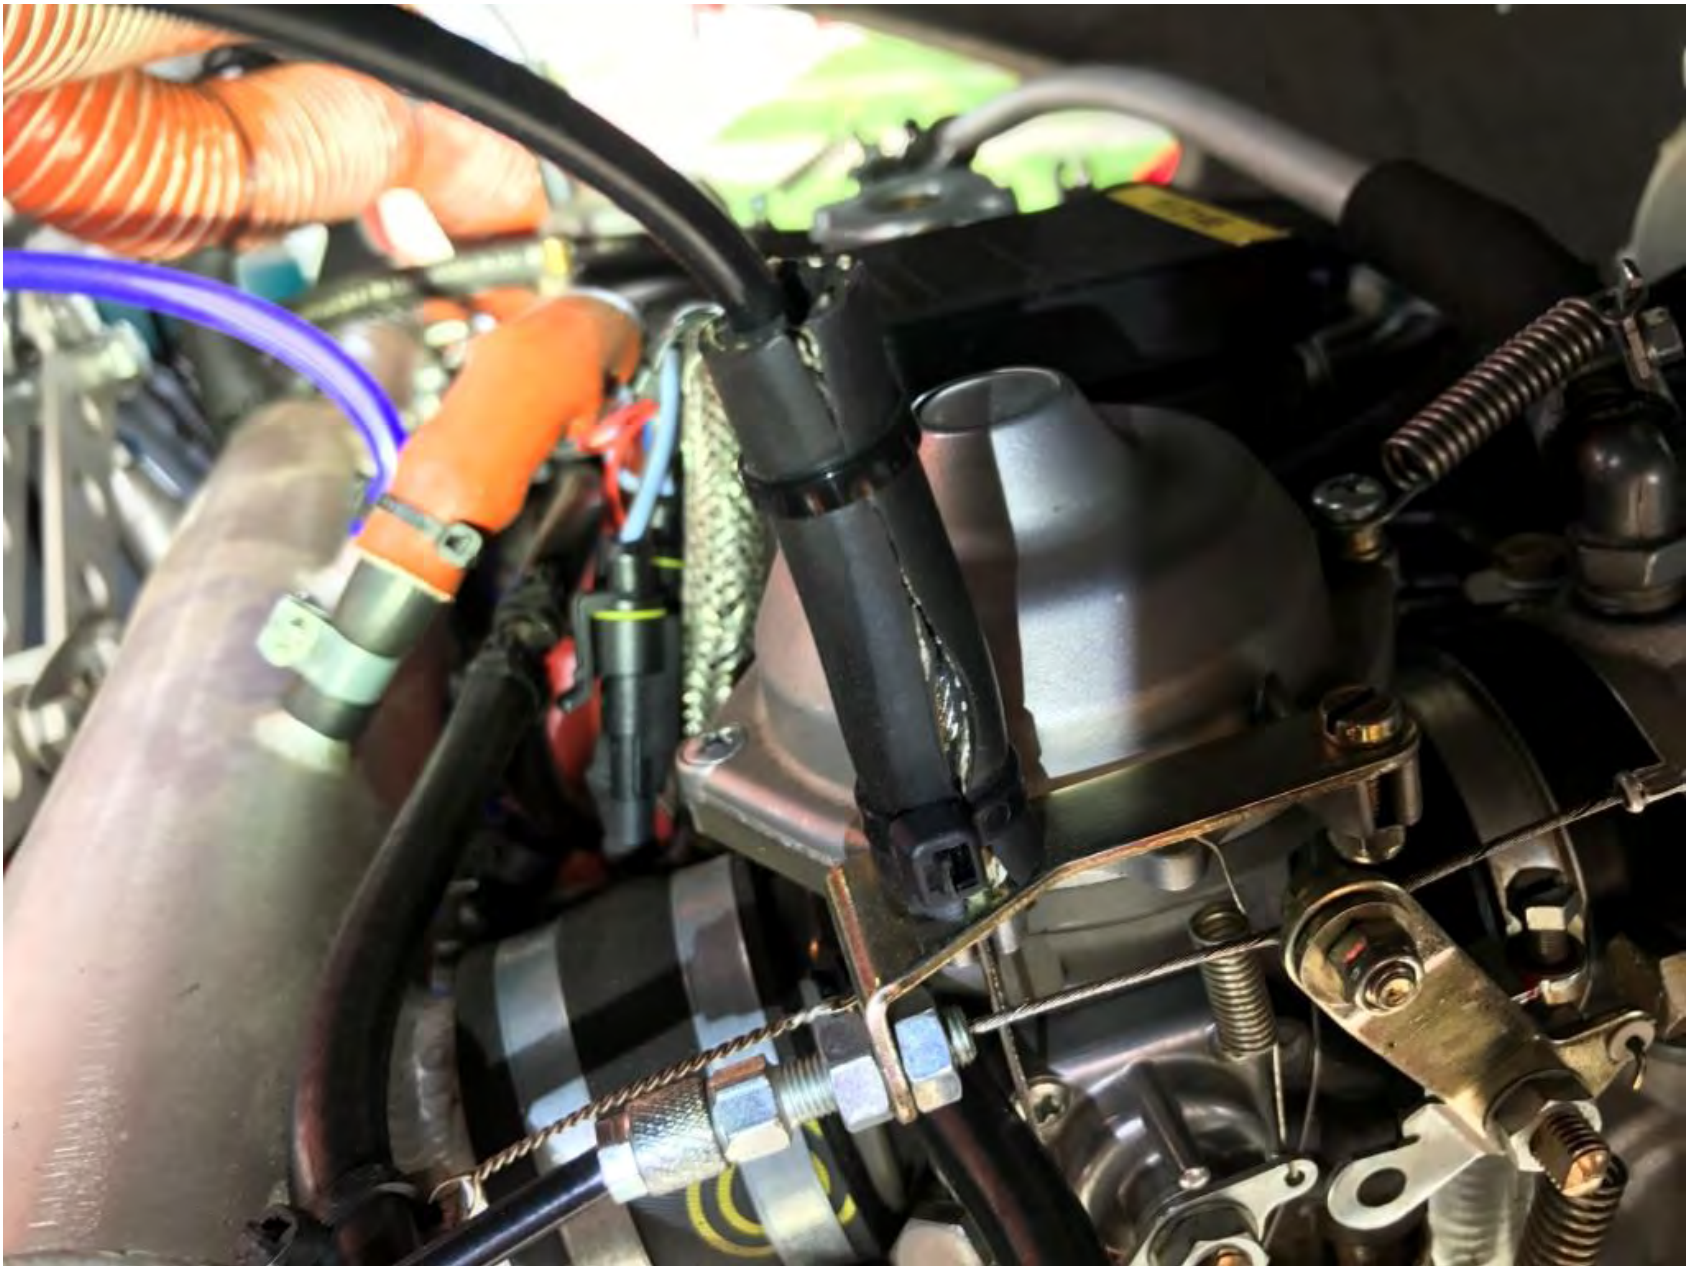
**Photo 13 – View of the left carburetor and airbox**

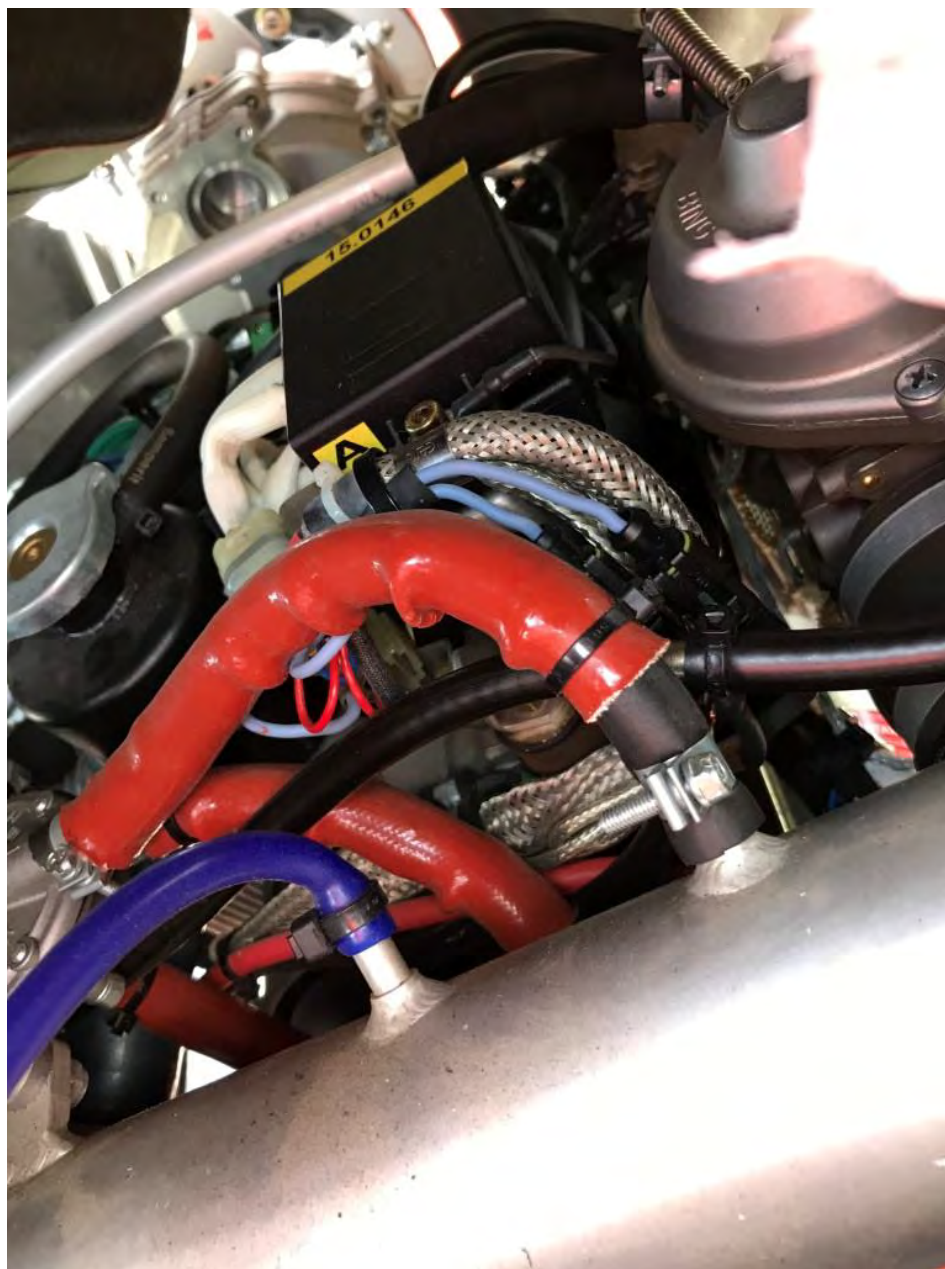
**Photo 14 - View of airbox and black ignition boxes**

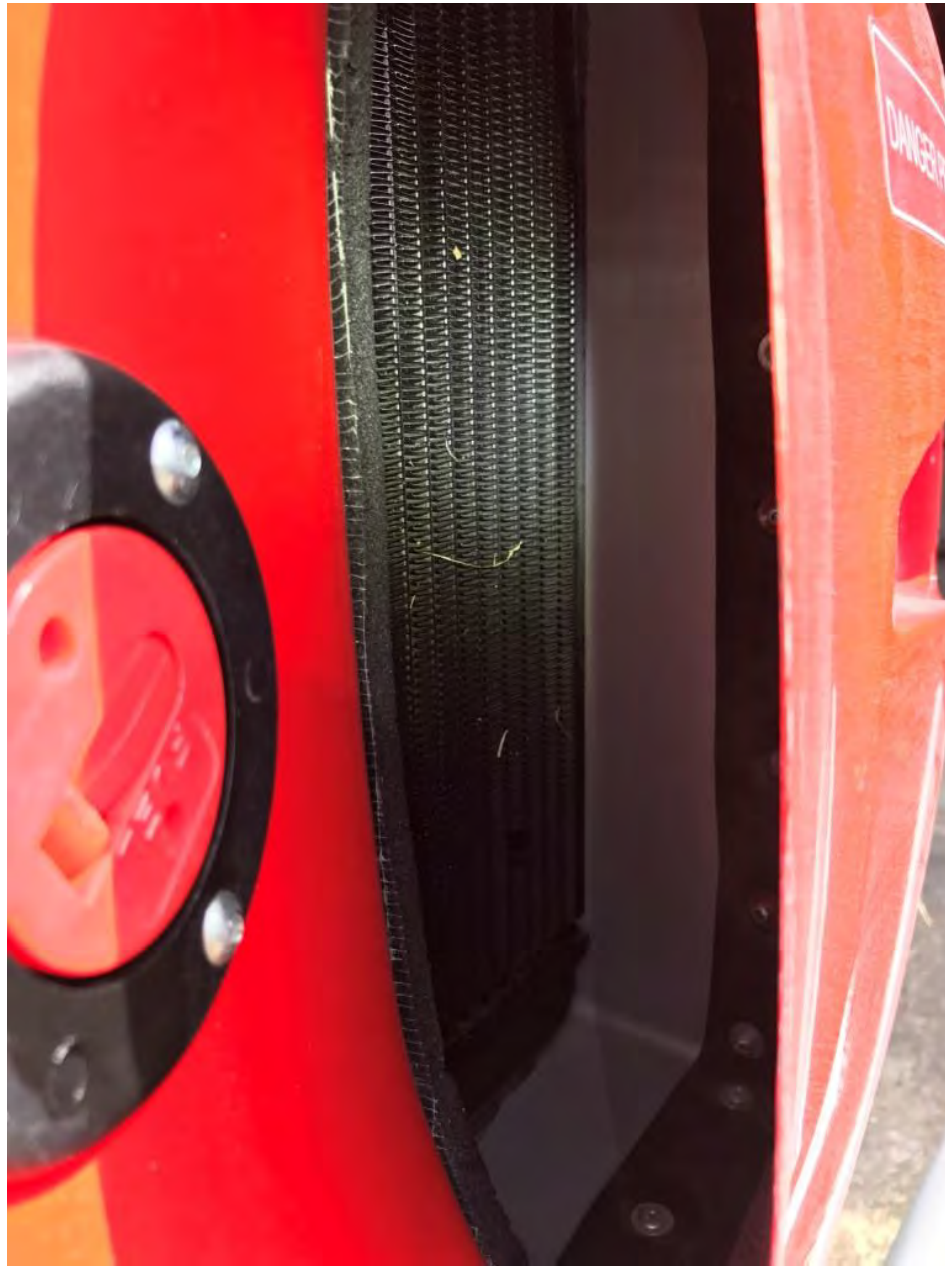
**Photo 15 – View of the left coolant radiator (Intercooler)**

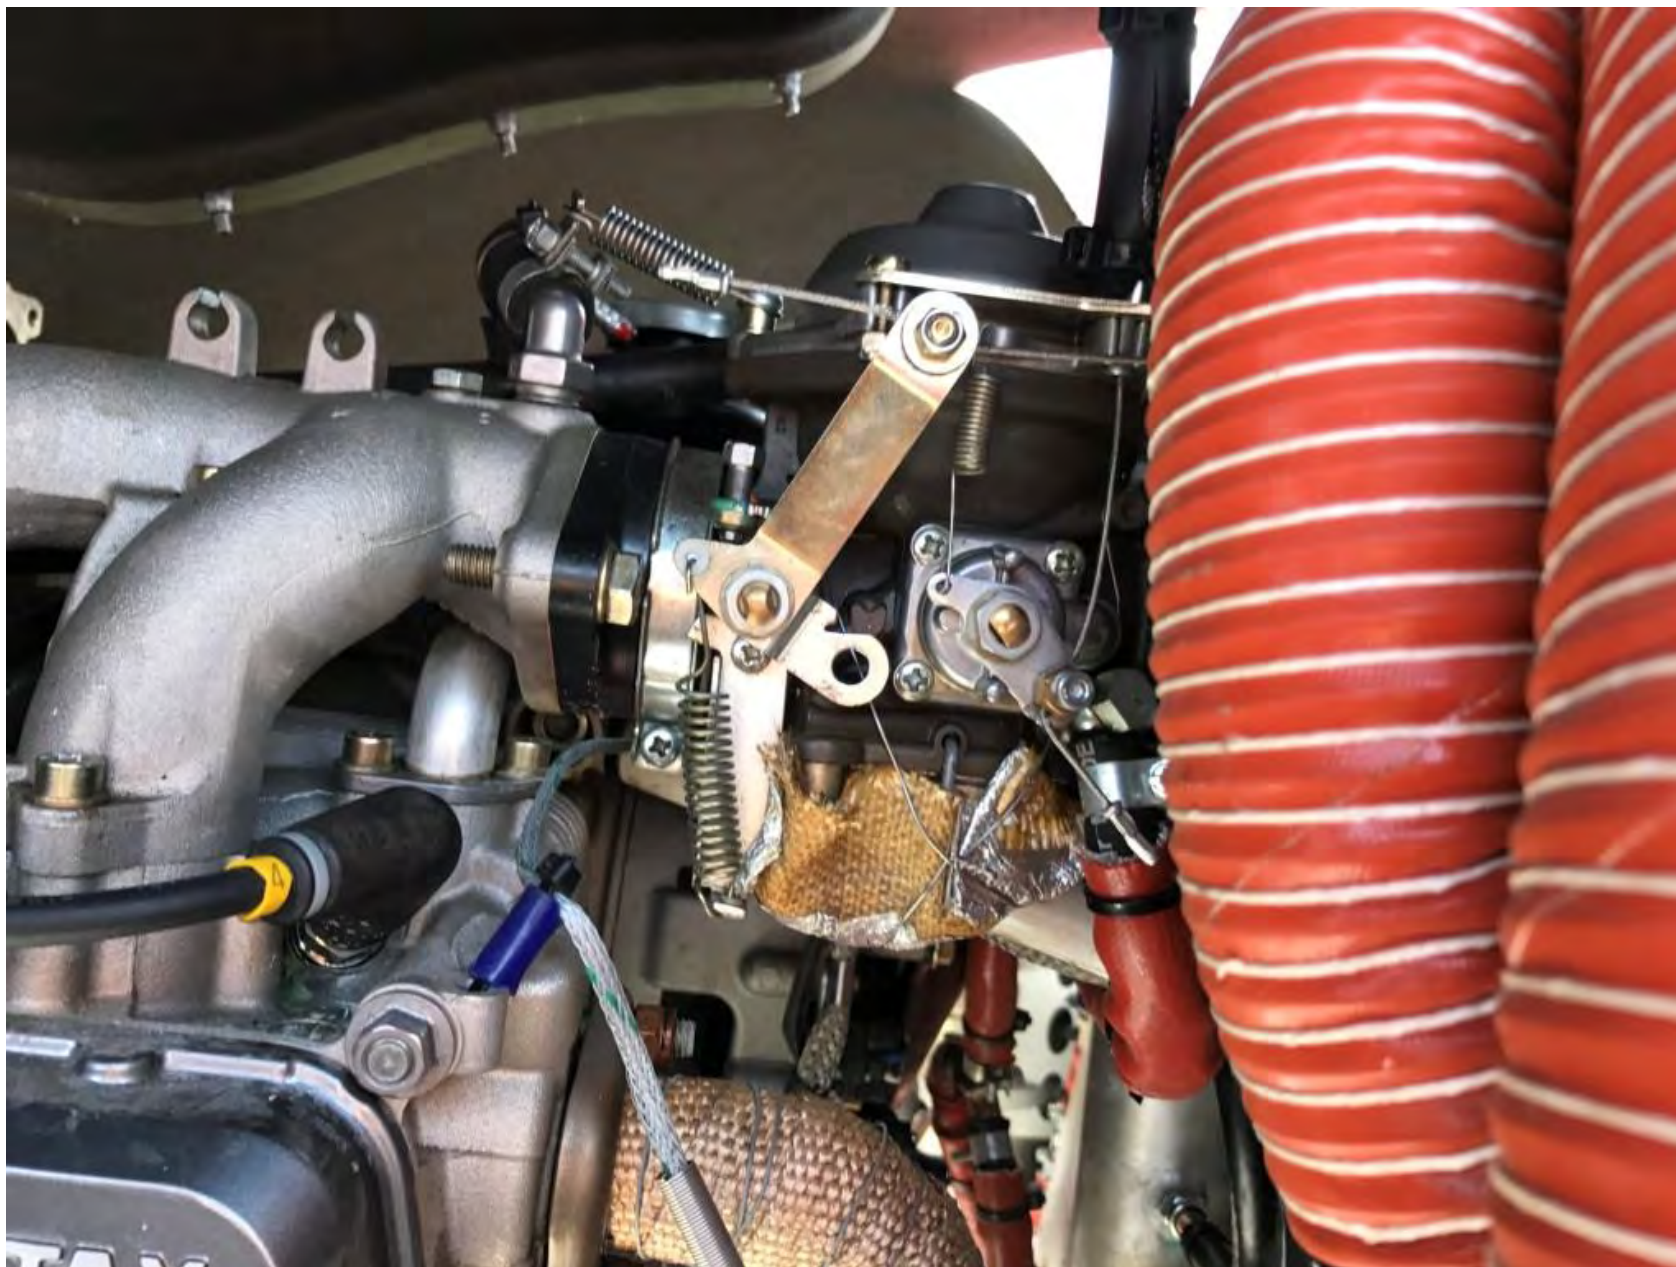
**Photo 16 – View of right Bing carburetor**

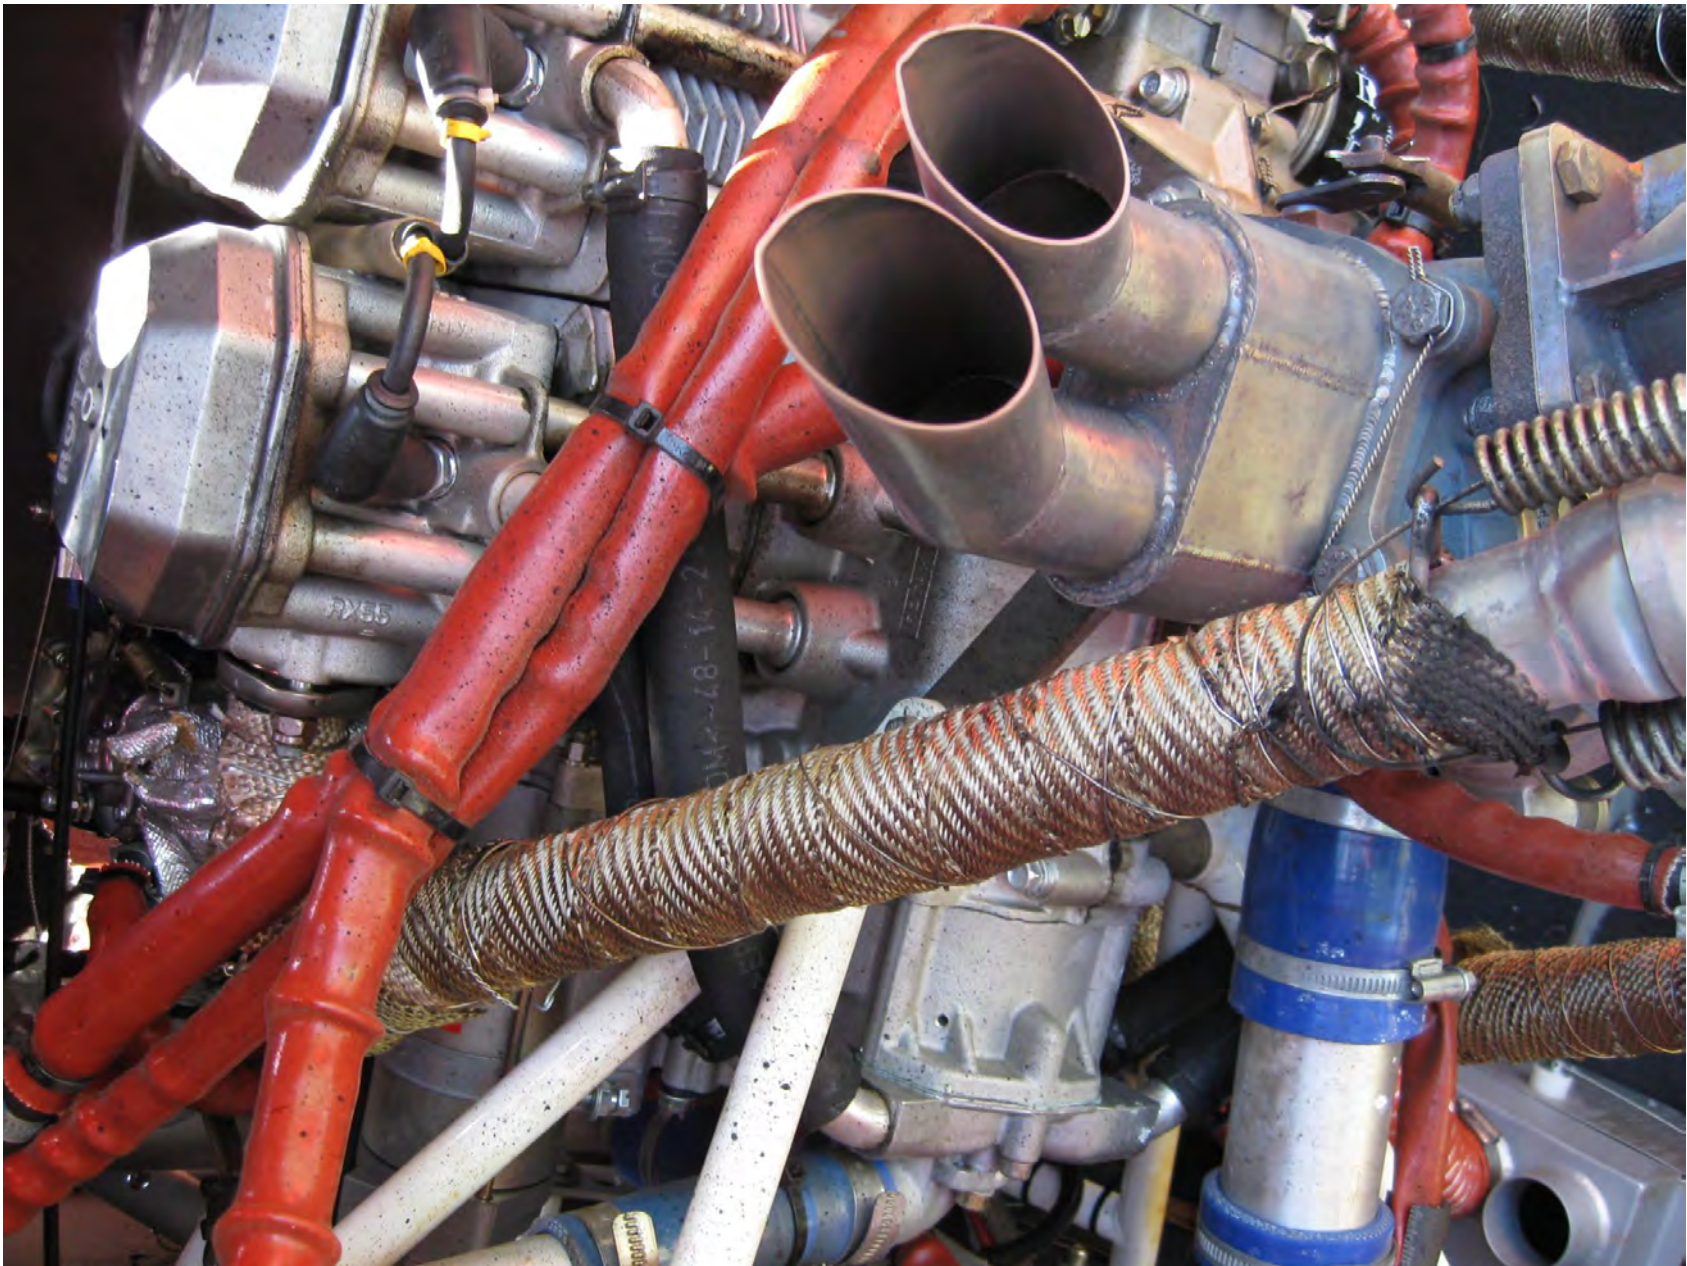
**Photo 17 – View of the exhaust outlet**

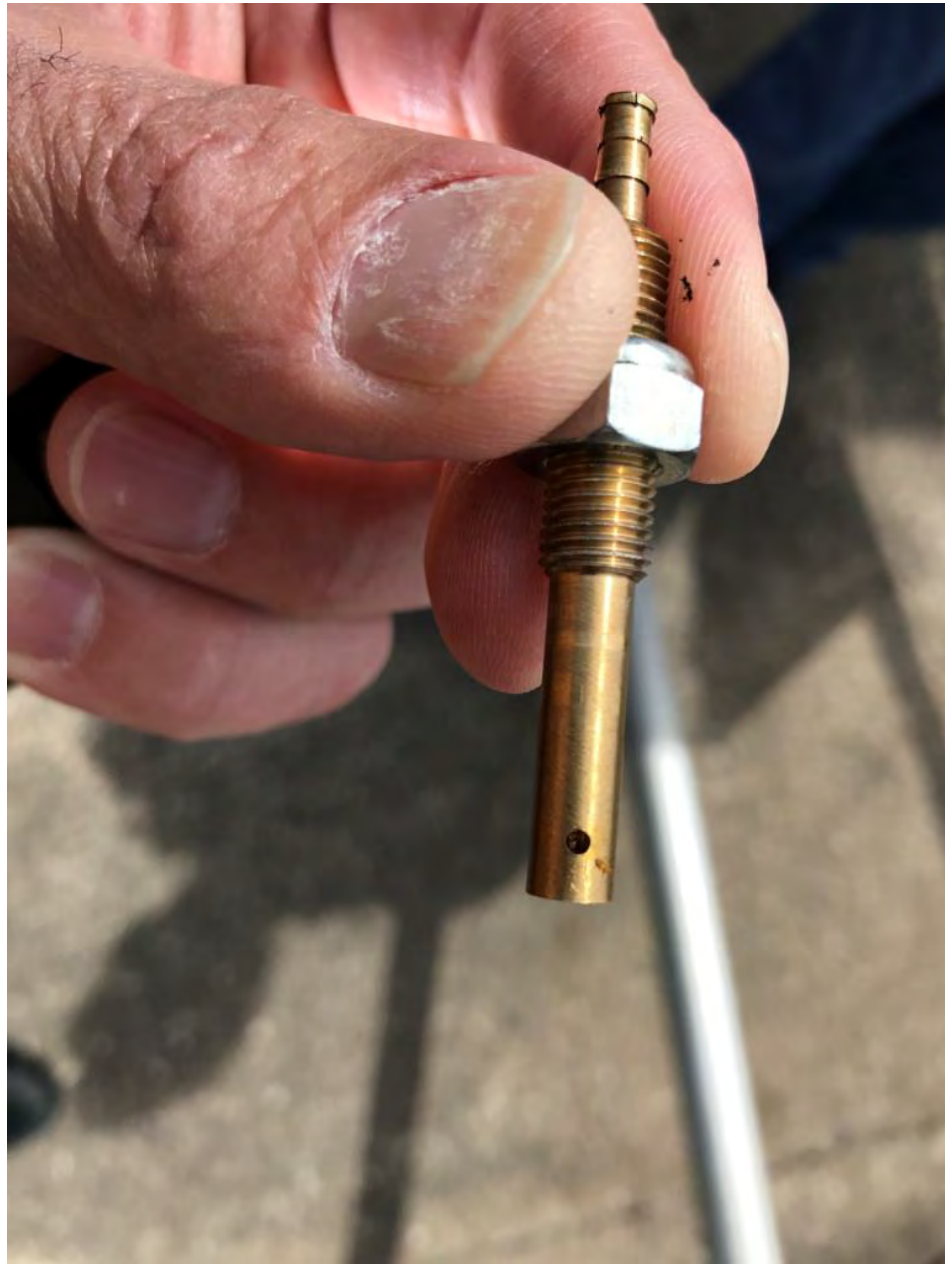
**Photo 18 – View of the manifold pressure probe**

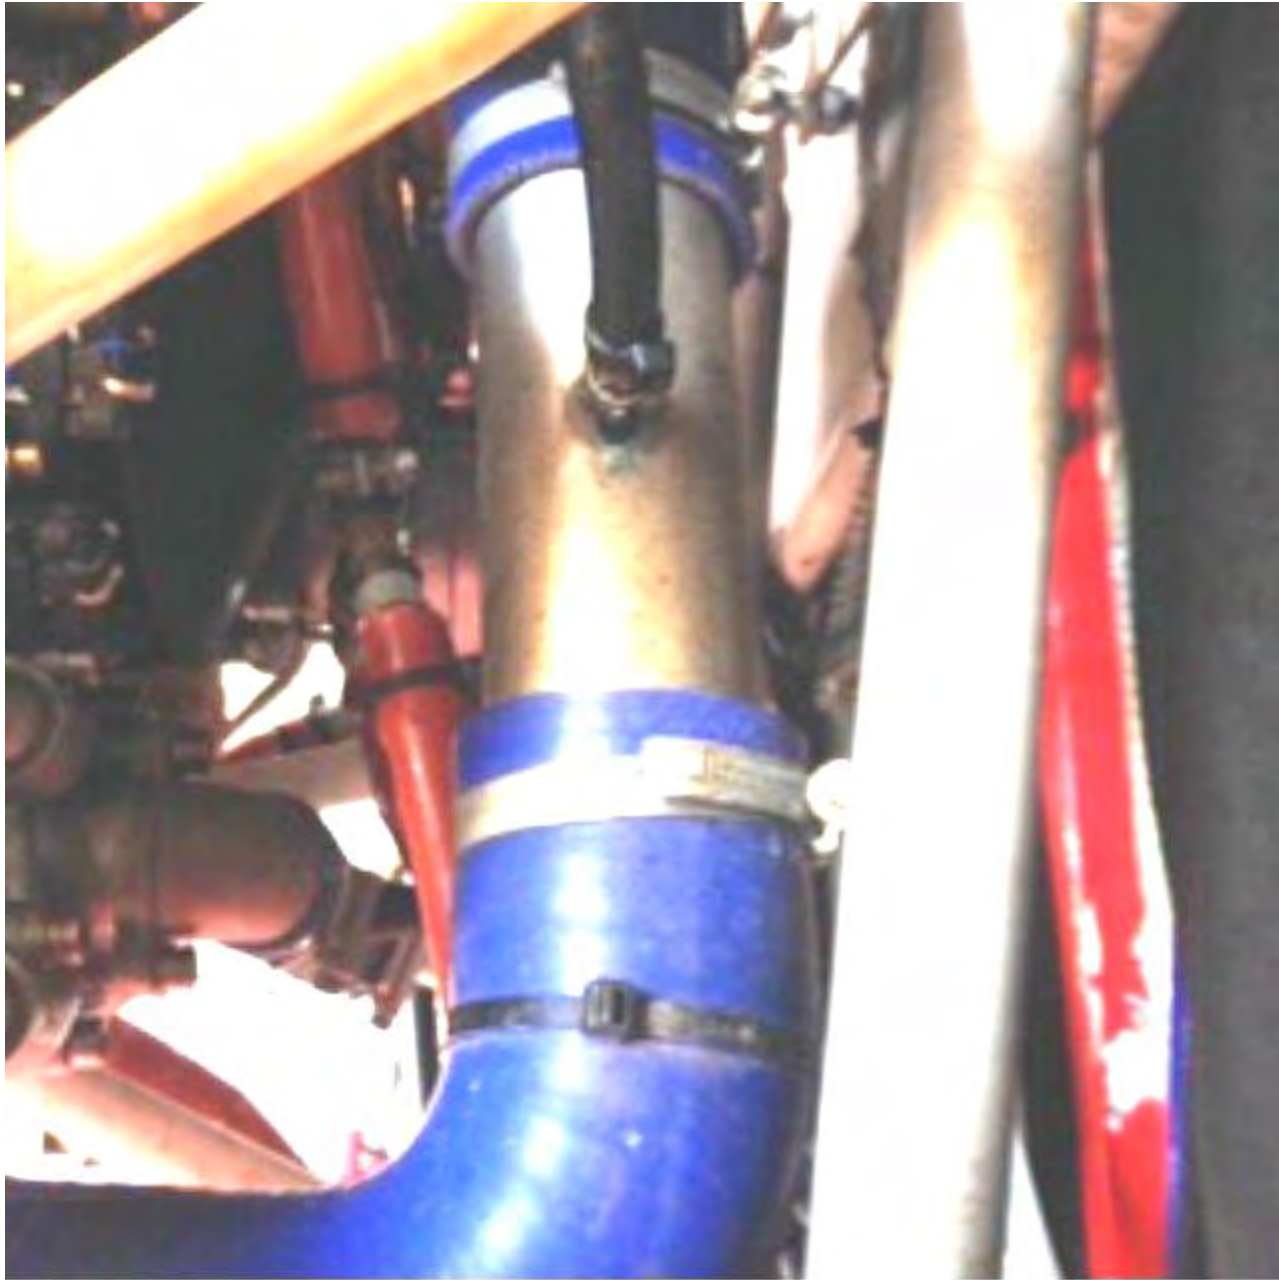
Photo 19 - Manifold pressure probe installation

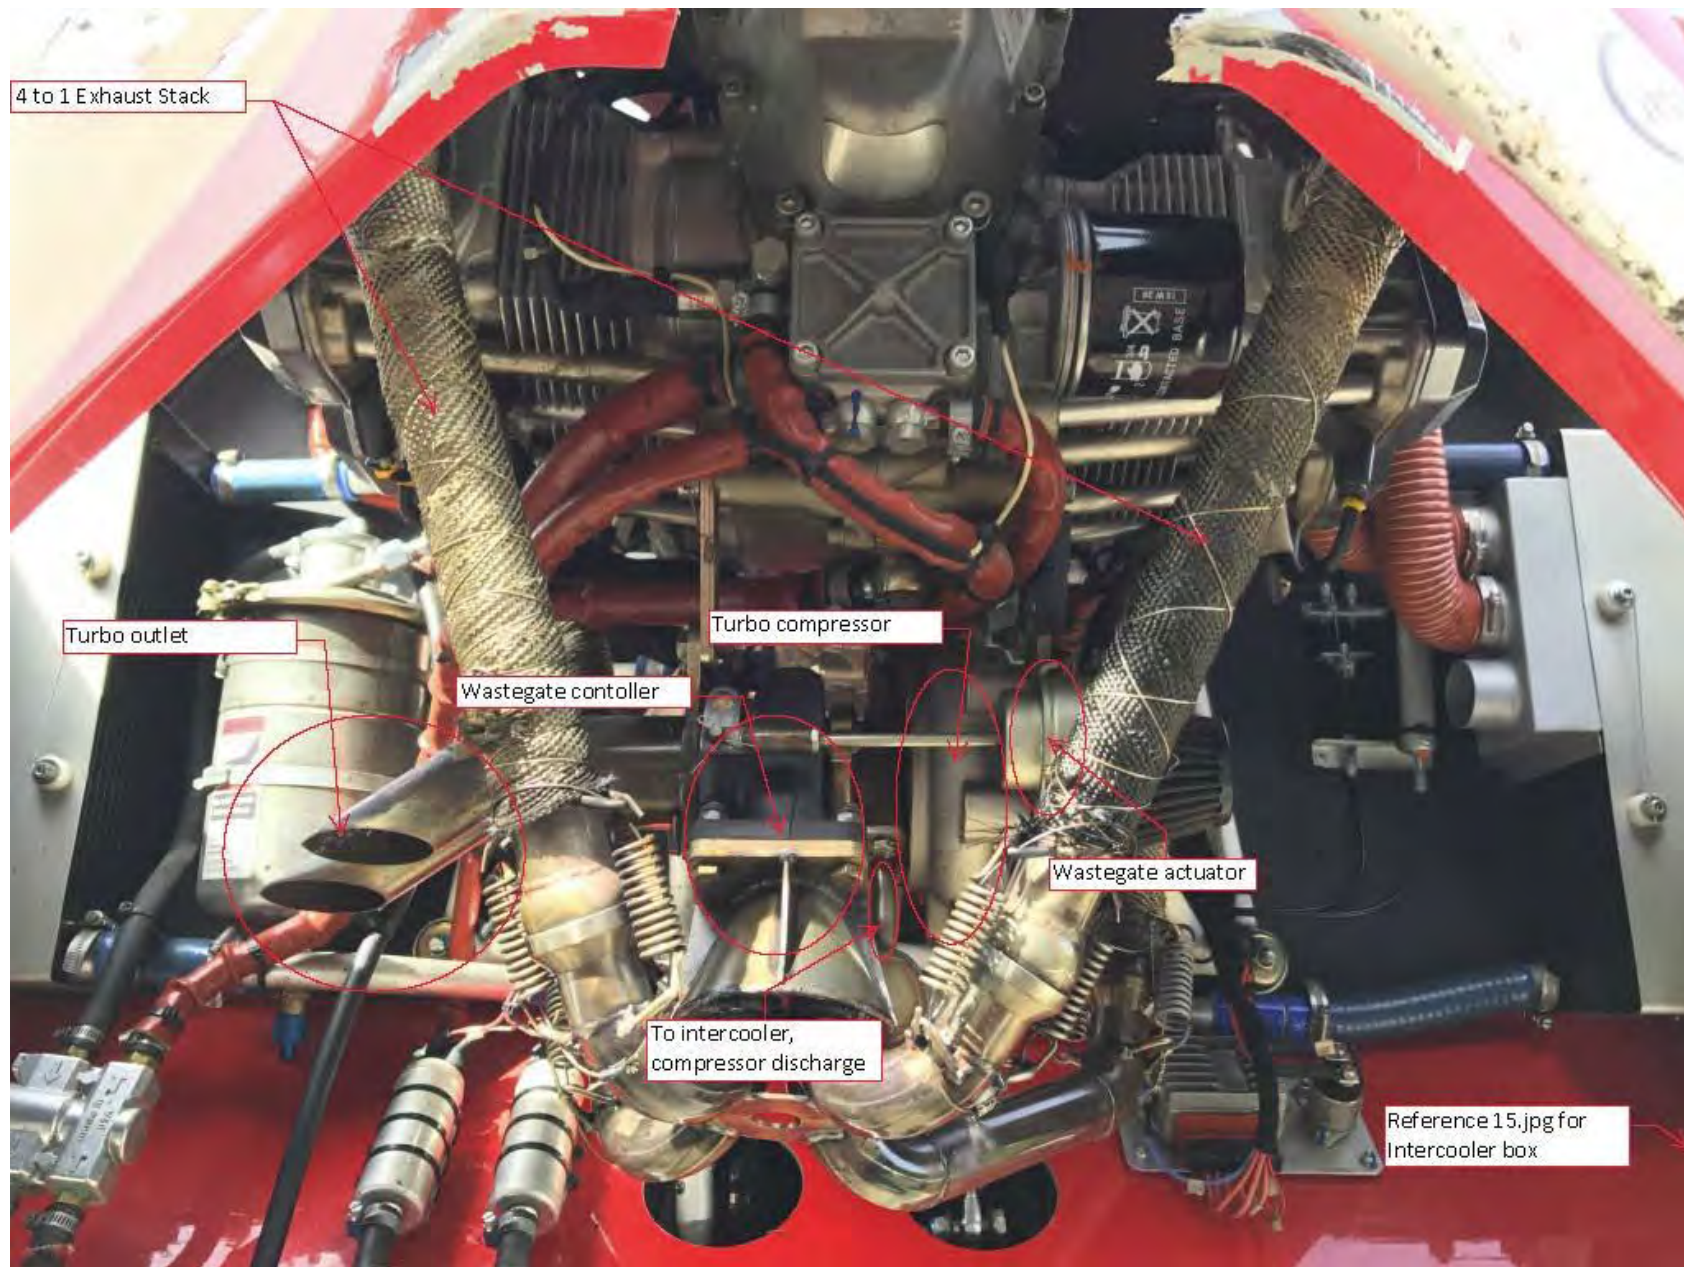
**Photo 20 – View of engine with turbocharger parts identified**
