# NATIONAL TRANSPORTATION SAFETY BOARD

MATERIALS LABORATORY FACTUAL REPORT

Report No. 17-061

Place : Venice, Louisiana  
Date : May 2, 2017  
Vehicle : Bell 407, N457PH  
Operator : PHI International  
NTSB No. : CEN17LA174  
Investigator : Arnold Scott, AS-CEN

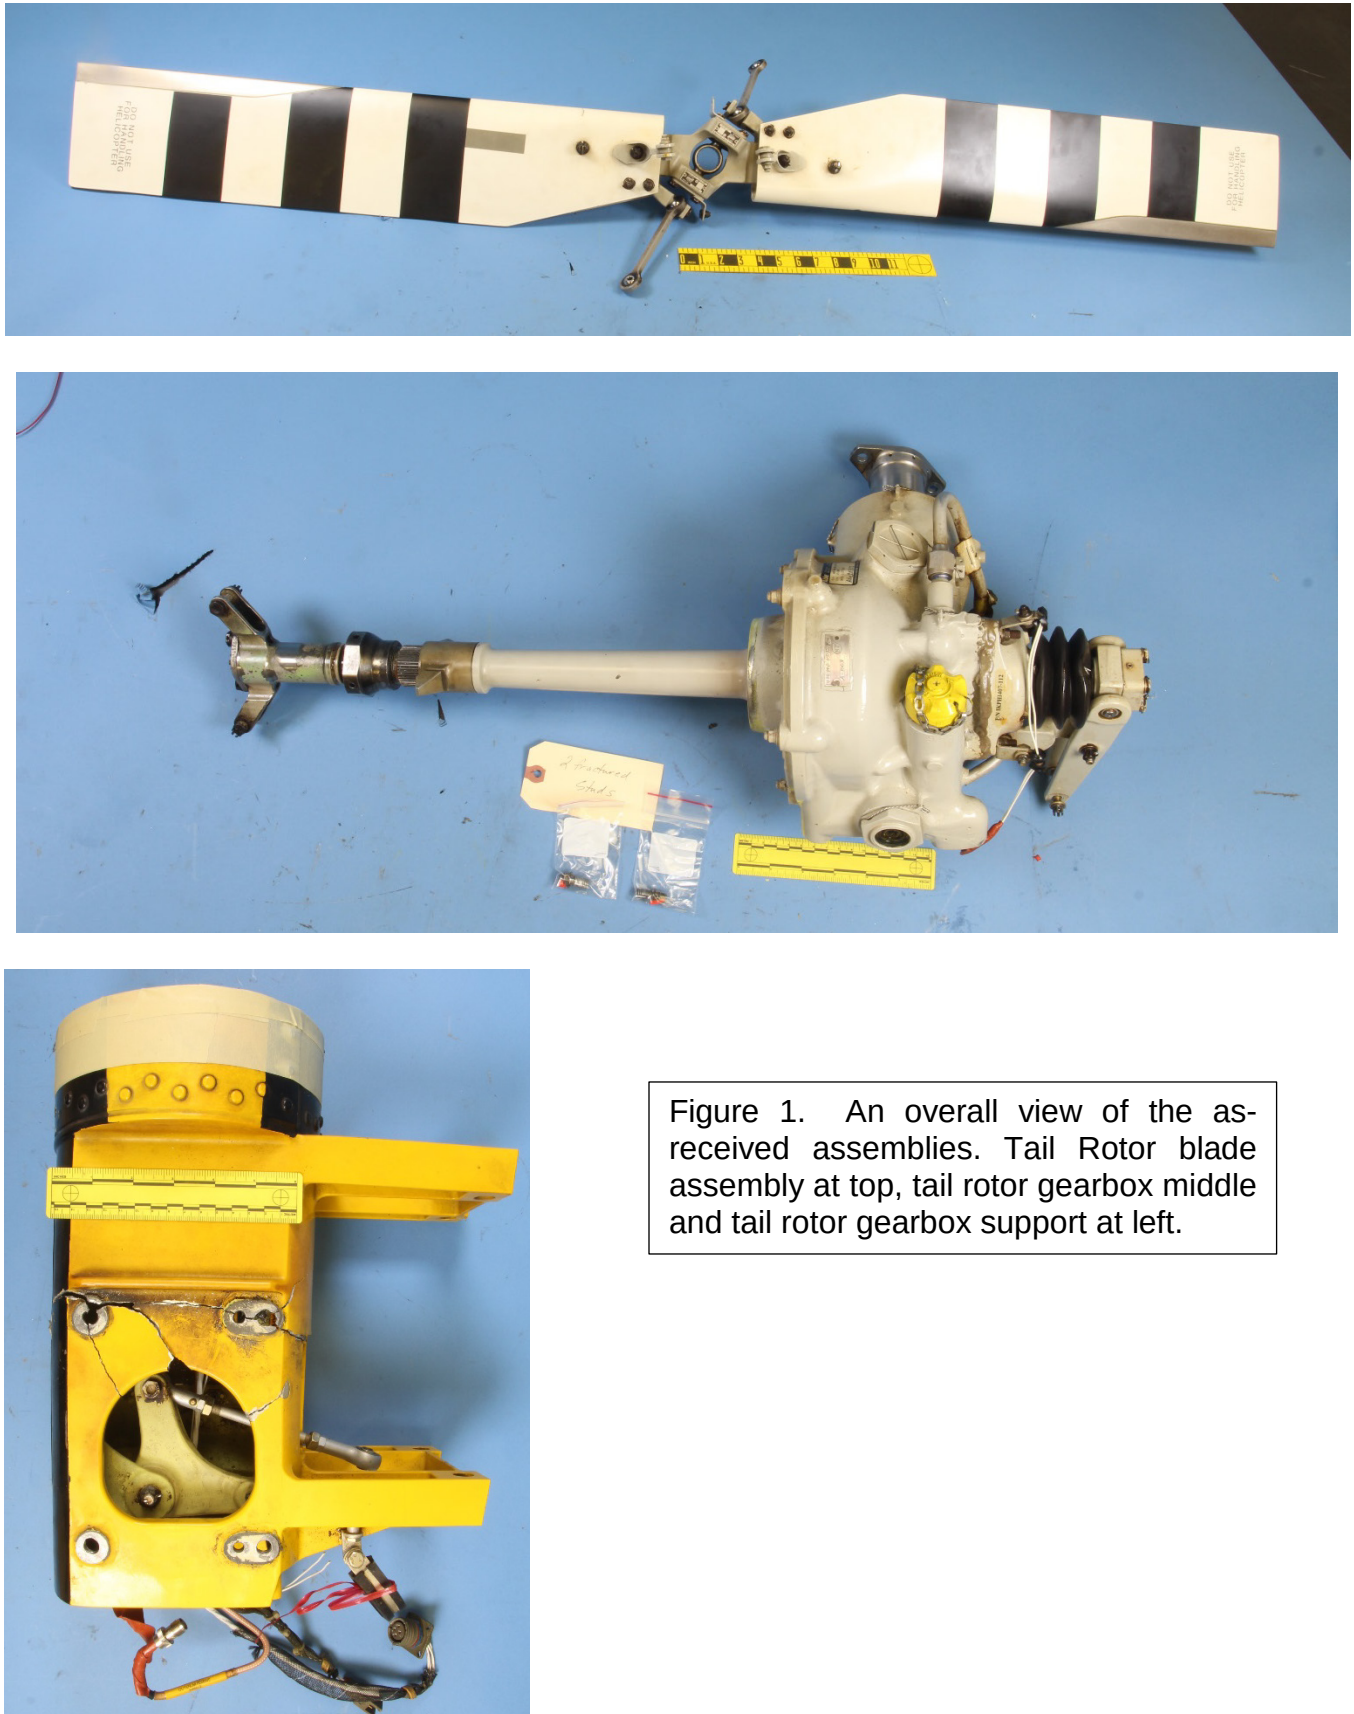
The tail rotor hub and blade, gearbox and gearbox support assemblies were received as three separated units. They reportedly remained attached to the aircraft but were disassembled from the aircraft at the scene. As received, the tip block and weights were missing from one blade, two gearbox mounting studs were fractured on the gearbox and the tail boom structure was extensively cracked. No other damage was apparent on the blades or hub and the gearbox appeared to remain functional with free rotation.

Figure 1. An overall view of the as-received assemblies. Tail Rotor blade assembly at top, tail rotor gearbox middle and tail rotor gearbox support at left.

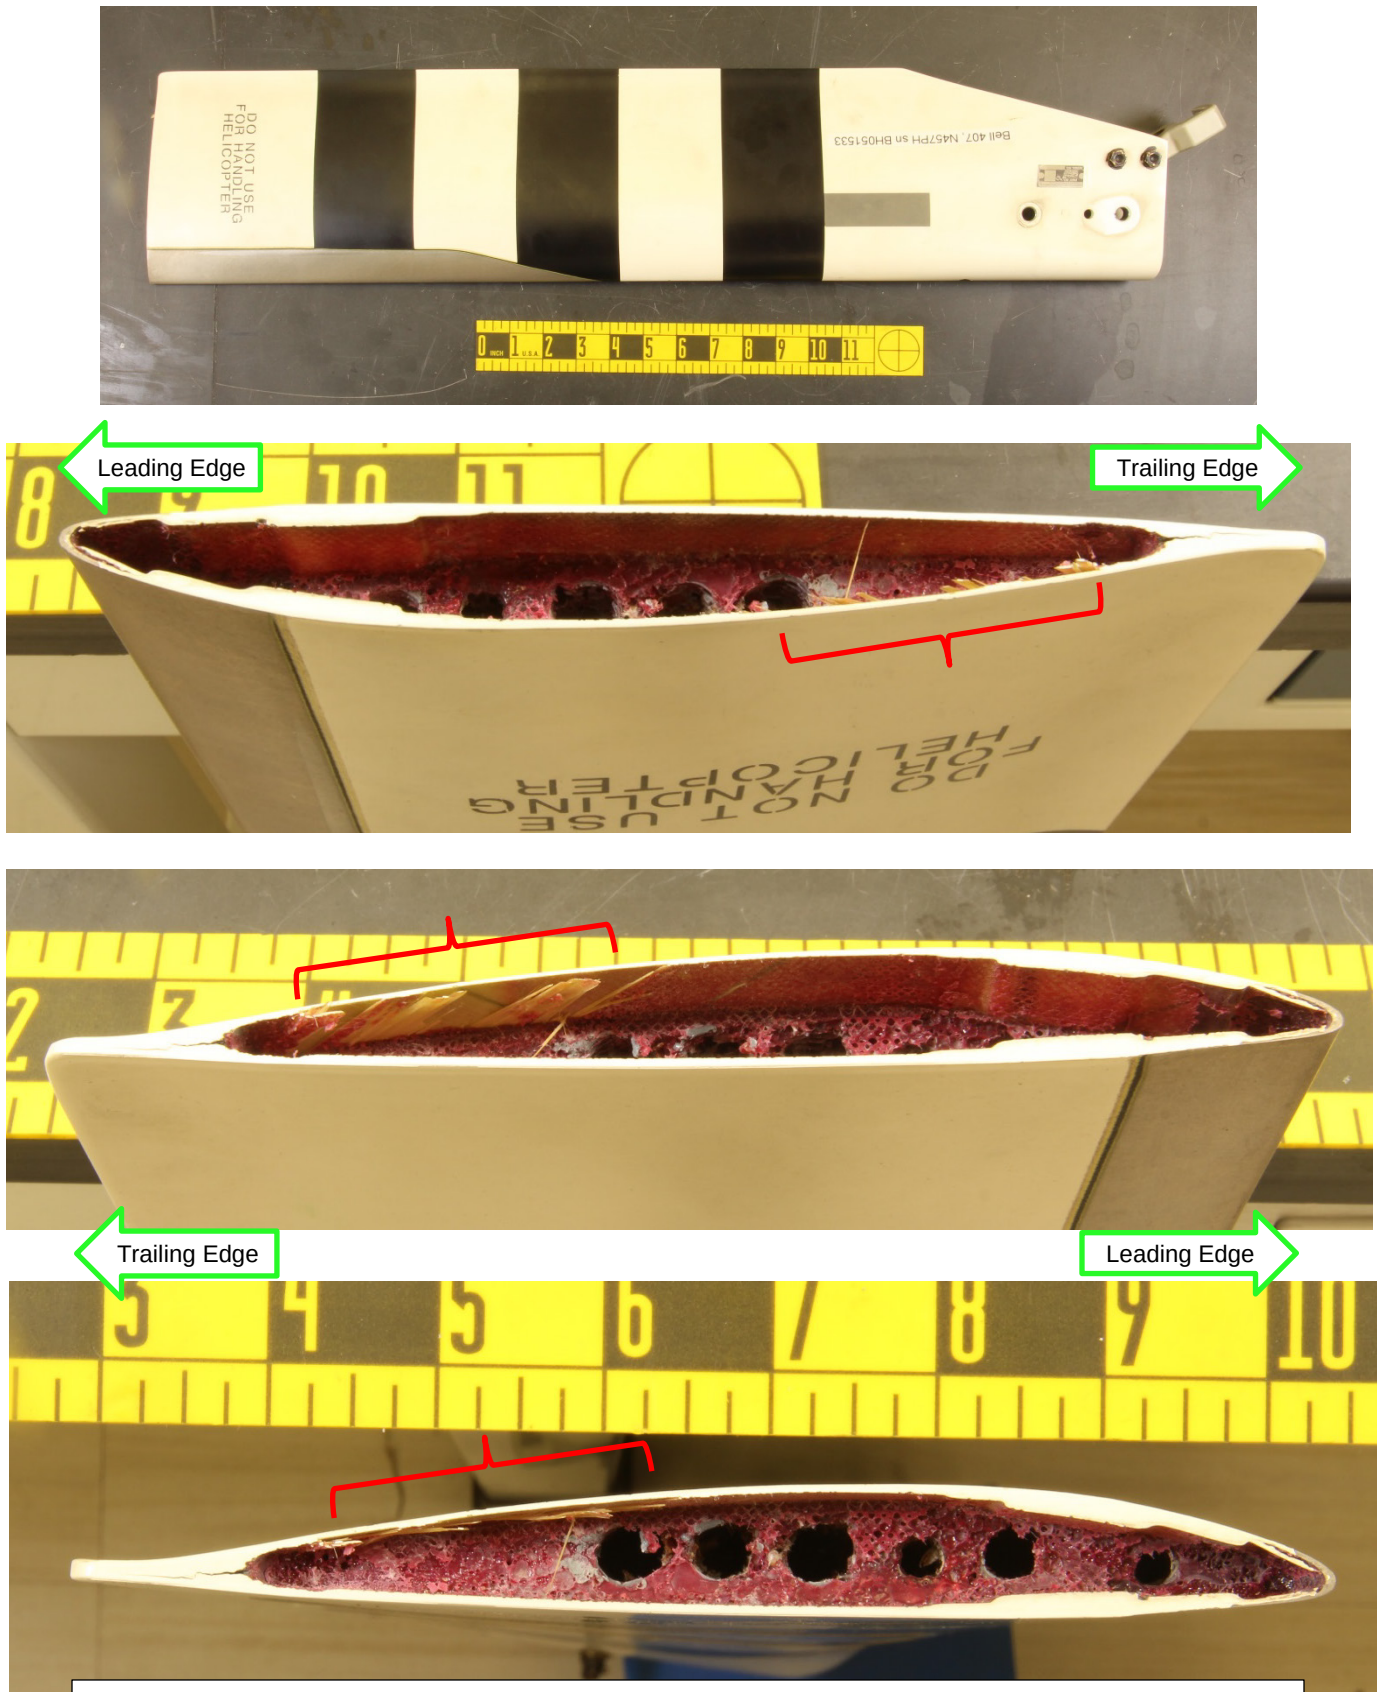
The tip block had separated from blade s/n BH051533, shown in figure 2, along with the weights and was not recovered. The blade had a total service life of 2658.65 hours and had a tip block replacement repair<sup>3</sup> approximately 65 hours prior to the separation.

The tip block was reportedly bonded into the blade with 3M manufactured AF 163-2K structural adhesive film. AF 163-2K film is red in color. Remnants of the red adhesive are visible in the lower views of figure 2. Adhesive remnant indicated that the tip block had been inserted about 0.6 inch and 0.4 inch into the blade at the leading and trailing edge respectively. This would equate to about 2.60 in<sup>2</sup> bond surface on the flat side and 2.65 in<sup>2</sup> on the camber side.

Close examinations found that where it was adhered, the bond line separated at the adhesive interface with the tip block, leaving the majority of the adhesive attached to the skin as shown in figure 2. One large area of skin inter-ply separation was present toward the trailing edge on the camber skin as denoted by the bracket in figure 2.

Figure 2. Upper view shows the camber side of blade s/n BH051533. Two middle views are oblique views of the inner surfaces of the flat and camber skins. Lower view looks directly inboard at the void from the separated tip block. Red adhesive visible. Red bracket indicates where the separation was in the skin material.

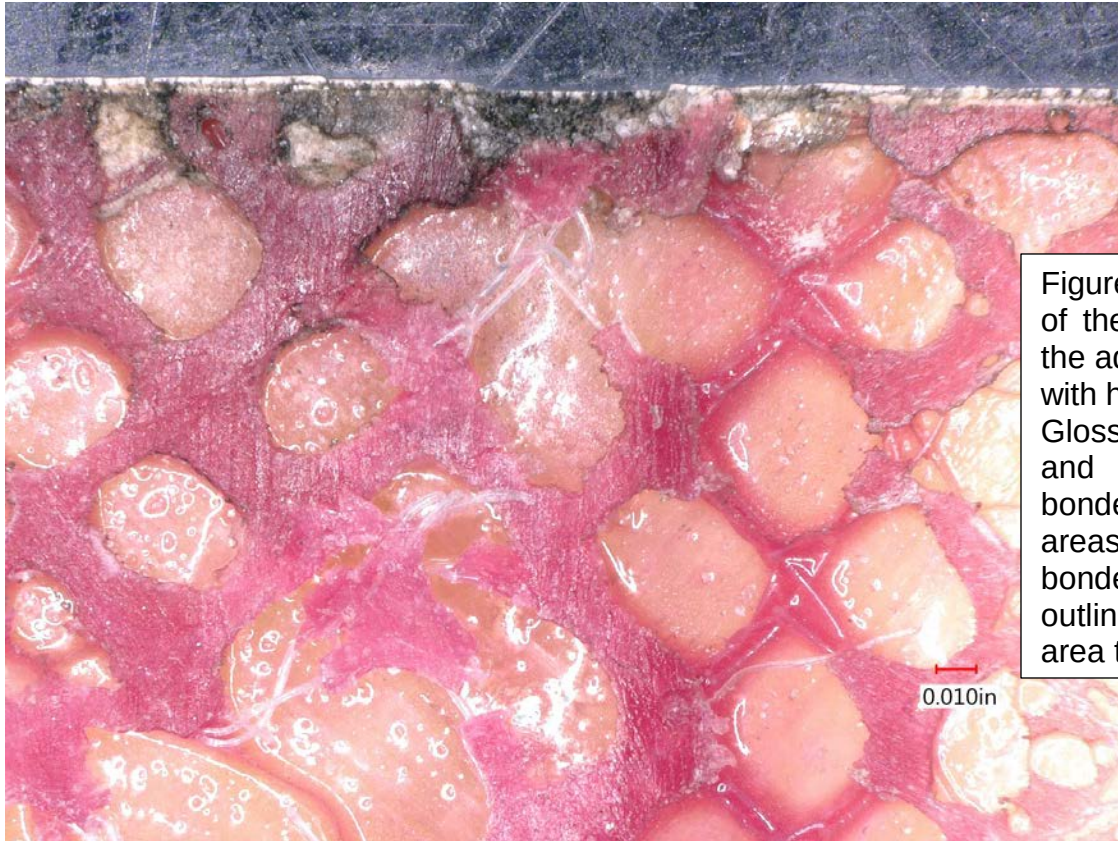
The adhesive remaining on both skins appeared as a waffle pattern of high (thick) and low (thin) areas with the high areas following the pattern of the open weave carrier cloth as shown in the two views of figure 3. Magnified examinations found that the adhesive surfaces of the high areas displayed a textured matte surface indicative of bonding and subsequent interfacial separation, outlined in yellow in the lower view of figure 3. A small percentage of the area had a textured glossy surface indicating areas of the adhesive that had contacted the surface of the tip block but did not bond to it. One unbonded area is outlined in red in the lower view of figure 3. Many of the high areas also displayed fine parallel lines in the surfaces. The orientation of the lines varied over the separation surface as indicated by the double yellow arrows in figure 3. The lines were consistent with the fiber pattern in the surface of the tip block and are also visible and indicated in figure 6. The lower areas had predominately smooth and glossy surfaces consistent with voids and lack of contact between the adhesive and the tip block. Some of the inboard void areas had a powder like coating that was not removed by blowing with low pressure air.

Figure 3. Typical views of the waffle pattern of the adhesive separation with high and low areas. Glossy areas are voids and matte area were bonded. Yellow outlined areas below were bonded high areas. Red outlined area was a high area that did not bond.

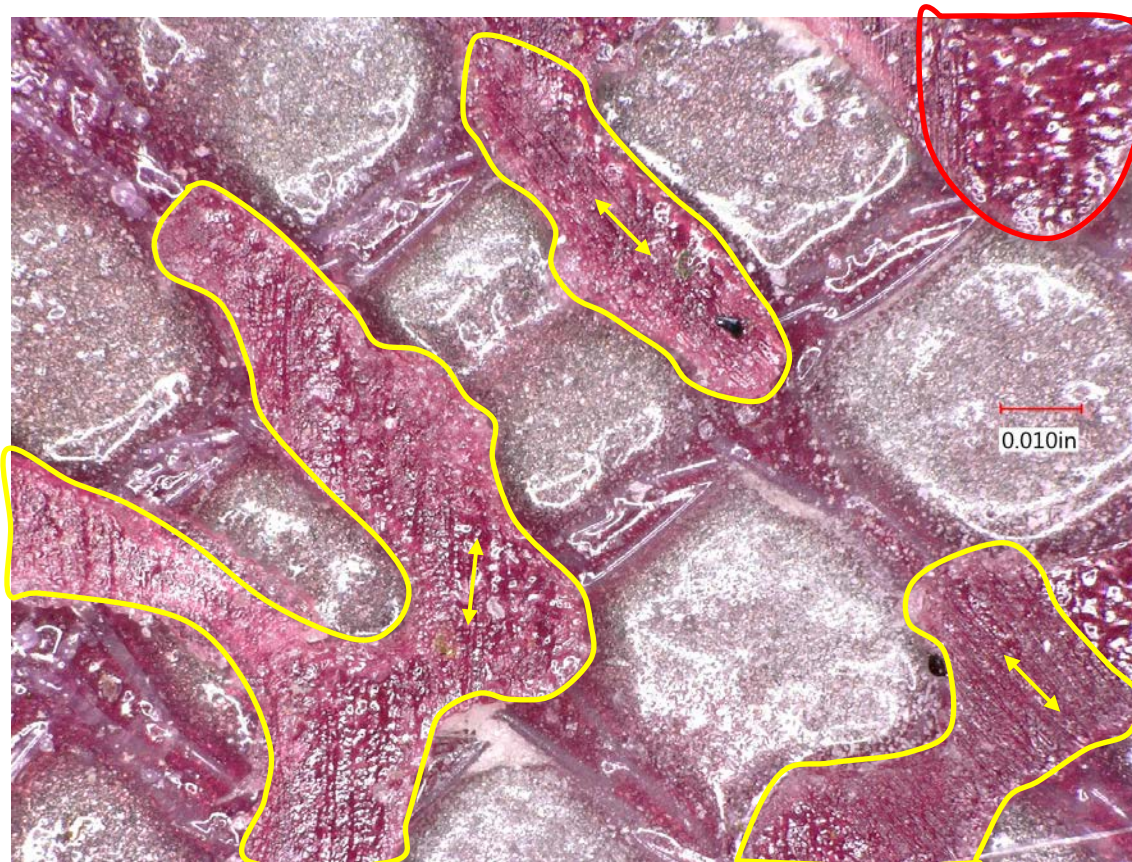
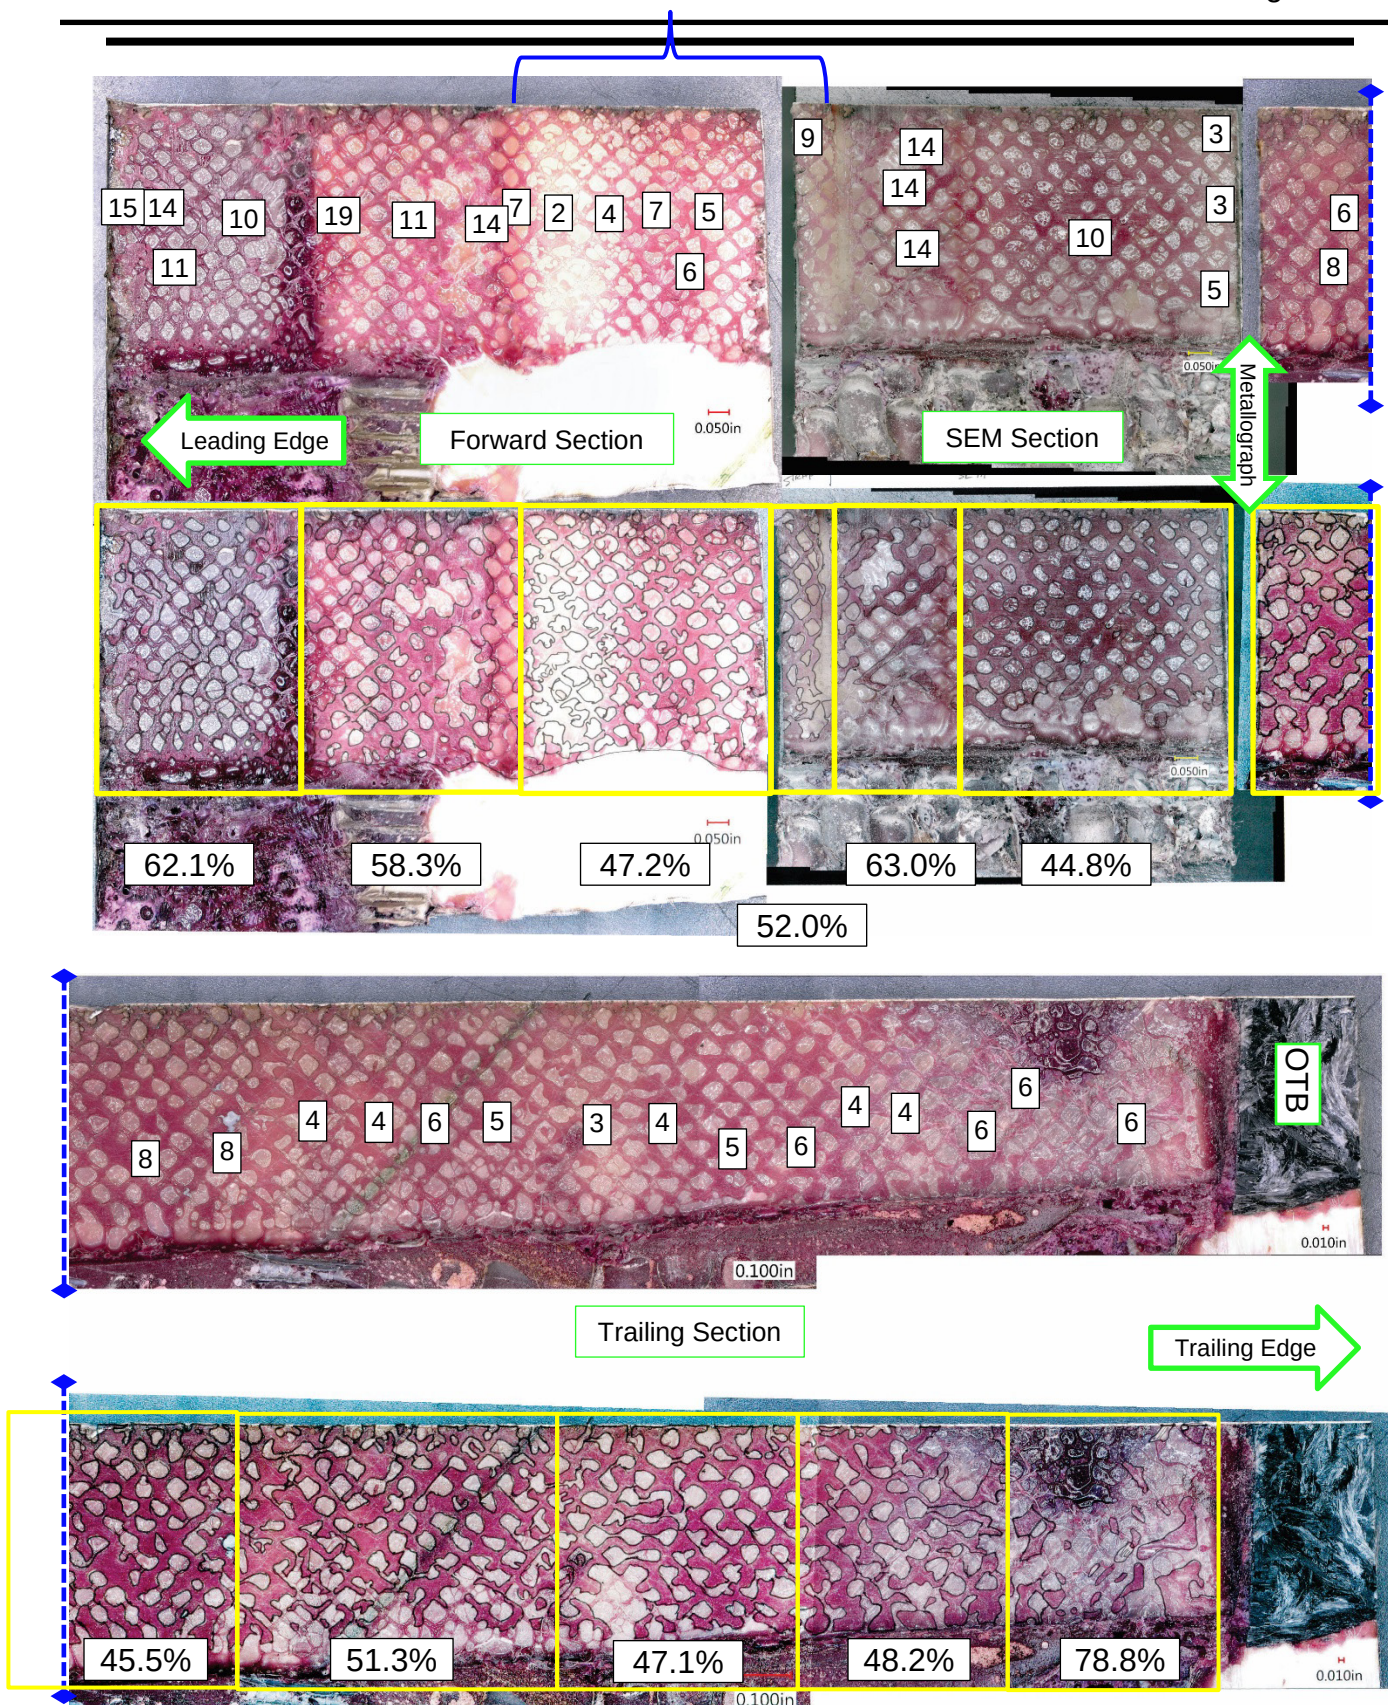
The flat side skin in the area of the tip block was cut from the blade in four sections, as denoted in the montage of figure 4. The forward section was used for visual and Fourier transform infrared spectroscopy (FTIR) testing and examinations, the adjacent section was used for scanning electron microscope (SEM) examinations, a small strip (not shown) was a metallographic section and the trailing edge section was visually examined then forwarded to Bell Helicopter (Bell) for additional testing.

Removal of the flat side skin allowed direct viewing of the separation surfaces of both skins. The waffle pattern was apparent throughout both skin separations as visible in figures 4 and 5. In these figures, the upper portions of each image shows the as-received adhesive surfaces<sup>4</sup> of the skins. In the lower portions of each image, the void areas have been highlighted by black outlines.

Estimates of the area percentage of voids were made on each skin side by software based pixel counting<sup>5</sup> in arbitrarily defined areas of images. The defined count areas are defined by yellow boxes in figures 4 and 5. The skin separation area was not included. Void area percentages ranged from a low of about 40% to a high of 79% with the aggregate void percentage of 50.5% (49.5% bond) for the camber side and 53.8% (46.2% bond) on the flat side. No clear pattern was apparent except for high void content at both leading edge areas under the abrasion strip.

The thickness of the adhesive layer was estimated by measuring the height of the high points relative to adjacent lower voids using proprietary software<sup>6</sup>. The apparent adhesive heights ranged from 0.002 inch to 0.027 inch and are presented on the views in figures 4 and 5 as thousandths of inches. One location measured 0.060 inch in height but it was found to be mostly filler material. The adhesive thickness averaged 0.0072 inch on the flat side and 0.0101 in the camber side (not including the 0.060 inch measurement). These values do not include the thickness of the adhesive in the voids.

Figure 4. A montage of the flat side skin. Upper two images are of the same area from leading edge to about mid chord with the upper image annotated with adhesive thicknesses in thousandth of inches. Lower image has the void areas outlined and percentage void per measurement area (yellow box) denoted. Lower two images show the surface from mid chord to trailing edge with the same annotations. The blue bracket denotes the approximate location of the blade strap. The remains of the original tip block is denoted "OTB".

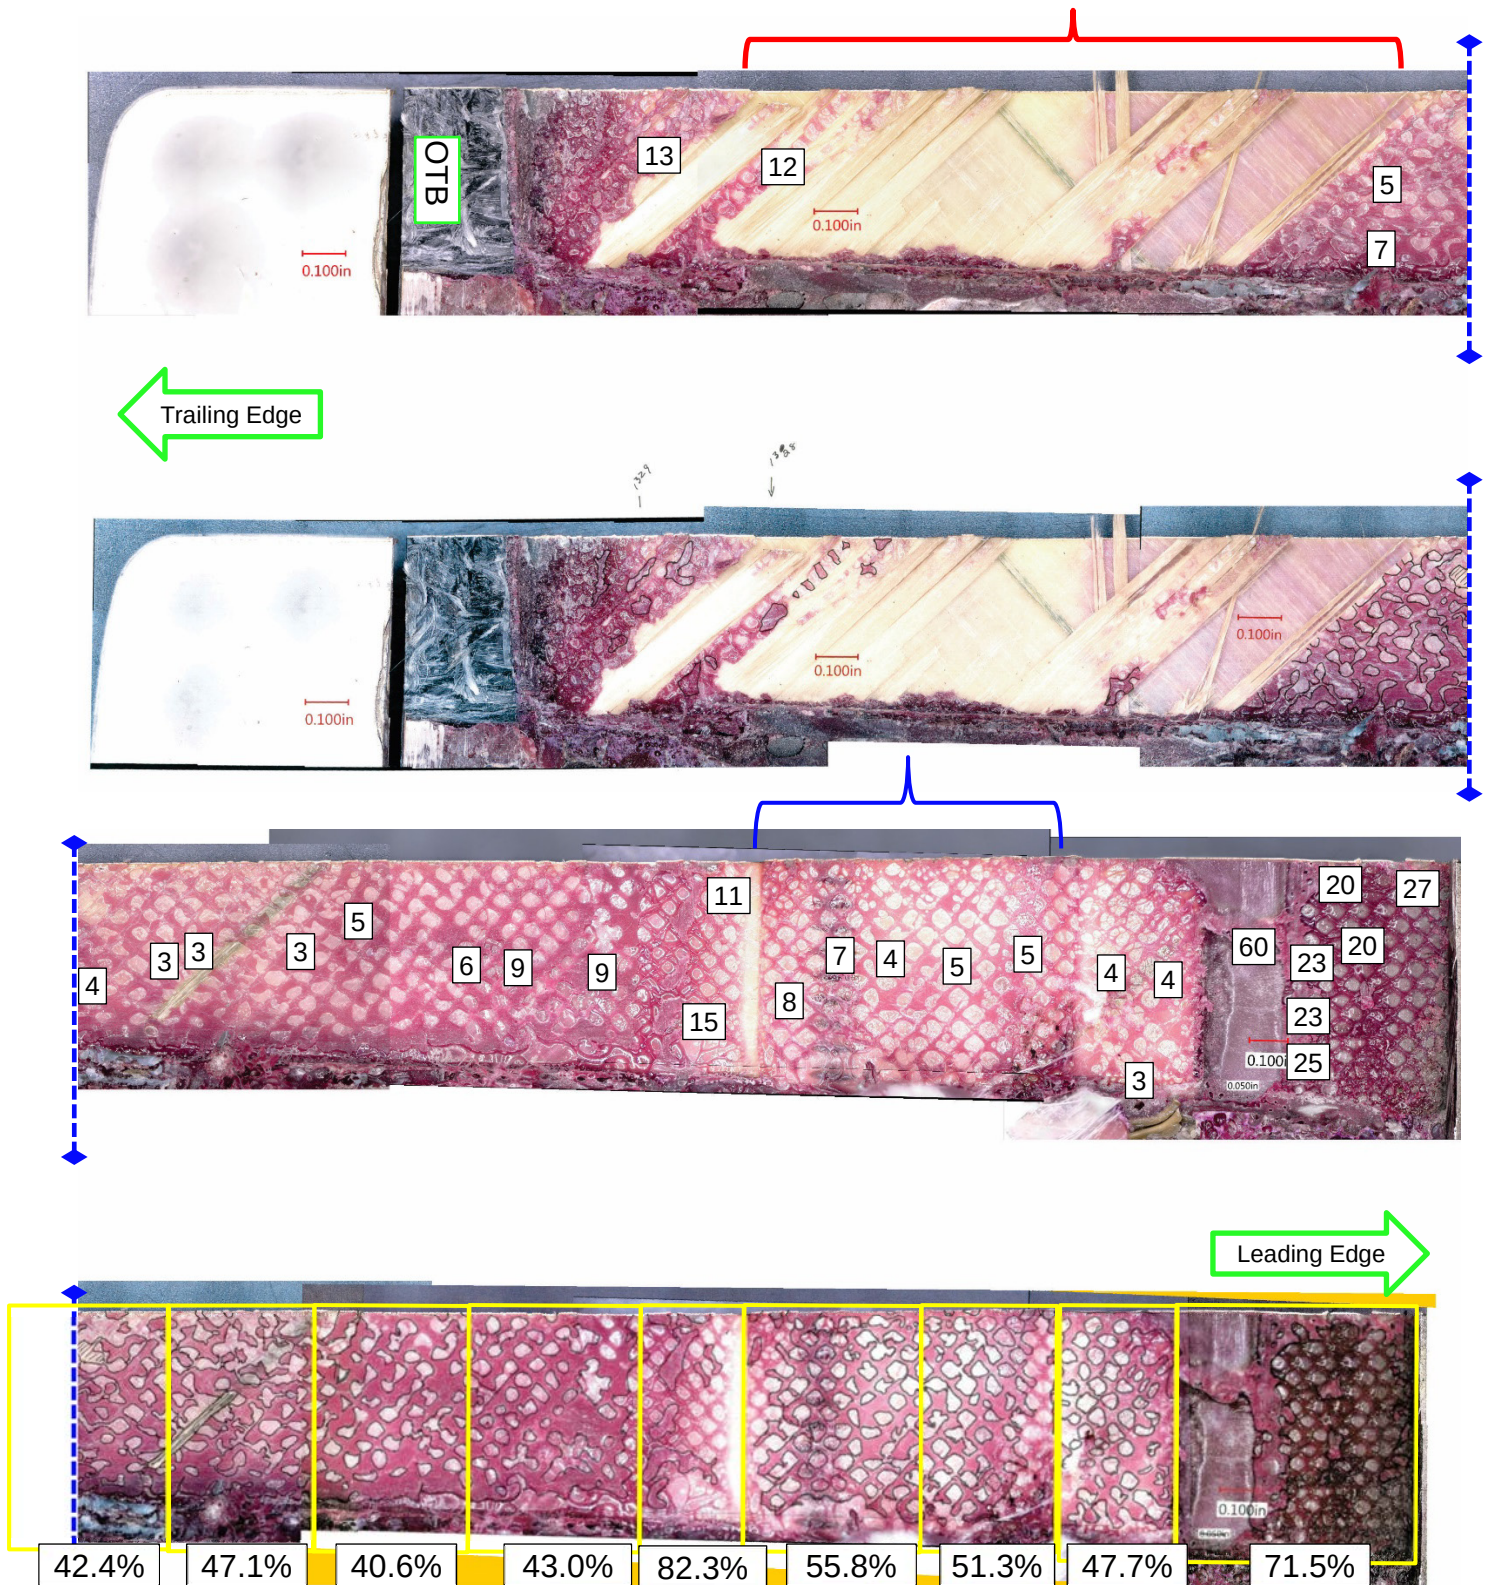
Figure 5. A montage of the camber side skin. Upper two images are of the same area from trailing edge to about mid chord with the upper image annotated with adhesive thicknesses in thousandths of inches. Lower image has the void areas outlined and percentage void per measurement area (yellow box) denoted. Lower two images show the surface from mid chord to leading edge with the same annotations. The blue bracket denotes the approximate location of the blade strap. The remains of the original tip block are denoted "OTB".

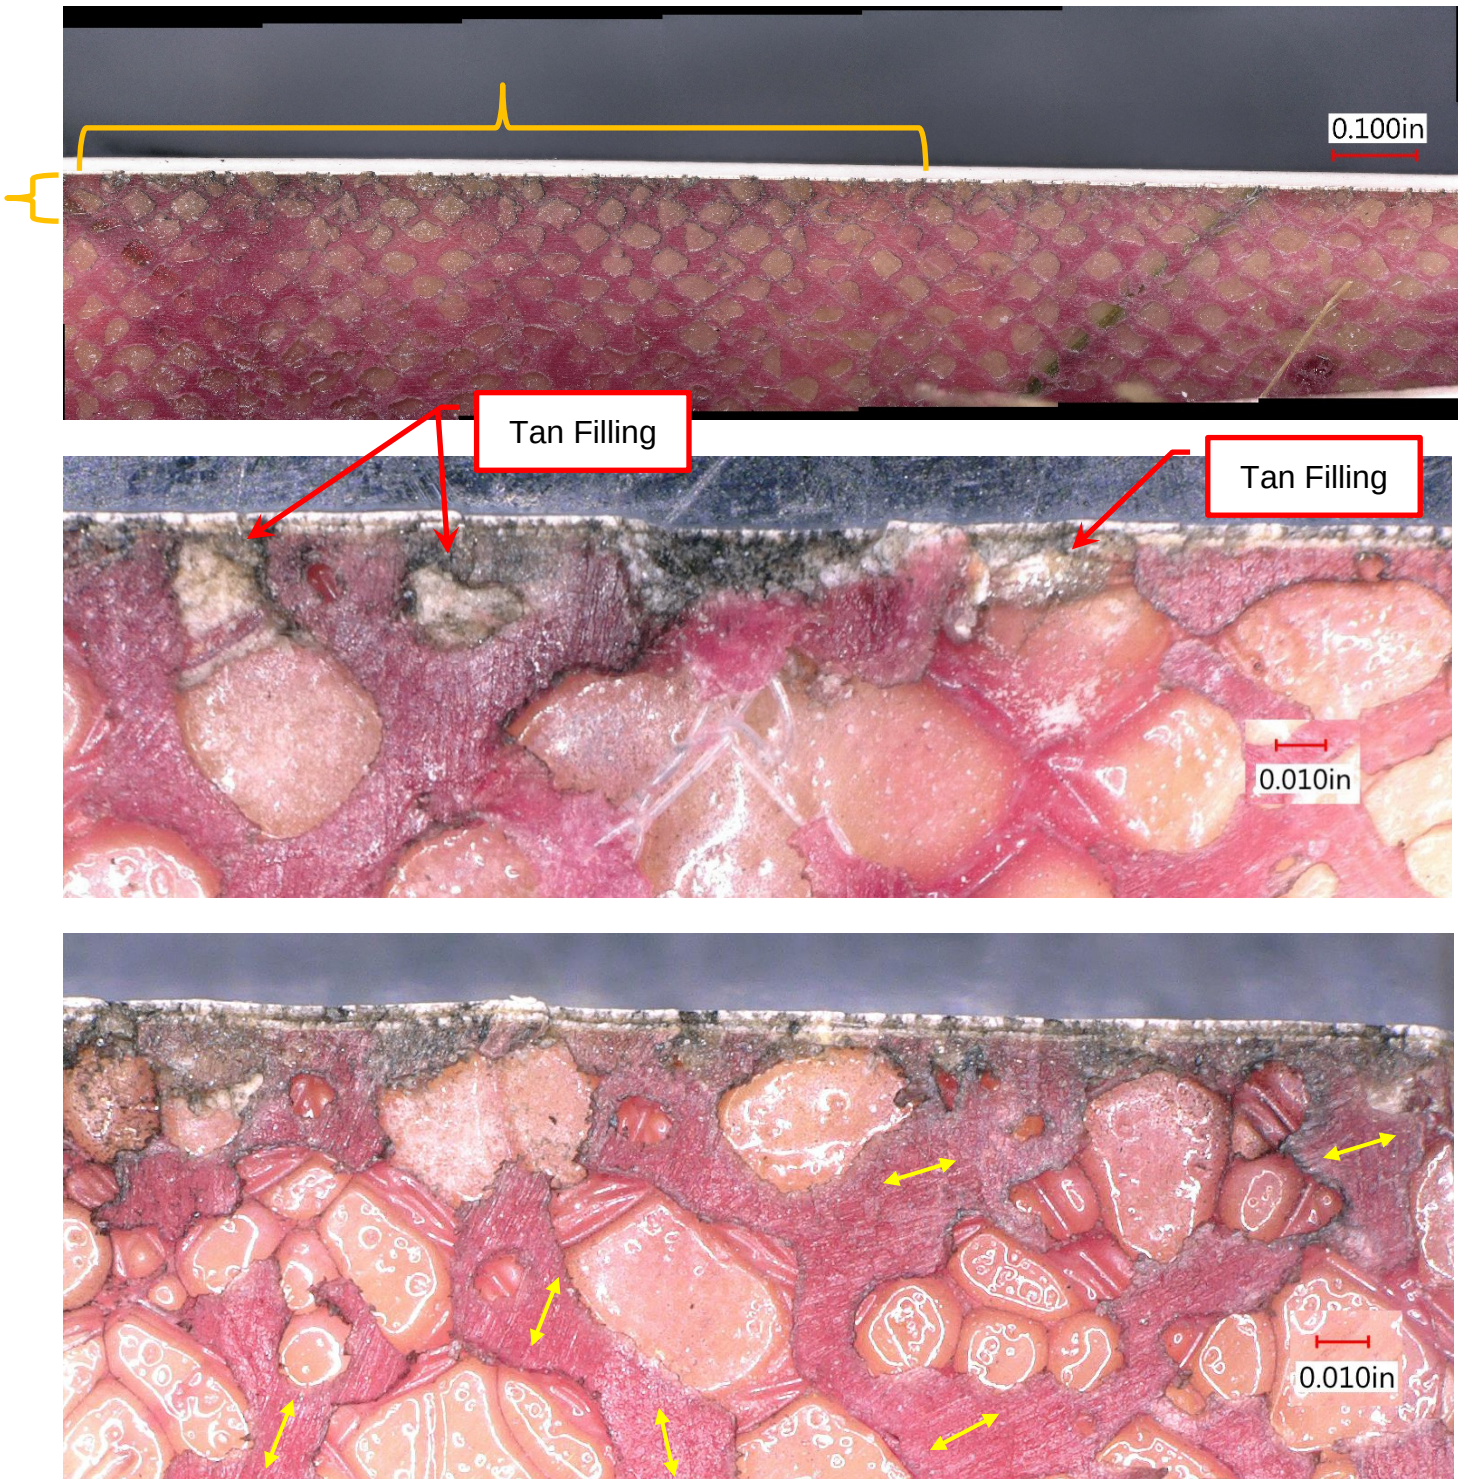
The outboard edge of the separation on the flat side of the blade displayed a darker band of surface deposits adjacent to the tip, as shown in figure 6. The band extended inboard about 0.1 inch at its maximum. The dark band was visible for about 3 inches chordwise aft from a location forward of the strap. FTIR analysis established it to be a carbonaceous material. Close examinations found that a large number of voids intersected the tip of the blade. Several of them were filled with a light tan material as identified in the middle view of figure 6.

Figure 6. Three views of the flat side adhesive separation showing the dark band and tan filling at the blade tip. Lower view has double arrows showing the fiber impression directions in the adhesive.

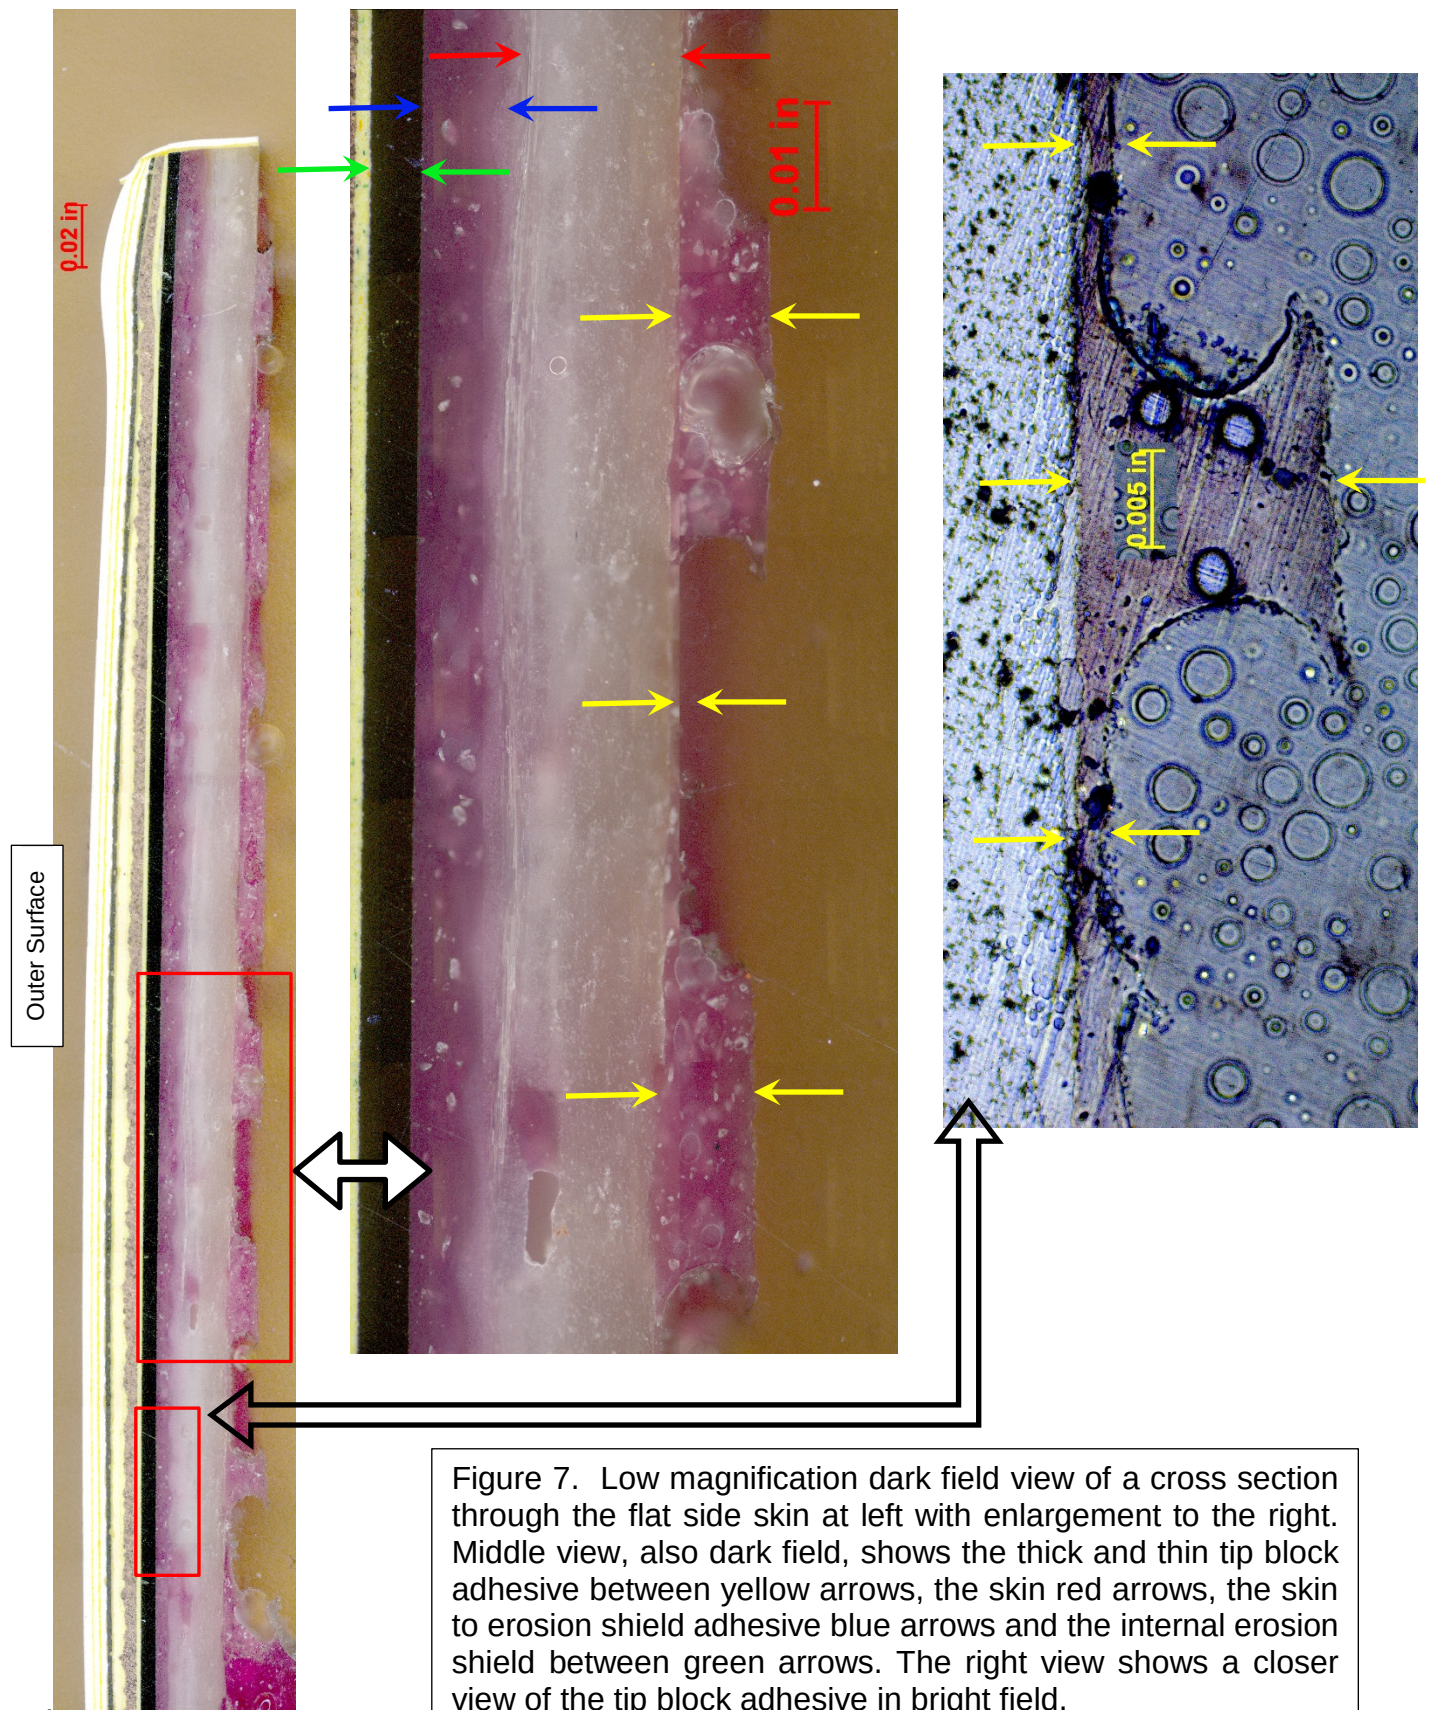
A metallographic specimen was prepared by mounting a spanwise section of the flat side skin in room temperature curing epoxy and polishing to reveal the skin and adhesive structure in cross section. The section revealed complex layers of adhesives, skin, erosion shield and various surface coating as shown in figure 7. The waffle pattern of thick (bonded) and thin (voids) adhesive was apparent on the specimen and enlarged views of features are also shown in figure 7. A continuous layer of adhesive had adhered to the skin material with the void area adhesive measuring between 0.001 inch and 0.002 inch thick. The thicker bonded adhesive areas corresponding to the scrim cloth locations mostly measured between 0.006 inch and 0.009 inch with the most inboard area measuring 0.013 inch thick.

Figure 7. Low magnification dark field view of a cross section through the flat side skin at left with enlargement to the right. Middle view, also dark field, shows the thick and thin tip block adhesive between yellow arrows, the skin red arrows, the skin to erosion shield adhesive blue arrows and the internal erosion shield between green arrows. The right view shows a closer view of the tip block adhesive in bright field.

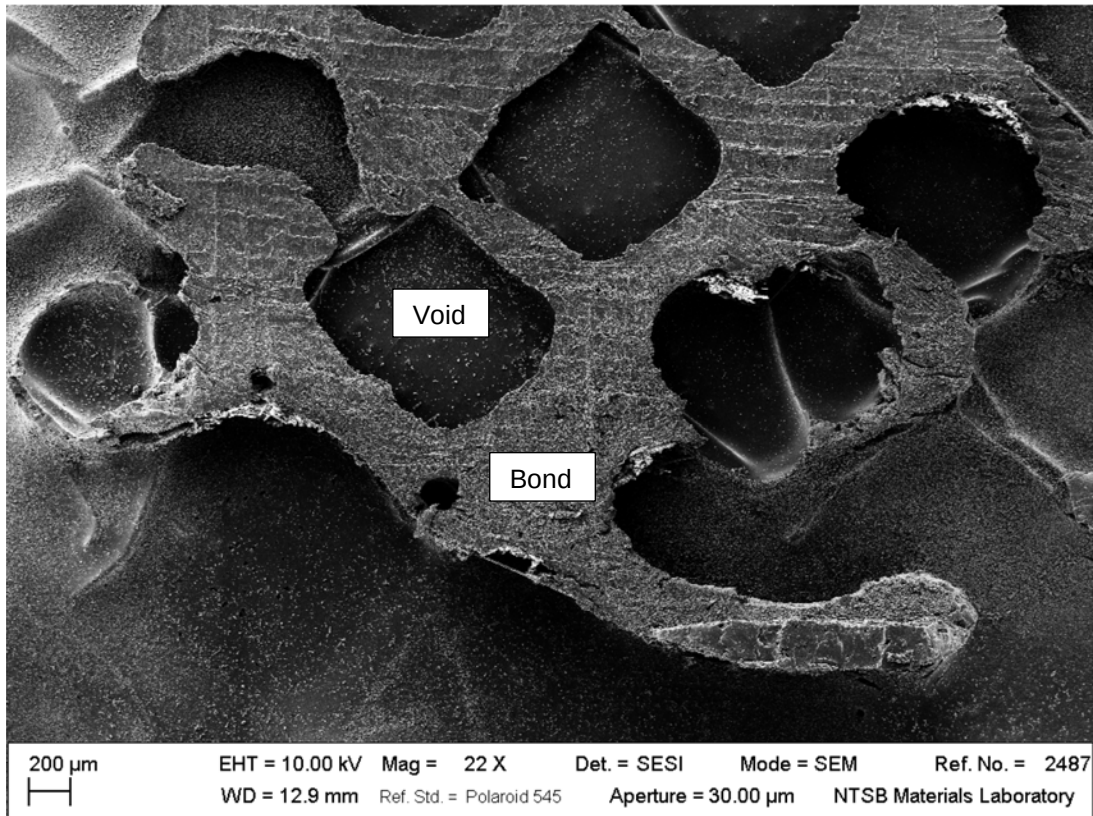
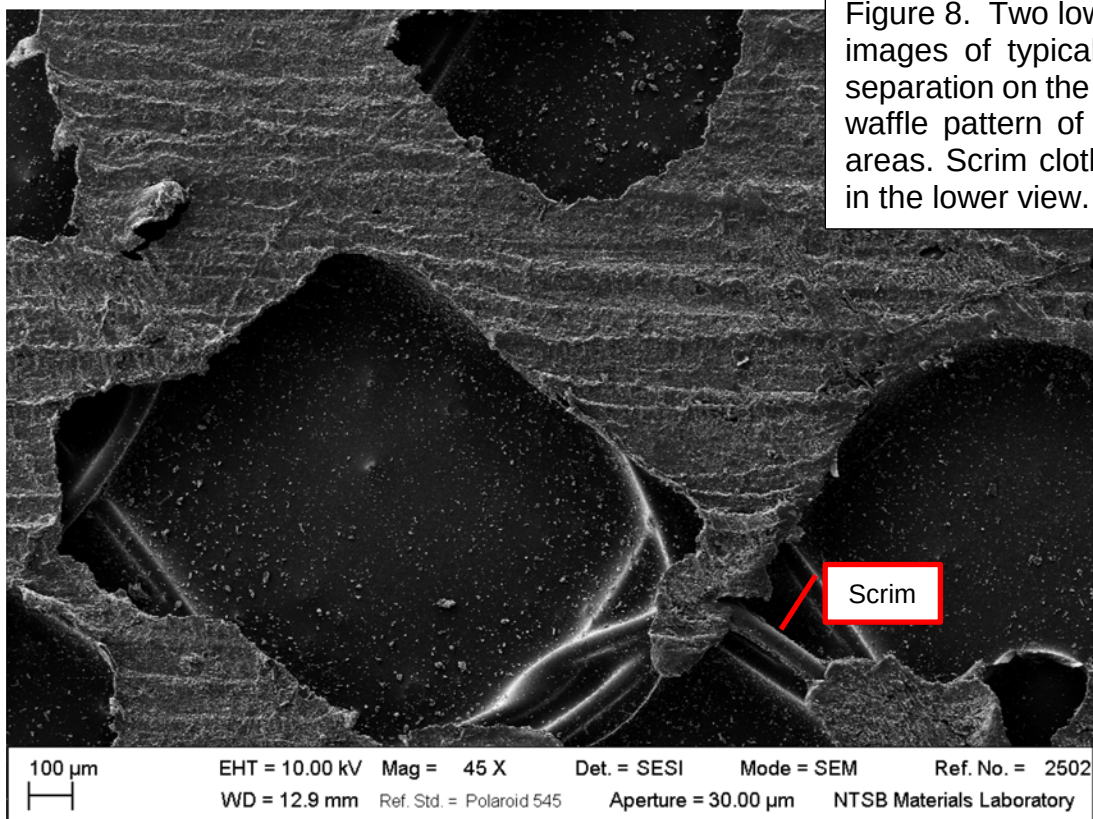
Figure 8 displays low magnification SEM views of two typical areas of adhesive showing both the bonded and void areas. The bond areas displayed texturing of the surfaces while the void areas had smooth surfaces. The threads of the scrim cloth are partially visible in some of the void spaces as denoted.

Figure 8. Two low magnification SEM images of typical areas of adhesive separation on the flat skin showing the waffle pattern of bonded and voided areas. Scrim cloth fibers are denoted in the lower view.

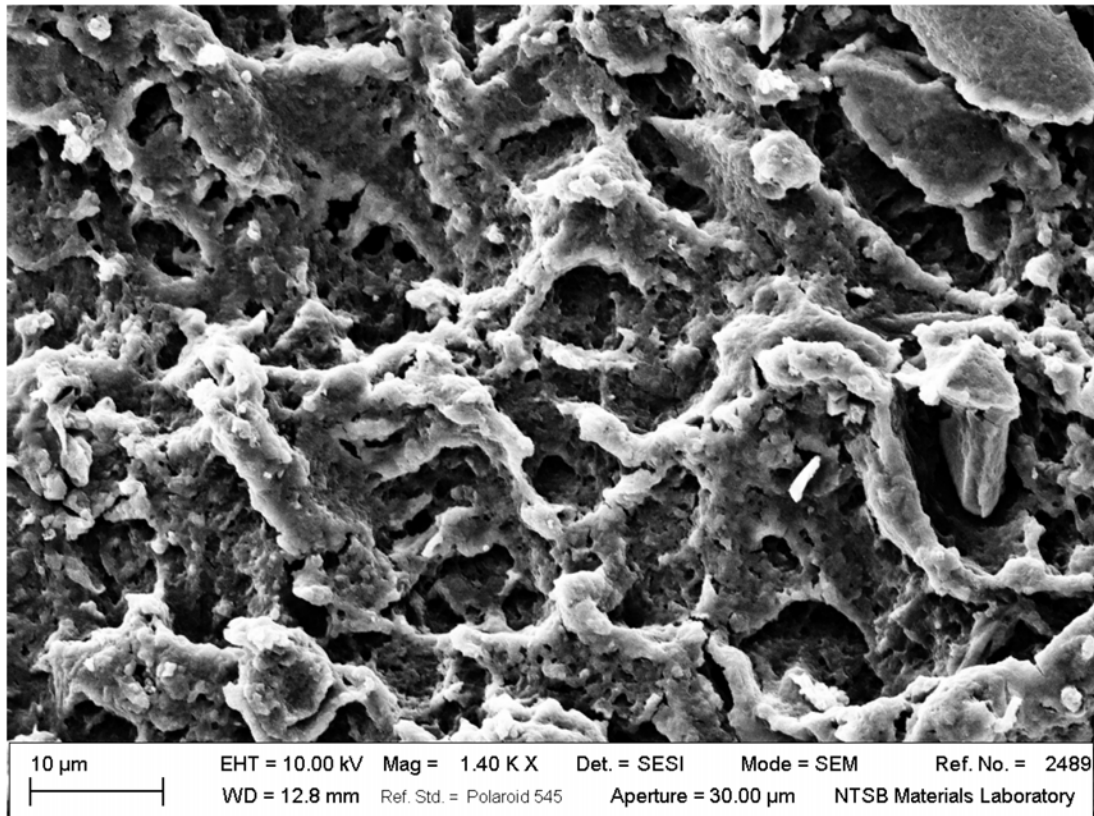
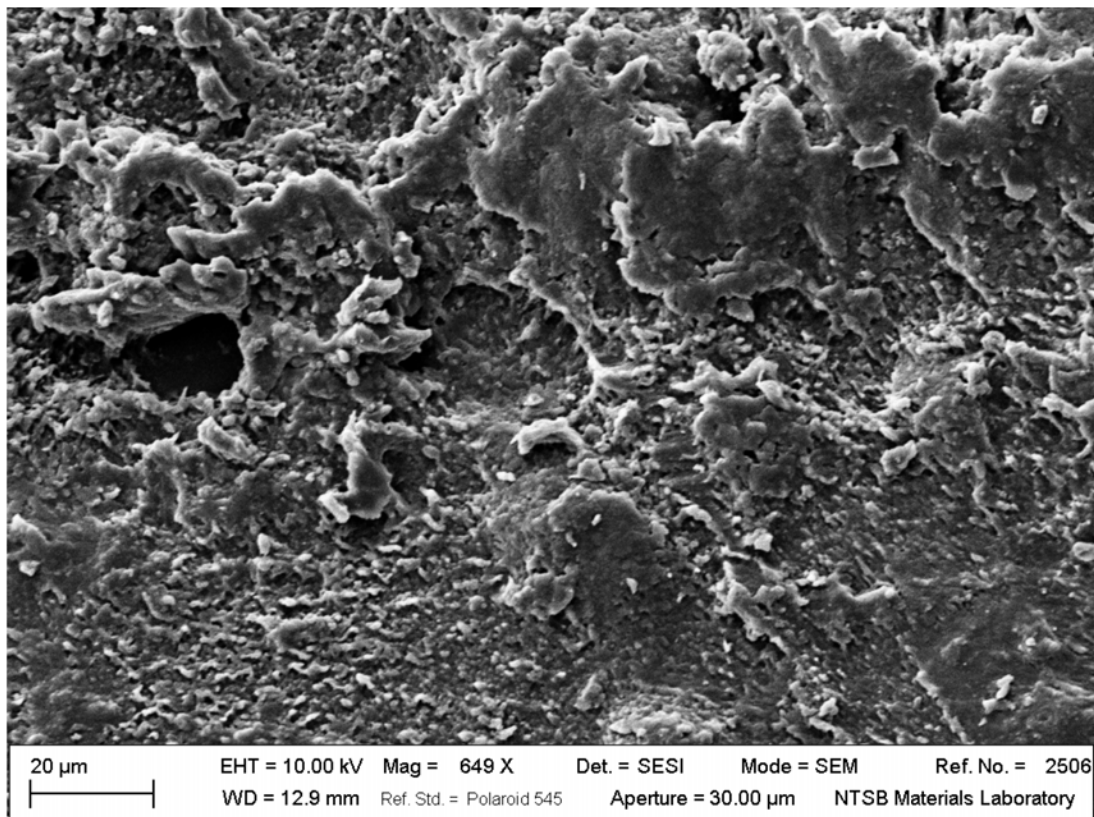
At higher magnification, figure 9, the texturing indicative of bond separation was visible on large parts of the surface. Remnant fibers and fiber tracks from the tip block were also present as shown in figure 10. The texturing and fiber markings were most visible toward the inboard half of the tip block bond line. The bond surfaces in the outboard portion of the bond line particularly near the blade tip displayed worn appearances with fine features rubbed away, as shown in figure 11. The worn areas also contained more debris on the surfaces as shown in figure 12.

Figure 9. Two SEM images showing texturing indicative of bond separation.
