# NATIONAL TRANSPORTATION SAFETY BOARD

MATERIALS LABORATORY FACTUAL REPORT

Report No. 17-061

Place : Venice, Louisiana  
Date : May 2, 2017  
Vehicle : Bell 407, N457PH  
Operator : PHI International  
NTSB No. : CEN17LA174  
Investigator : Arnold Scott, AS-CEN

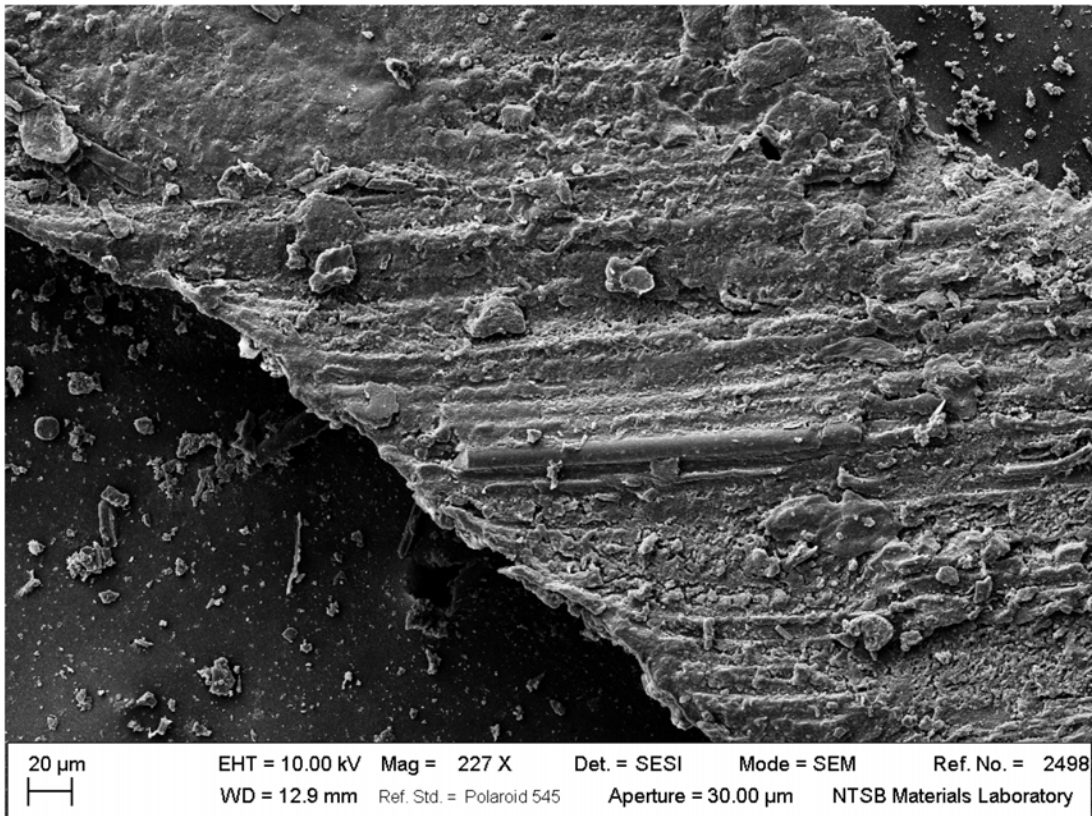
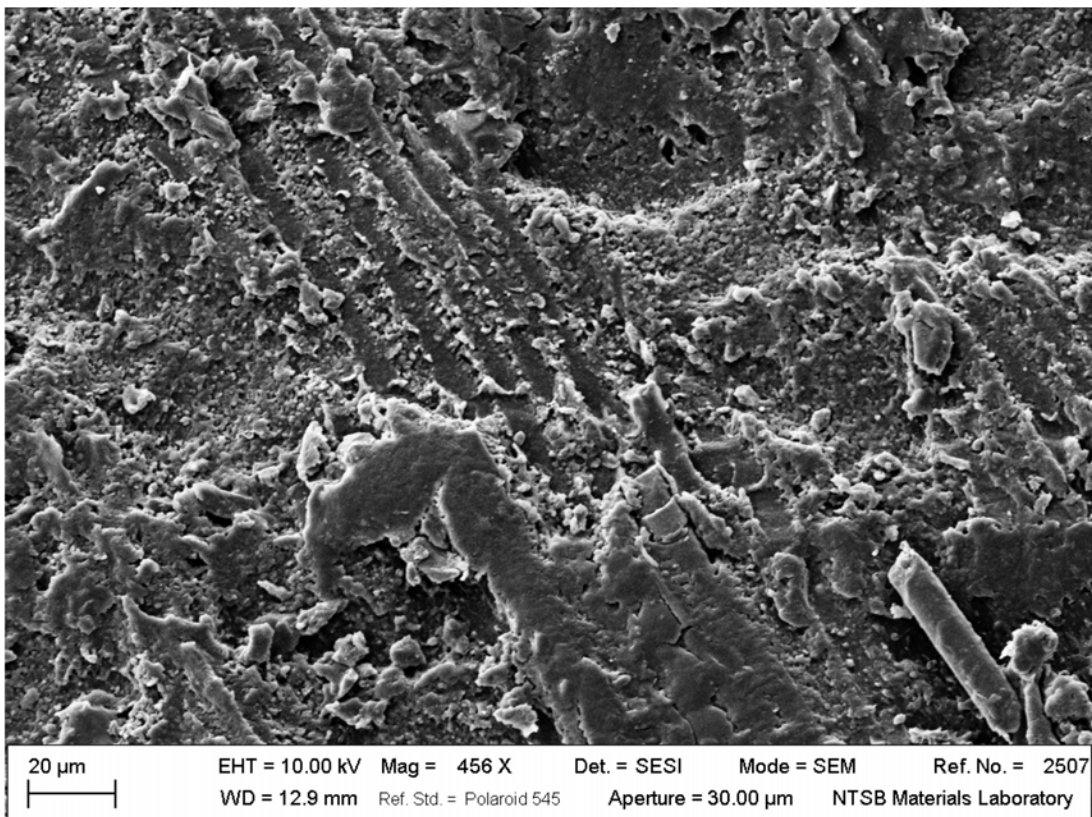
At higher magnification, figure 9, the texturing indicative of bond separation was visible on large parts of the surface. Remnant fibers and fiber tracks from the tip block were also present as shown in figure 10. The texturing and fiber markings were most visible toward the inboard half of the tip block bond line. The bond surfaces in the outboard portion of the bond line particularly near the blade tip displayed worn appearances with fine features rubbed away, as shown in figure 11. The worn areas also contained more debris on the surfaces as shown in figure 12.

Figure 10. SEM images showing remnant tip block fibers (top) and fiber tracks (bottom) in the separation surface.

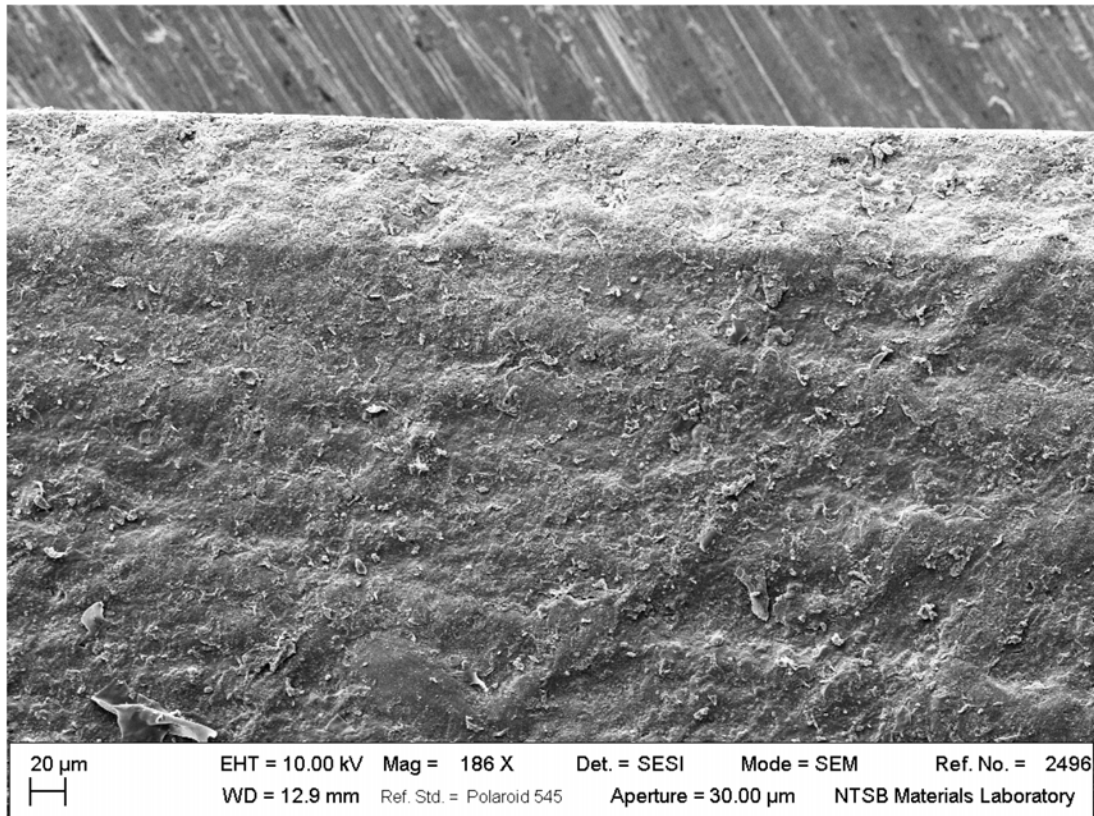
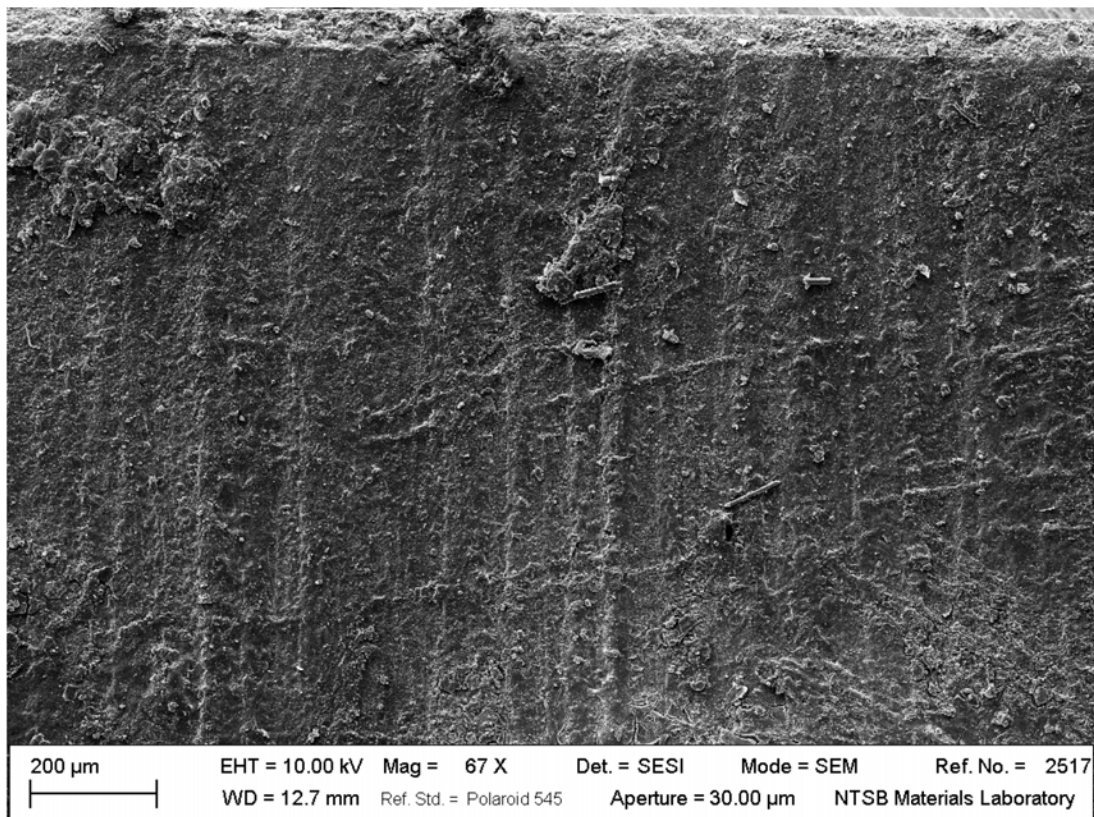
Figure 11. SEM images of worn separation features near the tip edge of the blade on the flat side.

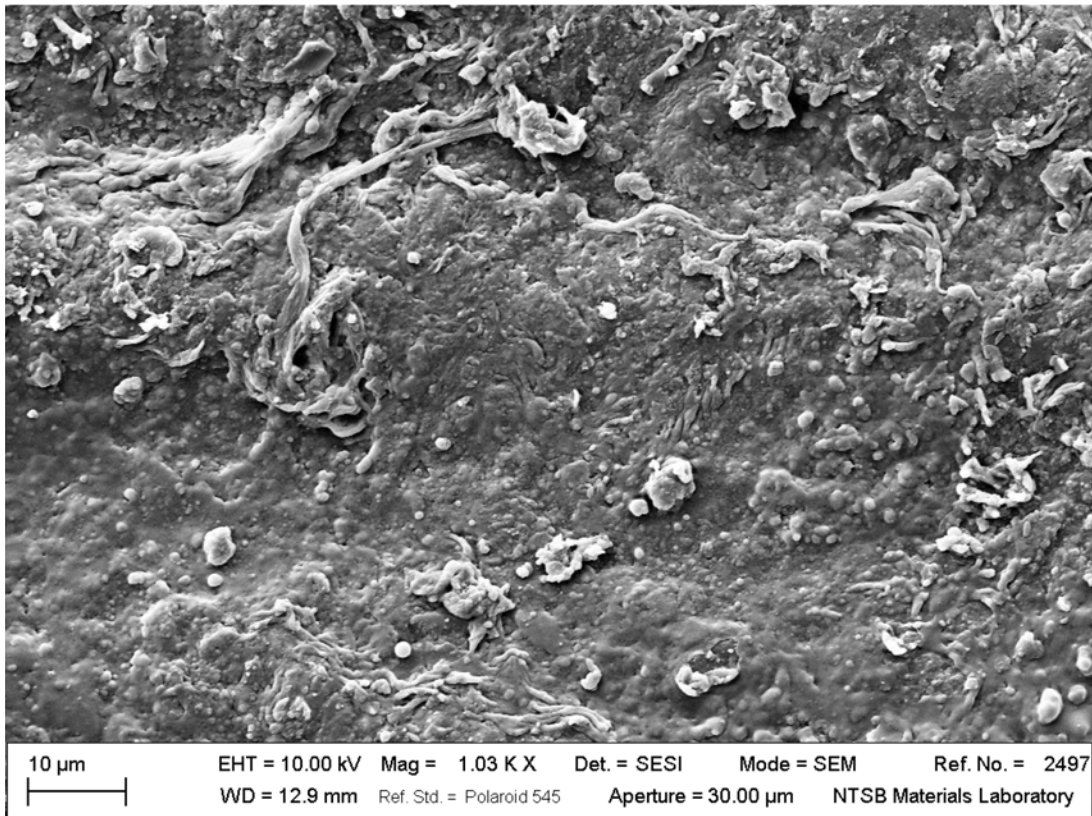
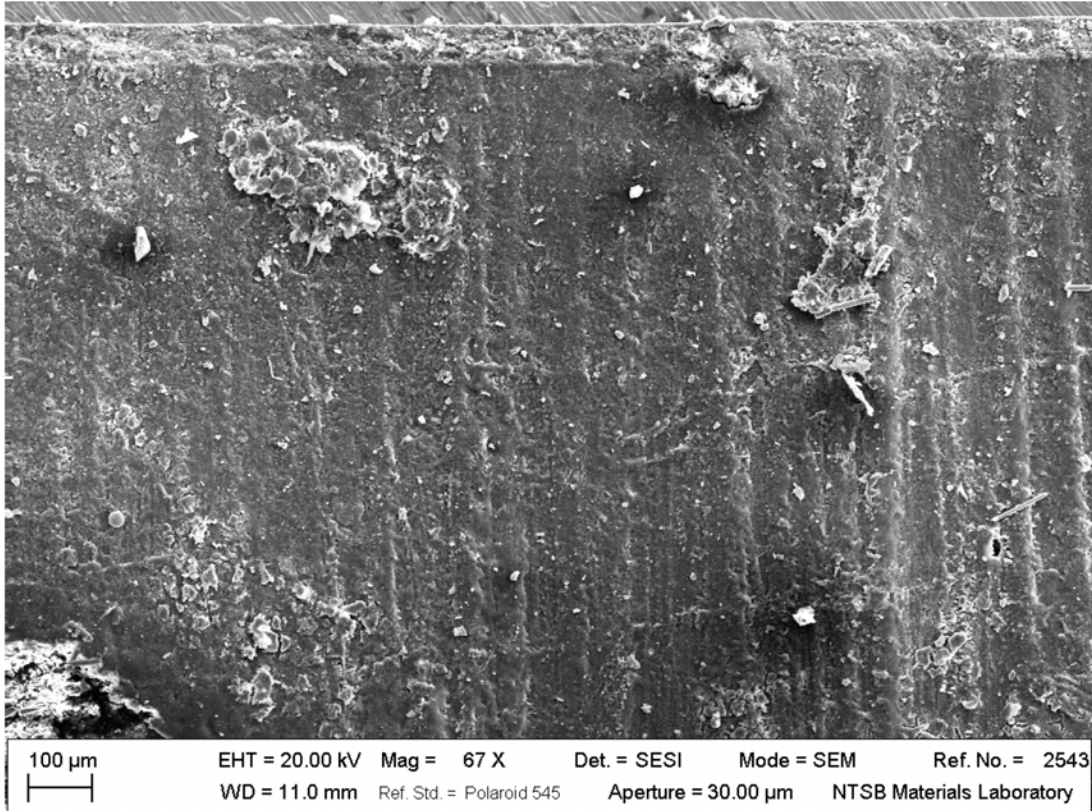
Figure 12. More SEM images of worn separation features with attached debris including scrim and glass fiber fragments.

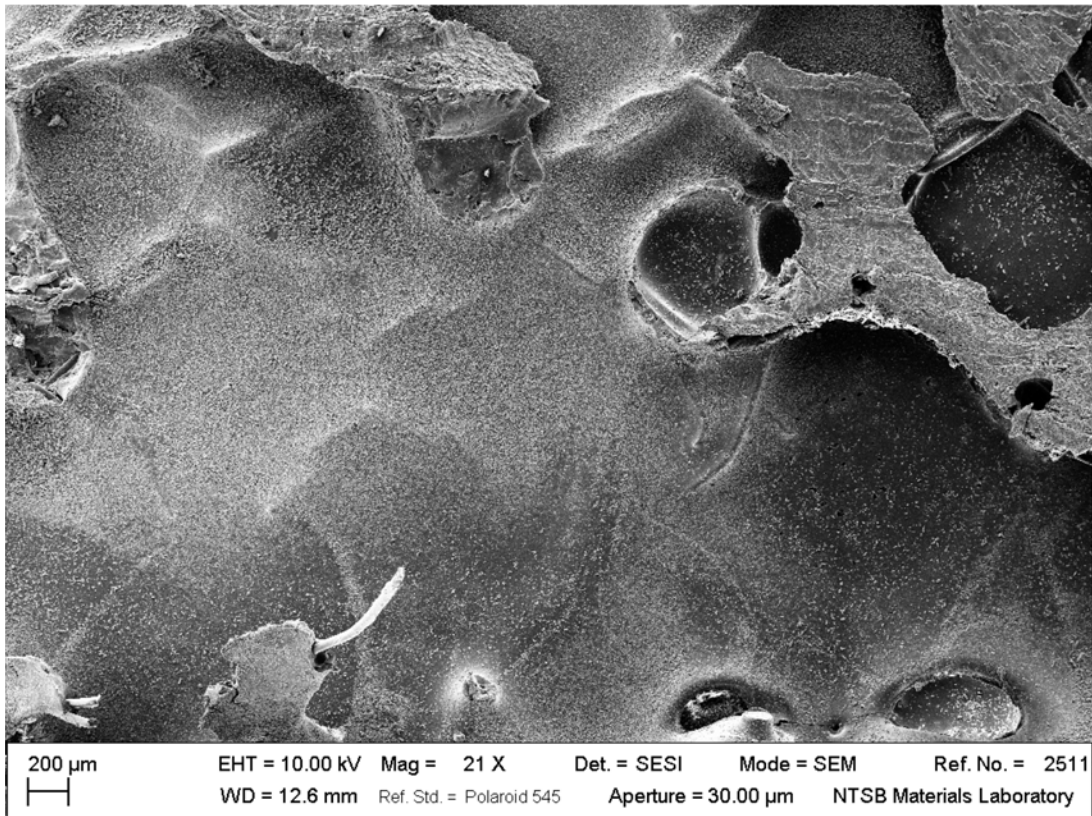
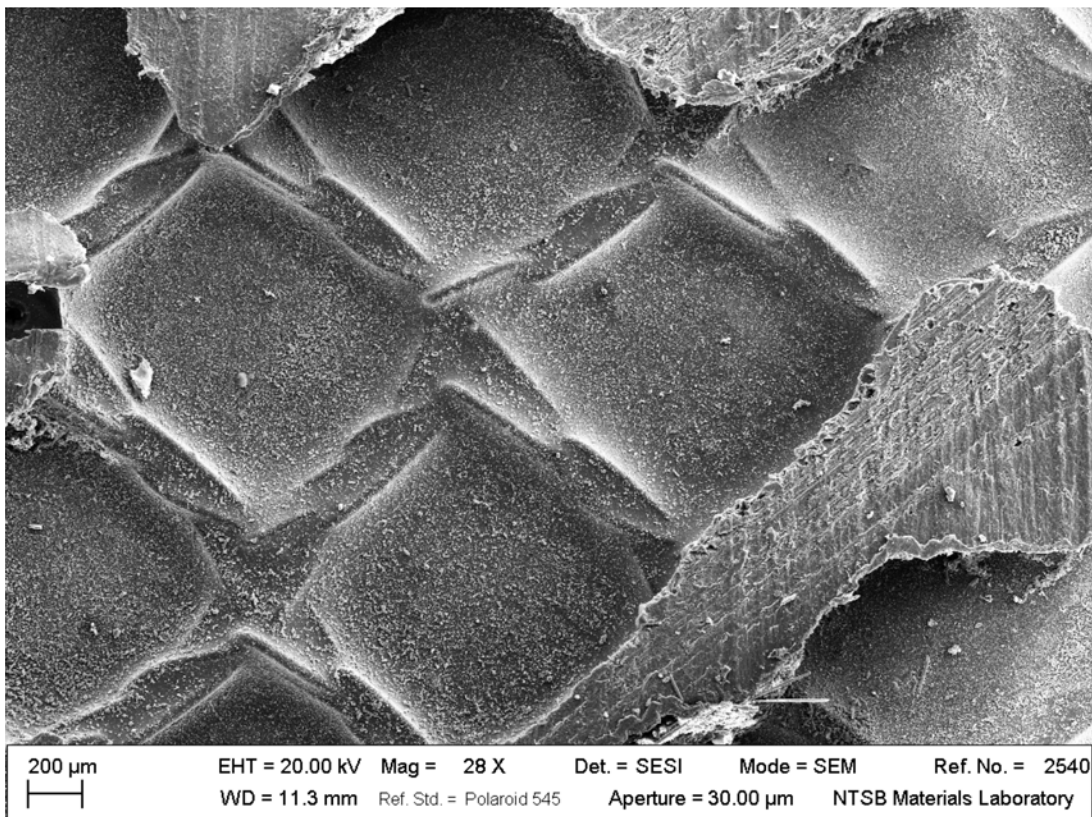
Large amounts of particulate debris were also noted in many of the voids, particularly toward the inboard portions of the bond line, as presented in figure 13. At higher magnifications, figure 14, the debris was visible as granules and fragments of fibers.

Figure 13. SEM images of fine particulate debris (light colored granular appearing) on the void surfaces.

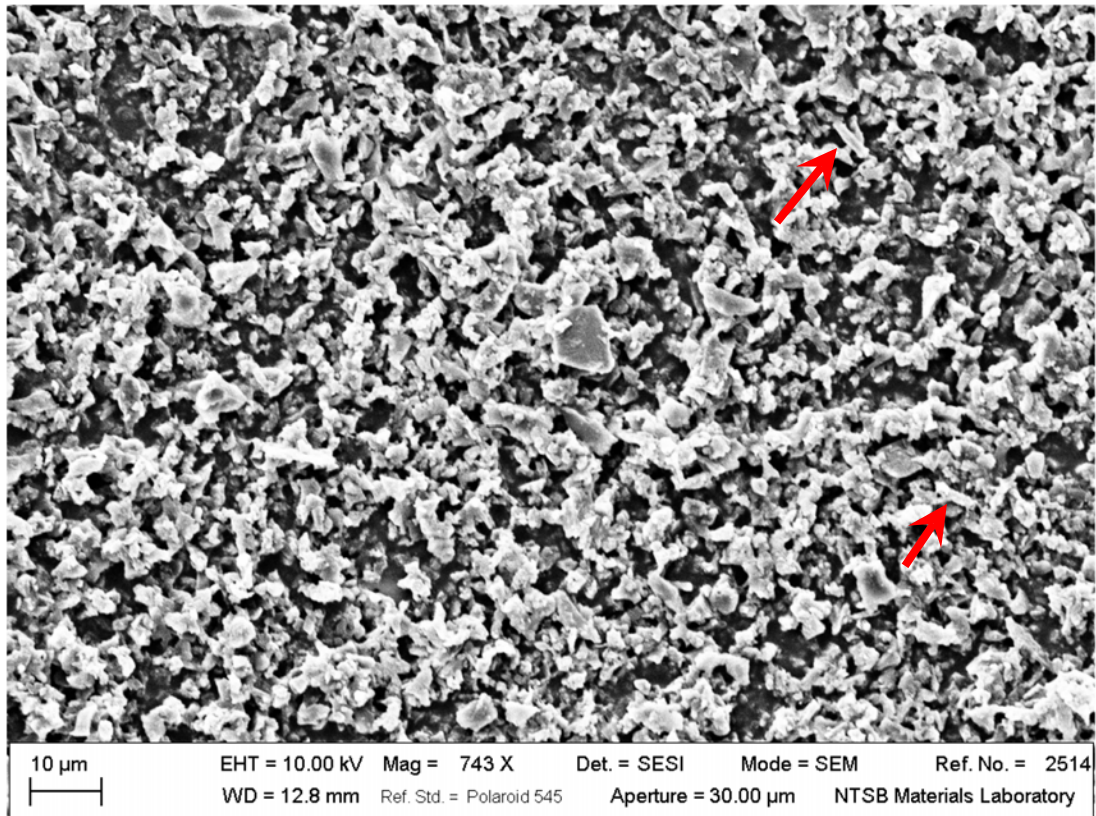
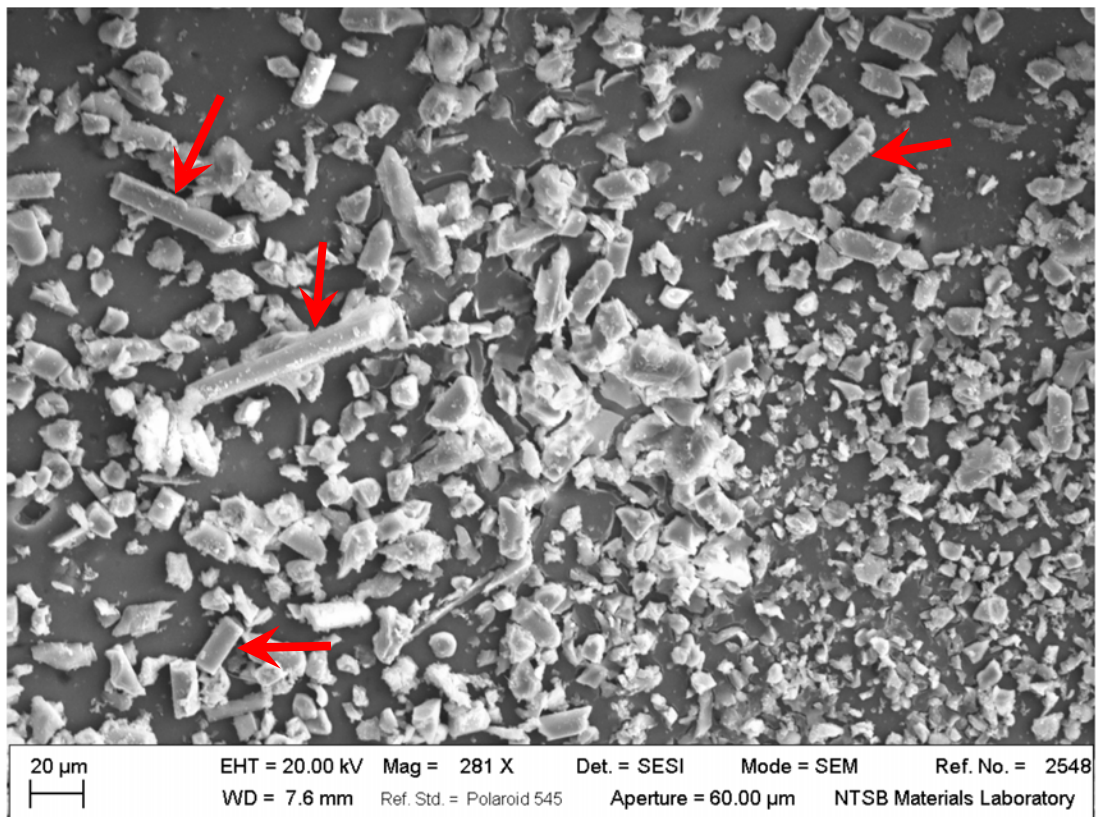
Figure 14. Higher magnification SEM micrographs of the particulate debris from figure 13. Fragmented fibers at red arrows.

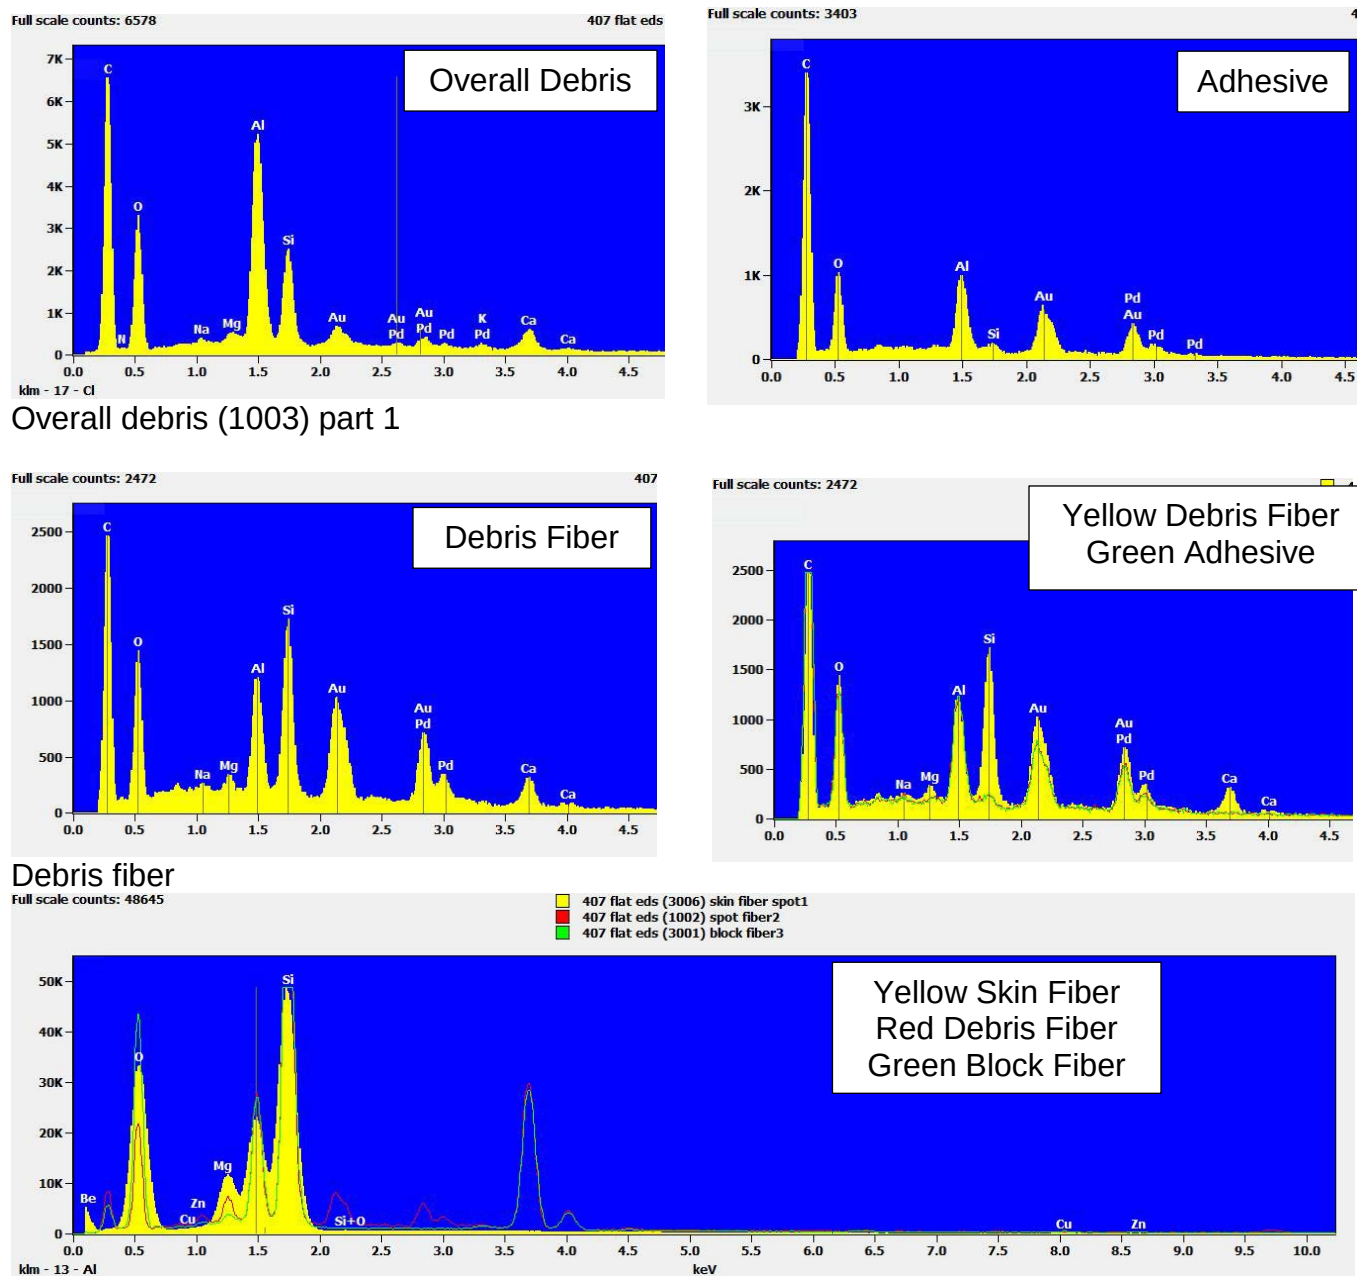
As measured by energy dispersive x-ray analysis at 20 kV (EDS), the major elements in the particulate debris were carbon (C), oxygen (O), aluminum (Al) silicon (Si) and calcium (Ca), upper left spectra of figure 15. Carbon (C), oxygen (O) and aluminum (Al) were the major elements in the adhesive with a minor peak for silicon (Si), upper right spectra of figure 15. Identifiable individual debris fibers had spectra showing major peaks for carbon (C), oxygen (O), aluminum (Al) silicon (Si) and calcium (Ca) with a minor

magnesium (Mg) peak. With the exception of the carbon peak, this composition was consistent with E-glass<sup>7</sup> fiberglass. Overlaying the spectra and EDS spectral mapping of the elements, found the composition of the particulate debris to be consistent with a mixture of adhesive and E-glass fibers and possibly other organic materials.

Spectra were also acquired from samples of the skin reinforcing fibers and the block reinforcing fibers. Both were silicon glass fibers with the skin fibers containing oxygen (O), aluminum (Al) silicon (Si) and magnesium (Mg) consistent with a typical composition for S-glass<sup>8</sup>. The block fibers contained oxygen (O), aluminum (Al) silicon (Si) and calcium (Ca) consistent with E-glass. The presence of calcium in the debris fibers indicates E-glass consistent with the glass fiber reinforcement of the tip block. An overlay of the fiber spectra is shown in the lower view of figure 15.

Figure 15. EDS spectra of various regions and components of the blade and debris. All spectra collected at 20kV. Gold (Au) and palladium (Pd) peaks are from the coating. Upper left is an overall spectrum of the debris. Upper right is from the adhesive. The middle left is a spot spectrum from a fiber fragment in the debris. The middle right compares the debris fiber spectrum to the adhesive. The lower compares spectra from debris fibers to that of skin fibers and tip block fibers and establishes that the debris fibers were consistent with the tip block fibers.

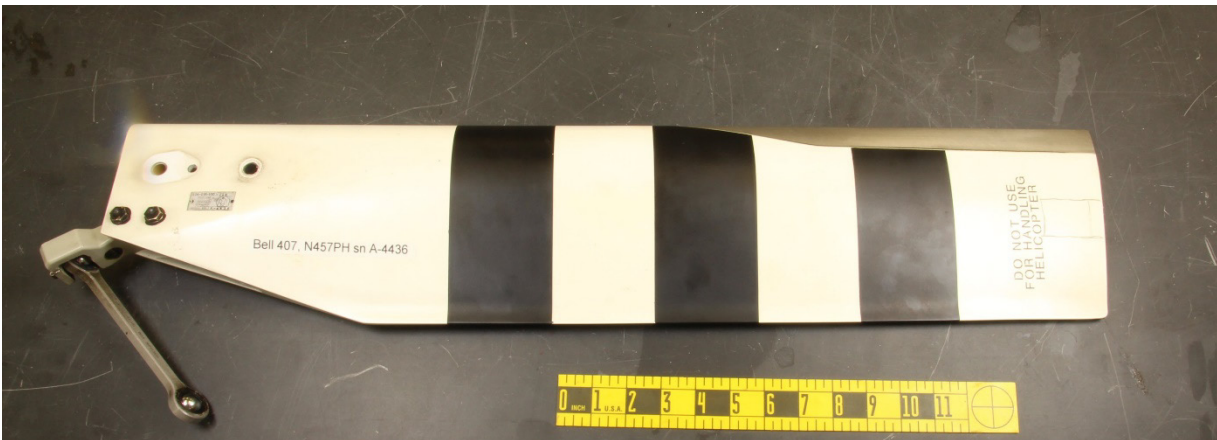
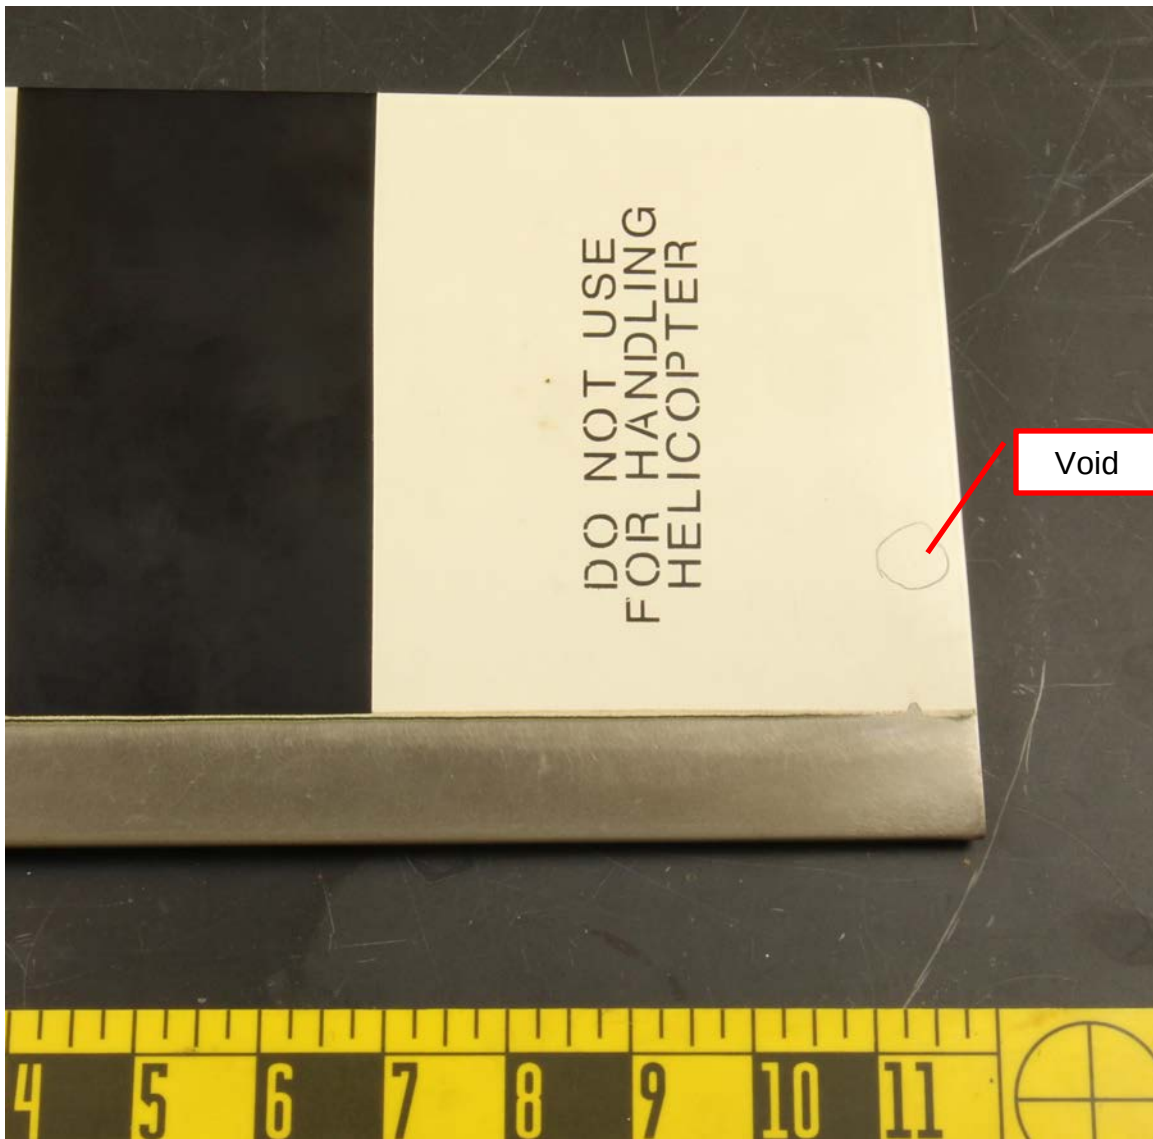
Blade s/n A-4436, figure 16, appeared intact with no obvious damage and no cracking was noted in the coatings on the tip of the blade. The blade had a tip block replacement and wire mesh repair<sup>10</sup> at a service time of 6,808.26 hours about 65 hours

prior to the incident. Tap testing<sup>11</sup> the area of the tip block at the outboard end of the blade uncovered a void indication as shown in figure 16. The void was located on the flat side of the blade just aft of the leading edge abrasion strip. It was estimated to be about ½ inch in diameter.

Figure 16. Upper view shows the camber side of intact blade s/n A-4436. Lower view shows the circled location of a void indication in the tip block area on the flat side of the blade.

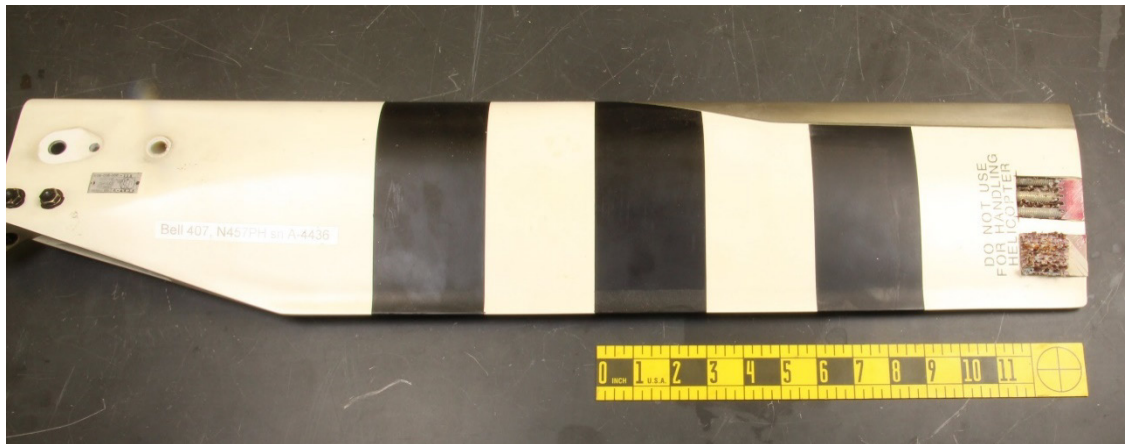
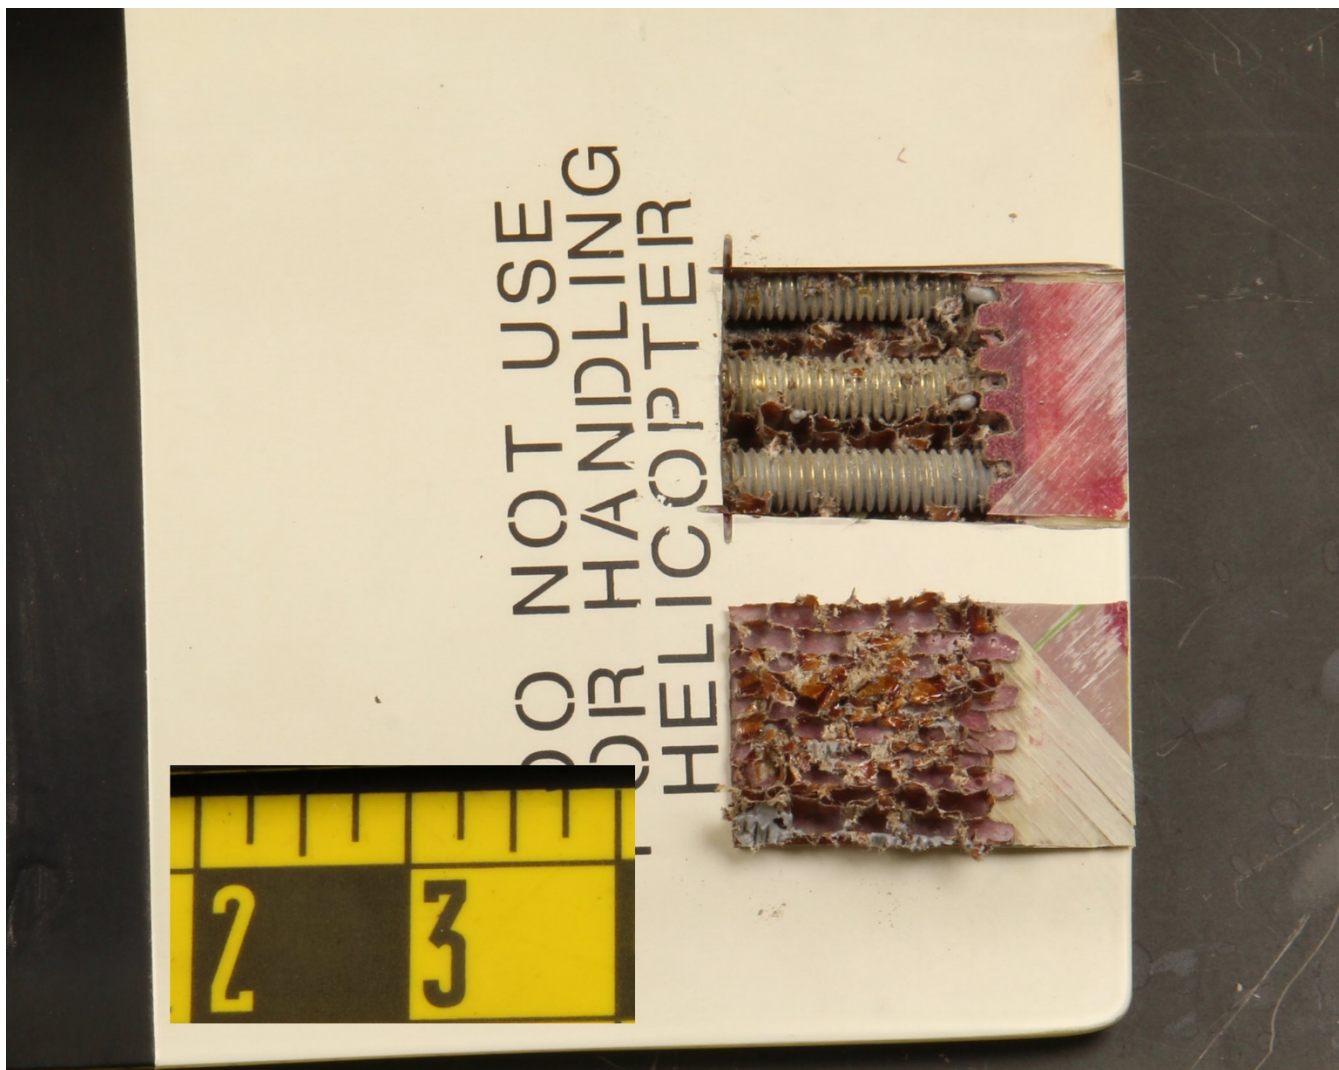
An approximate one inch by 1.75 inch strip of the blade skin over the tip block was cut near the middle of the camber skin of the blade. The strip was lifted at the inboard end to induce a separation in the skin to tip block adhesive joint. The separated skin strip is displayed in figure 17. Magnified examination found that the majority of the separation occurred within the skin plies and only a small portion occurred at the adhesive skin interface. No indications of a waffle pattern were visible.

Figure 17. Two views showing blade s/n A-4436 after a test strip was peeled from the camber side of the blade at the tip block. Separation was mostly in the skin material.

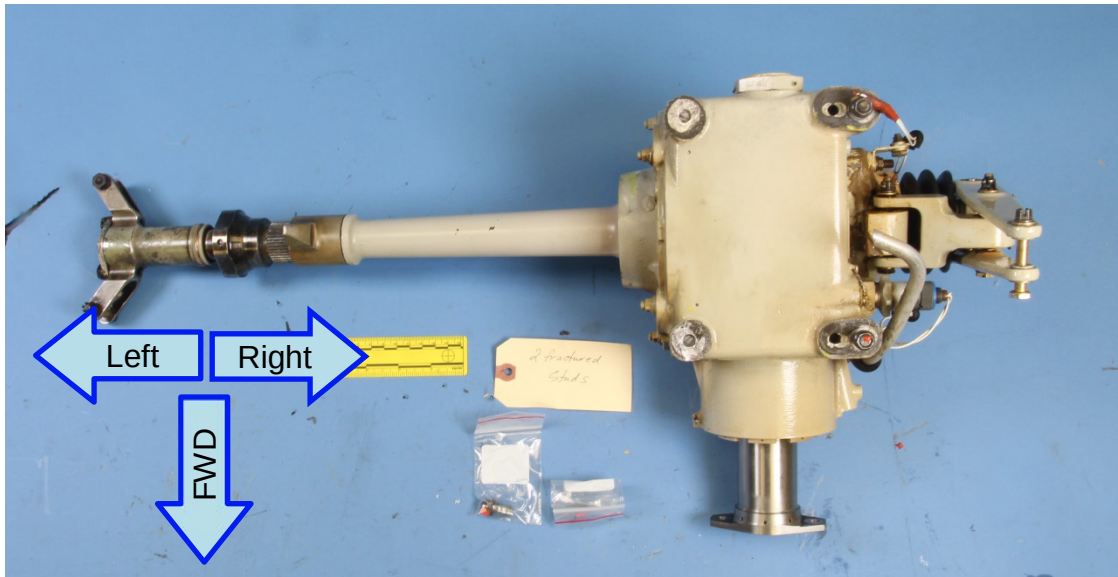
Figure 18

The as-received tail rotor gearbox and support assemblies are displayed in figure 18. The gearbox was disassembled and removed from the support structure on-scene and the tailboom was subsequently cut to remove the support assembly.

The gearbox support assembly consisted of an aluminum support casting on the upper side (p/n 407-030-016-105, s/n 33488) and a sheet metal skin and inspection cover on the lower side. The entire support casting was fractured and all but 2.7 inches of the skin and the four inch wide cover were cracked. The fracture in the casting and crack in the skin both appeared consistent with overstress separations. Additionally, a piece of the support casting was broken out at the left forward stud area.

The gearbox mounting pads surrounding the stud holes displayed surface fretting patterns on both the gearbox and nut sides. All four stud bores had thread marks consistent with all around contact with the stud threads. Locating pin holes were positioned adjacent to the two right-hand stud holes. The pins were not received and were reportedly not recovered during disassembly of the tail rotor. The support casting was fractured through the forward right-hand stud and pin hole.

Figure 18. overall views of the as-received tail rotor gearbox assembly with fractured studs (top) and the cracked gearbox support assembly (right).

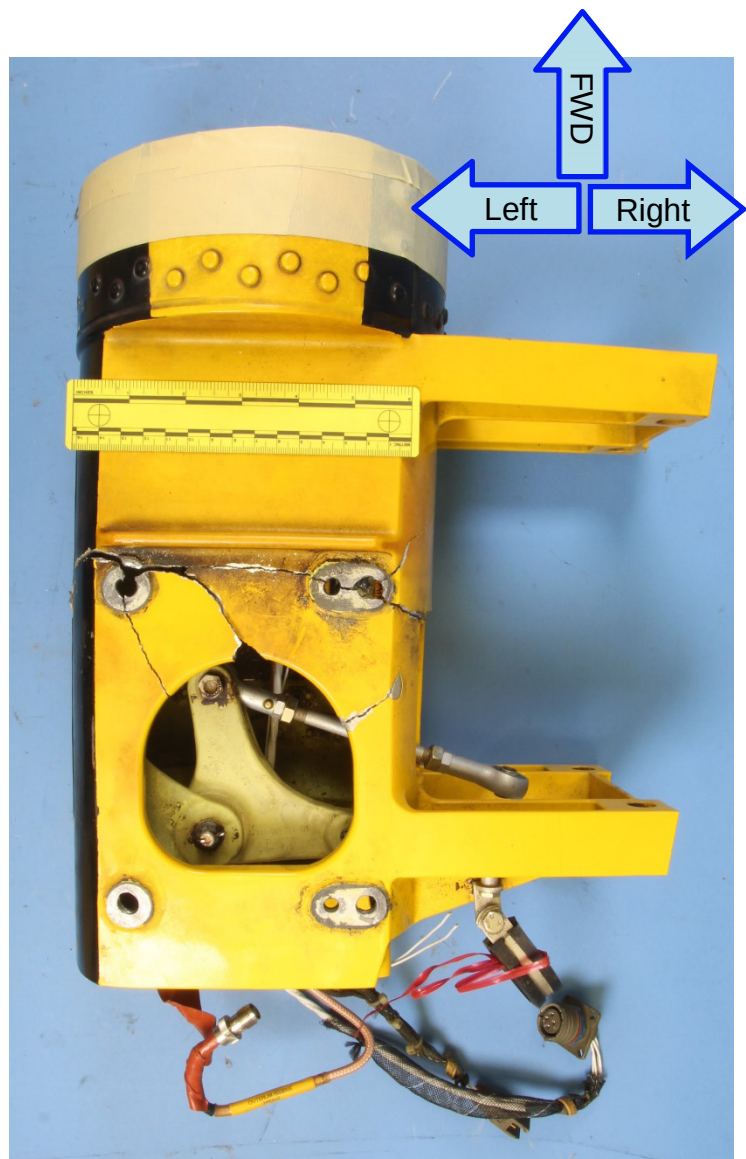
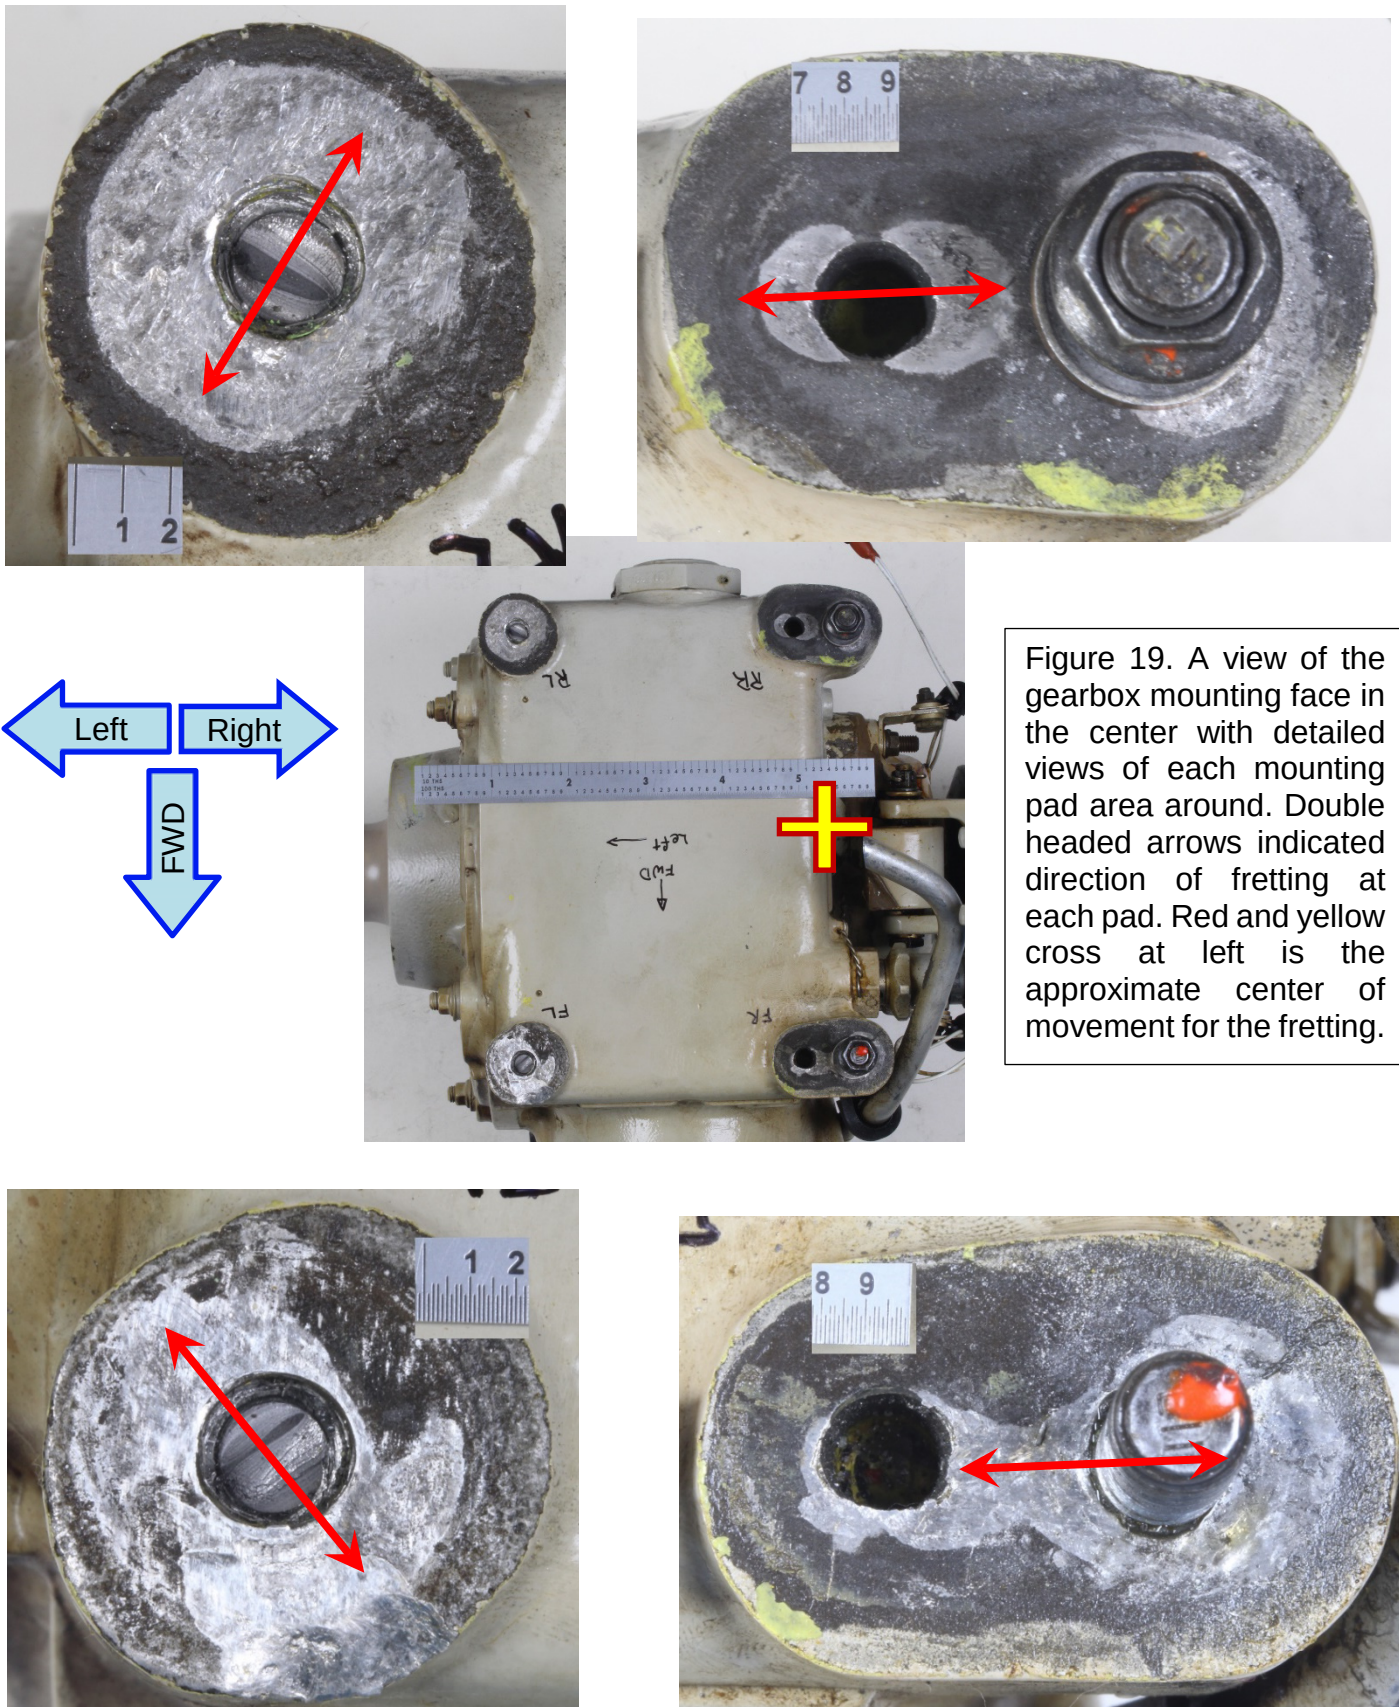
recovered. The mounting surfaces displayed directional fretting patterns mirroring those seen on the support casting, as shown in figure 19. The gearbox assembly otherwise appeared intact and relatively undamaged.

Macroscopically both fractured left-hand studs displayed reversed bending fatigue fractures. The directional orientation of the fatigue progression matched the respective directions of the adjacent fretting. Fretting and fatigue directions are indicated by double headed red arrows in figure 19. The directions of fatigue and fretting are consistent with a common axis of rotation for the gearbox relative to support located near the right edge of the gearbox housing midway between the right stud locations, as denoted by the red and yellow cross in the central view of figure 19.
