# NATIONAL TRANSPORTATION SAFETY BOARD

MATERIALS LABORATORY FACTUAL REPORT

Report No. 17-061

Place : Venice, Louisiana  
Date : May 2, 2017  
Vehicle : Bell 407, N457PH  
Operator : PHI International  
NTSB No. : CEN17LA174  
Investigator : Arnold Scott, AS-CEN

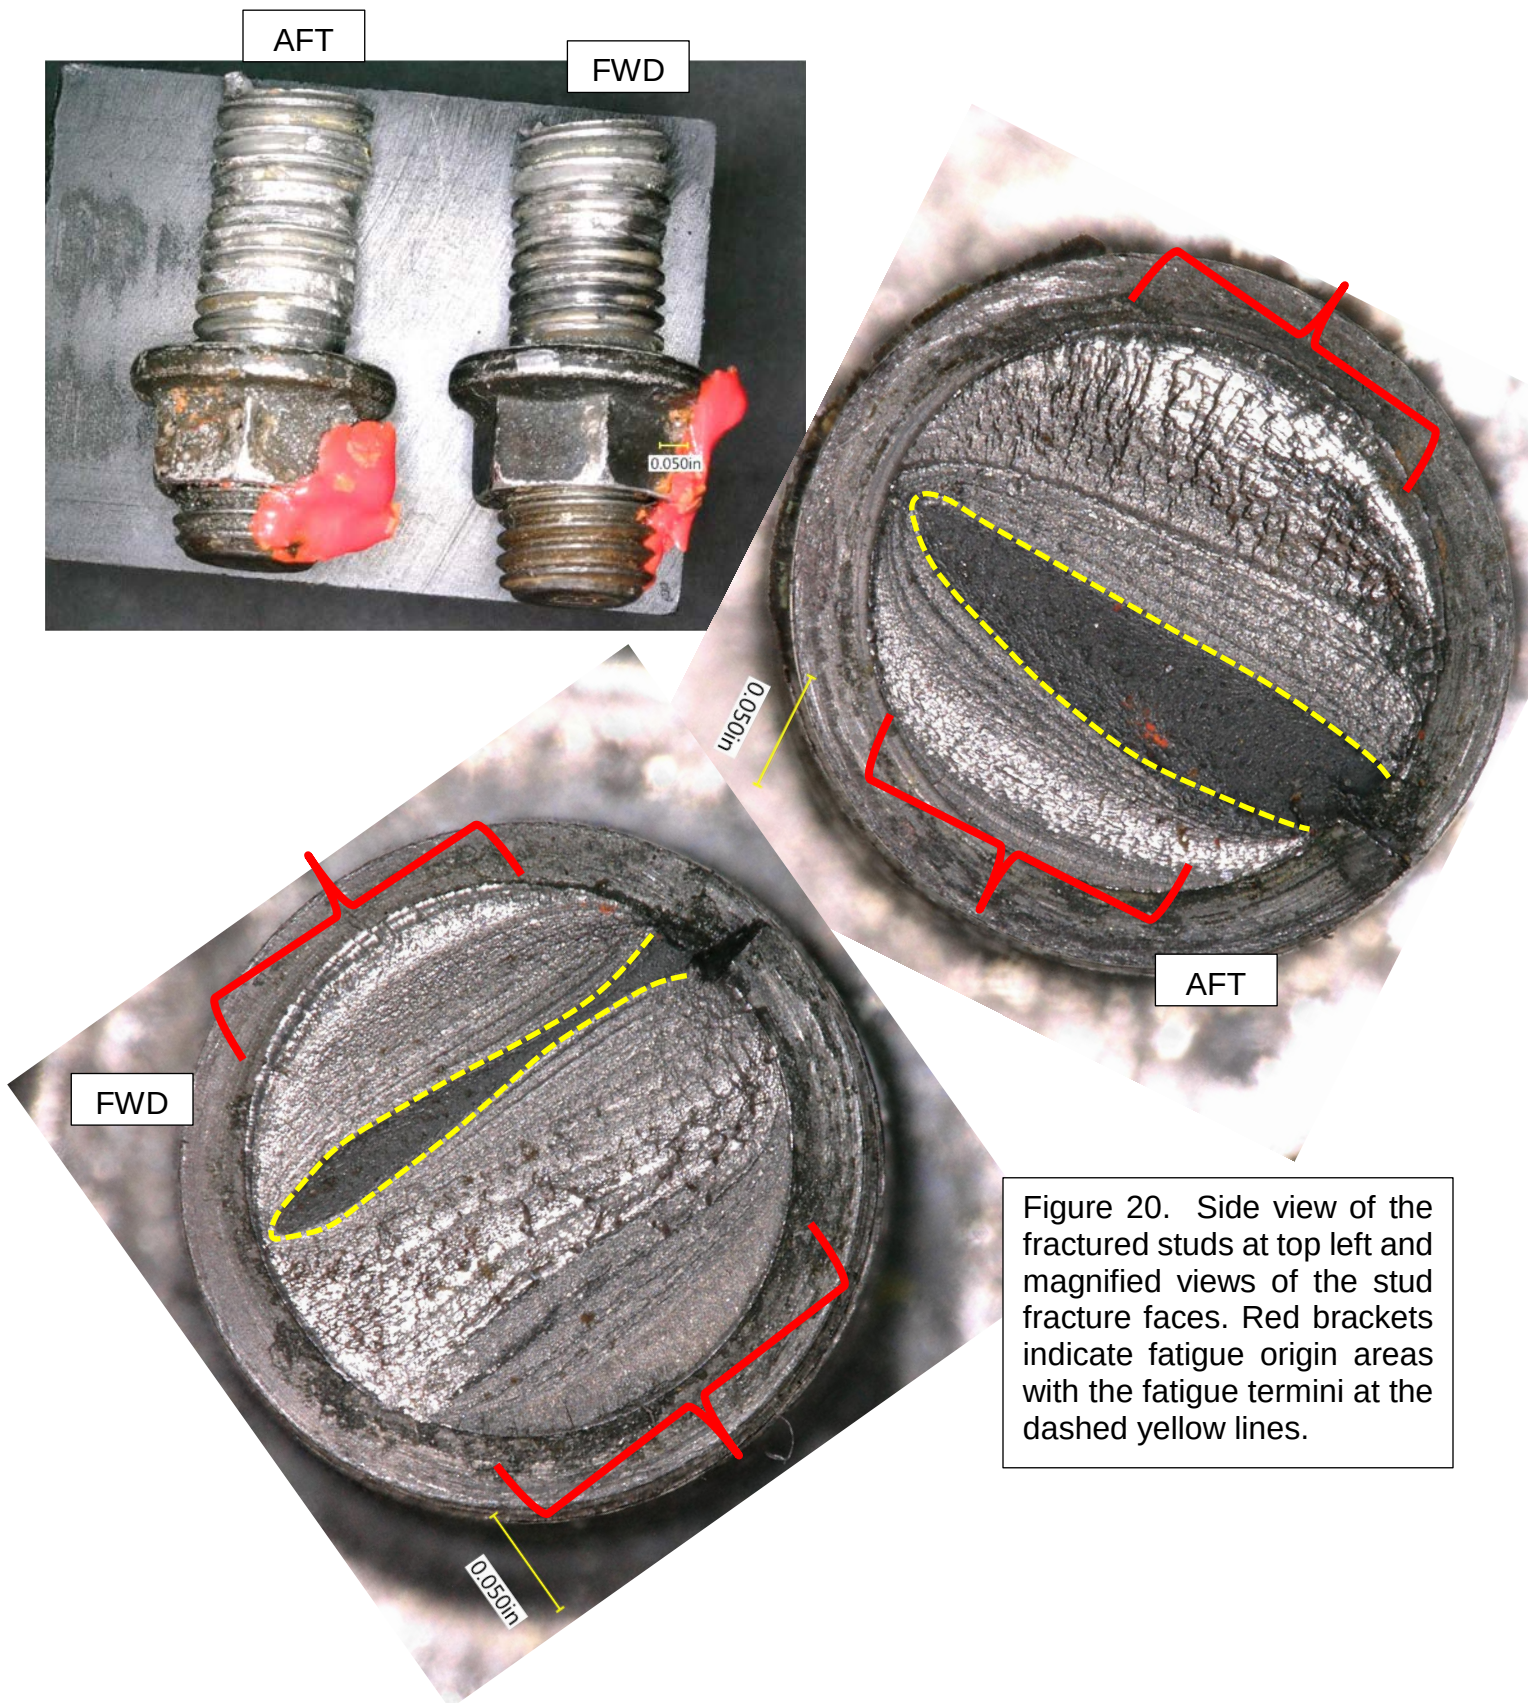
The fractured stud shanks were recovered with nuts threaded on and torque paint in-place as shown in the upper left image of figure 20. The stud segments were between 0.92 and 0.93 inch in length. Based on the stud segment lengths and the locations of the fractures, the left-hand studs originally extended approximately the same distances above the gearbox surfaces as the right-hand studs, 0.78 inch. The Illustrated Parts Breakdown (IPB) indicated that AN126XXX studs<sup>12</sup> were to be installed. AN126324 studs were reported installed at last overhaul.

As can be seen in figure 20, the nuts were at different positions relative to the ends of the fractured studs. The red torque paint indicates that the nuts had not moved since installation. The forward nut was threaded on to the stud 0.190 inch or about 0.055 inch further than the aft nut. No washers were received with the stud and nut segments but the washers received with the right-hand studs measured about 0.060 inch in thickness. The thread roots below the nuts were partially embedded with material consistent with the aluminum of the gearbox support casting.

The studs were fractured in the coarse threaded portions of the studs. Cracks and thread stretching were noted in the root radii adjacent to the fractures. Magnified optical examinations of the fracture faces revealed features and topographies consistent with multiple origin reversed bending fatigue initiating in the respective root radii on opposed sides of each studs. Fatigue origins were between the 4<sup>th</sup> and 5<sup>th</sup> threads from the center on one side and between the 3<sup>rd</sup> and 4<sup>th</sup> threads on the opposite side. Progression was inward with increasing coarseness until final overstress fracture. Fatigue progression penetrated about 90% of the forward and 80% of the aft stud before final overstress fracture. The fatigue initiation areas are indicated by red brackets in figure 20 and the fatigue termini are indicated by the dashed yellow lines. Closer optical examinations found significant fracture face mechanic damage consistent with crack face closure.

Figure 20. Side view of the fractured studs at top left and magnified views of the stud fracture faces. Red brackets indicate fatigue origin areas with the fatigue termini at the dashed yellow lines.

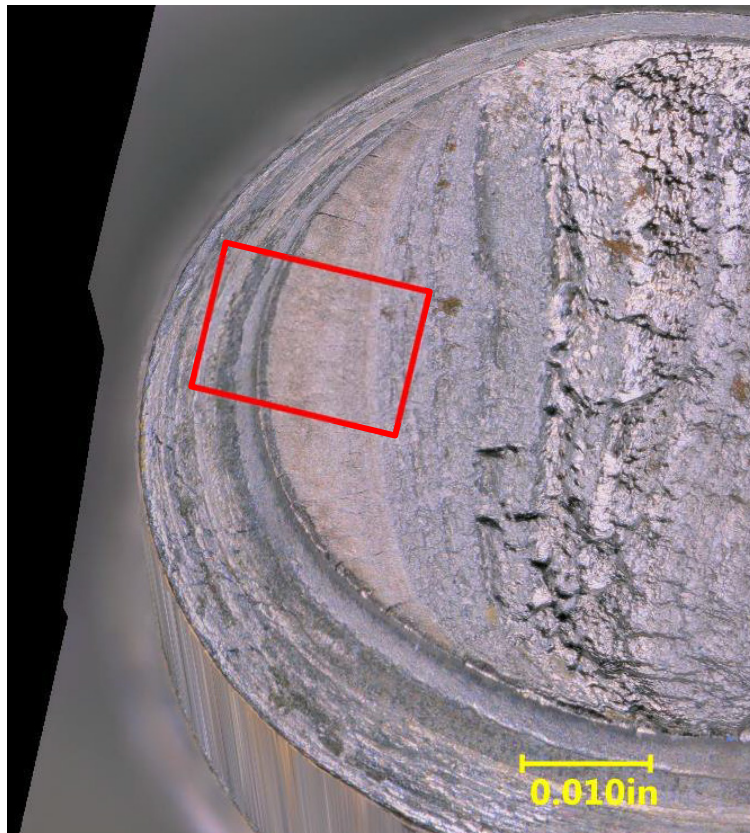
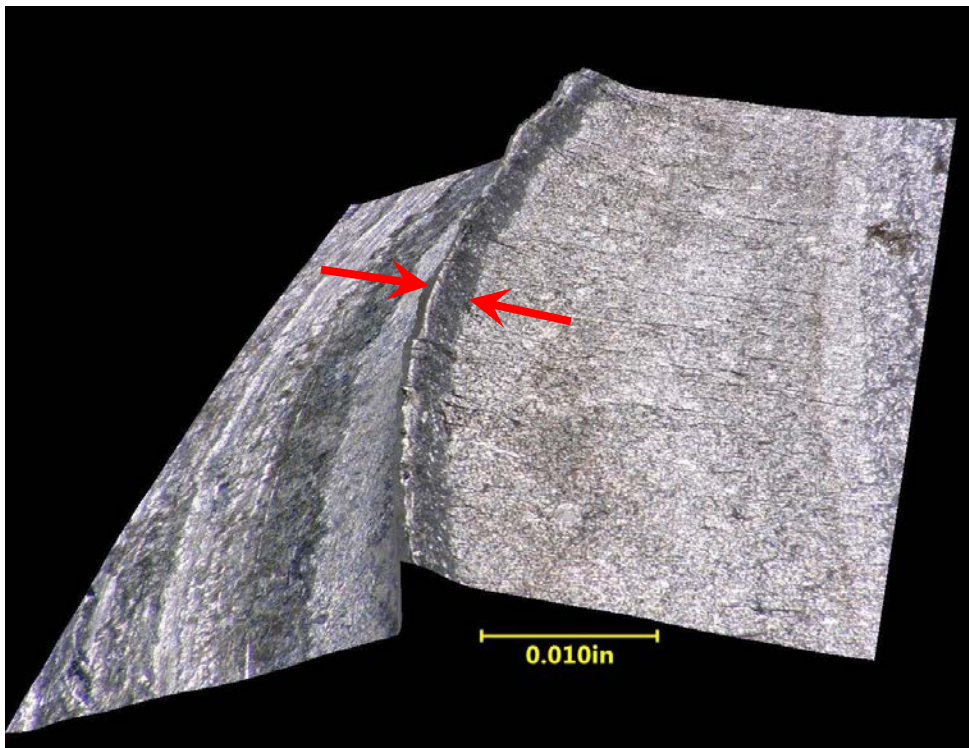
High magnification optical and SEM viewing also uncovered small slant fracture planes at all four origin areas. The slant planes measured between 0.003 and 0.005 inch in width. A typical fracture origin area is shown in figure 21 with the slant region denoted. Scanning electron microscope (SEM) viewing of the studs uncovered ductile dimples on the slant region in undamaged locations as shown in figure 22.

Figure 21. Three-dimensional optical constructions of one fatigue side of the forward stud typical of other fatigue regions. Red box area of upper view showing the small slant plane (between red arrows) at higher magnification below.

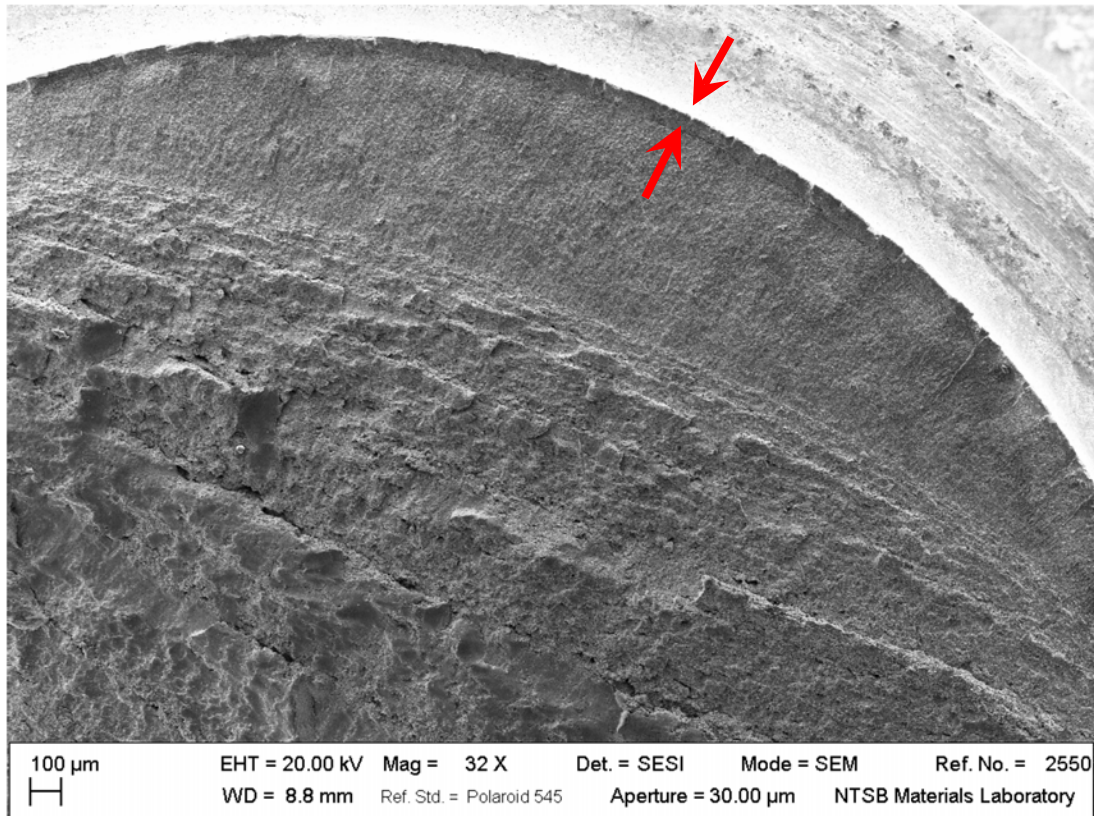
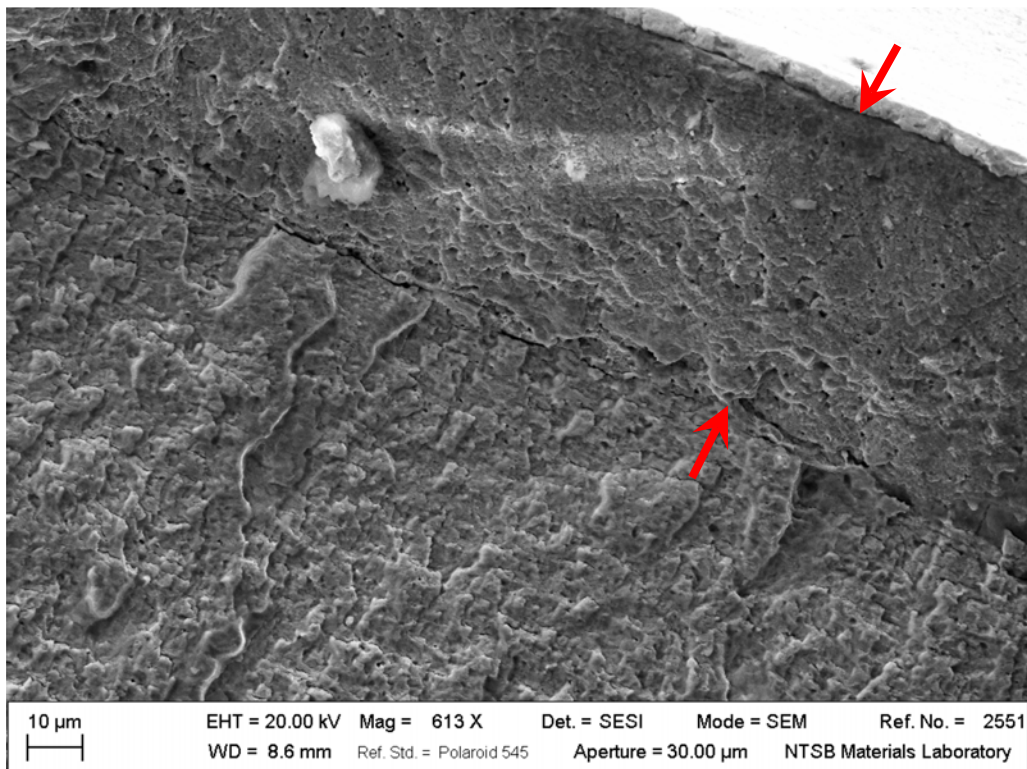
Figure 22. SEM images showing the slant plane (between red arrows) at the fatigue origin of the forward stud. Ductile dimples are visible on the plane in the lower view along with fatigue features emanating from the plane.
