**Rotor Blades, Inc. LA**

**Blanket Expanded Repair Approval Requisition**

**RBI # - 125A**

**Component:** Tail rotor blades

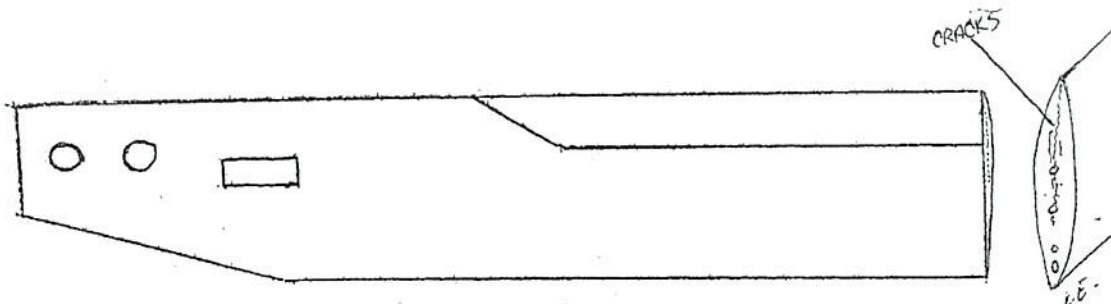
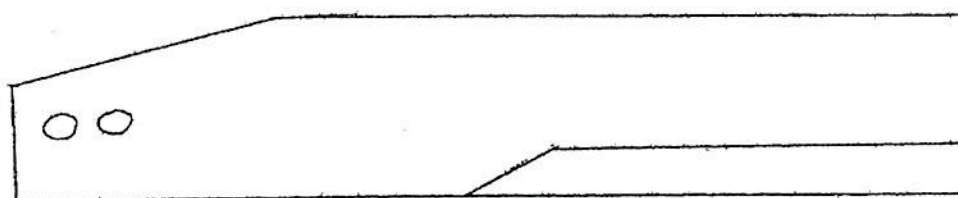
**Please See Attached Sketch**

Discrepancy: **Tip block Cracked.** Crack is extending from tip weight screw hole. Possibly caused during tip weight installation or removal operations.

**Corrective Action: Tip Block Replacement**

- 1.) Using a Dremmel tool or suitable cutter. Remove damaged tip block from blade. Do not damage blade skin.
- 2.) Clean blade thoroughly and prepare blade and block for bond with dry grit blast per BPS 4352 .

- 3.) Place a one inch strip of supported adhesive around the nose of the tip block, then cover the entire bonding surface of the tip block with adhesive using AF163-2K. An additional layer of unsupported is acceptable to fill variations in fit.

- 4.) Position the tip block in the blade per B/P and install blade in bonding tool. Bond tool shall consist of clamps, pressure plates and heating elements as required to provide uniform bond line pressure (14 psi min), and contour control. Heat bond line to 230° F and cure for 2 hours. On excess portion of tip block, prepare and bond a fiberglass test strip in conjunction with tip block.

- 5.) Allow to cool to 130° F and remove blade from tooling
- 6.) Inspect bond by tapping, **NO VOIDS ALLOWED.** Peel fiberglass test strip from excess and inspect for cohesive bond failure. Any indication of improper bonding shall be cause for tip removal and rework.

- 7.) Apply a tension proof load of 1320 lbs to the excess portion of the tip block. The root end should be restrained using a 406-012-102 Yoke and NAS6606 bolts or equivalent. After completion of the proof load test, inspect the tip for signs of disbonding. Any indications will be cause for block replacement

- 8.) Cut away excess tip block. Finish tip profile by sanding with 220 grit
- 9.) Refinish and Balance as required. Refinish per BPS 4488 and balance to master T/R blade.

- 10.) Tooling must be adequate to maintain blade twist and contour
- 11.) Use tip block P/N 406-016-110-103
