**Photo 1 – N457PH after precautionary landing at Grand Bay Receiving Station near Venice, Louisiana.**

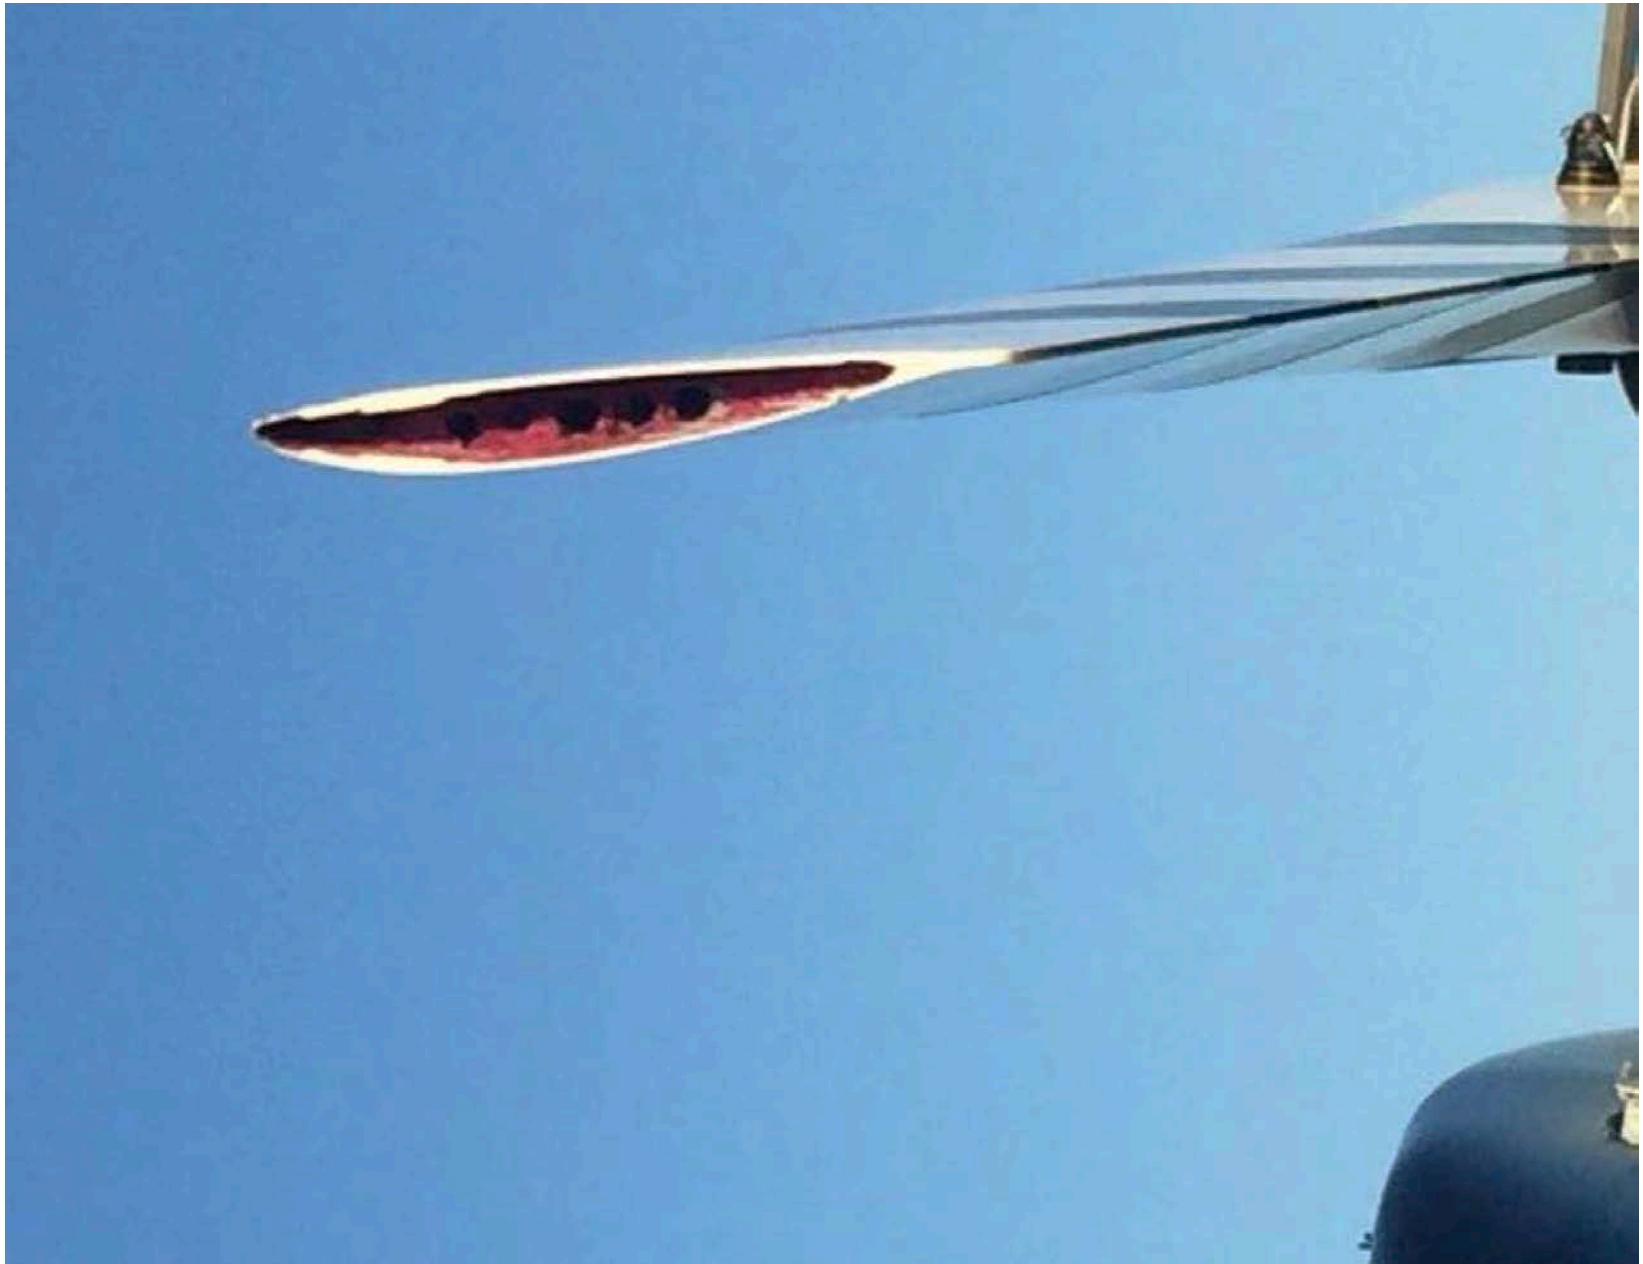
**Photo 2 – Tail rotor blade with tip cap missing.**

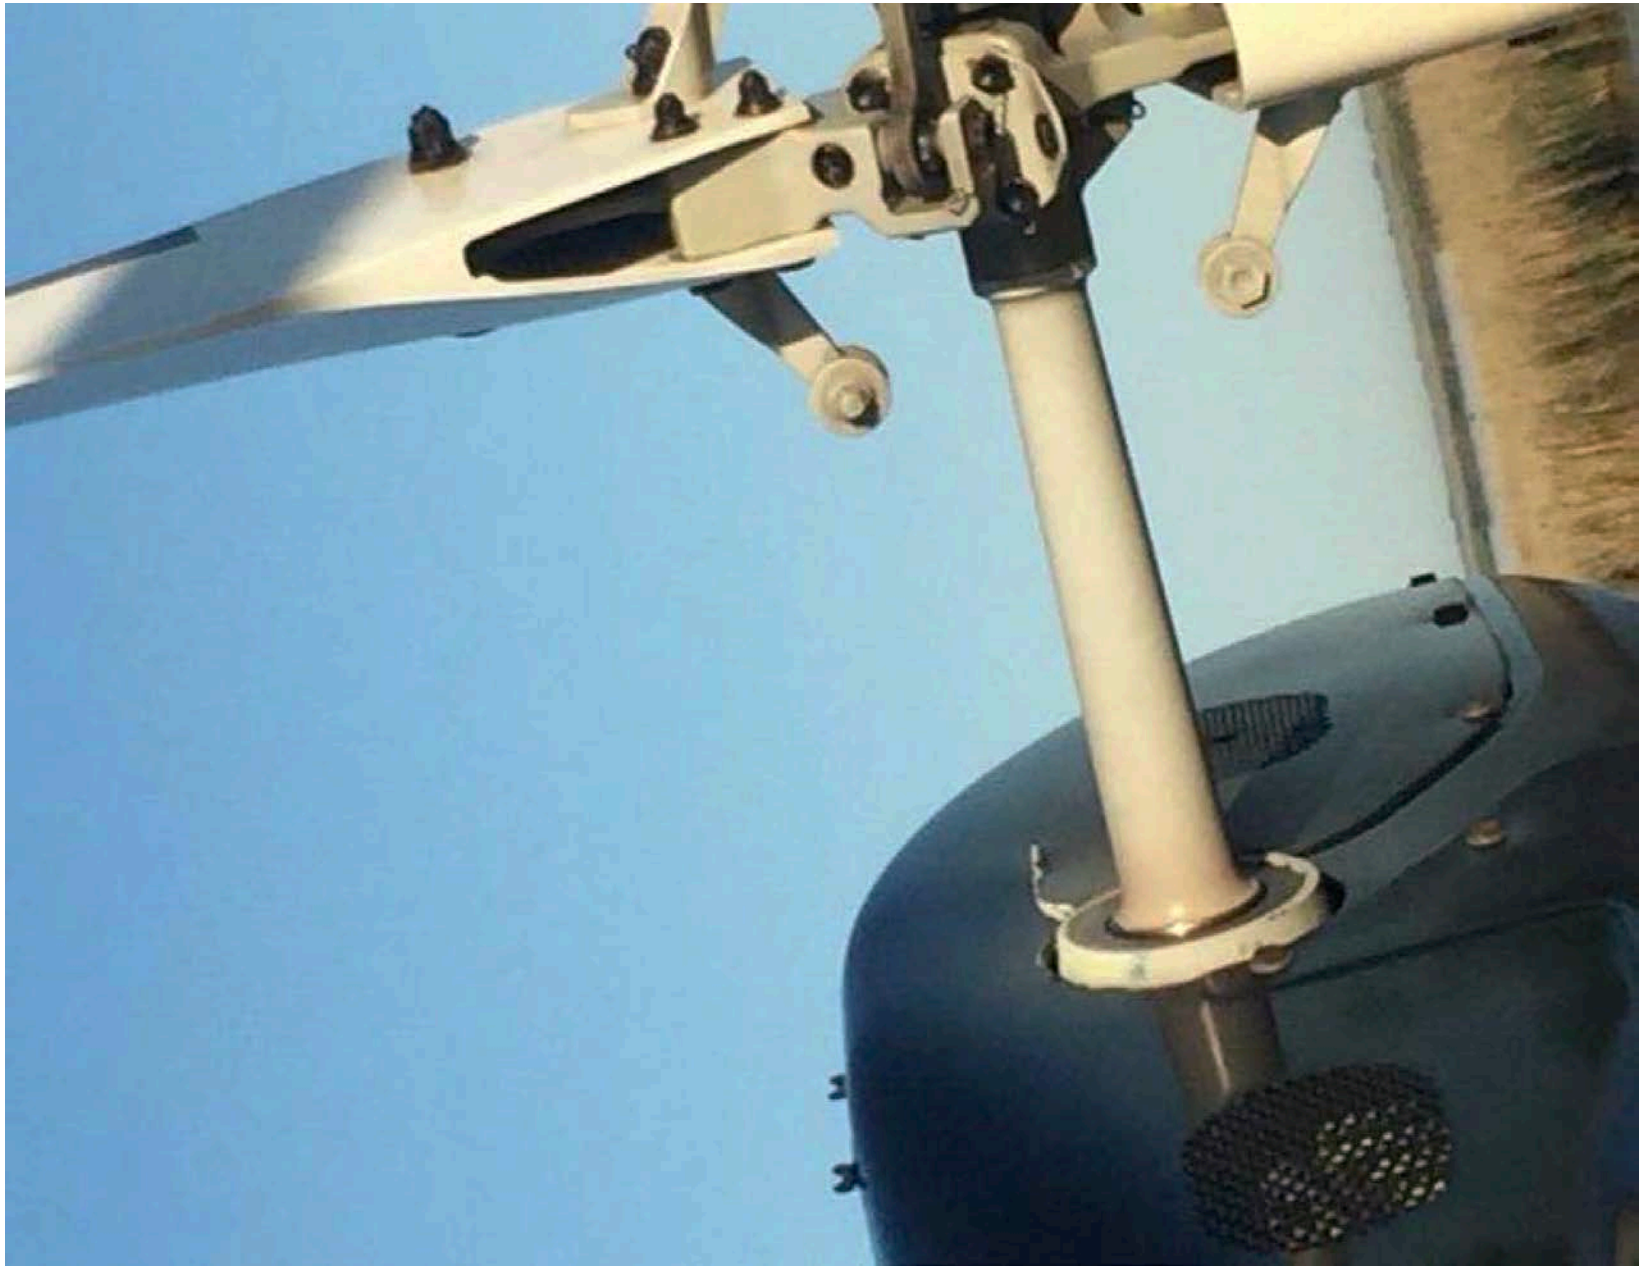
**Photo 3 – Crack in tail rotor gear box housing.**

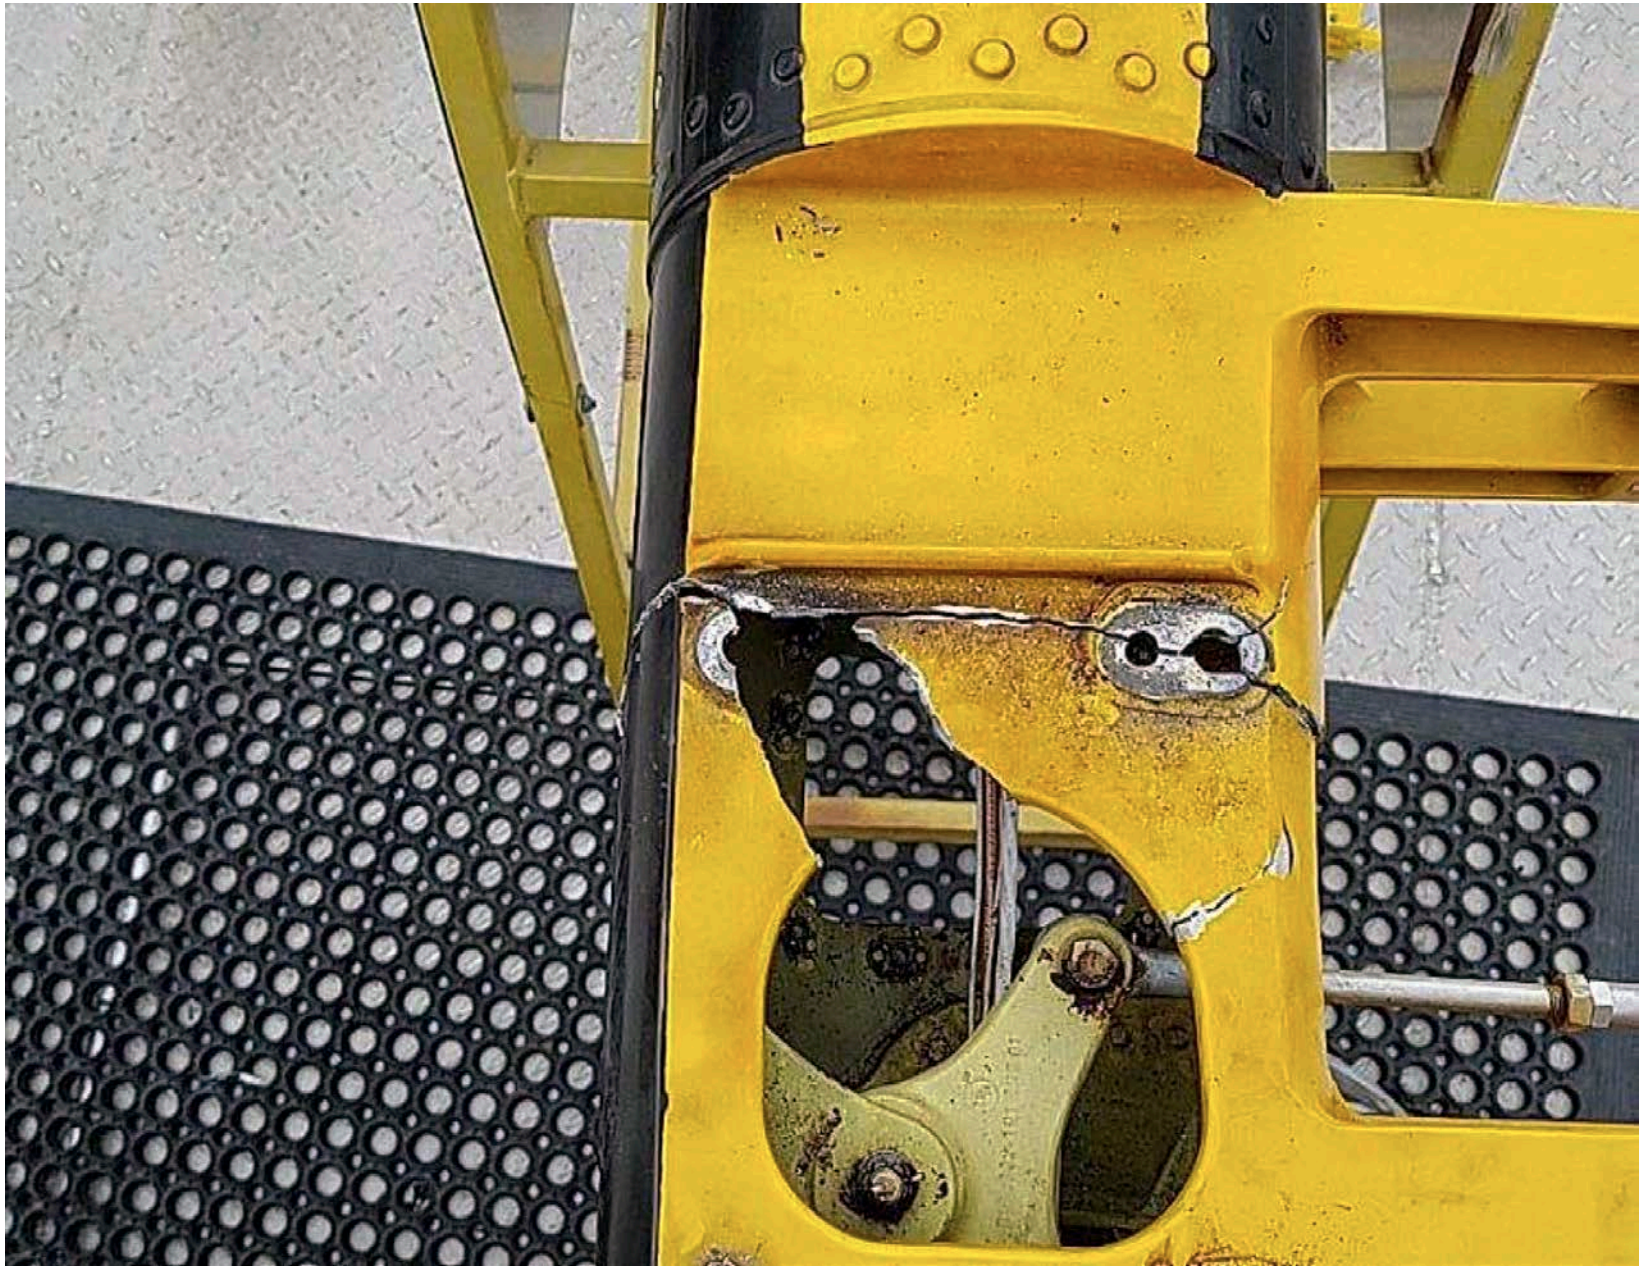
**Photo 4 – Cracks in the tail boom support casting.**

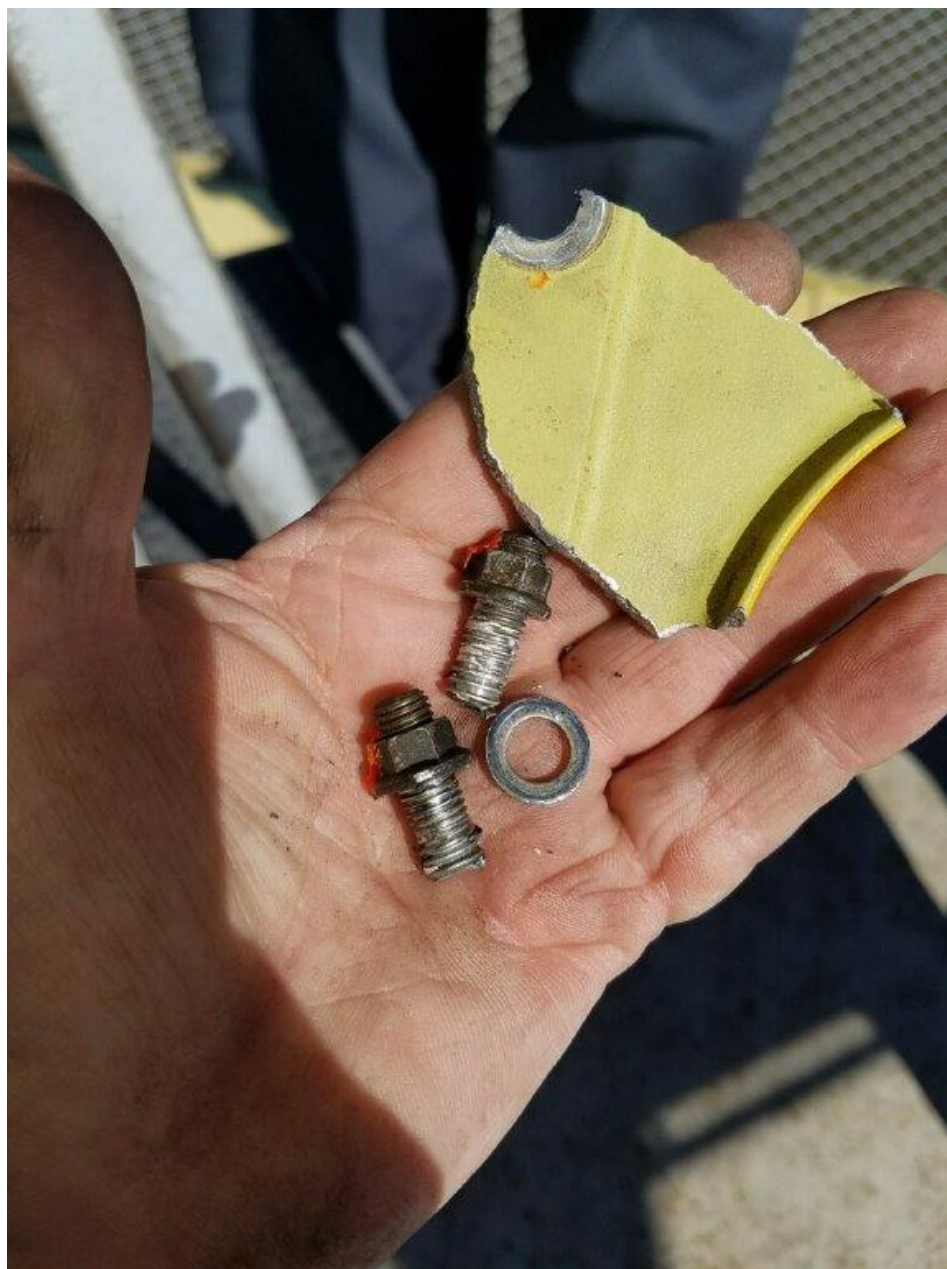
**Photo 5 – Sheared studs removed from tail rotor gear box housing.**
