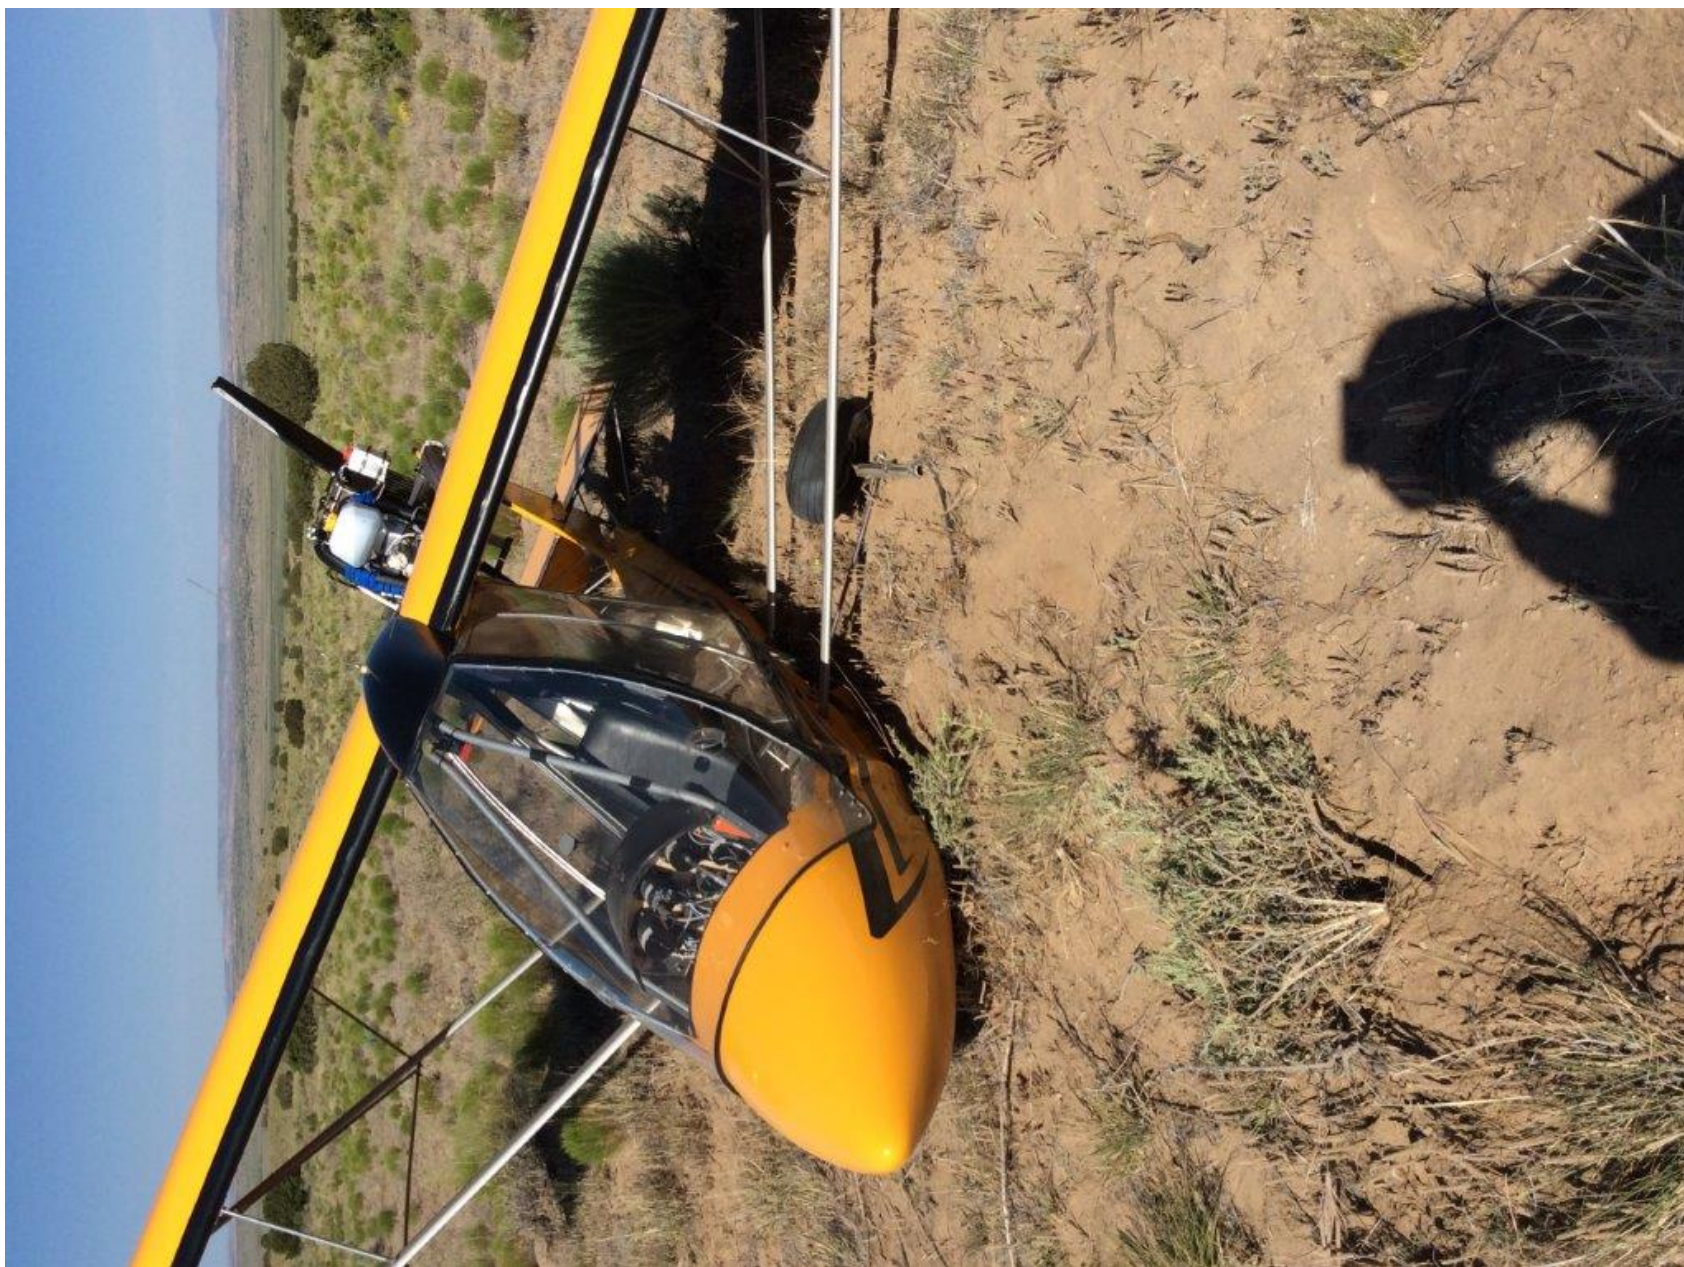
**Photo 1 – Aircraft at Accident Site**

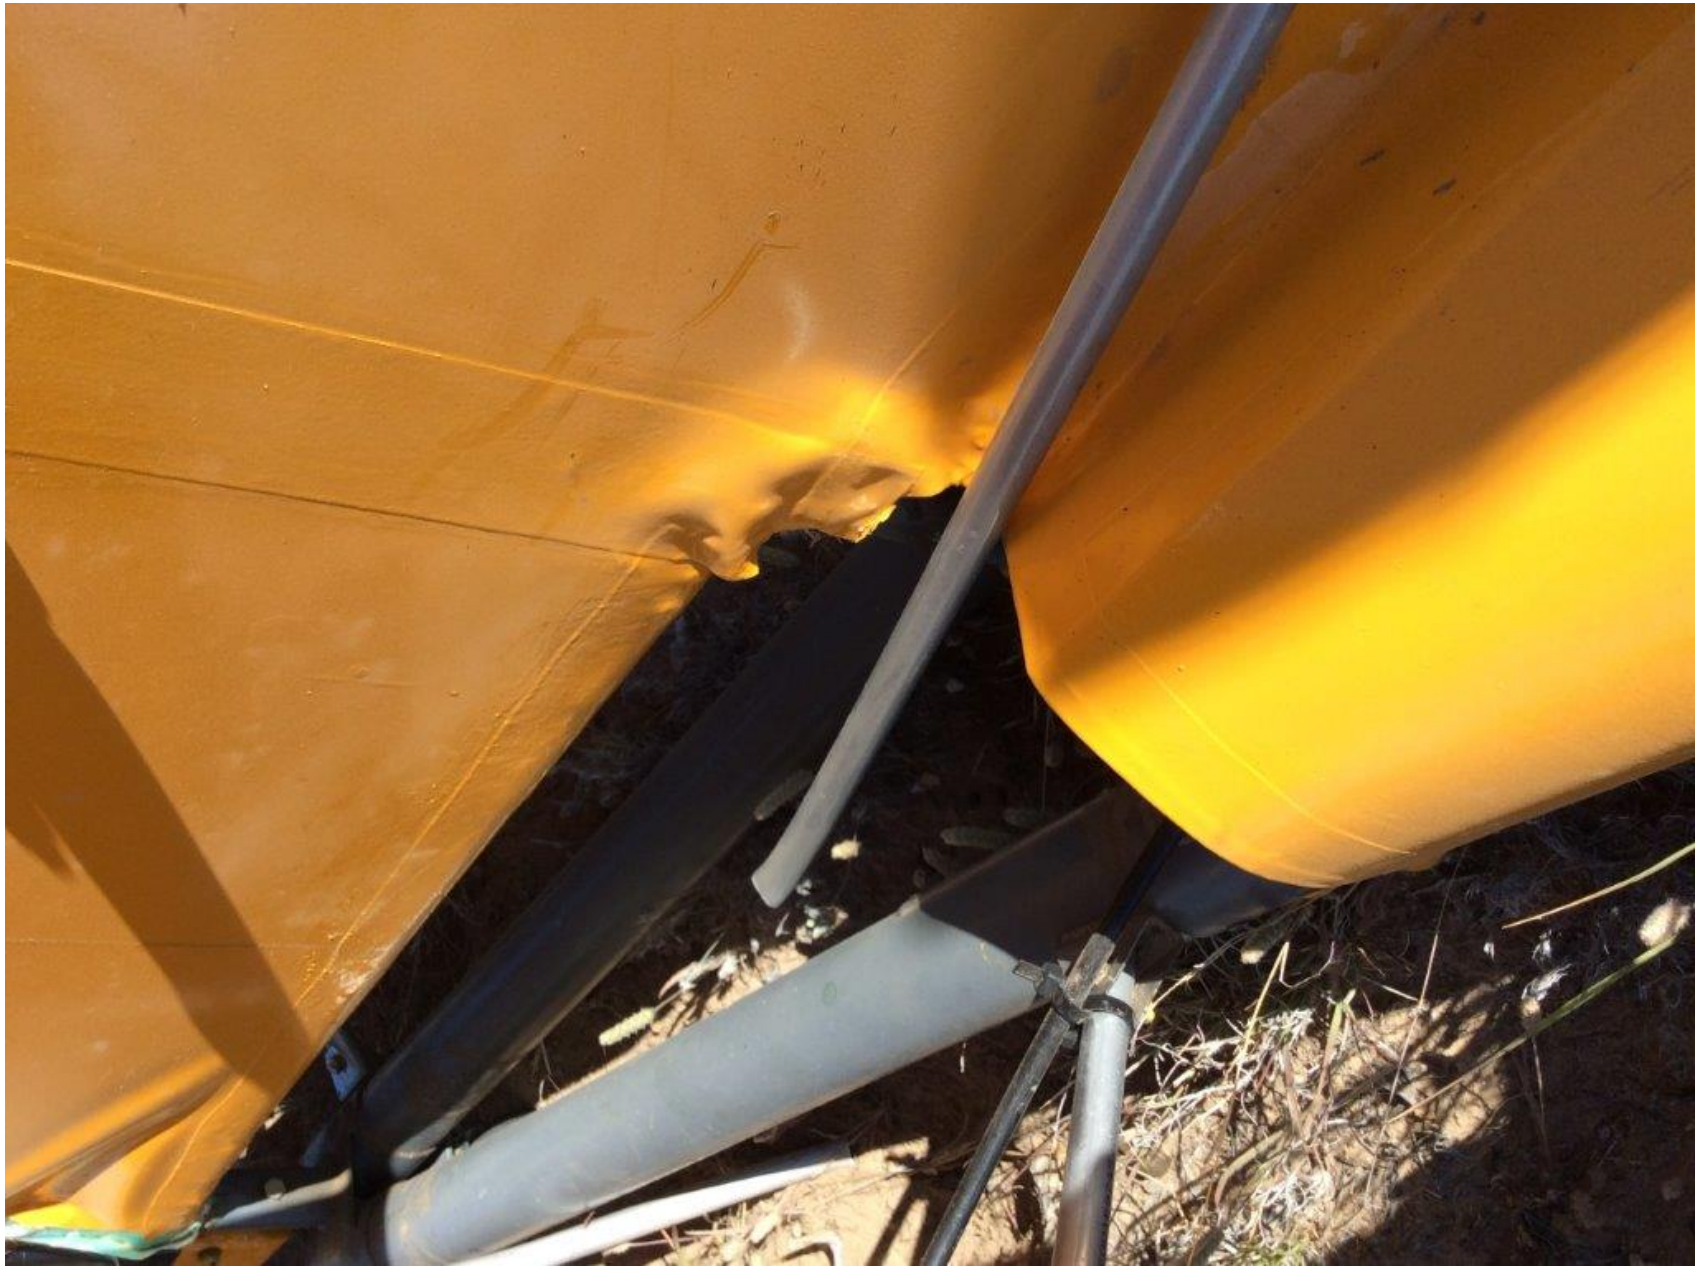
**Photo 2 – Fractured Right Elevator Control Rod at Accident Site**

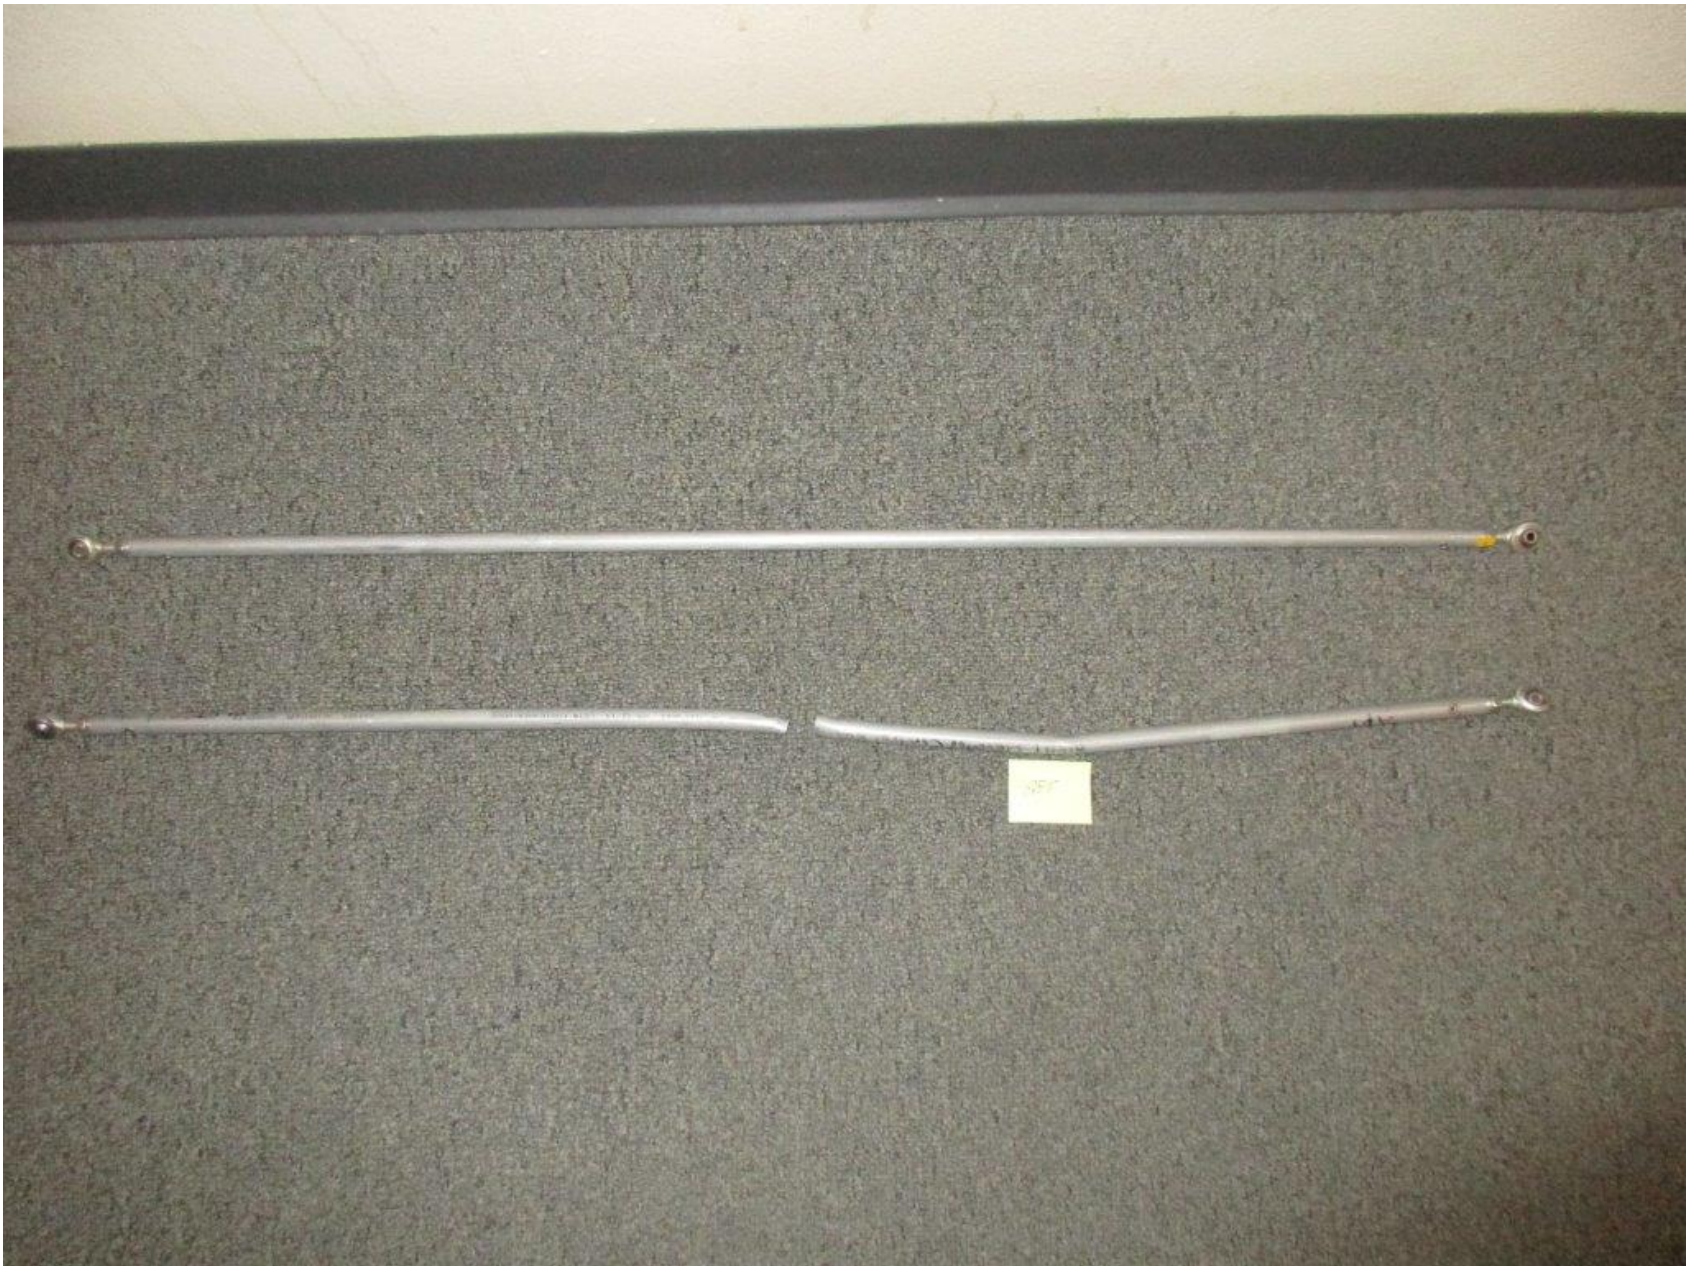
**Photo 3 – Left and Right Elevator Control Rods**
