# Continental Motors

## ENGINE FIELD RUN REPORT

| ENGINE MODEL | IO-520-D |
| FILE NUMBER | 16-642 |

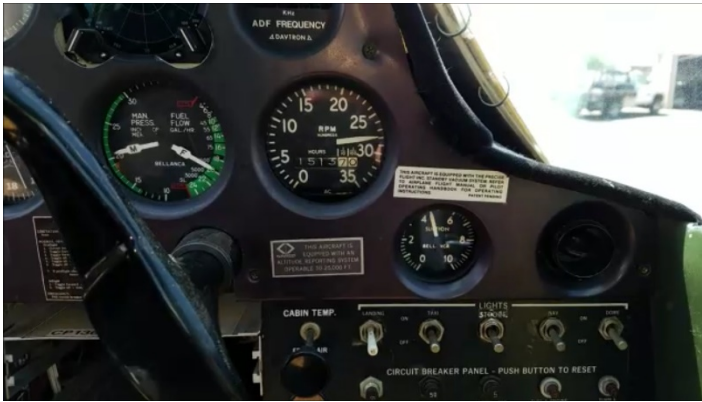
Max RPM Observed

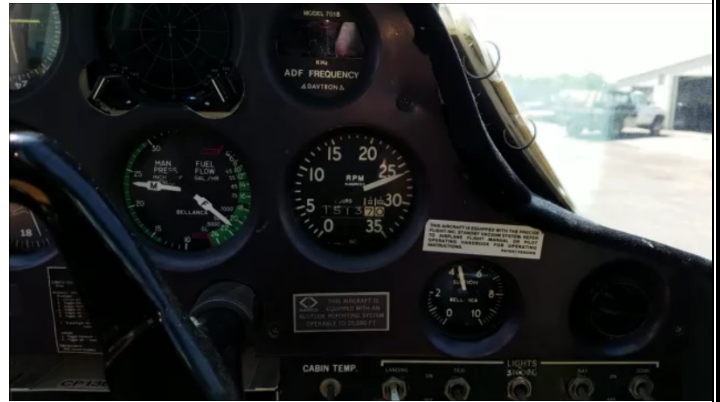
RPM after stabilized by propeller governor
