# Continental Motors

## ENGINE FIELD RUN REPORT

| ENGINE MODEL | O-300-C |
| FILE NUMBER | 16-687 |

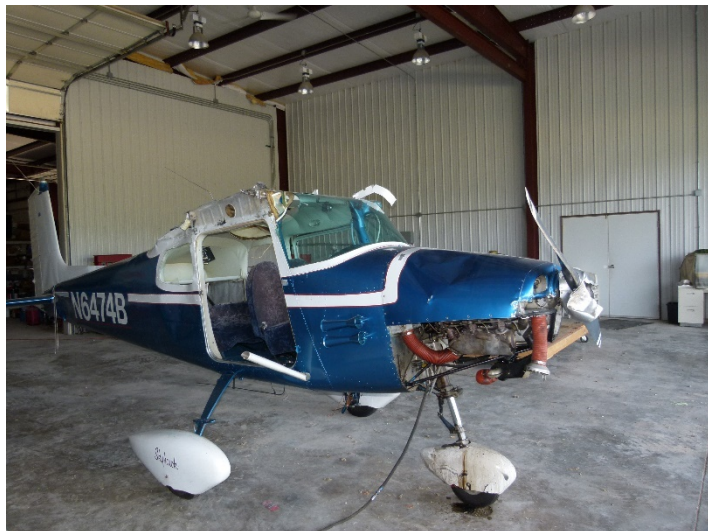
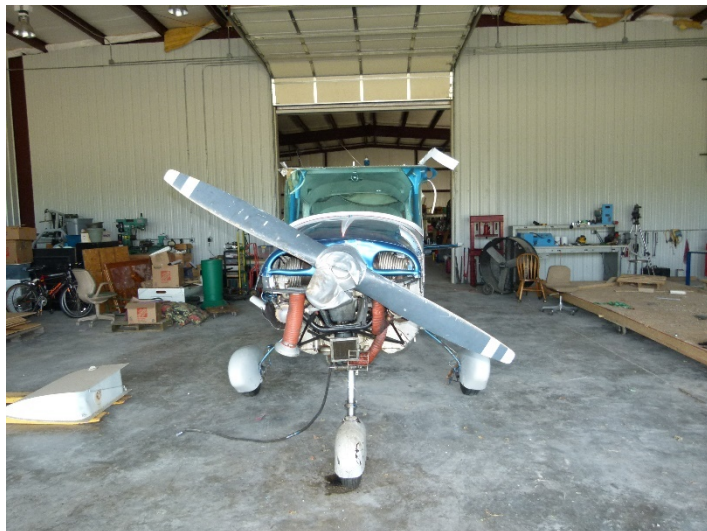
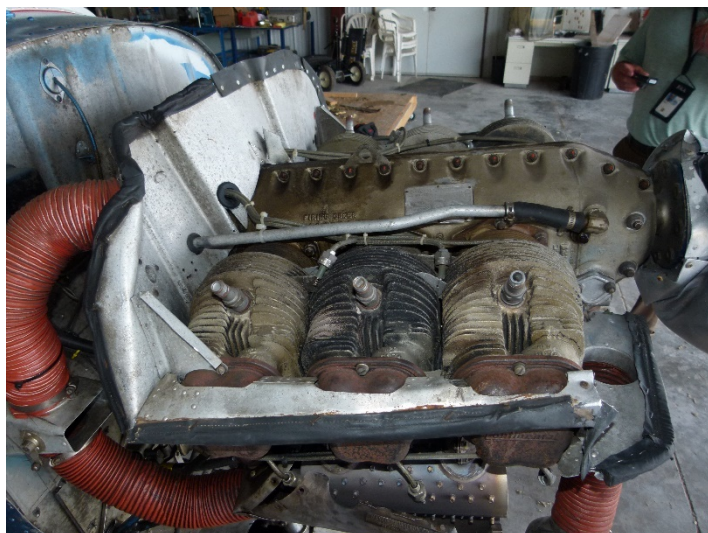
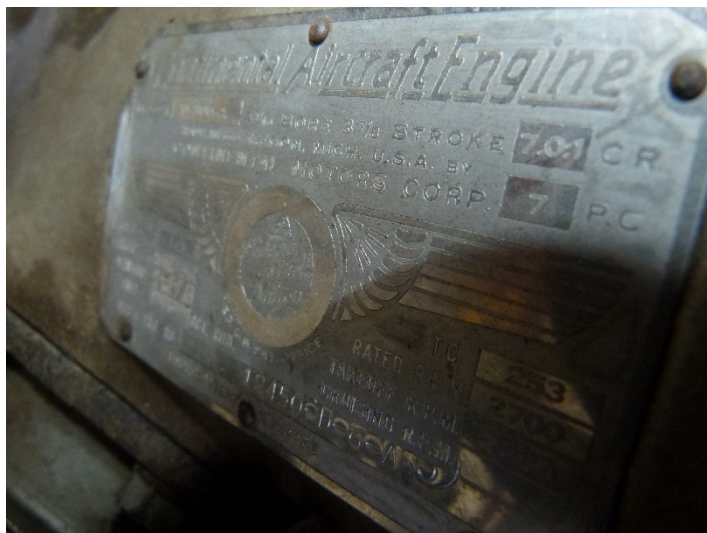
The engine remained attached to the airframe and exhibited minimal damage. The spinner was crushed against the propeller hub and one propeller blade was slightly bent. The two rear engine mount legs were broken. A small hole in the side of the engine oil sump was noted.

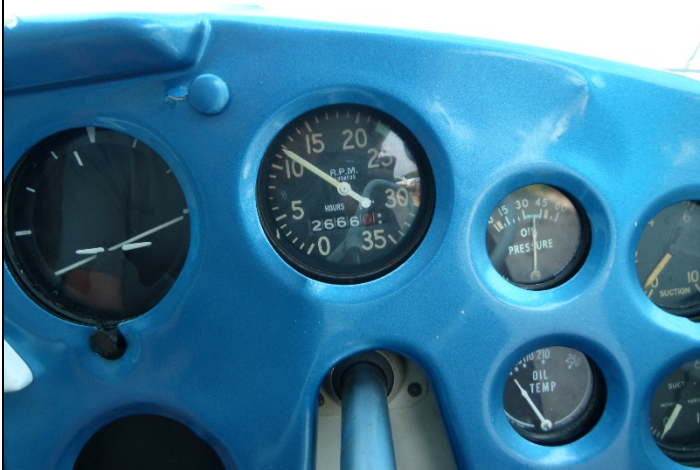
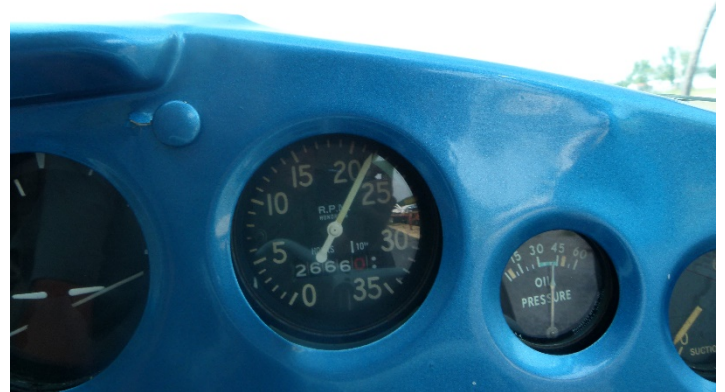
The engine started normally on the second attempt and allowed to warm up. The throttle was advanced to 1000 RPM's and a magneto check was performed. Each magneto produced an approximate 50-75 RPM drop. The engine was advanced to approximately 2300 RPM before reducing the throttle to approximately 1000 RPM where a second magneto check was performed with the same results as the first magneto check. The throttle was then reduced to idle and the engine was shut down normally using the mixture control. The oil pressure gauge indicated in the green arc throughout the engine run.

\*A full power/full RPM run was not attempted due to a vibration believed to be caused by the crushed propeller spinner and concerns from the aft engine mounts being broken.
