**NATIONAL TRANSPORTATION SAFETY BOARD  
OFFICE OF AVIATION SAFETY  
WASHINGTON, D.C. 20594**

**POWERPLANTS GROUP CHAIRMAN'S FACTUAL REPORT**

**NTSB ID No.: CEN17LA254**

Location: Alpine, Texas  
Date: July 3, 2017  
Time: 1815 Central Daylight Time  
Aircraft: Cessna 208B, Registration: N9714B

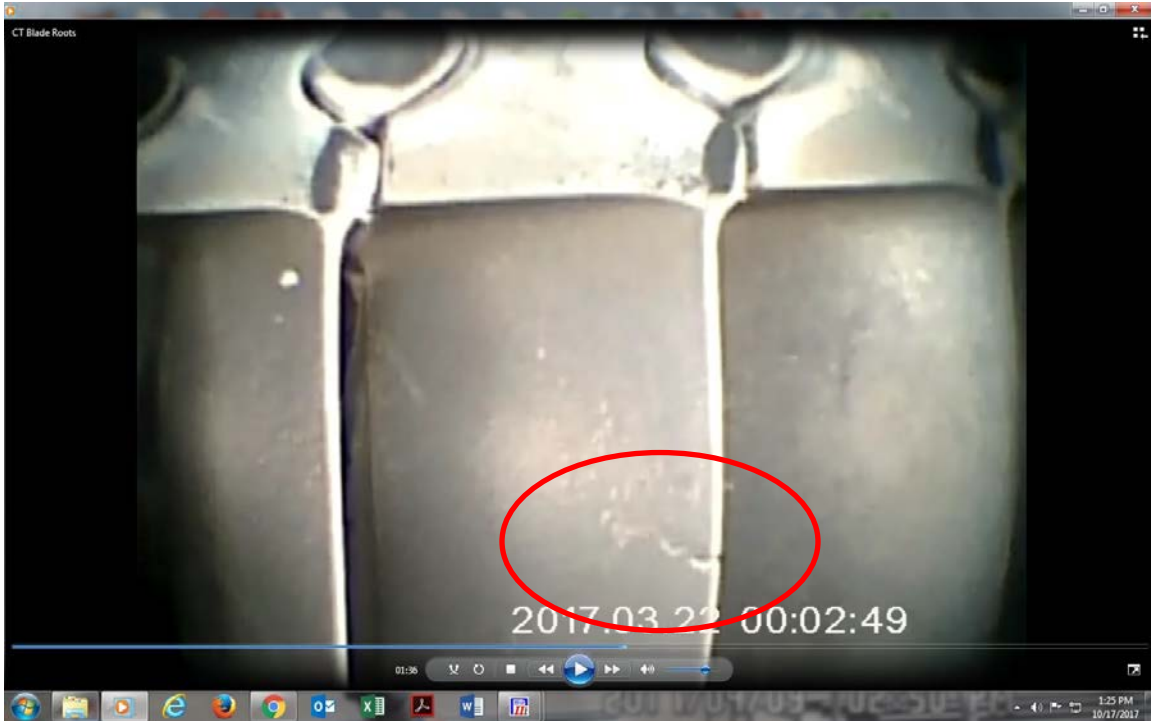
The last CT borescope blade inspection, was performed at the phase 1 inspection on April 12, 2017, 96.3 hours prior to this event (See [Table 1](#)) and no defects were reported by the inspector. The video recording of the inspection was reviewed by the team on Oct. 18, 2017 and an anomaly in one the CT blade, not previously noted at the time of the inspection, was now observed. Still images of the video which revealed that one blade was cracked at the time of the hot section borescope inspection were recorded ([Figure 1](#)). The technician who performed the task stated that during the borescope inspection, he was paying attention to the tip clearance of the blades and did not notice the cracks.

Figure 1 - Still of Inspection Video Taken on April 12, 2017 – Training Edge Crack

Martinaire counselled the inspector on Oct. 18, 2017 and began an internal process to review past video recordings of all recent CT blade borescope inspections. No adverse blade conditions were discovered from this review. They also reviewed their inspection process and will make changes to prevent future occurrences.

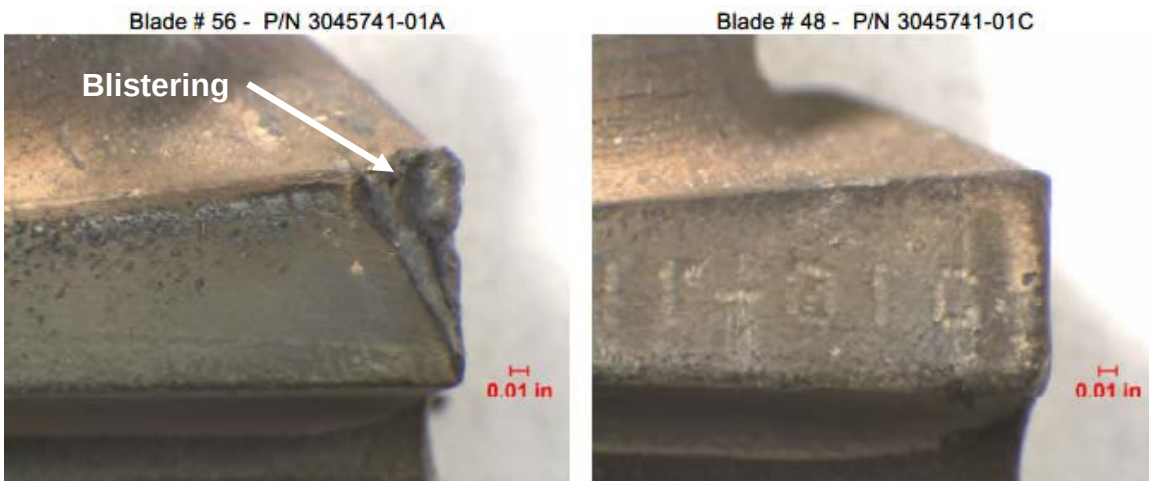
All the blades were sent to the P&WC laboratory for detailed analysis. A total of 11 blades were identified with P/N 3045741-01C with the remaining blades showing P/N 3045741-01A. The latter blades exhibited significant hot corrosion (blistering) along the leading-edge platform (Figure 2).

Figure 2 – Differences between Leading Edge Platforms of -01A & -01C blades

The CT blade condition seen in Figure 2, is consistent having been installed in a blistered condition during the last CT repair. Hours in operation are not tracked on CT blades; they are inspected and returned to service if they are in good condition. The 47 P/N 3045741-01A CT blades were possibly marginally serviceable at the last overhaul.

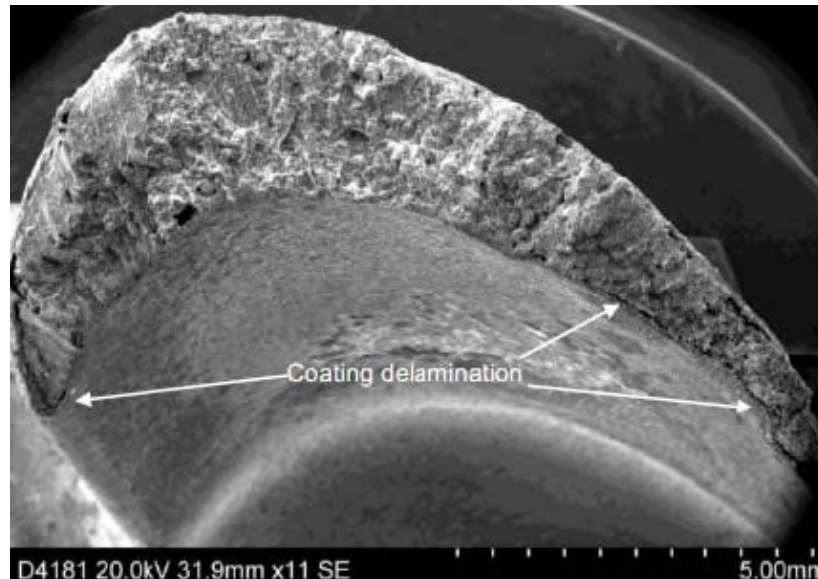
The fracture surfaces of all the blades showed exposure to elevated temperatures, causing the coating of some blades to delaminate from the base material (Figure 3).

Figure 3 – Delamination of Coating from Base Material

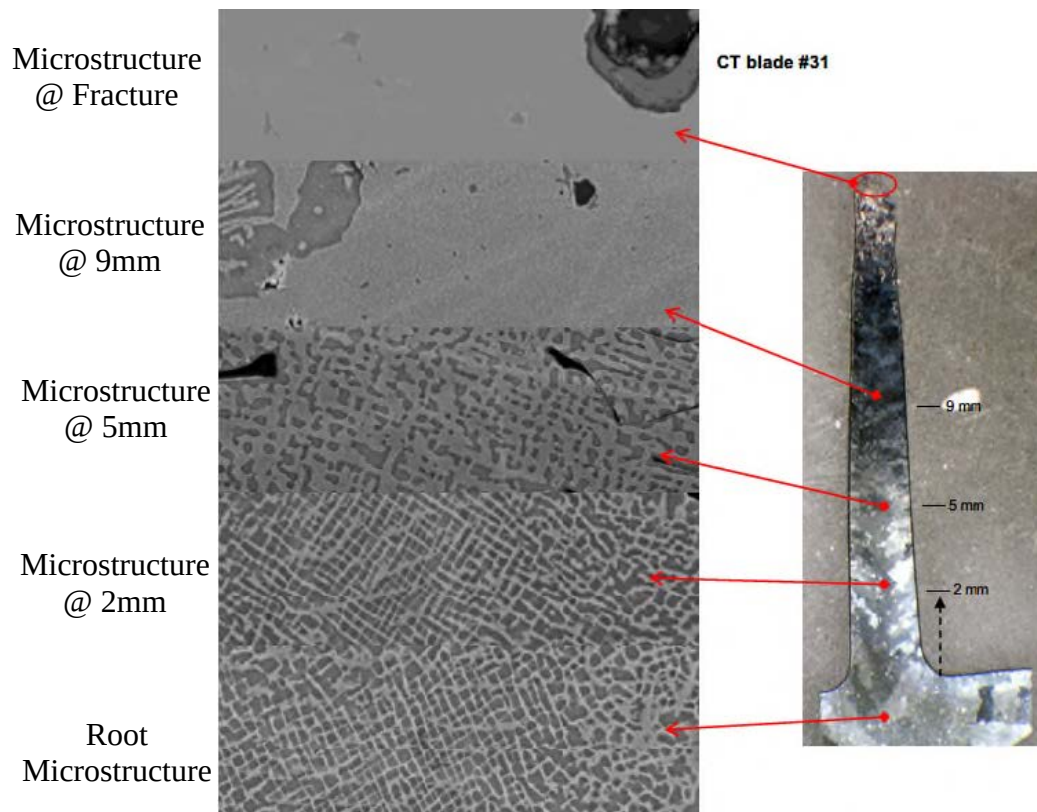
A cross-section through the airfoil span-axis of the trailing edges of four CT blades showed similar results as shown in Figure 4. The findings were:

- 1) The root microstructure used for comparison of the microstructure in the remnant of the airfoil, consisted of unaltered cuboidal gamma prime precipitates.
- 2) At 2 mm above the root platform no significant alteration of the microstructure was observed.
- 3) At 5 mm above the root platform partial solutioning of the gamma prime precipitates was observed.
- 4) At 9 mm above the root platform, the microstructure, in the region of the micro voids, shows a partial to complete solutioning of the gamma prime precipitates. Micro-voids along grain boundaries oriented perpendicular to the axis of stress, indicative of creep<sup>2</sup>.
- 5) The region next to the fracture showed complete solutioning of the gamma prime precipitates.

Figure 4 – Typical Cross Section Results from Four Sample CT Blades

The CT blade condition seen in Figure 4, is consistent with having been operated above operational limits for an extended period.

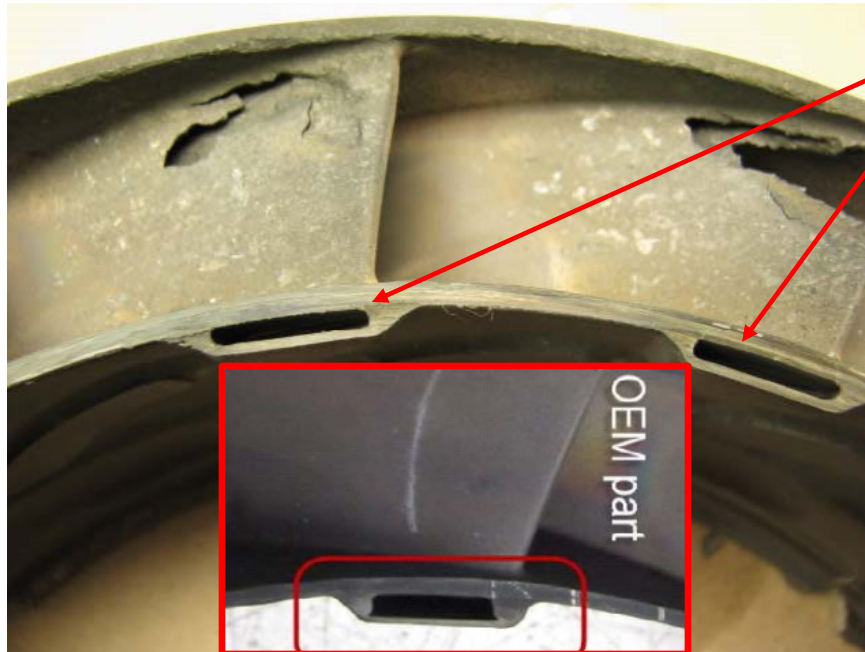
A visual examination of the CTVR revealed dimensional differences that did not conform to an OEM part. The vane cooling air exit slots differed in shape and size from an exemplar P&WC vane ([Photo 16](#)). The vane sealing plates welding differ from the P&WC vane ([Photo 17](#)). Additionally, upon visual examination the axial locations of the vane trailing edges, which should all be on the same plane, appeared to be staggered. A hand measurement between the rear mount plane to the aft position of the trailing edge using a depth gauge indicated that they varied by approximately 0.03 inches ([Photo 18](#)). When a new OEM exemplar CVTR was examined, no variation of the vanes axial position could be observed. A variation of the axial stagger of the compressor turbine vanes would induce a flow variation to the CT blades, thereby increasing their one-per-rev vibration amplitude. It is unknown how large an effect on CT blade longevity this variation would have on pre-SB1669 blades. Because the event CTVR was damaged, it could not be tested.

Photo 17 – Event CTVR vs OEM Vane Sealing Plates Welds
