# NATIONAL TRANSPORTATION SAFETY BOARD

## MATERIALS LABORATORY FACTUAL REPORT

Report No. 17-092

Place : Big Lake, Minnesota  
Date : July 6, 2017  
Vehicle : Bell 47D1, N153B  
NTSB No. : CEN17LA264  
Investigator : Edward Malinowski, AS-CEN

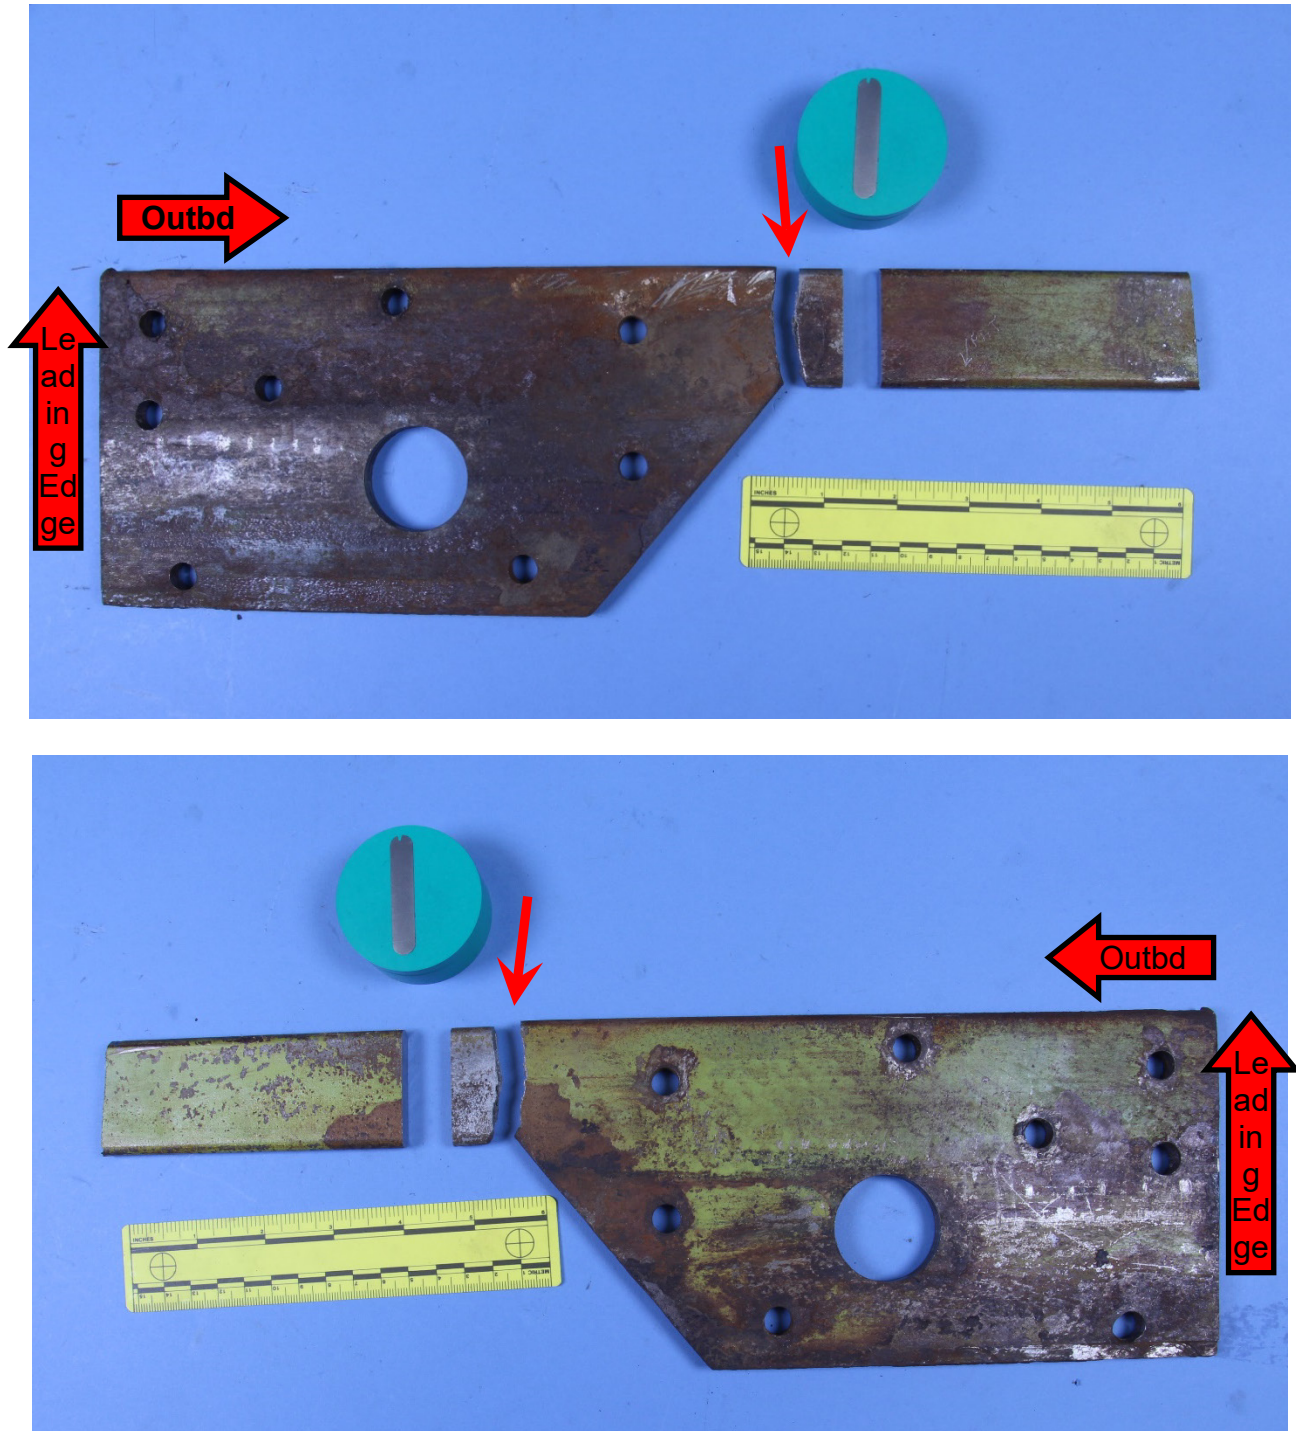
The core assembly was fractured through the bar at the outboard edge of the lug as indicated by the red arrows in figure 1. Visual examinations of the fracture faces revealed a corroded region at the trailing edge of the bar with fracture markings and arrest lines indicative of fatigue progression from the trailing edge. Ratchet marking also indicated multiple origins in the area indicated by the red brackets in figure 2. The fatigue had propagated toward the leading edge about 0.25 inch. The fatigue terminus is indicated by the dashed red line. The initial portion of the fatigue was heavily corroded and the fracture surface obscured while the later areas were not. The remaining fracture was consistent with brittle overstress propagation with small shear lips around the periphery of the bar.

X-ray fluorescence spectrograph<sup>2</sup> found the bar material consistent with an unalloyed carbon steel such as the specified AISI 1025 material. A chordwise cross section was cut through the bar outboard of the fracture as shown in figure 1. Direct

The upper surface of the core assembly displayed significant surface corrosion with almost all the yellow green primer missing or discolored. The lower surface had less attack but had corrosion removing and undercutting the primer in many places particularly in the fracture area.

Figure 1. Upper (top) and lower (bottom) surfaces of the core pieces with separation at red arrows. Polished cross section shown above the bar at removal location. Green primer most visible on lower surface.

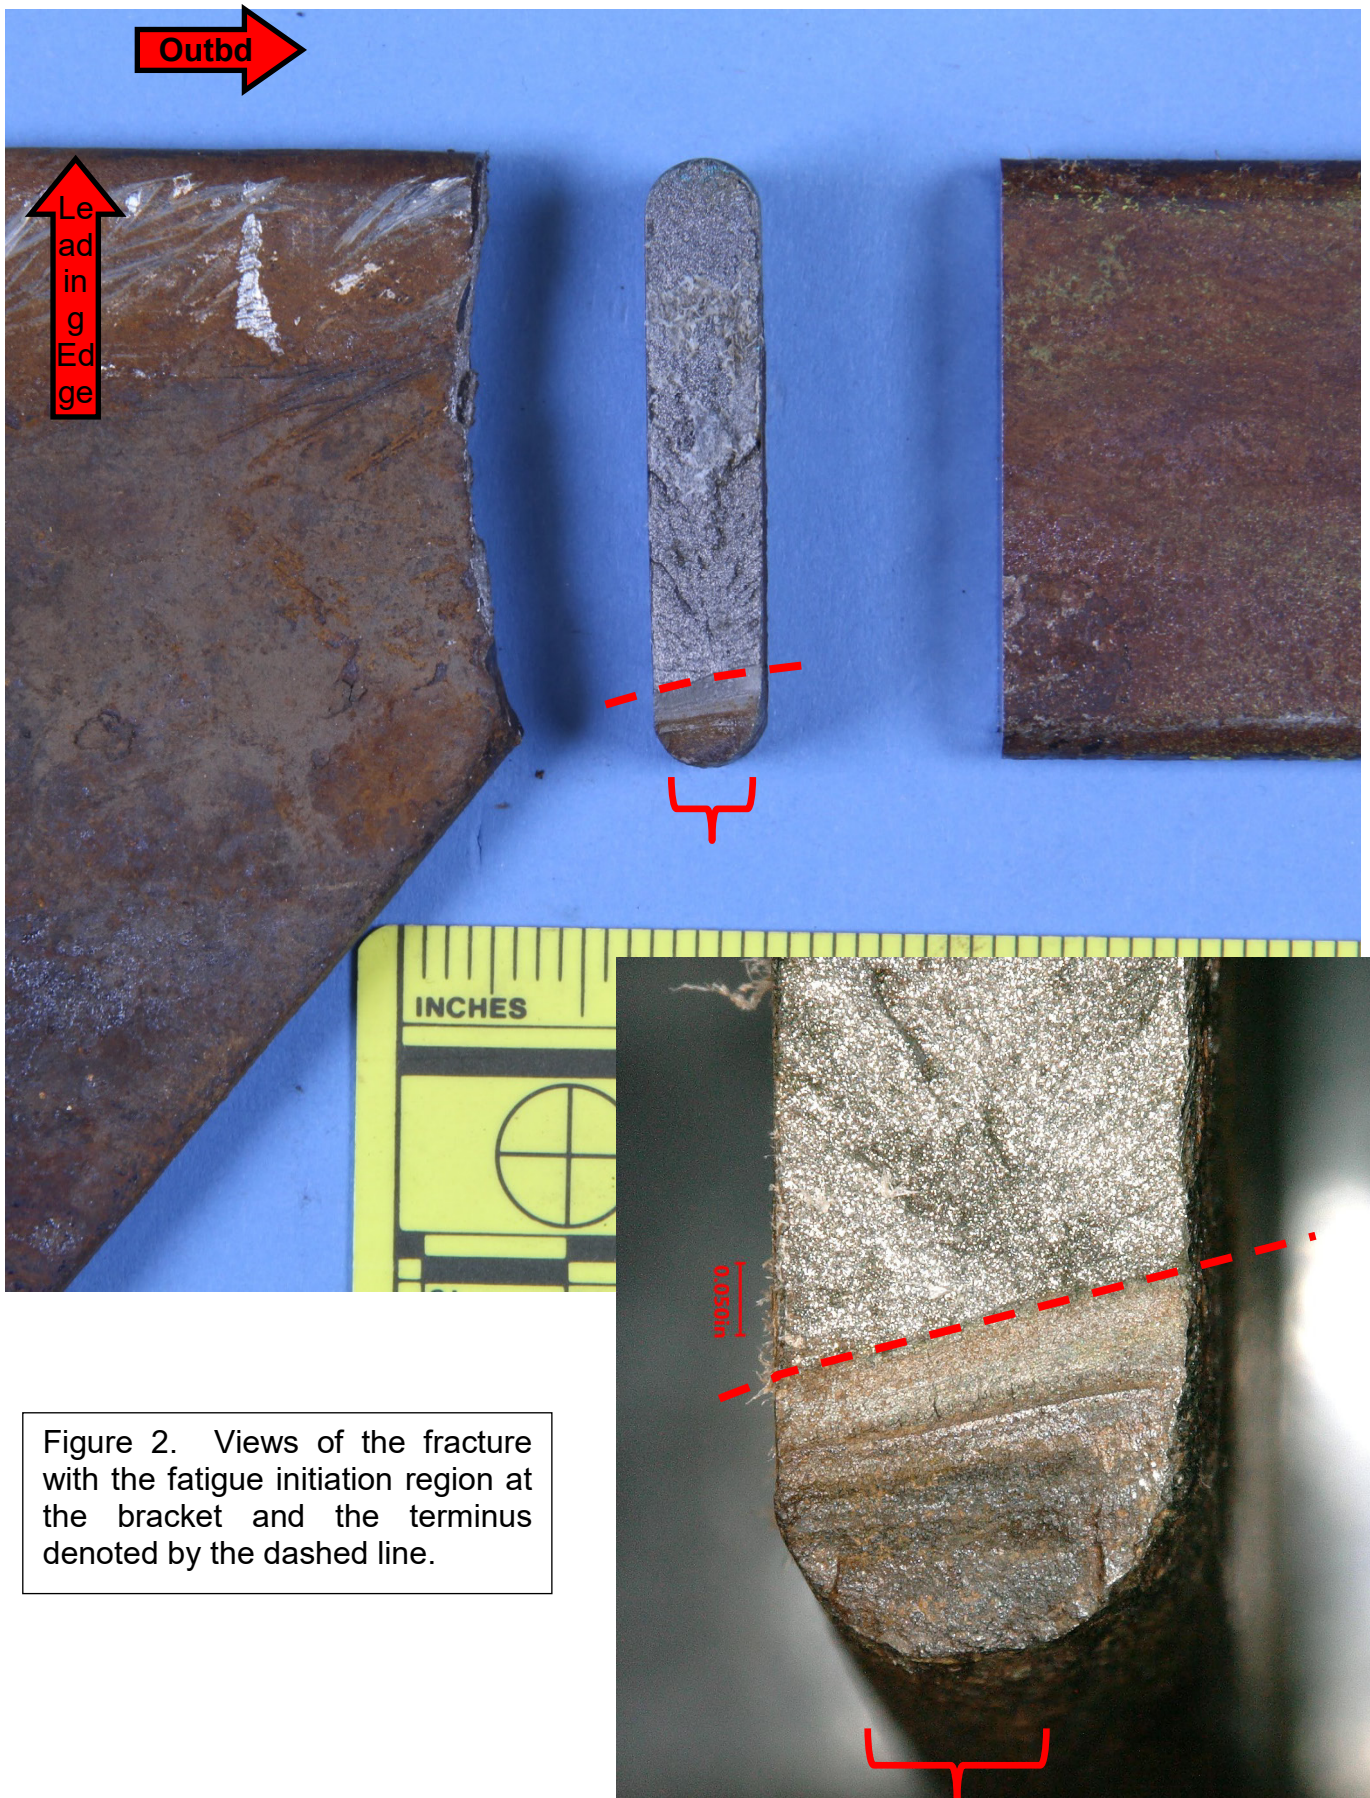
Figure 2. Views of the fracture with the fatigue initiation region at the bracket and the terminus denoted by the dashed line.

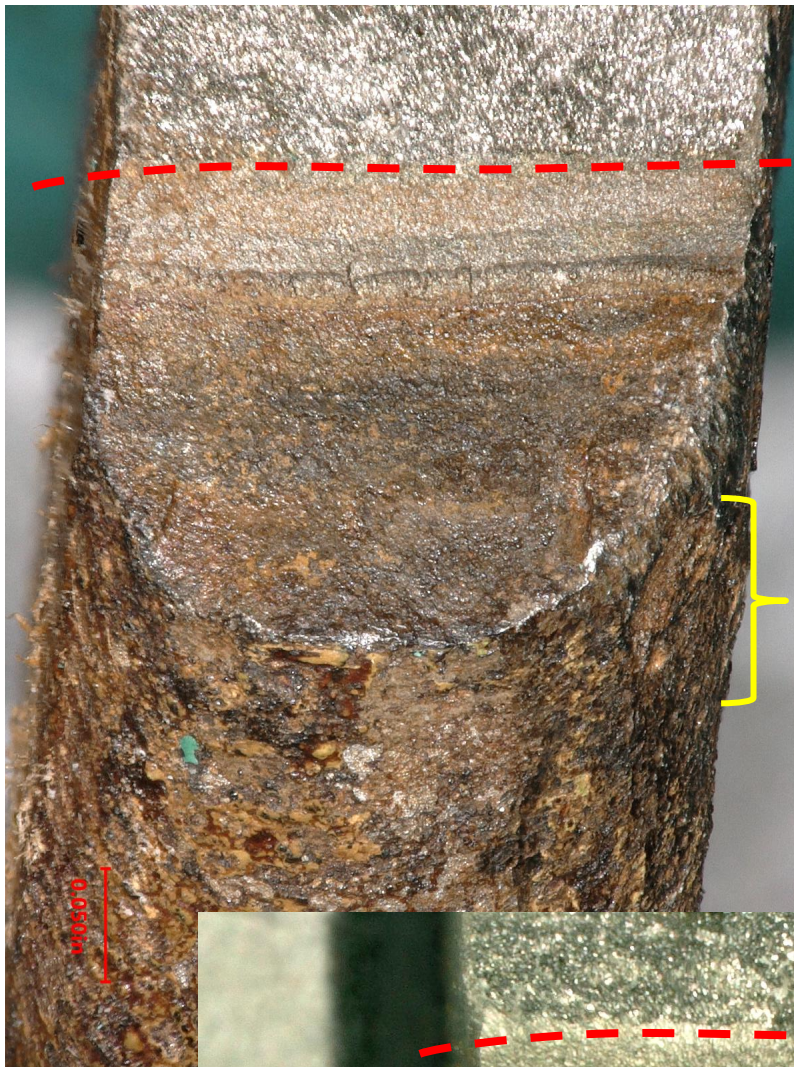
Figure 3 displays the trailing edge of the bar as-received and after ultrasonic cleaning in acetone. The fatigue origin area had some surface corrosion, but no large pits were noted and remnants of the primer remained. Large pits and material removal were seen in the adjacent areas of the upper surface of the bar, denoted by yellow bracket in figure 3.

Figure 3. Views of the trailing edge fatigue initiation area showing corrosion before (left) and after cleaning. Yellow bracket shows area of heaviest corrosion on the upper surface.
