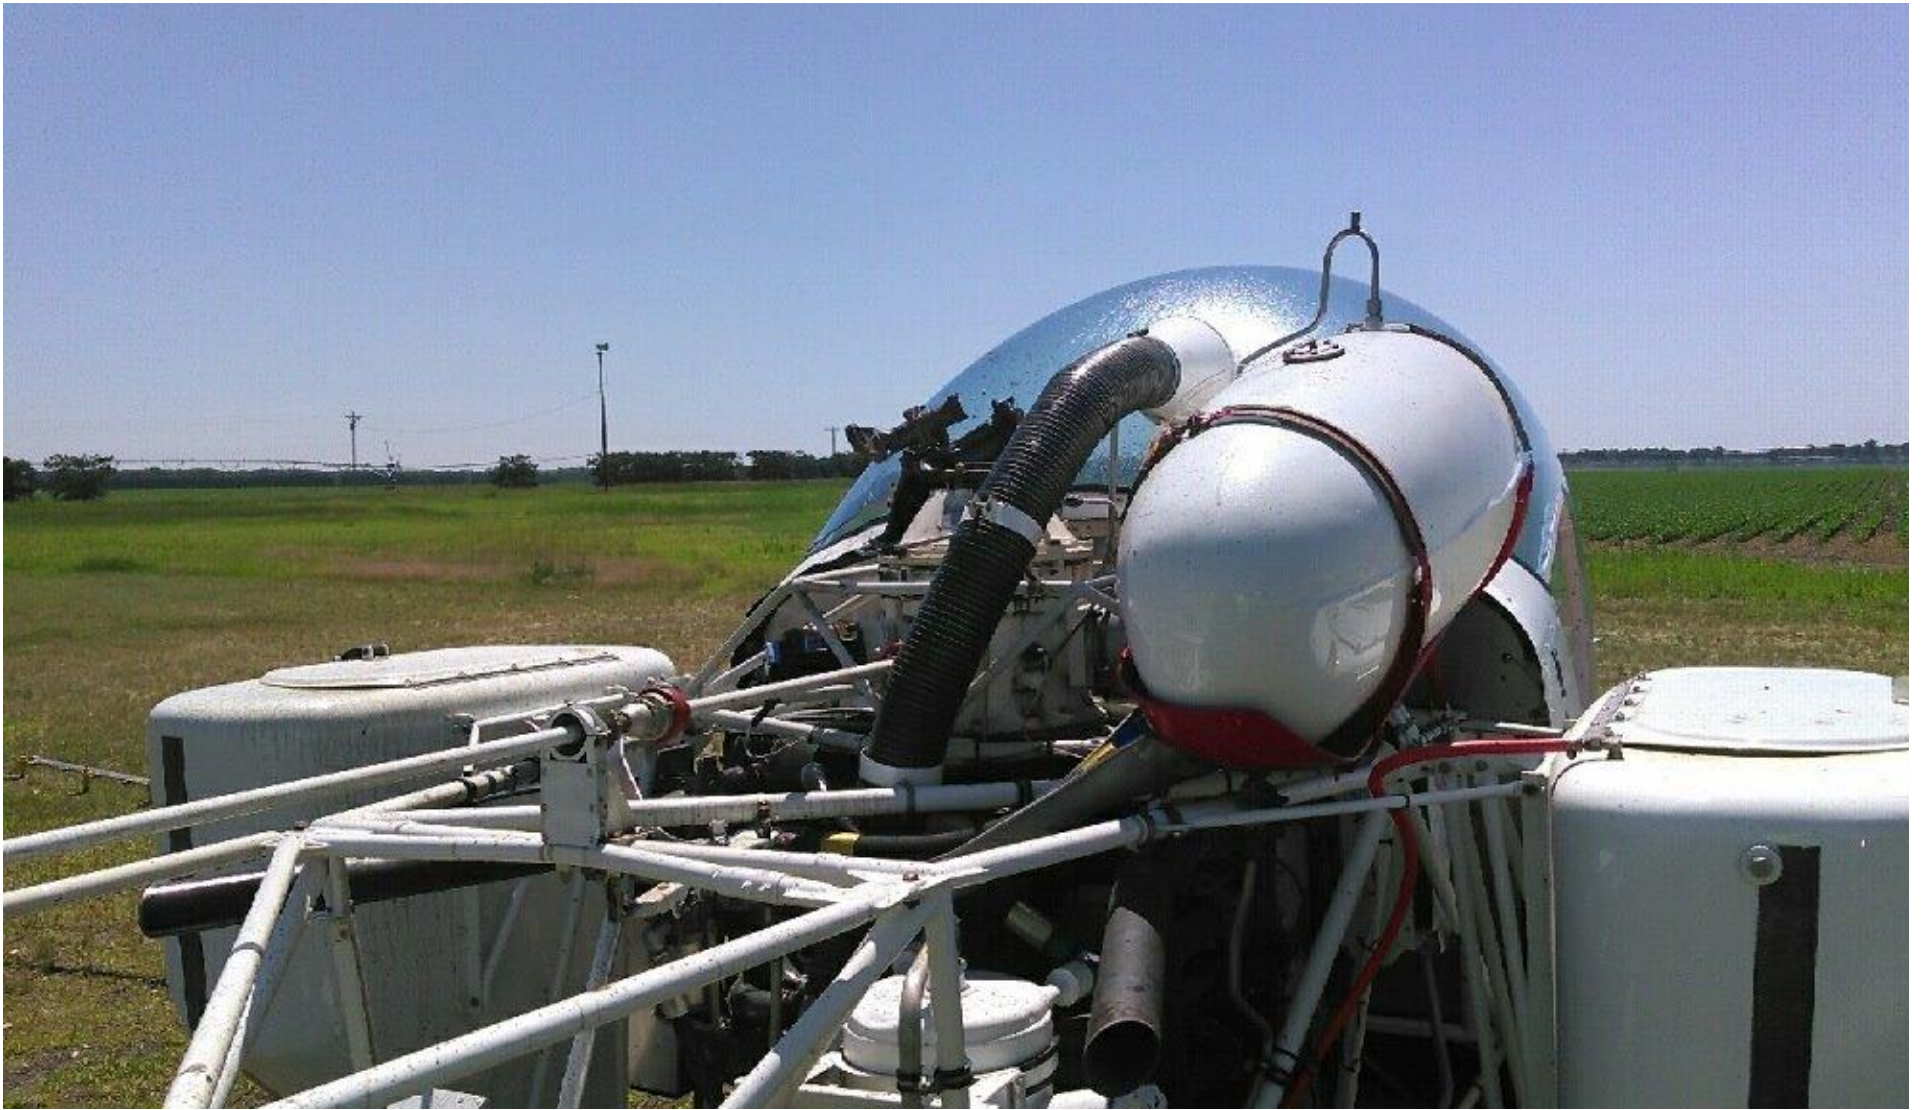
**Photo 1 – View of the helicopter looking forward from its right rear side.**

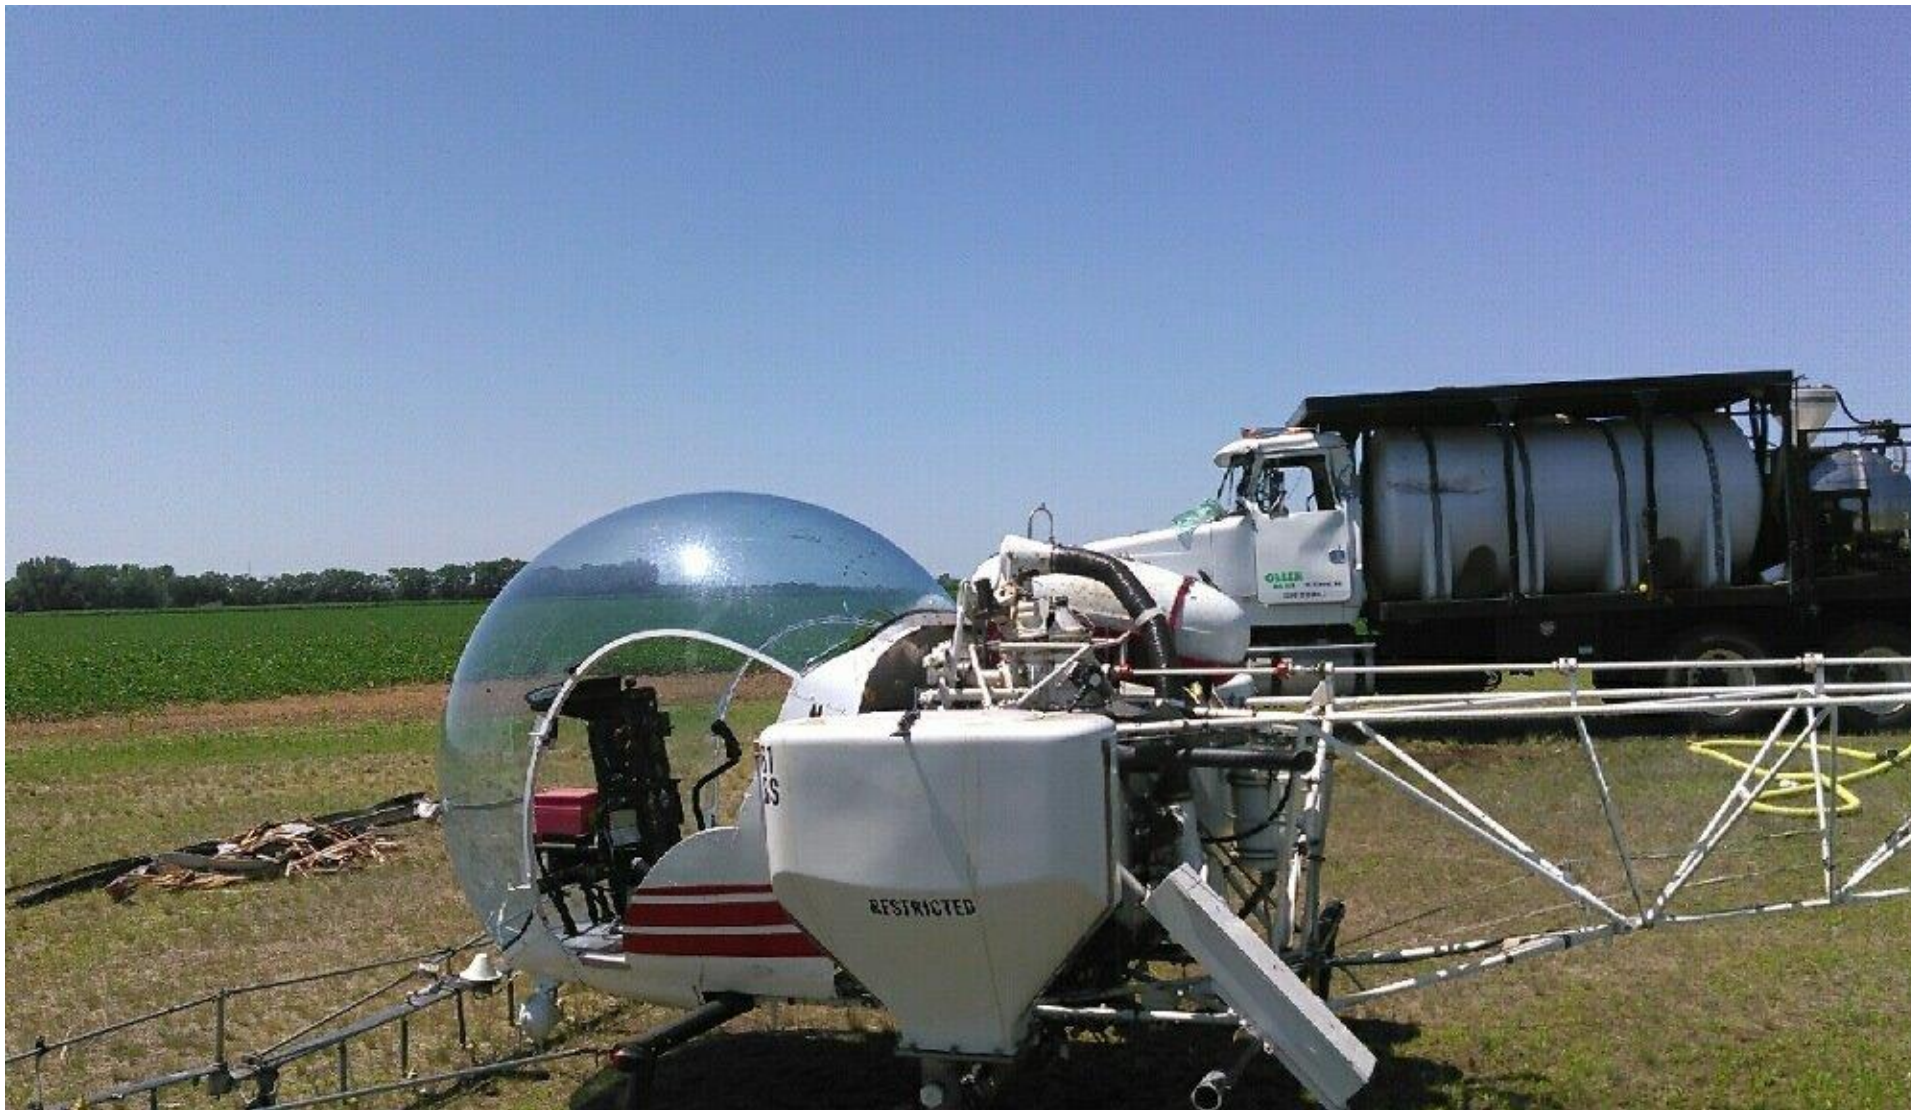
**Photo 2 - View of the helicopter looking towards its left side with the truck and the splintered wooden blade present.**

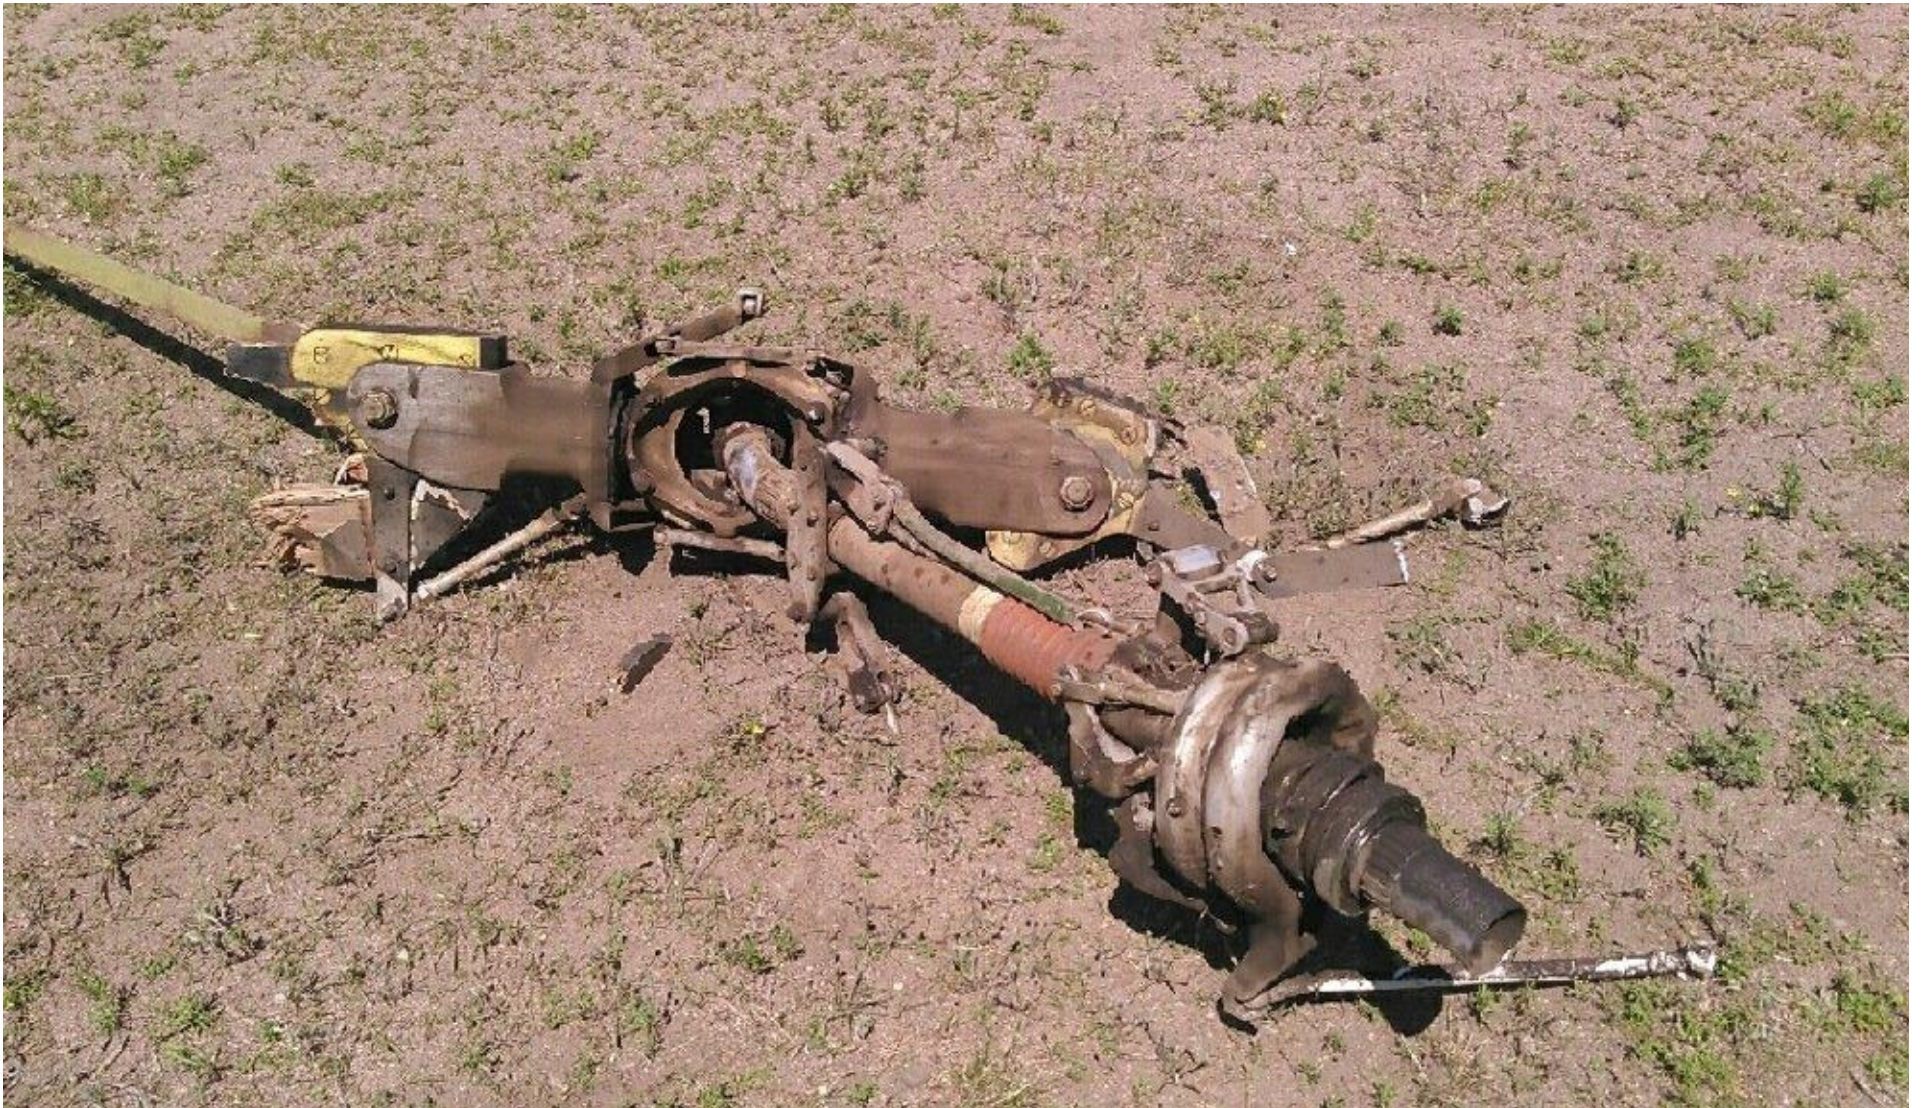
**Photo 3 - View of the separated rotor mast.**

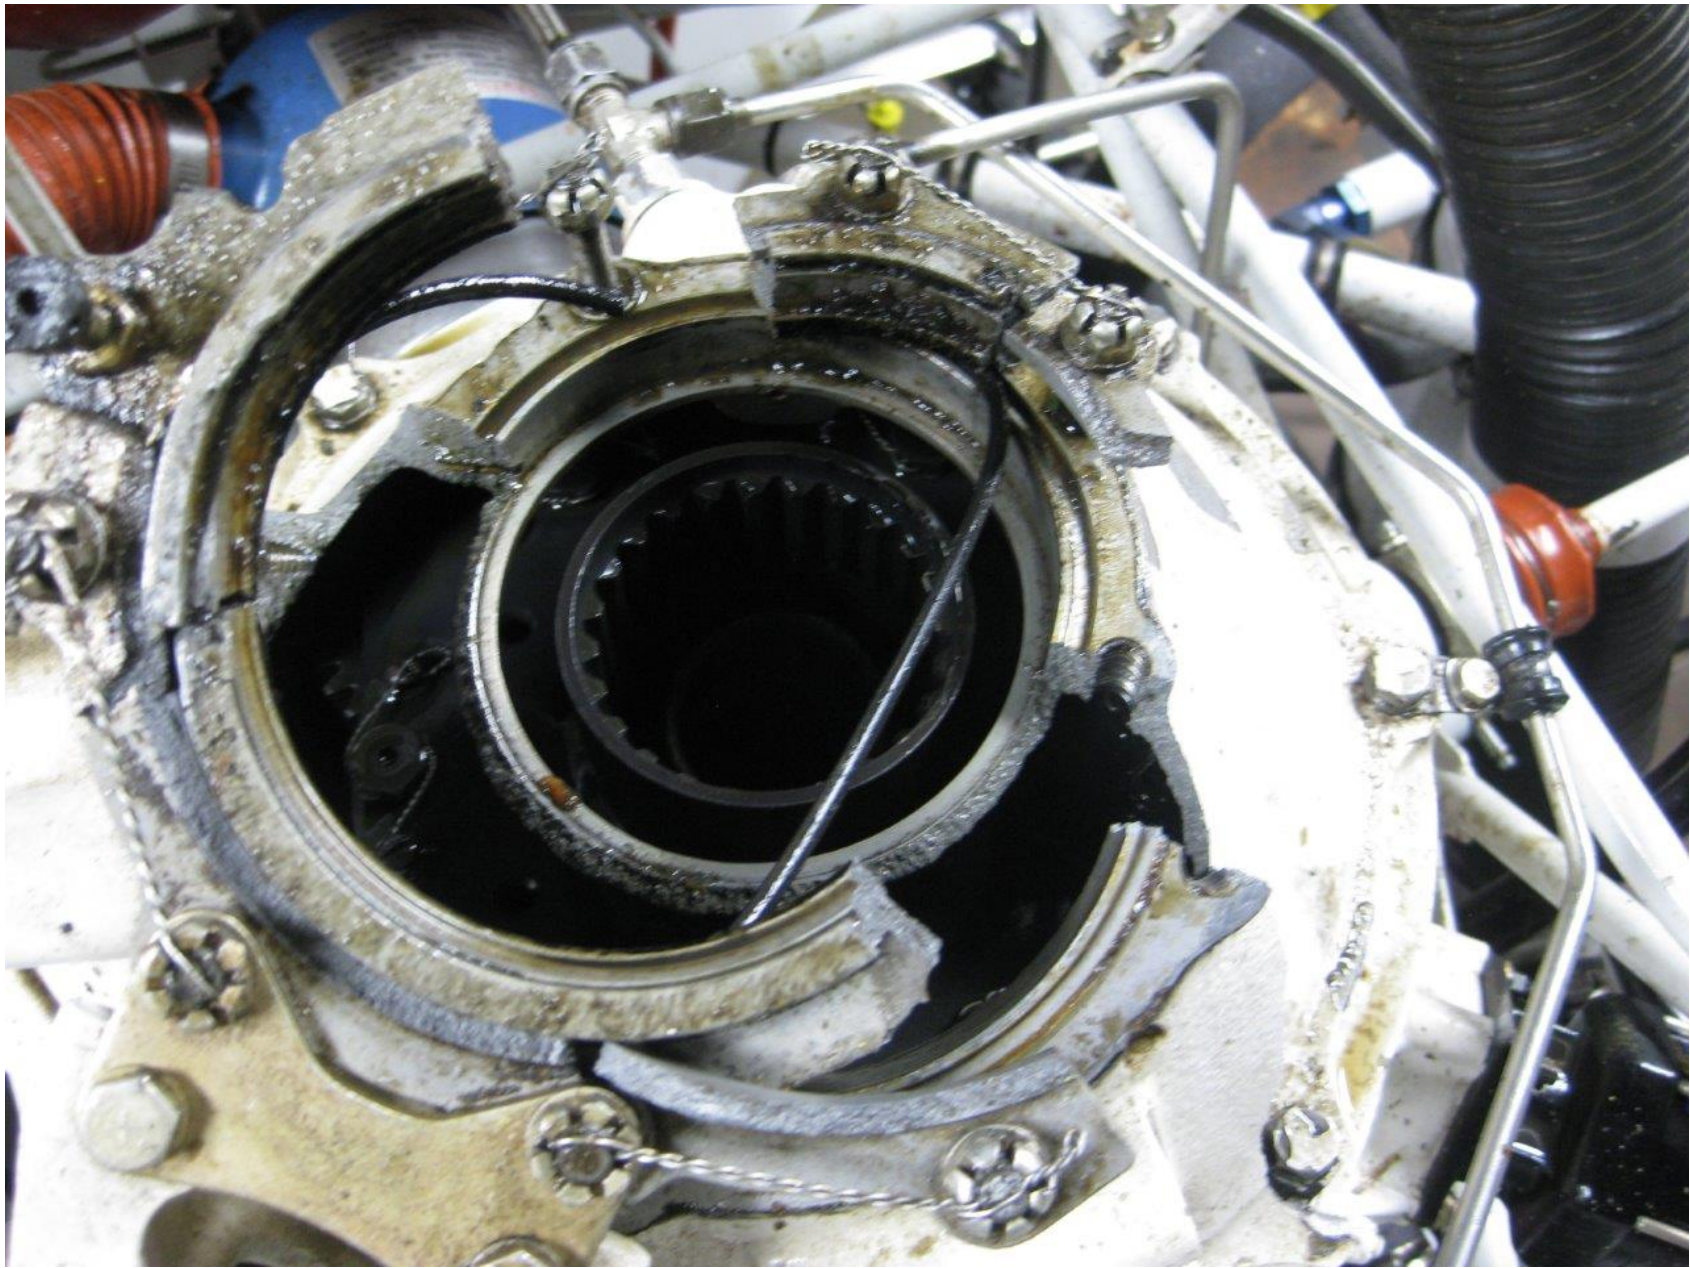
**Photo 4 - View of the fractured transmission case.**

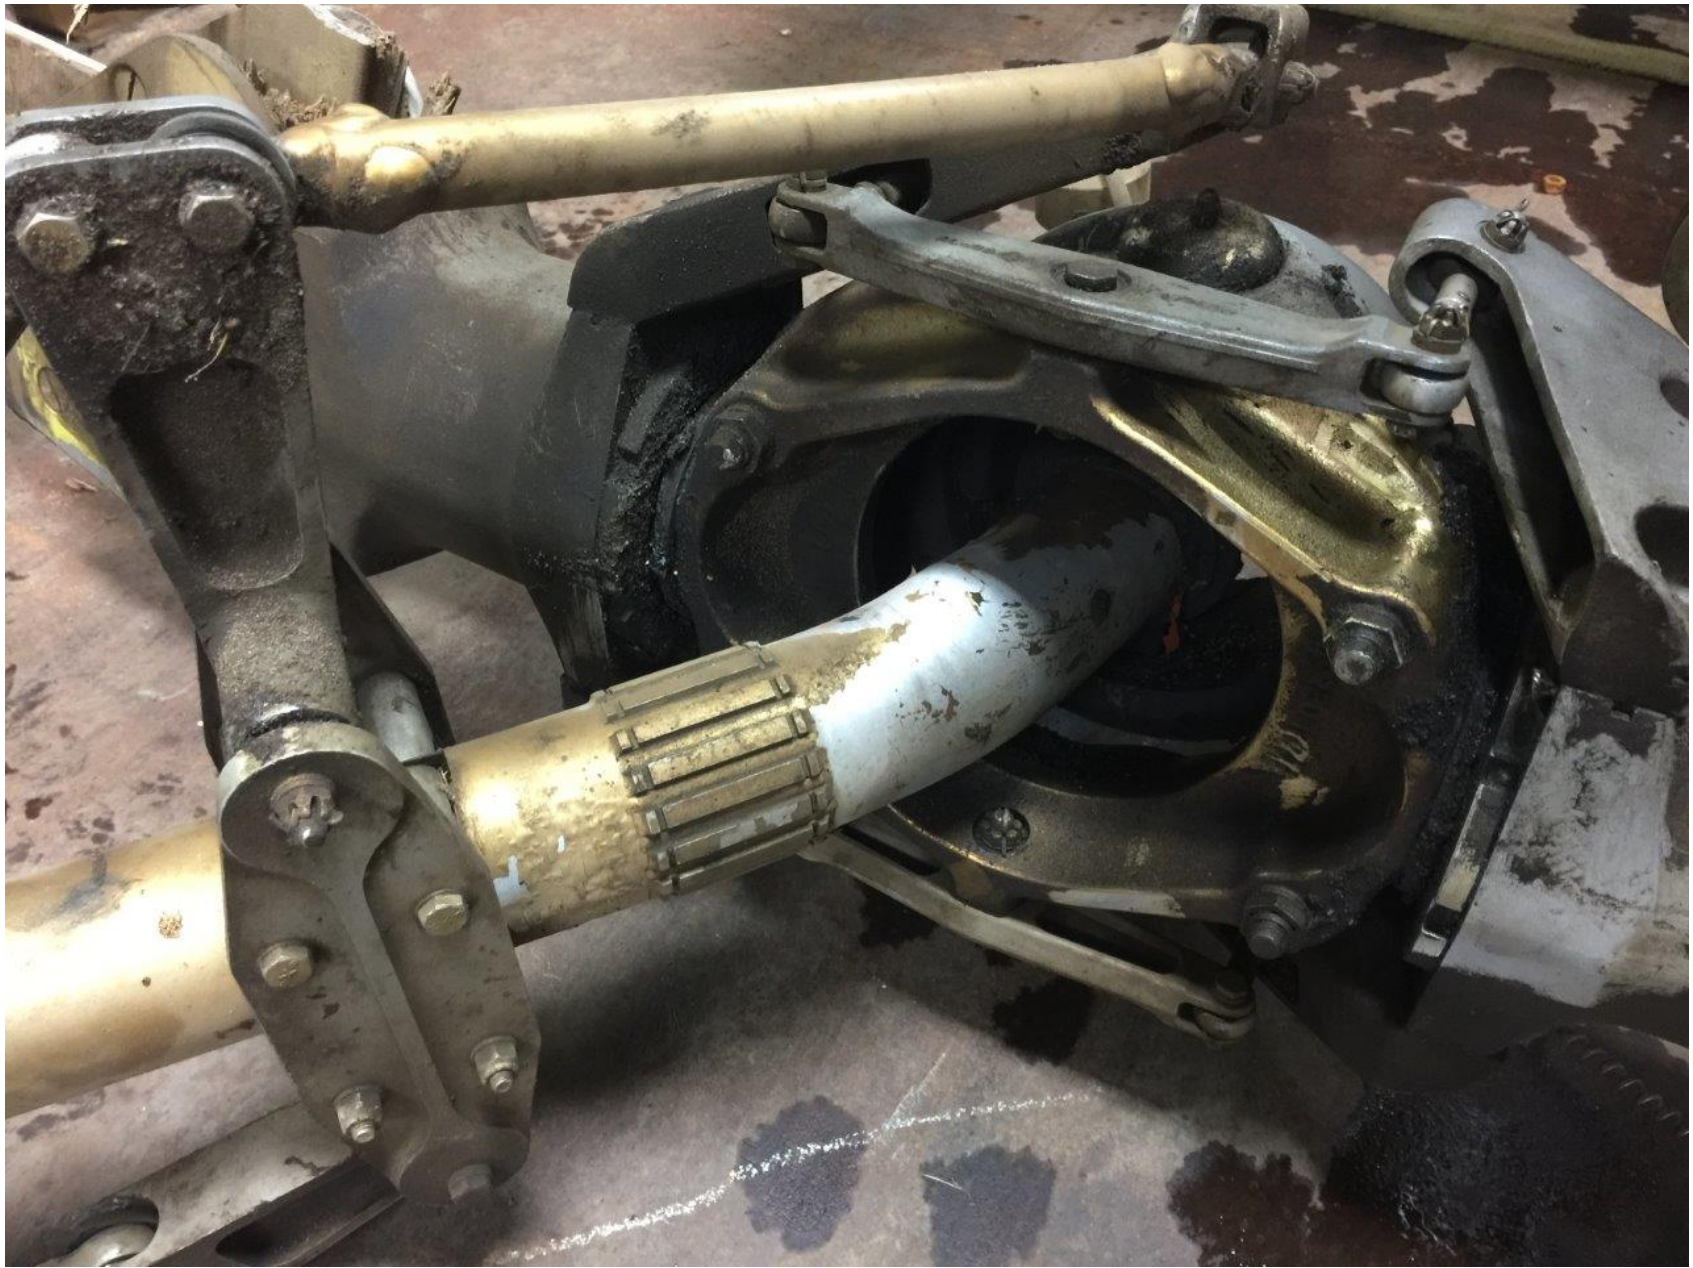
**Photo 5 - Close-up view of the bent rotor mast,**

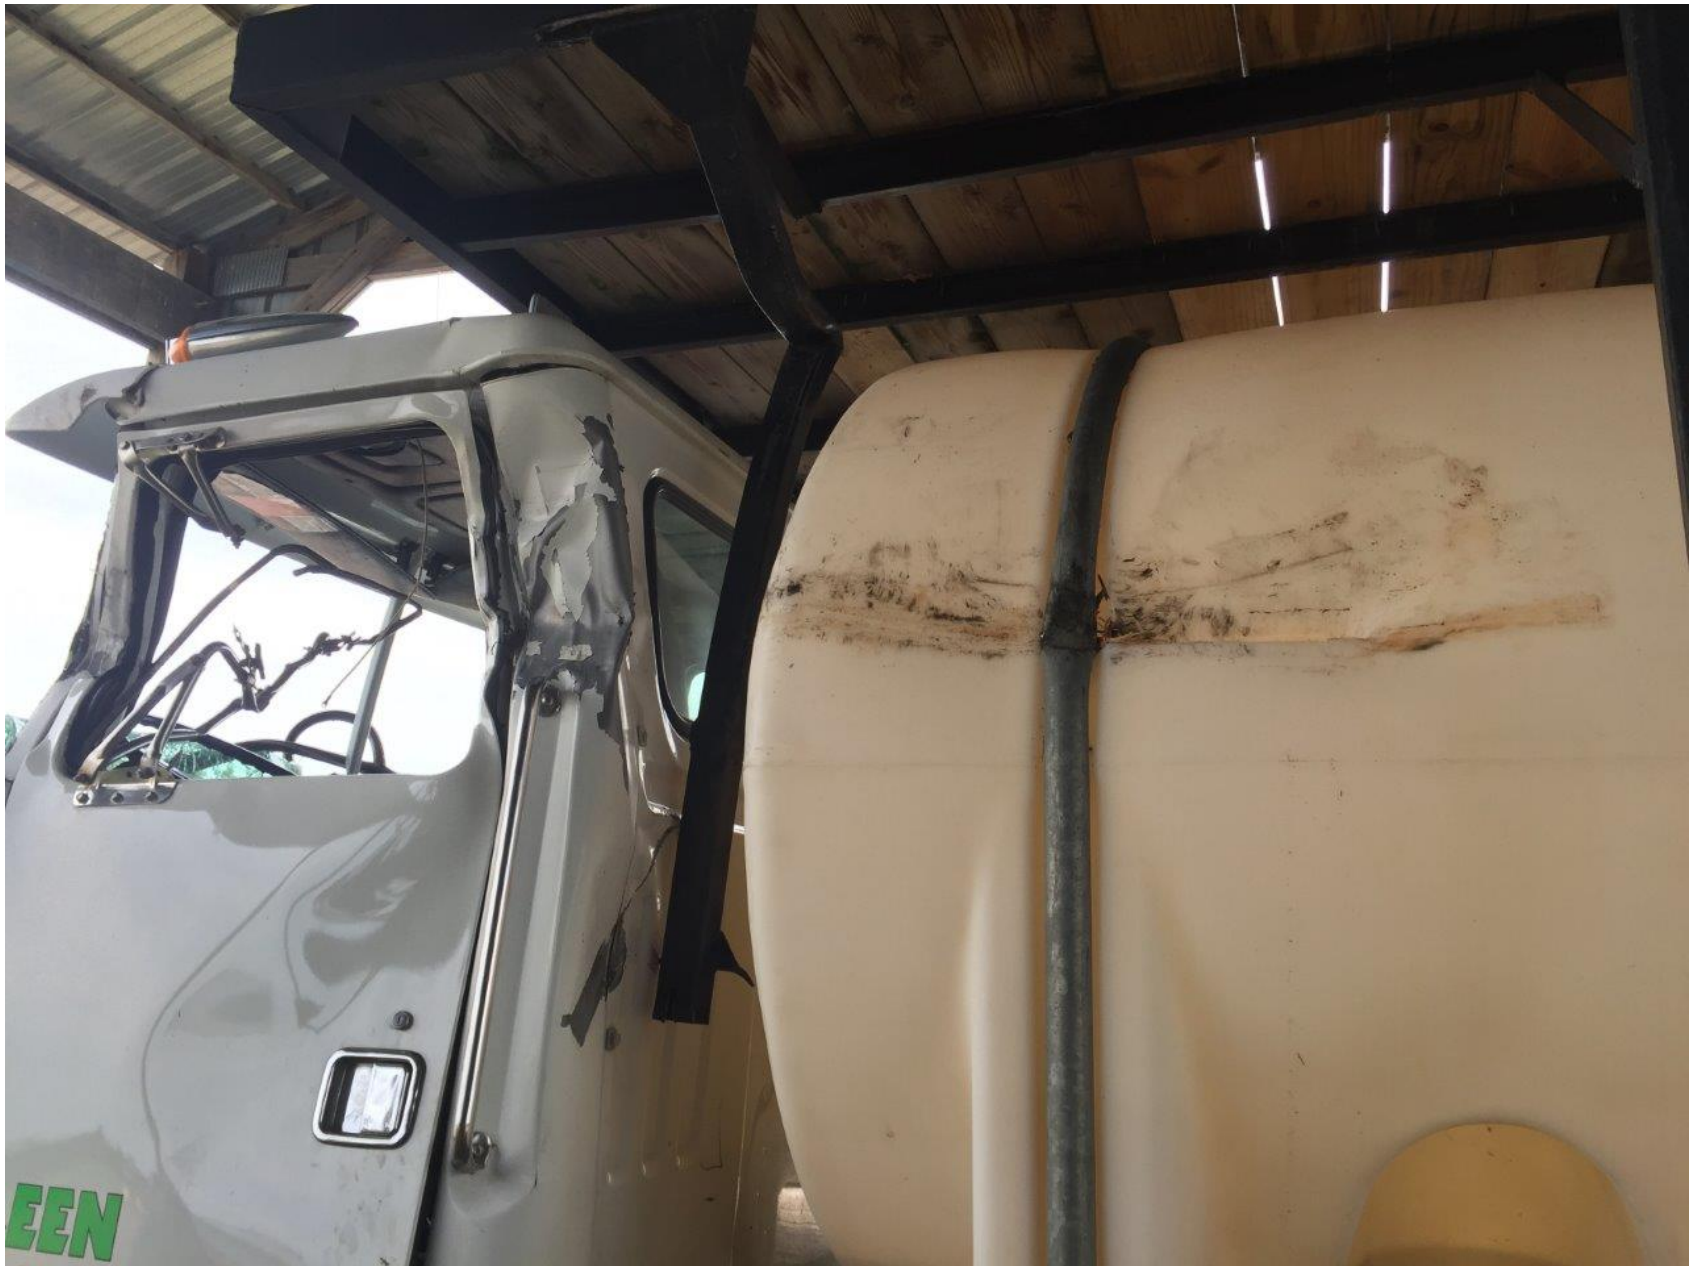
**Photo 6 - Close-up view of the truck cab and water tank damage.**

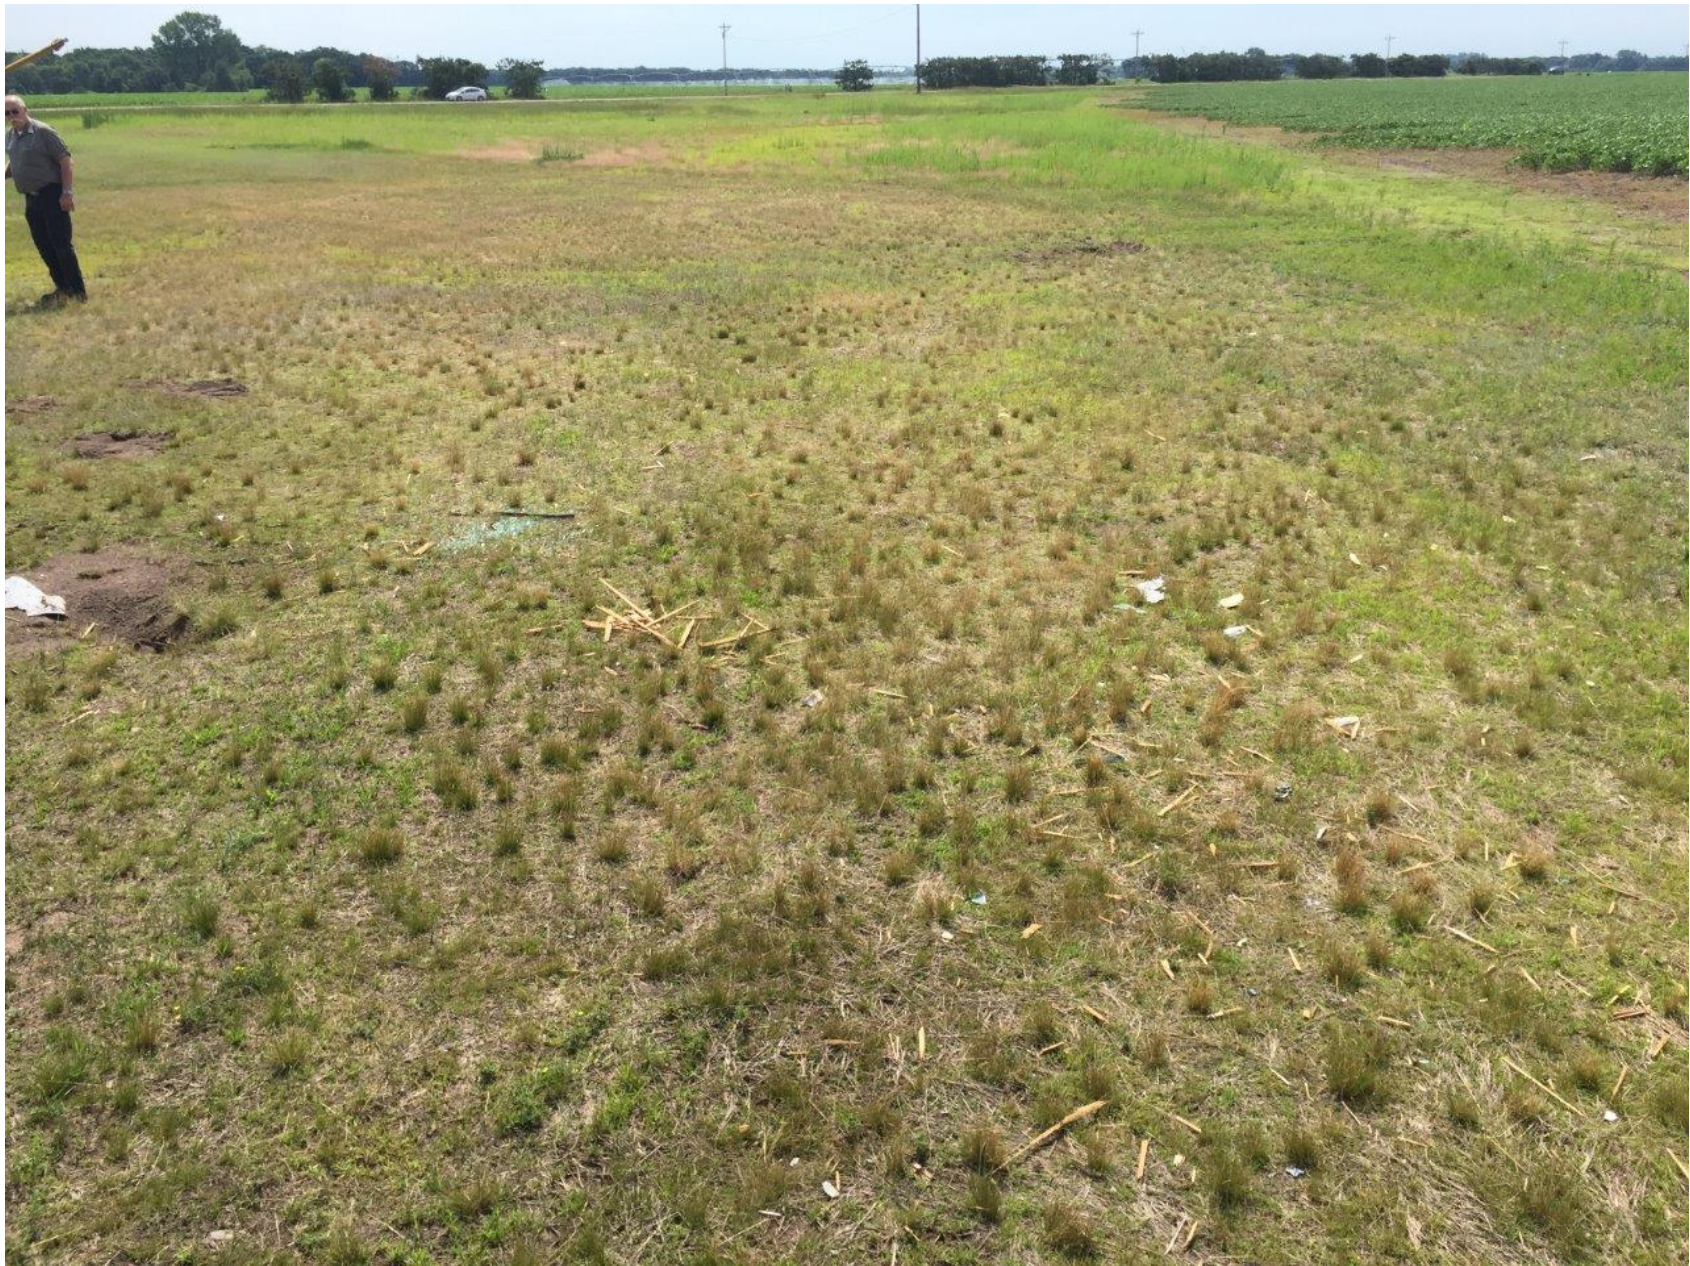
**Photo 7 - View of random splinters in the area..**

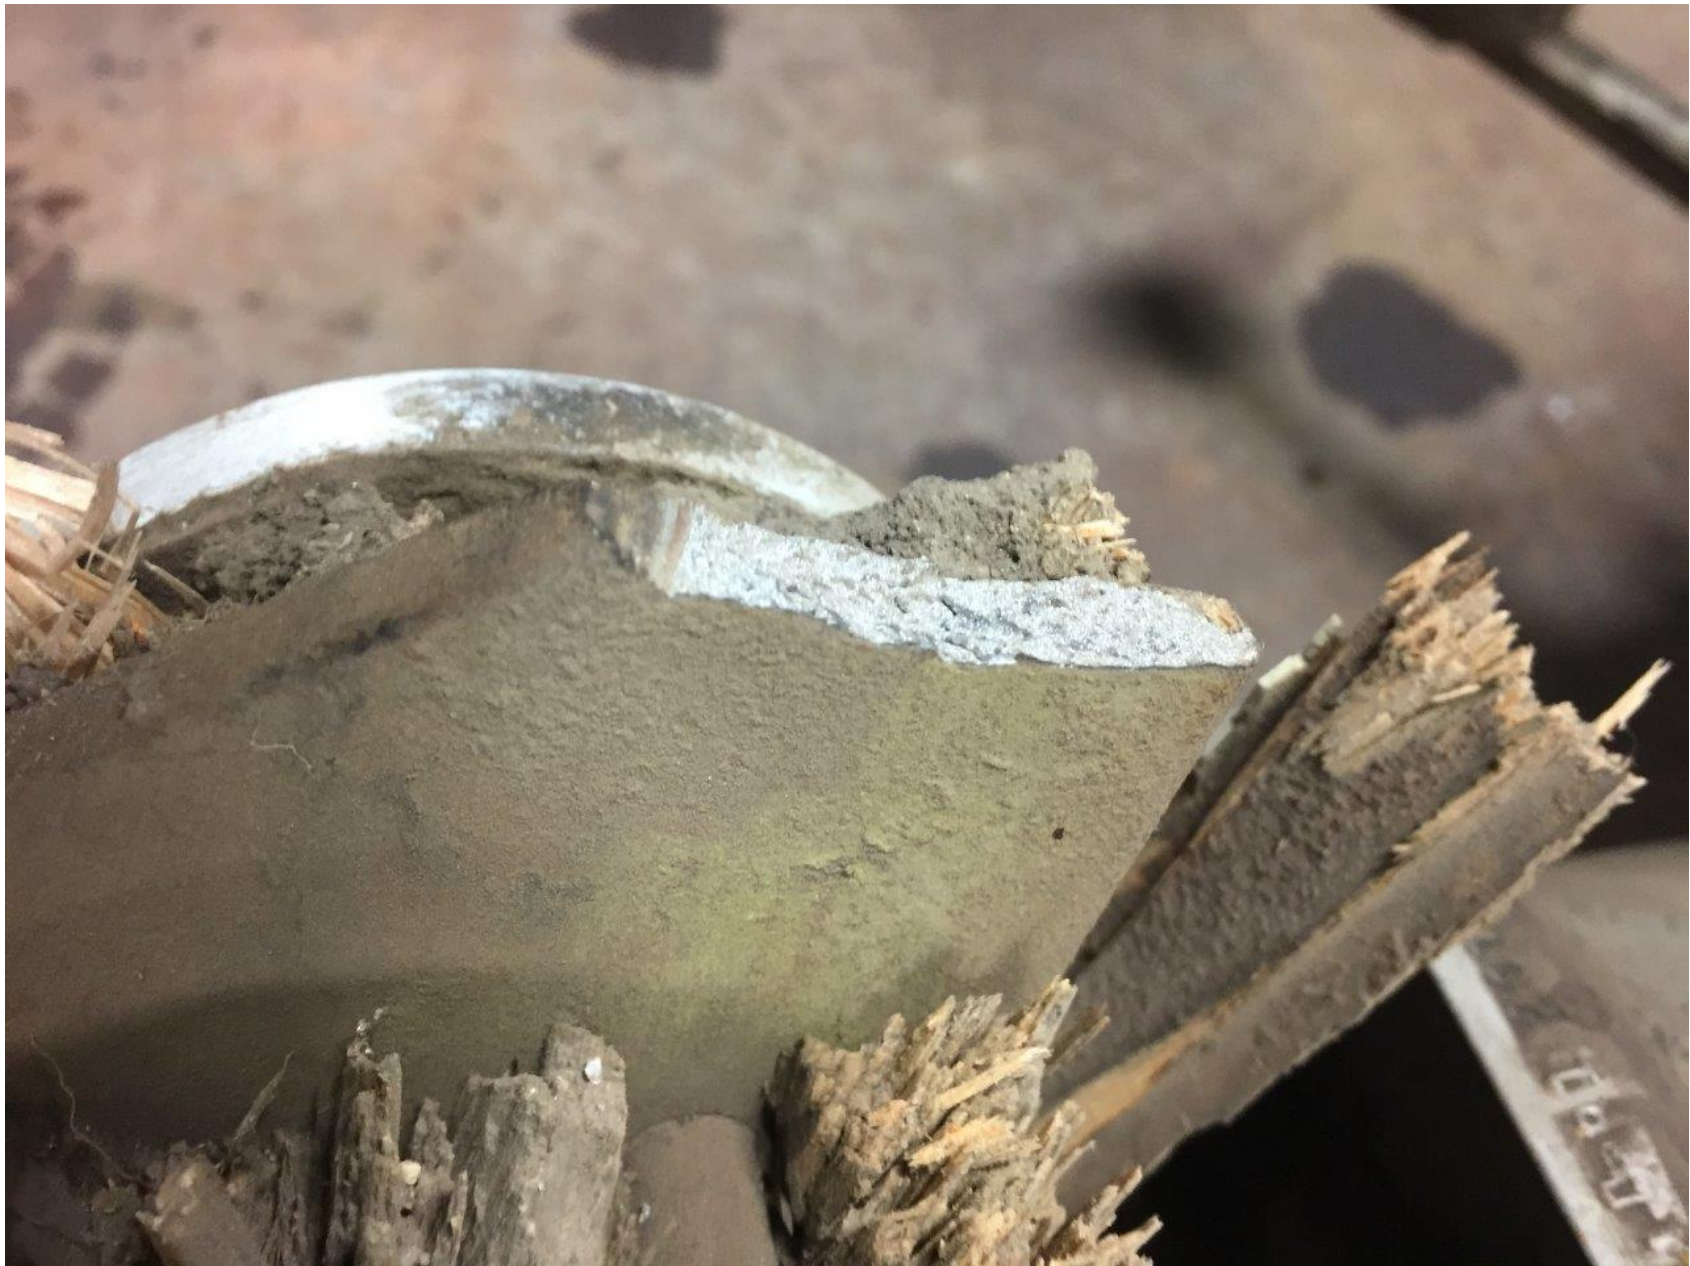
**Photo 8 - Close-up view of a section of main rotor blade spar.**

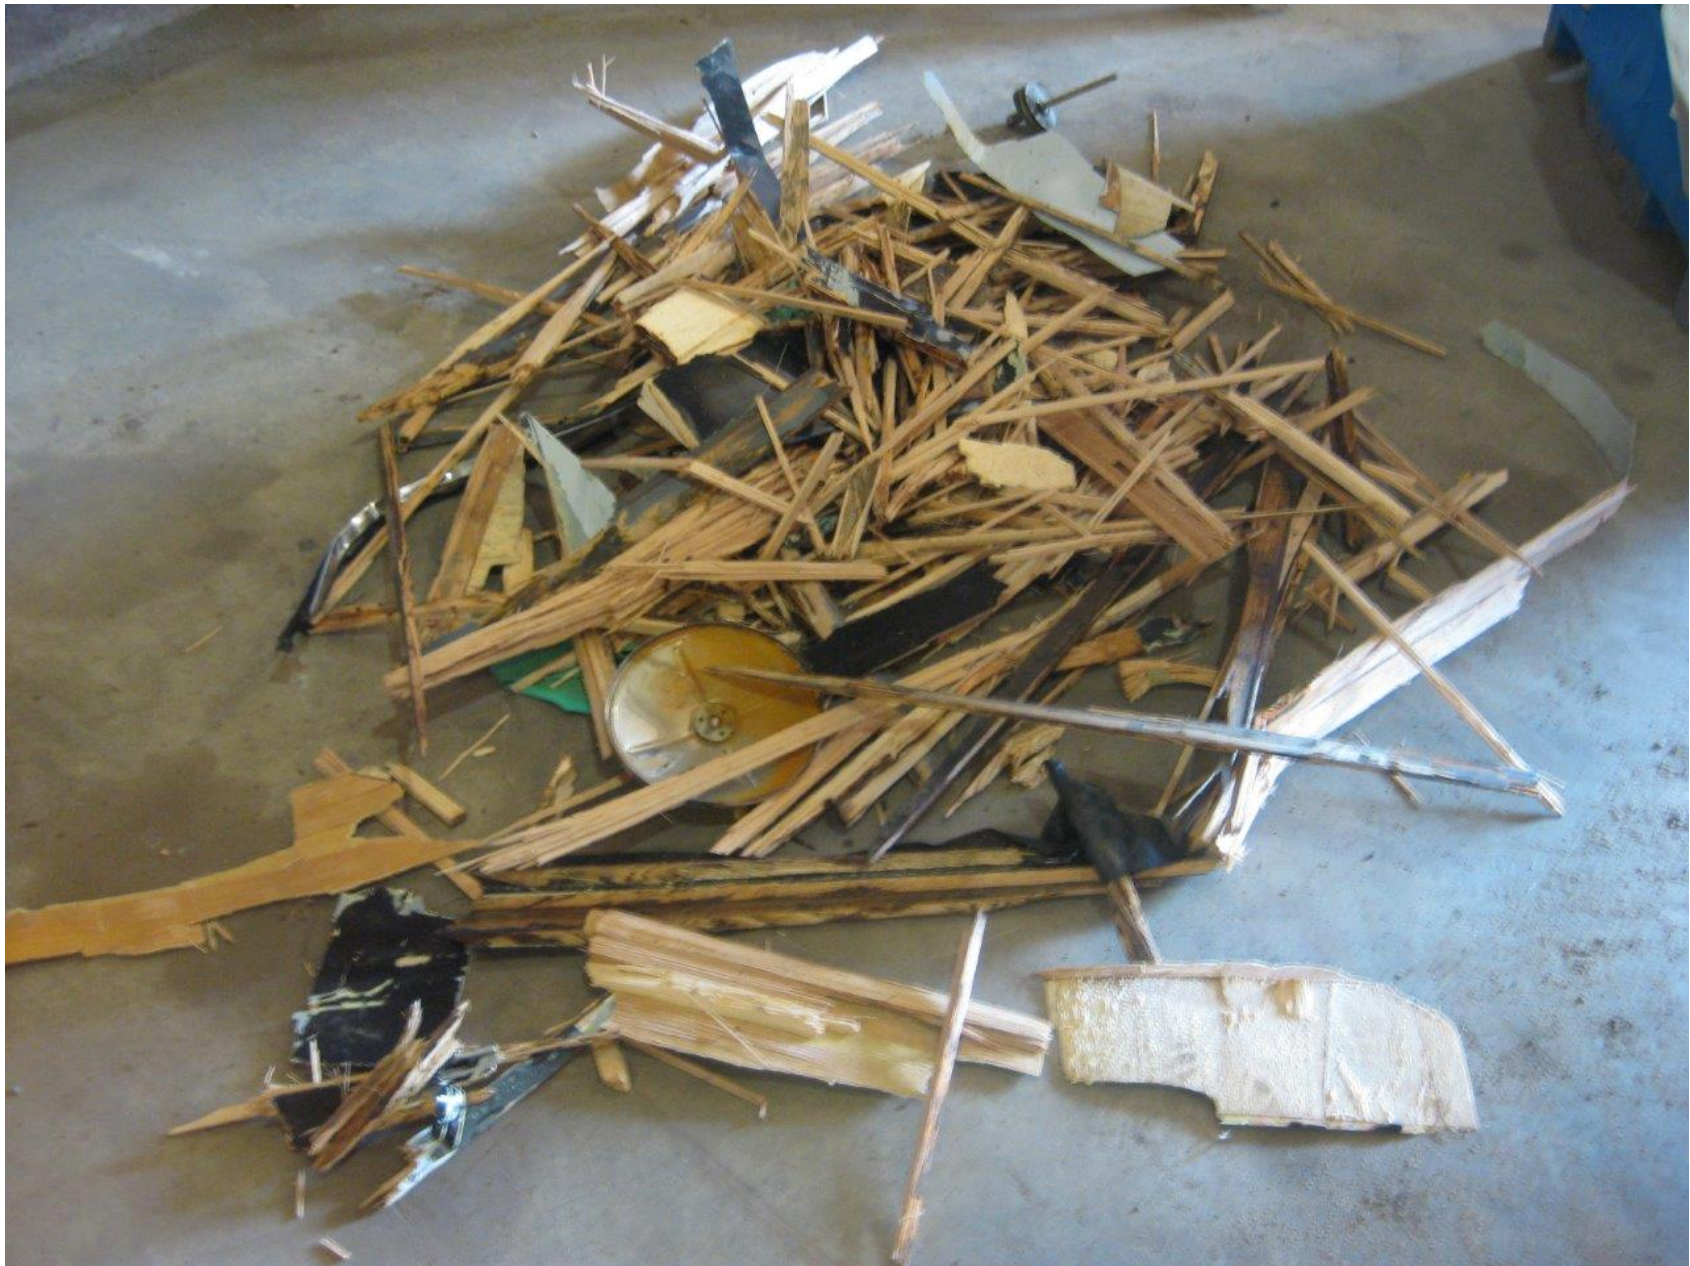
**Photo 9 - View of recovered main rotor blade splinters.**

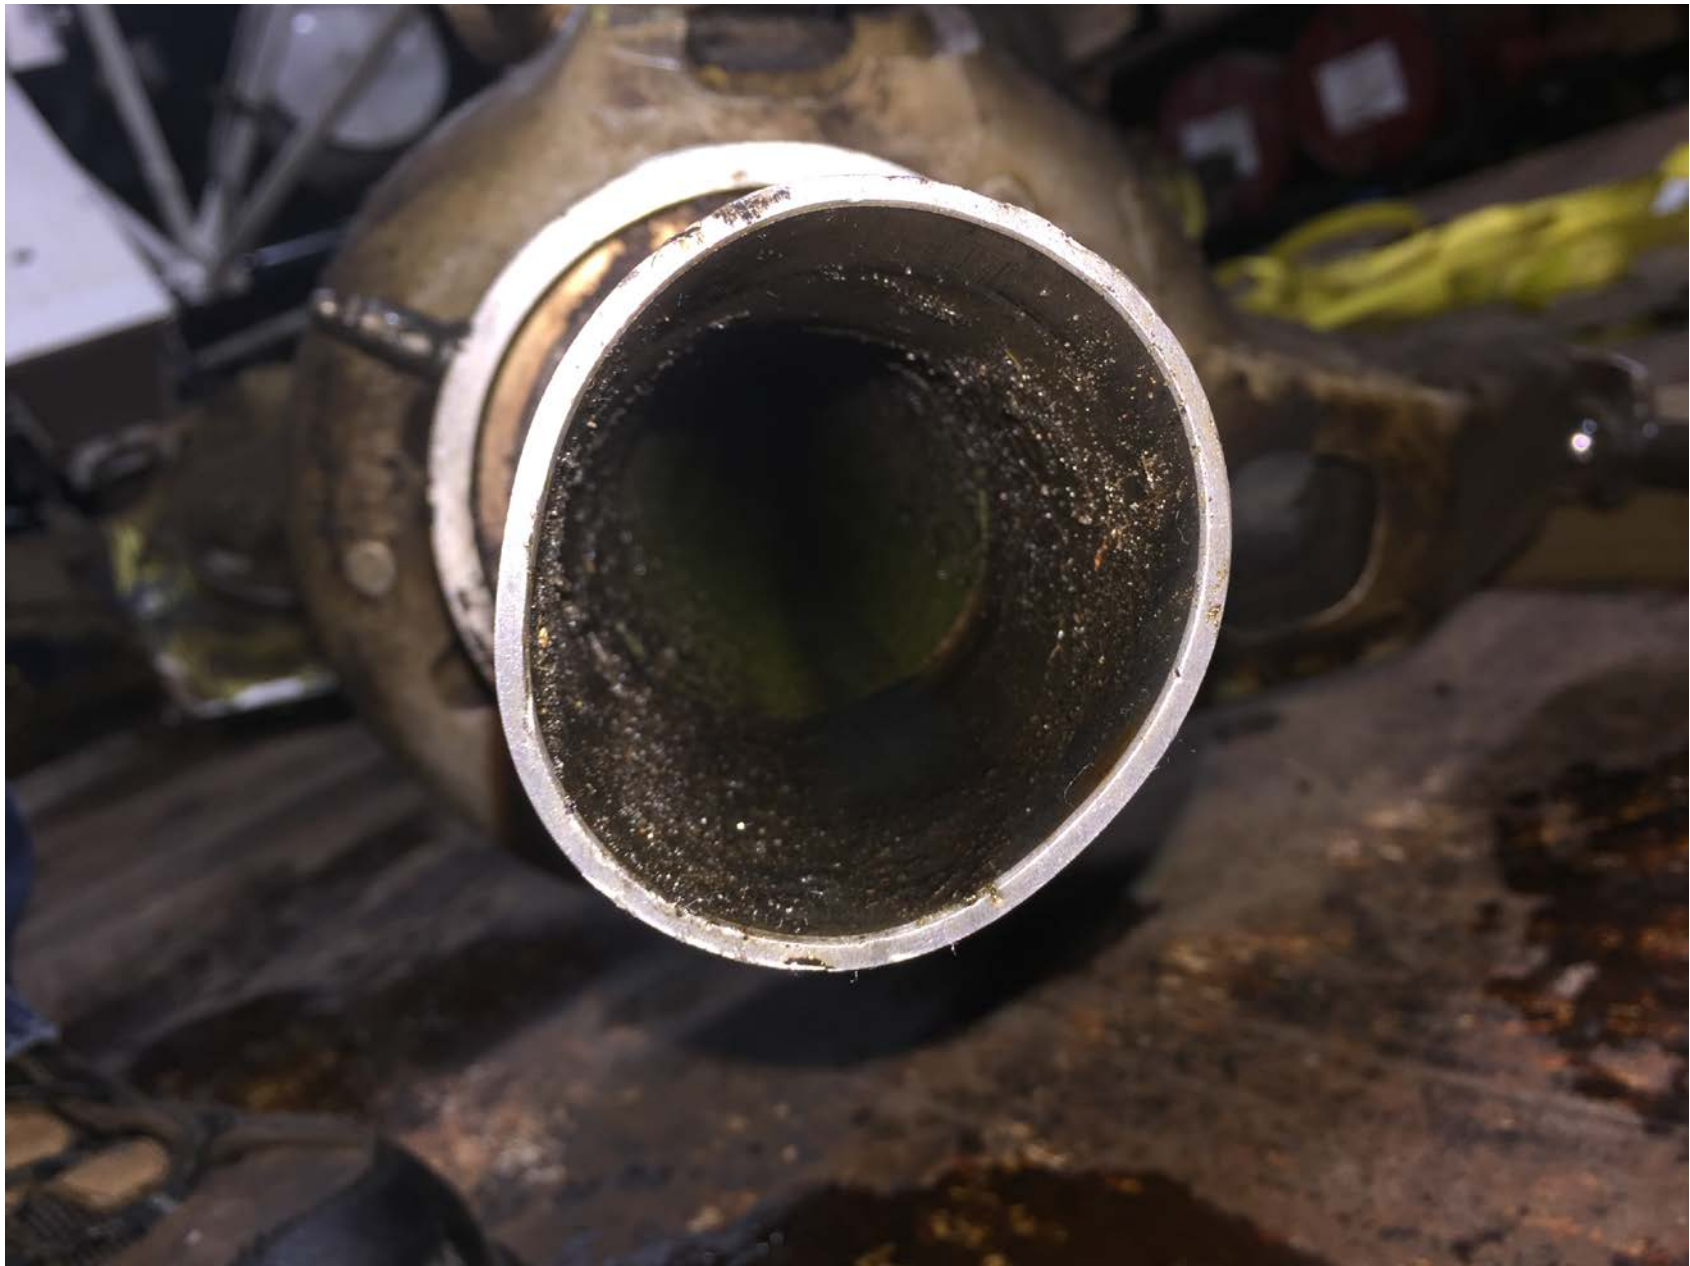
**Photo 10 - View inside the rotor mast.**
