**Air Tractor, Inc.**  
Accident Investigation

**FIELD NOTES**

**CEN17LA284**

**18 Jul 2017**  
**Reyno, Arkansas**

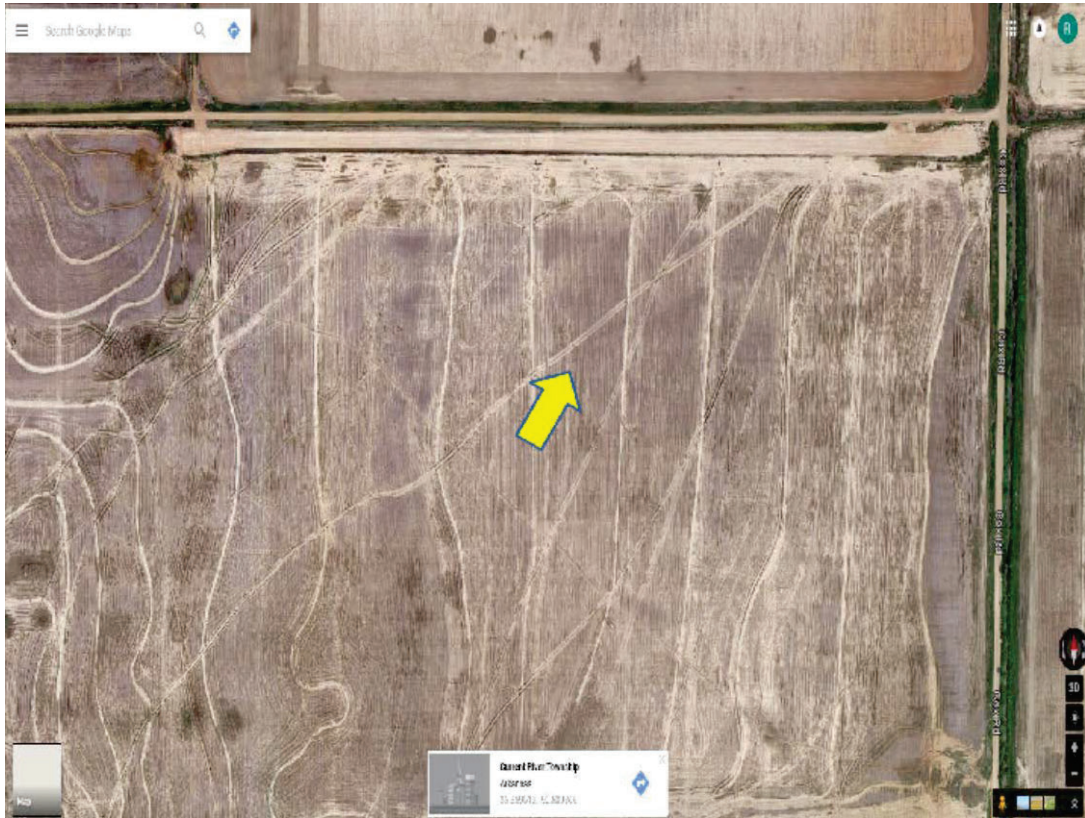
(Photo 1)

Upon arrival at the scene, it was noted that the aircraft was located in a soybean field approximately four (4) miles west of Reyno, Arkansas located on the west side of Cox Rd., one half (1/2) mile south of Hurst Rd. It was reported that the aircraft was being operated from the adjacent landing strip (unimproved) running east / west along the north edge of the soy bean field. The aircraft came to rest heading approximately 030° at approximately N35.359919°, W90.809365°, as depicted by yellow arrow. (See Photo 1)

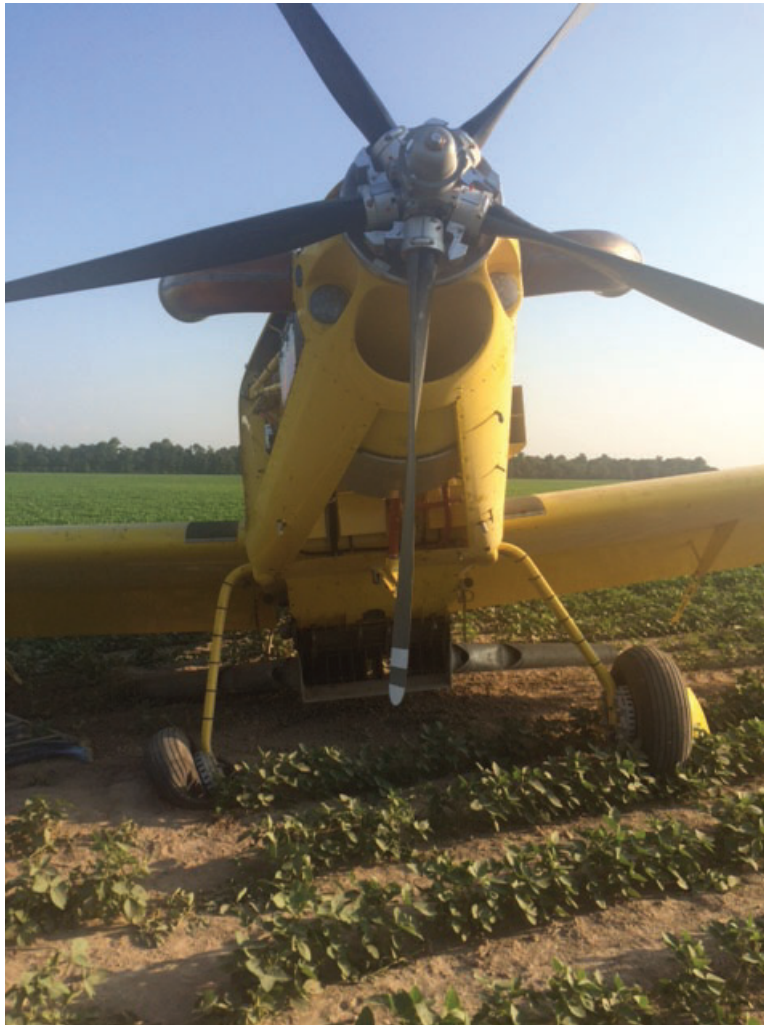
The aircraft was located in the soybean field in an upright position with the fuselage oriented on a north easterly heading (approximate heading 030°). The main landing gear sustained minimal damage / distortion, but was intact and remained attached to the mount structure, with no visible damage to landing gear mounting structure. The wings remained attached to the fuselage in their normal location, with minimal impact damage to the wingtips. The right wing sustained slightly more damage than the left, along with the right hand aileron and flap assemblies. The left hand wing was minimally damaged outboard towards the wing tip. The fuselage structure was generally undamaged. The aft fuselage and empennage were generally undamaged, other than the tail landing gear spring and rudder horn. The right hand elevator sustained minor impact damage.

**(Photo 7) Wreckage as viewed from the front**

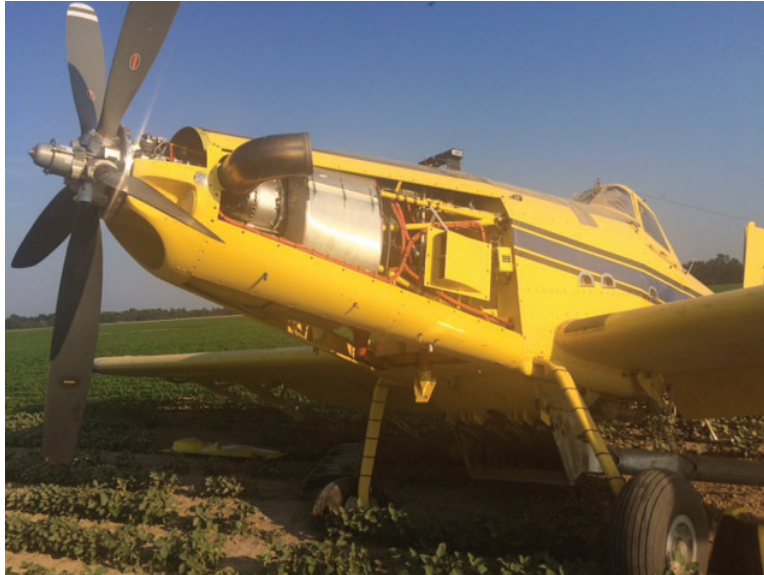
**(Photo 8) As viewed from the front left**

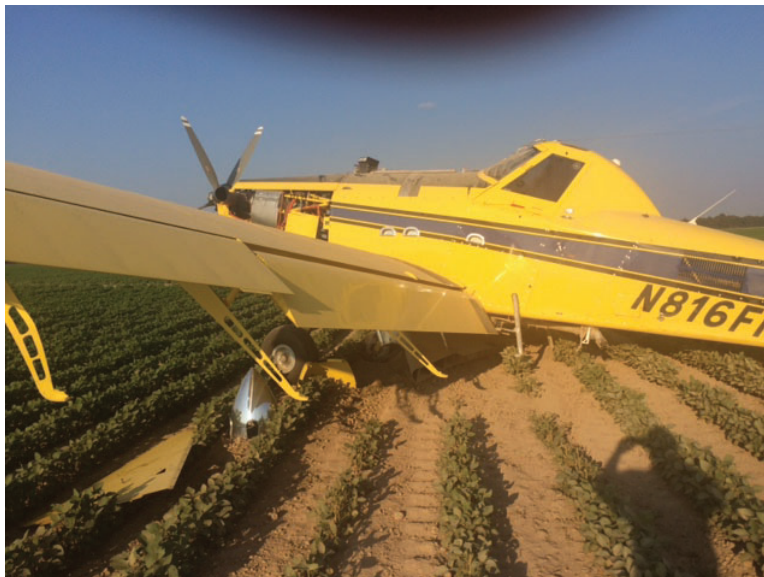
**(Photo 9) As viewed from left**

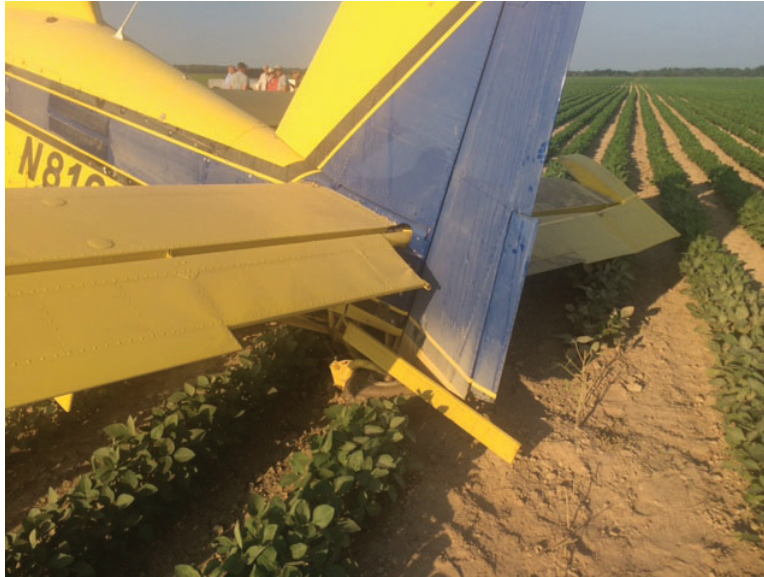
(Photo 10) As viewed from left rear

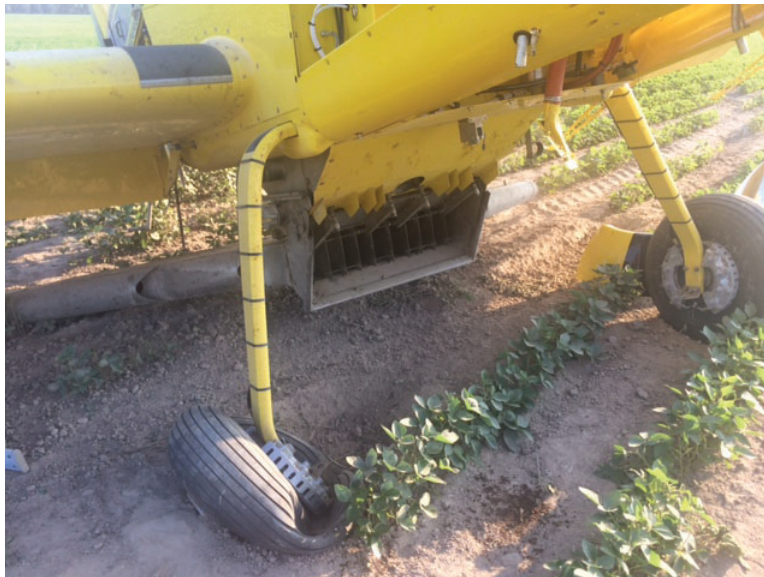
(Photo 11)

The fuselage was unaffected and completely intact with no damage. The right hand main landing gear was deflected inboard with permanent set (See Photo 11). The left hand main landing gear appeared generally undamaged (See Photo 12).

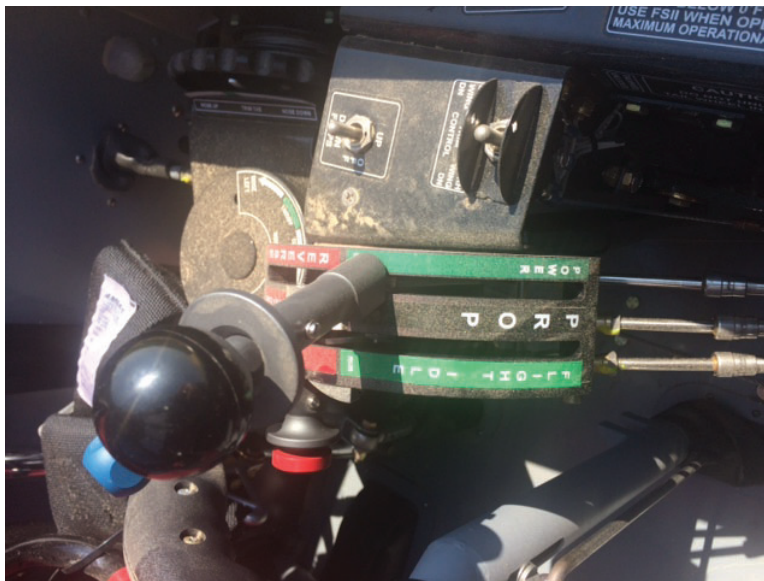
(Photo 13)

The interior of the cockpit was examined with no anomalies noted. The aircraft was fitted with AmSafe cockpit restraint system airbags and were not deployed. The Kawak throttle quadrant was intact with control linkages properly connected. All engine controls moved freely through full range of motion (See Photo 13).

The engine was confirmed to be a PT6A-65AG engine serial number PCE-PN0314. The engine exhibited no apparent damage or external oil or fuel leaks. All engine controls were checked for continuity and full range of motion. No anomalies noted. The engine controls were noted as being in the following positions: Power Lever – Idle, Propeller – feather, Condition Lever – Cut-off (See Photo 13).

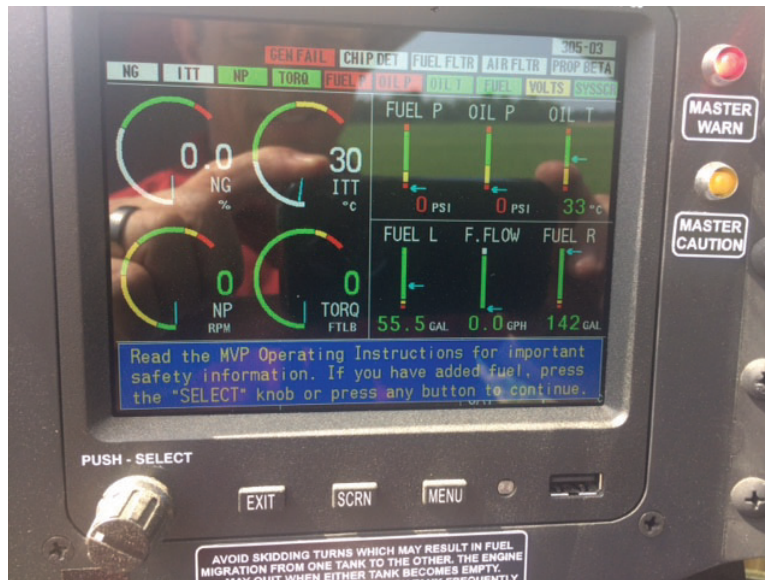
(Photo 14)

Fuel indication on MVP-50T displayed 55.5 gallon in left fuel tank and 142 gallon in the right (See Photo 14). A fuel sample was taken from both wing tanks to verify presence of fuel. The engine fuel control unit (FCU) fuel filter housing was removed to verify presence of fuel at the engine. Fuel existed at all locations.

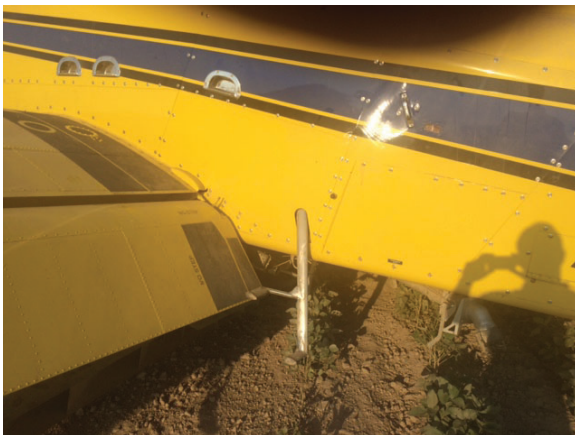
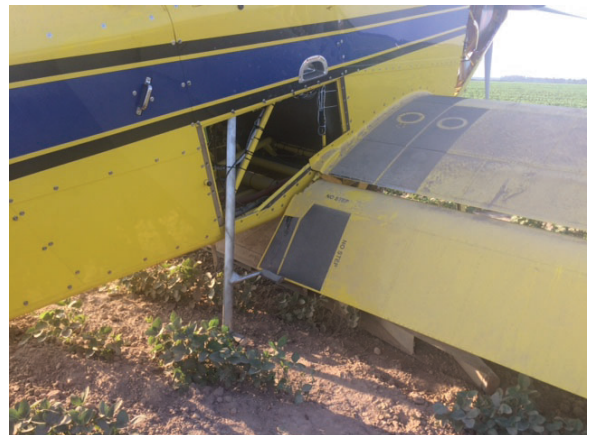
Both wings remain intact with damage by ground impact. The flaps were symmetrically extended and properly connected. (See photo 15 and 16) The right hand flap sustained damage on the outboard end trailing edge (See photo 19). The left hand flap appeared undamaged (See photo 20). The right hand wing sustained significantly more damage than the left. The right hand wing exhibited impact marks from the flap outboard to the wing tip (See photo 17). The left hand wing displayed minor impact damage on trailing edge outboard of aileron (See Photo 18).

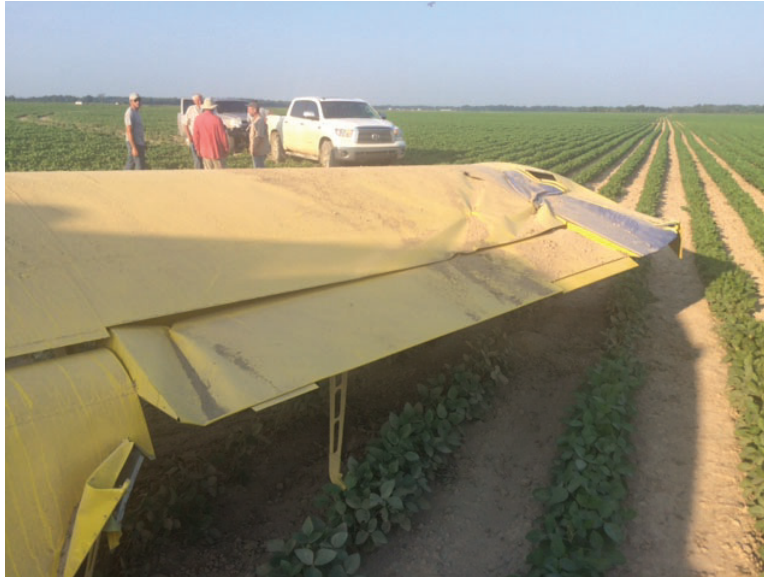
(Photo 19)

Both ailerons remained intact and installed in their proper placement on the wings. The right aileron received minimal damage (See Photo 19).

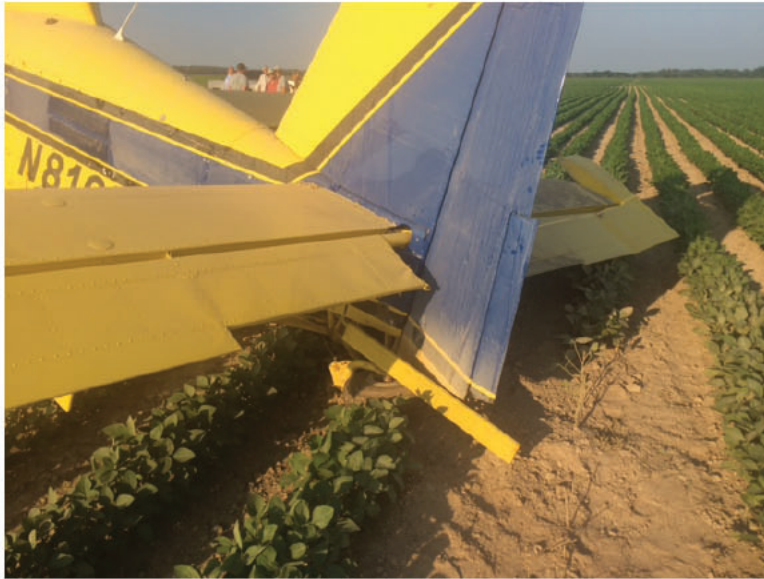
(Photo 21)

The tail landing gear was detached from the mount structure and lay adjacent to the empennage. (See photo 21). The vertical fin and rudder remained intact, with minimal impact damage to the rudder horn (See photo 22 and 23). The left hand elevator boost tab separated from its mounting locations but controls remained attached (See photo 22).

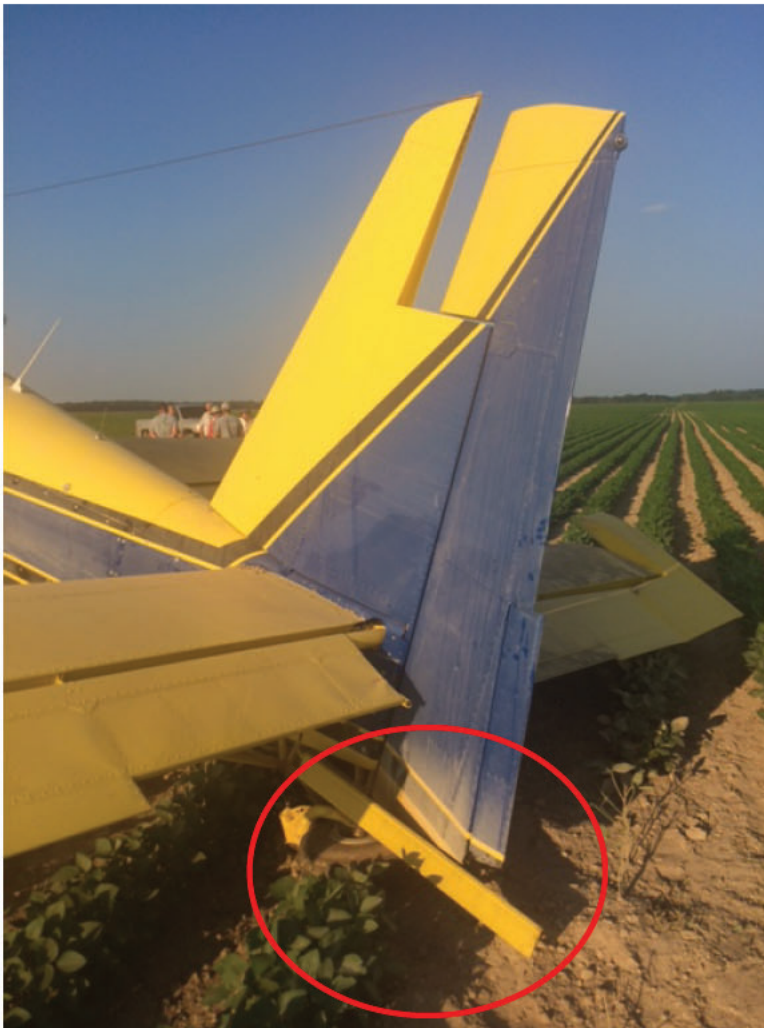
(Photo 22) L/H elevator boost tab circled in red

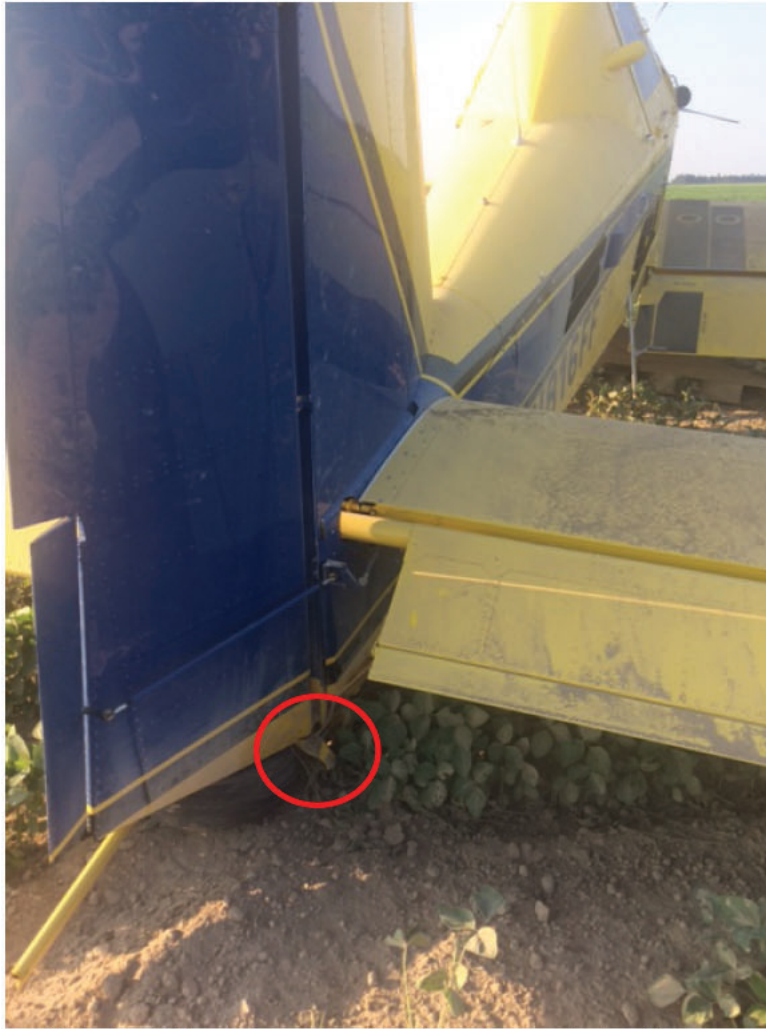
(Photo 23) – Damaged rudder horn circled in red

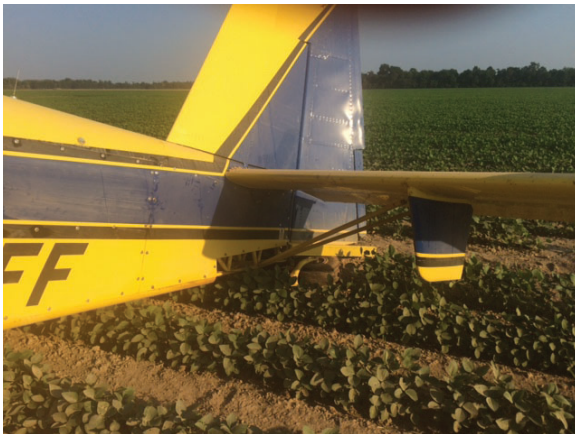
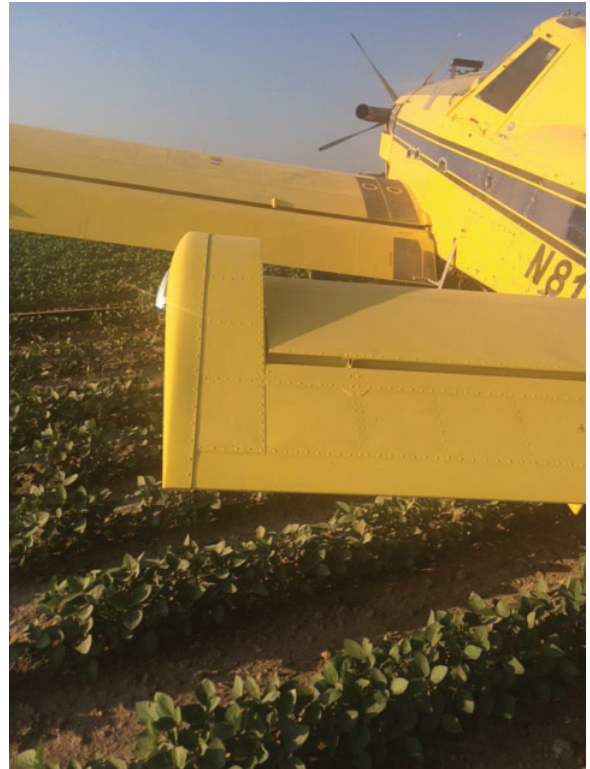
The left hand horizontal stabilizer was generally undamaged, with the exception of the separated aforementioned elevator boost tab (See photos 24 and 25). The right hand elevator exhibited impact damage on outboard end (See Photo 26)

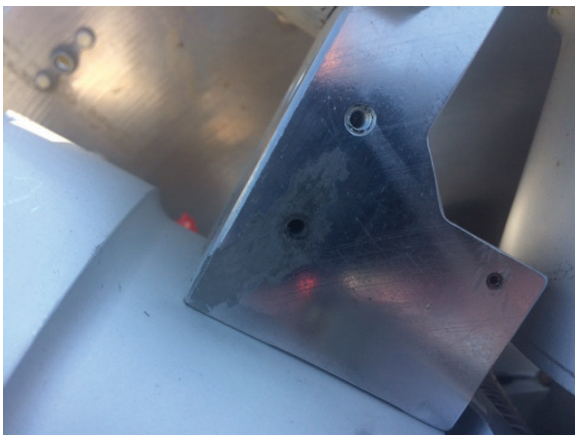
(Photo 43)

The propeller beta system was correctly connected and continuous. The beta plunger appeared properly rigged (flush) and beta block properly seated under the guide pin in the propeller beta ring (See Photo 41). The low pitch “beta nuts” were undisturbed (See Photo 42). The only anomaly noted was slight surface corrosion on propeller counterweight (See Photo 43).
