Service Investigation  
**Accident / Incident Report**

**Report No.: 17-108**

**C & C Flying Service  
Air Tractor AT-802 Registration # N816FF  
Reyno, Arkansas  
18 July 2017  
PT6A-65AG  
S/N PN0314**

**Date of Issue:** 11 April 2018

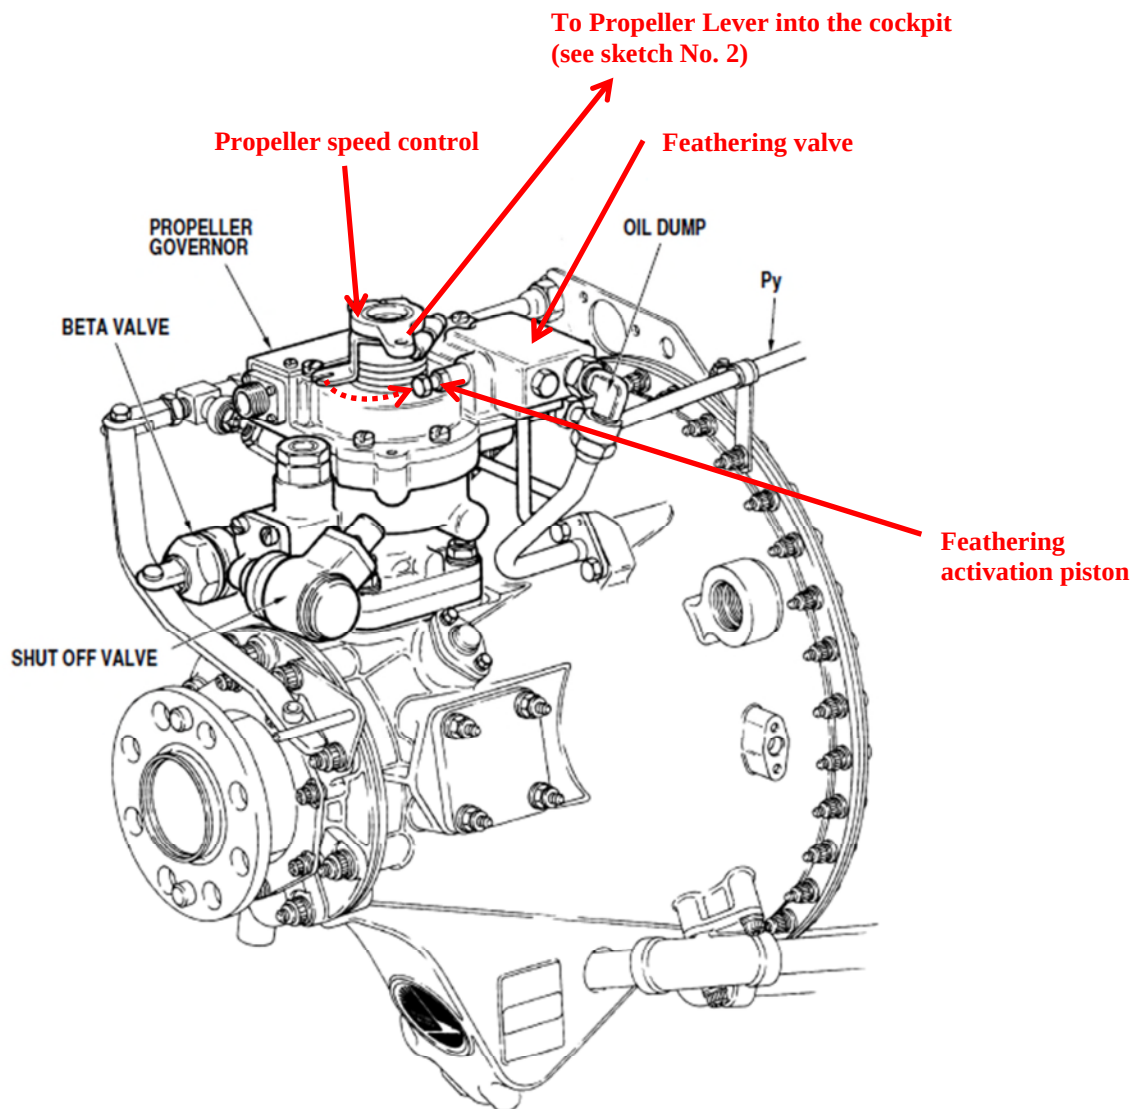
Sketch No. 1  
Propeller Governor

- 3.1 No engine anomaly was found to preclude normal engine operation prior to the event.
- 3.2 As per Woodward Inc. CSU test data and flight data recorder analysis, it is believed the feather valve was activated by a movement of the Propeller Lever from the pilot. Consequently, the torque increased, the propeller speed and the thrust decreased.
- 3.3 Subsequently, the pilot moved the power lever to attempt to increase thrust. Because the propeller was into feather position, instead of getting a thrust increase, the torque exceeded the limit.

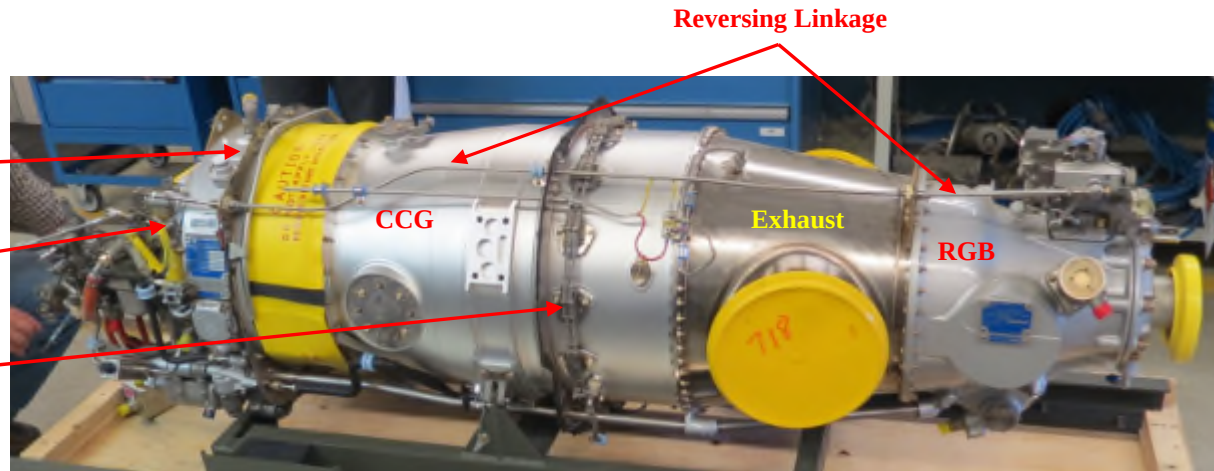
Photo No. 1  
Right hand view

**Reduction Gearbox (RGB):** No damage was observed (Photos No. 1 to 3).

**Exhaust Duct:** No dent, nicks and metal splatted were observed on the surface of the exhaust gas path. No damage was observed on the external (Photos No. 1 and 2).

**Gas Generator Case (GGC):** No damage was observed (Photos No. 1 and 2).

**Accessory Gearbox (AGB):** No damage was observed (Photos No. 1, 2 and 4).

**Inlet Case / Oil Tank:** No damage was observed and the inlet screen was intact (Photos No. 1, 2 and 5). Data plat showed the engine S/N (Photo No. 6).

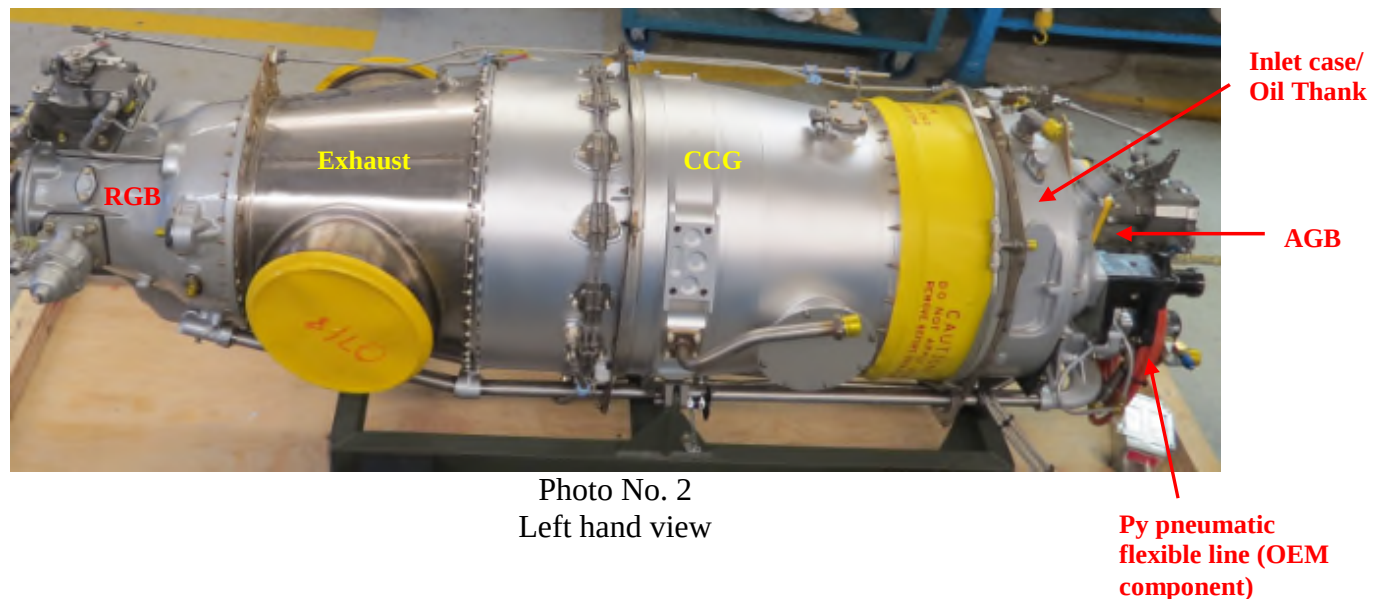
Photo No. 2  
Left hand view

**Power Turbine Control (Py):** As received, the OEM Py flexible line was not connected to the propeller governor and no water was observed inside the OEM flexible tube (Photos No. 2 and 4).

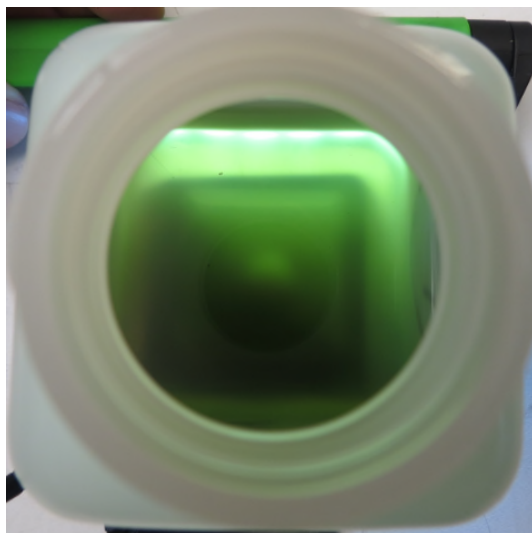
Photo No. 7  
Engine oil

Oil was drained from the RGB and it was collected. The oil was observed to be greenish in color and had no acrid smell (Photo No. 7). The oil appeared to have a watery consistency, less viscous than normal oil. Chemical analysis revealed the oil met all specifications. The greenish appearance was due to the residual oil from P&WC production test which bleu dye was added to facilitate the oil leak inspection.

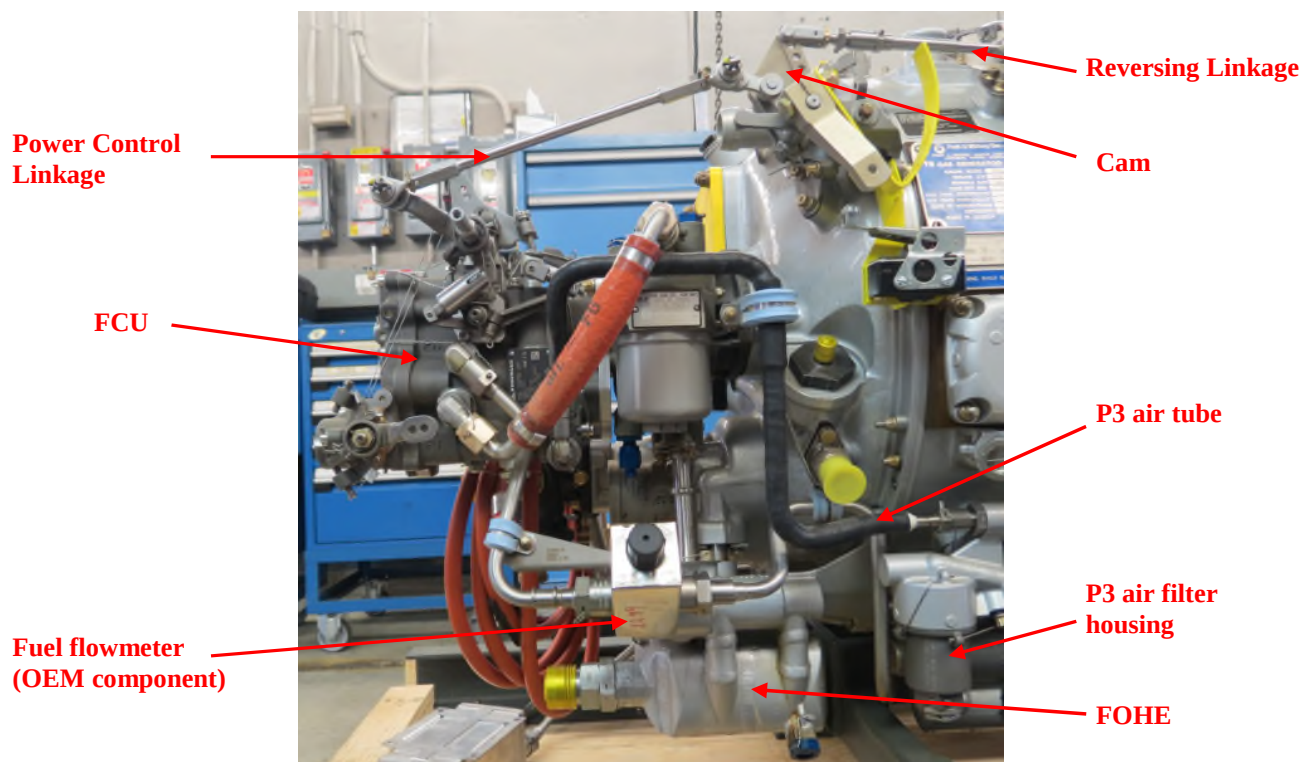
Photo No. 9  
AGB Right view

Reversing linkage was intact and continuous from the reversing cam up to the propeller governor (Photos No. 1 and 9).

The power control was intact and continuous from the Fuel Control Unit (FCU) up to the reversing cam (Photo No. 9).

**Compressor Discharge Air (P3):** The P3 air tube was intact and continuous from the FCU up to the P3 air filter housing (Photo No. 9). The P3 air tube was intact and continuous from the P3 air filter housing up to the GGC (Photo No. 10).

The Fuel Oil Heat Exchanger was not removed. No damage was observed on the external (Photo No. 9).

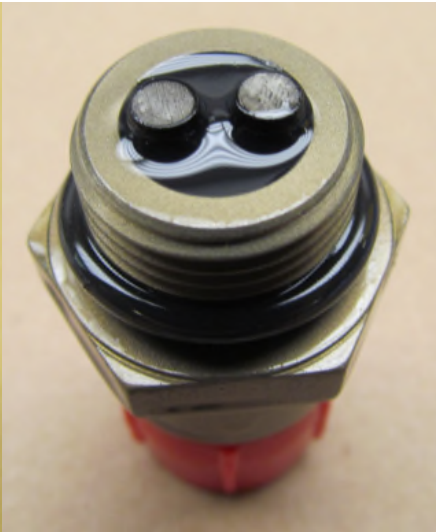
Photo No. 12  
AGB MCD

**AGB MCD:** The MCD was removed from the accessory gearbox; it was found clean (Photo No. 12).

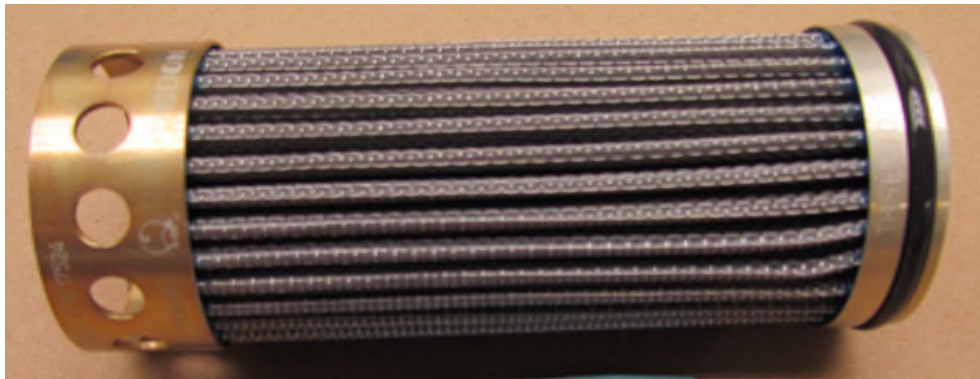
Photo No. 13  
Oil filter

**Oil Filter:** Oil filter was removed and found clean (Photo No. 13).

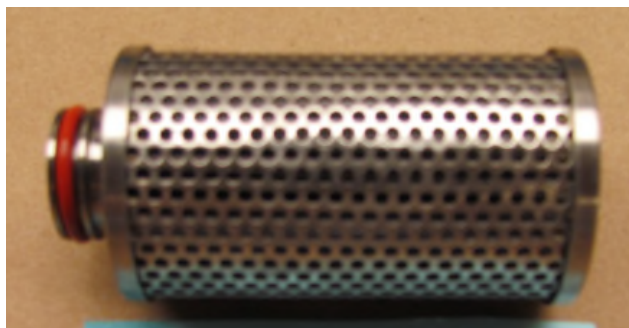
Photo No. 14  
P3 air filter

**P3 air Filter:** P3 air filter was removed and found clean (Photo No. 14).

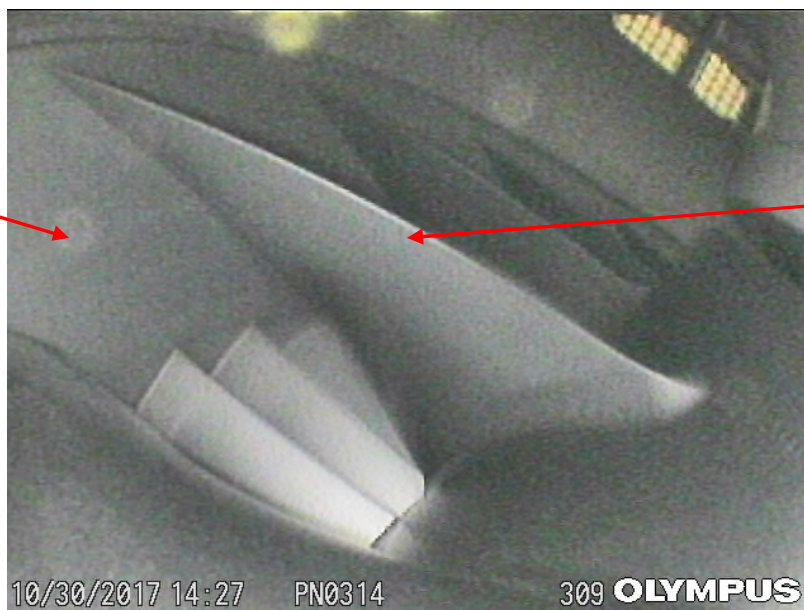
Photo No. 15  
1<sup>st</sup> stage compressor rotor blades  
Boroscope inspection

**Compressor 1<sup>st</sup> to 4<sup>th</sup> Stage Discs and Blades:** Through the air inlet case, all the 1<sup>st</sup> stage axial compressor rotor blades were intact (Photo No. 15). The 2<sup>nd</sup> to 4<sup>th</sup> stages axial compressor rotors were not assessed.

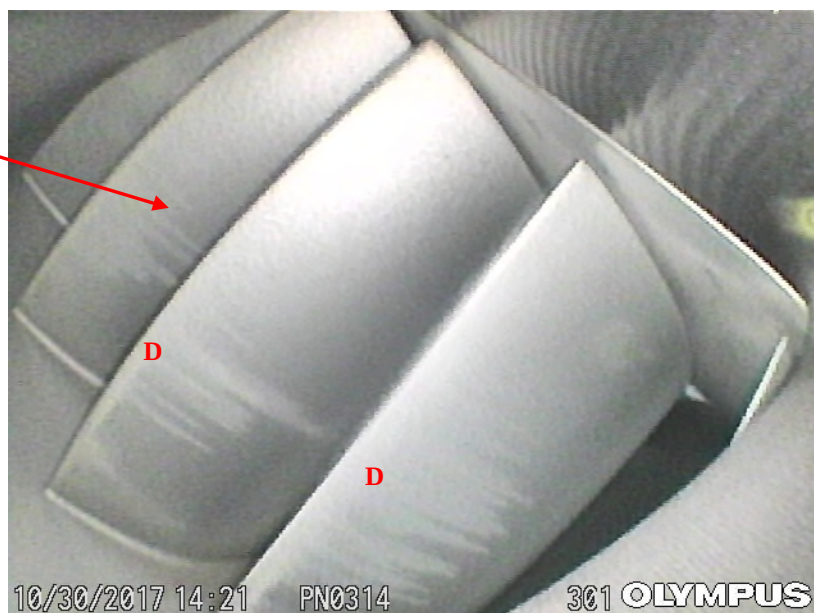
**Compressor 1<sup>st</sup> to 4<sup>th</sup> Stage Stators and Shrouds:** Through the air inlet case, all the 1<sup>st</sup> stage stator vanes and shroud were intact (Photos No. 15 and 16). The vanes showed light grey dust deposit at the leading edge (Photo No. 16). The 2<sup>nd</sup> to 4<sup>th</sup> stages stator vanes and shrouds were not assessed.

Photo No. 16  
1<sup>st</sup> stage stator vanes  
Boroscope inspection  
Dust deposit (D)

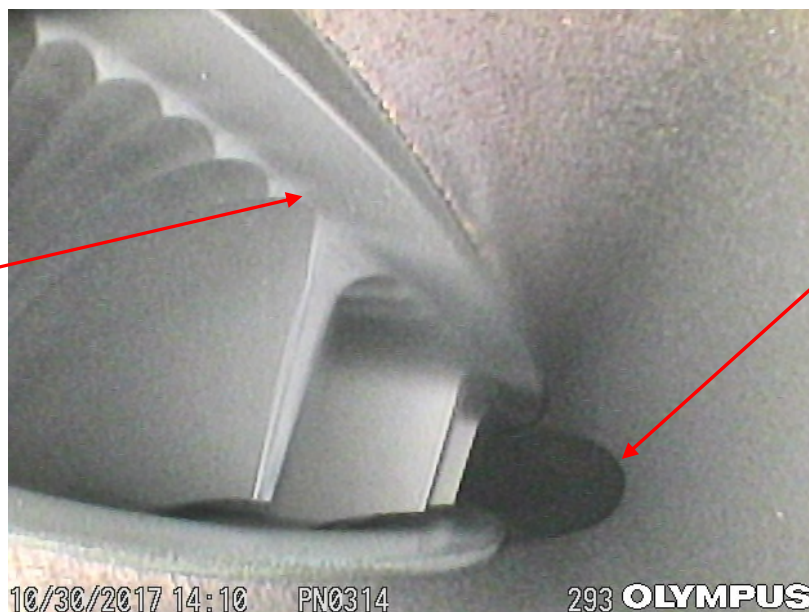
Photo No. 17  
1<sup>st</sup> stage stator vanes  
Boroscope inspection

**Centrifugal Impeller:** The impeller compressor exducer and diffuser apex were inspected with a boroscope through a diffuser pipe and no anomalies or damaged was noted (Photo No 17).

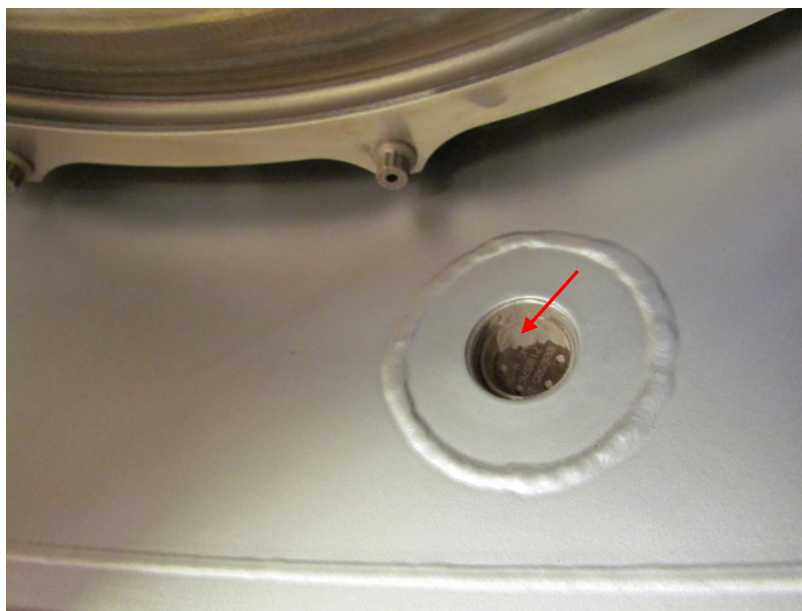
Grey dust was found at the bottom of the GGC drain valve near the combustion liners (Photo No. 18).

Photo No. 18  
GGC drain valve  
Grey dust (arrow)

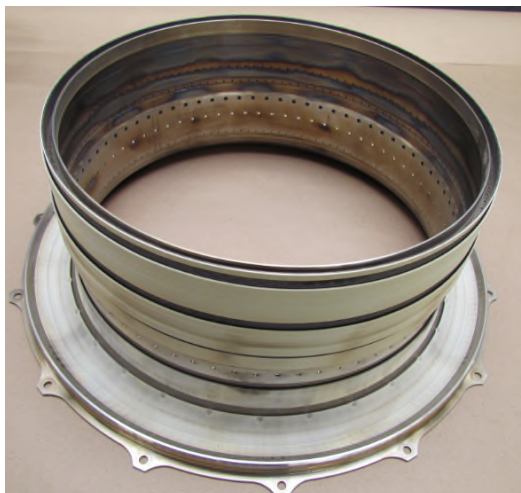
Photo No. 19  
Inner liner

**Combustion Chamber Liner:** No damage was observed on the inner and outer liner (Photos No. 19 and 20).

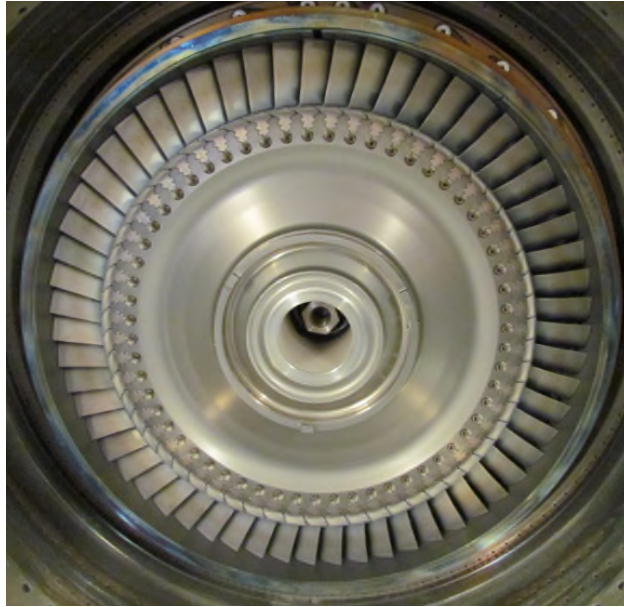
Photo No. 21  
CT disk assembly in situ

**Compressor Turbine Shroud:** No damage was observed (Photos No. 21 and 22).

**Compressor Turbine:** CT disk assembly was intact (Photo No. 21).

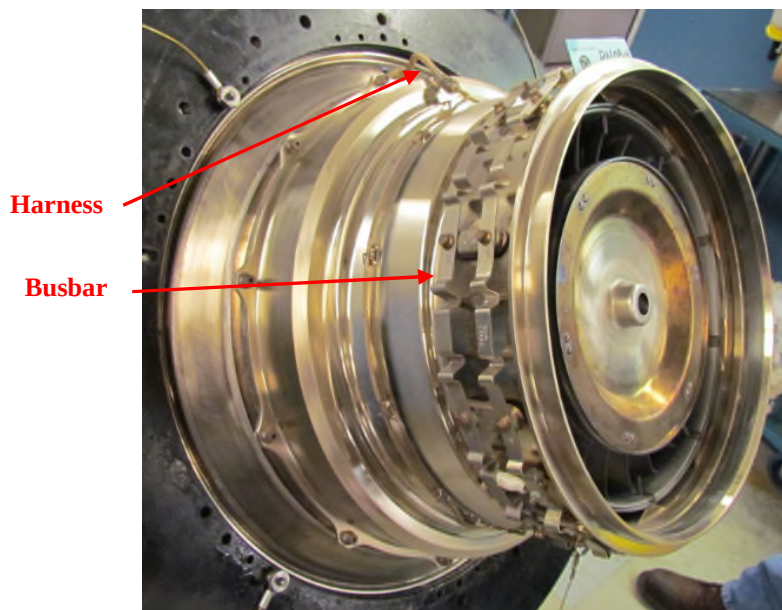
Photo No. 23  
Power turbine housing assembly

**ITT Probes, Busbar, and Harness:** No damage was observed (Photos No.23 and 24).

**Power Turbine Housing:** No damage was observed (Photos No.23).

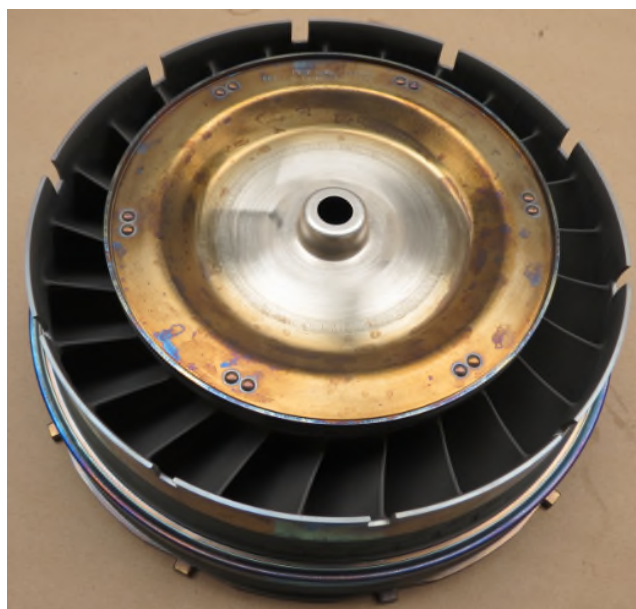
Photo No. 25  
PT1 vane upstream side

**1<sup>st</sup> stage Power Turbine Guide Vane Ring and Interstage Baffle:** No damage was observed (Photos No. 25 and 26).

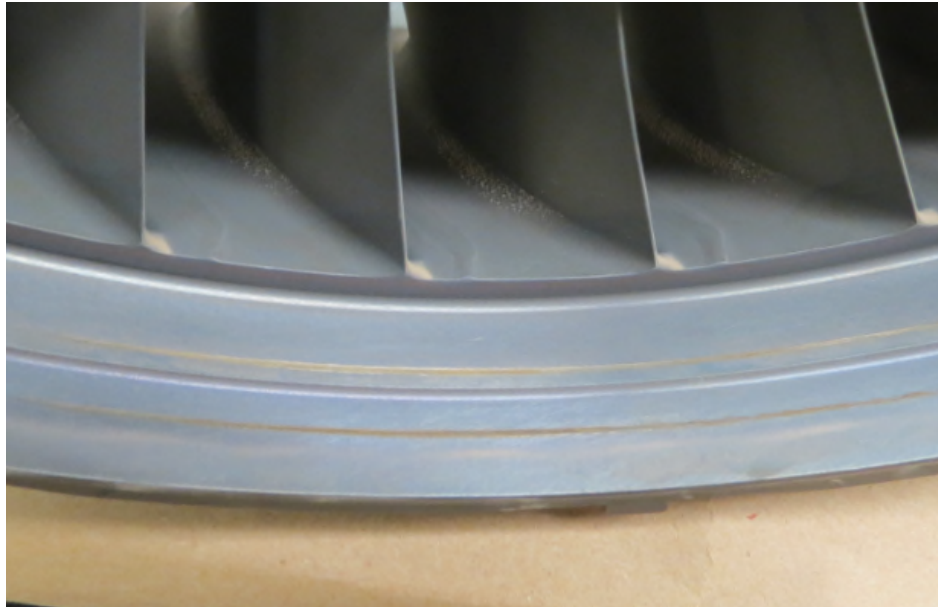
Photo No. 27  
PT1 shroud

**1<sup>st</sup> stage Power Turbine Shroud:** No damage was observed (Photo No.27).

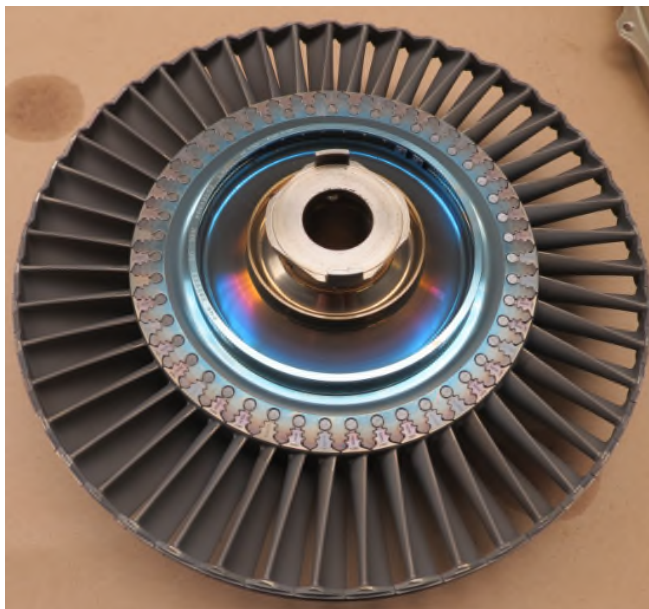
Photo No. 28  
PT1 disk upstream side

**1<sup>st</sup> stage Power Turbine:** No damage was observed (Photos No. 28 to 30).

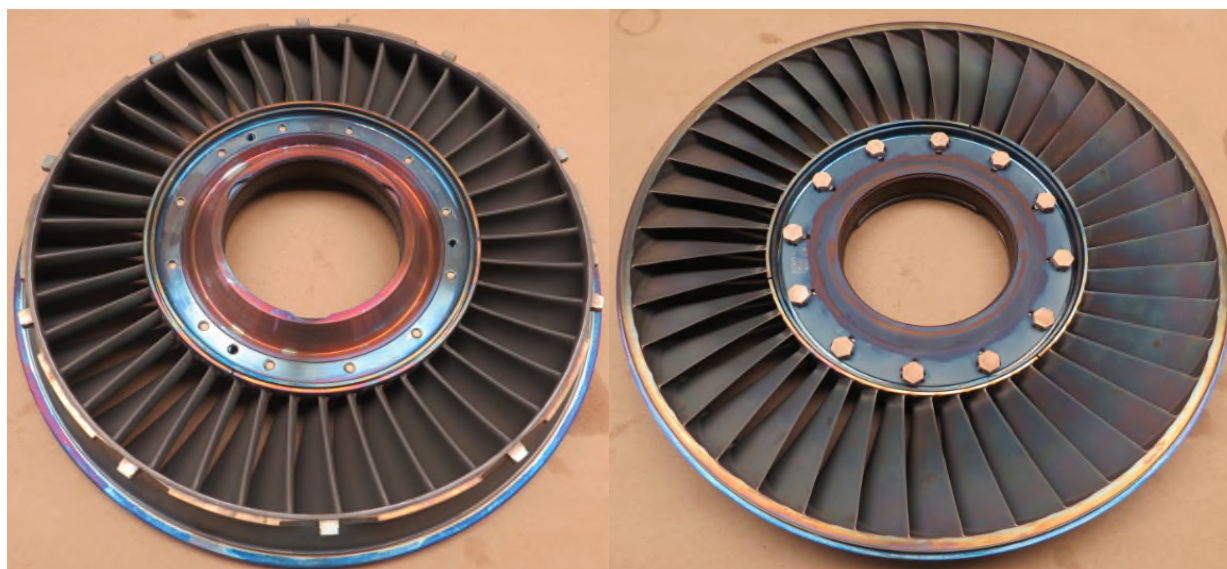
Photo No. 31  
PT2 vane upstream side

**2<sup>nd</sup> stage Power Turbine Guide Vane Ring and Interstage Baffle:** No damage was observed (Photos No. 31 and 32).

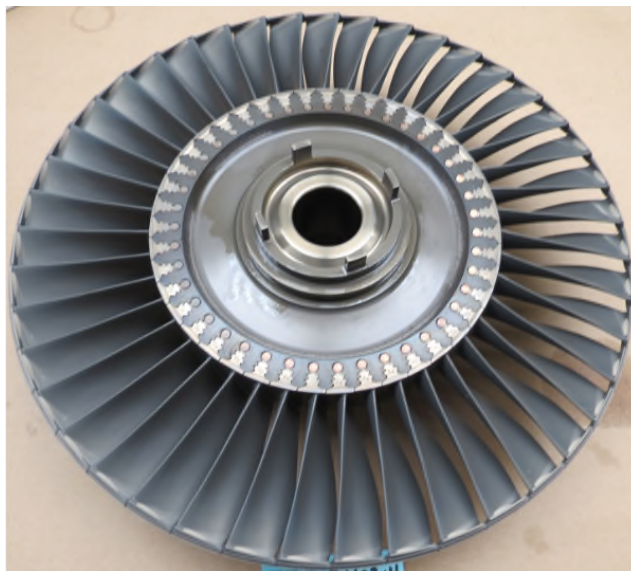
Photo No. 33  
PT2 disk upstream side

**2<sup>nd</sup> stage Power Turbine:** No damage was observed (Photos No. 33 to 35).

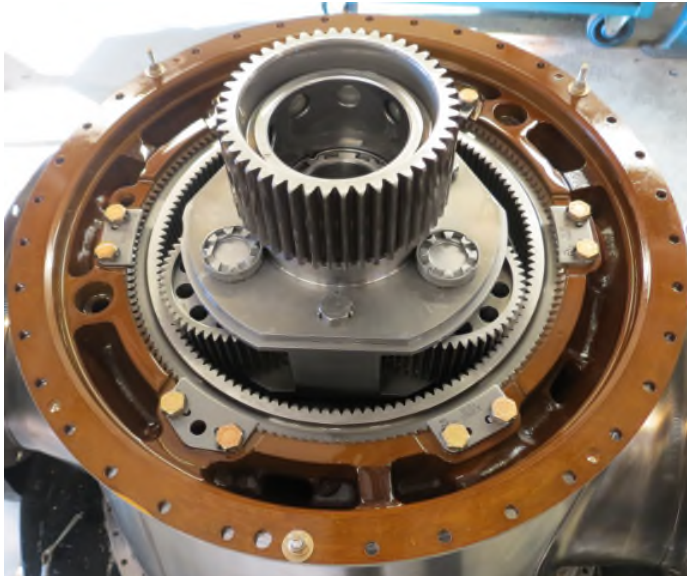
Photo No. 36  
1<sup>st</sup> stage planet gear assembly in situ

**Rear Housing:** No damaged observed (Photo No. 36).

**1<sup>st</sup> Stage Planet Gear Carrier:** No damaged observed (Photo No. 36).

**1<sup>st</sup> Stage Planet Gears:** No damaged observed (Photo No. 36).

**1<sup>st</sup> Stage Ring Gear:** No damaged observed (Photo No. 36).

**2<sup>nd</sup> Stage Sun Gear:** No damaged observed (Photo No. 36).

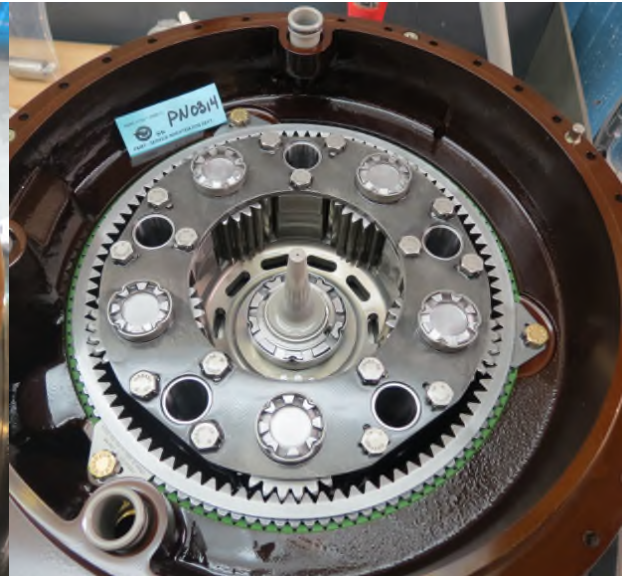
Photo No. 37  
2<sup>nd</sup> stage planet gear assembly in situ

**2<sup>nd</sup> Stage Planet Gear Carrier:** No damaged observed (Photos No. 37 to 39).

**2<sup>nd</sup> Stage Planet Gears:** No damaged observed (Photos No. 37 to 39).

**2<sup>nd</sup> Stage Ring Gear:** No damaged observed (Photo No. 37).

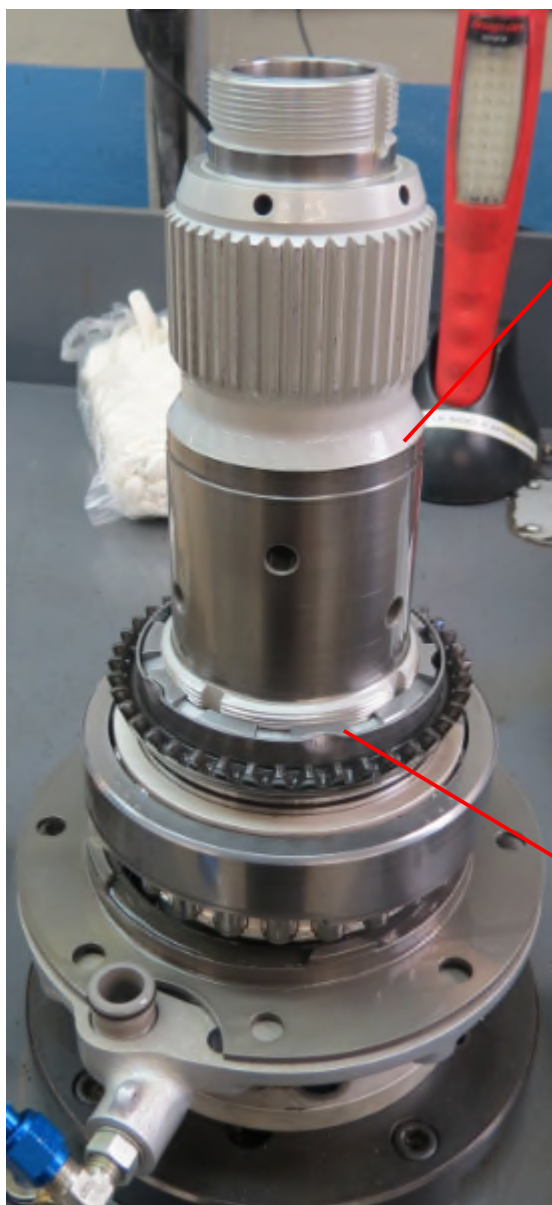
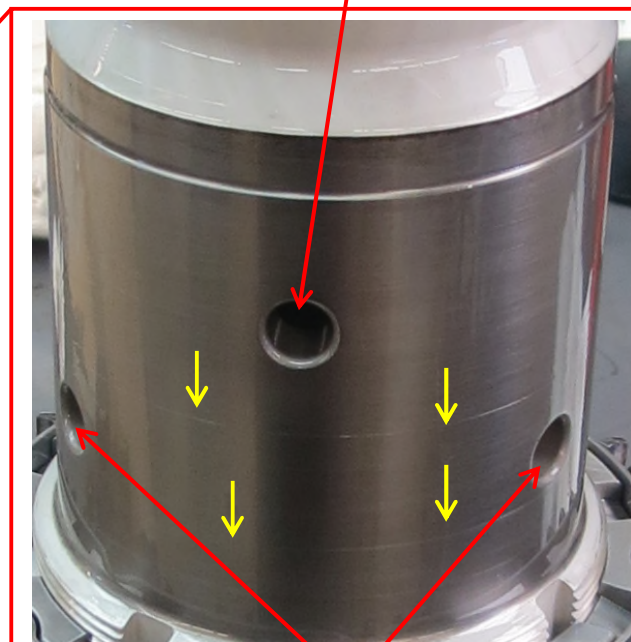
Photo No. 40

**Propeller Shaft:** The propeller shaft where the propeller oil transfer sleeve was located exhibited a 360° thin circumferential score line between the oil inlet port holes and the servo pressure holes (Photo No. 40). The score mark was visual and could be felt tactilely by finger nail. Another 360° thin score line was visible, which could not be felt, forward of the servo pressure holes (Photo No. 40). The fit between the propeller shaft and the propeller sleeve was measured and met the drawing requirement. The internal oil transfer tube/oil jet was in good condition and no debris or obstructions were noted (Photos No. 42 and 43). The o-rings and the seals were all present and in good condition (Photo No. 43). The fits between the propeller shaft and the internal oil transfer tube/oil jet were measured and meet the drawing requirements.

Propeller shaft - propeller shaft oil sleeve contact face  
Scores (yellow arrows)

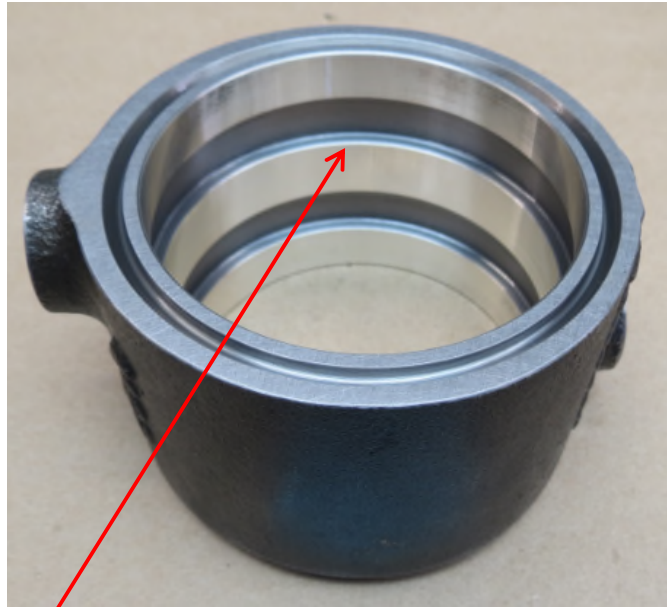
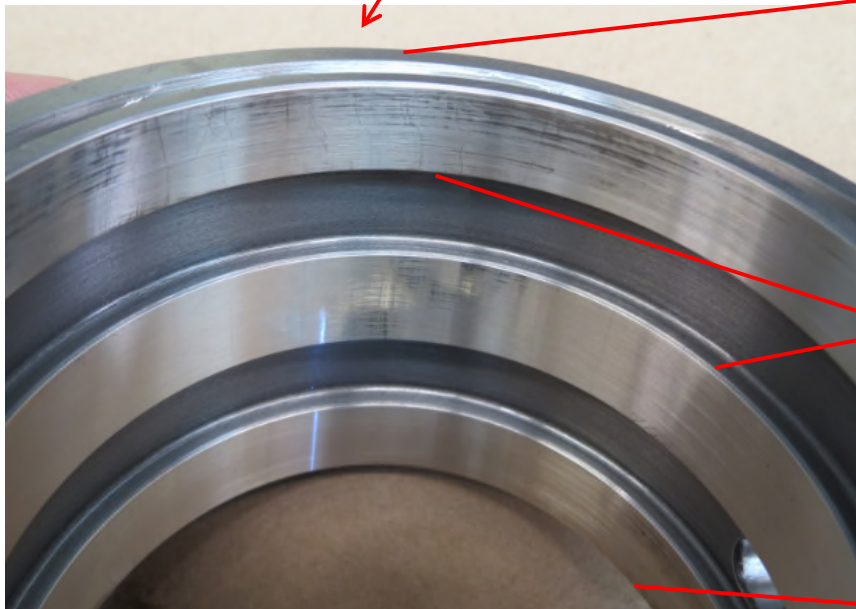
**Propeller sleeve:** The propeller shaft oil sleeve was in good condition except for light scoring marks noted on the running lands (Photo No. 41).

Photo No. 41  
Propeller sleeve  
Score marks (yellow arrows)

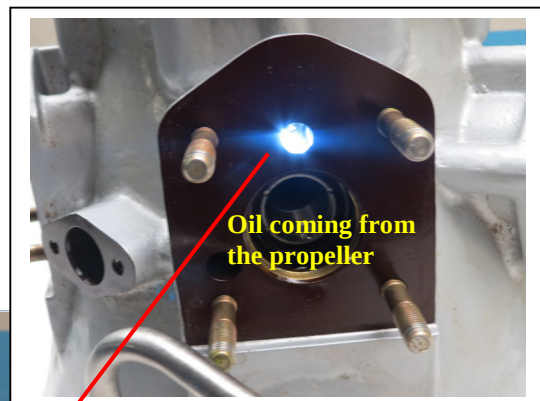
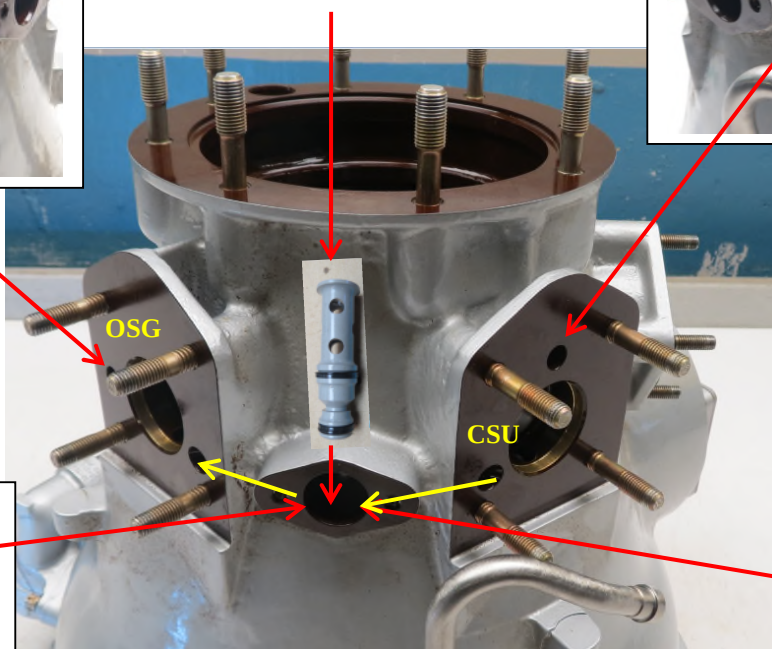
**Front Housing:** All internal oil passages for the propeller governor (CSU) and the overspeed governor (OSG) in the front RGB housing were visually examined and no obstruction was observed (Photo No. 44).

Photo No. 44  
Front RGB housing  
Oil passages (yellow arrows)  
for the propeller governor  
and overspeed governor

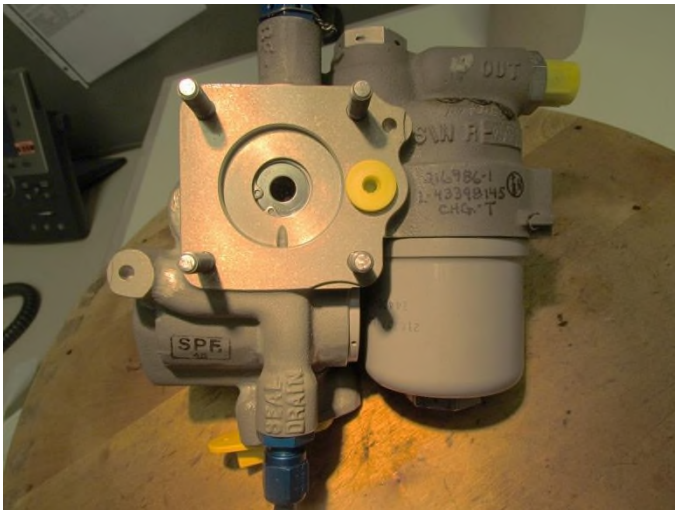
Picture 1

The fuel pump was in good condition (picture 1). The input shaft was rotating without restriction. The lockwire of the filter bowl was missing. Remaining Lock wires/safety cables were present and intact. The lockwire between the motives flow fitting and the cap plug on the filter upstream pressure port looked different. The lockwire was measured and meet the drawing requirement. Prior testing, the filter bowl was removed. The remaining fuel was collected and placed into a plastic container (Picture 2). The fuel within the container was water free. The fuel filter was removed and visually inspected. The filter appeared clean (Picture 2). Examination of the filter bowl revealed traces of dark debris suspended in the fuel (Picture 3). This is not an unusual condition. The inlet screen port cover was removed to allow access to the inlet screen assembly. The screen meshing was clean with the exception of a small piece of black debris. This is not an unusual condition. The debris was collected and placed in a container. The fuel pump was reassembled and was tested satisfactorily (Picture 4). The pressure port plugs and fittings were removed to allow fuel pressure monitoring in the course of the fuel pump fuel filter bypass test (Picture 5). After testing, the fuel pump was returned to its as received condition. As agreed with the NTSB representative, the fuel pump disassembly was not performed.

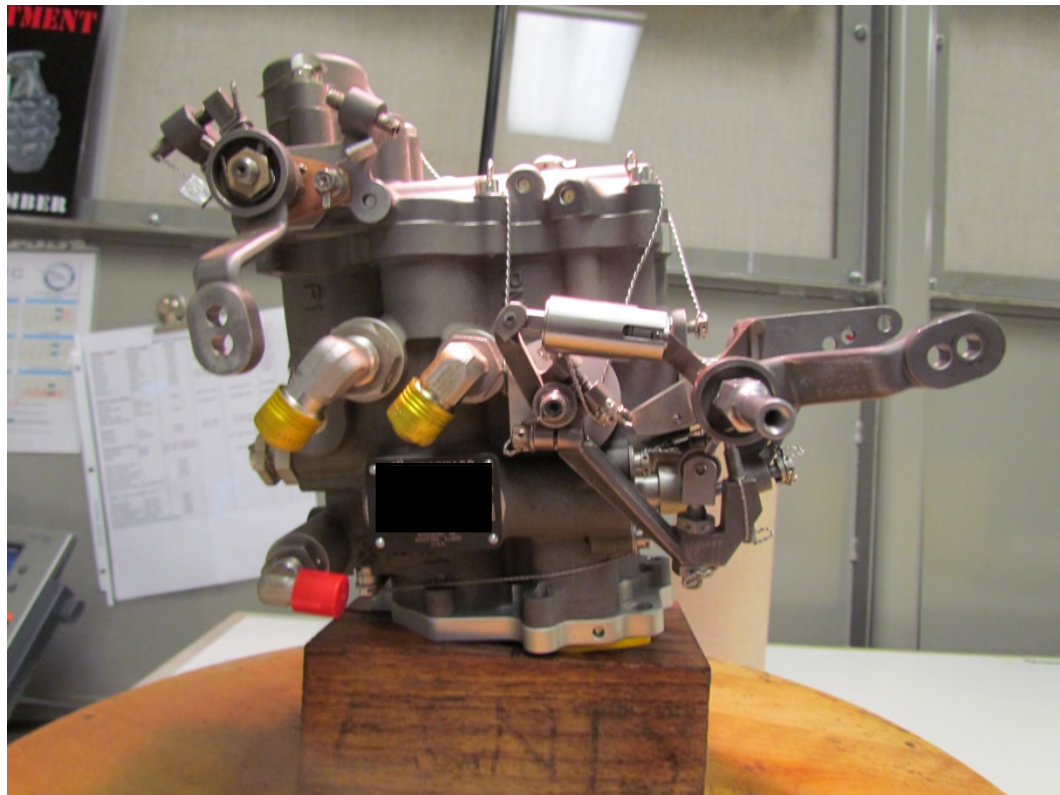
Picture 6

The FCU was in good condition (Picture 6). The input shaft was rotating with typical resistance. The manual override lever was lockwired on the normal position stop. The throttle and condition levers were moving freely. The cut off valve was moving freely on its full travel. Lockwires and safety cables were present and intact. The lockwire seal on the cut off adjustment was stamped with the letter W. There were seals stamped with the letter (W) on the manual override normal and maximum position adjustment screws, on the Fuel valve port adjustment cap plug. There was white paint on the bolts head of the base plate, on the bellow adjustment and on the cut off valve adjustment. The P3 (compressor discharge air) fitting was removed from the air inlet port.

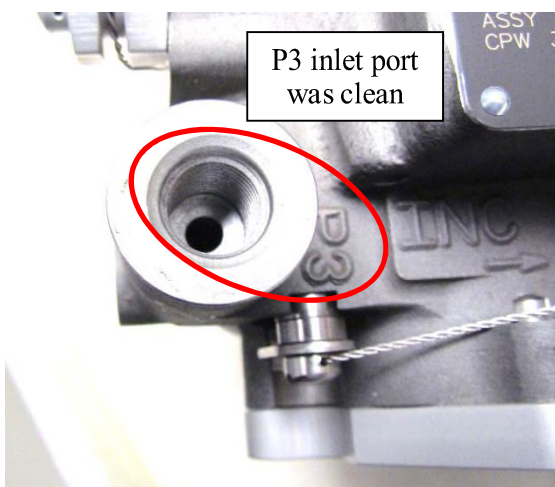
Picture 7

The P3 inlet port was clean (Picture 7). The P1 (fuel inlet) and PN (fuel nozzle flow) fittings were removed. The inlet fuel filter in the P1 port and the PN outlet port were both found uncontaminated (Picture 8). Picture 9 shows the hardware removed from the FCU for installation of the test fixtures (Picture 10). The removed hardware was kept in a seal bag with the FCU. The fuel control was tested in accordance with the [REDACTED]. The FCU operated normally within the test requirements except for the High idle, the maximum reverse and maximum forward speed setting, which were slightly above the maximum limit. These are normal field adjustments. As agreed with the NTSB representative, the FCU disassembly was not performed.

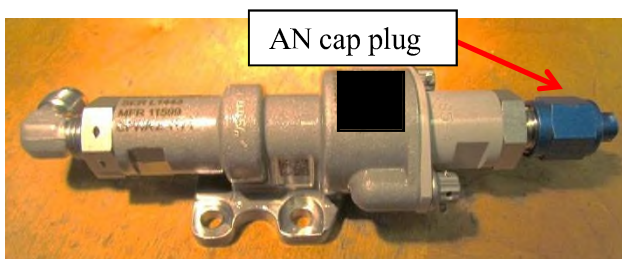
Picture 11

The flow divider was in good condition (Picture 11). The dump valve fitting was capped with a blue AN cap plug. The safety wire was present on the bolts holding the dump valve housing to the main housing. The flow divider was tested satisfactorily per the [REDACTED] (Picture 12). As agreed with the NTSB representative, the flow divider disassembly was not performed.

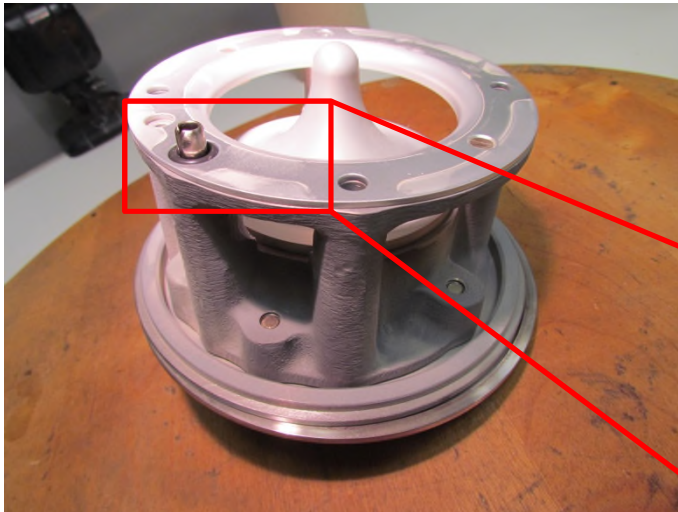
Picture 13

The bleed valve was in good condition. Fine grey powder was present on the P2.5 path (Picture 13-14). The piston was moving freely. Lock wire was present between both plugs on the cover. Note, there is no specific bench test for the Bleed Valve. The bleed valve closing point is checked and calibrated while installed on the engine. The closing point of the bleed valve is matched with the engine compressor performance. The bleed valve closing point may require adjustment if the compressor performance changes. To evaluate the piston seal ring performance, the bleed valve was installed on a test fixture to monitor the differential pressure between the P3, air supply from the engine to the bleed valve inlet port, and PX, pressure acting on the piston (Figure 1). The differential pressure was measured to be 0.01 psid, thus indicating that the leakage from the piston sealing ring was minimal. Note, the PX chamber port plugs on the cover, was removed to allow pressure monitoring (PX) (Picture 15). The plug was reinstalled after testing. As agreed with the NTSB representative, the bleed valve disassembly was not performed.

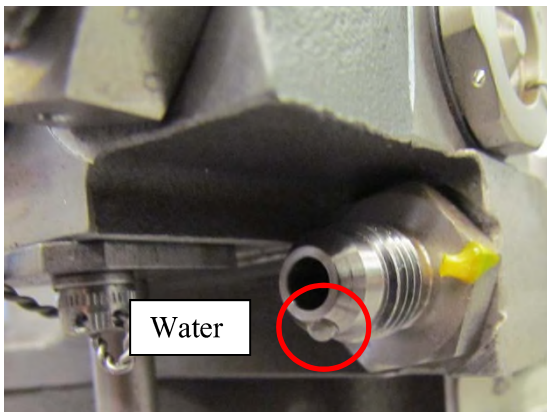
Picture 16

With the CSU installed on the engine, the cap on the PY port fitting was removed and a drop of water was observed on the edge of the fitting (Picture 16). Water was also observed inside of the removed cap (Picture 17). Once removed from the engine, the Constant Speed Unit (CSU)/Propeller governor looked in good condition (Picture 18). The solenoid valve assembly connector was capped with a black plastic cap. The cap was secured in place with a lockwire. The on-site accident pictures were reviewed by the NTSB representative and confirmed that the cap and lockwire were in the same condition as viewed on the accident site (Picture 19). The input shaft was turning freely. The reset arm was moving freely. The feathering piston was free to move on its entire stroke. The speed control lever was moving freely and was returning to the maximum speed stop with its own spring tension. Lockwires were present and intact. The seal on the regulating valve adjustment was present and intact. Torque seal on the feathering valve adjustment and to the reset arm adjustment was present and intact. With the NTSB agreement, the CSU was shipped to [REDACTED] for testing and disassembly. [REDACTED] was created providing the instructions to investigate the CSU. The CSU was sent to [REDACTED] on the P&WC Delivery note [REDACTED] and the [REDACTED].

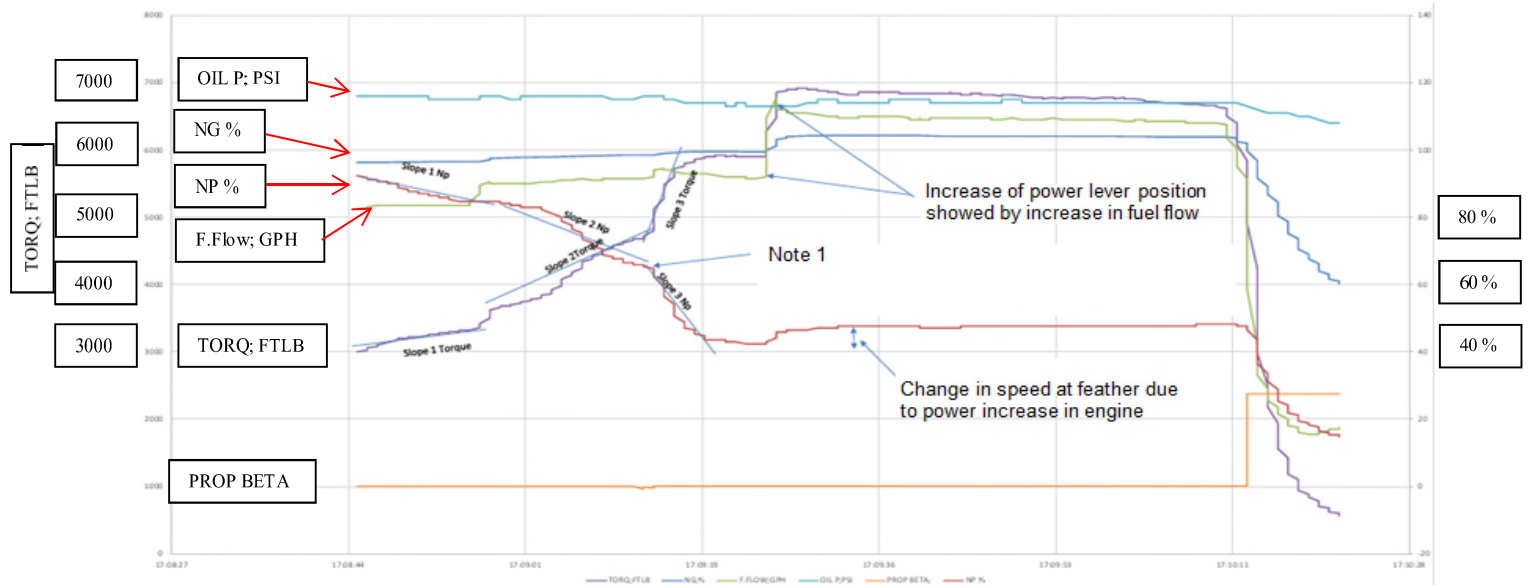
Graph No. 1

- 2.5 As per [REDACTED] flight data recorder analysis, the torque (Tq) rate of change (slope #3 on the graph No.1 from P&WC Accessories Accident report 18ECN00120) increased rapidly at 62% propeller speed and the propeller speed (Np, slope #3) rate of change decreased rapidly at the same moment (time stamp 25:09:14). As per [REDACTED] CSU test results, the propeller speed control lever activated the feather valve at 62% propeller speed position (dotted arrow, Sketch No.1). This observation indicates the feather valve was activated by a movement of the Propeller Lever from the cockpit (arrow, Sketch No. 2). Consequently, going towards feather position, the engine thrust was reduced.

- 2.6 The flight data recorder analysis (graph No.1 from P&WC Accessories Accident report 18ECN00120) showed a sudden fuel flow increase at time stamp 17:09:25. This observation indicates that the pilot moved the Power Lever (dotted arrow, Sketch No. 2) to increase thrust. Consequently, the Tq increased up to 6920 ft-lb.

Note 1: The speed at the location is 62% or 1060 RPM Prop speed. This is the same speed position where the propeller speed control lever will activate the feather valve. Testing of the propeller governor showed the feather valve was activated at 62% speed (2644 RPM Prop Gov. Input speed). This also shows an increase in rate of change in propeller pitch indicating the feather valve was activated.

From the chart it was observed that the NP speed changed at 3 different rates between 17:08:44 time frame and 17:09:19 time frame. This indicates a change in propeller speed control lever position that changes at different rates. The three different slope areas are defined as;

In the Slope 1 time frame, the engine NP dropped from 92 to 84% speed (1570 to 1440 Prop RPM). Torque increased from 3000 ft. lbs. to 3620 ft. lbs. From the Hartzell data regarding the thrust at this condition, very little change in thrust was observed in this range.

Slope 2 time frame, a similar condition occurred. NP dropped from 84 to 65%. However, the thrust only decreased by 10% in this time frame.

In the slope 3 time frame, a different situation occurred. It should be noted the start of the slope change occurred at 62% or 1060 RPM propeller speed. This is the same speed that the propeller speed control lever on the propeller governor is set to activate a feather activation piston. The rate of the oil flow out of the propeller piston increased from a rate of 1.1 to 3.13 in<sup>3</sup>/second. 3.13 in<sup>3</sup>/sec converts to about 3.24 quarts/min. This combined with the pump flow in this underspeed condition (62%) would be about 9.1 quarts/min that needs to be drained from the propeller piston. This flow rate (using the pressure drop value during the as received testing) roughly calculates to a pressure drop from the piston of about 170 psi. This is comparable to the pressure generated by the propeller spring and counterweights. Both the flow and speed activation point indicate the feather activation piston was activated by the propeller speed control lever causing a low thrust condition. In addition, the speed was decreasing at slower rates up until the feather activation speed, indicating the propeller speed control lever was moving during the incident and the propeller governor was operating as designed controlling this speed per the propeller speed control lever input.

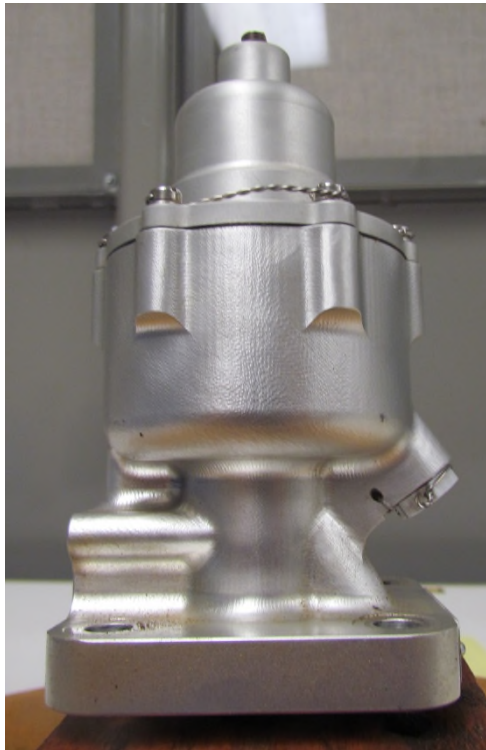
Picture 20

The Overspeed Governor (OSG) was in good condition (Picture 20). The input shaft was rotating without restriction. The electrical connector was clean but there was no protective cap on the connector (Picture 21). One of the contact pin was slightly damaged on the tip (Picture 22). Lockwires were present and intact. The solenoid body was properly secured. White paint was present on the speed adjustment. With the NTSB agreement, the OSG was shipped to [REDACTED] for testing and disassembly. [REDACTED] was created providing the instructions to investigate the OSG. The OSG was sent to [REDACTED] on the P&WC Delivery note [REDACTED] and the [REDACTED]
