**Air Tractor, Inc.**  
**Accident Investigation**

**ENGINE REMOVAL NOTES**

**CEN17LA284**

**18 Jul 2017**  
**Reyno, Arkansas**

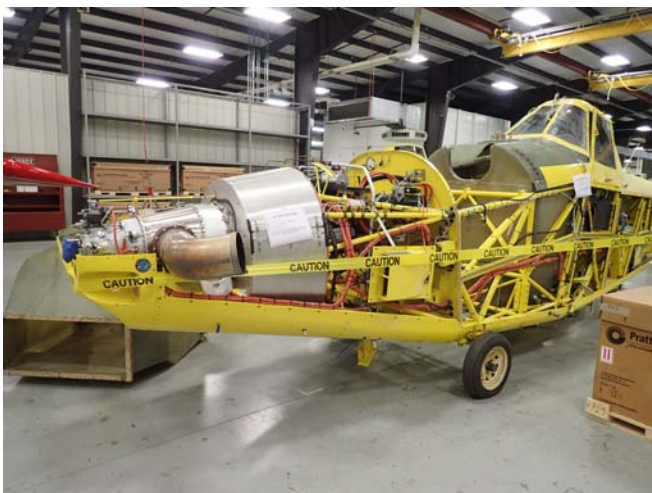
The aircraft wreckage had been placed in a storage area of the Air Tractor factory and had been segregated from other aircraft parts. Signage was posted to indicate that this wreckage was sensitive and could not be handled without permission of the NTSB. In addition, the area was roped off with yellow CAUTION tape to further isolate the wreckage (Photos 1 and 2).

**Photo 1 - Quarantined Wreckage**

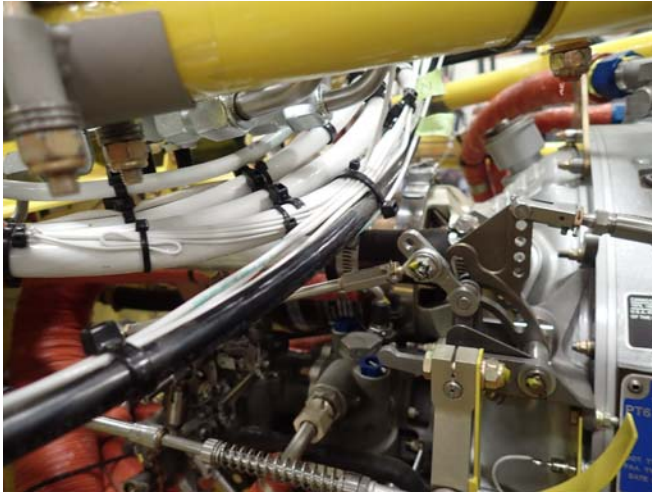
1. This aircraft was equipped with an aftermarket hydraulic installation that had displaced the electrical cables coming from the engine Starter/Generator. These cables were deflected downward within one inch of the engine power controls. These cables were not supported and moderate hand pressure could deflect the cable into the power controls. No signs of contact between the cables and the power controls were obvious. (See Photo 3)
2. The aircraft radio stack had been removed from the radio console. This had been done prior to arrival at Air Tractor. (See Photo 4)

**Photo 3 - Cabling routed near engine controls**

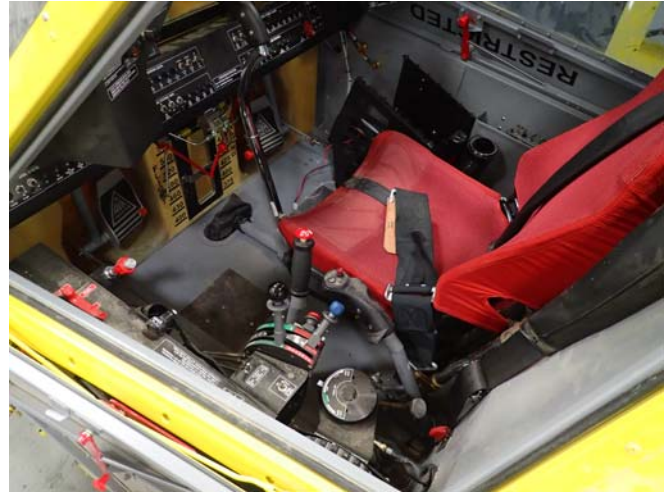
**Photo 4 - Cockpit with no radios installed**

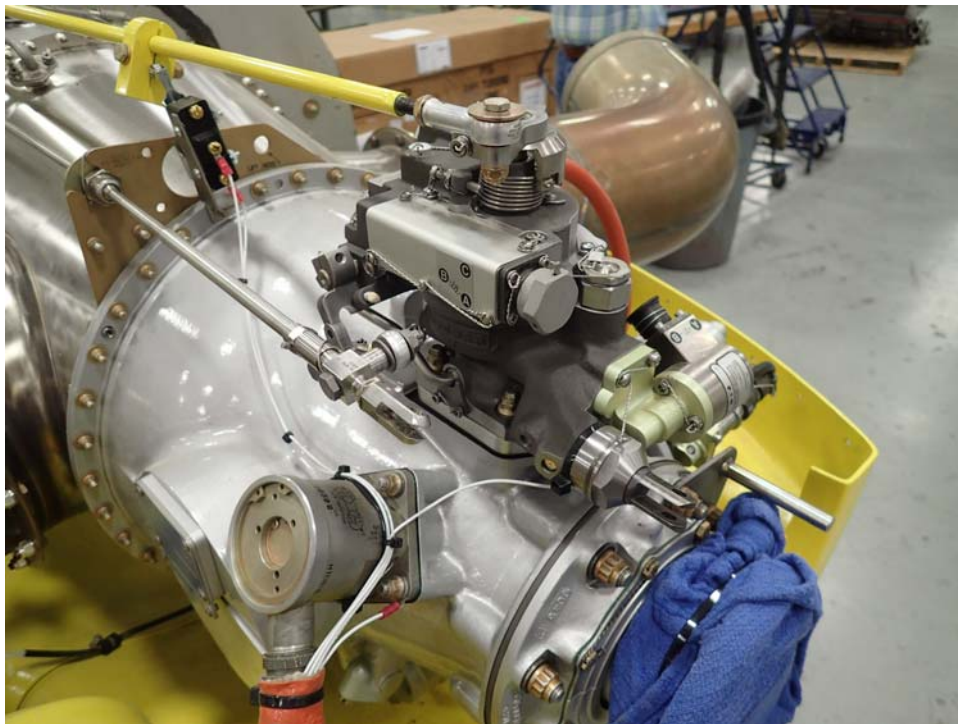
Yellow torque seal was freshly applied to the four nuts securing the Propeller Governor (Photo 7). The Propeller Governor was not removed from the engine (Photo 5 & 6). The Propeller Overspeed Governor was not disturbed except that the upper-forward mounting nut had to be removed for the removal of a ground wire ring terminal (Photo 6). The nut was reinstalled.

**Photo 5 - Propeller Governor as installed**

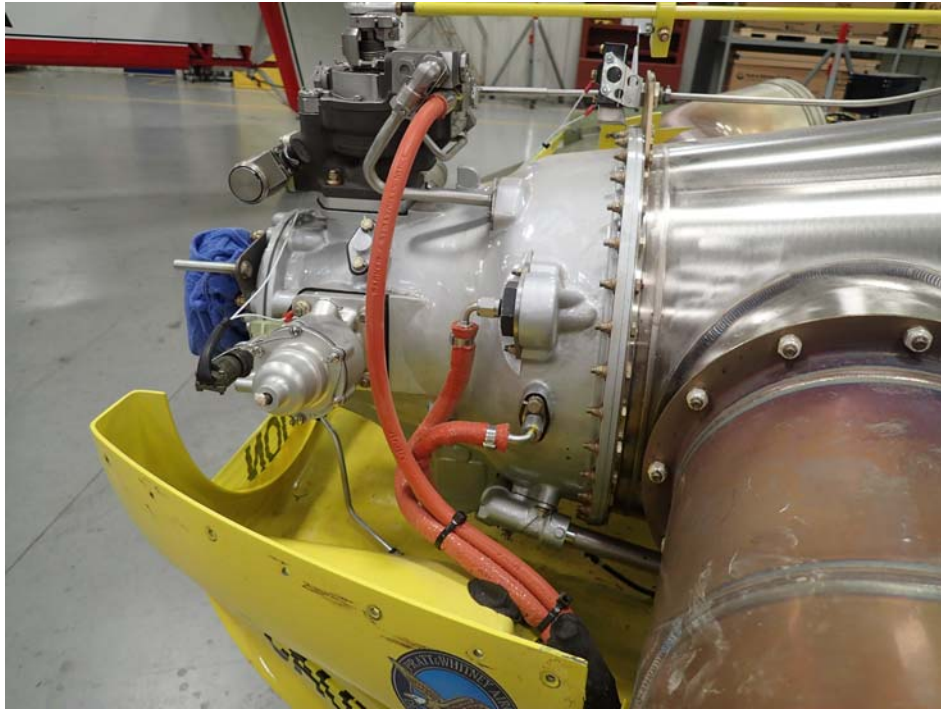
**Photo 6 - Propeller Governor and Overspeed Governor**

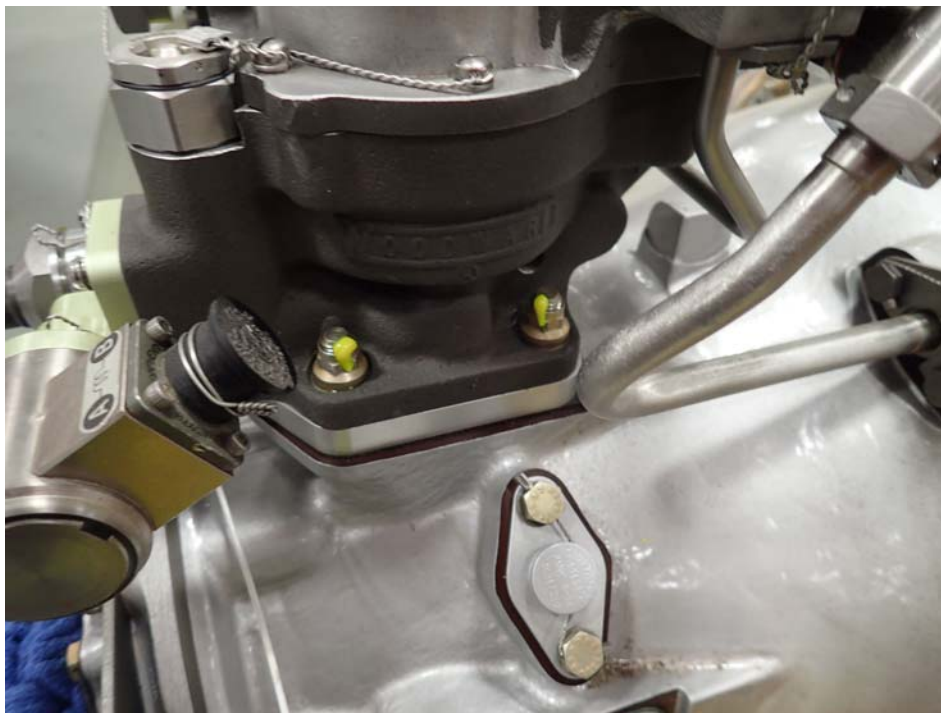
**Photo 7 - Yellow Torque Seal added to nuts on Propeller Governor  
Lefthand side shown, Righthand side similar.**

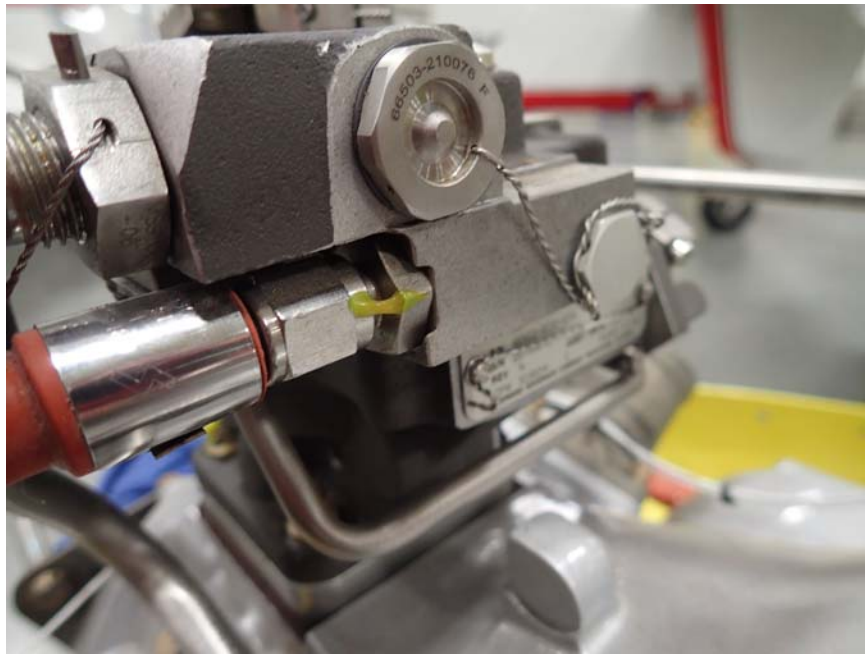
The flexible Py line that connects the FCU to the propeller governor was checked for security. Both ends of the Py line were connected with a line of torque seal applied (from initial production - see Photo 8 & 9). The forward end of Py line was removed from the Propeller Governor and capped. The fitting had been tight prior to removal. The entire length of the Py line was inspected and no gouges, cuts, or abrasions were noted. The Py line was coiled and remained installed at the FCU.

**Photo 8 - Forward end of Py line attached at Propeller Governor**

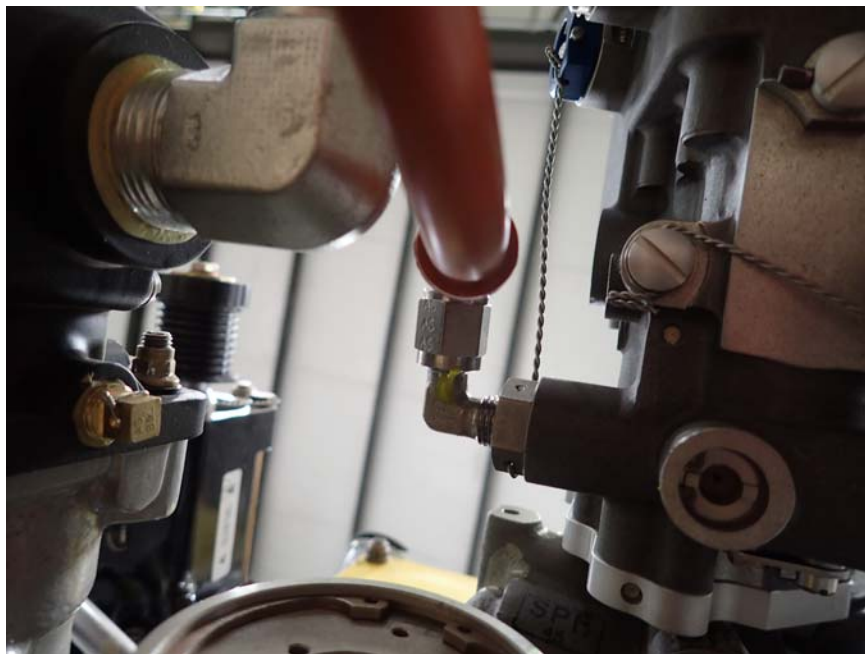
**Photo 9 - Aft end of Py line attached at Fuel Control Unit**

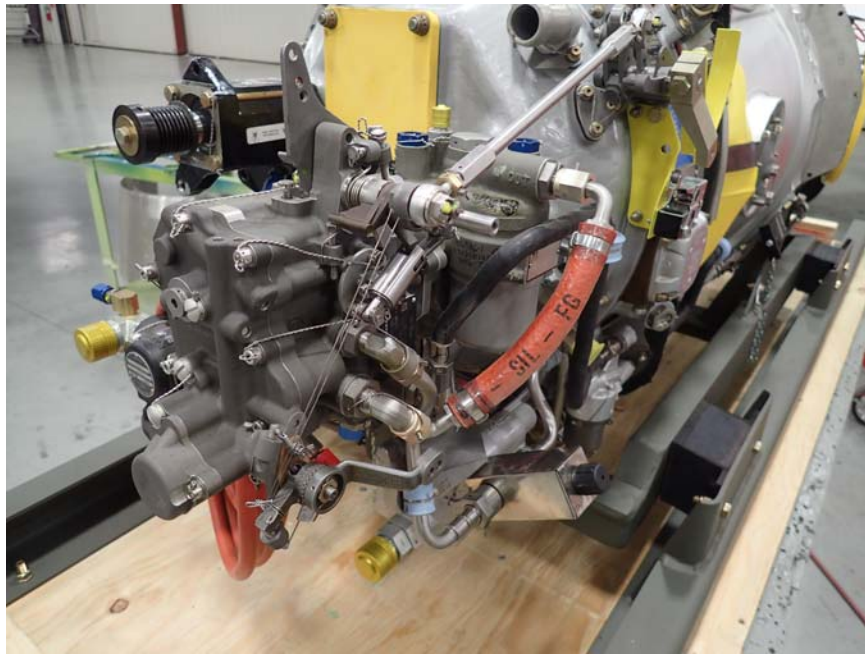
The engine starter/generator was removed from the engine and retained with the aircraft wreckage (see Photo 10). The engine pad was covered with the proper cover plate (yellow). The air conditioning compressor was removed from the engine, but the drive pad assembly remained installed.

**Photo 10 - Fuel Control Unit shown after engine placed on shipping skid**
