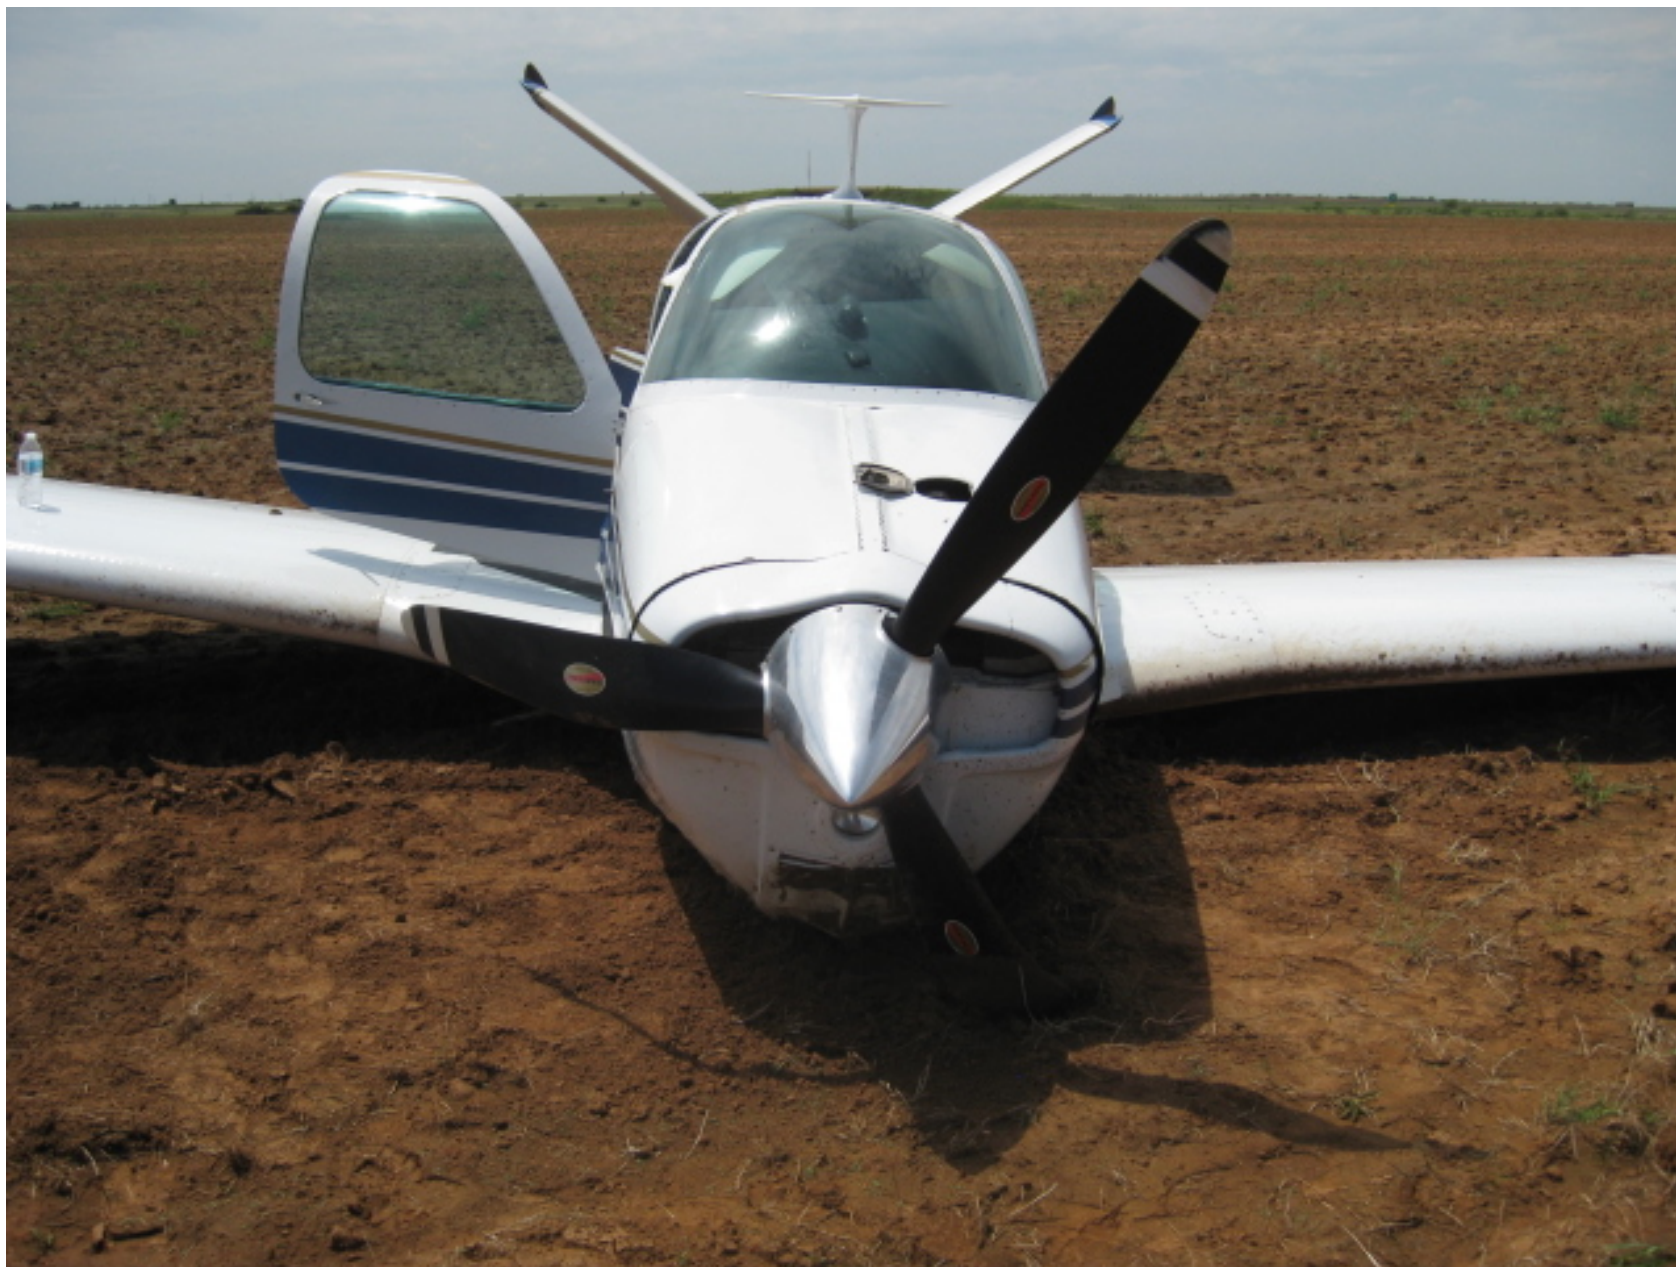
**Photo 1 – Airplane at Accident Site**

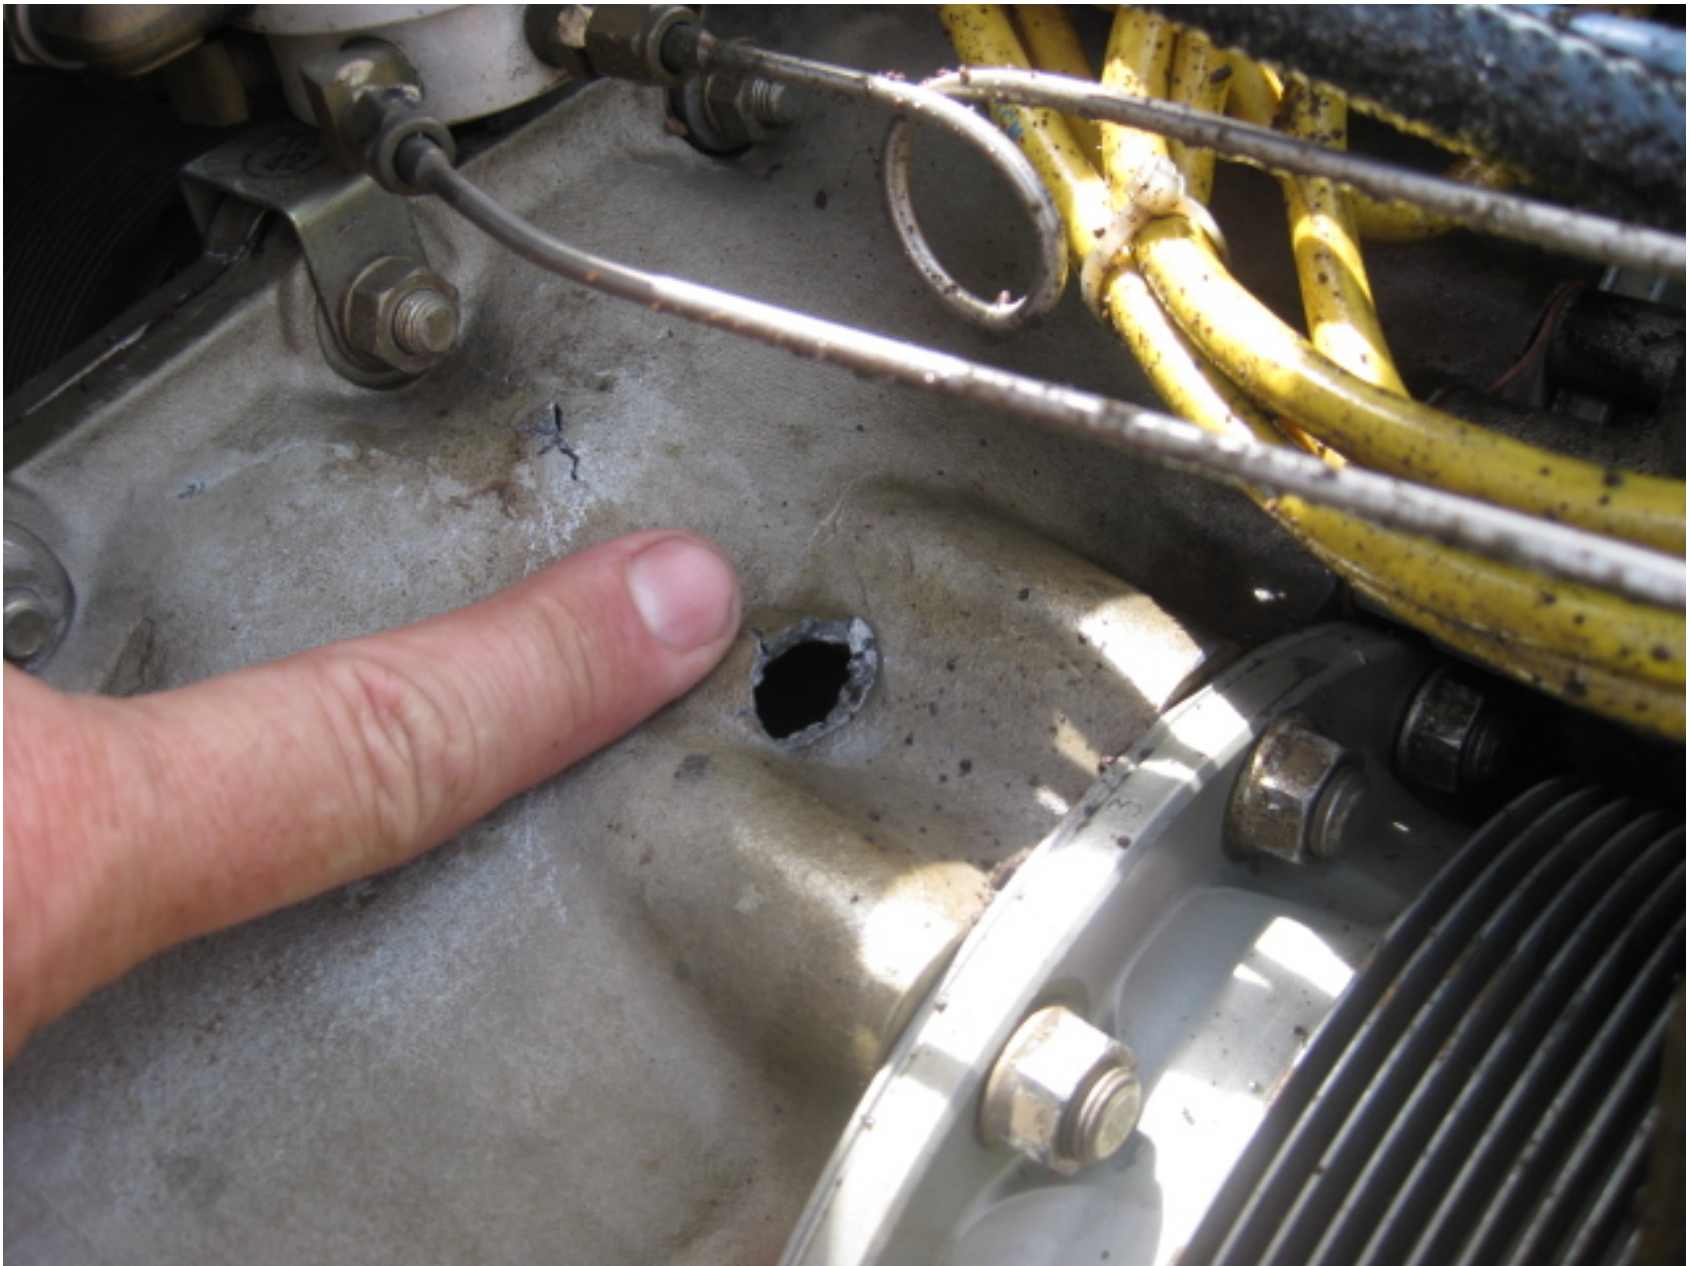
**Photo 2 – Hole Adjacent to Number 4 Cylinder**

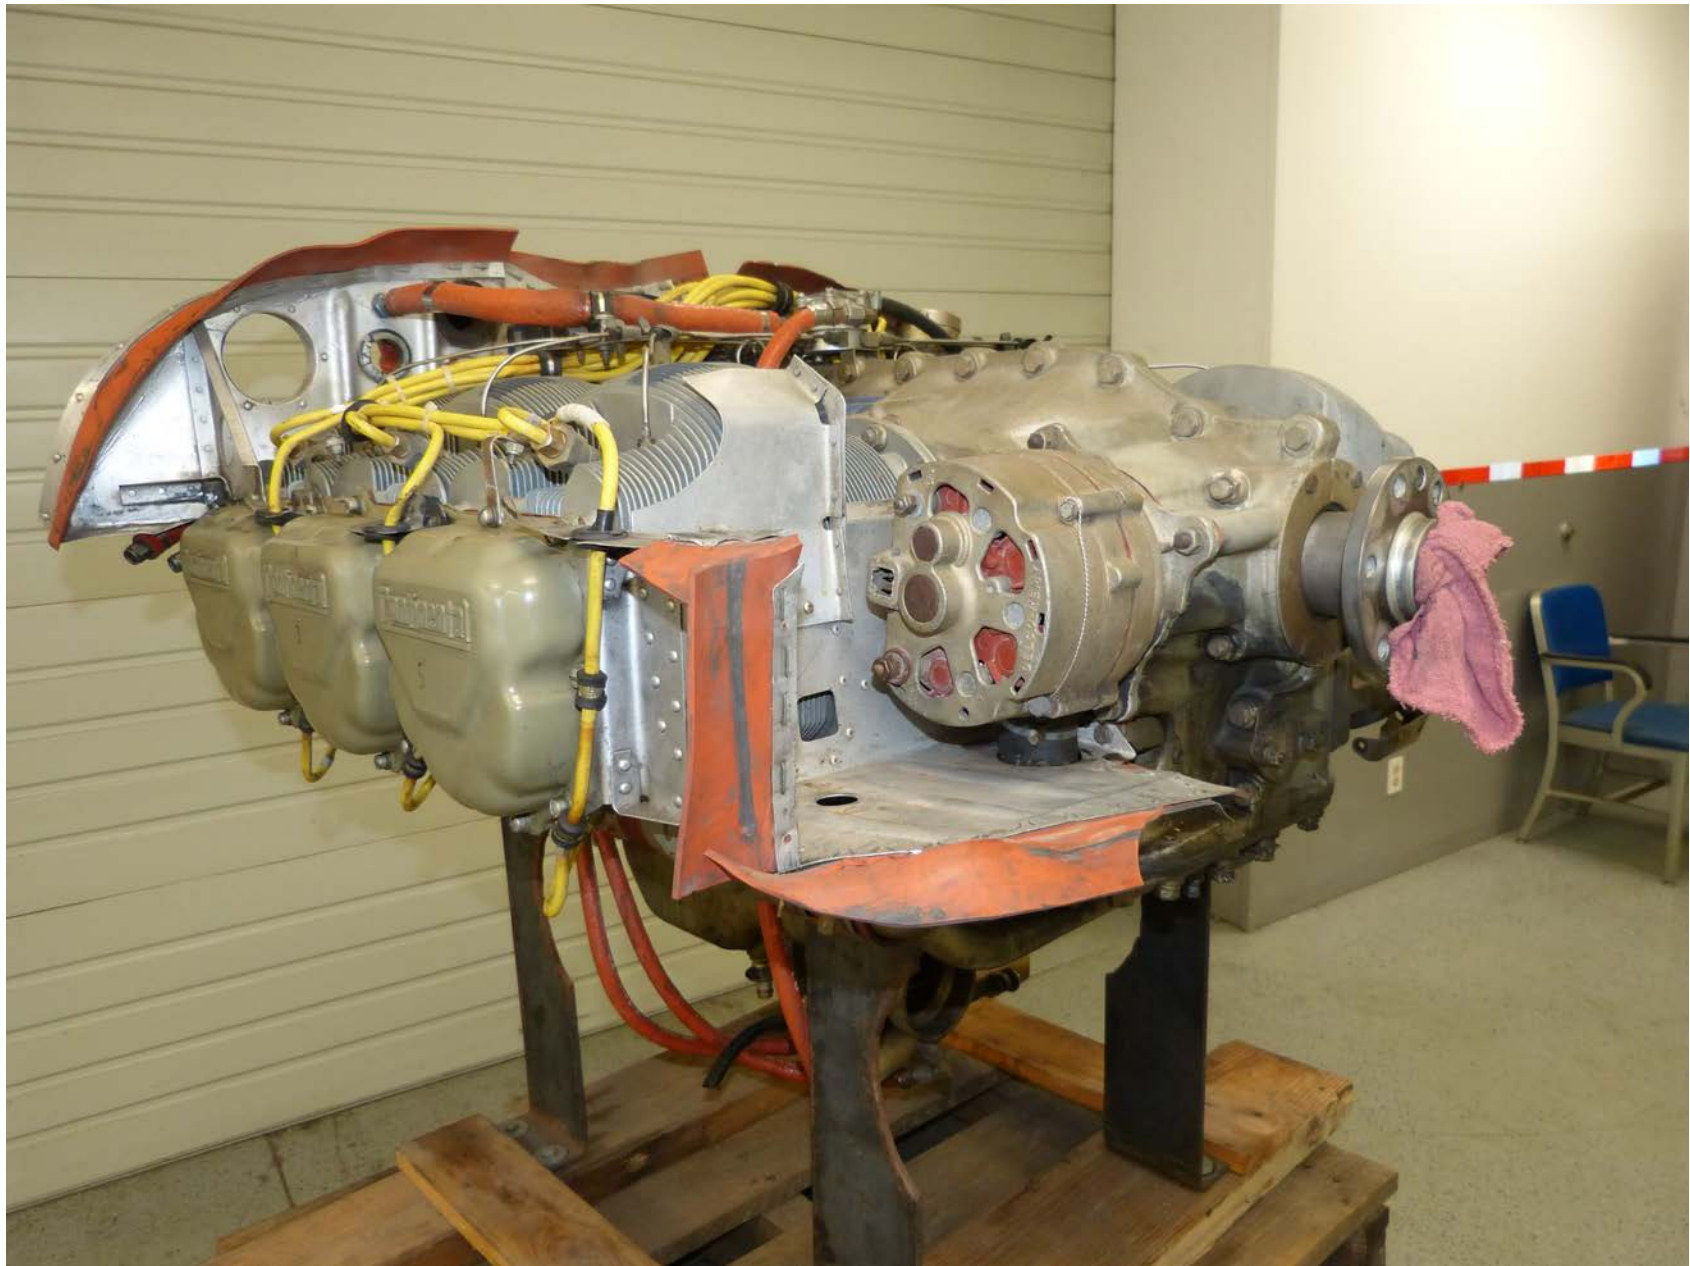
**Photo 3 – Removed Engine Prior to Examination**

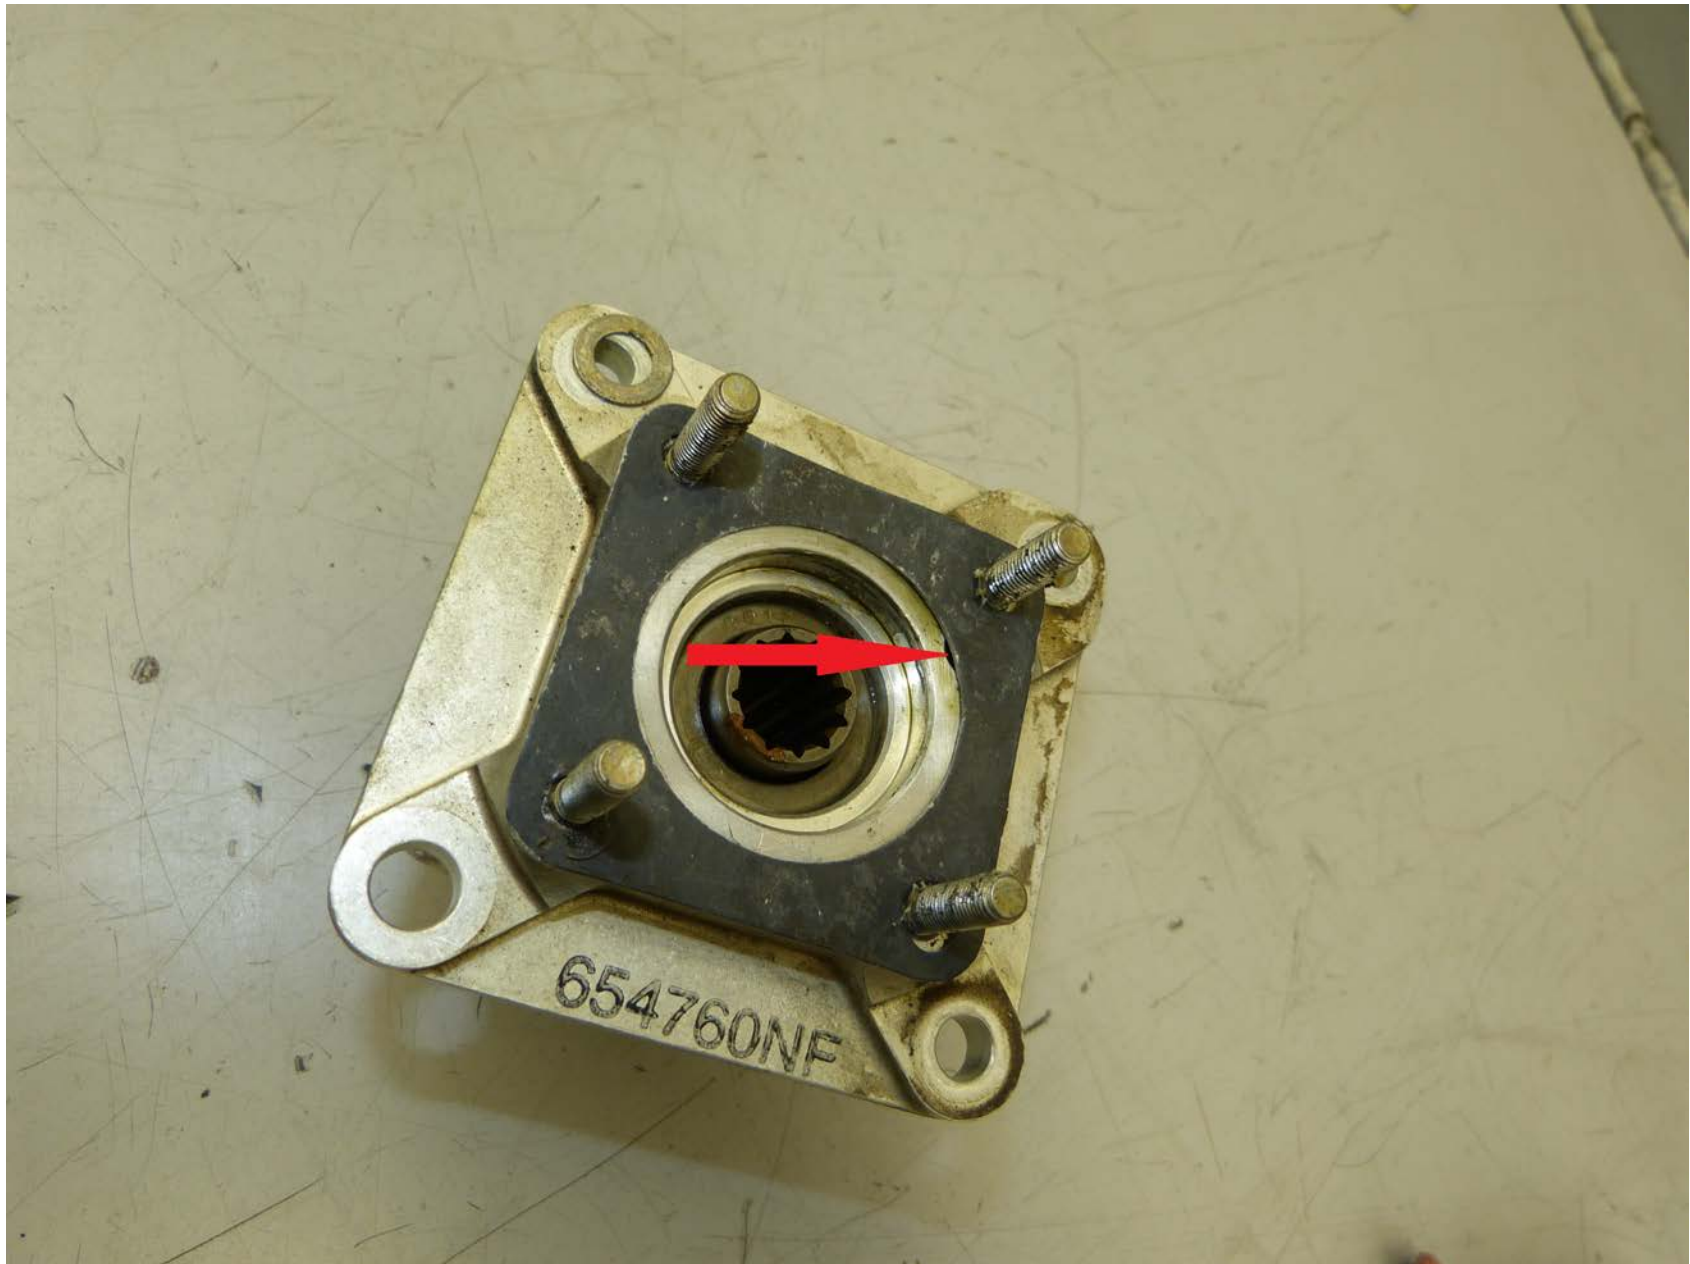
**Photo 4 – Vacuum Pump Gasket as Discovered (Red Arrow Indicates Exposed Oil Orifice)**
