# NATIONAL TRANSPORTATION SAFETY BOARD

## MATERIALS LABORATORY FACTUAL REPORT

Report No. 17-083

Place : Tahlequah, Oklahoma  
Date : July 30, 2017  
Vehicle : Piper PA-46, N786MD  
NTSB No. : CEN17LA292  
Investigator : Jim Silliman, AS-CEN

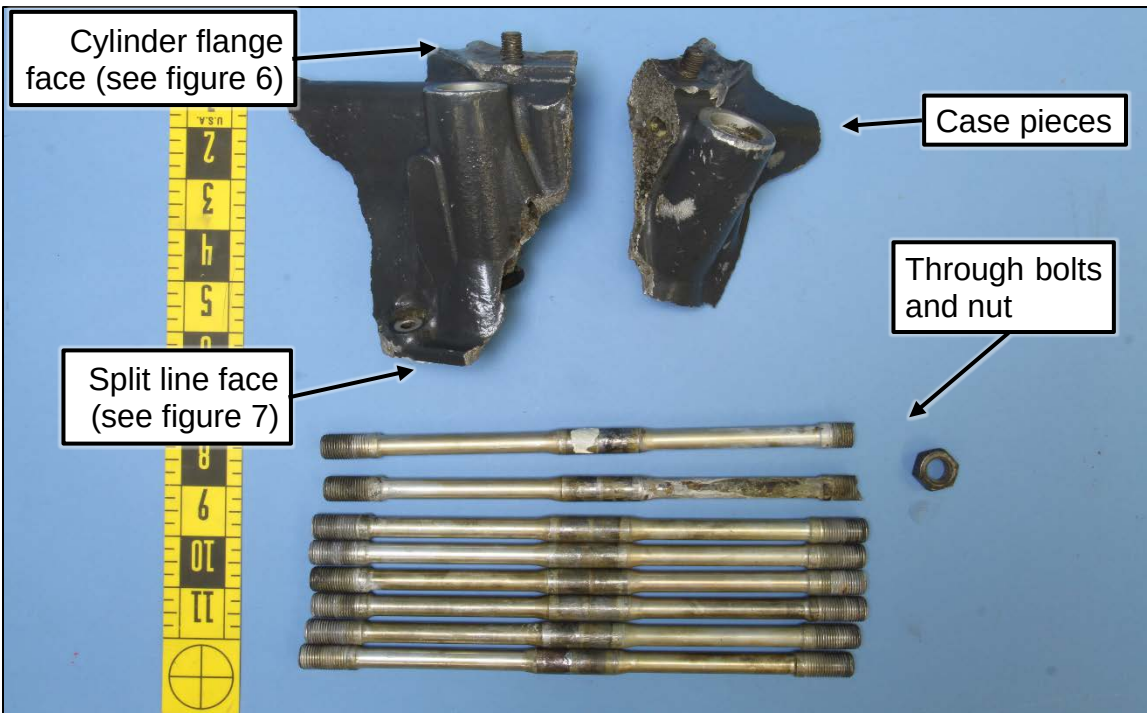
An overall view of the submitted components is shown in figure 1. The components included 2 pieces of the crankcase with two fractured cylinder attachment studs. Two of the eight submitted through bolts were also fractured.

Figure 1. Overall view of the submitted components.

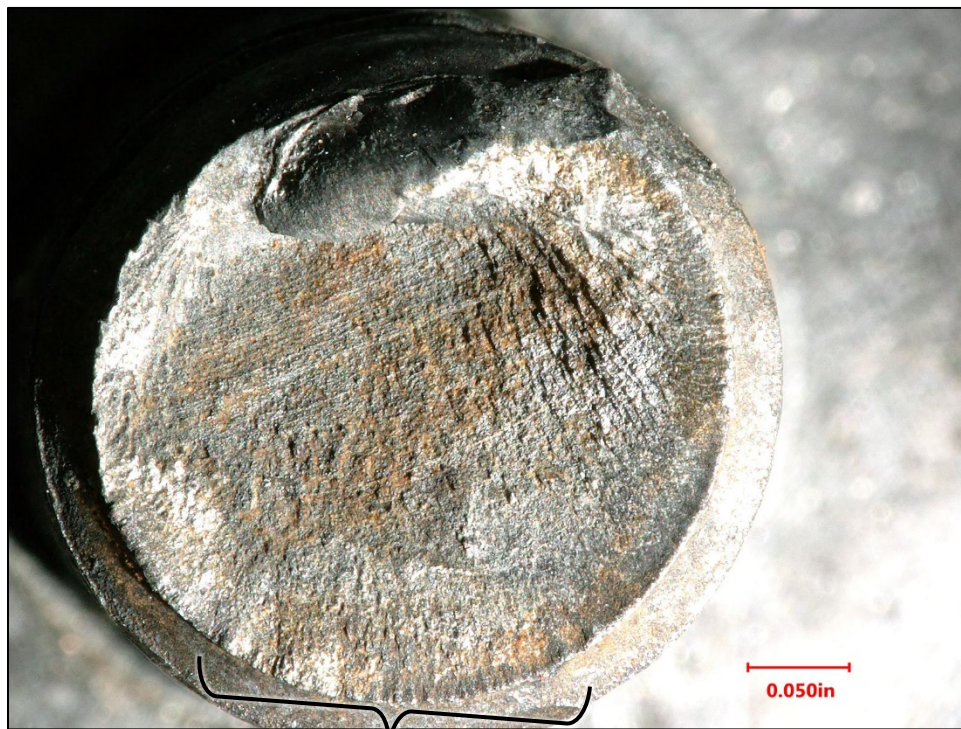
Optical images of the fracture surfaces on the cylinder attachment studs are shown in figures 2 and 3. Crack arrest lines and ratchet marks<sup>1</sup> were observed on the stud fracture surfaces, features consistent with fatigue with multiple origins in the areas indicated with brackets in figures 2 and 3. Fracture features in the fatigue regions had a relatively rough appearance consistent with relatively high cyclic stresses.

Figure 2. Fracture surface on one of the studs. A bracket indicates the approximate fatigue origin area.

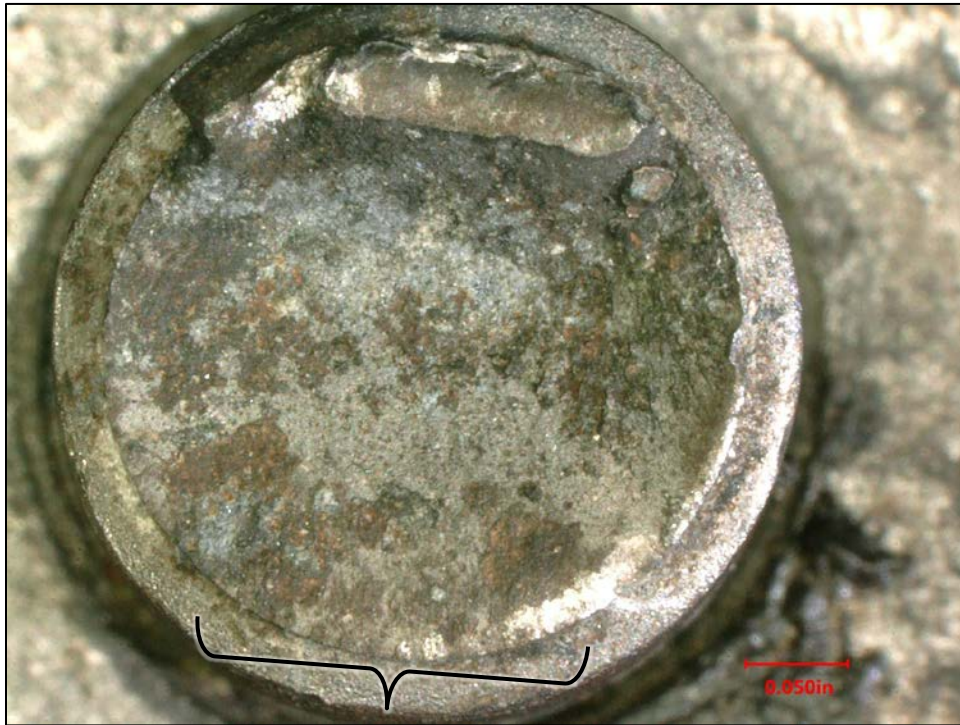
Figure 3. Fracture surface on one of the studs. A bracket indicates the approximate fatigue origin area.

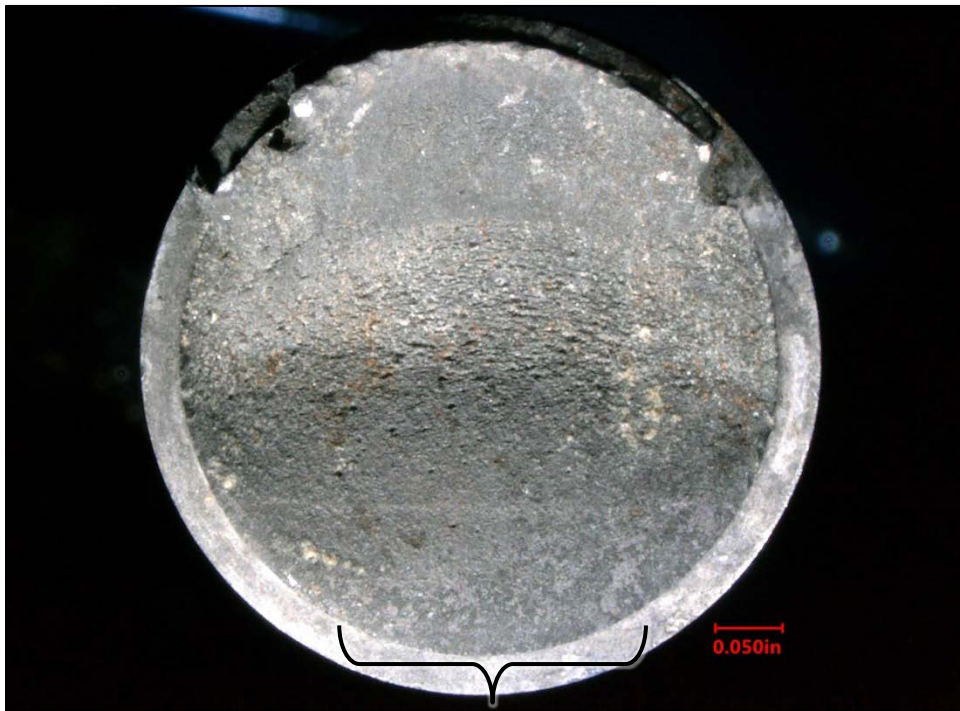
Optical images of the fracture surfaces on the two fractured through bolts are shown in figures 4 and 5. Relatively smooth areas oriented transverse to the bolt axis were observed on one side of the thread consistent with fatigue fracture. Brackets in figures 4 and 5 indicate approximate fatigue origins. The fatigue regions in each case transitioned to rougher matte gray features with a shear lip at the side opposite from the fatigue origin, features consistent with overstress fracture across the majority of the cross section.

Figure 4. Fracture surface on one of the through bolts. A bracket indicates the approximate fatigue origin area.

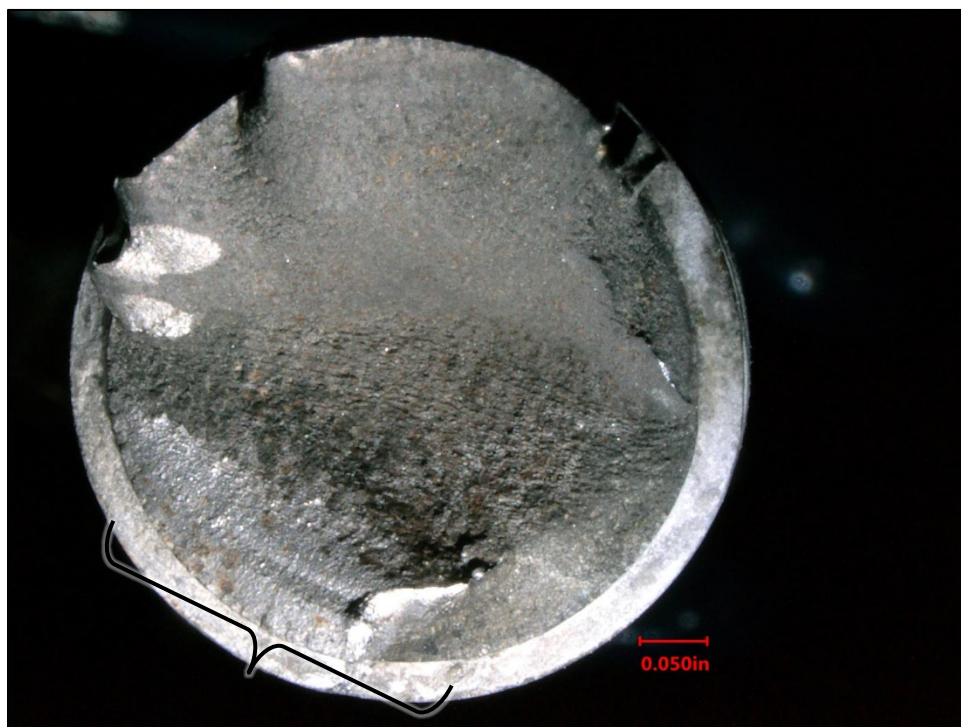
Figure 5. Fracture surface on one of the through bolts. A bracket indicates the approximate fatigue origin area.

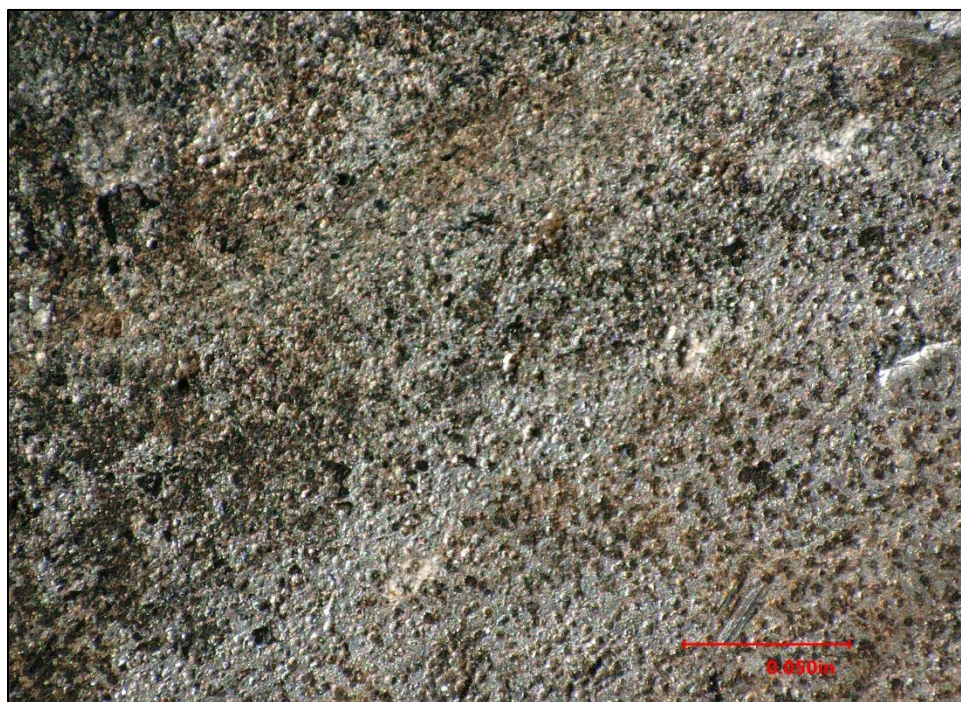
The machined surfaces of the crank case pieces, including the cylinder attachment flange, the crank case split line, and the cam shaft bore surfaces, all had a gritty or frosted visual appearance. When viewed under an optical stereoscope, the surfaces were rough

with generally semispherical pits or craters. Close views of the machined surfaces showing the pits and crater-like features are shown in figures 6 through 9.

Figure 6. Magnified optical image of the cylinder flange contact face illuminated with low-angle lighting from the right side of the image.

When grit-blasting parts[,] do not use sand or any metallic abrasives. It is recommended instead that mildly abrasive organic substances such as rice, baked wheat, plastic pellets, or crushed walnut shells be used. All machined surfaces must, of course, be adequately masked...

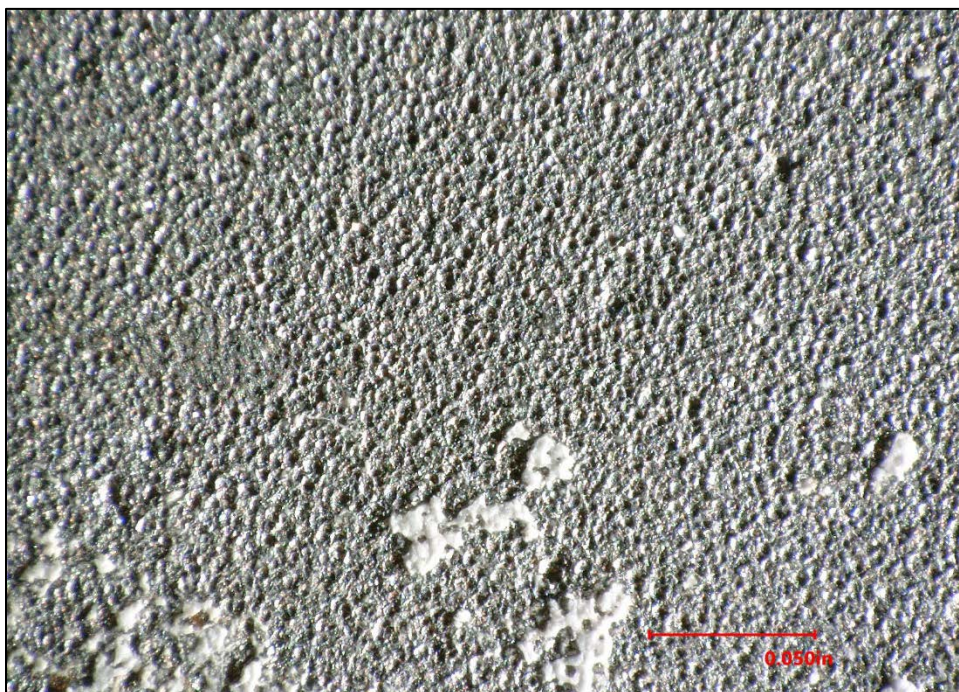
Figure 7. Magnified optical image of the case split line contact face illuminated with low-angle lighting from the right side of the image.

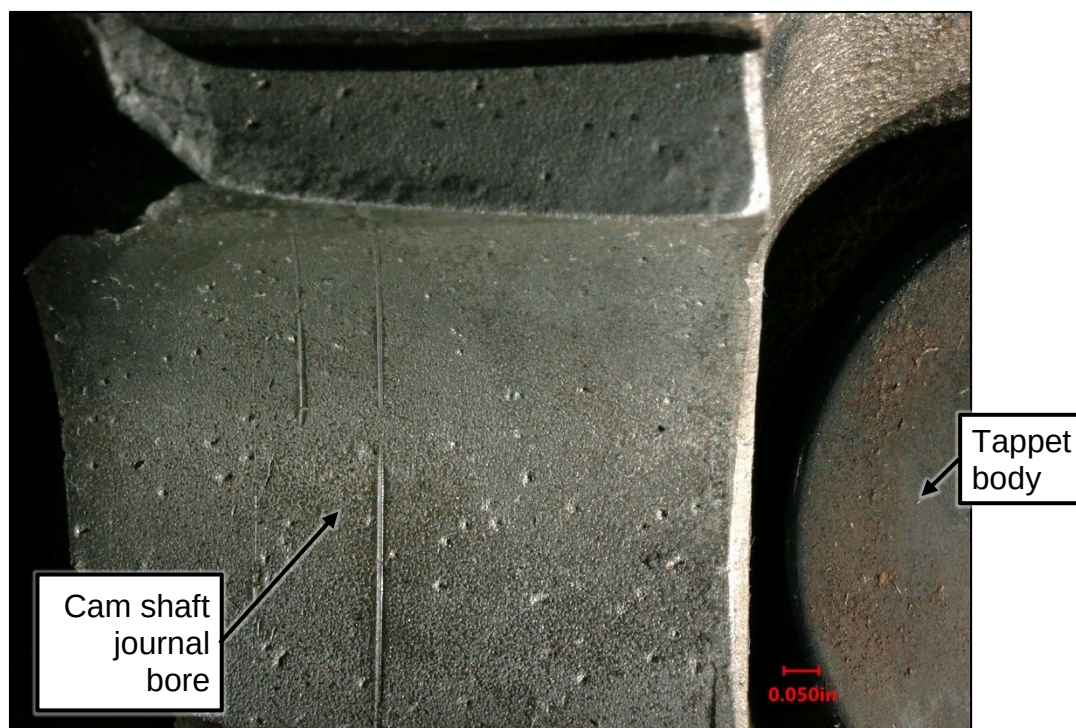
Figure 8. View of the case interior showing the cam shaft journal bore.

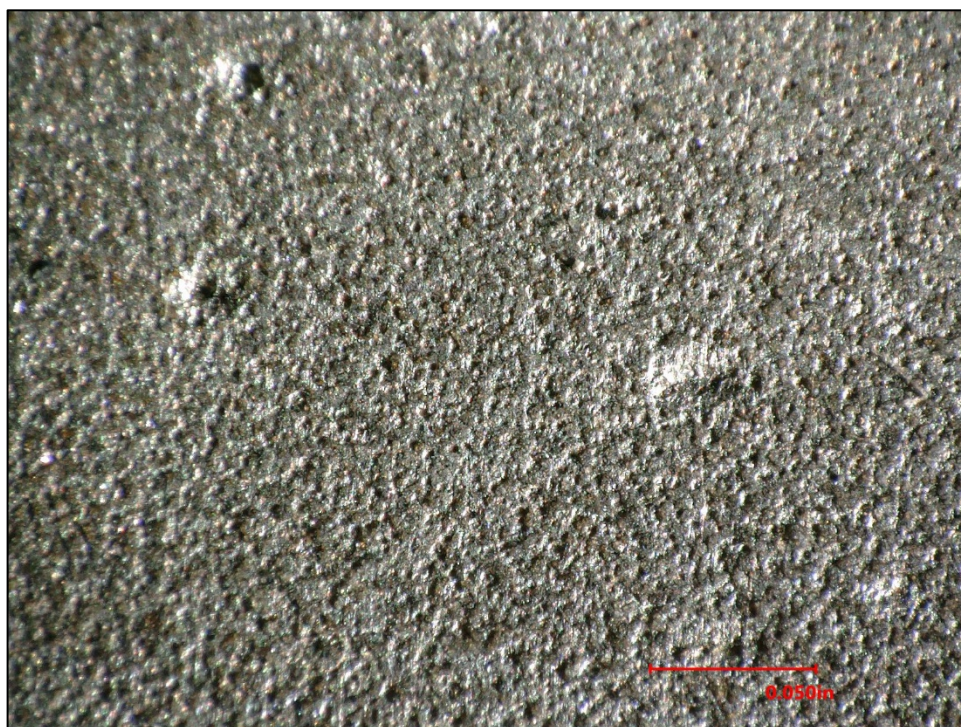
Figure 9. Magnified optical image of the cam shaft journal bore surface illuminated with low-angle lighting from the right side of the image.

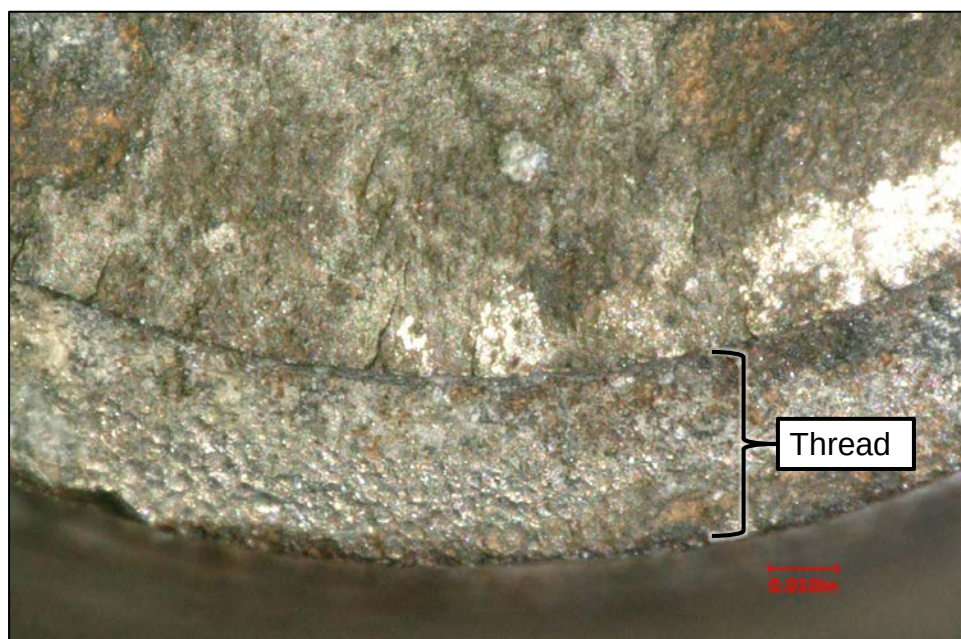
Crater-like features were also observed on the stud threads as shown in figure 10. The threads on the through bolts were free from pits or crater-like features.

Figure 10. Magnified optical image of the stud shown in figure 3 illuminated with low-angle lighting from the upper side of the image.
