# Continental Motors

## ENGINE EXAMINATION REPORT

| ENGINE MODEL | O-200-A38 |
| FILE NUMBER | 17-087 |

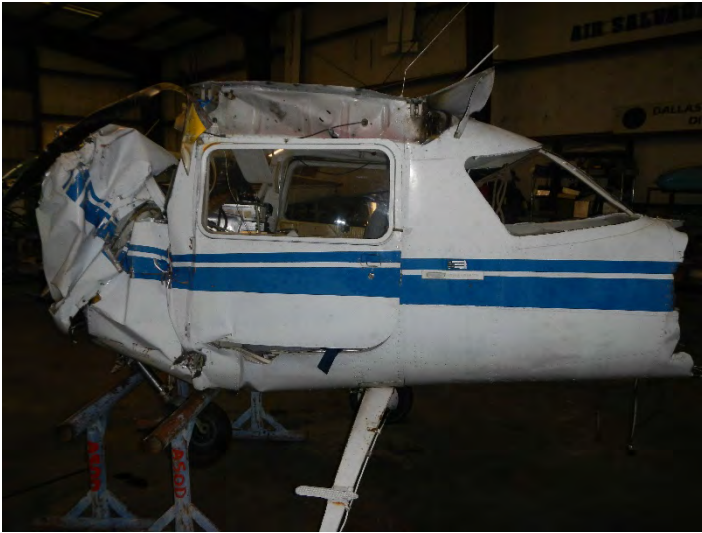
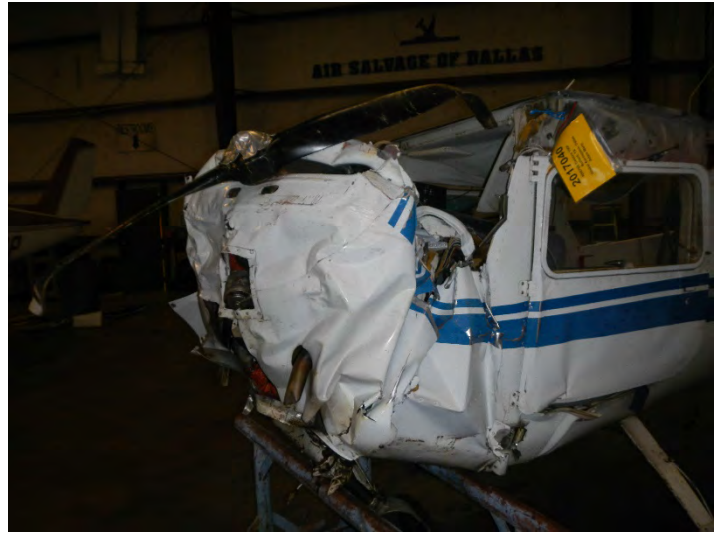
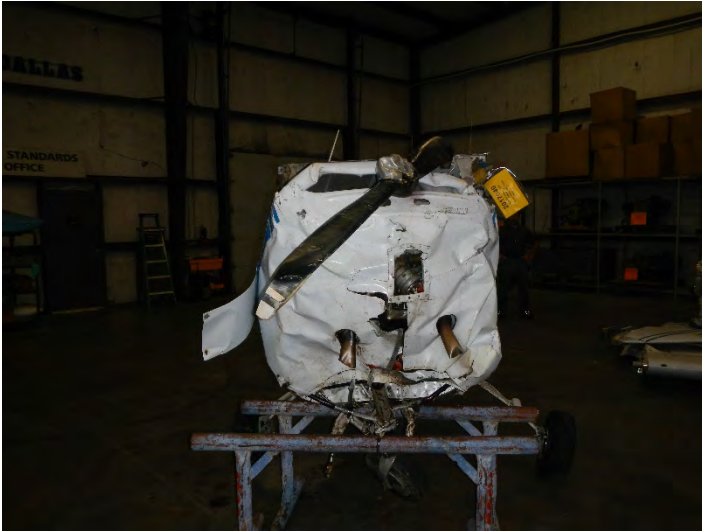
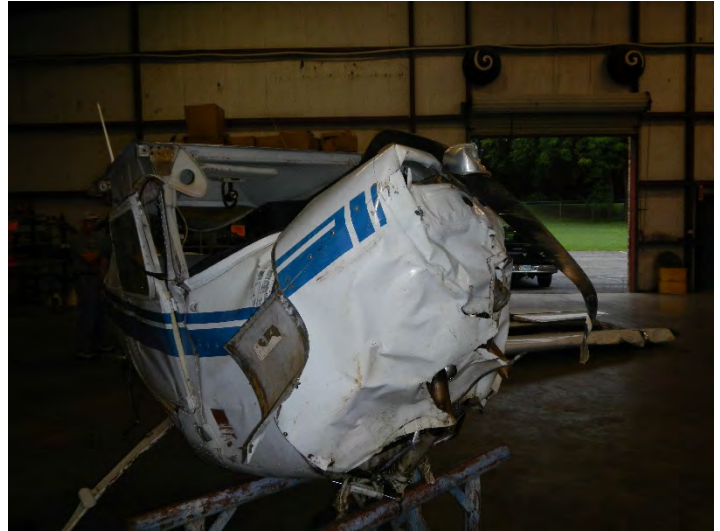
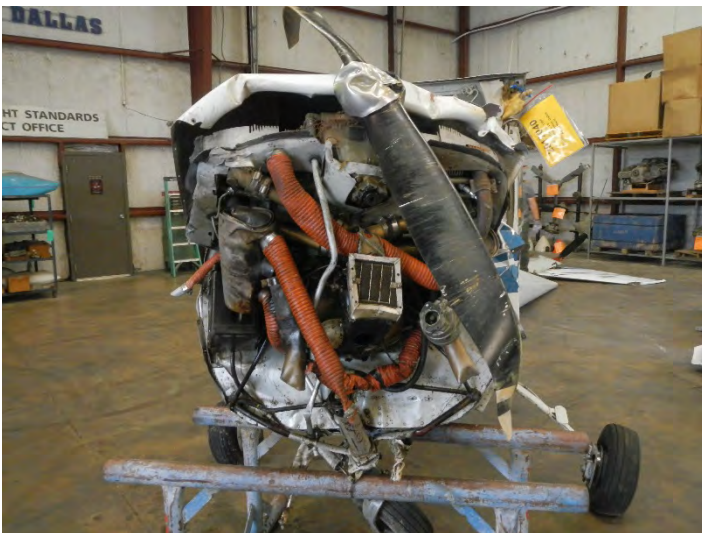
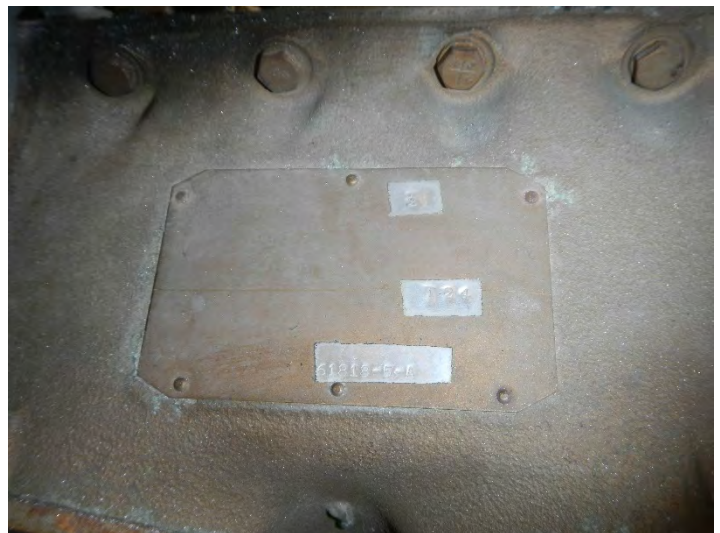
The engine was displaced aft into the firewall with the nose of the engine pointing up. The fixed-pitch propeller remained attached to the crankshaft, but the crankshaft just aft of the propeller flange was bent and cracked. The engine cowling was accordion crushed aft on the left side. The vacuum pump mount was fractured and the pump protruded from the engine cowling through the induction filter opening.

Removal of the engine cowling revealed that the exhaust system and oil sump sustained impact-related deformation and puncture damage. The carburetor mounting flange was fractured, but the carburetor remained attached to the engine via a bracket, the throttle and mixture control cables, and the fuel supply line.

The airframe engine mounts had to be cut to facilitate the removal of the engine from the firewall. There were no external pre-accident anomalies noted with the engine or engine-related systems. The right magneto was displaced slightly from the mounting pad and was rotated out of its original, pre-impact, position. A few of the ignition harness leads displayed pinching damage.

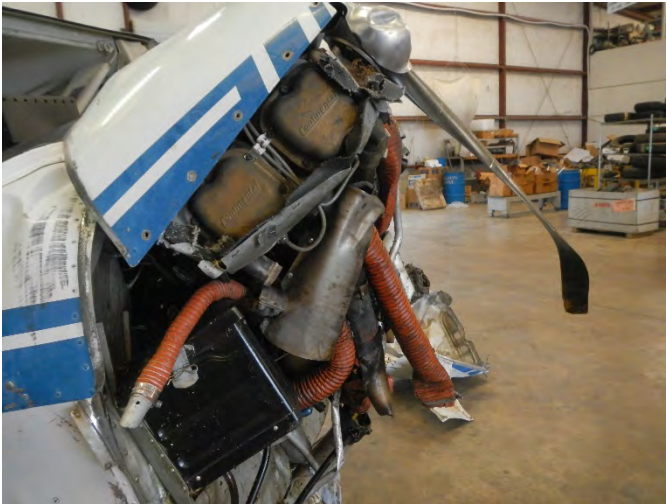
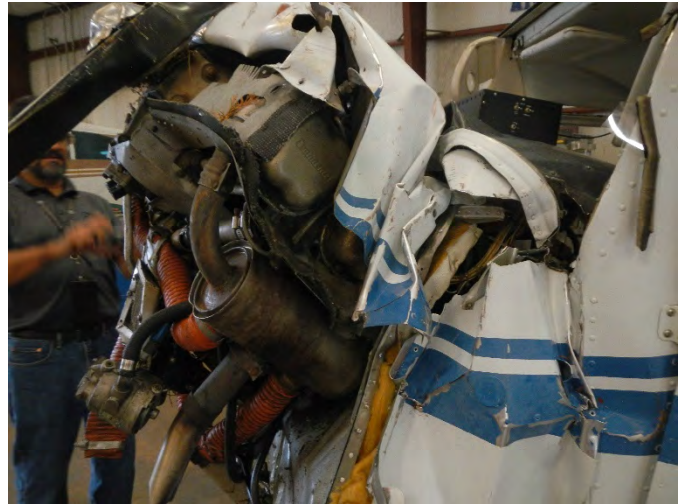
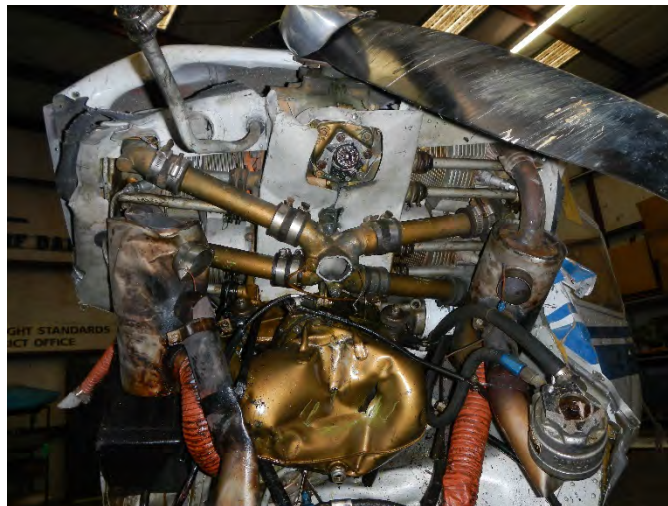
The exhaust system sustained deformation damage that displaced and deformed the right muffler. The left muffler remained attached to its exhaust risers.

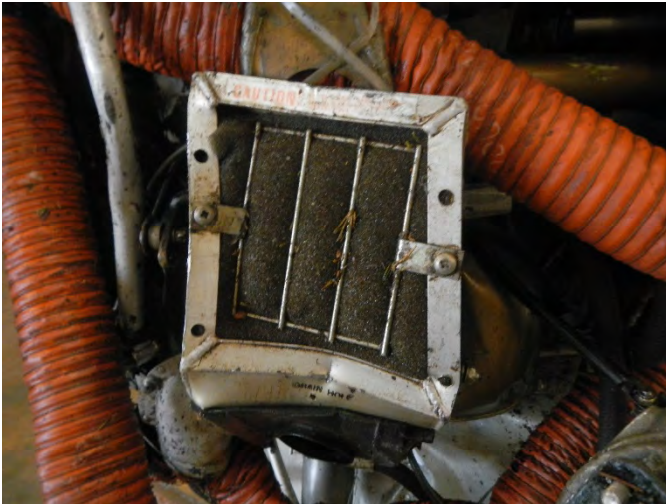
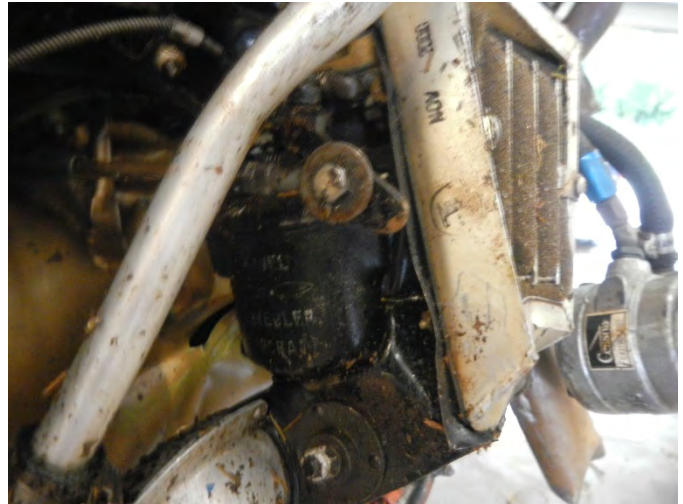
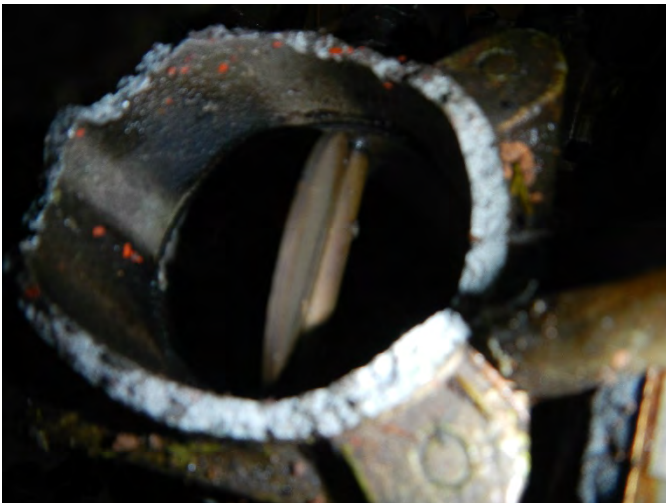
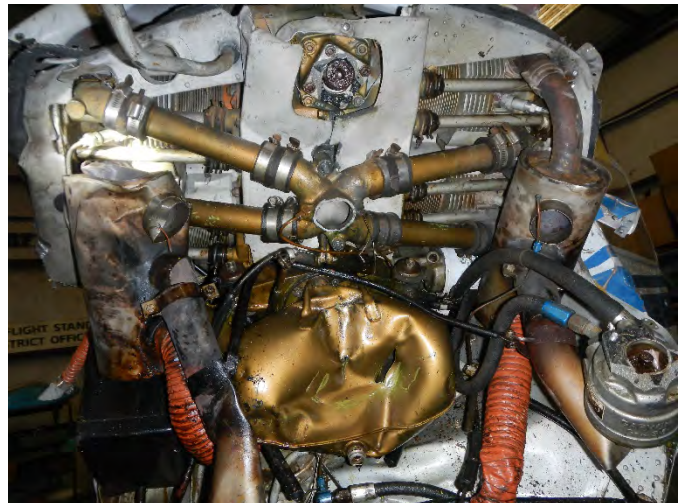
Condition: The induction filter remained attached to its bracket and it was deformed and displaced from the cowling. There were no pre-accident anomalies noted with the intake filter. The induction air box was deformed up around the carburetor. The carburetor mounting flange was fractured and the carburetor was separated from the intake tubes. The throttle control cable remained attached to the throttle control lever and the throttle valve was in the full open position.

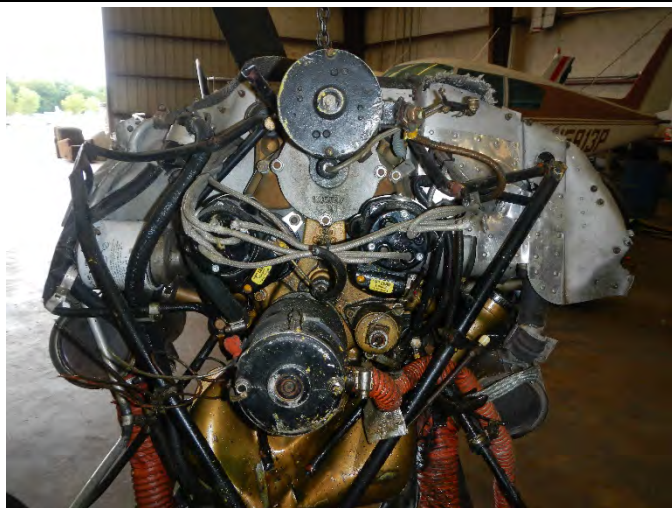
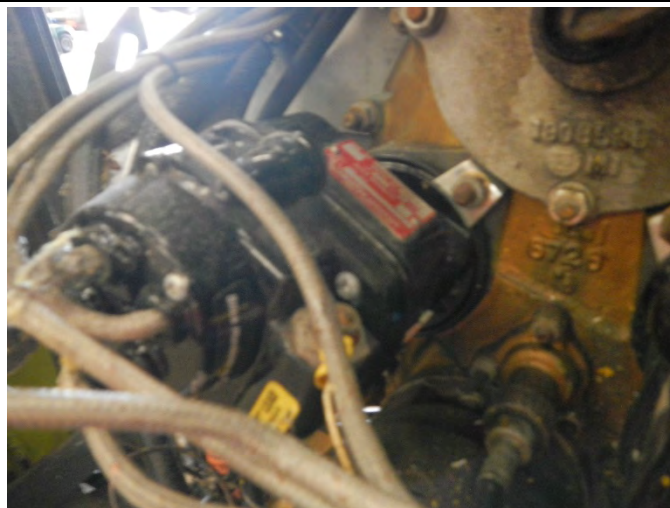
| LEFT MAGNETO | Manufacturer: Slick | P/N: 1301 | S/N:12051965 |
|---|---|---|---|
| Condition: | The left magneto remained attached to the backside of the engine and manual manipulation of the magneto revealed it was secured in place. The ignition harness remained attached to the magneto. A functional test of the magneto revealed it was capable of producing a spark through its ignition harness to the top left sparkplugs during rotation of the crankshaft and snap of the impulse coupling. | | |

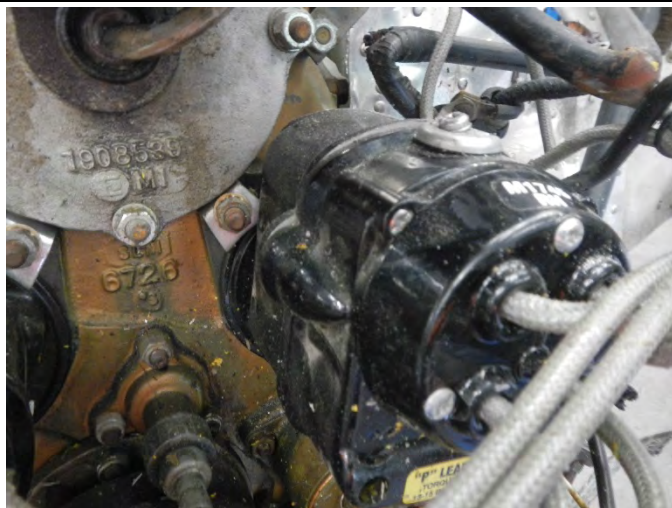
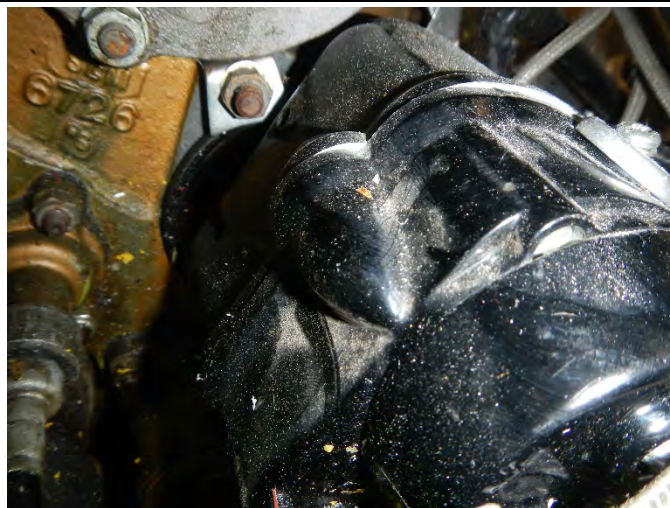
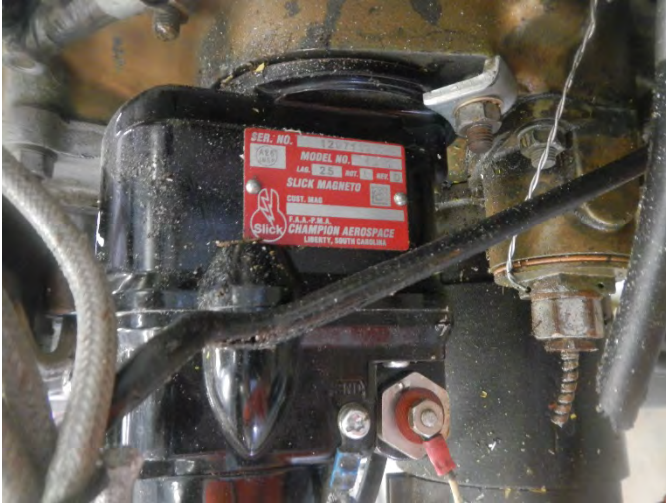
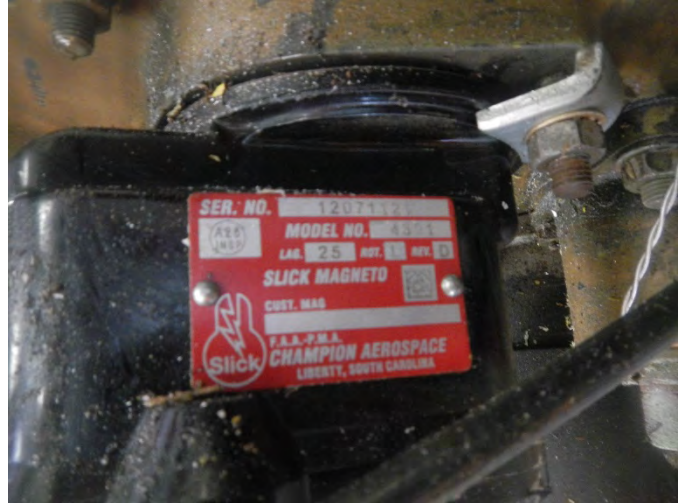
| RIGHT MAGNETO | Manufacturer: Slick | P/N: 1301 | S/N: 12071121 |
|---|---|---|---|
| Condition: | The magneto remained attached to the backside of the engine, but it was displaced aft slightly and rotated on its mounting pad. A functional test of the magneto revealed it was capable of producing a spark through its ignition harness to the top right sparkplugs during rotation of the crankshaft and snap of the impulse coupling. | | |

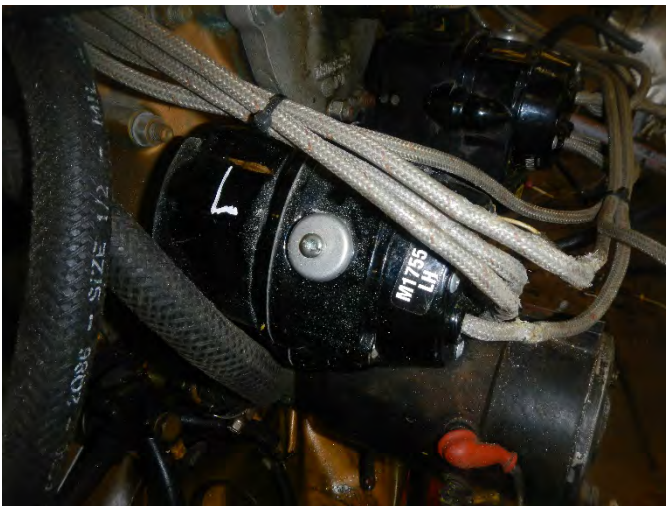
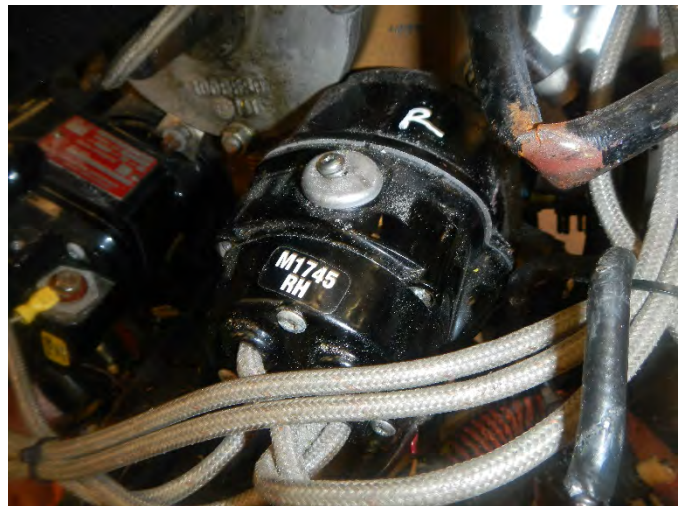
**Condition:** The ignition harness remained attached to the magnetos and the terminals remained attached to their respective sparkplugs. A few of the ignition leads sustained pinching and separation damage from being displaced into the firewall. Functional test of the magnetos revealed no pre-accident anomalies with the ignition harness.

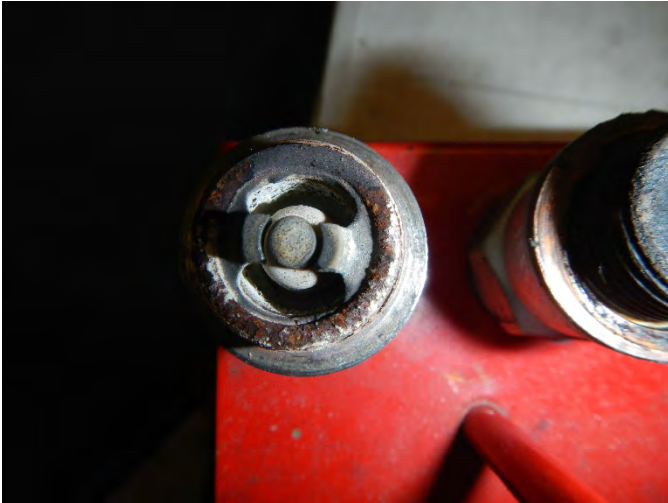
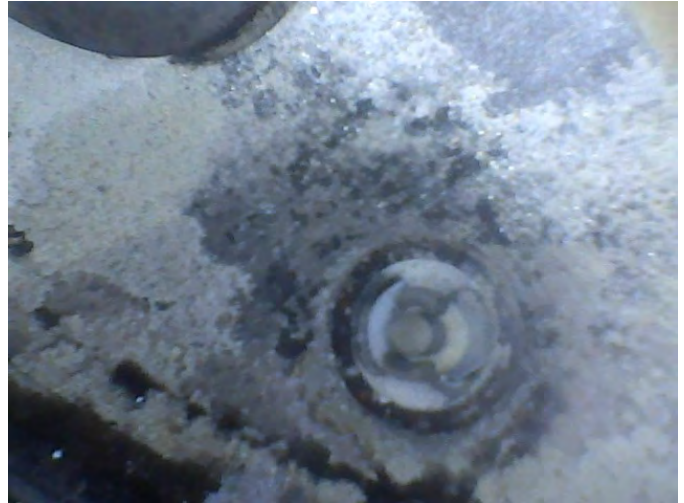
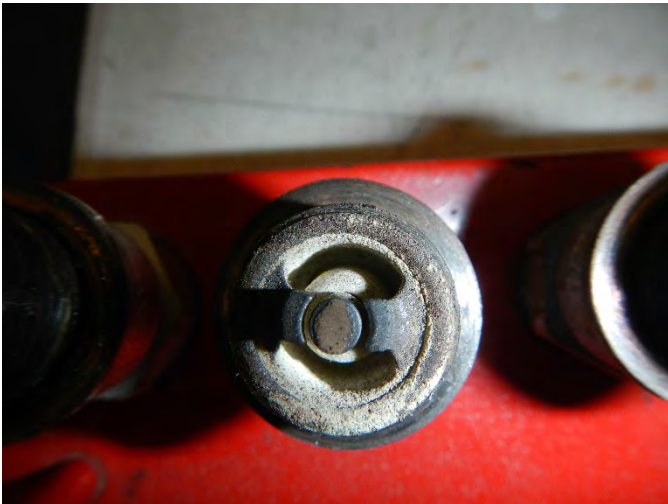
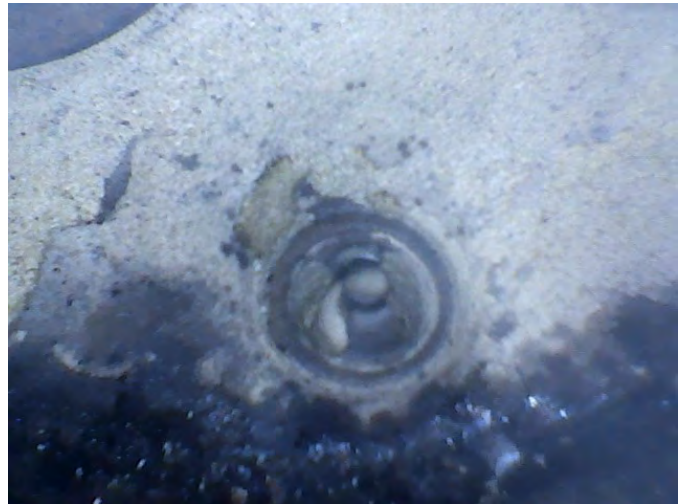
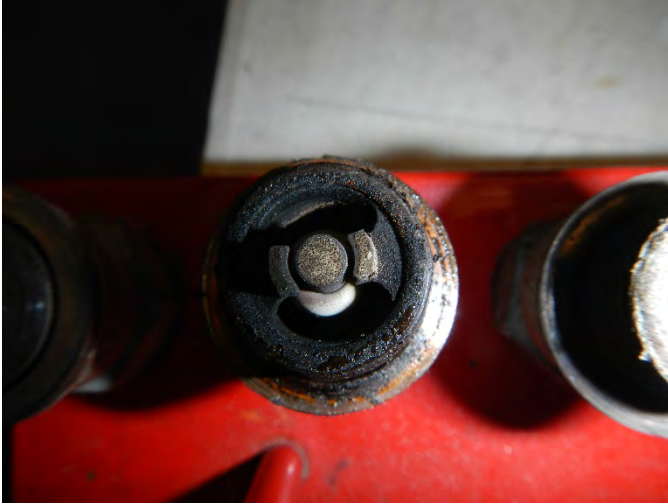
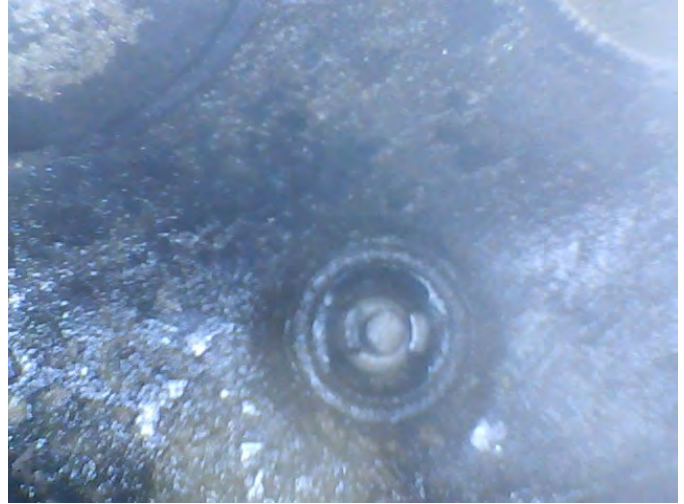
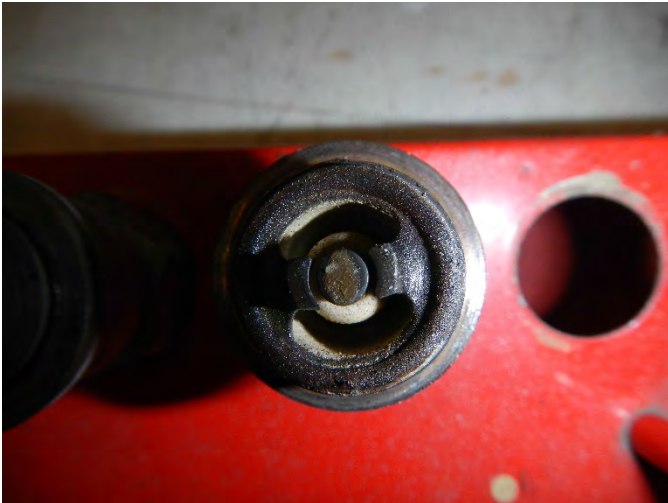
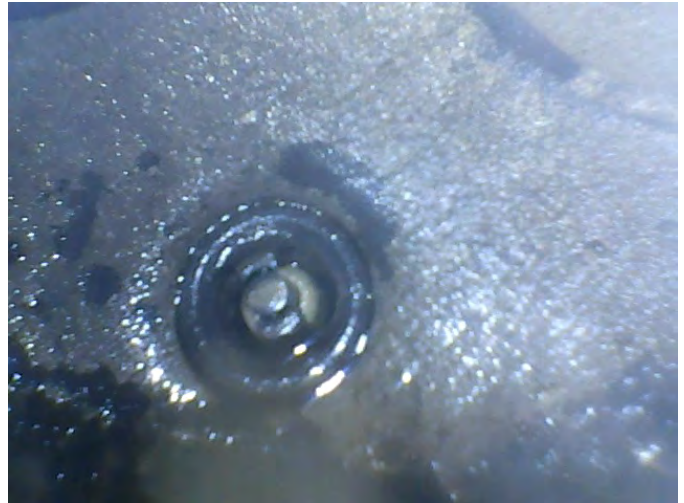
The sparkplugs remained secured to their respective cylinders and the ignition terminals remained secured to the sparkplugs. The top sparkplugs were removed and the bottom sparkplugs were examined and documented via a lighted borescope. The sparkplugs displayed normal wear signatures and combustion deposits with no signs of lead or carbon fouling.

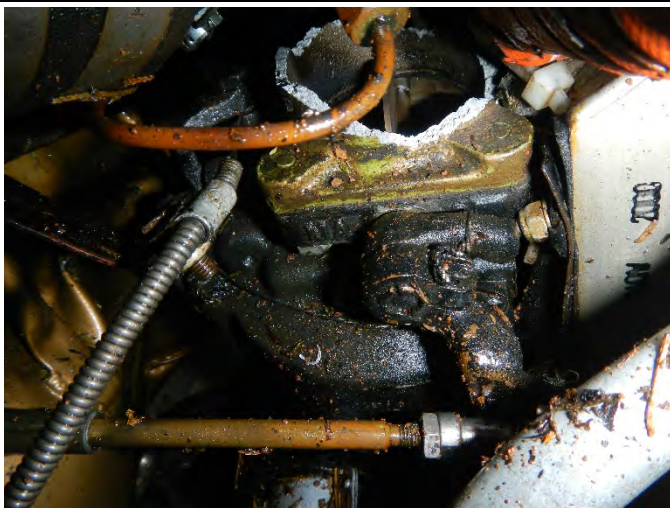
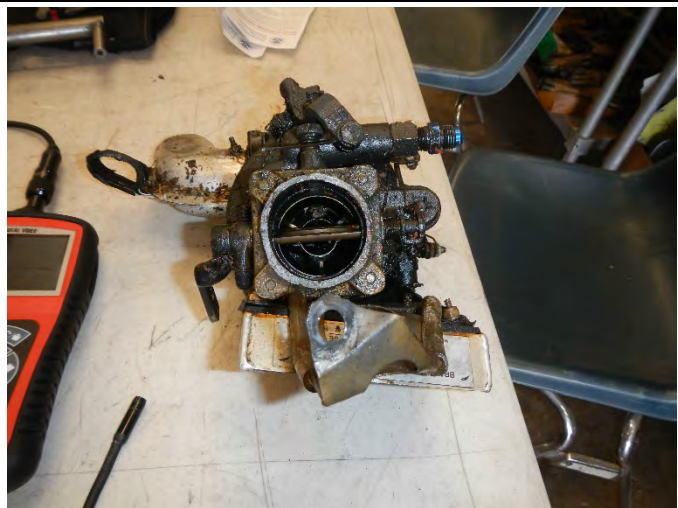
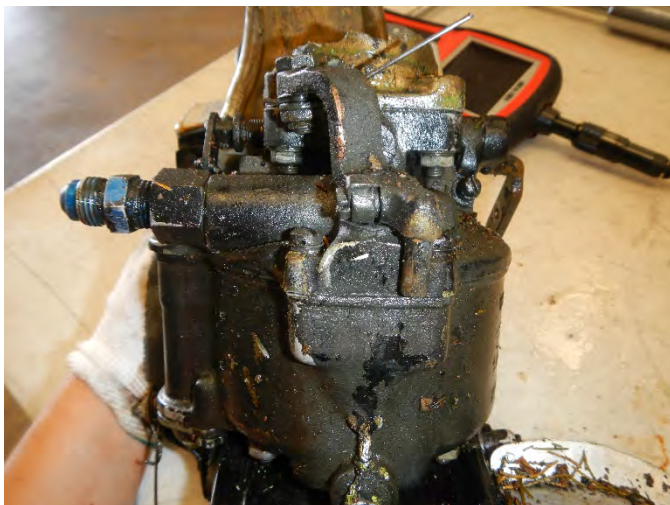
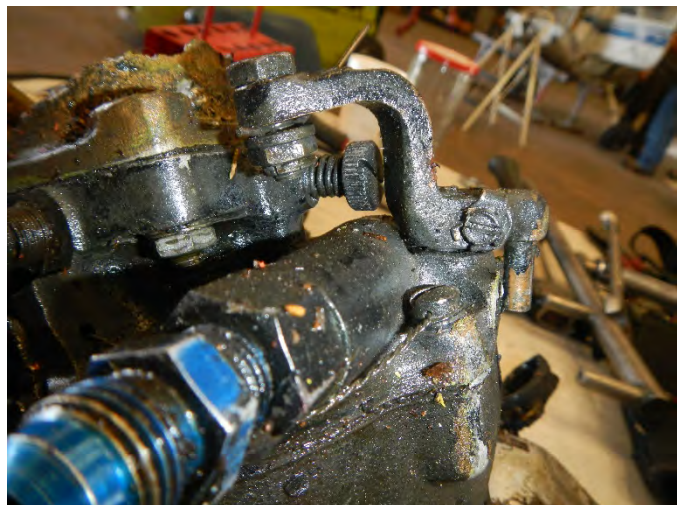
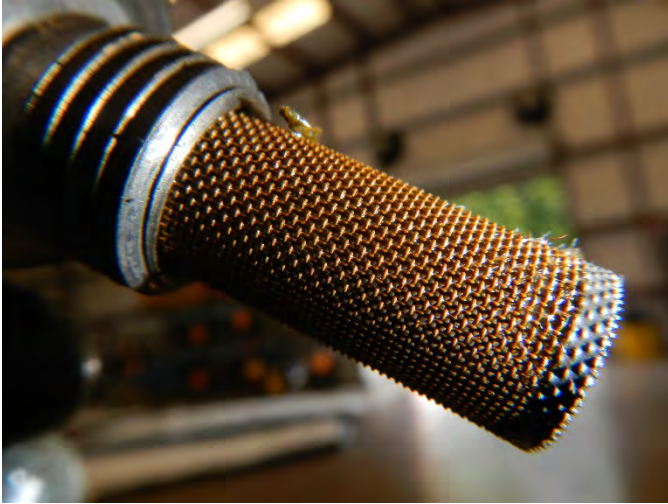
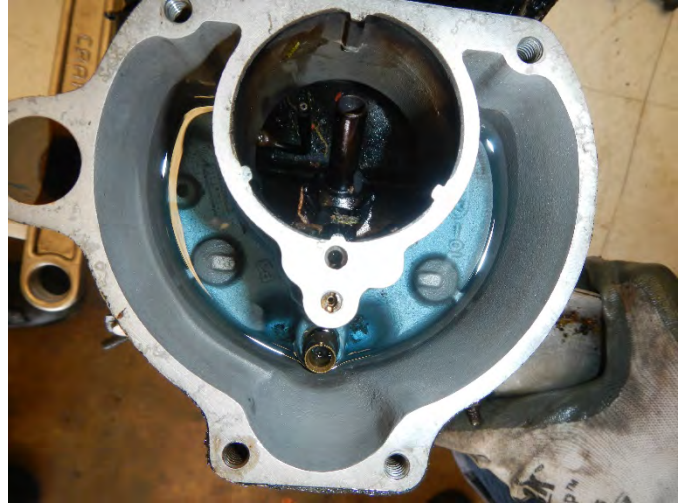
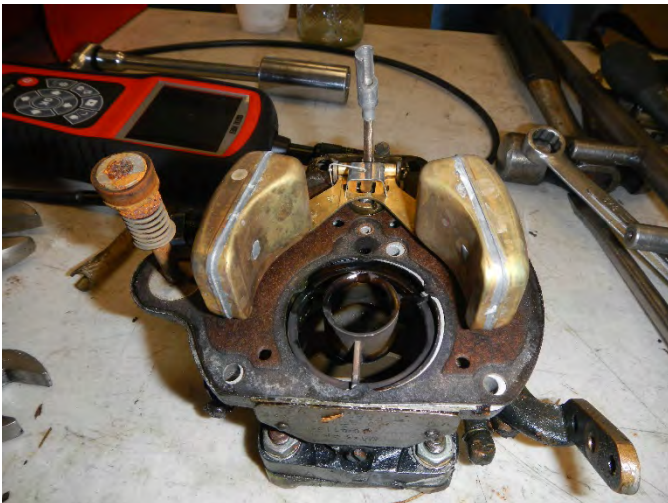
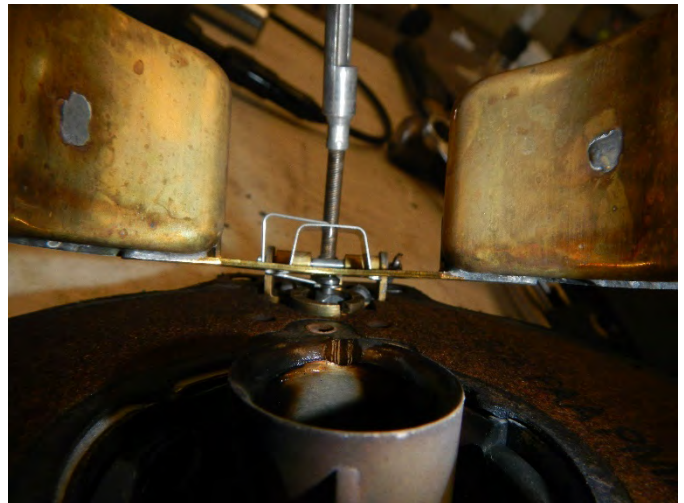
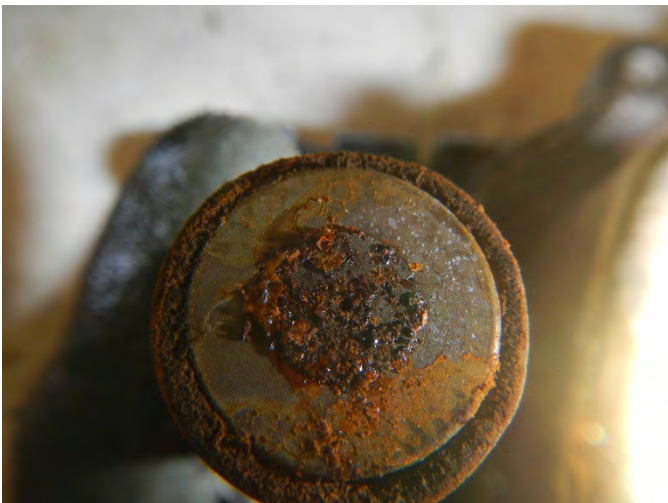
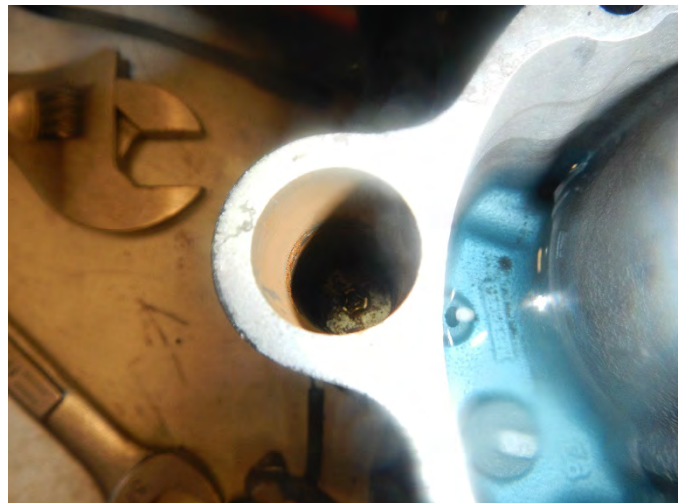
| <b>CARBURETOR</b> | Manufacturer: Marvel<br>Schebler MA-3 SHA | P/N: 10-4115-1 | S/N: AV23055 |
|---|---|---|---|
| Condition: | <p>The induction air box and filter remained attached and displaced around the carburetor. The carburetor remained attached to the engine via an attach bracket, the mixture and throttle control cables, and the fuel inlet line. However, the attach flange was fractured and the throttle valve was visible (it was found in the full open position). The carburetor was removed from the throttle and mixture control cables and attach bracket. The fuel inlet line was disconnected and the inlet fuel screen was clear. The mixture control lever was displaced due to impact damage and could not be moved through its normal range. It was found in the full rich setting. The carburetor was disassembled and the metallic floats appeared to be intact and fuel consistent in color and odor as 100LL was observed in the bowl. Some sediment was observed in the bowl, but the nozzle appeared clear. Movement of the floats resulted in a coinciding movement of the needle valve. Rust covered the base of the accelerator pump and fuel did not discharge from the accelerator pump nozzle during rapid actuation of the throttle lever prior to disassembly.</p> | | |

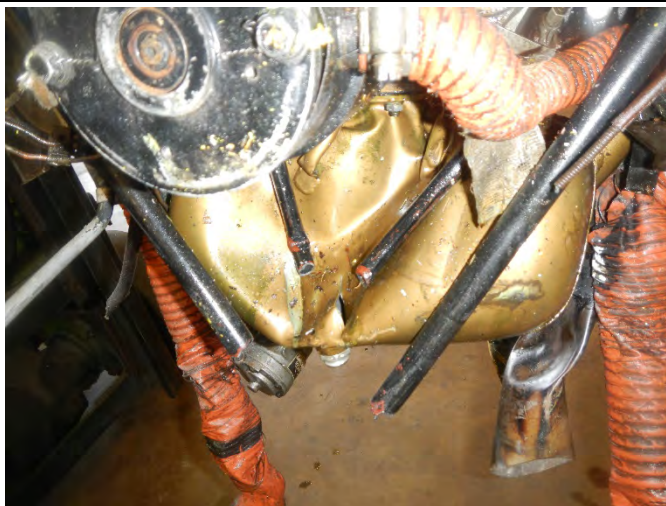
| <b>Condition:</b> | The oil sump was deformed and punctured. The quick drain plug was missing, but there were no signs of lubrication distress with any of the components. |

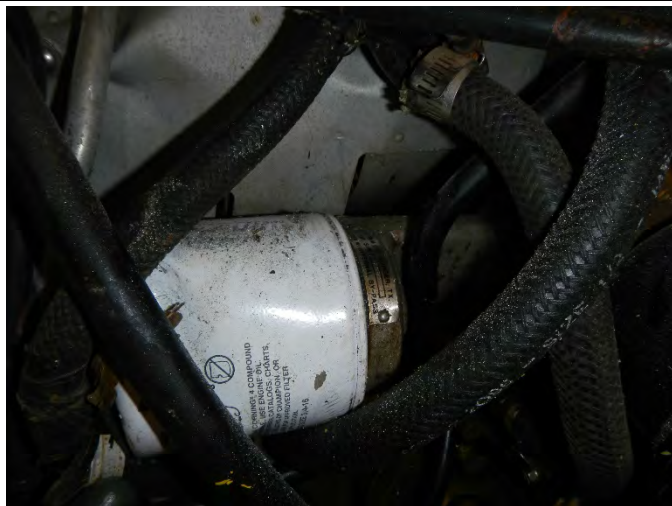
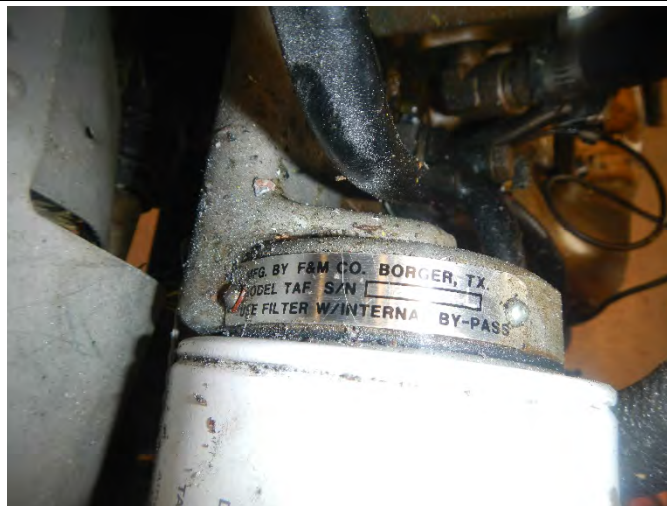
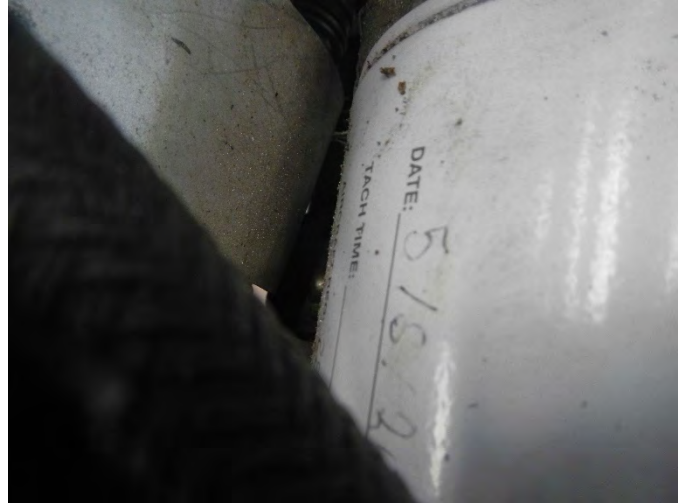
| <b>Condition:</b> | The oil filter remained attached and safety-wired to the oil filter adapter. The filter sustained deformation damage |

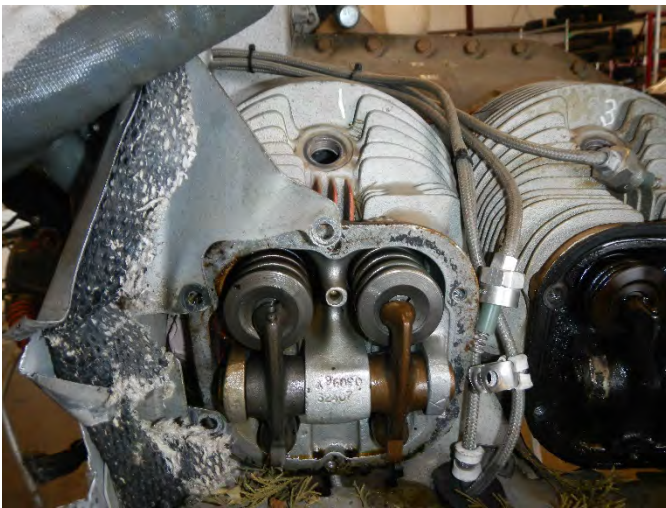
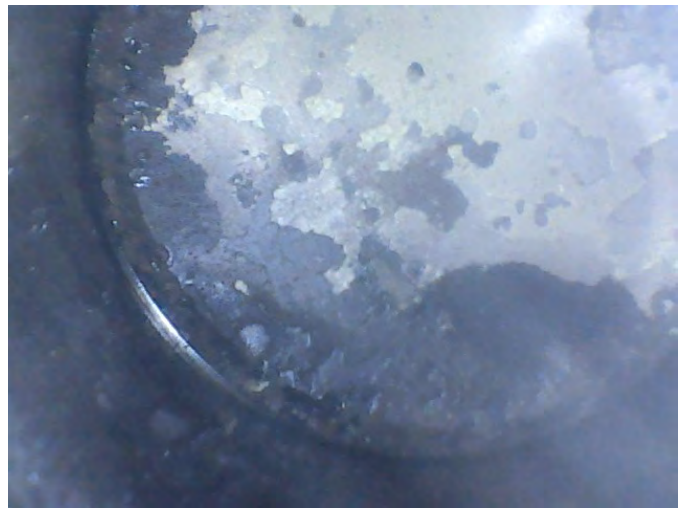
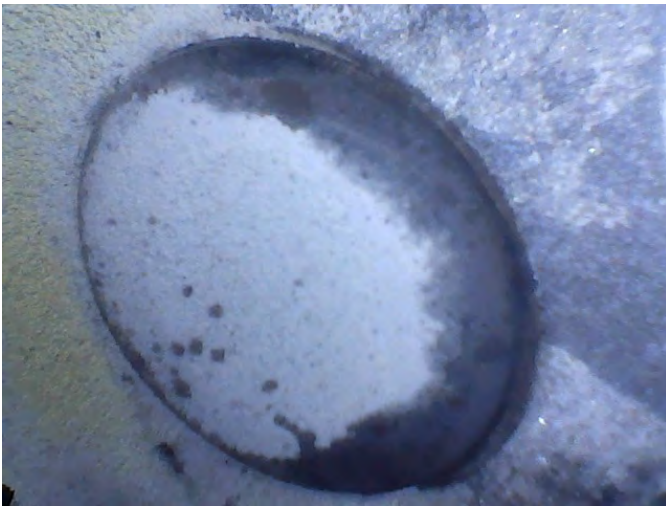
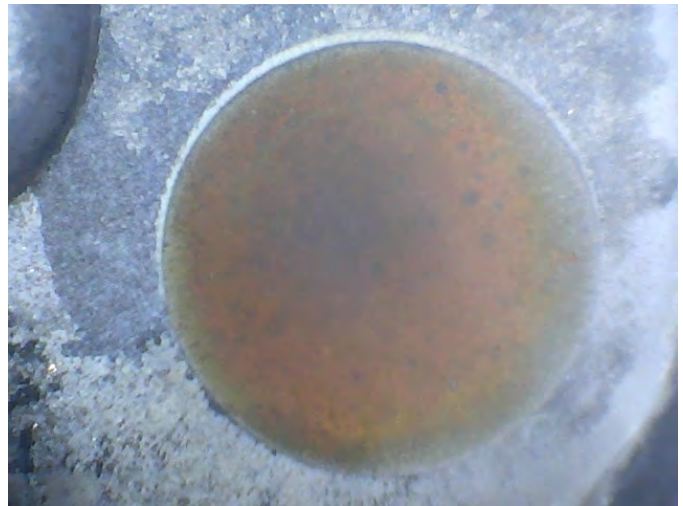
#### CYLINDER #1

Condition: The cylinder remained attached to the crankcase with no external pre-accident anomalies noted. The rocker cover was removed and no pre-accident anomalies were noted with the rockers and valve springs. The cylinder was borescope inspected with no pre-accident anomalies noted with the piston, valves, or valve seats. Thumb compression was obtained and valve movement was observed during crankshaft rotation.

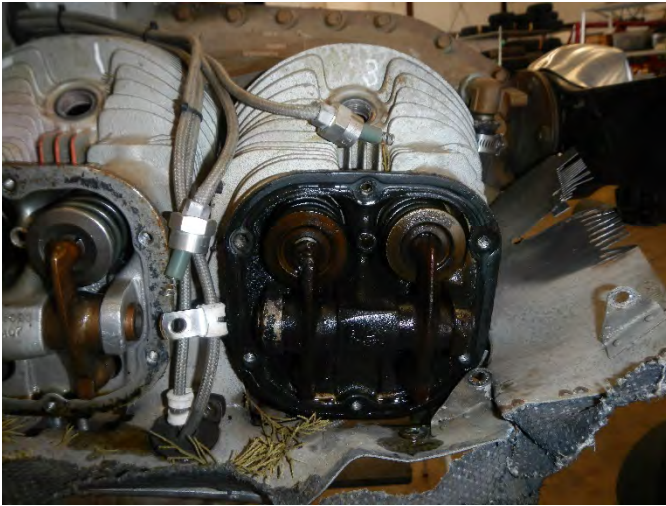
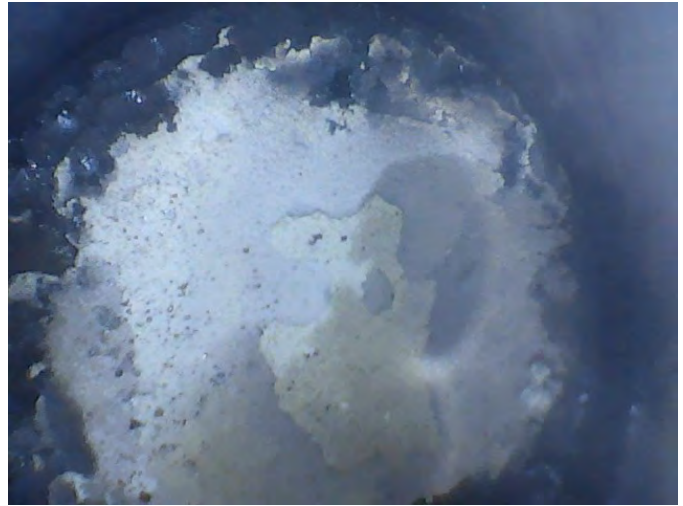
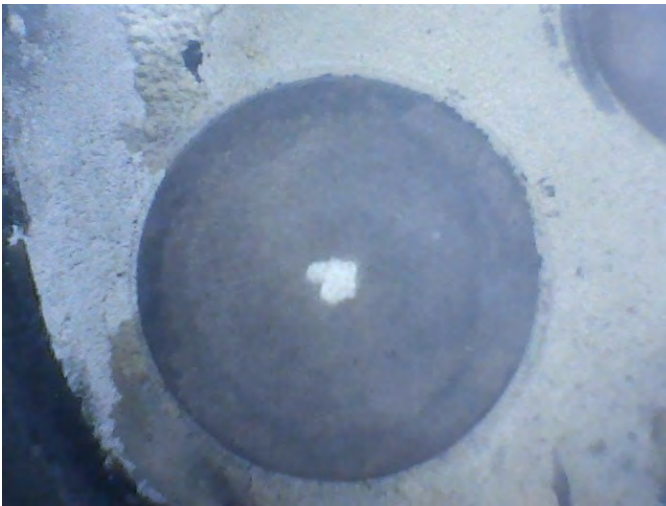
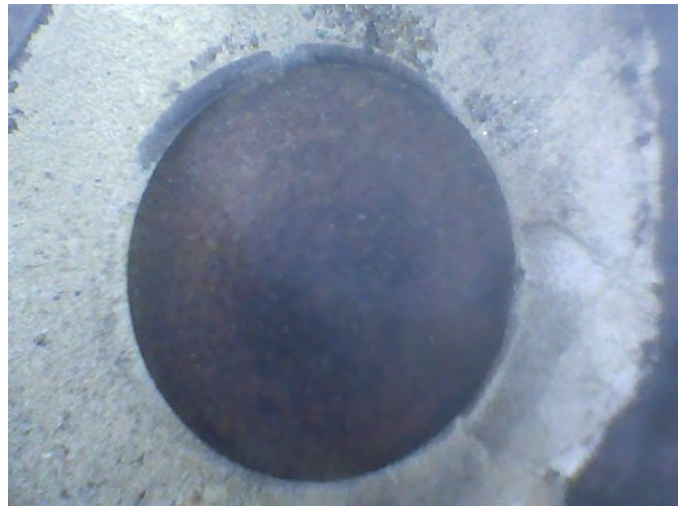
### CYLINDER #3

Condition: The cylinder remained attached to the crankcase with no external pre-accident anomalies noted. The rocker cover was removed and no pre-accident anomalies were noted with the rockers and valve springs. The cylinder was borescope inspected with no pre-accident anomalies noted with the piston, valves, or valve seats. Thumb compression was obtained and valve movement was observed during crankshaft rotation.

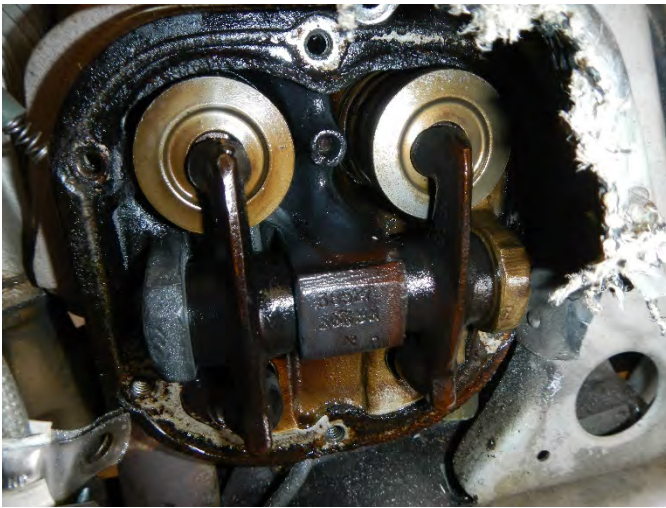
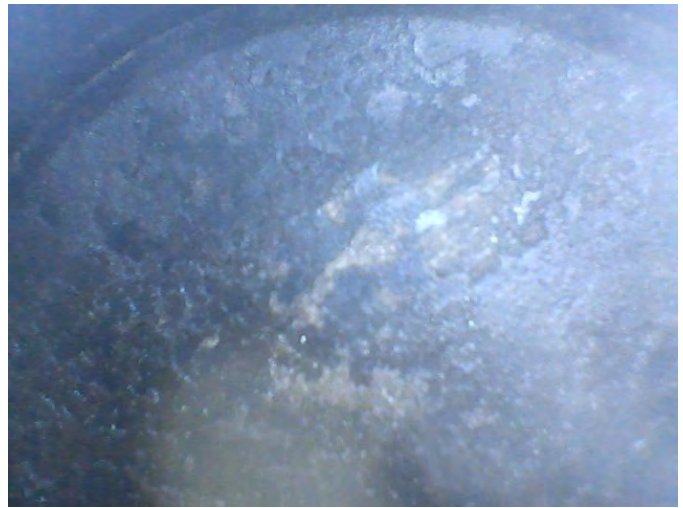
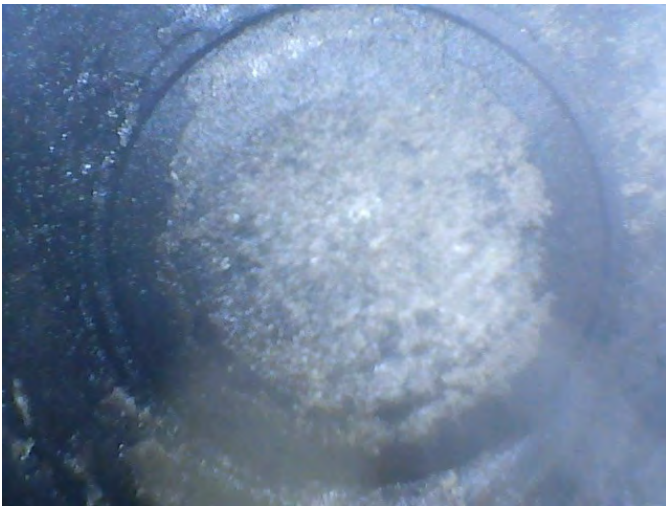
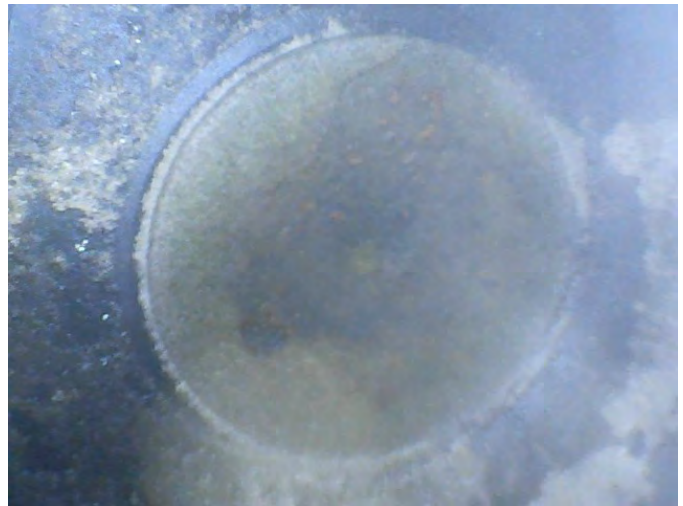
### CYLINDER #2

Condition: The cylinder remained attached to the crankcase with no external pre-accident anomalies noted. The rocker cover was removed and no pre-accident anomalies were noted with the rockers and valve springs. The cylinder was borescope inspected with no pre-accident anomalies noted with the piston, valves, or valve seats. Thumb compression was obtained and valve movement was observed during crankshaft rotation.

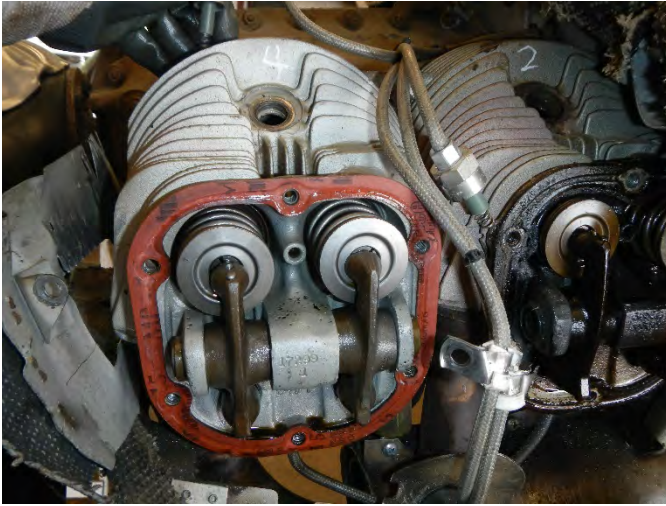
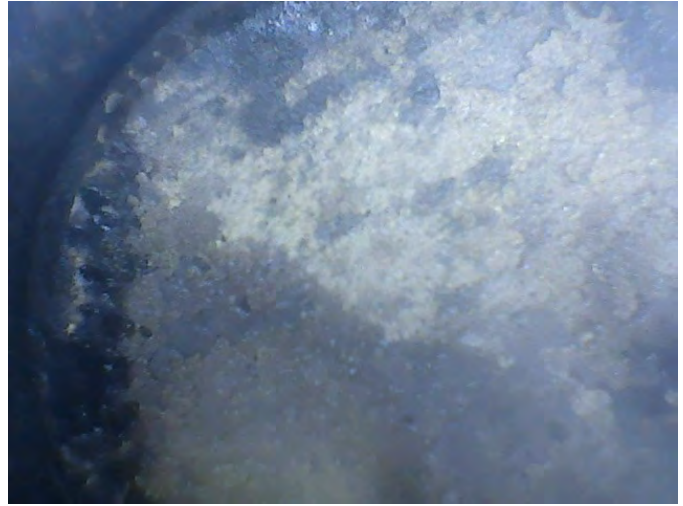
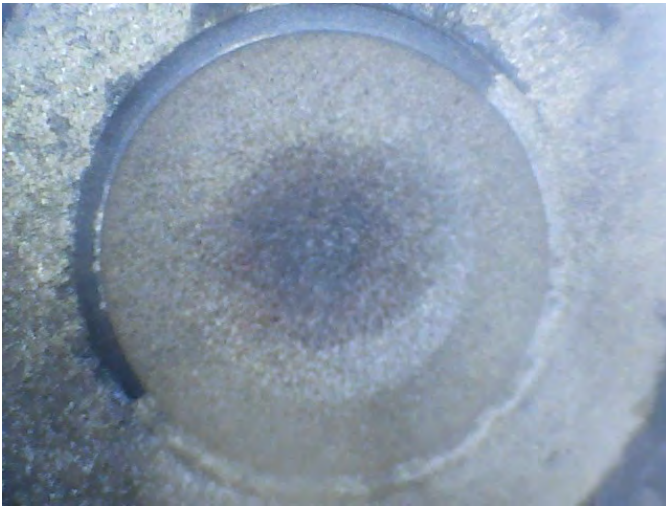
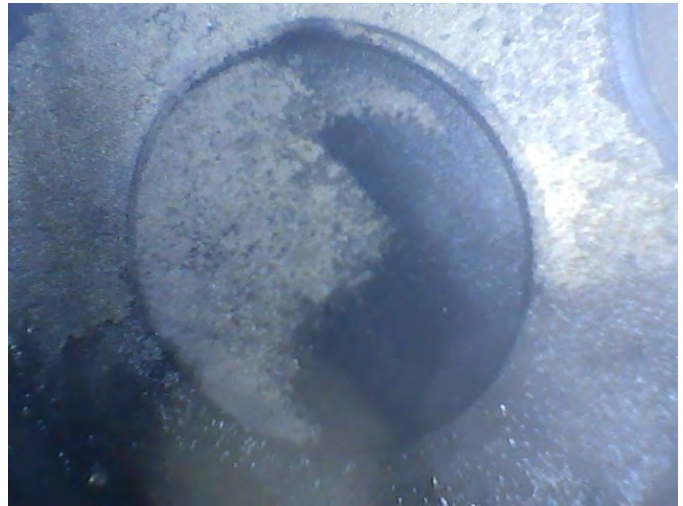
### CYLINDER #4

Condition: The cylinder remained attached to the crankcase with no external pre-accident anomalies noted. The rocker cover was removed and no pre-accident anomalies were noted with the rockers and valve springs. The cylinder was borescope inspected with no pre-accident anomalies noted with the piston, valves, or valve seats. Thumb compression was obtained and valve movement was observed during crankshaft rotation.

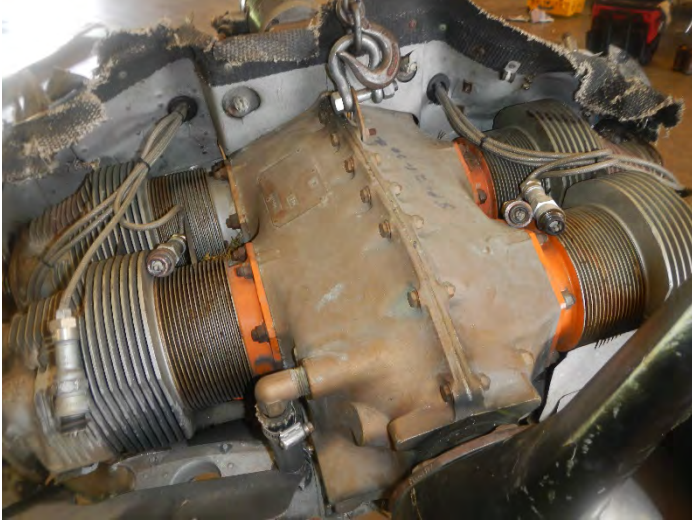
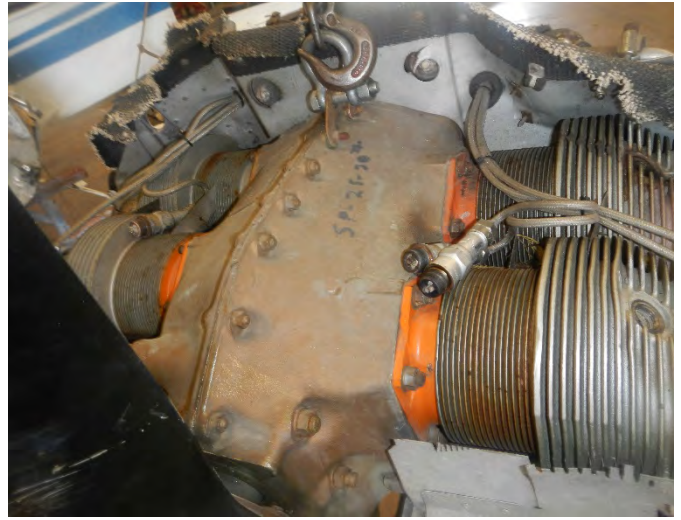
Condition: The crankcase halves remained intact and all cylinders remained attached. During crankshaft rotation, there was no sign of binding with any of the main bearings.
