# Continental Motors

## ENGINE EXAMINATION REPORT

| ENGINE MODEL | O-200-A38 |
| FILE NUMBER | 17-087 |

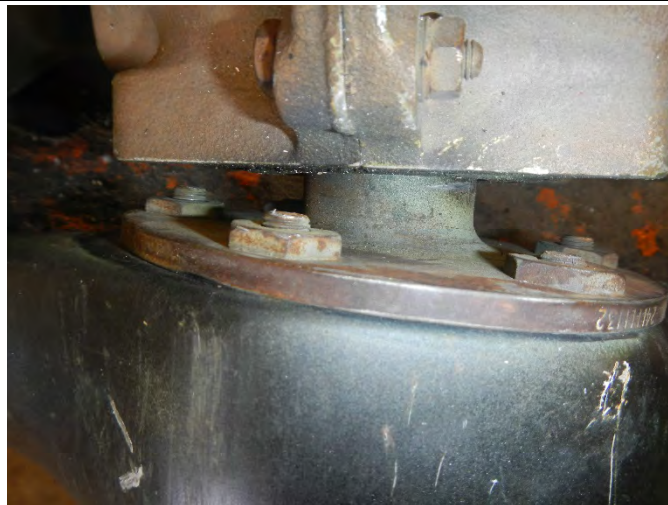
Condition: Though the crankshaft was not observed in its entirety, crankshaft continuity was confirmed from the propeller flange aft to the accessory end and out to each connecting rod during a thumb compression test on the cylinders. The crankshaft aft of the propeller flange was bent and cracked.

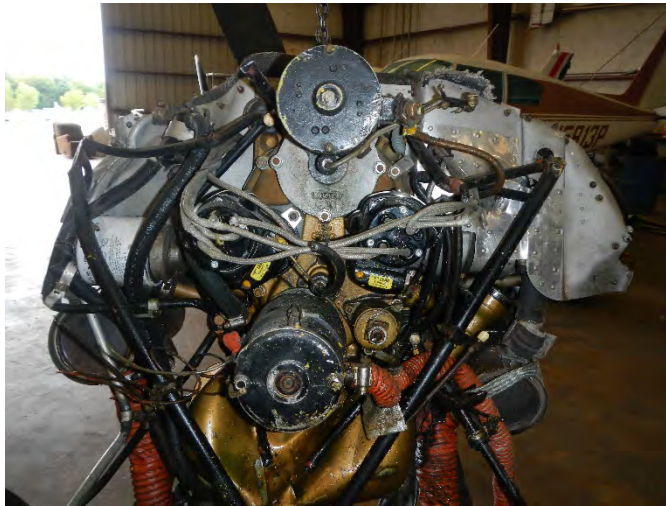
| Condition: | The starter remained attached to the backside of the engine with no pre-accident anomalies noted. | | |

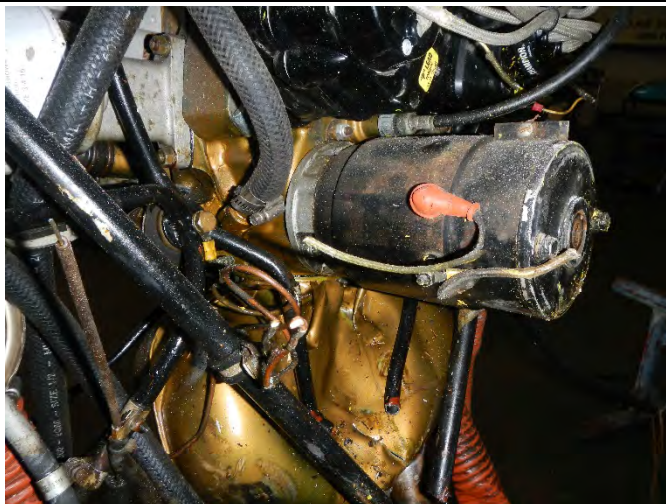
| Condition: | The generator was not examined as part of the investigation. | | |

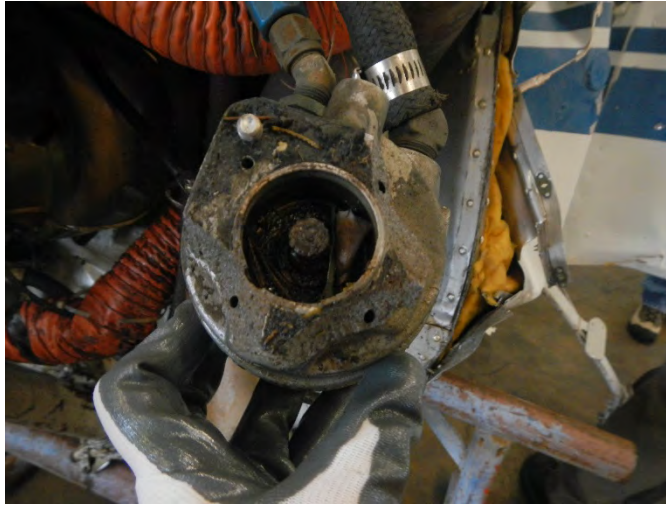
| Condition: | The vacuum pump mounting flange was fractured and its drive coupling was bent. The pump remained attached to the engine via its oil lines. The pump was not examined in any detail as part of this investigation. | | |

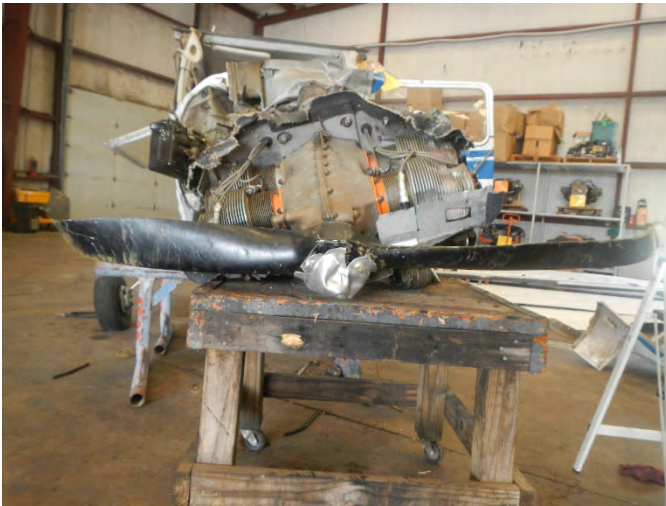
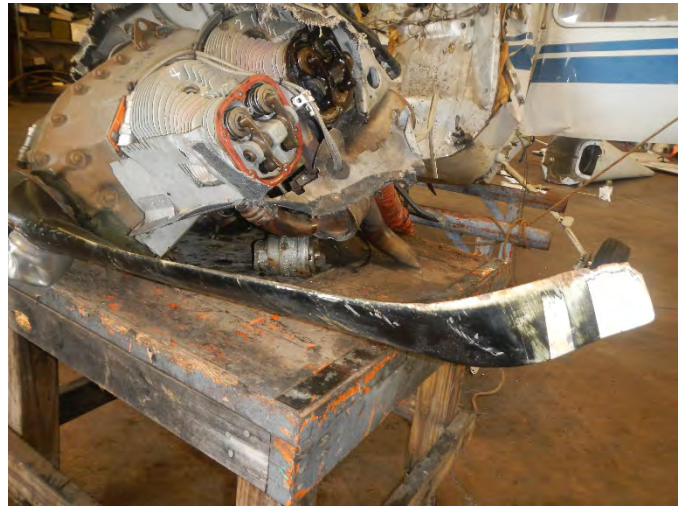
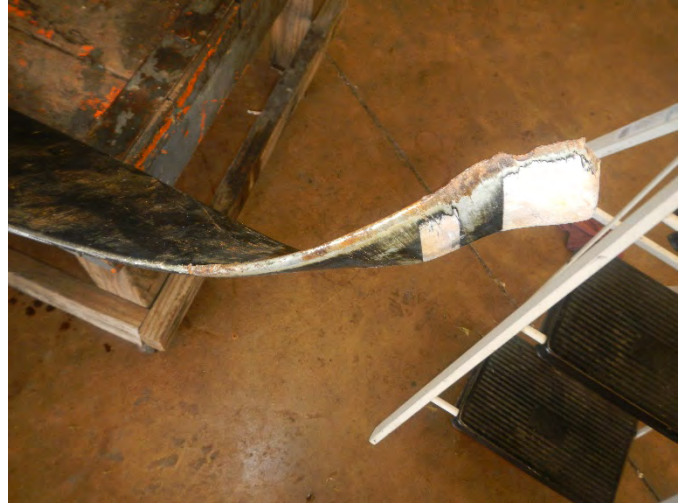
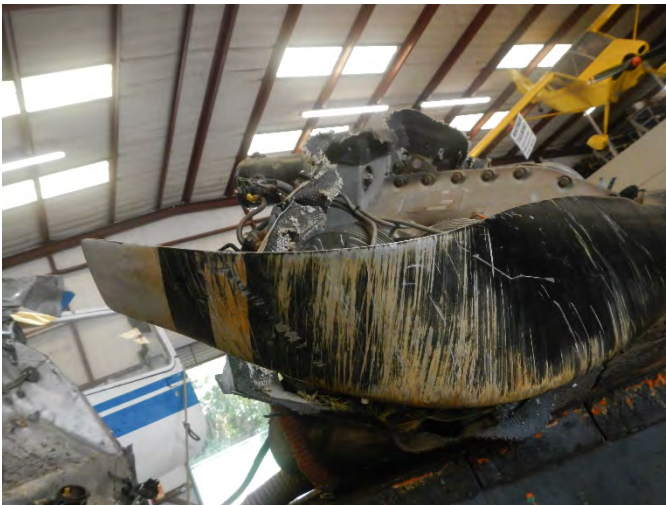
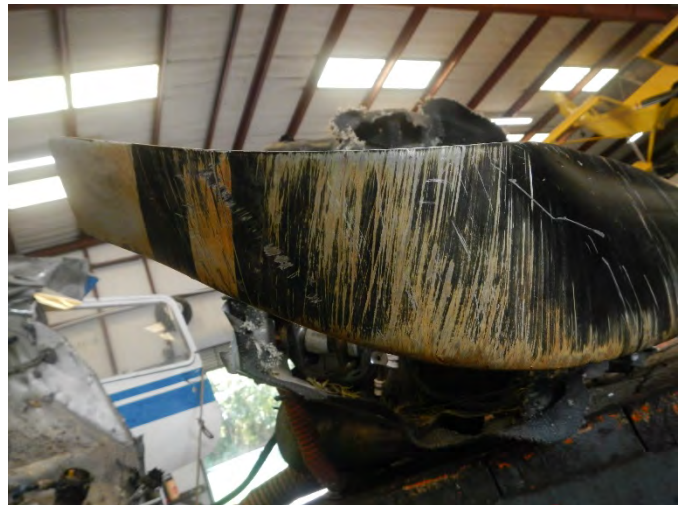
| Condition: | The propeller remained attached to the crankshaft propeller flange. The spinner was displaced aft around the propeller hub. Both fixed-pitch propeller blades displayed chord-wise scrapes and paint erosion. One blade also displayed deep leading edge gouges and a twist toward low pitch. | | |
