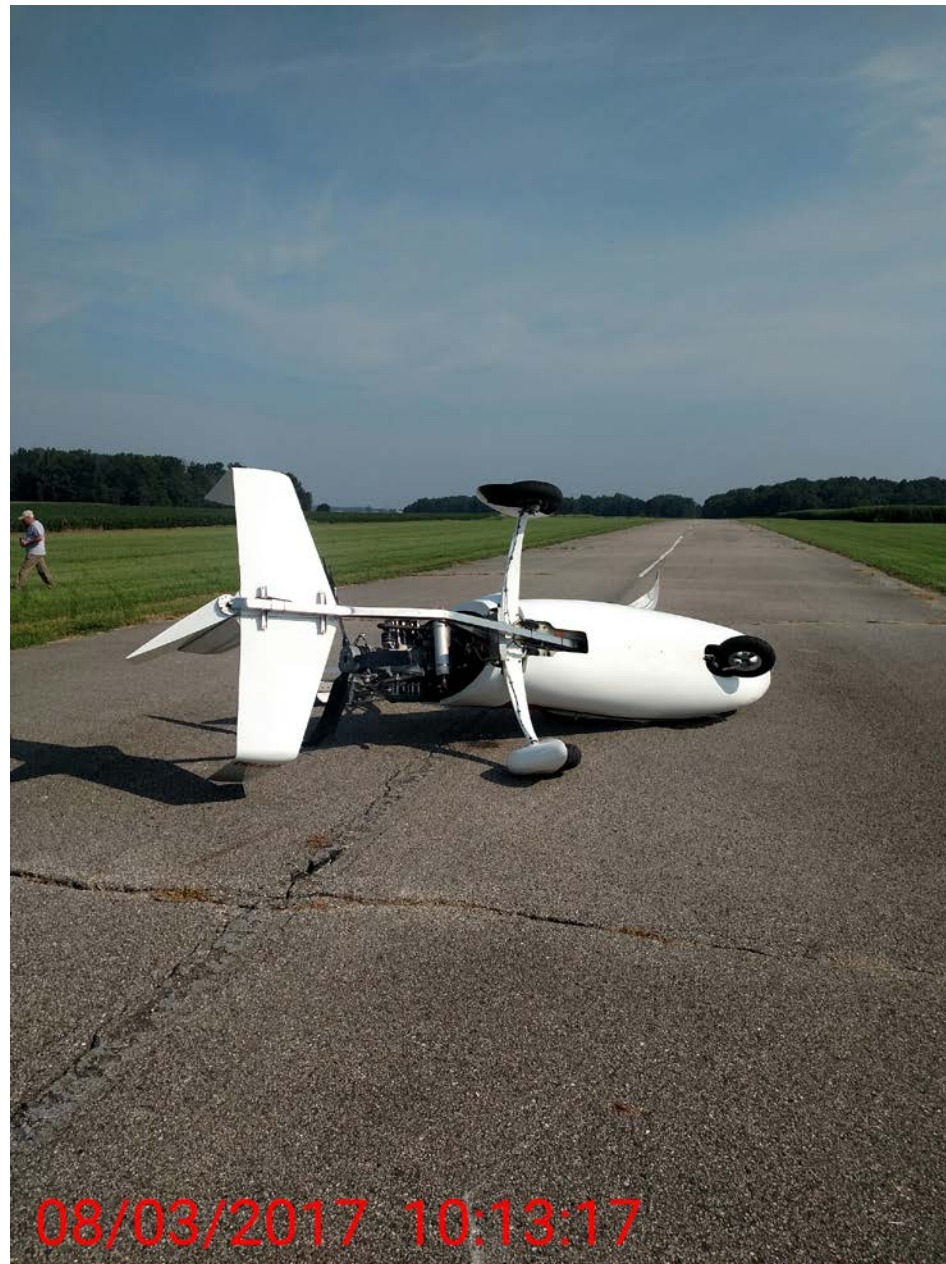
**Photo 1 – N571UJ on runway 36, shortly after the accident.**

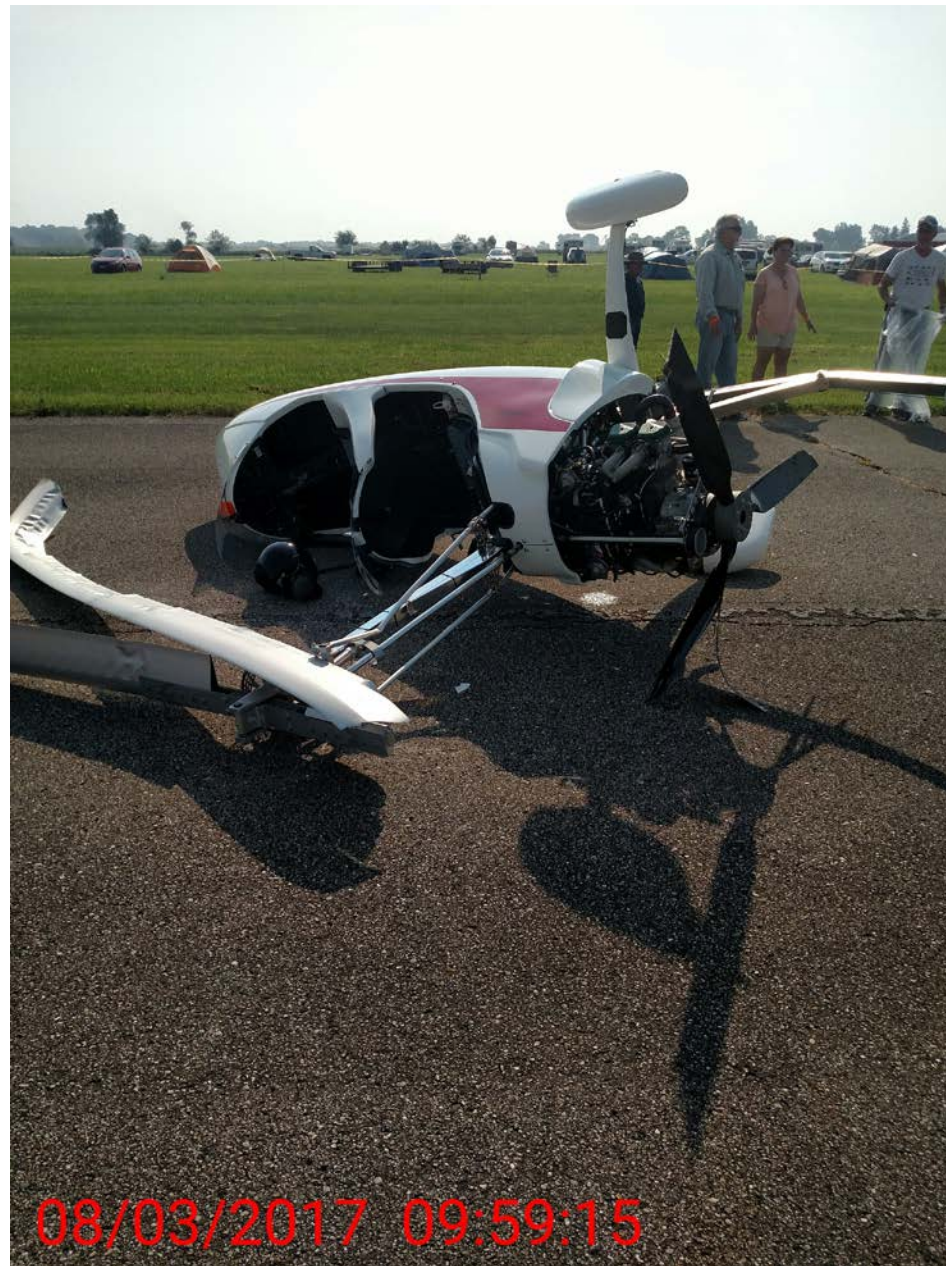
**Photo 2 – Damage to the gyroplane included the main rotor blades and propeller blades.**

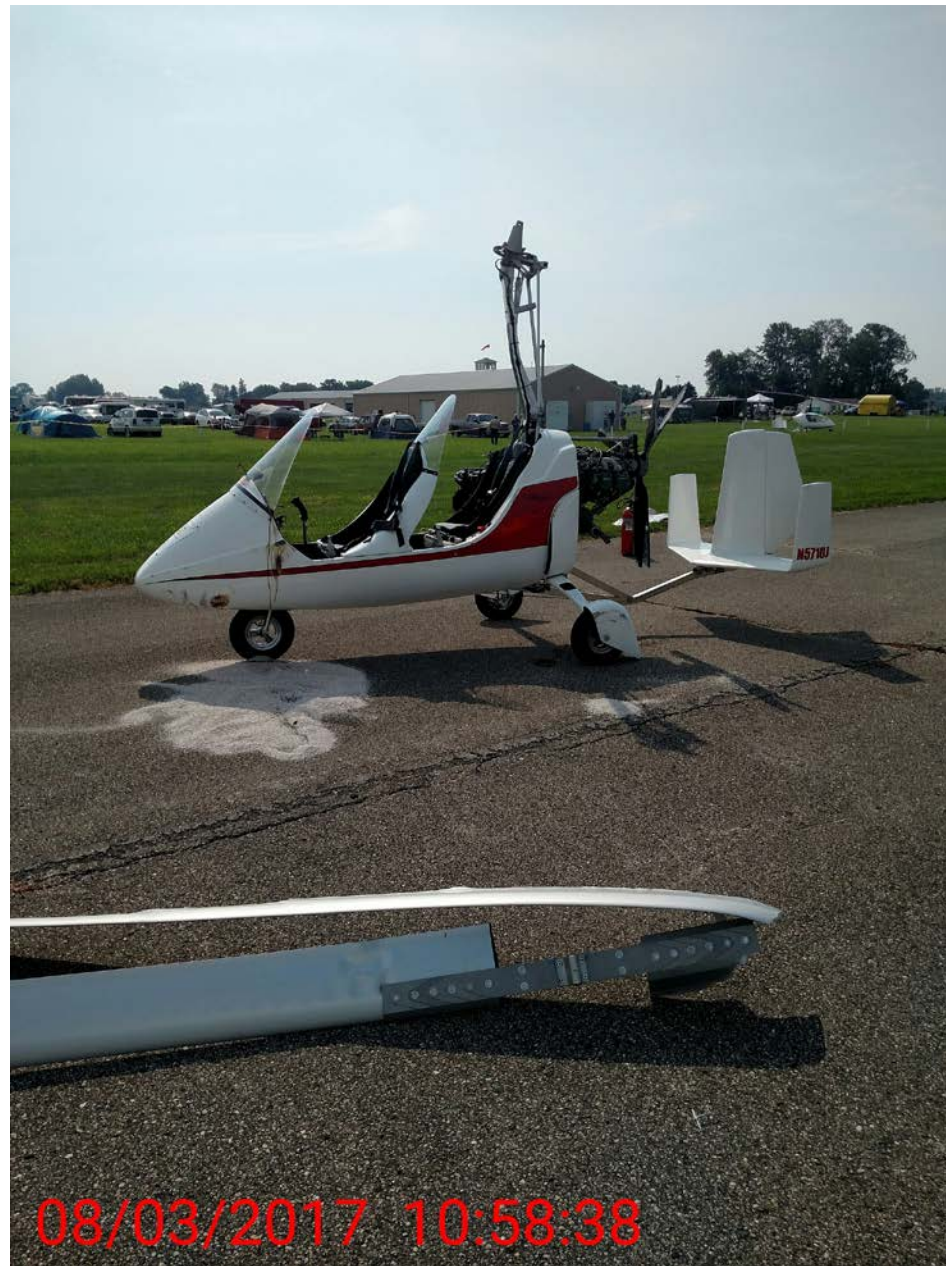
**Photo 3 – N571UJ after being placed back on its landing gear.**
