**Photo 1 – View of Lycoming Engine**

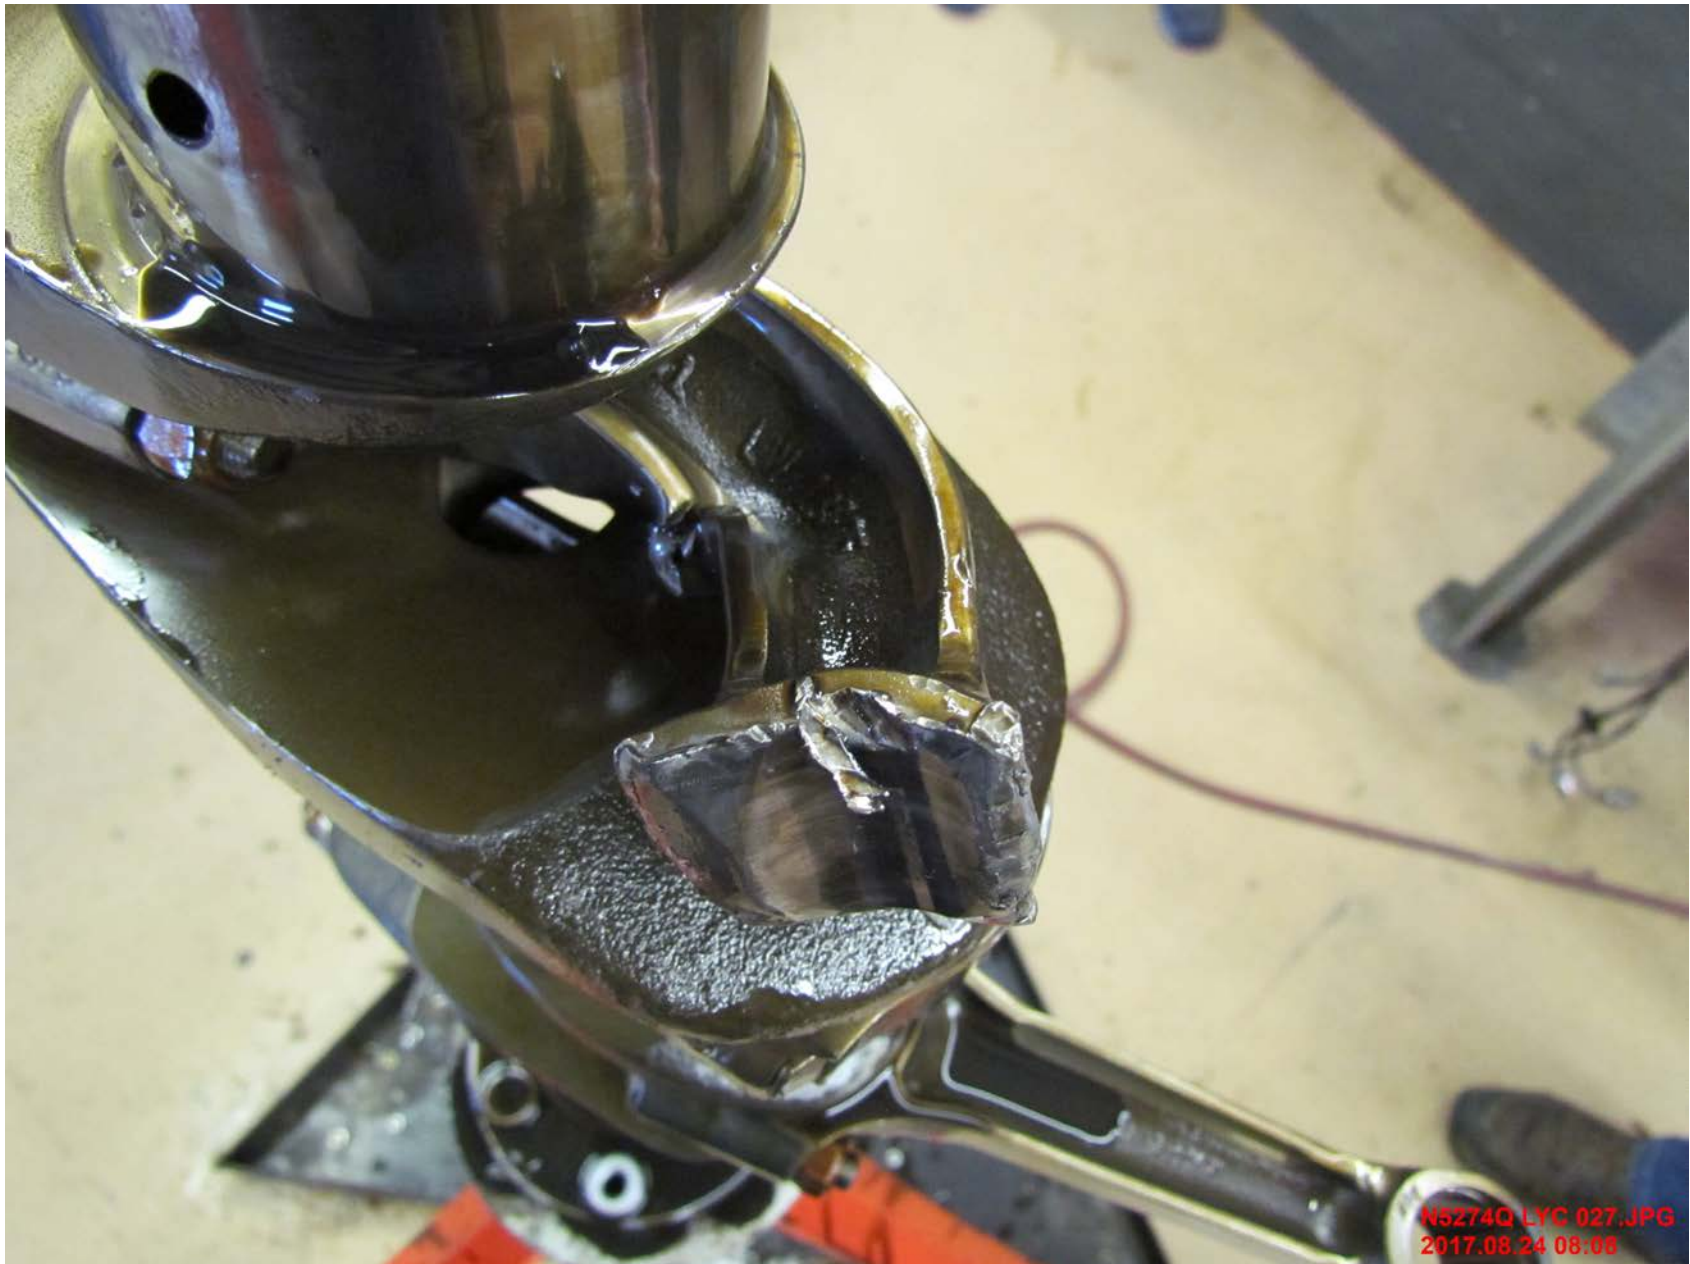
**Photo 2 – View of Fractured Connecting Rod**

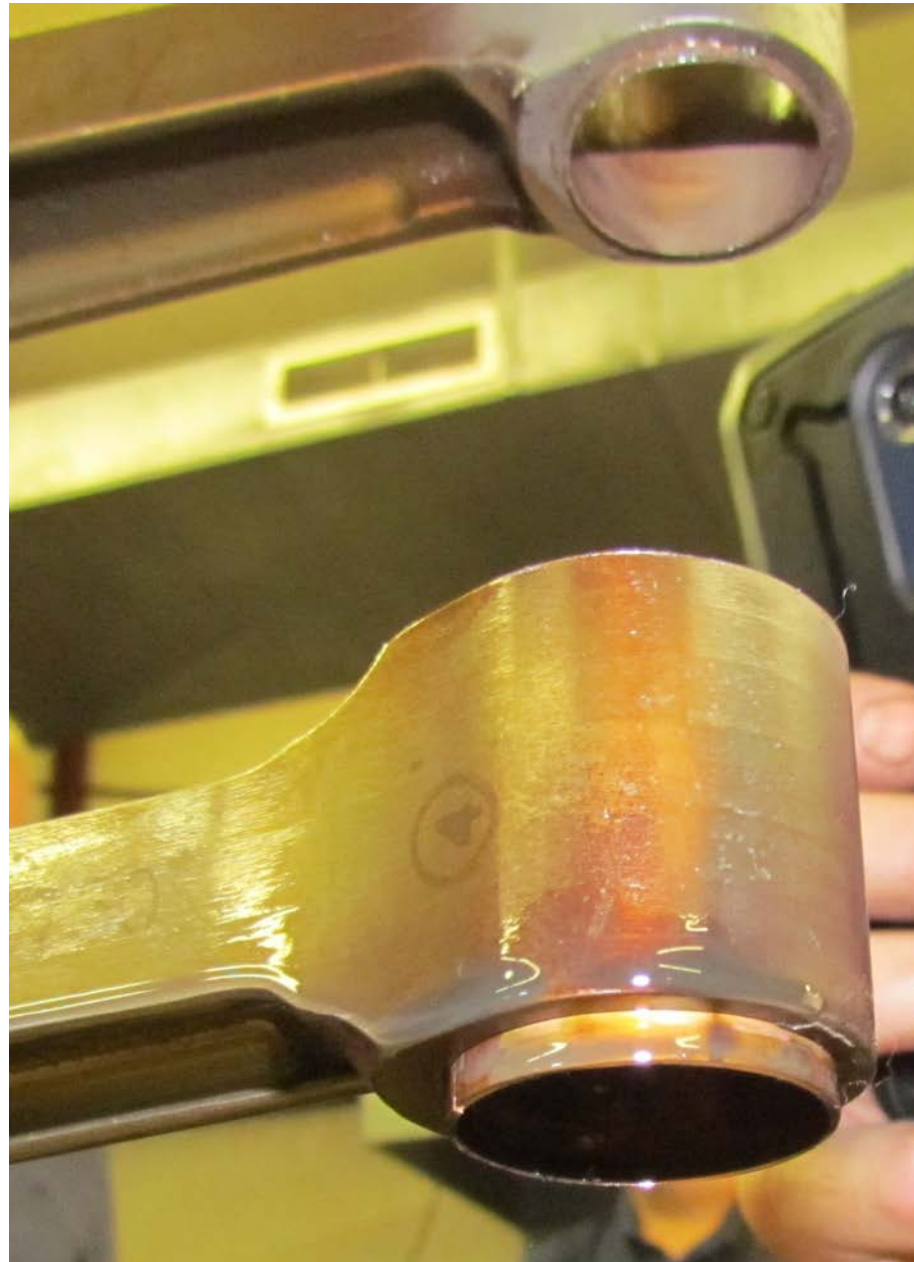
**Photo 3 – View of Connecting Rod Bushing**
