# NATIONAL TRANSPORTATION SAFETY BOARD

## MATERIALS LABORATORY FACTUAL REPORT

Report No. 18-024

Place : Beckville, Texas  
Date : August 14, 2017  
Vehicle : Piper PA-22-135, N2591A  
NTSB No. : CEN17LA317  
Investigator : Tim Sorensen, AS-CEN

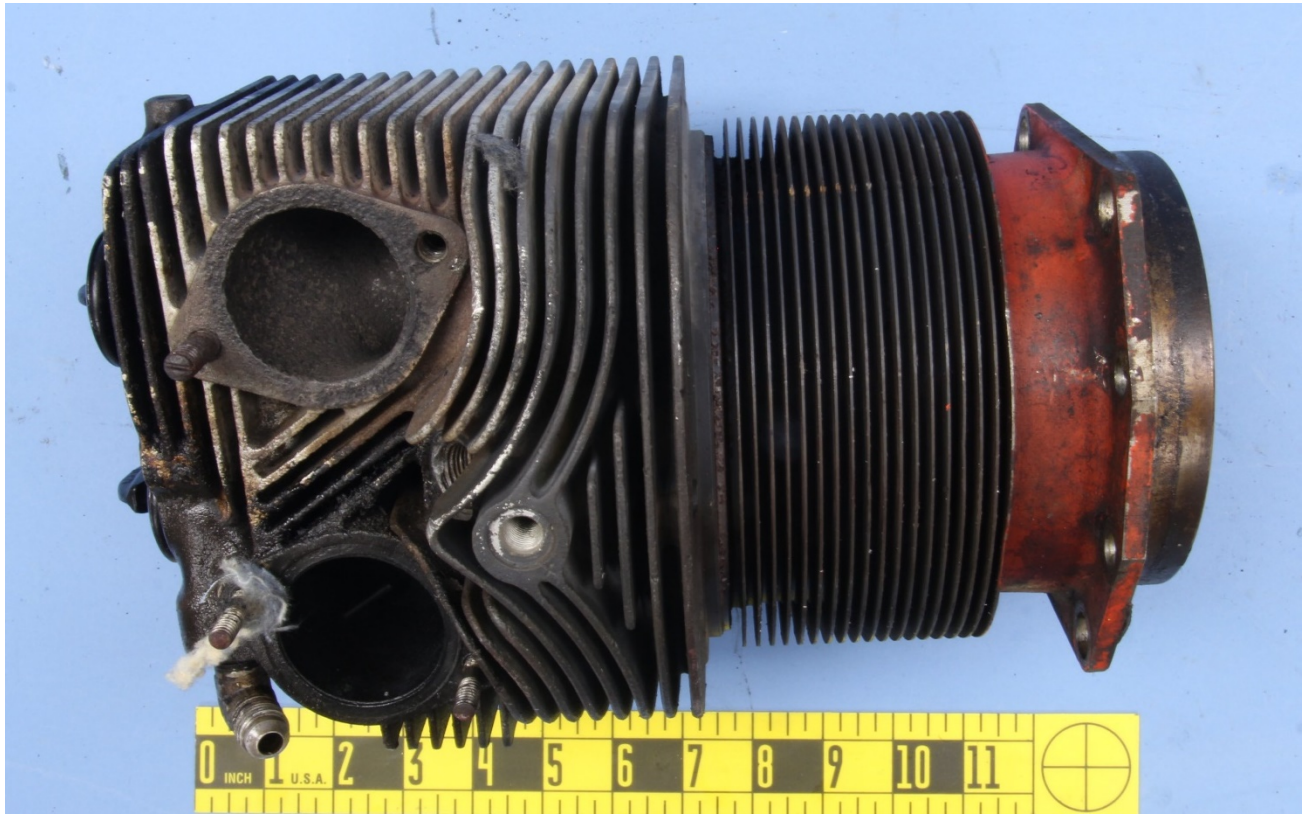
Figure 1 through Figure 3 show the #3 cylinder assembly from the accident engine, as received. As shown in upper left of Figure 1, the areas in and around the exhaust port, such as the cooling fins, exhibited white-colored coking deposits. These were consistent with exposure to elevated temperatures. Several components had already been removed or disassembled, notably the rocker box cover and pushrods, as seen in Figure 2. There was no observable plastic deformation or wear with the rocker arms or shaft, and all the components appeared to be coated with engine oil.

Figure 1 – The #3 cylinder, as received, viewed from the side. The engine valve rocker cover had been removed prior to receipt.

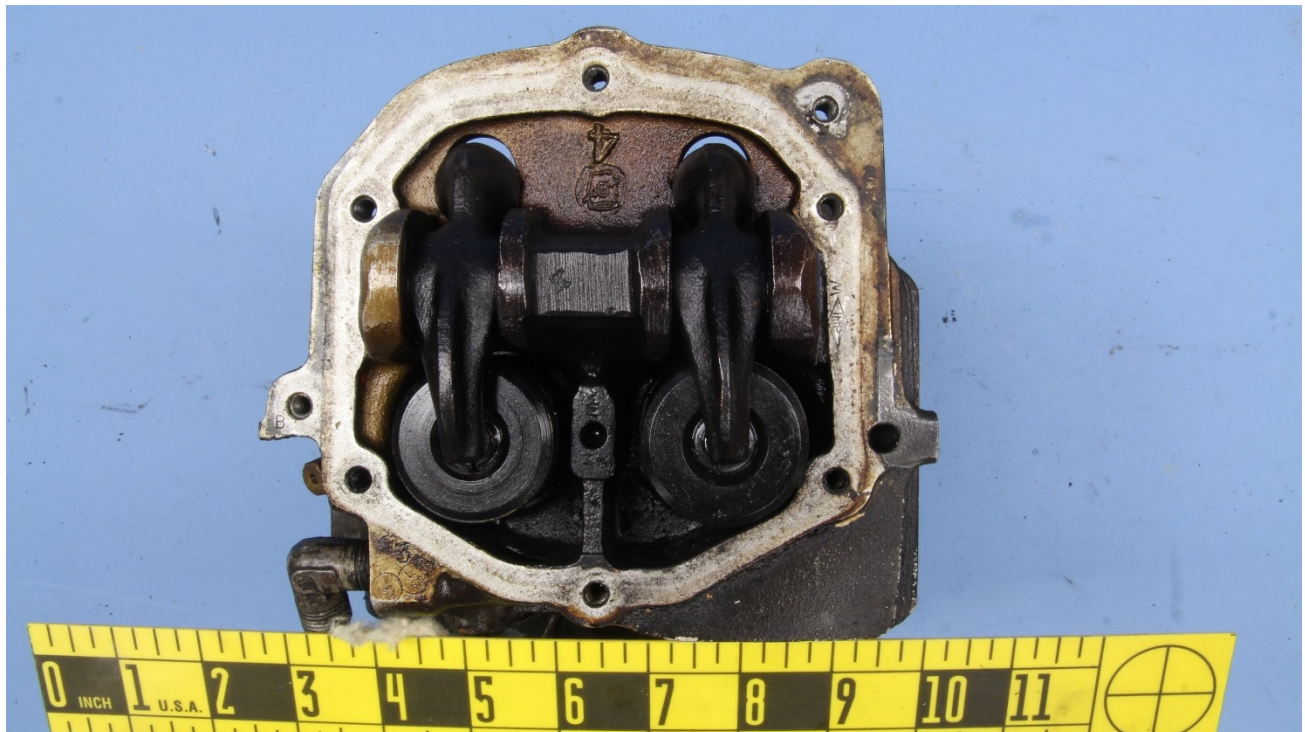
Figure 2 – The rocker section of the #3 cylinder, as received.

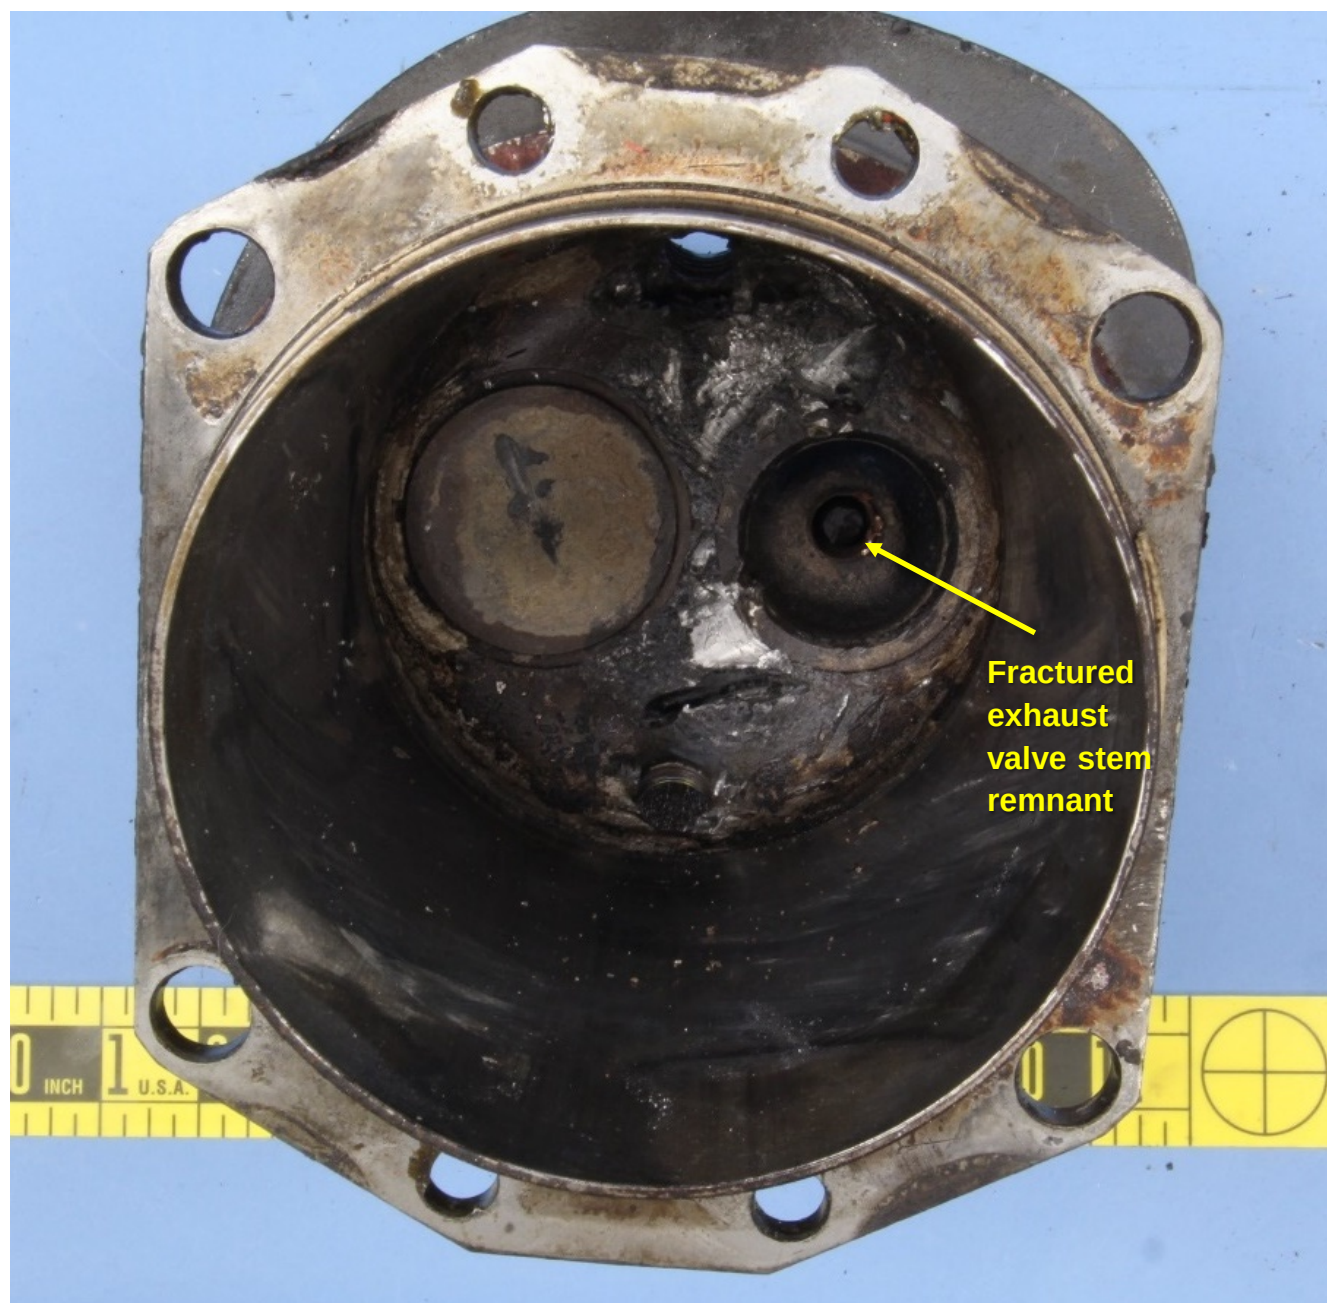
The interior combustion chamber of the #3 cylinder is shown in Figure 3 and Figure 4. These interior surfaces exhibited severe batter, scraping marks, and gouging on the one of the cylinder side walls. Many of these batter and impact marks were semi-circular or curved, consistent with the size and shape of the exhaust valve head (shown later in Figure 11a and Figure 11b). As shown in Figure 4, regions of white- and yellow-colored deposits, consistent with lead-based compounds, were present on the corners of the cylinder and the face of the intake valve.

Figure 3 – The piston chamber of the #3 cylinder, as received, showing the exhaust valve stem fragment on the right.

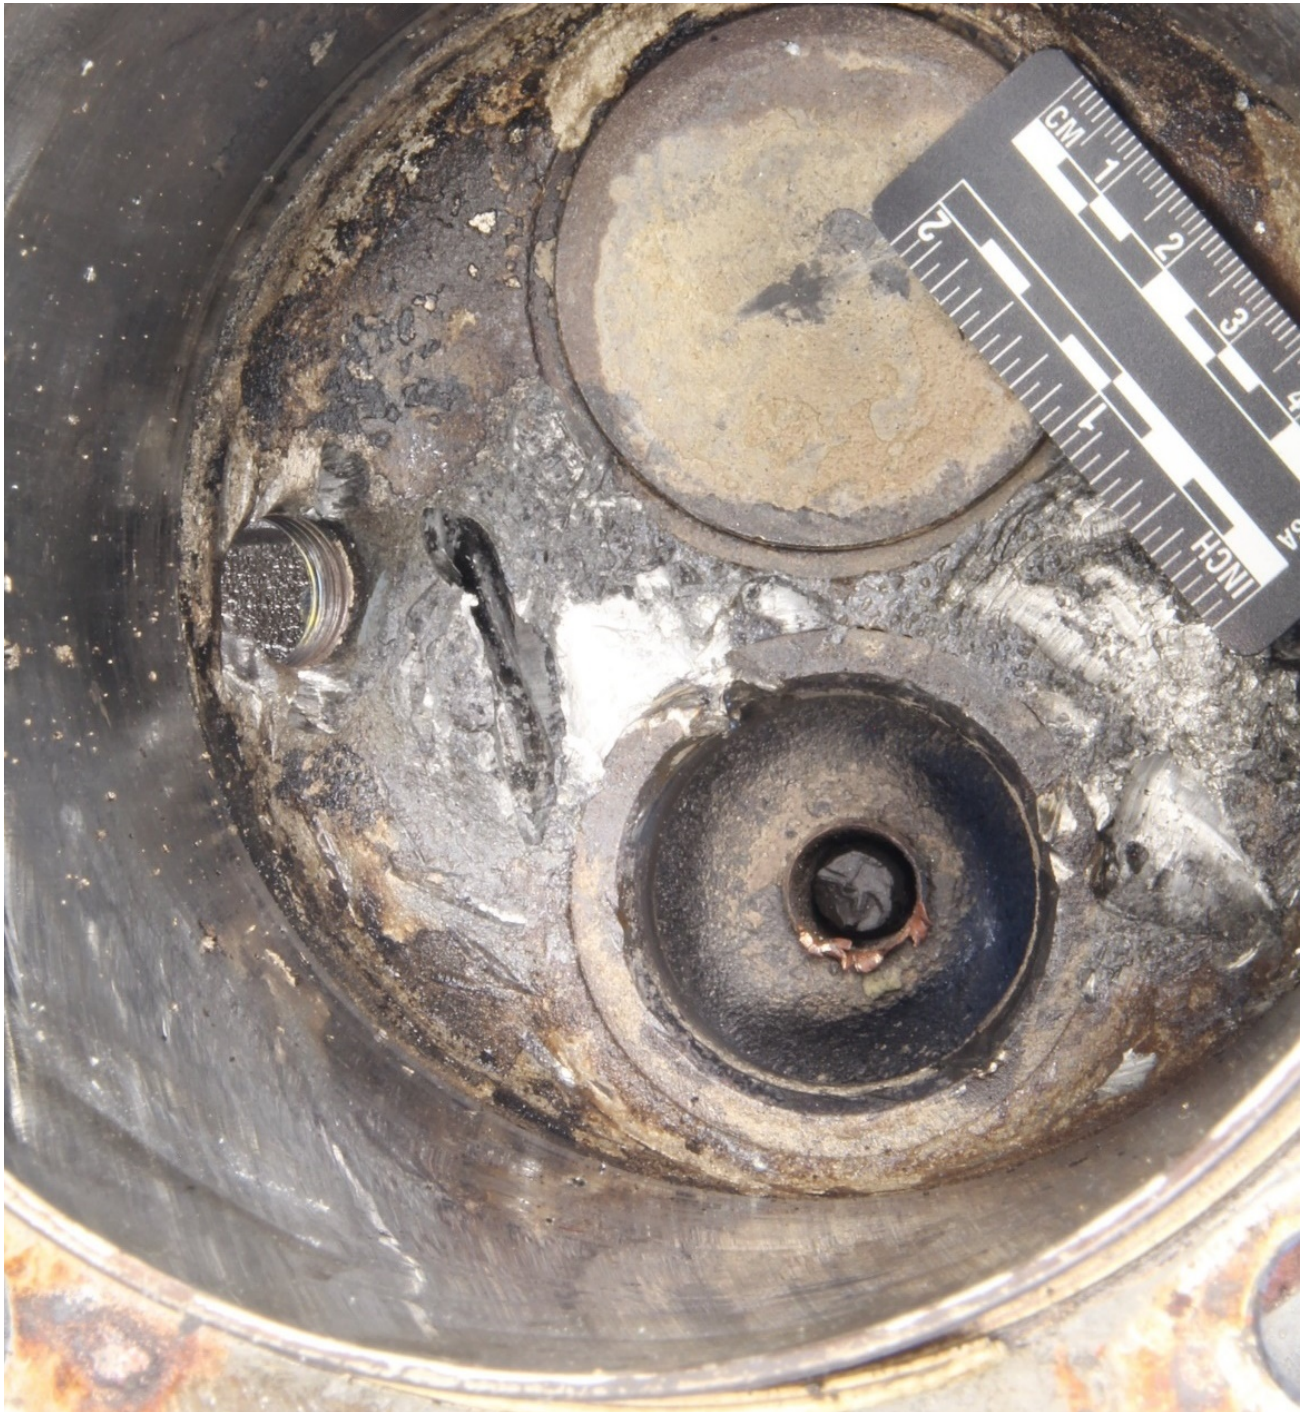
The intake valve was intact and still in place, along with the stem of the exhaust valve. However, the head of the exhaust valve had fractured from the exhaust valve stem. Figure 4 shows a closer view of the fracture surface of the exhaust valve stem, in position in the valve guide within the valve seat. The valve seat recess showed indications of deformation on the edges, as well as the white- and yellow-colored compounds, consistent with lead-based compounds.

Figure 4 – A closer view of the piston chamber of the cylinder, showing the exhaust valve stem fracture surface on the bottom.

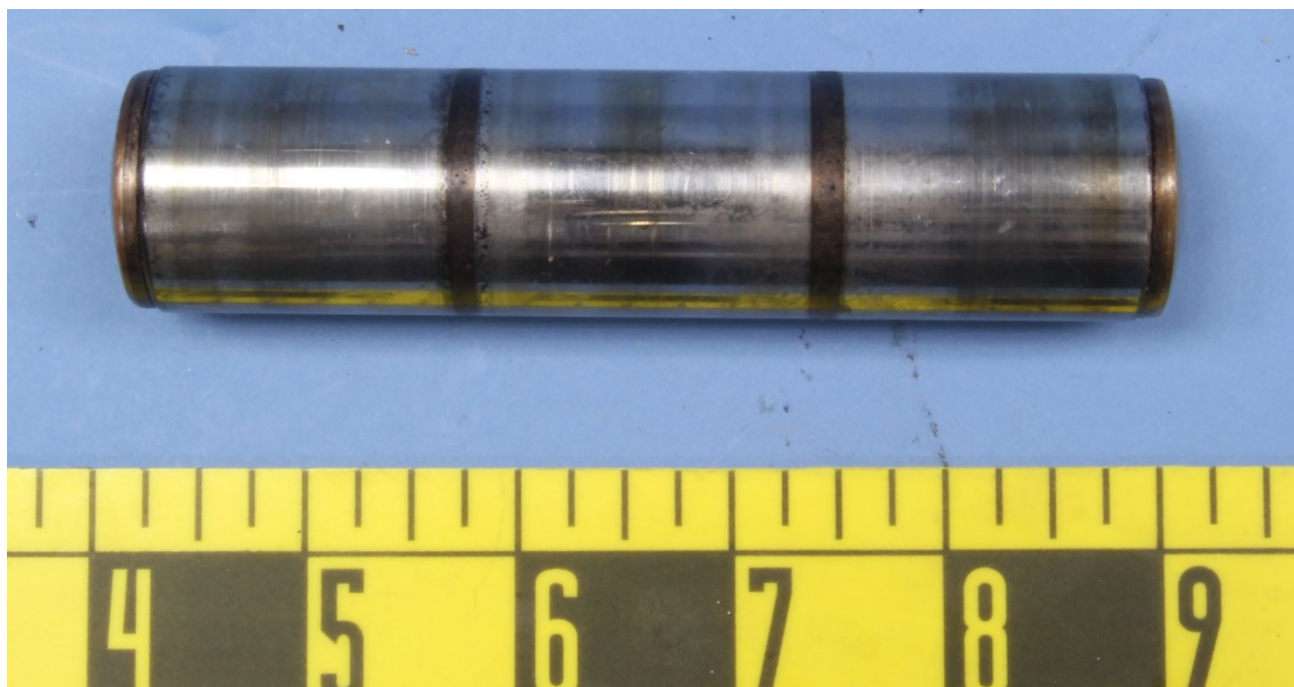
Figure 5 shows the piston pin, as received. The pin exhibited two darker circumferential marks, consistent with the position of the connecting rod pin bore (not received). The pin did not exhibit any other features consistent with significant sliding wear or damage prior to or during the accident.

Figure 5 – The piston pin from the #3 piston, as received.

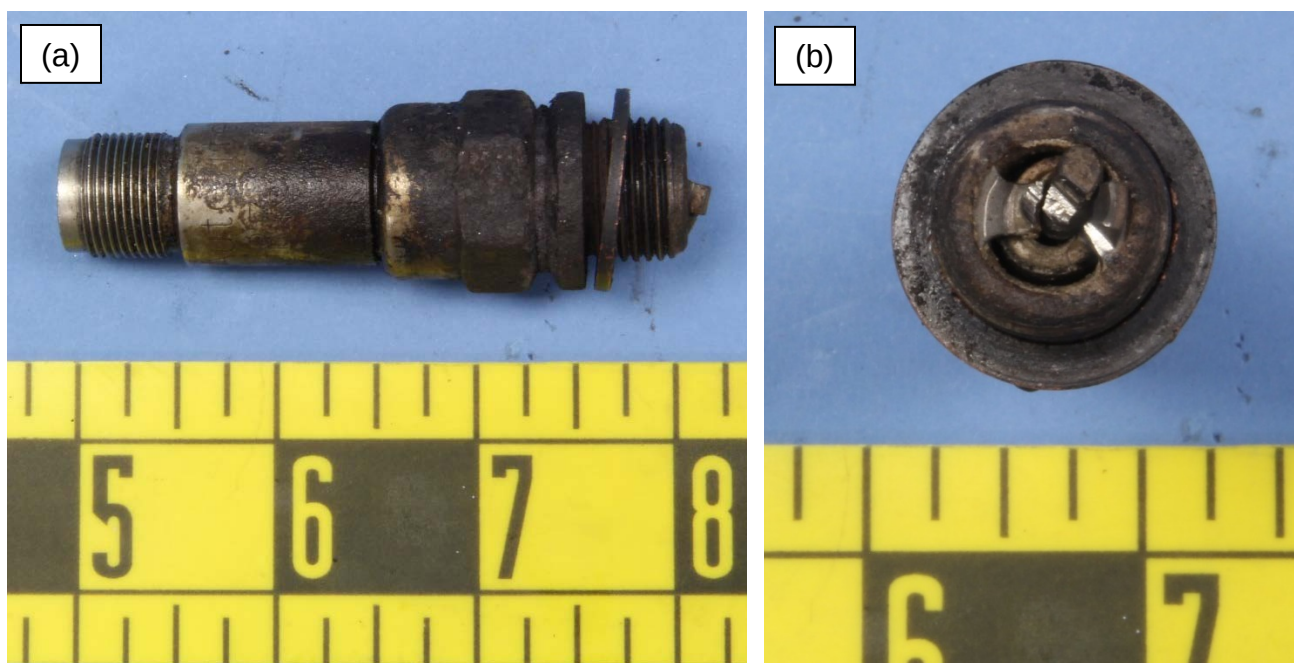
Figure 6 shows the spark plug removed from the #3 cylinder, as received. The spark plug exhibited dark viscous oil deposits on the side and the head. The side electrode tip of the spark plug appeared shiny and reflective, consistent with impact damage from an adjacent component. There was no other damage present on the either electrode of the spark plug.

Figure 6 – One of the spark plugs from the #3 cylinder, as received, viewed from (a) the side and (b) from the electrode side.

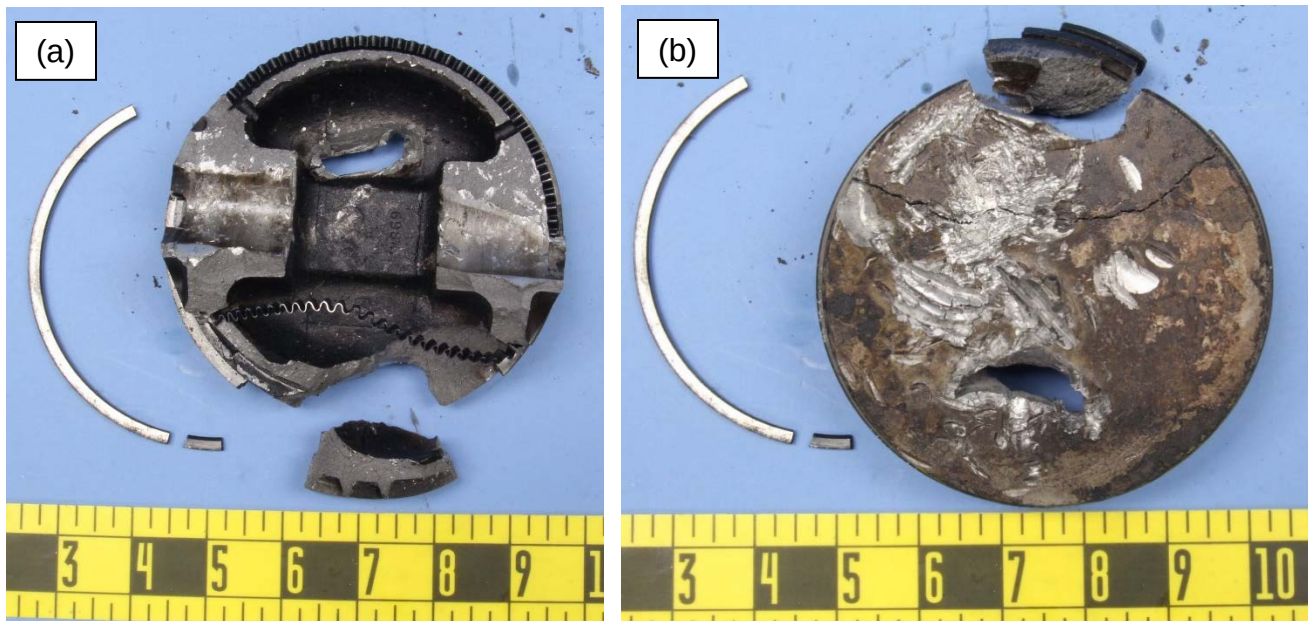
Figure 7 and Figure 8 show the parts of the piston assembly, as received. The piston had fractured in several locations, as shown in Figure 7a and Figure 7b. These fracture surfaces were dull in luster and rough in texture—features consistent with overstress fracture. The fractures were primarily located about the piston pin bore. A separate fragment submitted with the pin also exhibited fracture features consistent with overstress (Figure 8). Two fragments of one of the oil guide rings were received with the piston, both of which exhibited features consistent with overstress fracture. No features consistent with pre-existing cracking were observed on the piston or other components of the piston assembly.

The crown of the piston, shown in Figure 7b, exhibited multiple batter and impact marks. Like the combustion chamber of the cylinder, the impact marks were semicircular in shape, with one mark severe enough to penetrate the thickness of the piston crown. These marks were consistent with batter from the fractured exhaust valve head, shown in Figure 9 through Figure 11.

Figure 7 – The remanats of the piston, as received, viewed from (a) the skirt underside and (b) the crown.

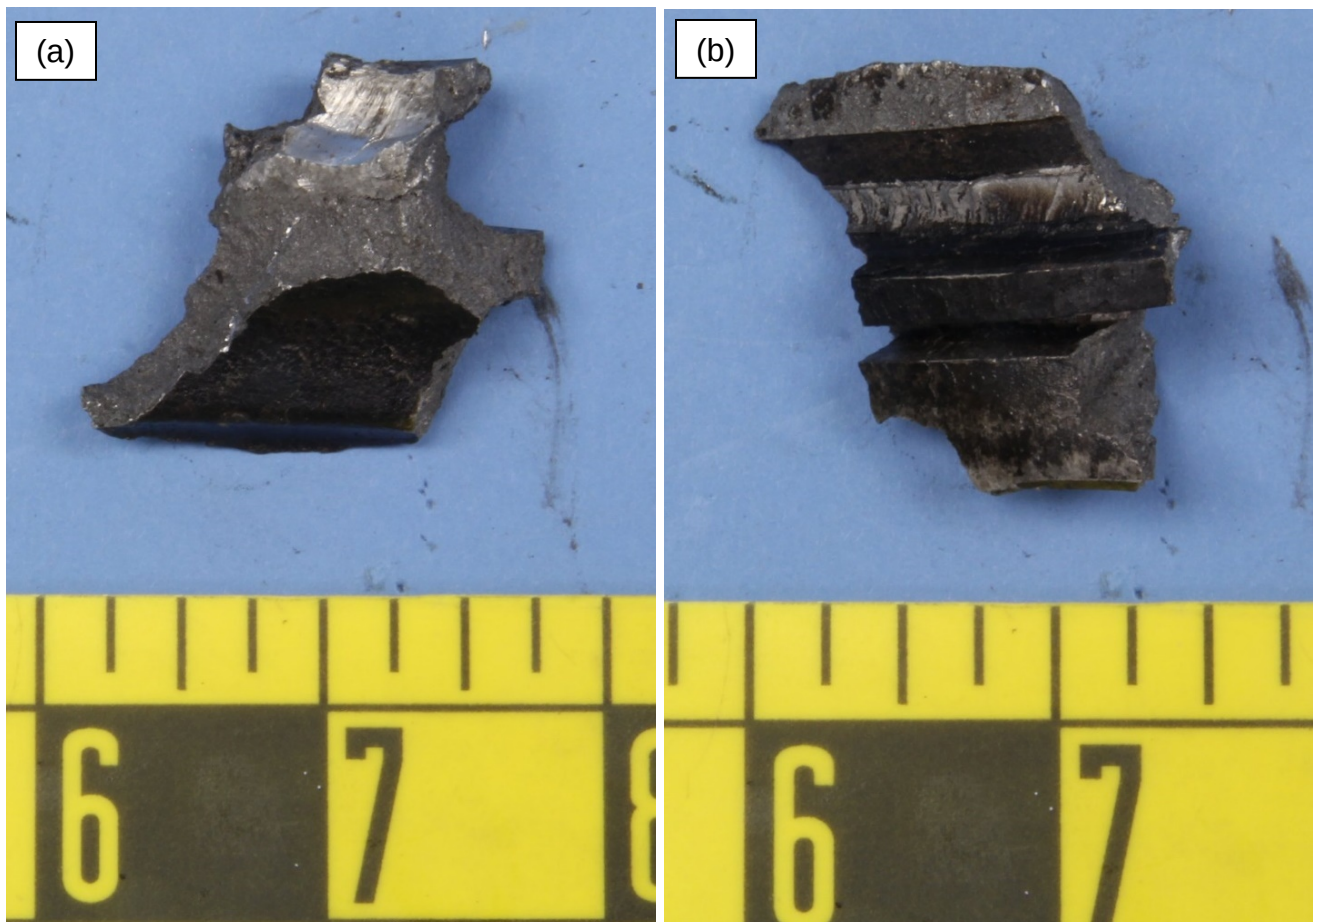
Figure 8 – The piston fragment viewed from (a) the fracture surface and (b) the reverse side.

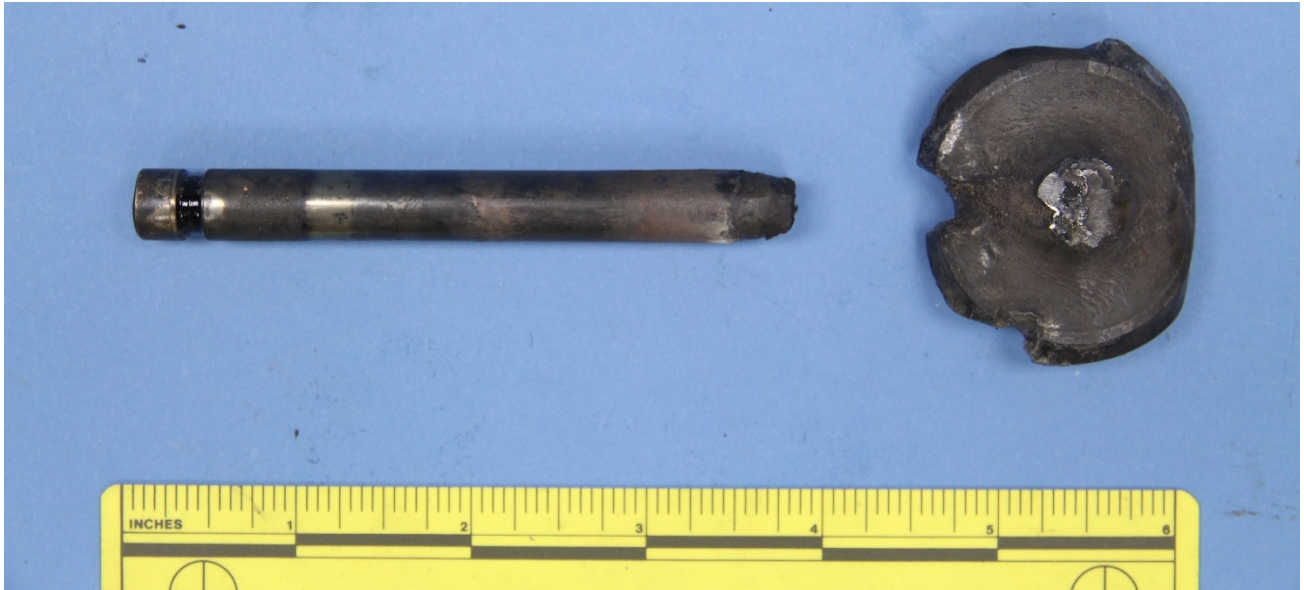
The fractured halves of the exhaust valve are shown in Figure 9 and Figure 10 after disassembly and removal from the cylinder assembly. The exhaust valve had fractured where the head geometry transitioned to the stem. Both fractured fragments exhibited dark coloring consistent with engine deposits. Figure 11 shows a closer view of the fractured

Figure 9 – The exhaust valve stem and exhaust valve head, after removal from the cylinder assembly, viewed from the fracture surface on the head.

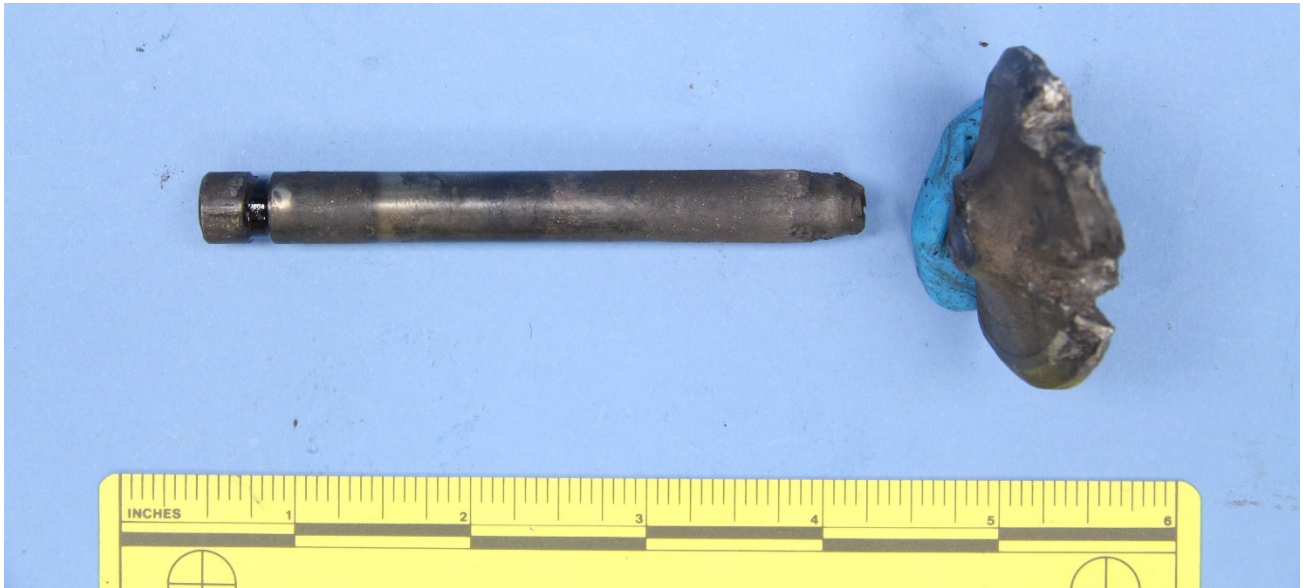
Figure 10 – The exhaust valve parts, shown on the side with the mating fracture surfaces facing each other.

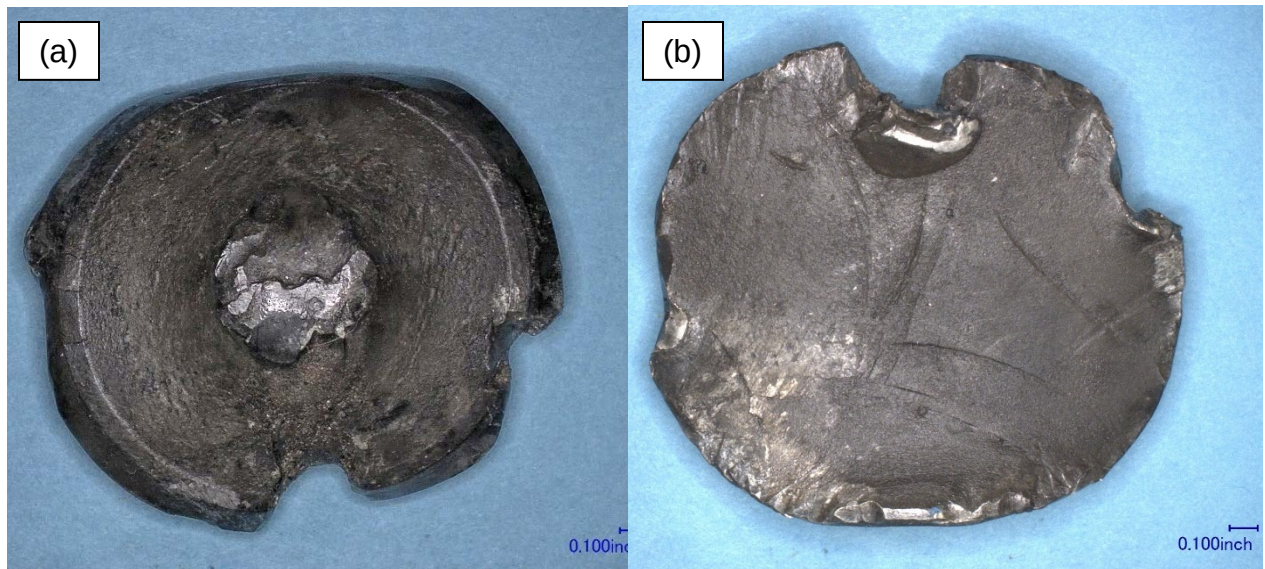
exhaust valve head from both sides. Three distinct portions of the exhaust valve head were severely deformed or missing. The face of the fractured valve head exhibited circular marks, consistent with impacts with the intake valve and/or the exhaust valve seat recess in the cylinder. These features were consistent with post-fracture batter inside the cylinder combustion chamber.

Due to the post-fracture batter damage, the fracture surface on the separated valve head was obliterated (see Figure 11a). However, the mating fracture surface on the stem was relatively undamaged and exhibited macroscopic fracture features. As shown in Figure 12 and Figure 13, the stem was found tapered or necked adjacent to the fracture surface—this tapering was not consistent with the design geometry of the part. The area of the valve stem adjacent to the tapered area exhibited dark and light non-metallic deposits. The fracture surface, shown in Figure 14, exhibited a rough texture and dull luster, with several ridges. The ridges exhibited a general radial pattern from the center outward. The orientation of these ridges was consistent with torsional loading at fracture.

Figure 11 – The exhaust valve head viewed from (a) the fractured stem side and (b) the cylinder chamber side.

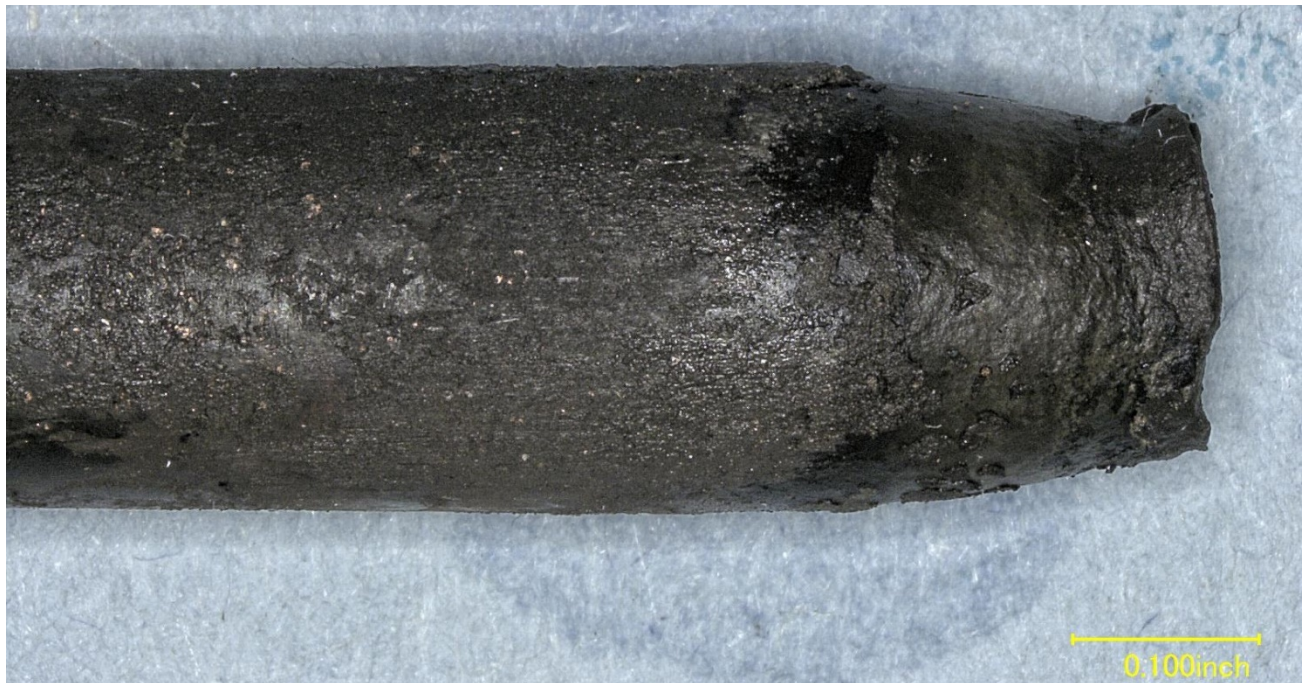
Figure 12 – Closer view of the exhaust valve stem fracture from the side, showing a tapered geometry near the fracture and dark non-metallic compounds on the surface.

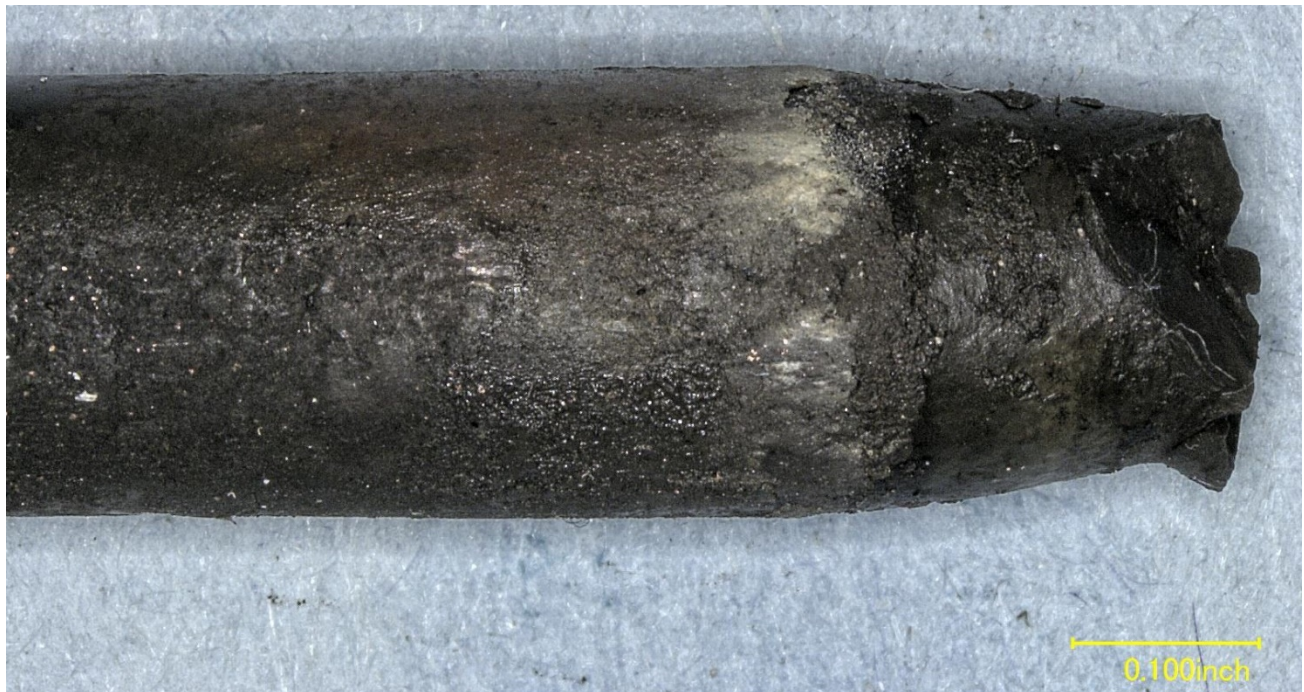
Figure 13 – The exhaust valve stem fracture from the side, rotated 180° from Figure 12.

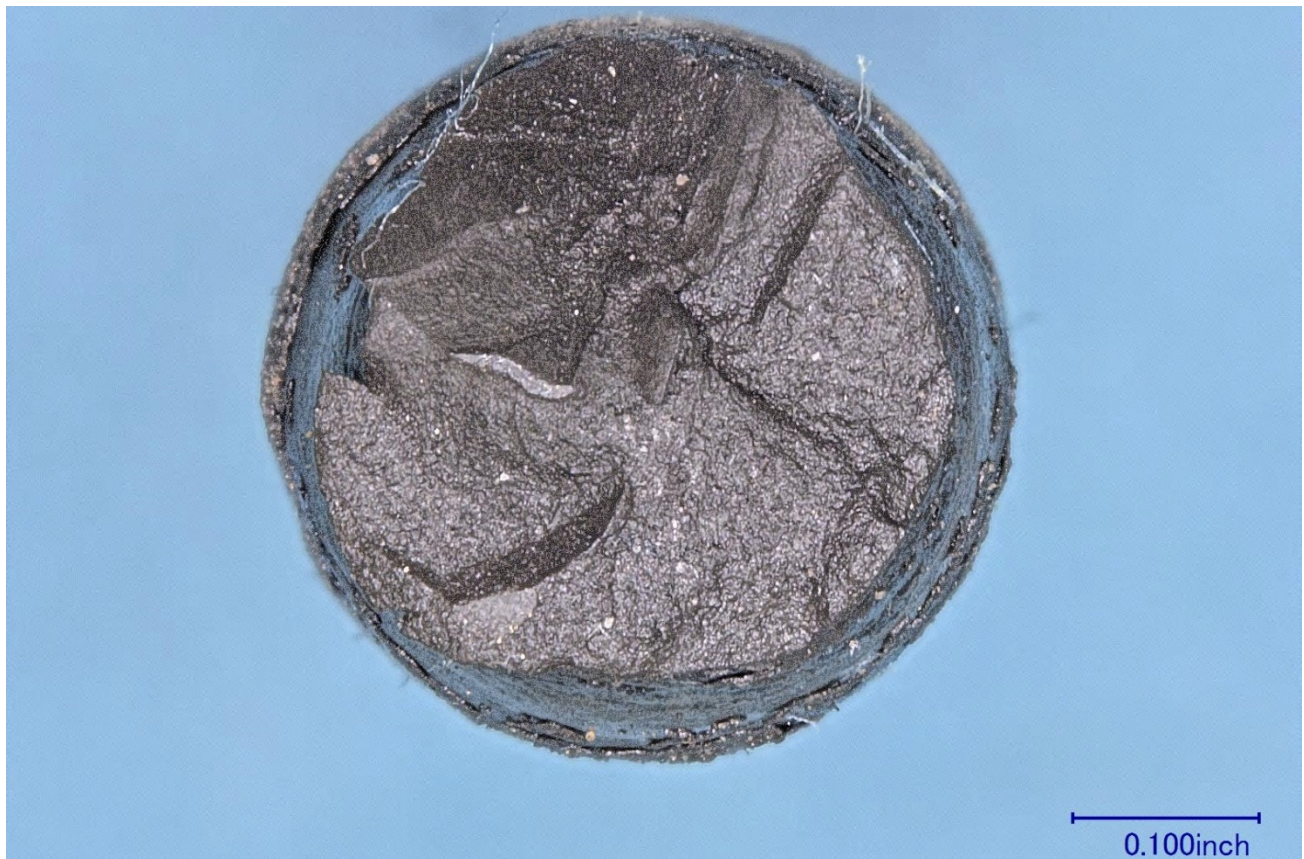
Figure 14 – Closer view of the exahust valve stem fracture surface, after sectioning.

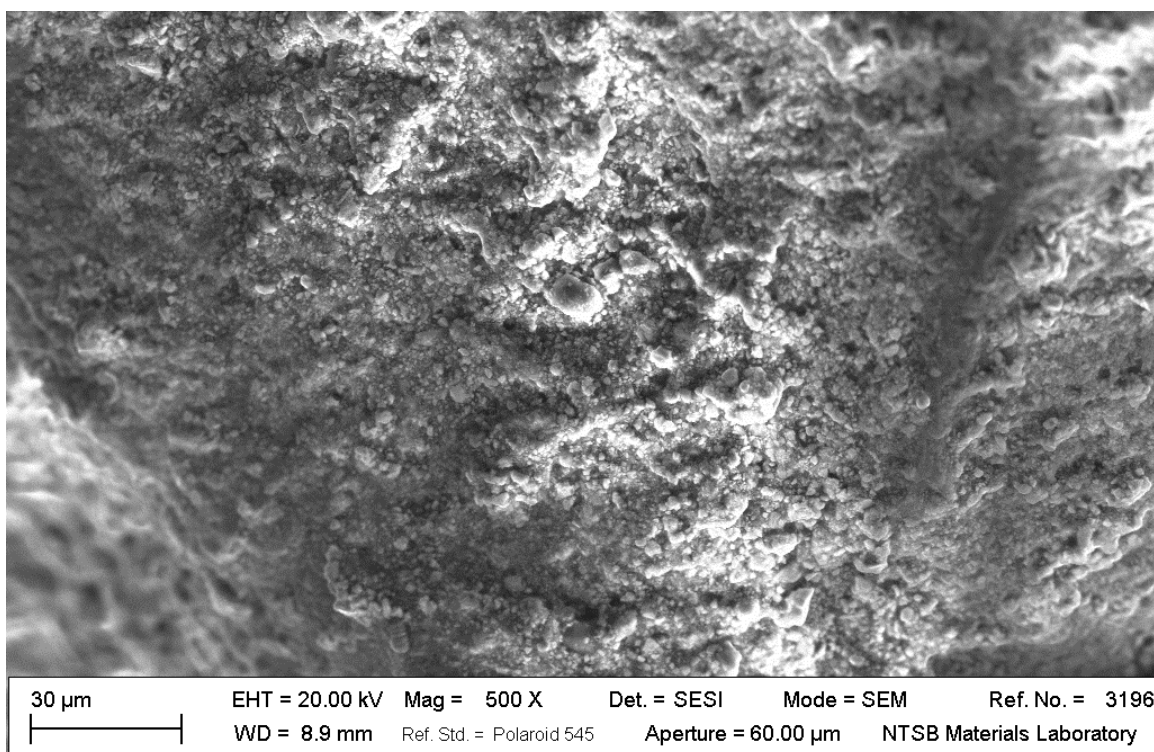
The valve stem fracture surface was sectioned, cleaned, and examined using a scanning electron microscope (SEM). A typical area of the fracture surface is illustrated in Figure 15. Much of the fracture surface was non-conductive as evidenced by the charging effects witnessed in the SEM, consistent with post-fracture oxidation. Many of these oxides were small blocky-shaped deposits (see Figure 16). Portions of the fracture surface exhibited interconnected voids open to the surface (Figure 17). These voids, along with the tapered region of the stem near the fracture surface, were consistent with high-temperature deformation under stress.

Figure 15 – Secondary electron (SE) micrograph of a typical area of the exhaust valve fracture surface.

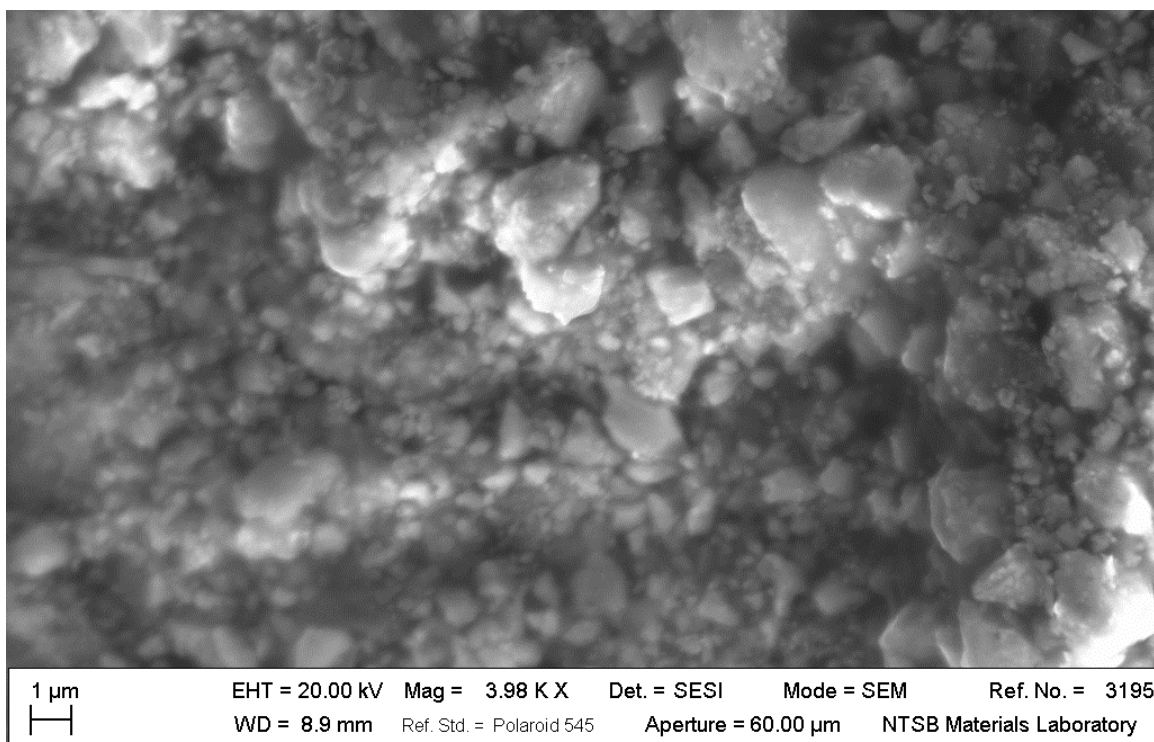
The chemical composition of the exhaust valve was examined using energy dispersive x-ray spectroscopy (EDS) and x-ray fluorescence (XRF). The chemical composition of a cross-sectioned polished portion of the valve stem was consistent with a stainless steel alloy. The fracture surface compounds (shown in Figure 16) were examined using EDS, with a typical spectrum illustrated in Figure 18. These deposits had elevated levels of lead (Pb), bromine (Br), along with phosphorus (P) and chlorine (Cl). The high lead and bromine contents were consistent with deposits from oxidation of anti-knocking compounds added to aviation fuel. The deposits on the outside of the valve stem were also examined using EDS, with a typical spectrum shown in Figure 19. This spectrum had elevated levels of chromium (Cr), iron (Fe), and nickel (Ni), which were the primary constituents of the valve alloy. This spectrum also exhibited elevated levels of lead, bromine, and phosphorus.

Figure 16 – SE micrograph of a closer area of Figure 15, showing small compound particles.

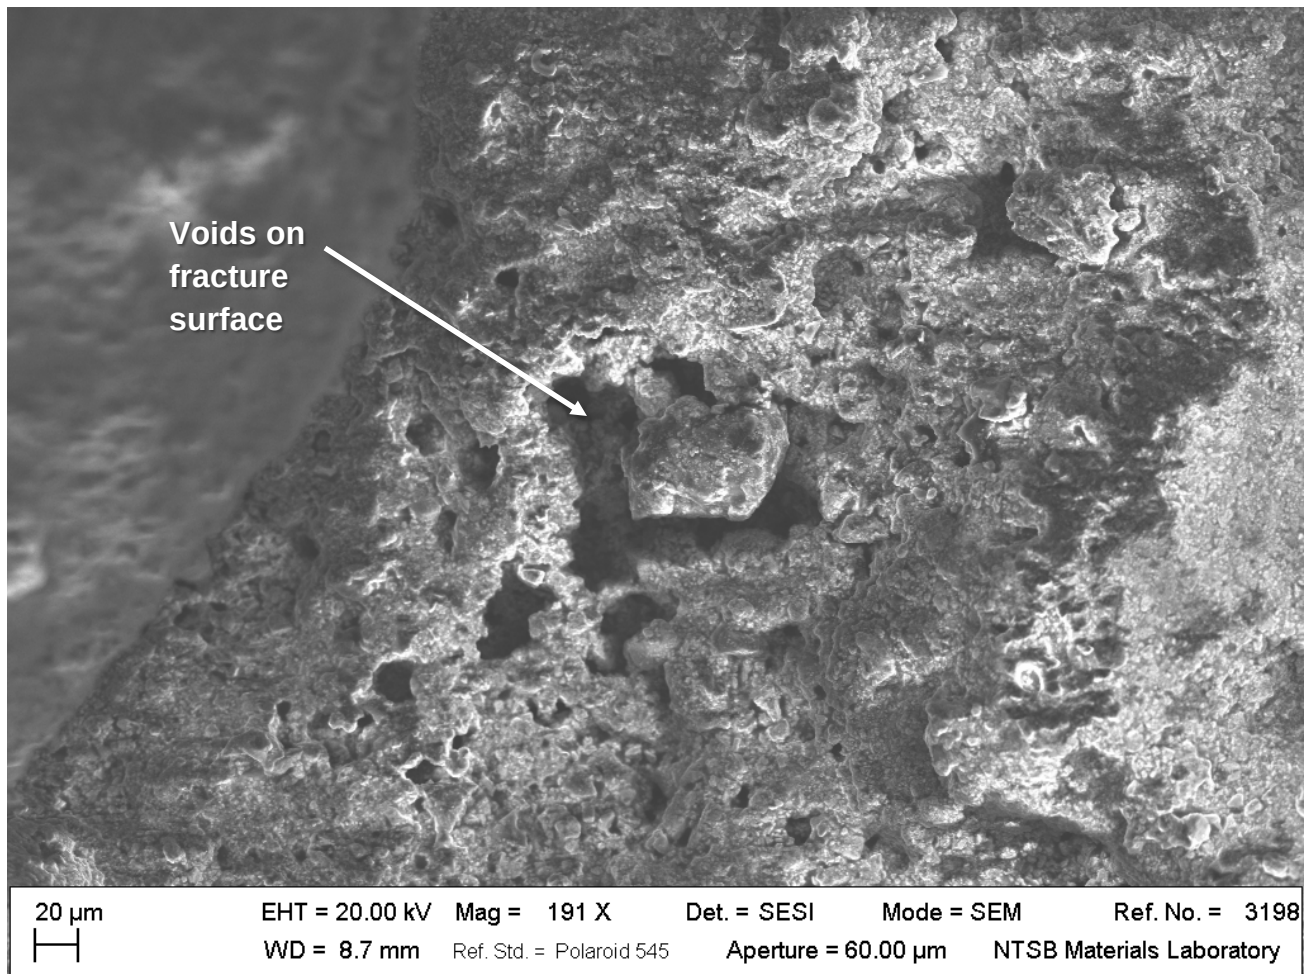
Figure 17 – SE micrograph showing voids (dark) on the valve stem fracture surface.

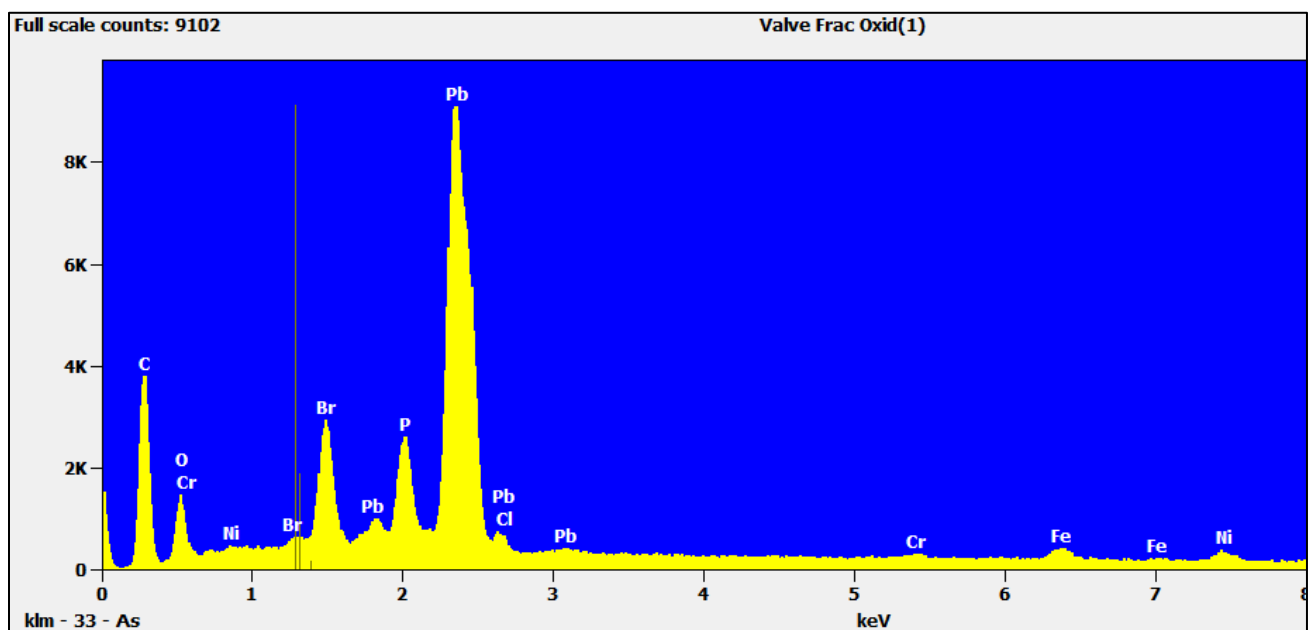
Figure 18 – EDS spectrum of the exhaust valve fracture surface (from Figure 16).

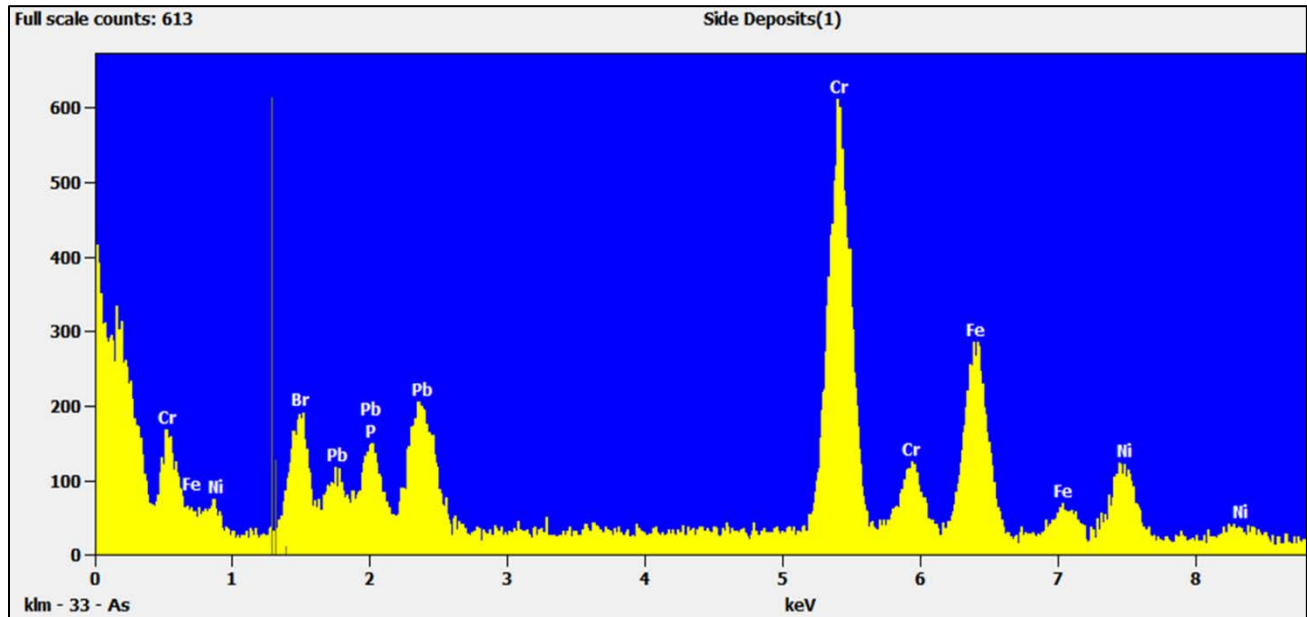
Figure 19 – EDS spectrum from deposits on the exhaust valve stem.
