# NATIONAL TRANSPORTATION SAFETY BOARD

## MATERIALS LABORATORY FACTUAL REPORT

Report No. 18-024

Place : Beckville, Texas  
Date : August 14, 2017  
Vehicle : Piper PA-22-135, N2591A  
NTSB No. : CEN17LA317  
Investigator : Tim Sorensen, AS-CEN

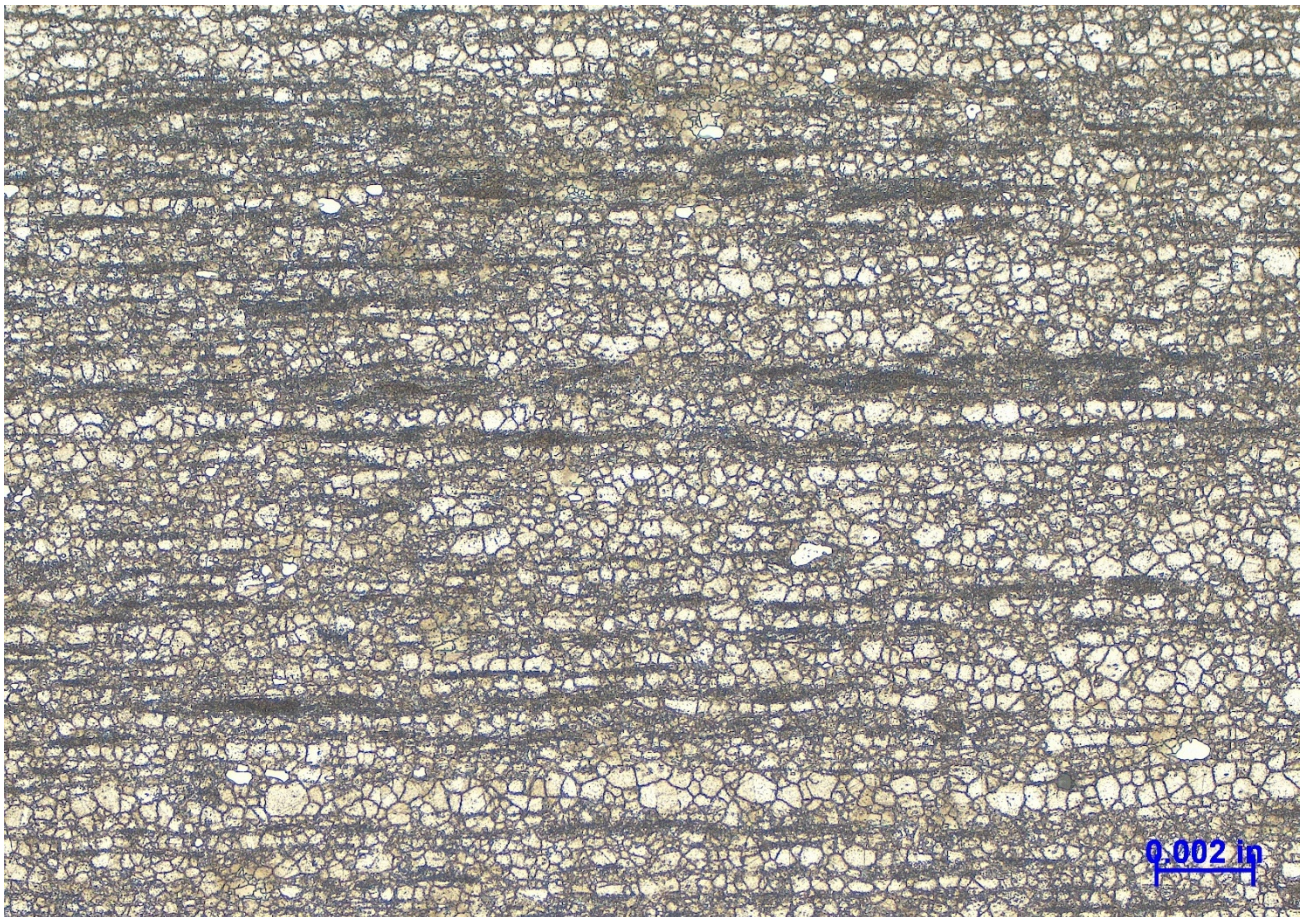
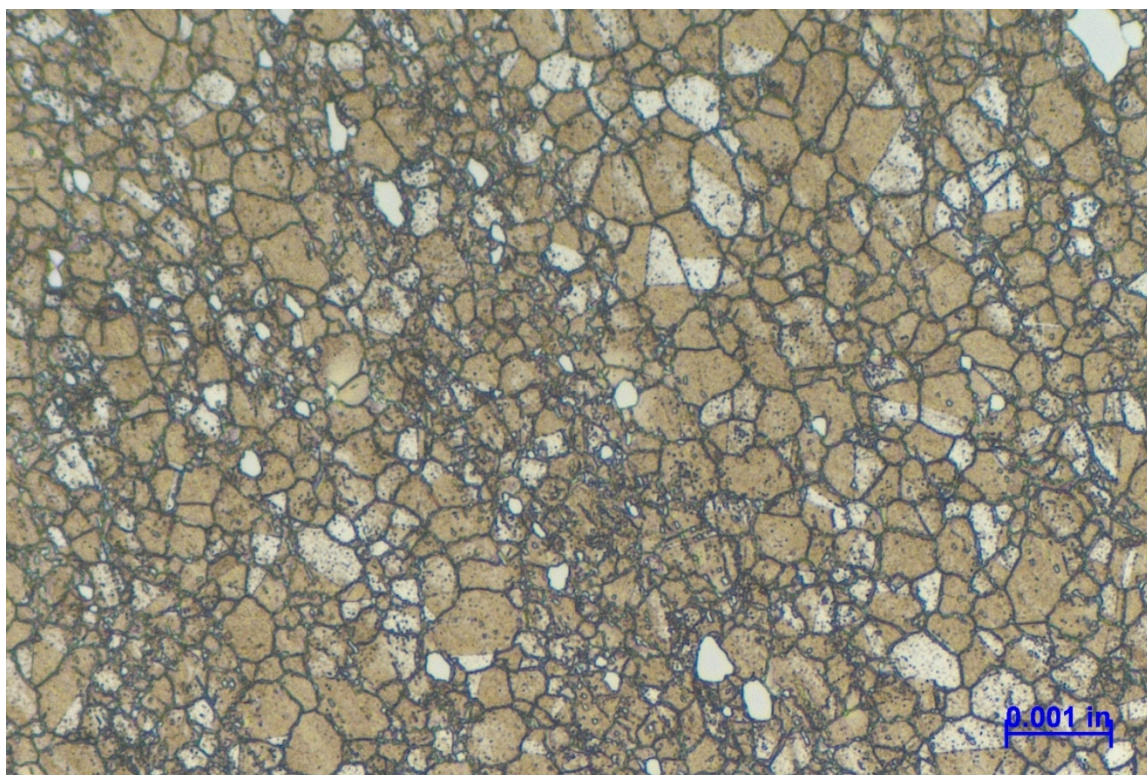
The valve stem was cross sectioned through the fracture surface and tapered end, mounted and polished. A typical region of the microstructure away from the fracture surface and the tapered end is shown in Figure 20 and Figure 21. The microstructure exhibited general grain flow in the direction of the stem direction, with general equiaxed-shaped grains. The grain boundaries did exhibit high carbide formation, consistent with exposure to elevated temperatures in excess of 800 °F (425 °C). Figure 22 and Figure 23 show a typical area of the microstructure adjacent to the fracture surface. As shown in Figure 22, the fracture surface exhibited intergranular oxidation and excessive grain flow.

Figure 20 – Bright field (BF) optical micrograph of a typical area of the exhaust valve microstructure away from the fracture surface (~200X, etched Fry's Reagent).

Figure 21 – BF optical micrograph of a typical area of the exhaust valve microstructure away from the fracture surface (~500X, etched Fry's Reagent).

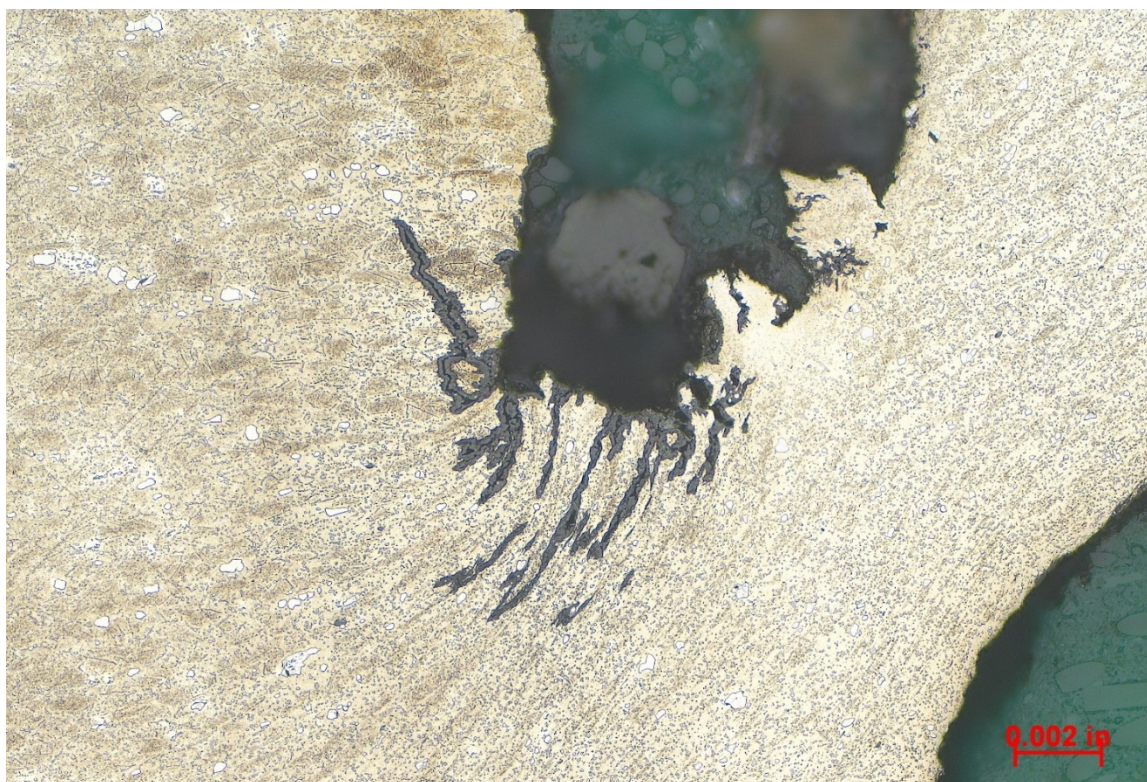
Figure 22 – BF optical micrograph of an area of the exhaust valve fracture surface, showing internal oxidation along grain boundaries (~100X, etched Fry's Reagent).

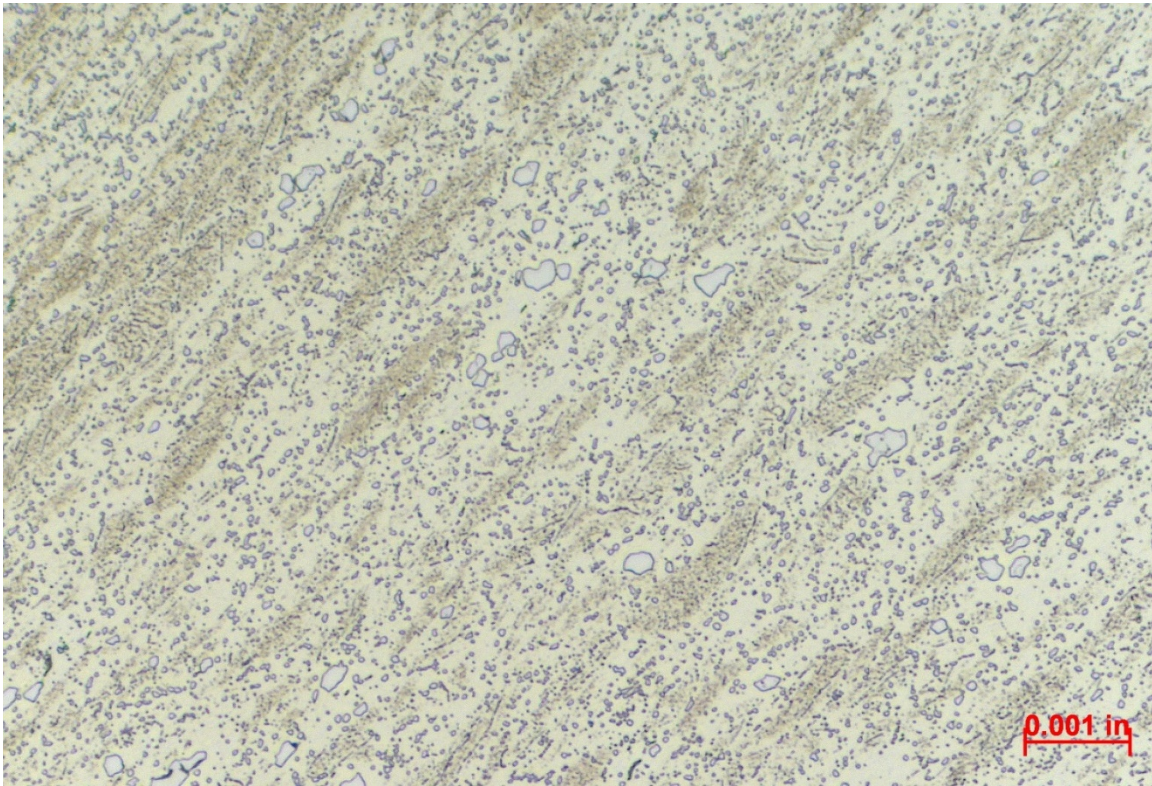
A closer examination of the microstructure in this area (Figure 23) showed a different structure than in Figure 22, with larger grains and large blocky chromium carbides in an austenitic matrix, consistent with exposure to even higher temperatures.

Figure 23 – BF optical micrograph of a typical area of the exhaust valve microstructure adjacent to the fracture surface (~500X, etched Fry's Reagent).

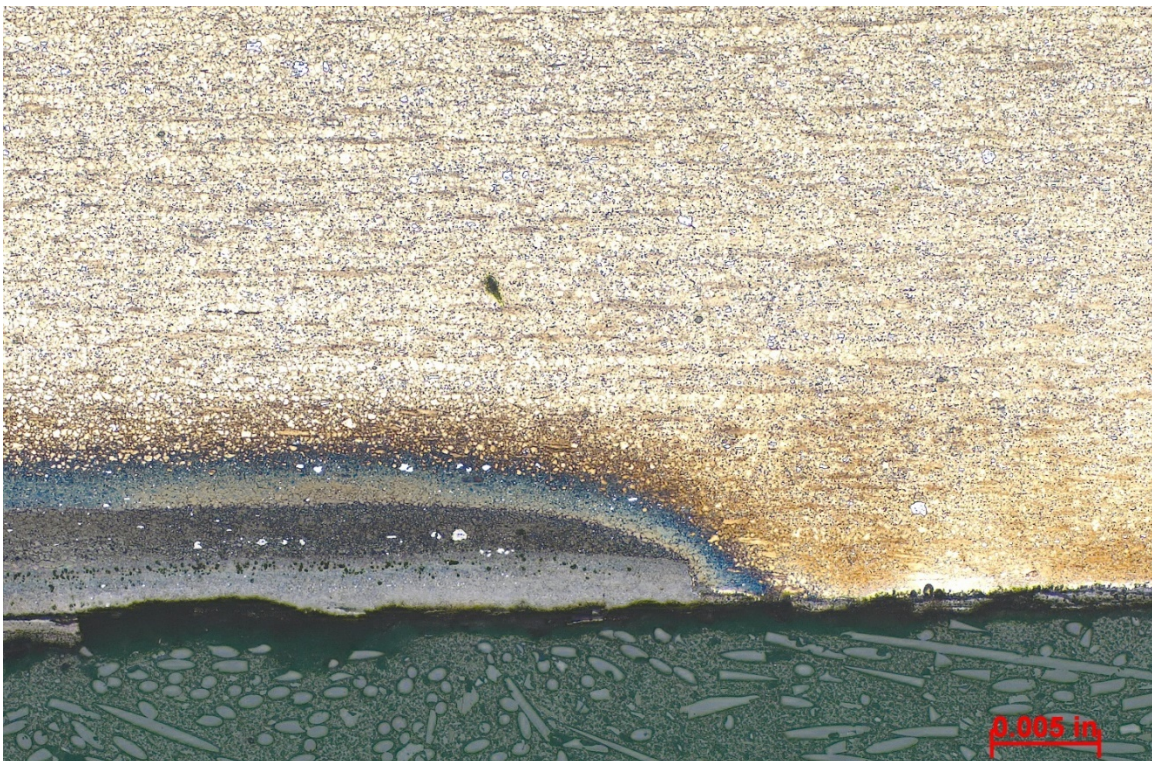
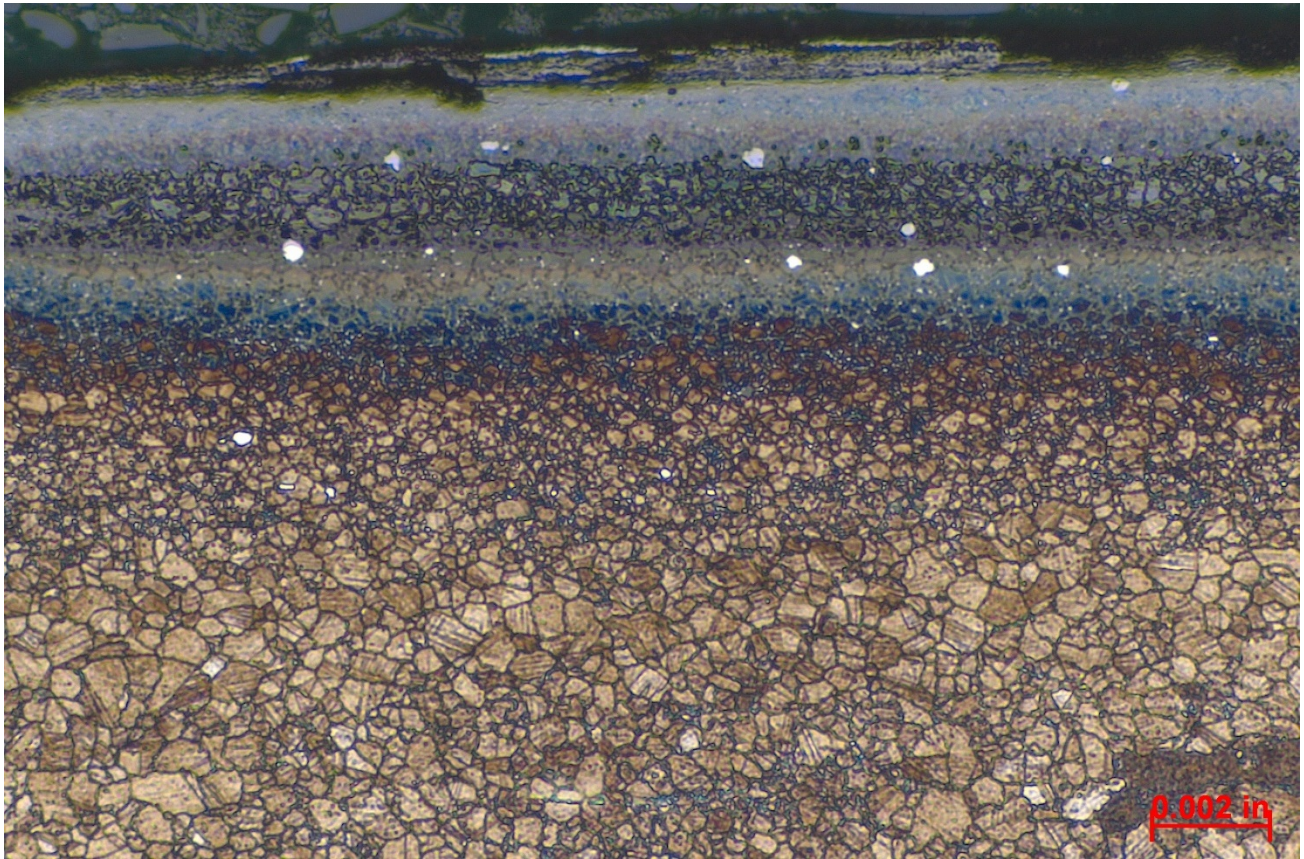
Portions of the valve stem surface away from the fracture surface exhibited subsurface bulk oxidation, as illustrated in Figure 24. This oxidation penetrated 0.005 to 0.010 inches into the surface of the valve (shown dark in Figure 24 and Figure 25). The portions of the valve alloy material adjacent to the surface oxidation exhibited subsurface oxidation and porosity, concentrated along the grain boundaries. These features were consistent with high-temperature oxidation processes over an extended period.

Figure 24 – BF optical micrograph of an area of the exhaust valve stem surface showing an area of oxidation and porosity (~100X, etched Fry's Reagent).

Figure 25 – BF optical micrograph of an area of the exhaust valve stem surface showing an area of oxidation and porosity (~200X, etched Fry's Reagent).
