# NATIONAL TRANSPORTATION SAFETY BOARD

## MATERIALS LABORATORY FACTUAL REPORT

Report No. 18-093

Place : Sweetwater, Texas  
Date : August 18, 2017  
Vehicle : Piper PA-18-150, N82912  
NTSB No. : CEN17LA324  
Investigator : Andrew Todd Fox, AS-CEN

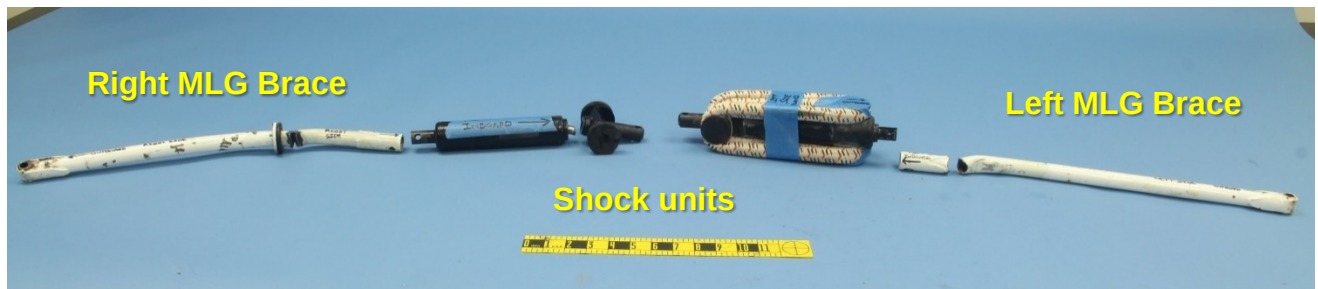
Figure 1 shows the landing gear components from the accident airplane, as received. This included components from two shock units, with the left and the right main landing gear (MLG) braces.

Figure 1 – The left and right main landing gear braces and the shock units, as received.

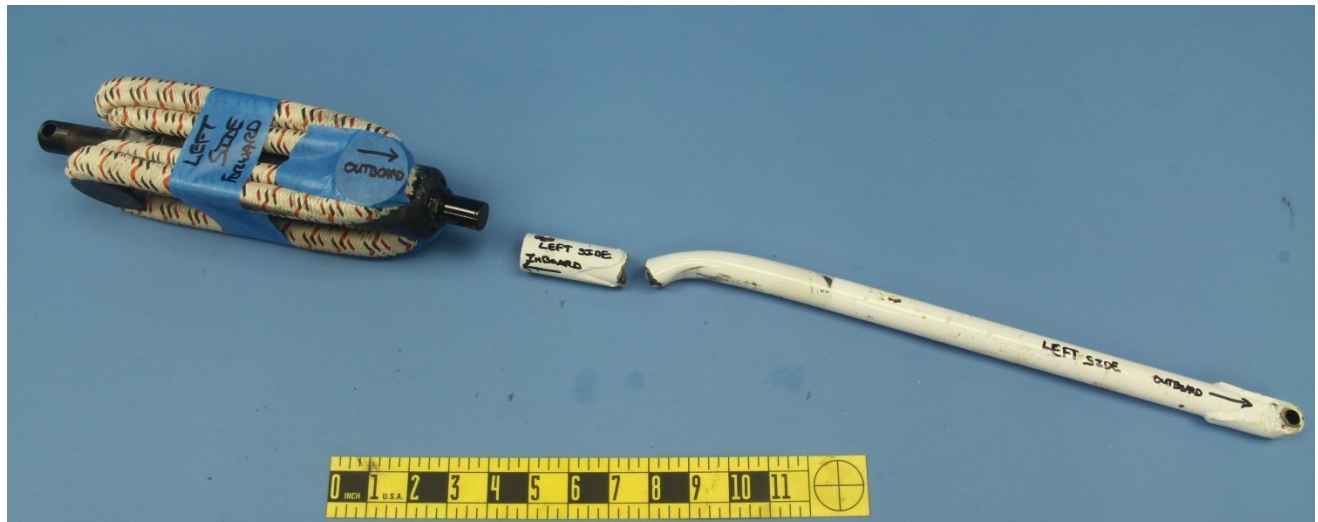
The left side shock unit and brace are shown in Figure 2. The shock unit was received intact, wrapped with blue masking tape for identification purposes. The unit included external shock cord rings, wrapped around the fitting tee flanges. The adjacent brace is shown in Figure 2 in the position it would attach to the shock unit. Approximately 2.75 inches from the fitting side, the brace tube on the left side had fractured (see Figure 3).

Figure 2 – The left side shock unit and main landing gear brace, as received.

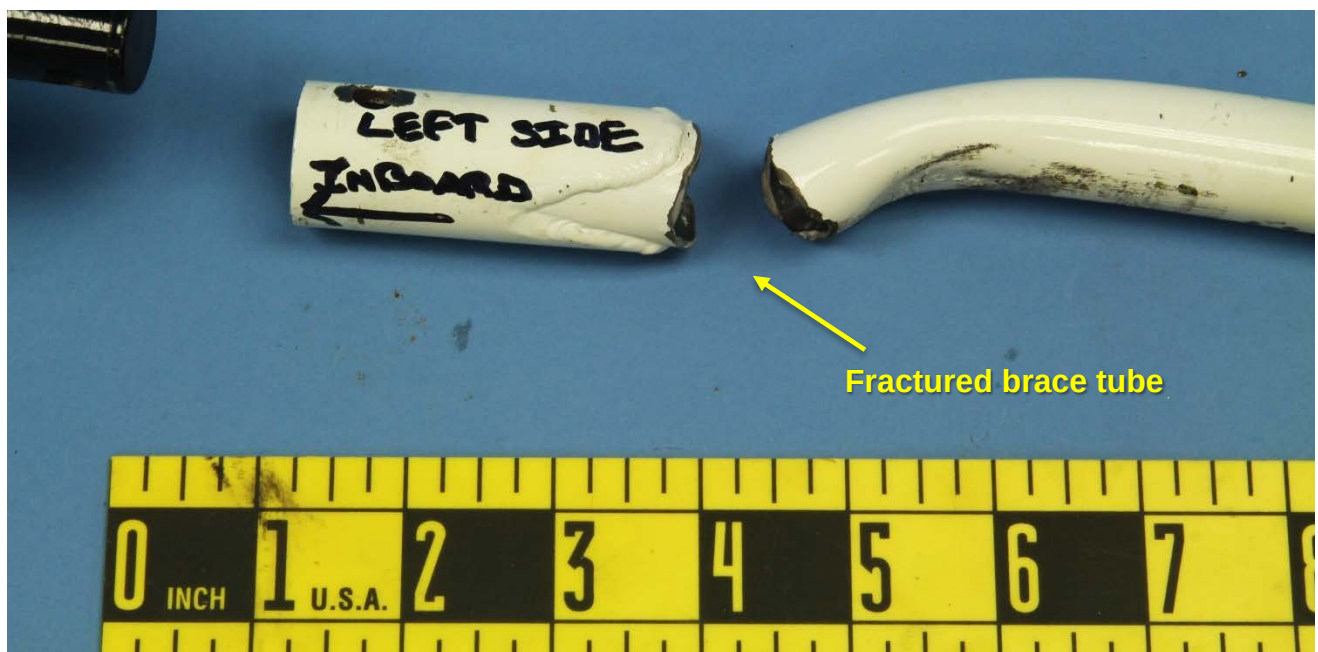
Figure 3 – The fractured left brace tube fragments, as received.

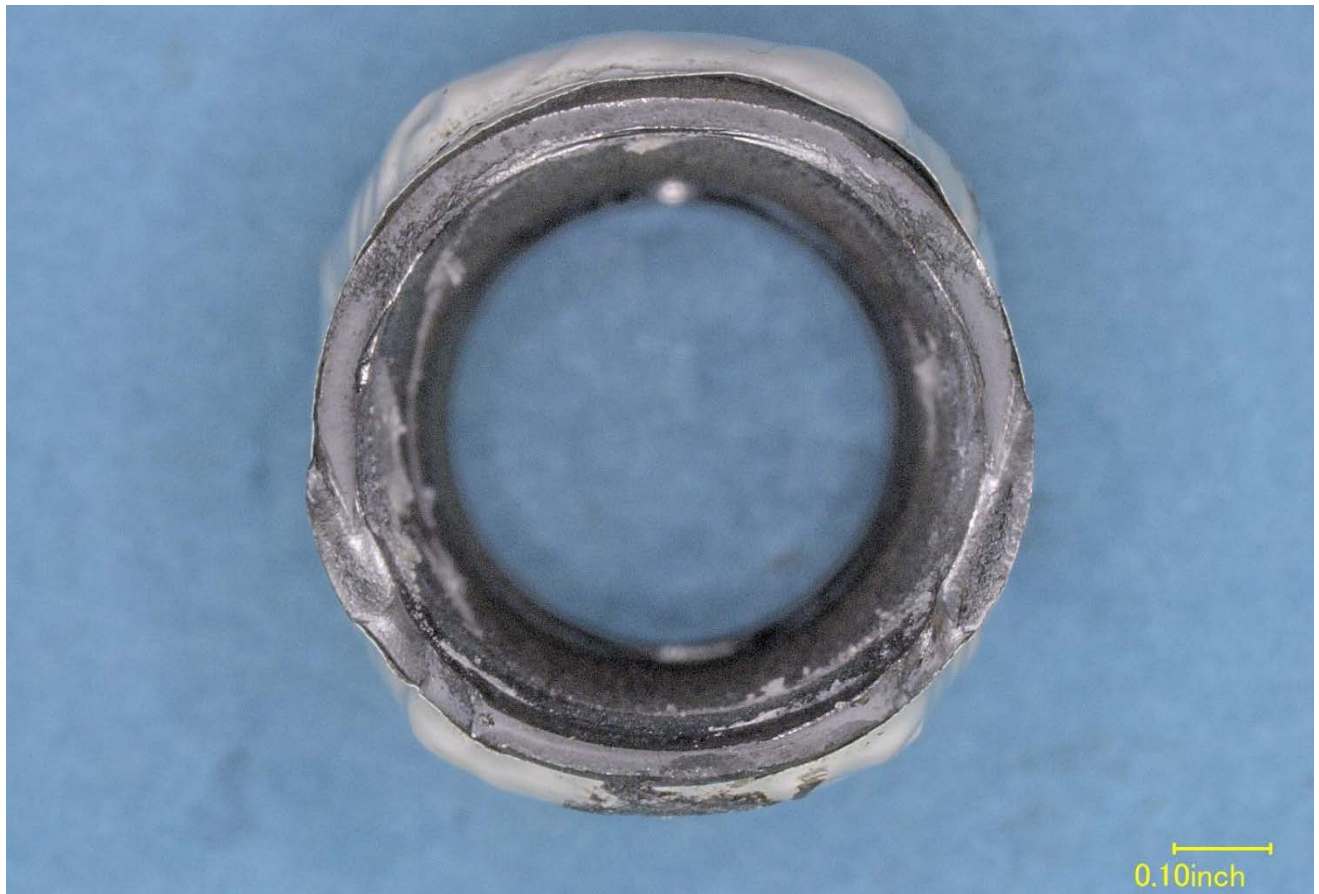
One of the mating fracture surfaces of the is shown in Figures 4 and 5. The fracture surface exhibited a generally dull luster, with a rough surface texture. Adjacent to the fracture surface, the tube had exhibited local thinning, or necking (see Figure 5). The fracture surface exhibited either a cup-shaped morphology, or a flat orientation, angled at approximately 45° relative to the tube direction. These features were all consistent with fracture from tensile overstress. No indications or features consistent with pre-existing cracks or damage were observed on the tube fracture surface.

Figure 4 – The inboard fracture surface of the left landing gear brace.

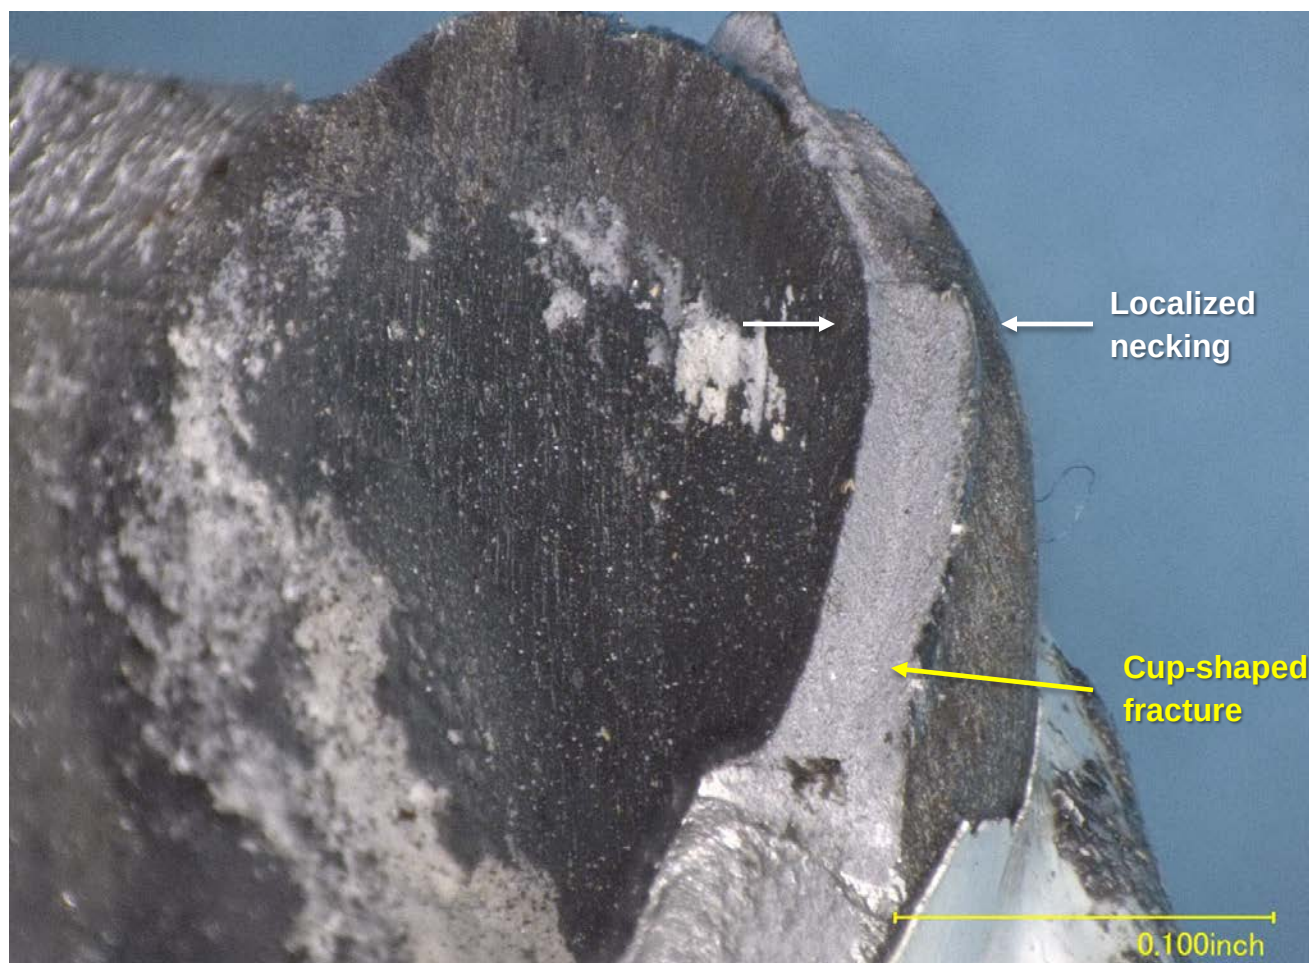
Figure 5 – Closer view of the left MLG brace fracture surface, with fracture features annotated.

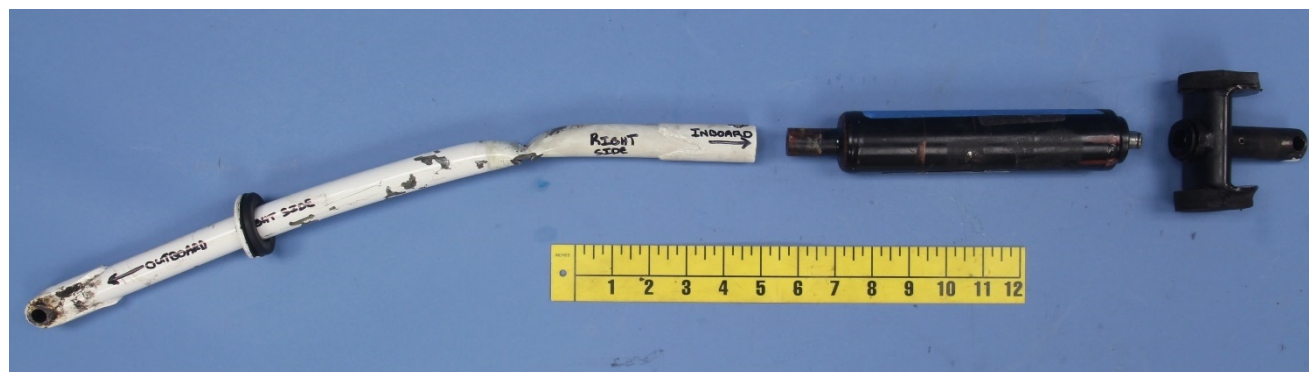
Figure 6 shows the right side shock unit and brace. The shock unit on this side did not include the external shock cord rings, as had the left side unit. The shock unit had fractured at the internal piston shaft. The landing gear brace had buckled and partially fractured approximately 5.75 inches from the fitting hole (see Figure 7). The partial fracture surface exhibited a generally rough texture, with a dull luster, consistent with tensile overstress fracture. The opposite side of the tube 180° from the partial fracture surface had buckled inward toward the fracture side. These features were consistent with failure from bending overstress. However, the amount of stress was not high enough to completely break through the tube.

Figure 6 – The right main landing gear brace and shock unit pieces, as received.

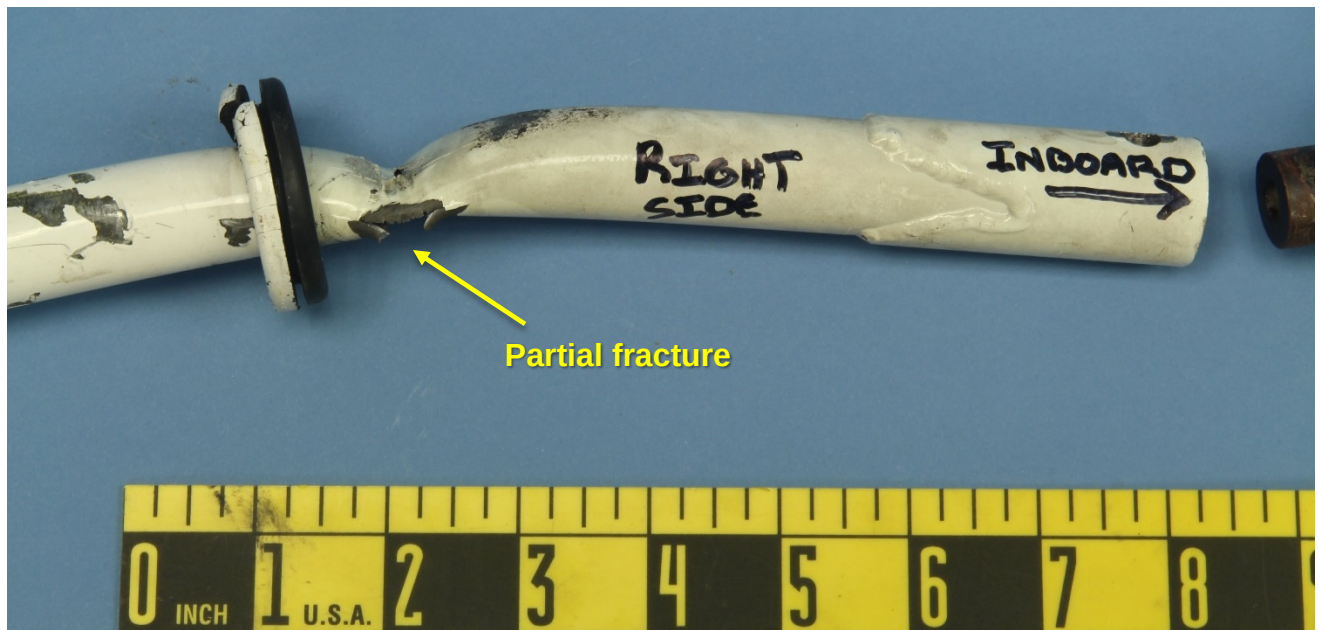
Figure 7 – The inboard side of the right brace tube, showing buckling and partial fracture on the downward side.

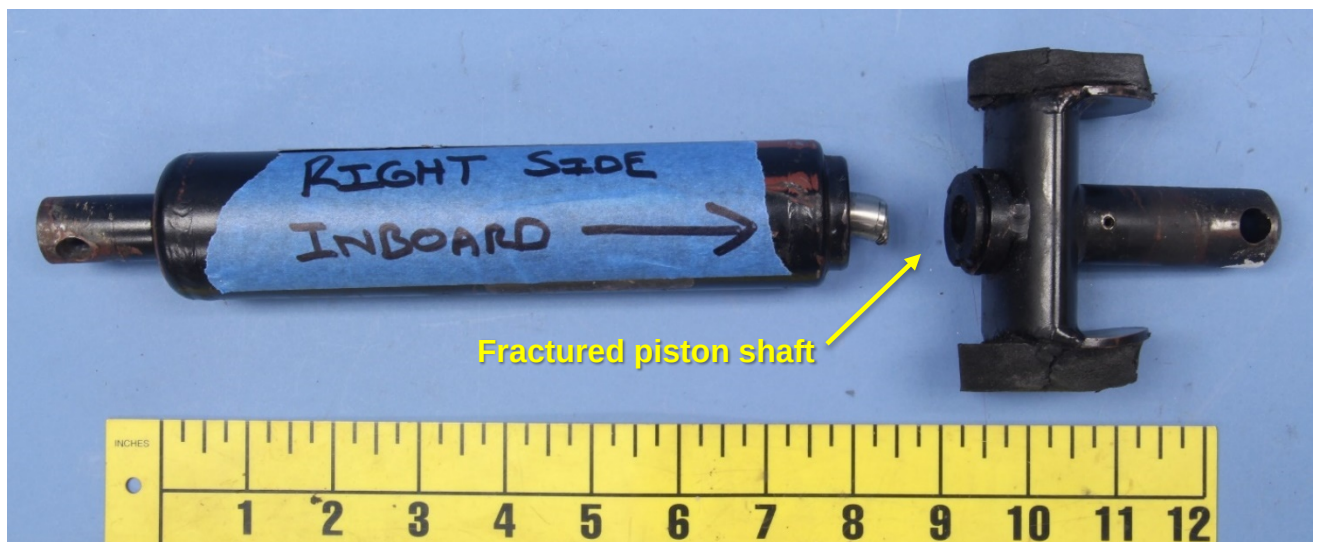
The fractured shock absorber unit is shown in Figure 8. As mentioned previously, the shock unit had fractured at the piston shaft that actuates inside the unit. The marking sticker on the unit barrel had been damaged, such that some of the lettering was obscured. What could be discerned stated, "HYDRASORB SHOCK...T", "P/N...58-1 FAA/PMA", "PA-...19, 20, 22, 25 SEE LIST". The unit barrel sticker also stated the part was made by Univair Aircraft Corporation, Aurora, CO.

Figure 8 – The right side shock unit fragments, as received. The piston shaft of the shock unit had fractured (right side).

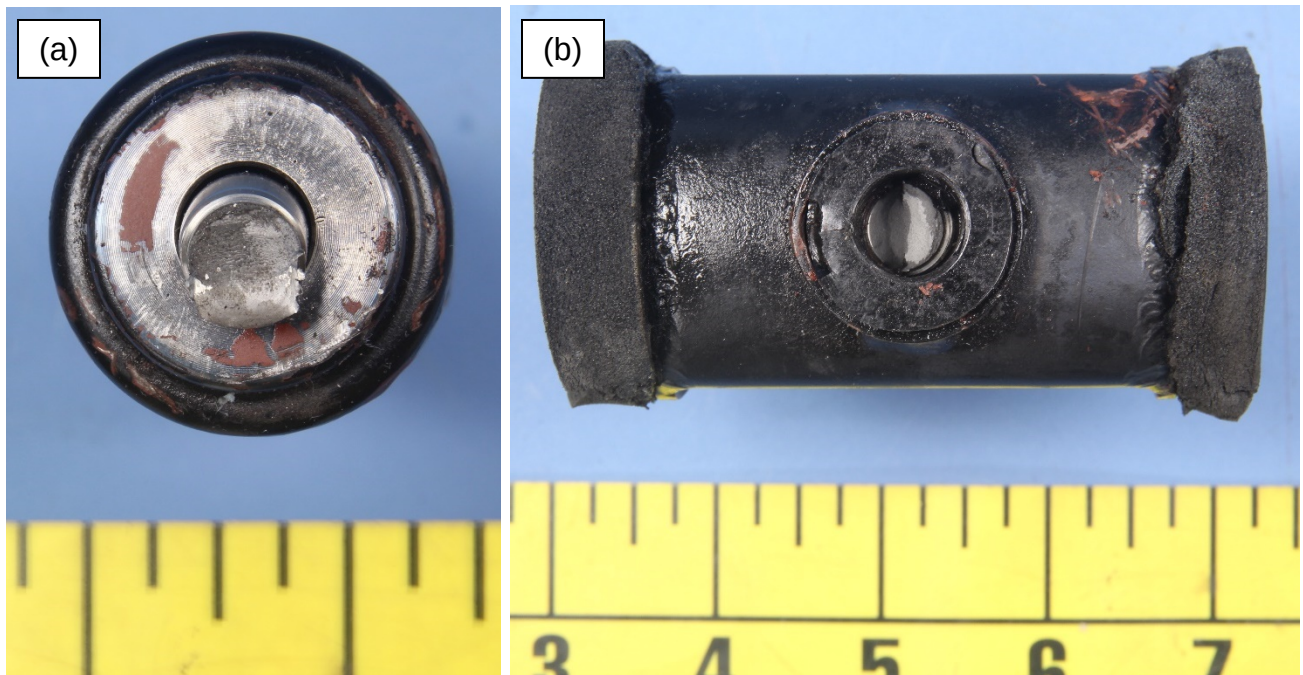
The mating fracture surfaces of the piston shaft are shown in Figures 9a and 9b from the outboard and inboard faces, respectively. The outboard side of the fractured shaft extended outside the unit housing, whereas the inboard side of the fractured shaft was located inside the bottom fitting bore (Figure 9b). Figure 10 shows the outboard fracture from the side. This figure was annotated to show various dimensions of the shaft protrusion from the unit face to the fracture surface. As shown in Figure 10, the shaft had bent downward adjacent to the fracture surface.

Figure 9 – The mating fracture surfaces of the fractured piston shaft from the (a) the outboard cylinder side and (b) the inboard side inside the housing of the top fitting.

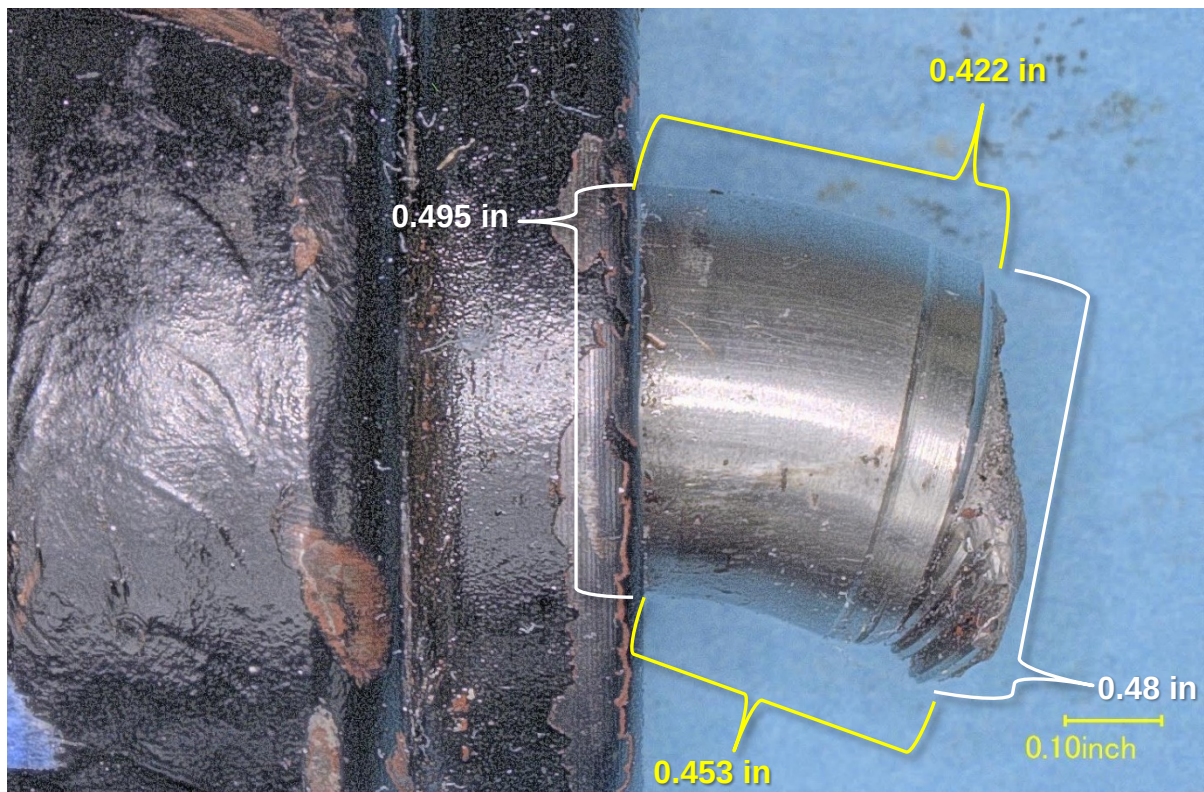
Figure 10 – The piston shaft fracture surface from Figure 8a, viewed from the side with selected measurements annotated.

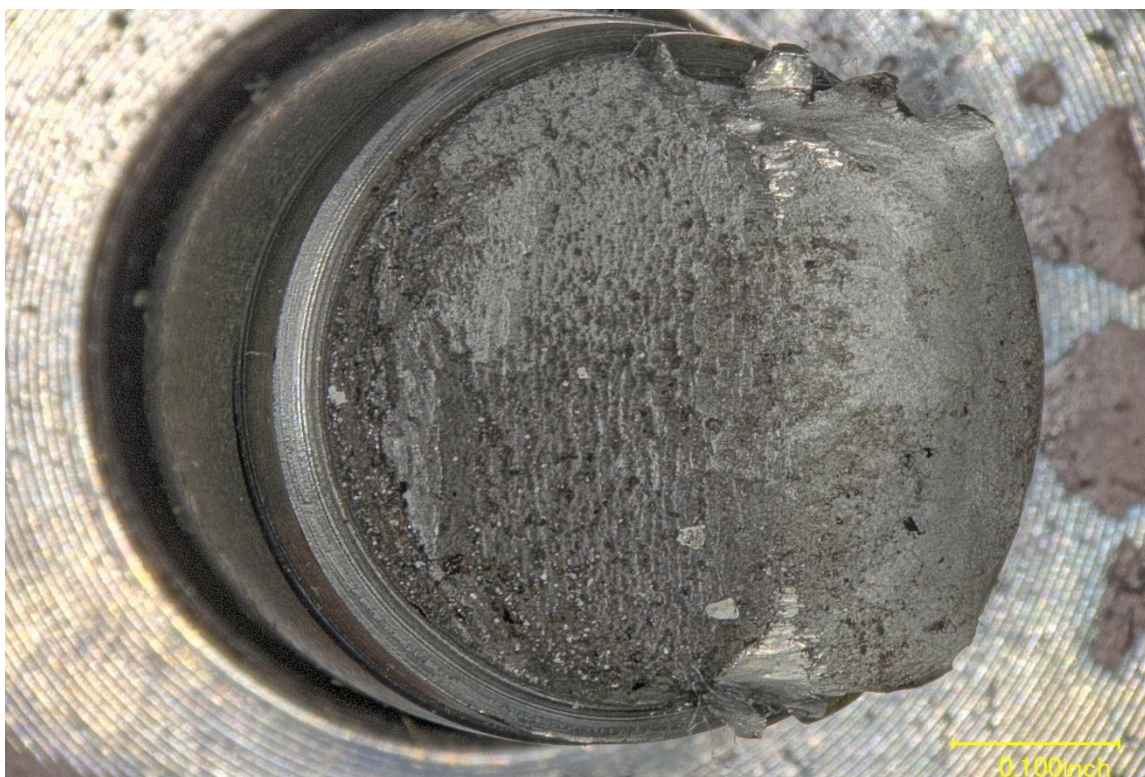
Figure 11 shows a closer view of the fracture surface. One side of the fracture exhibited a generally flat surface on one half (left side), which transitioned to a 45° lip (right side). The fracture surface exhibited river patterns and other features consistent with the shaft having fractured from left to right in Figure 11. For reference, this fracture direction is oriented top to bottom in Figure 10 (toward the shaft bending direction). The shaft fracture surface was examined using a scanning electron microscope (SEM). The fracture surface exhibited dimple rupture in a slanted orientation. These features were consistent with fracture in bending overstress of the shock unit piston shaft.

Figure 11 – Closer view of the piston rod fracture surface, with arrows showing the fracture direction.

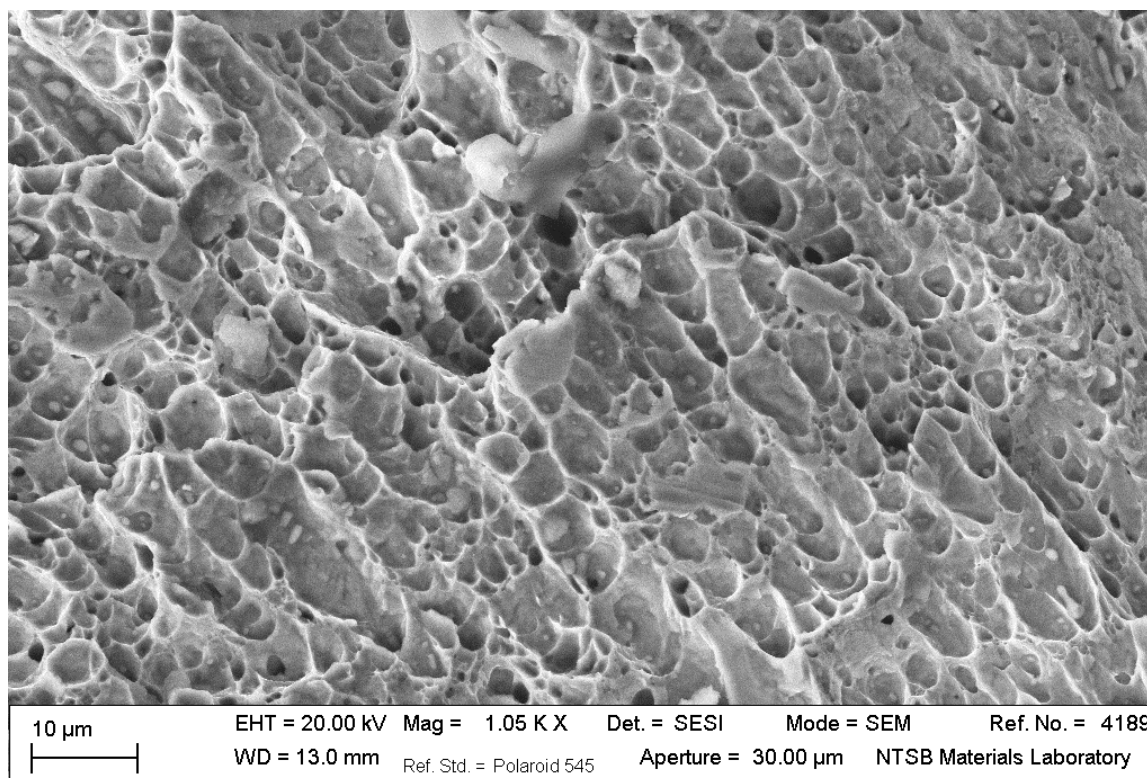
Figure 12 – Secondary electron (SE) micrograph of the shaft fracture surface, showing dimple rupture.

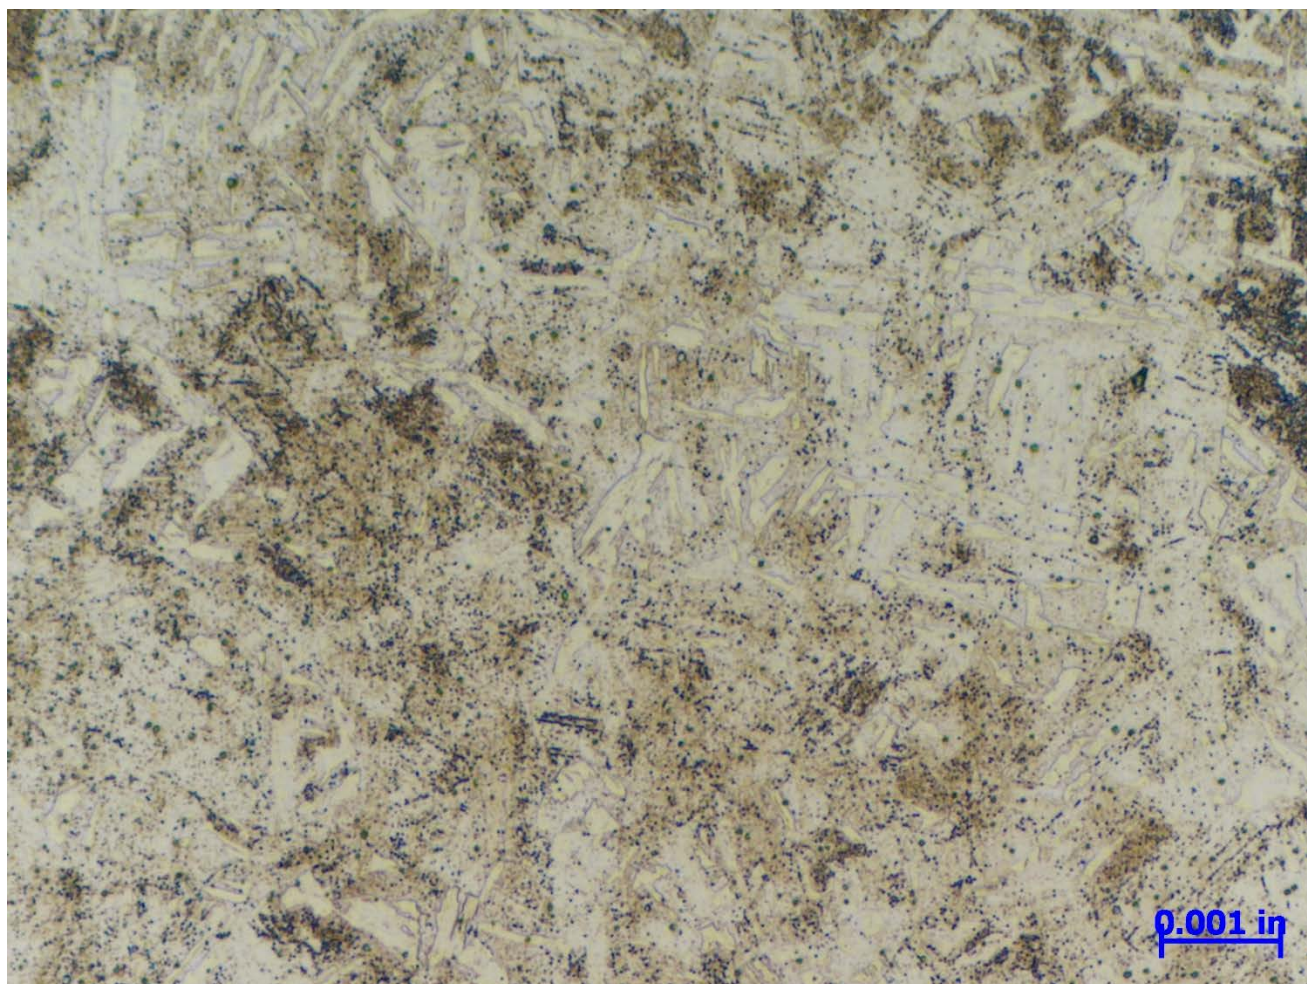
with a martensitic precipitation-hardened stainless steel, such as 17-4 PH.<sup>1</sup> Figure 13 and Figure 14 show a typical area of the microstructure after etching. The microstructure exhibited tempered martensite (darker, browner areas) with ferrite stringers (blocky and lighter colored) distributed throughout. These constituents were typical of those in martensitic precipitation-hardened stainless steel.

Figure 13 – Bright-field optical micrograph of a typical area of the piston microstructure (~500X, etched Ralph's Reagent).<sup>3</sup>

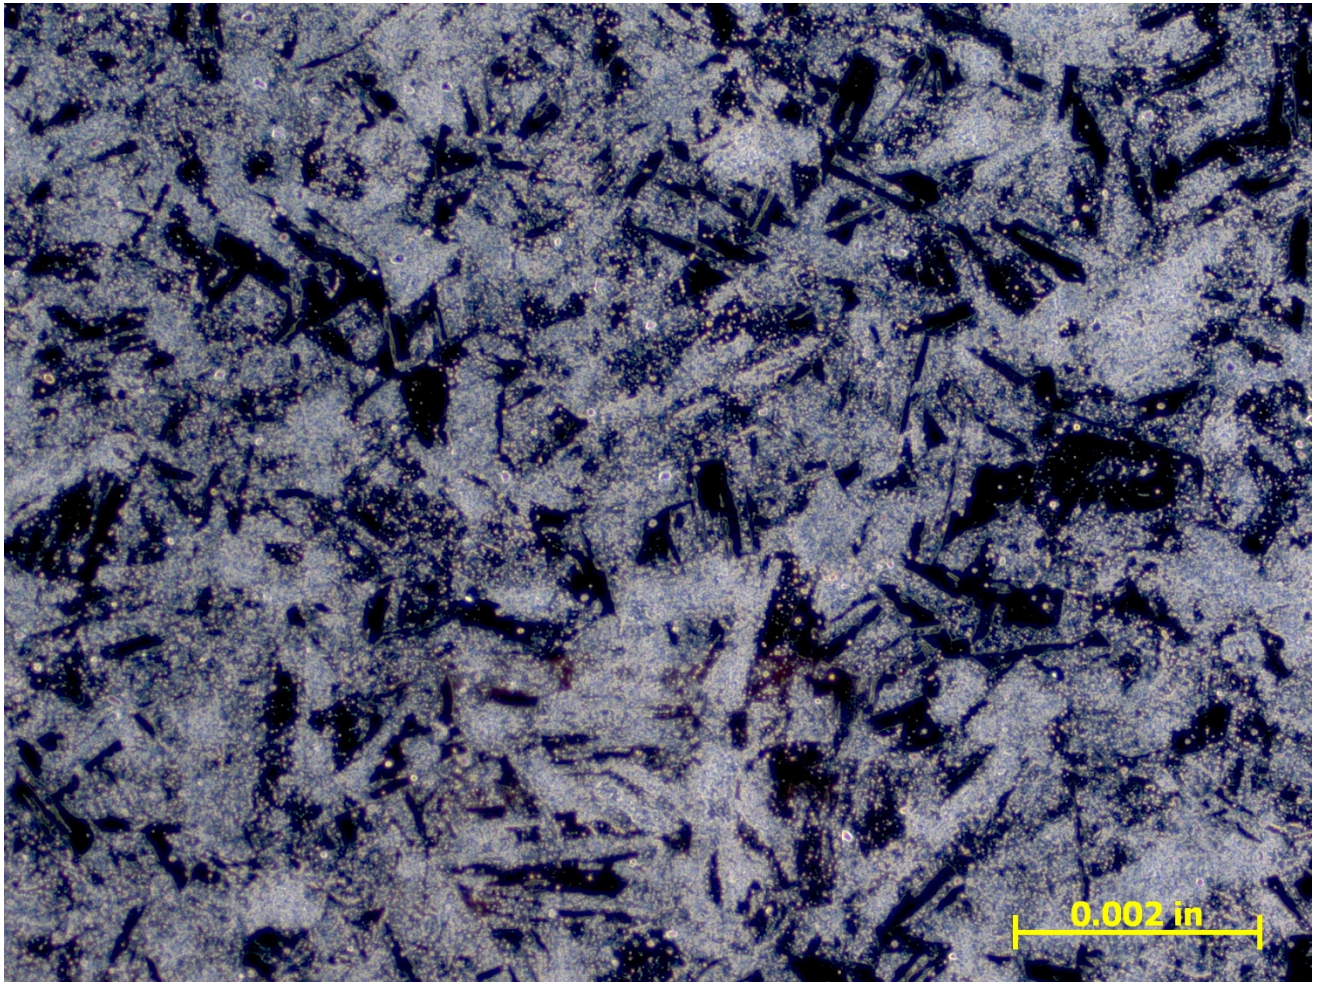
Figure 14 – Dark-field optical micrograph of a typical area of the piston microstructure (~500X, etched Ralph's Reagent).<sup>3</sup>
