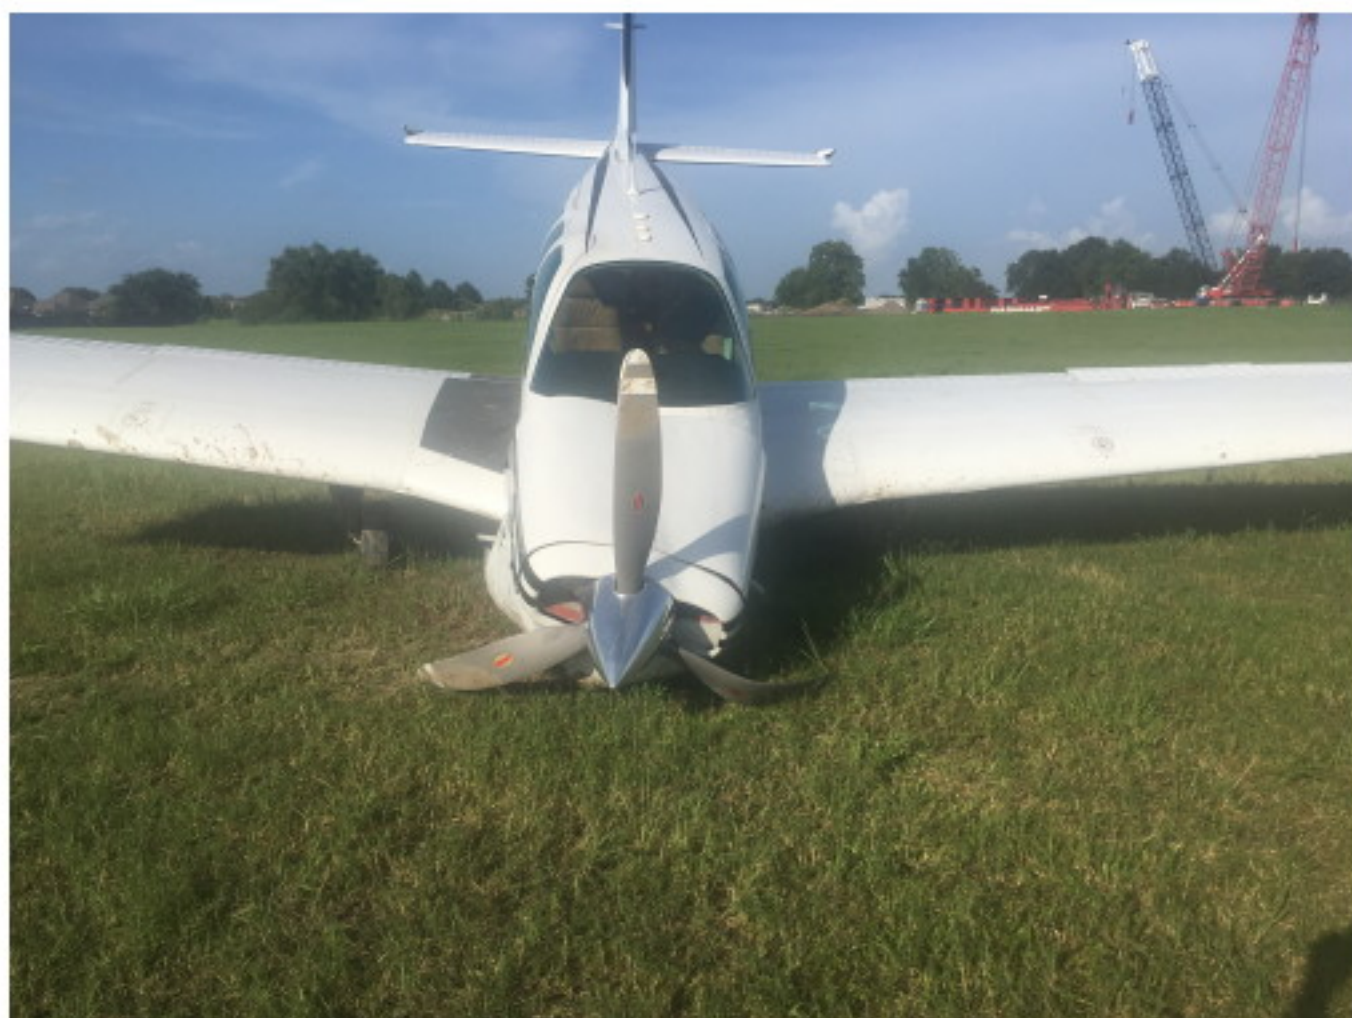
**Frontal view, note position of engine**

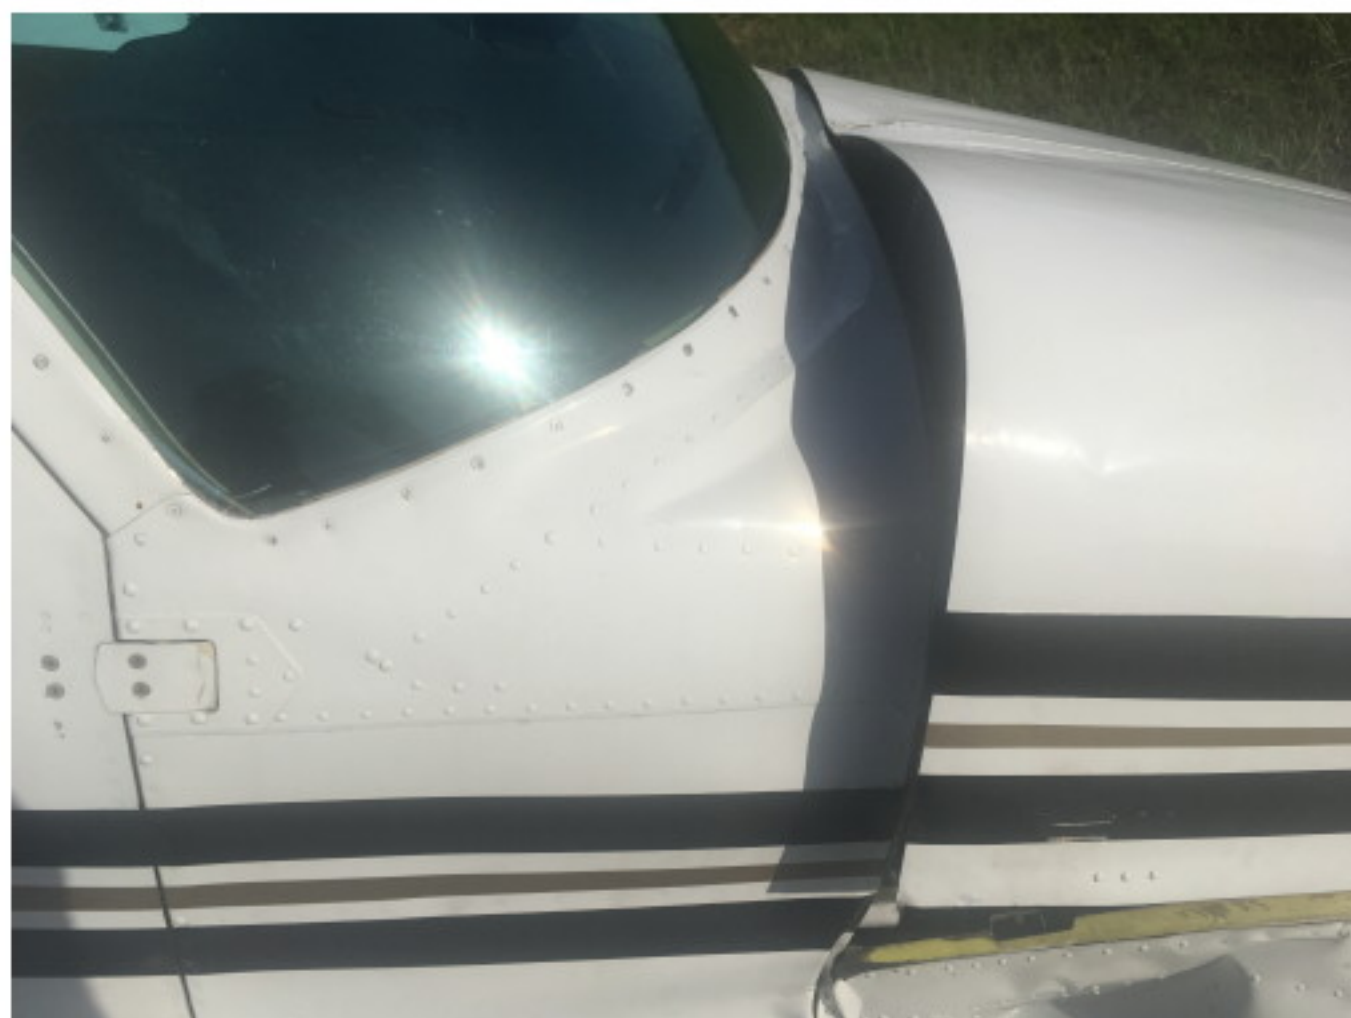
**Boot cowl crushed**

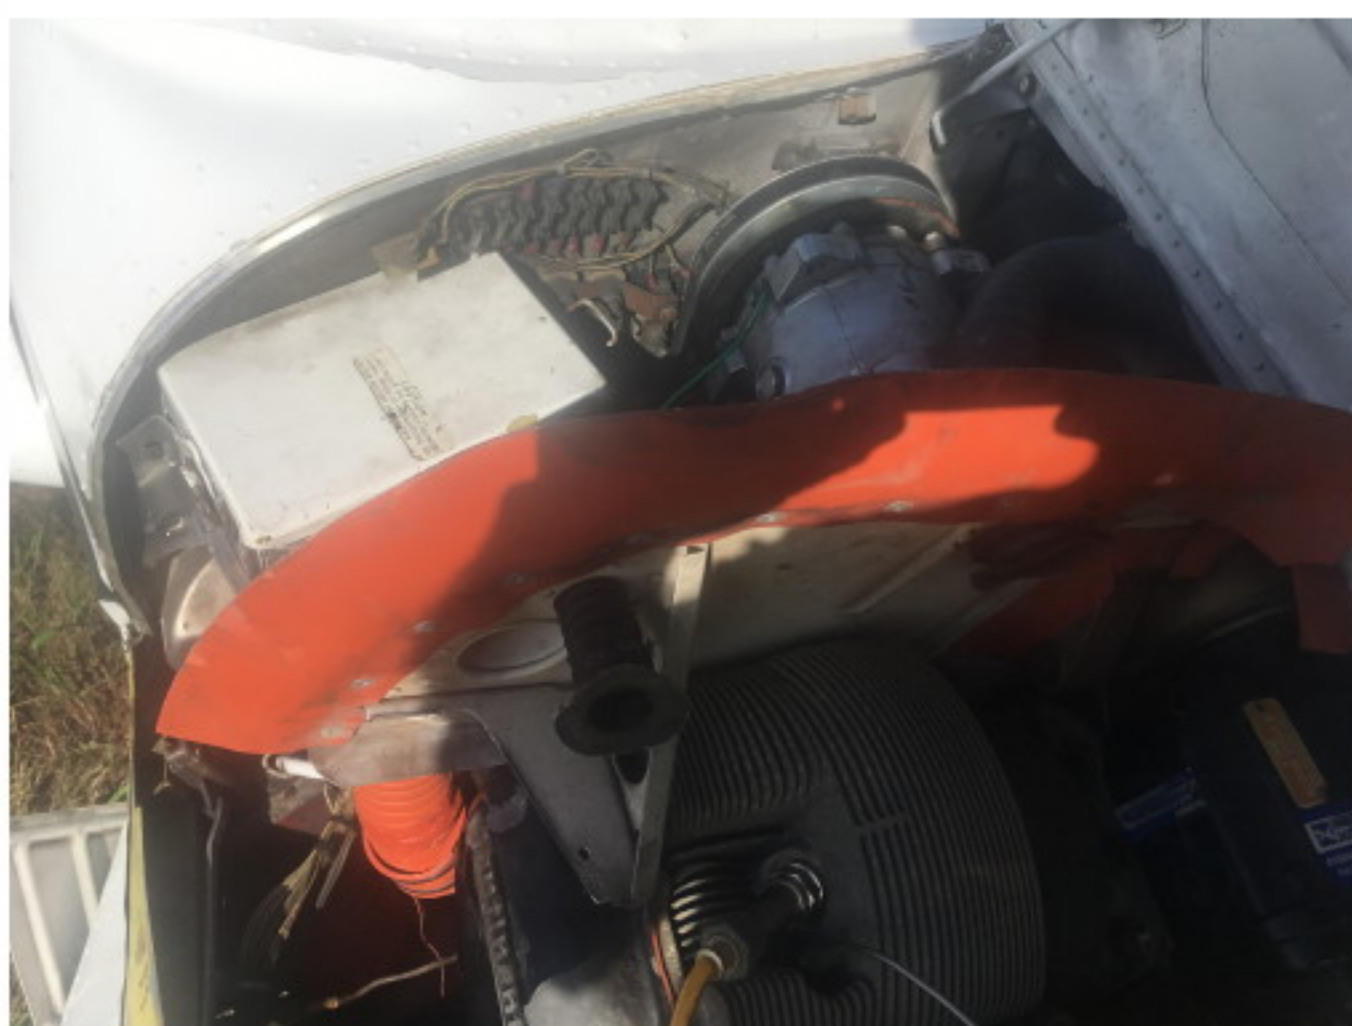
**Firewall and all supporting structure crushed inward**

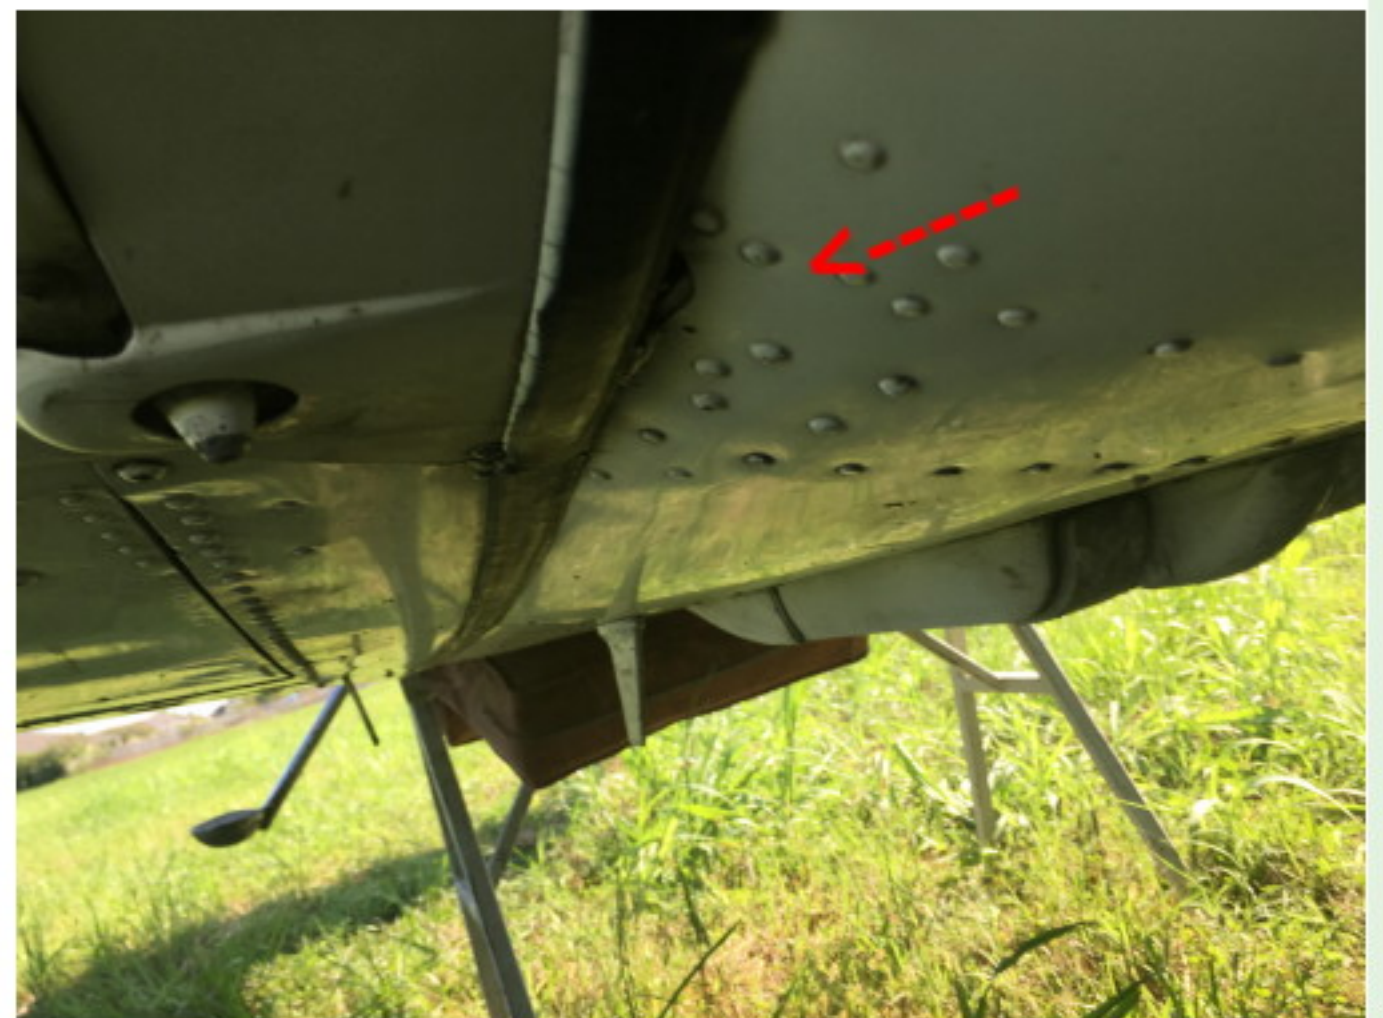
**Buckle in fitting support  
structure**
