# NATIONAL TRANSPORTATION SAFETY BOARD

## MATERIALS LABORATORY FACTUAL REPORT

Report No. 18-097

Place : Pearsall, Texas  
Date : August 24, 2017  
Vehicle : Air Tractor AT-401, N4532F  
NTSB No. : CEN17LA330  
Investigator : Andrew Todd Fox, AS-CEN

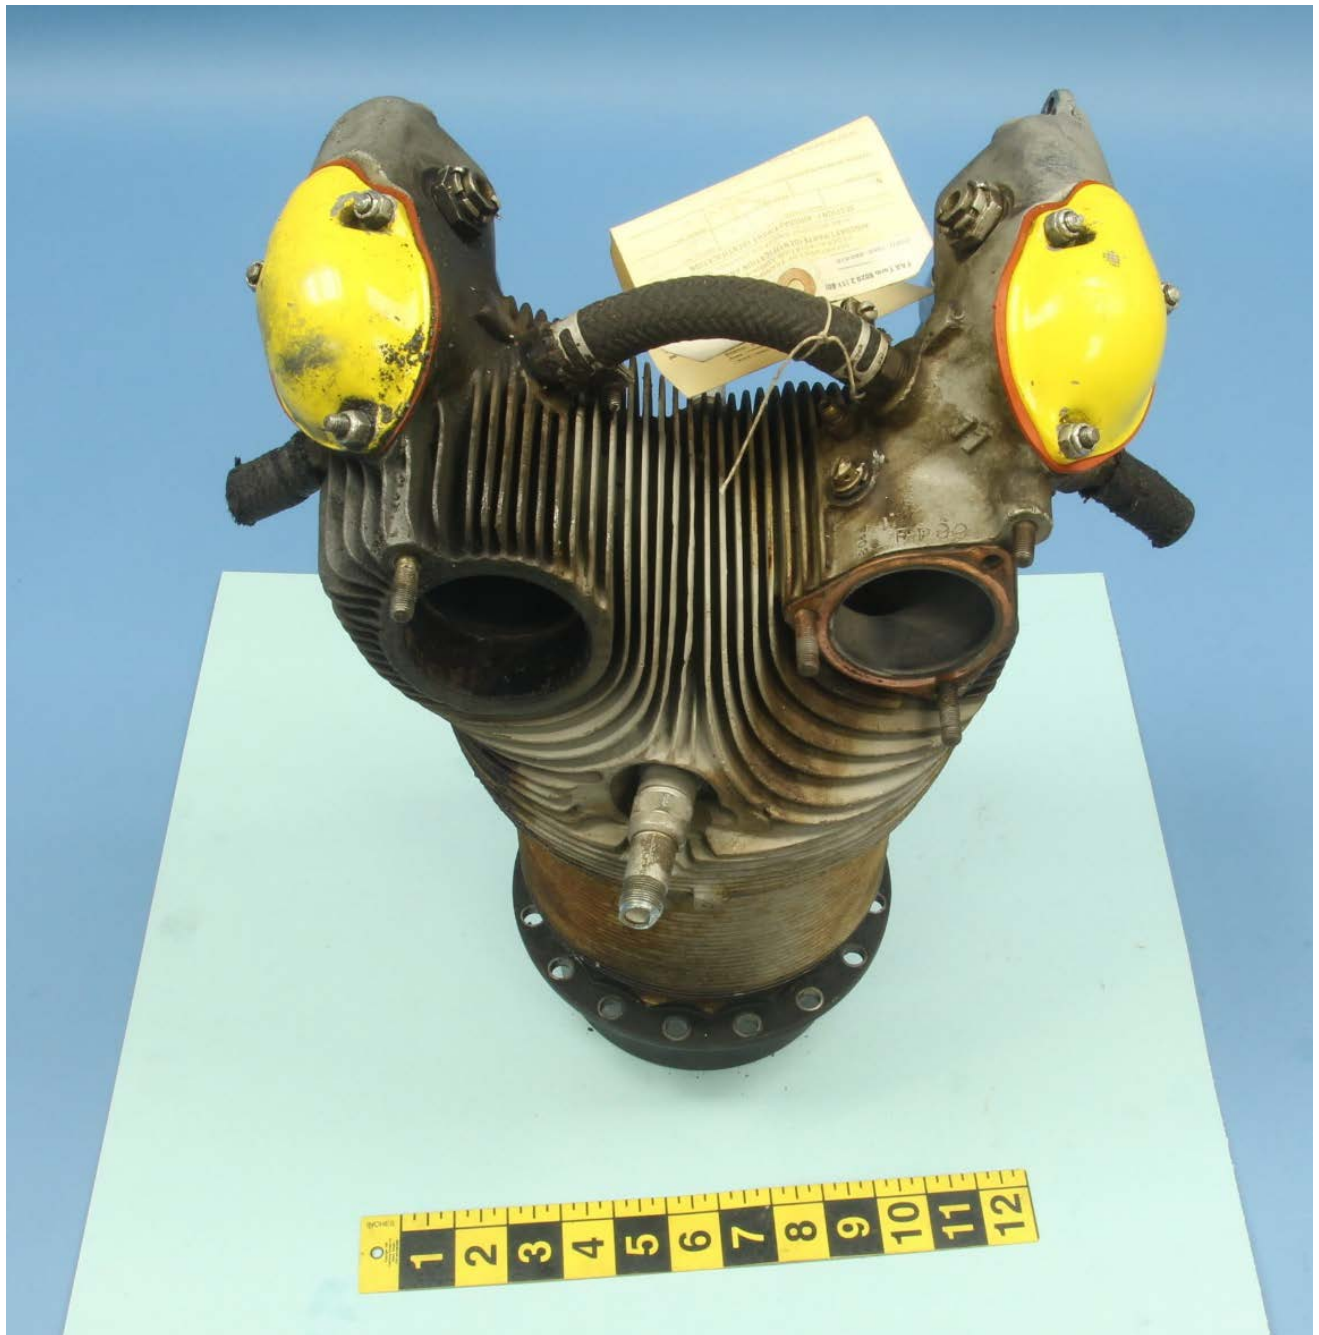
Figure 1 and Figure 2 show the components of the engine cylinder assembly, as received. The markings on the side of the cylinder housing stated, “S/N 4 4HN52 L215”. Some of the components exhibited plastic deformation, consistent with impact or compression damage. Figure 3 shows this damage to the tubes on the forward side that contained the pushrods. The inboard tube openings had buckled inward. Likewise, the forward side spark plug exhibited inward buckling deformation, shown in Figure 4.

Figure 1 – The No. 9 engine cylinder viewed from the aft side, as received.

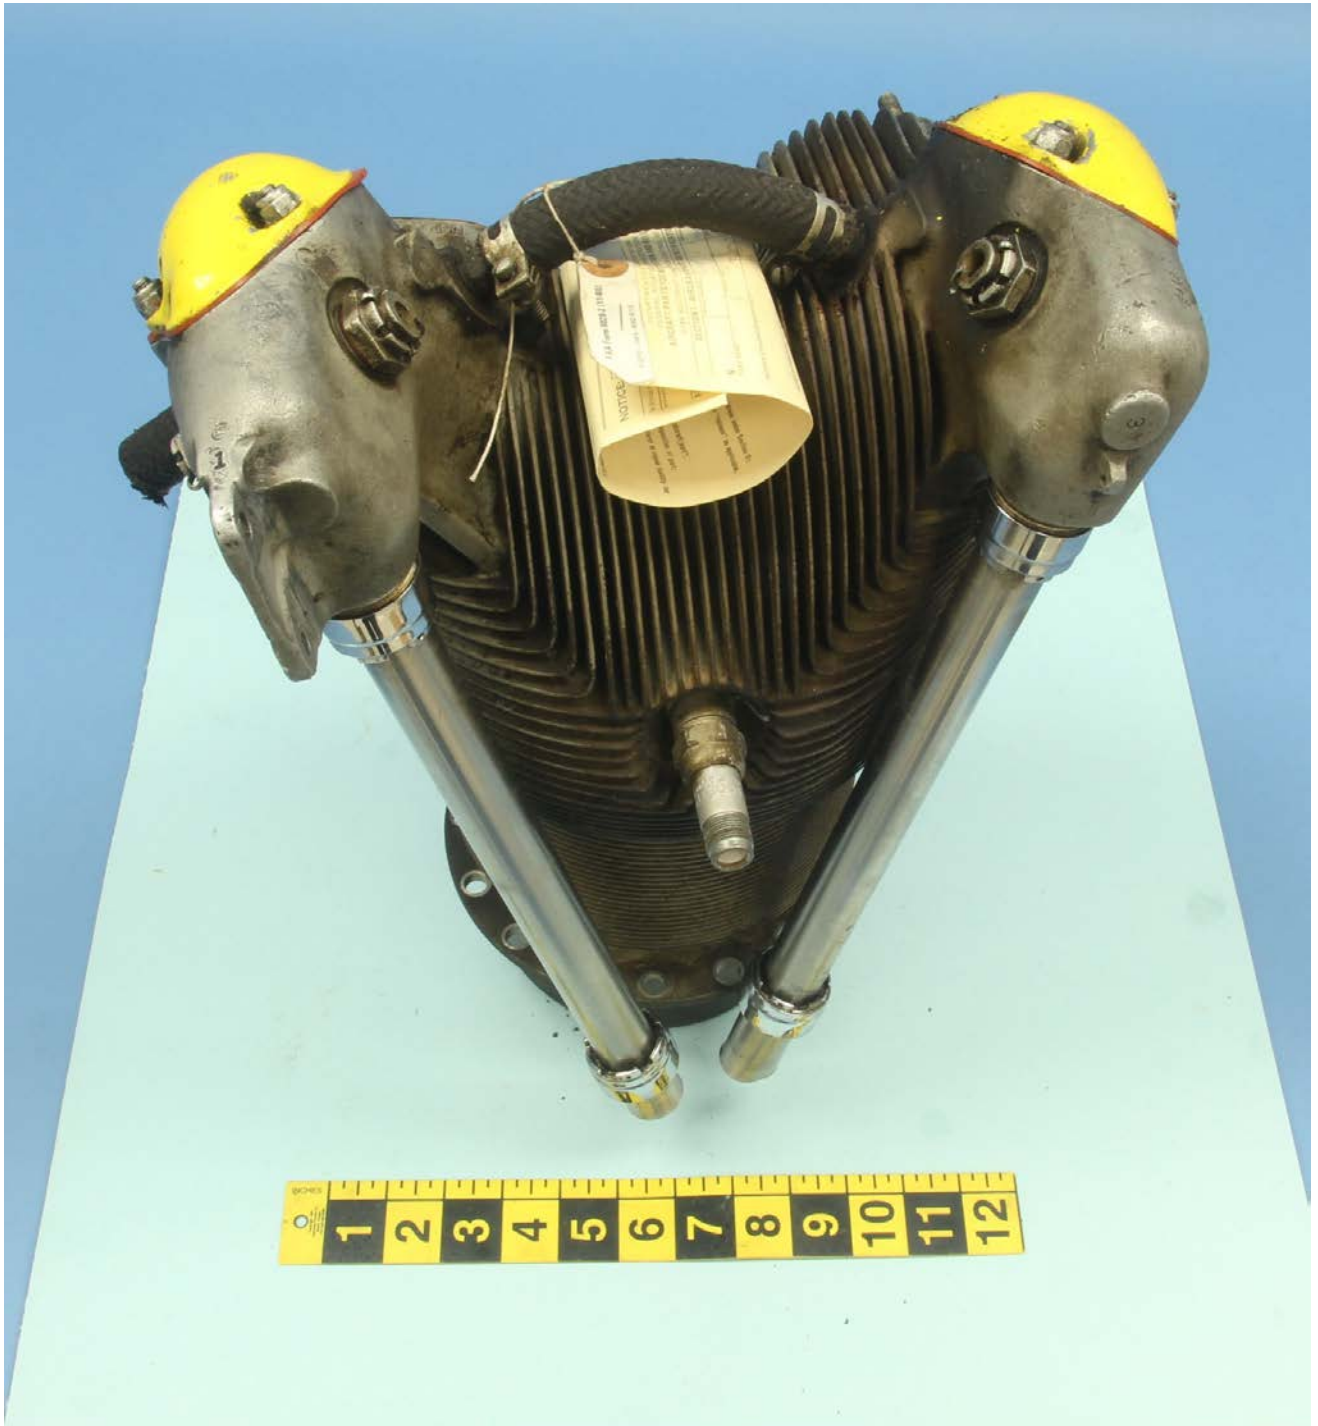
Figure 2 – The No. 9 engine cylinder viewed from the forward side, as received.

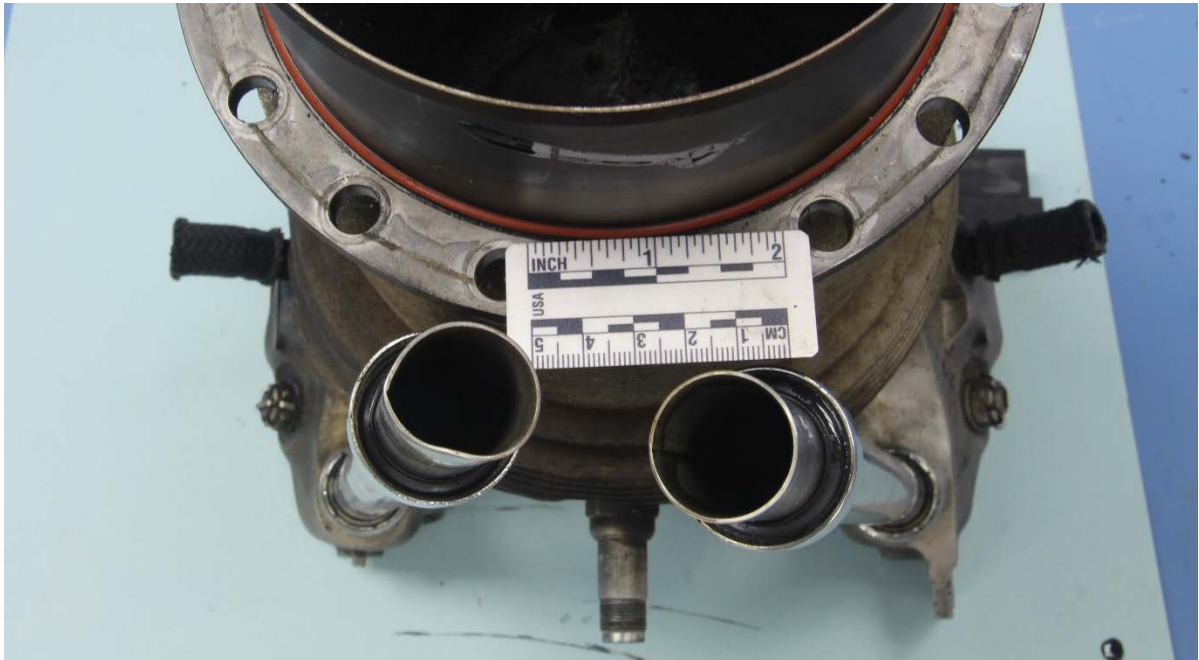
Figure 3 – The pushrod tubes on the forward side of the engine, showing denting damage.

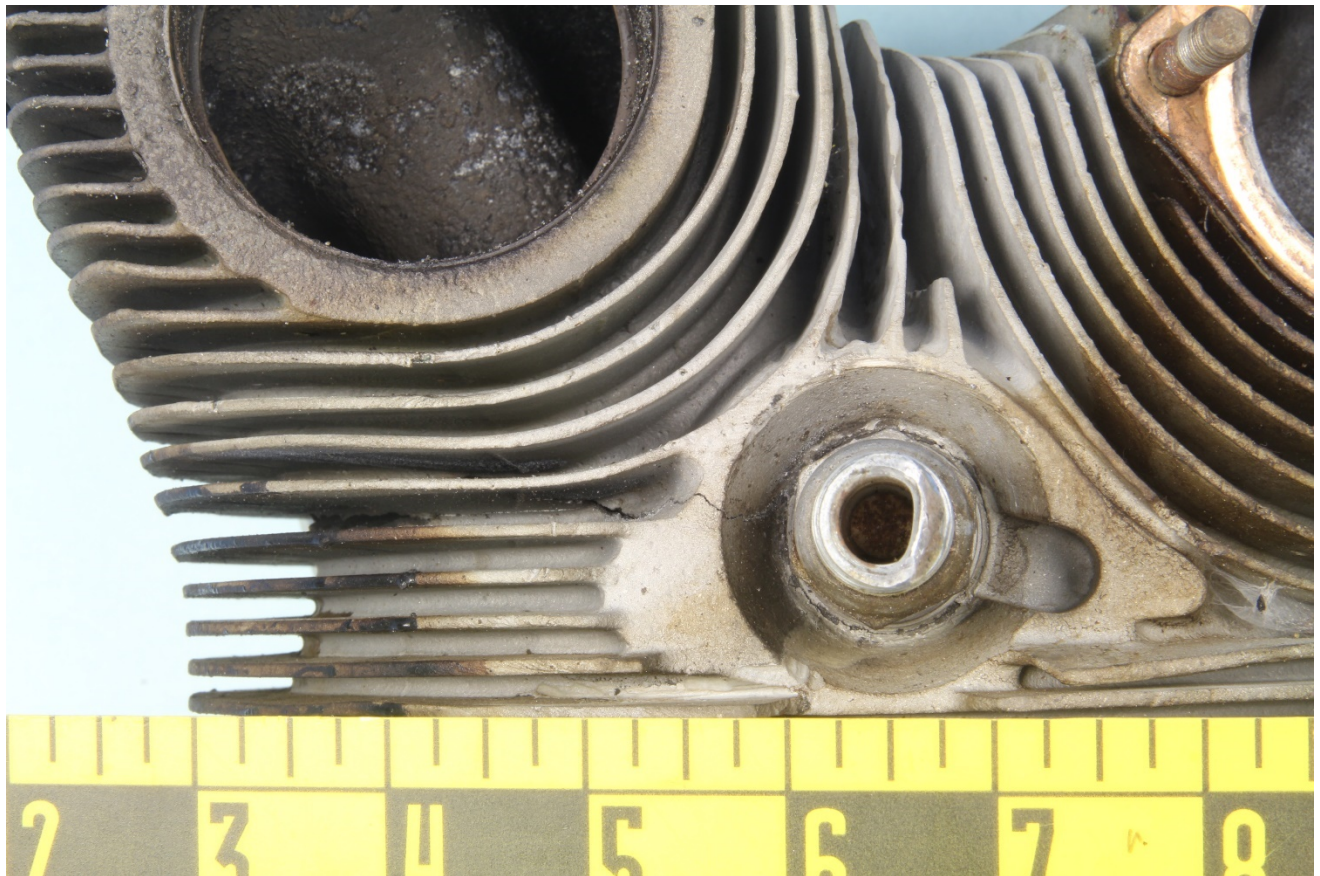
Of note on the cylinder was a large circumferential crack through the housing. The crack is displayed in a series of figures, from Figure 4 through Figure 7. The crack was generally located at the valley between two air cooling fins, although the crack was also located through the forward spark plug hole (Figure 6). The crack was measured circumferentially as 26.3 inches long, with approximately 5.6 inches of the remaining circumference uncracked. One end of the crack terminated at the aft spark plug hole (Figure 4), and the other end was located between two cooling fins 5.6 inches away (Figure 7). The widest opening of the crack, shown in Figure 5, was located 8.5 inches from the bottom side of the inboard flange, and 10.5 inches from the bottom opening of the cylinder.

Figure 4 – View of the aft spark plug, showing denting damage and the end of the crack between two cooling fins.

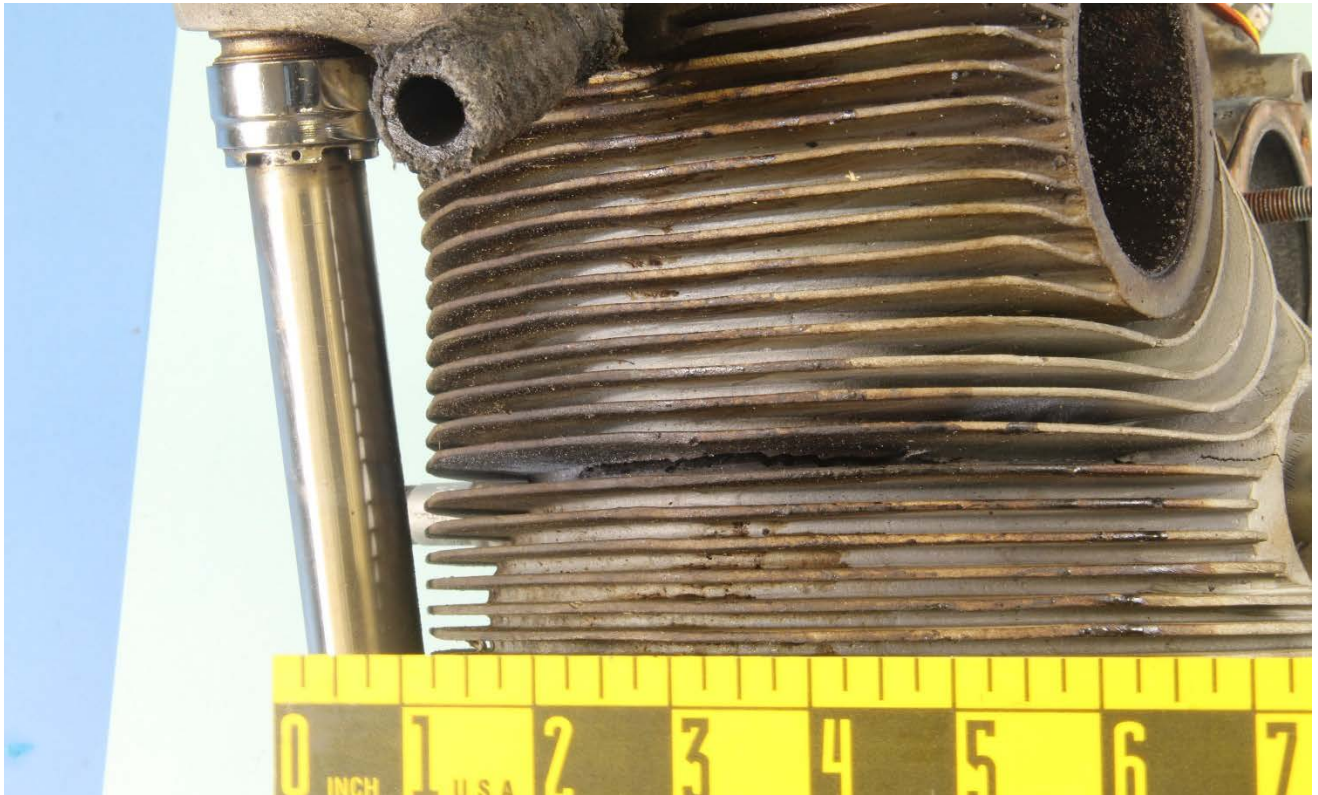
Figure 5 – The crack in the cylinder, rotated 90 from Figure 4, showing the largest opening.

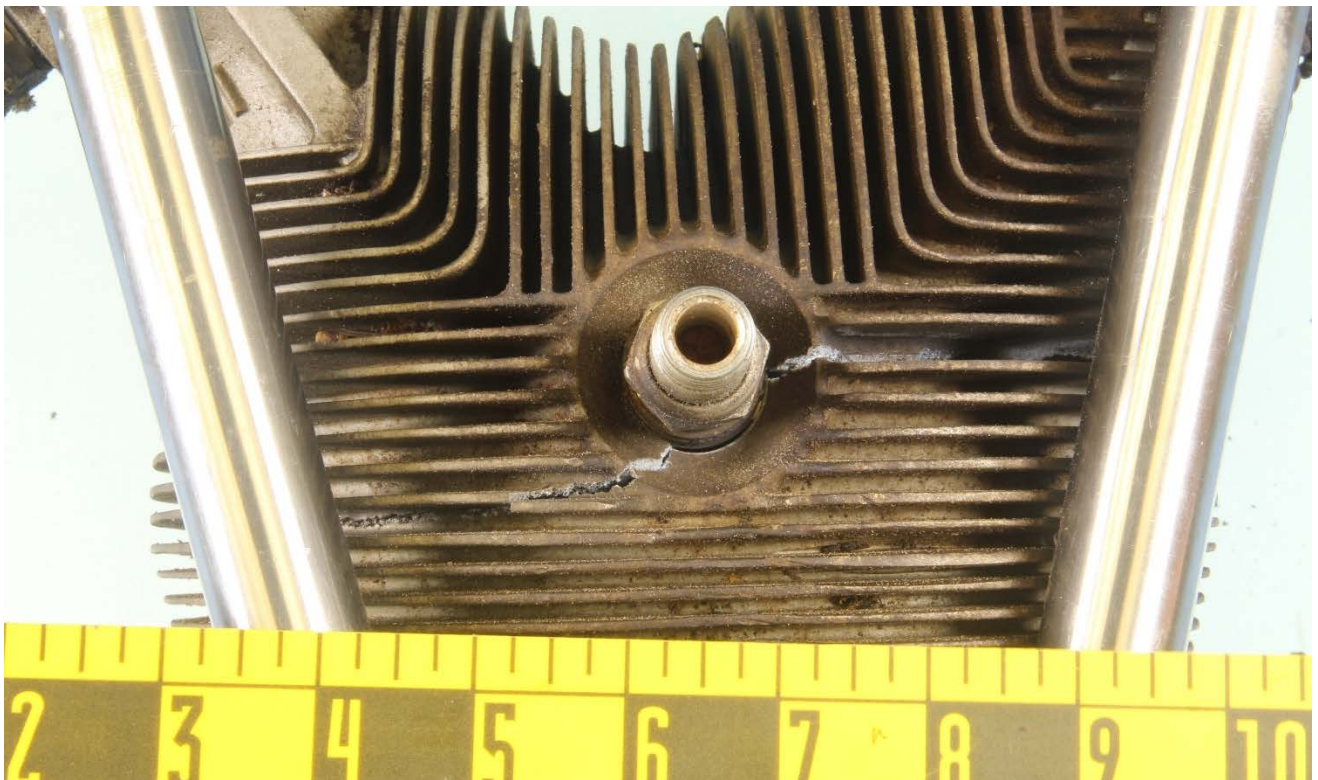
Figure 6 – The cylinder crack, viewed from the forward side (or rotated 90 from Figure 5).

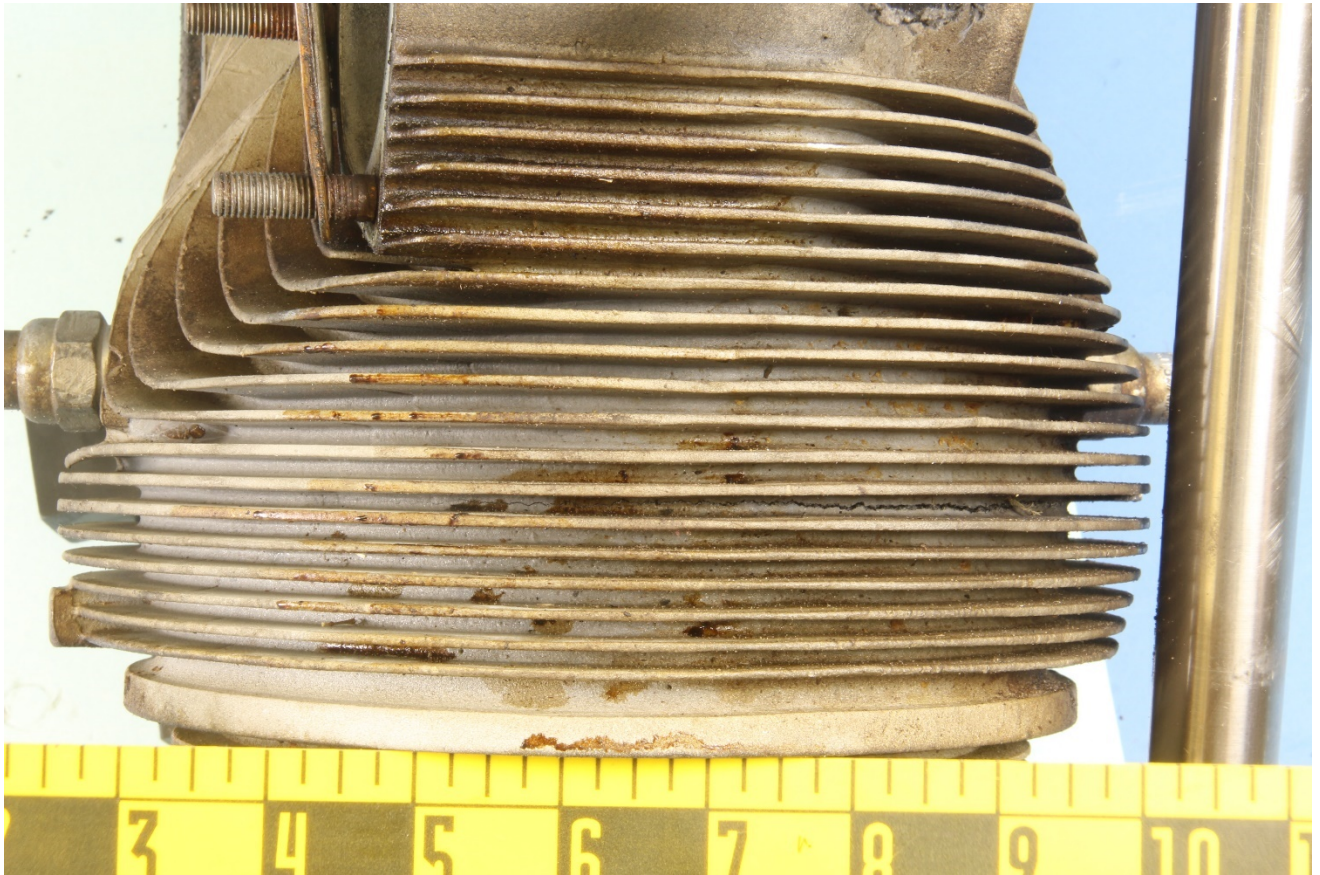
Figure 7 – View of the other end of the cylinder crack, rotated 90° from Figure 6.

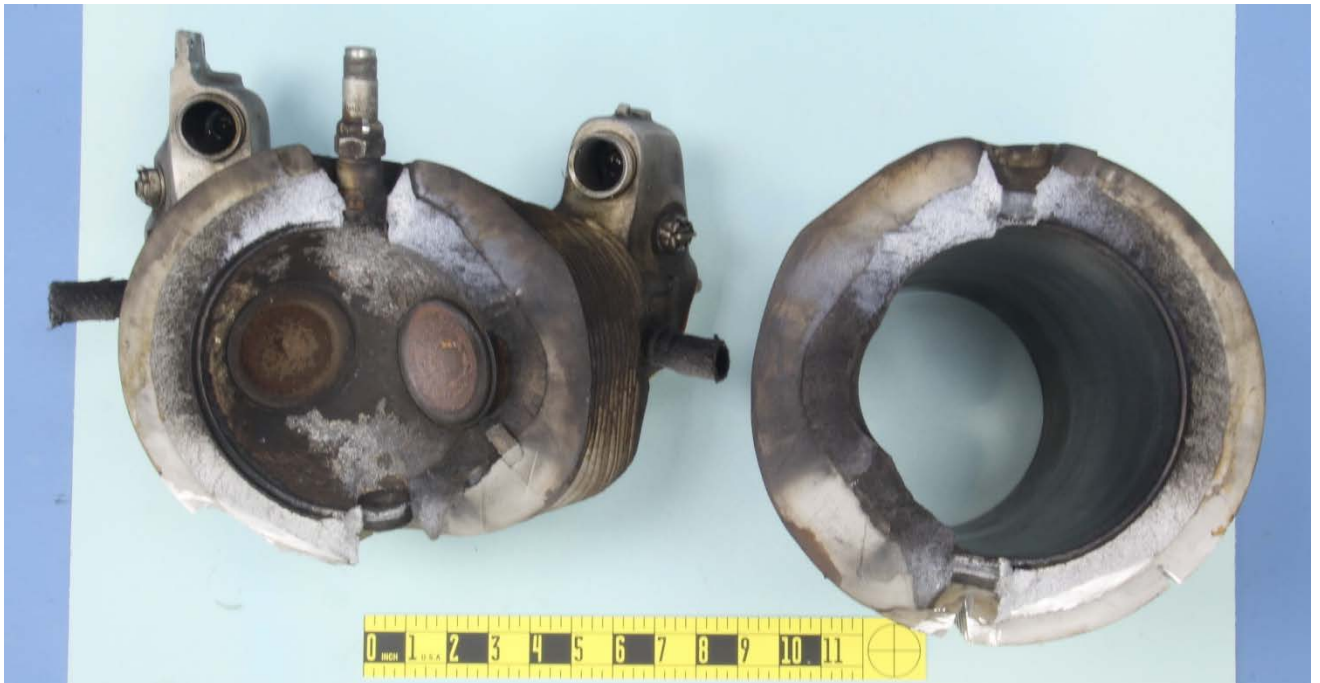
The remaining intact 5.6 inches of the cylinder between the crack tips was backcut and intentionally overstressed (laboratory opened) to reveal the mating crack faces, or fracture surfaces. These mating fracture surfaces are shown in Figure 8, after opening. As shown in the figure, the fracture surfaces exhibited distinct colors, consistent with exhaust and combustion gasses blowing past the surfaces for different lengths of time. The parts of the fracture surfaces in the middle of the figure exhibited a dark, dull soot color, whereas the rest of the fracture surfaces exhibited a lighter color with white deposits.

Figure 8 – View of the fracture surfaces of the cylinder crack, after laboratory opening.

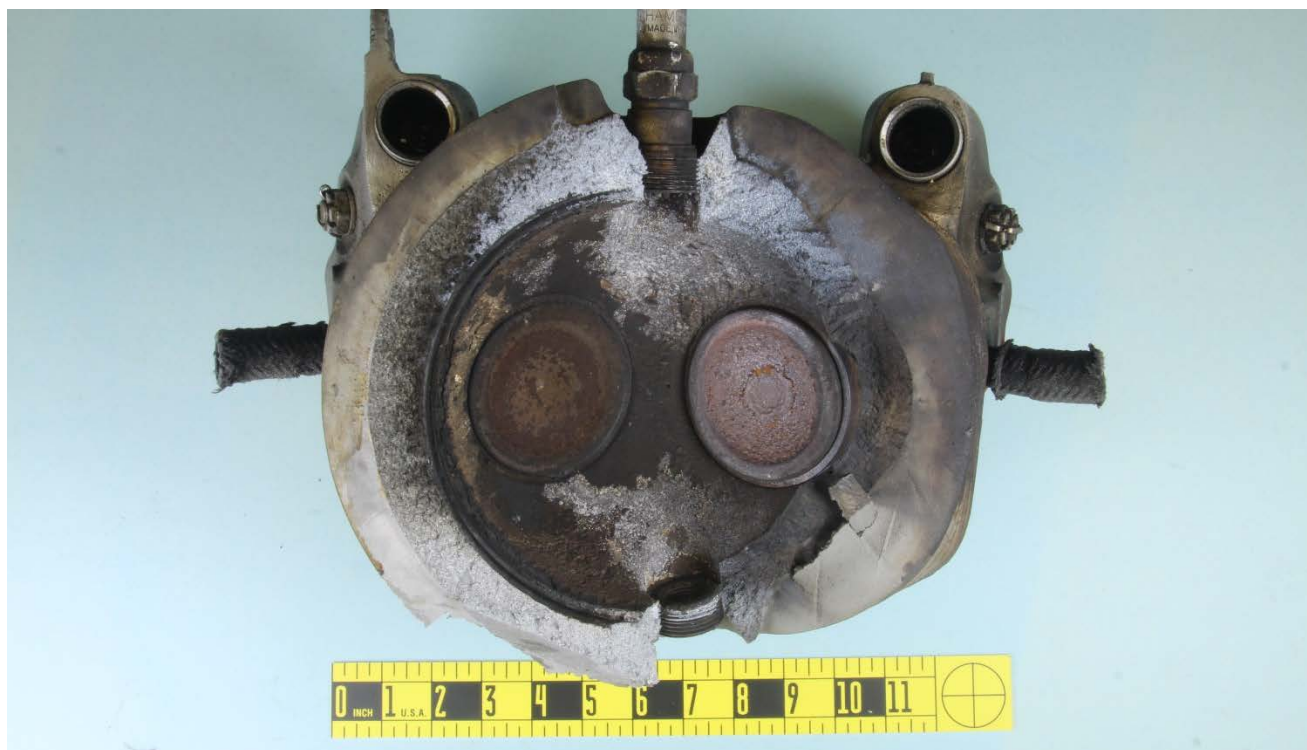
Figure 9 shows the outboard side of one of the laboratory-opened fracture surfaces. Macroscopically, the fracture features differed between the darker and lighter areas on the fracture surface. The lighter areas of the fracture surface exhibited a general rough and tortuous morphology, whereas the darker areas exhibited a generally flatter surface morphology. Figure 10 shows this portion of the fracture surface when viewed using oblique lighting. This region of the fracture surface exhibited crack arrest marks and ratchet marks, consistent with progressive cracking from multiple crack initiations sites.

The valve faces and the inner surface of the cylinder, shown in Figure 9, exhibited flat, flaky compounds that adhered to all the inner surfaces. These compounds exhibited a brownish-yellow color, with a waxy luster. Samples of these compounds were examined using energy dispersive x-ray spectroscopy (EDS). The EDS data found these flaky compounds to be consistent with lead oxides and lead bromide, as typified in Figure 11. These compounds were consistent with compounds that form after combustion of tetraethyl lead and 1,2-dibromoethane—the typical anti-knocking and lead-scavenging additives in aviation gasoline (avgas).<sup>2</sup>

Figure 9 – The outboard mating fracture surface, annotated to show the different fracture regions.

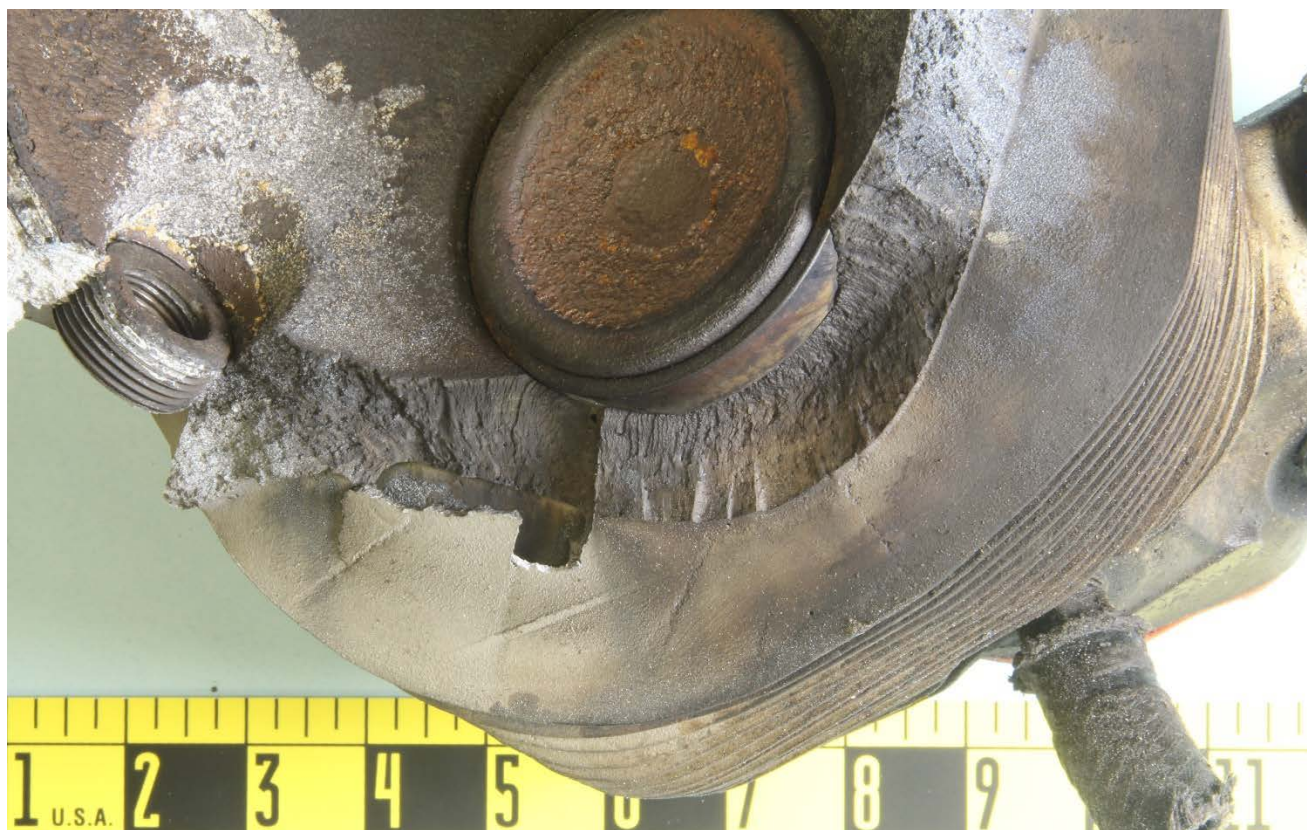
Figure 10 – The progressive area of the outboard fracture surface, using oblique lighting.

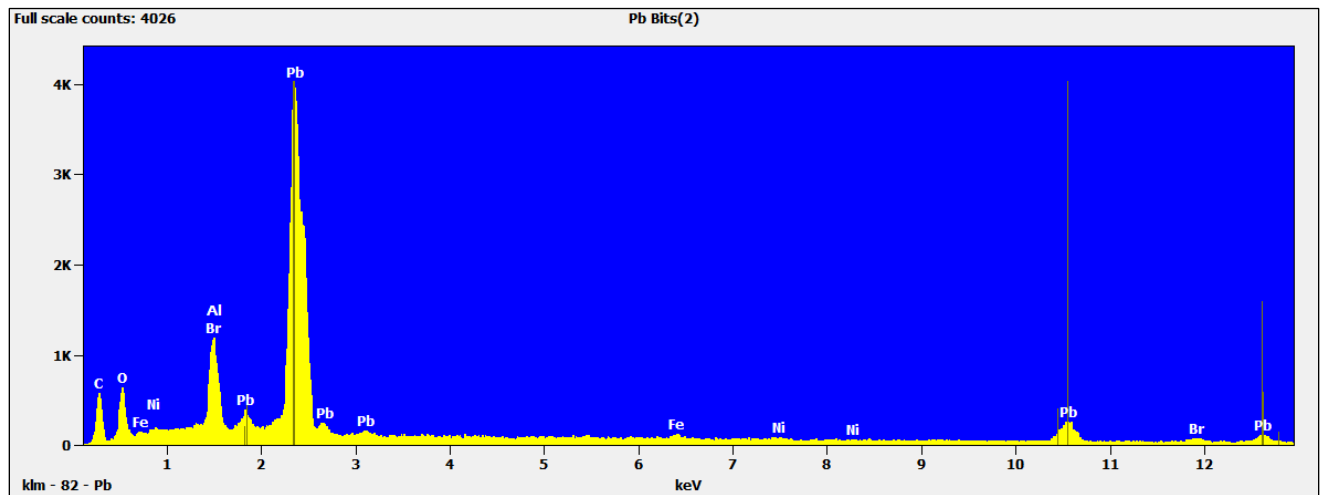
Figure 11 – EDS spectrum of the flaky compounds in the cylinder surface in Figure 10.

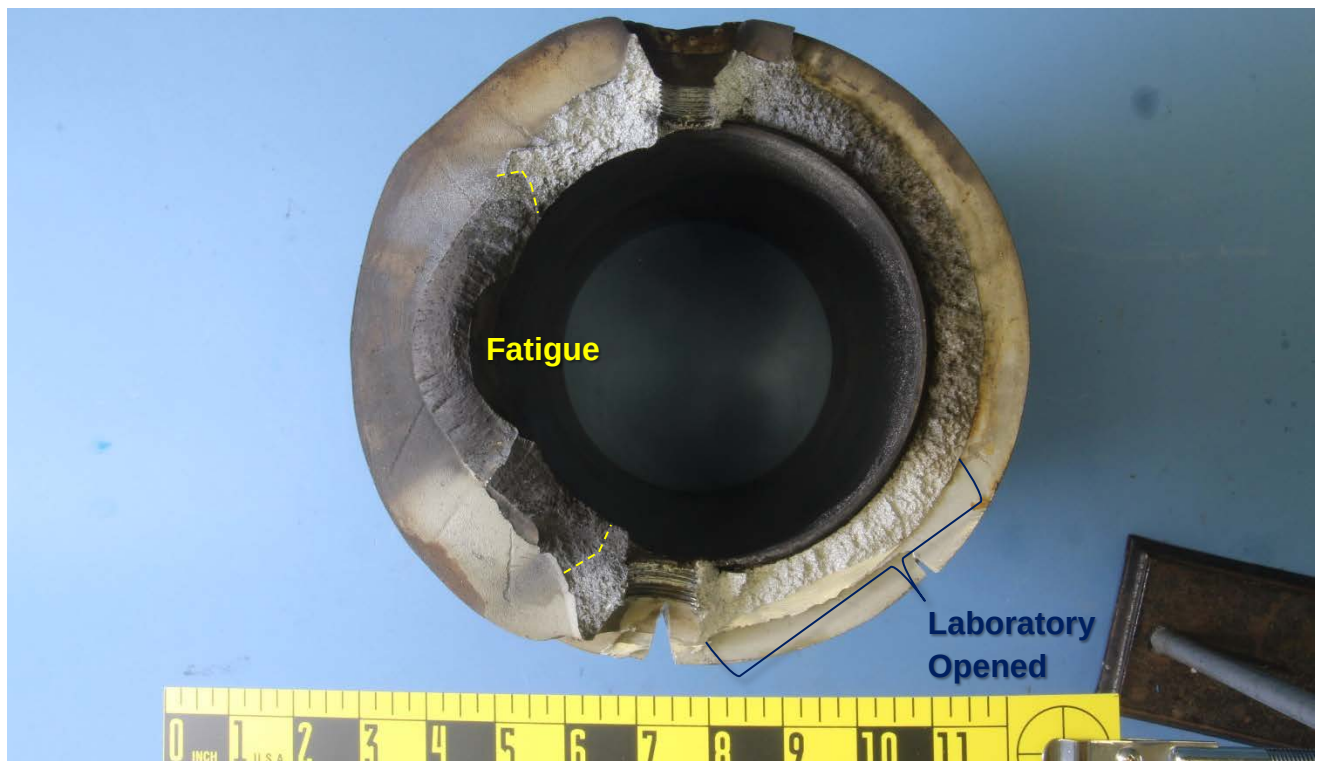
Likewise, the mating outboard fracture surface exhibited a darker-colored region consistent with progressive cracking, and a lighter-colored area with a rougher surface morphology (Figure 12). Figure 13 shows the progressive region of the fracture surface, which exhibited crack arrest marks and multiple ratchet marks. The nature of these features was consistent with crack propagation from outer cylinder surfaces towards the inside.

Figure 12 – The inboard mating fracture surface, annotated to show the different fracture regions.

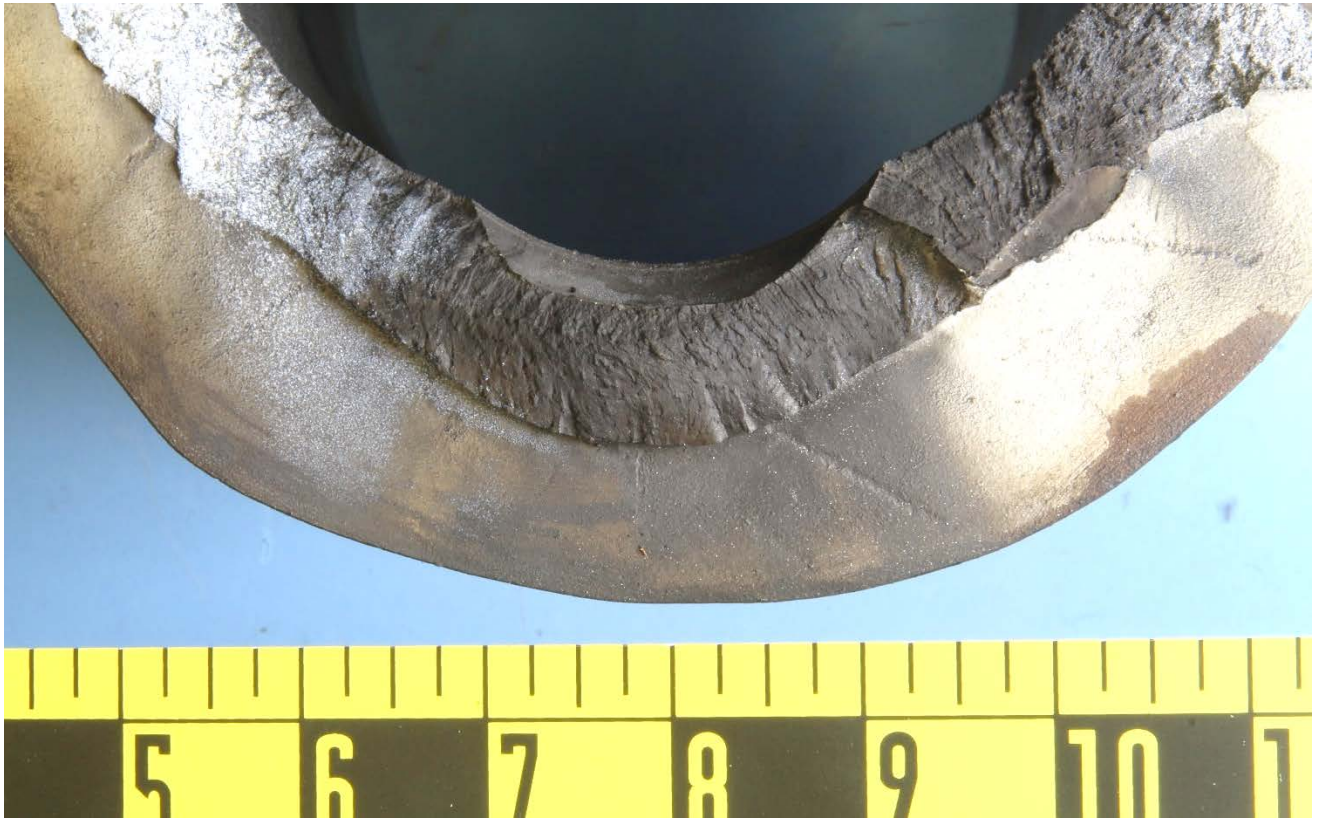
Figure 13 – The fatigue area of the outboard fracture surface, using oblique lighting.

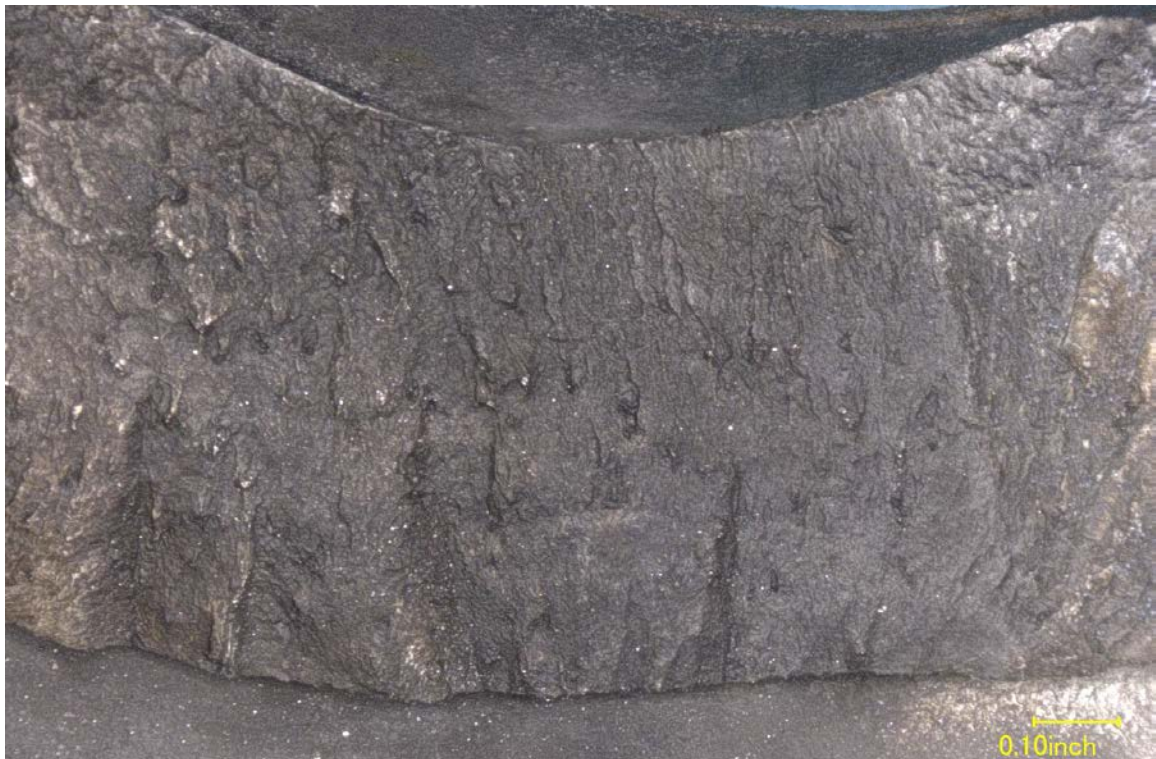
Figure 14 and Figure 15 show some of the crack initiation sites on the outboard fracture surface. These areas exhibited the aforementioned ratchet and crack arrest marks. There were no discernible discrepancies, such as corrosion pits, wear marks, or machine marks, present at these initiation sites.

Figure 14 – Closer view of the crack initiation sites, showing ratchet marks and crack arrest marks.

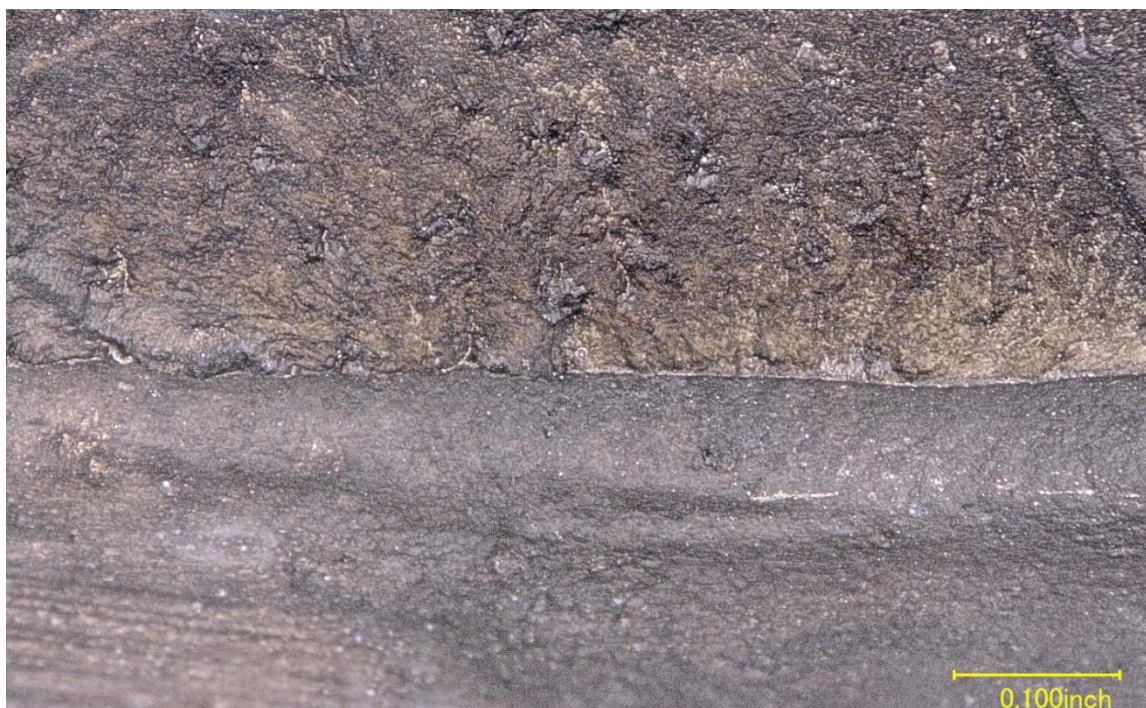
Figure 15 – Closer view of the crack initiation sites tilted at an angle, showing the cooling fin valley.

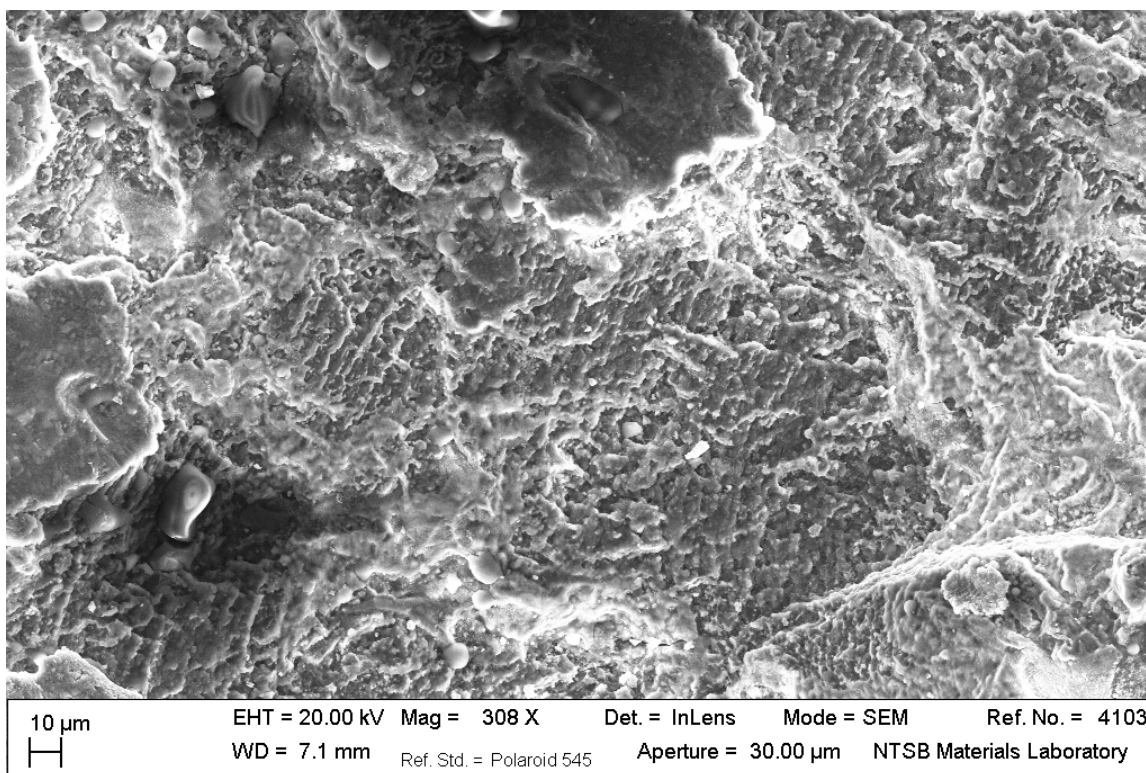
A section of the outboard fracture surface was sectioned, cleaned with acetone, and examined using a scanning electron microscope (SEM). A typical area of the progressive region of the fracture surface is illustrated in Figure 16. This portion of the fracture surface exhibited fatigue striations, consistent with fatigue cracking. Even with acetone cleaning, the fracture surface still exhibited oxidation, consistent with metal exposure to oxidative conditions at elevated temperatures. This oxidation obscured some of the details of the underlying fatigue striations (Figure 17).

Figure 16 – Secondary electron (SE) micrograph of fatigue striation on mid-distance of the inboard fracture surface.

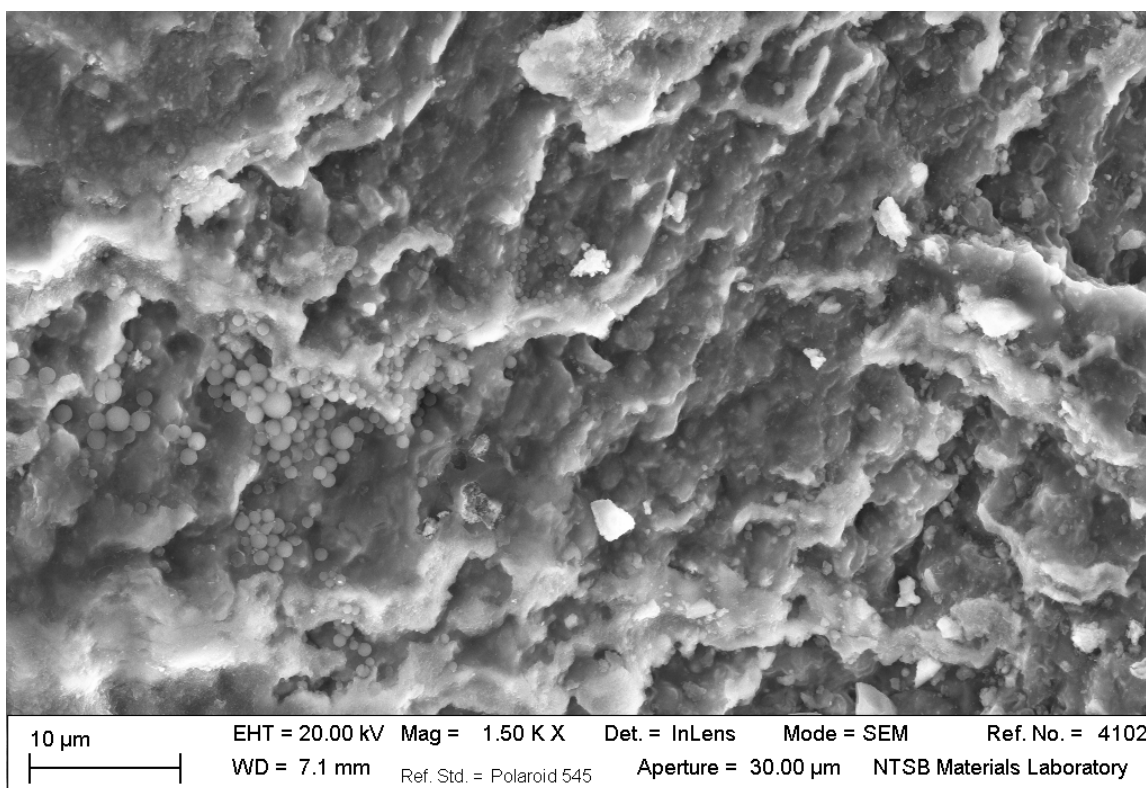
Figure 17 – SE micrograph showing a closer view of the striations in Figure 16.

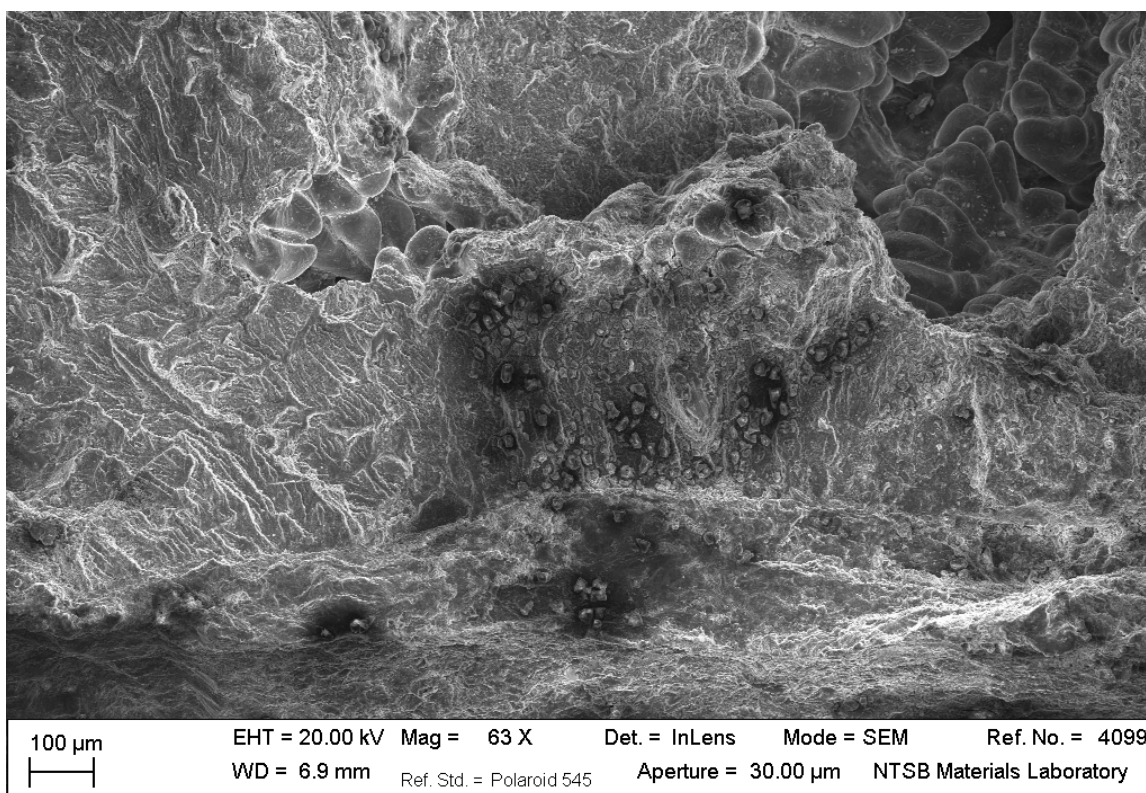
The presence of multiple ratchet marks on the fracture surface was consistent with multiple fatigue cracks that coalesce as they propagated from their individual initiation sites. As typified in Figure 18, these initiation sites were located on the outer surface of the cylinder in a root between two cooling fins. There were no discernible features at the crack initiation sites, such as corrosion pits, inclusions, or mechanical damage marks, that would have led to early fatigue crack initiation. As shown in Figure 18, solidification voids were present throughout the fracture surface. However, in examining the orientation of the fatigue striations near the initiation sites (Figure 19), they were not consistent with crack initiation at the voids.

Figure 18 – SE micrograph of one of the fatigue crack initiation sites.

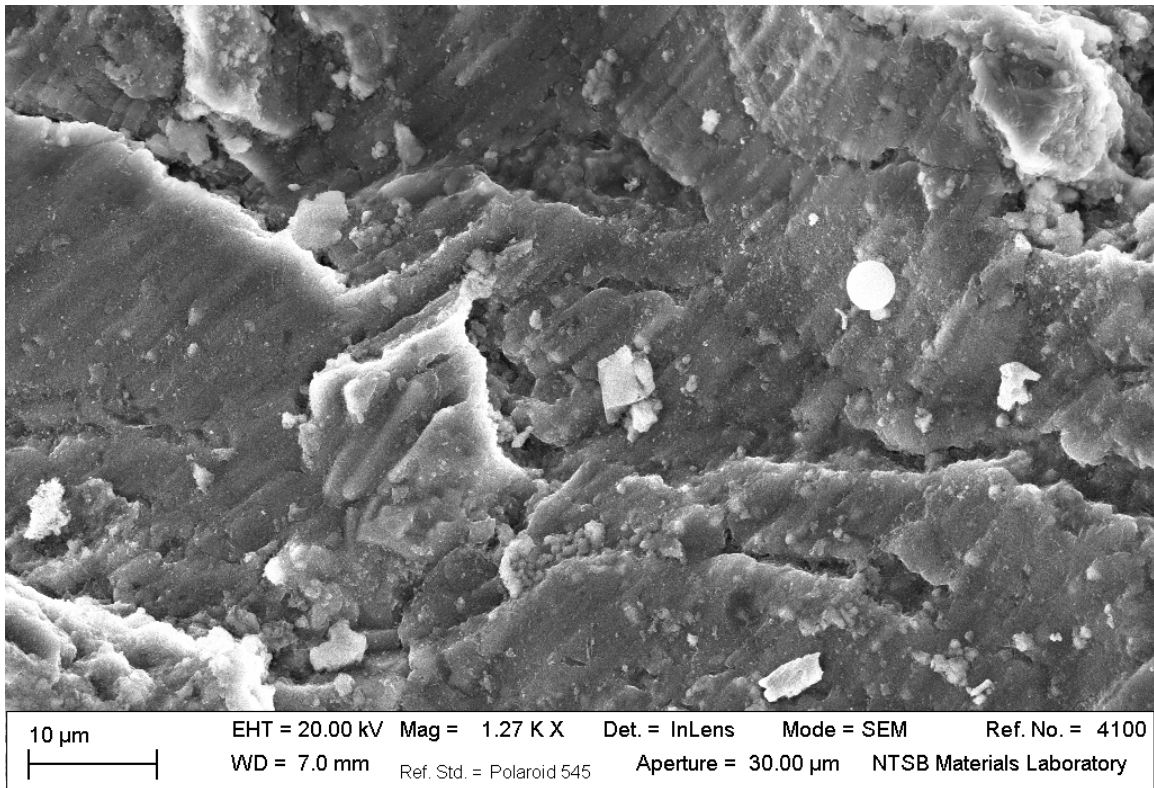
Figure 19 – SE micrograph of fatigue striations near a crack initiation site.

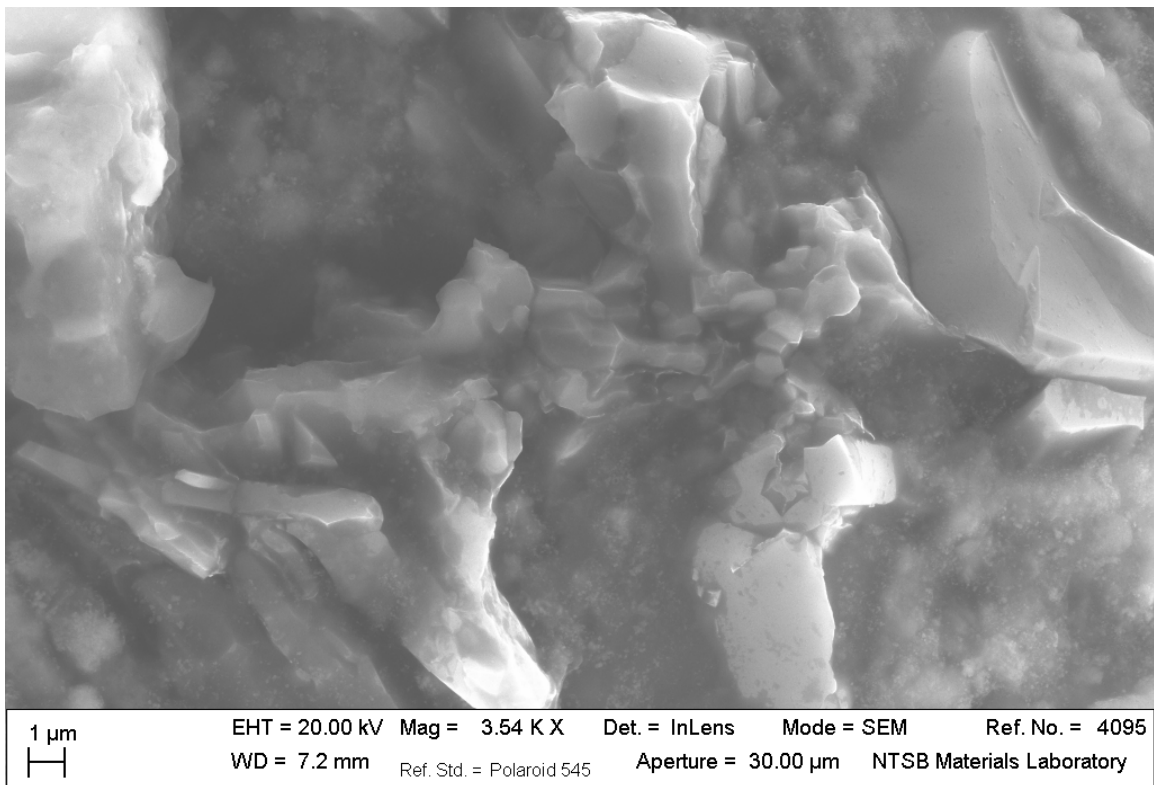
Outside the fatigue crack region, the fracture surface exhibited dimple rupture and ductile tearing, shown in Figure 20. The dimple rupture and tearing features were consistent with those present in the intentional overstressed areas (Figure 21). The areas outside of the fatigue cracking were consistent with subsequent overstress fracture.

Figure 20 – SE micrograph showing dimple rupture and tearing on the fracture surface outside the fatigue cracking region.
