# NATIONAL TRANSPORTATION SAFETY BOARD

## MATERIALS LABORATORY FACTUAL REPORT

Report No. 18-097

Place : Pearsall, Texas  
Date : August 24, 2017  
Vehicle : Air Tractor AT-401, N4532F  
NTSB No. : CEN17LA330  
Investigator : Andrew Todd Fox, AS-CEN

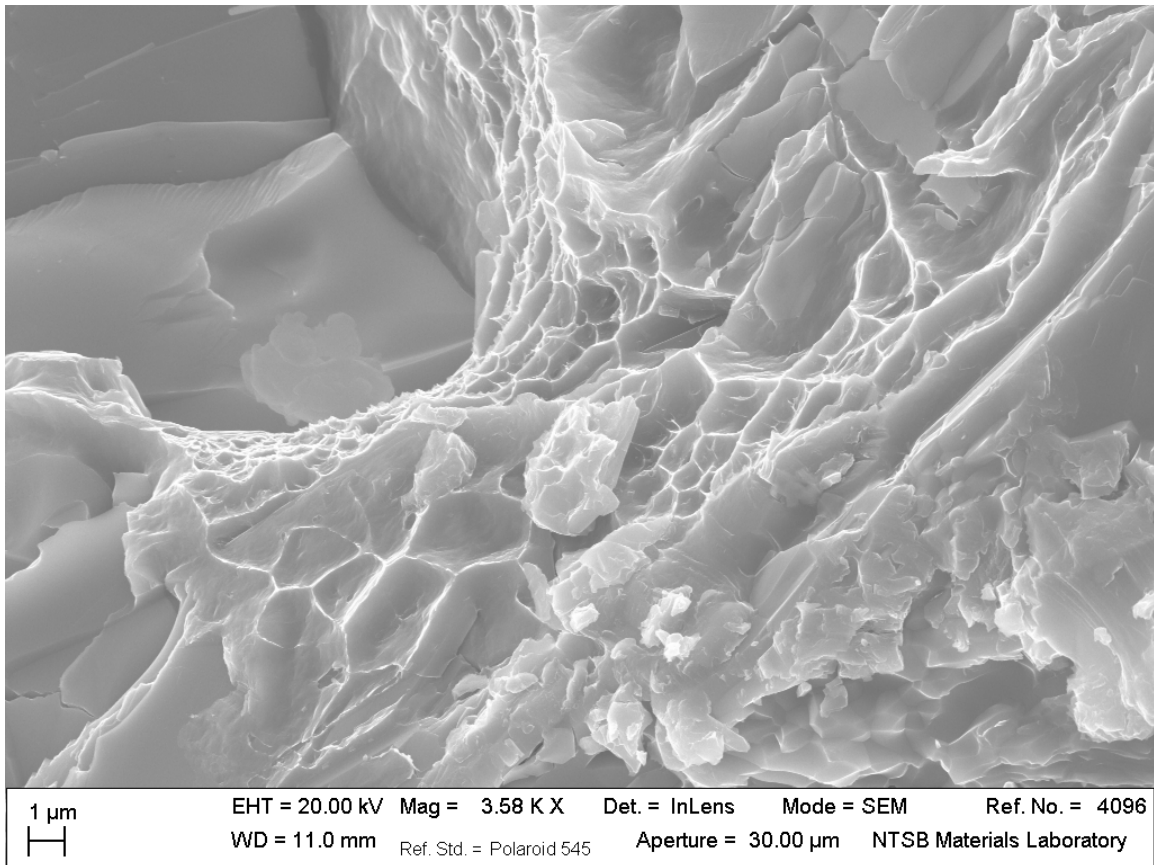
Outside the fatigue crack region, the fracture surface exhibited dimple rupture and ductile tearing, shown in Figure 20. The dimple rupture and tearing features were consistent with those present in the intentional overstressed areas (Figure 21). The areas outside of the fatigue cracking were consistent with subsequent overstress fracture.

Figure 21 – SE micrograph dimple rupture in the laboratory-opened part of the fracture surface.

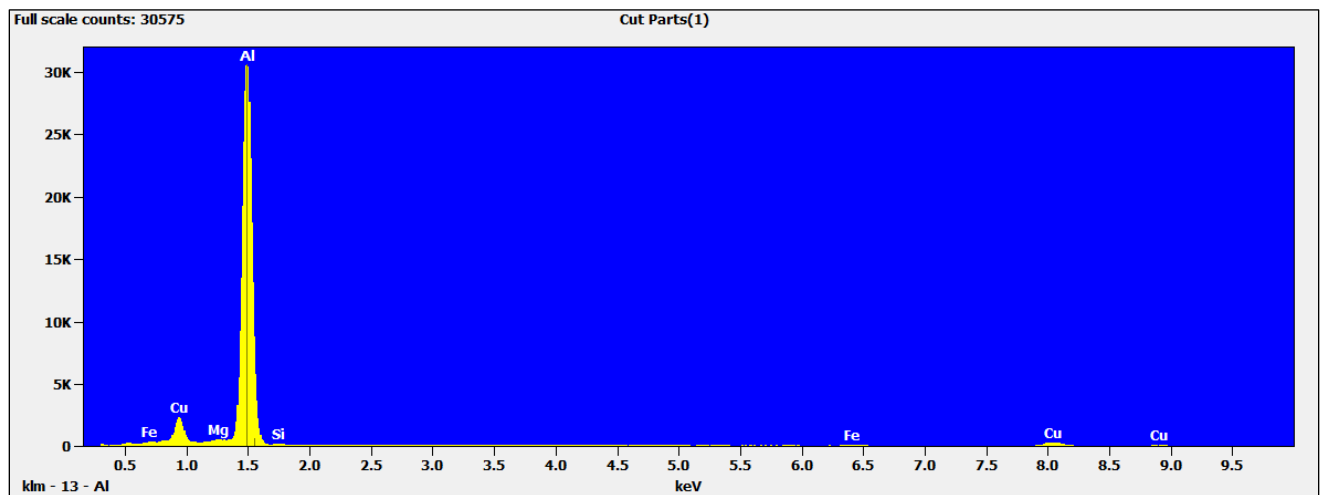
One of the cooling fins near the fracture surface was sectioned, mounted and polished. The chemical composition of the cylinder was inspected using energy dispersive x-ray spectroscopy (EDS) and x-ray fluorescence (XRF). A typical EDS spectrum is shown in Figure 22. The composition was consistent with an AA 200-series aluminum casting alloy.

Figure 22 – EDS spectrum of a typical area of the cylinder outer housing.

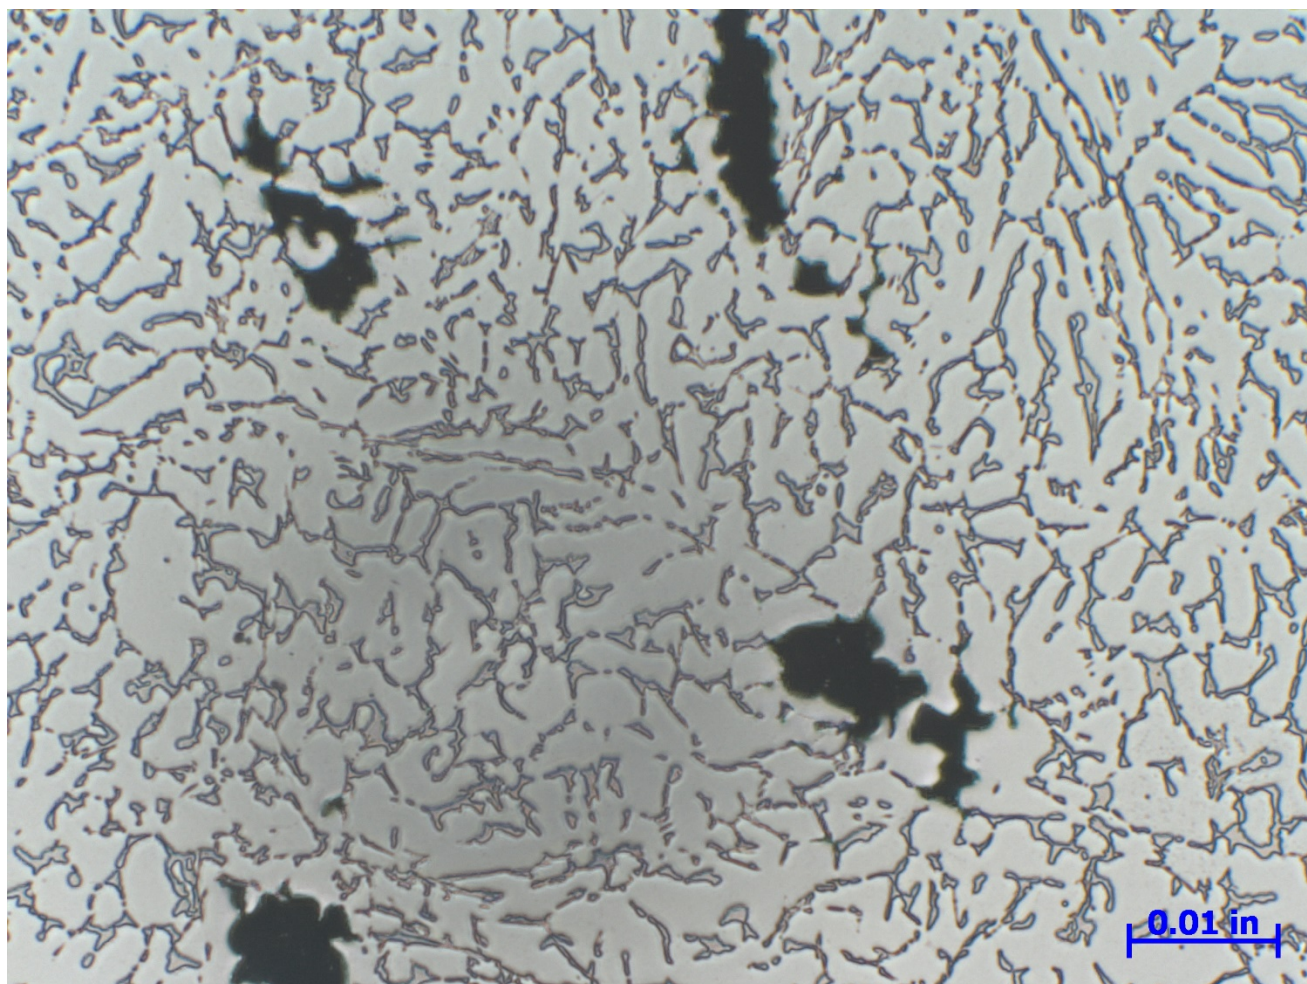
Figure 23 and Figure 24 show a typical area of the microstructure, as polished. The microstructure was dendritic, typical of cast parts. The interdendritic phases, shown as darker gray in the figures, were consistent with the last material to freeze during the casting process.

As shown in Figure 23, there were dark, globule-shaped areas along the interdendritic regions, consistent with solidification porosity. While examination of the fracture surface did not find any indications that the porosity acted as fatigue crack initiation sites, some subsurface cracking was found in the metallographic examination of the cylinder microstructure. Figure 25 shows cracking below the surface of the cooling fin. This cracking was located along the interdendritic regions, where some of the second phases had fractured locally, and/or where solidification porosity was located.

Figure 23 – Bright field (BF) optical micrograph of a typical area of the cylinder housing microstructure, showing a typical casting dendritic structure with some solidification voids (black) (~50X, as-polished).

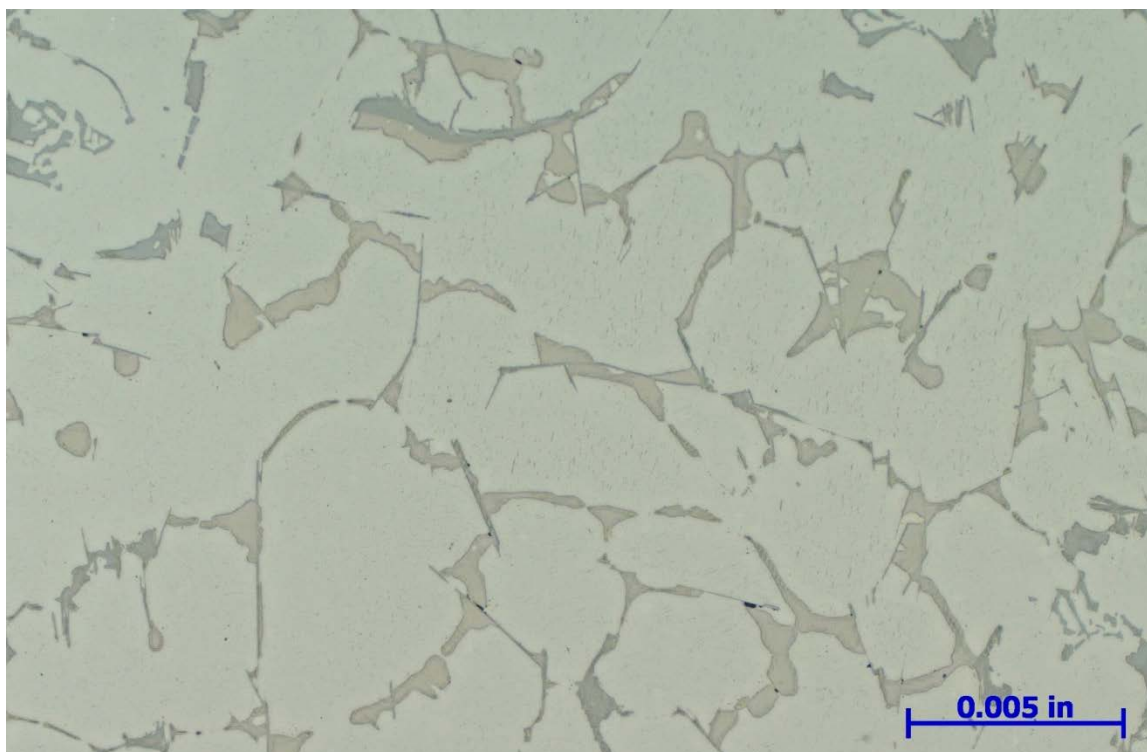
Figure 24 – BF optical micrograph the cylinder housing microstructure, showing the interdendritic phases (darker gray) (~500X, as-polished).

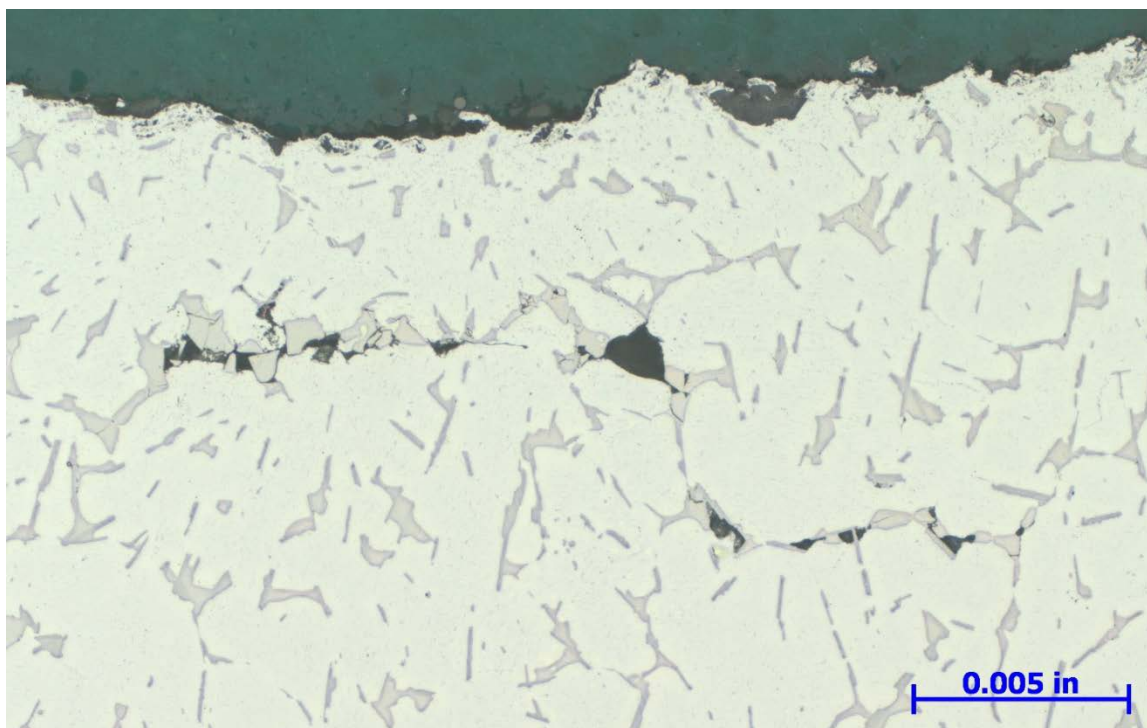
Figure 25 – BF optical micrograph, showing subsurface interdendritic cracking with some surface corrosion (~500X, as-polished).
