# SERVICE BULLETIN

No. 1787

**TITLE:** R-1340 CYLINDER HEAD - FLUORESCENT PENETRANT INSPECTION AND VISUAL INSPECTION OF

**ENGINES AND MODELS AFFECTED:** R-1340, Wasp Engines, All Models.

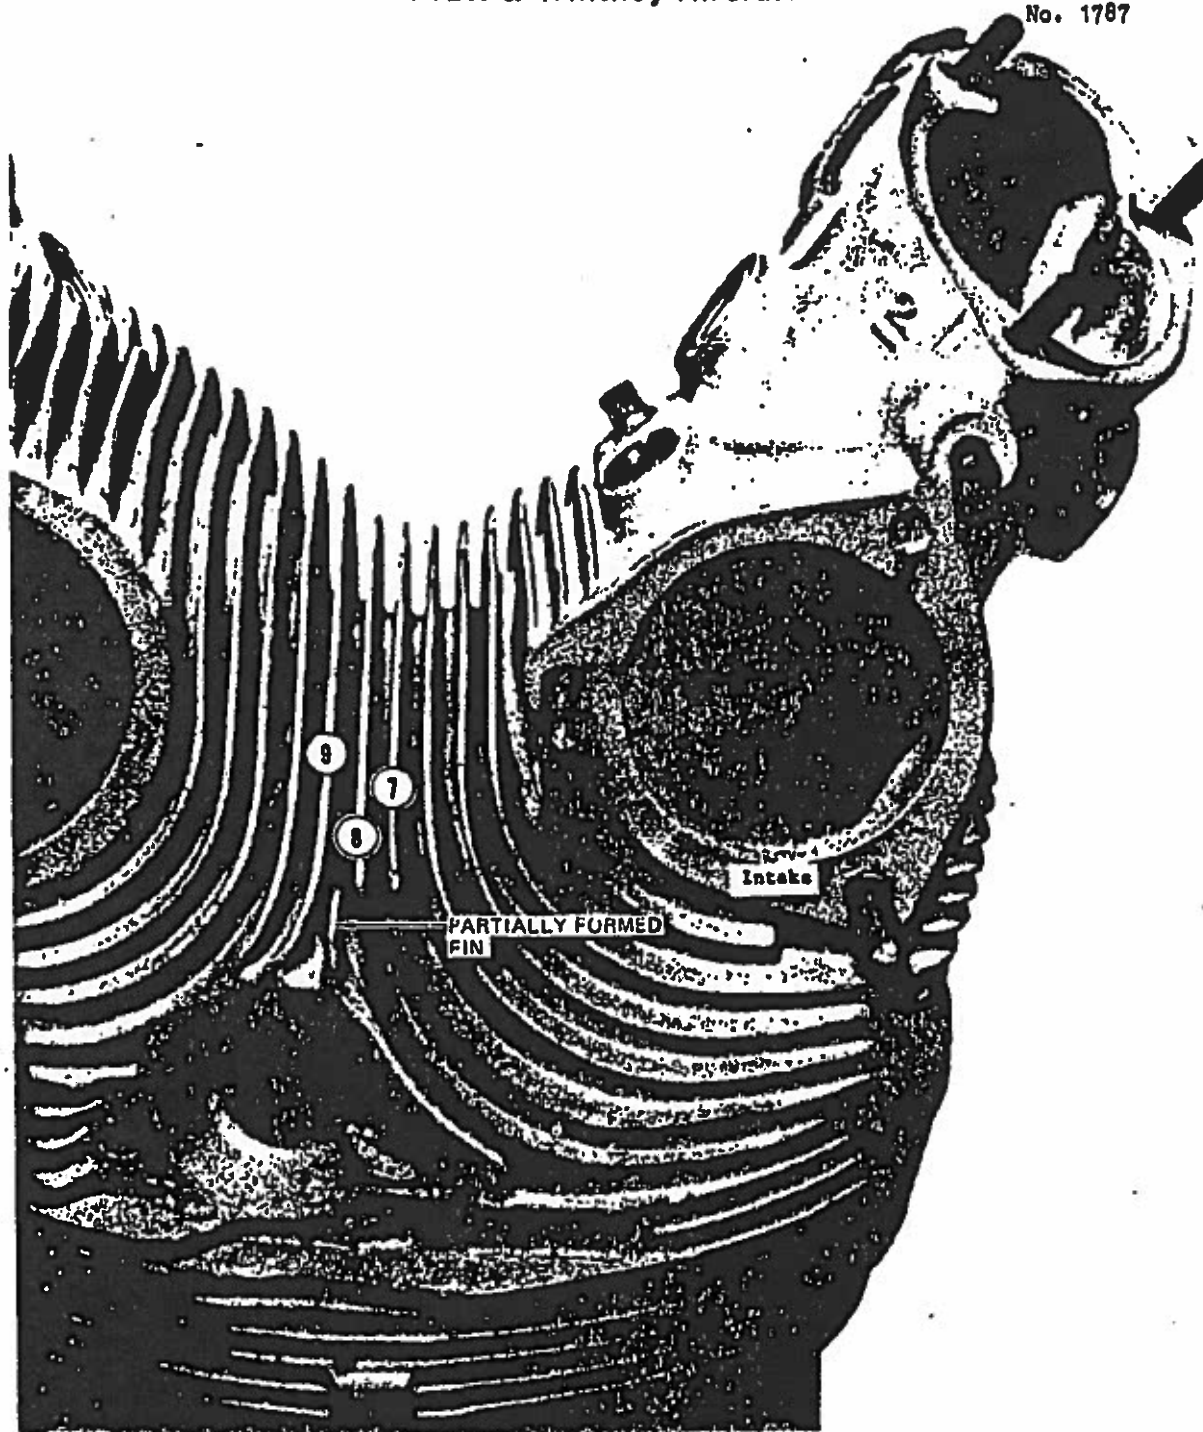
CYLINDER HEAD SHOWING FINS NO. 7 - NO. 9  
FIGURE 1

**REASON FOR BULLETIN:** Service experience indicates that some R-1340 Wasp cylinder heads, which due to rebarreling or cylinder barrel chromium plating, have operated for longer than normal usage or time (Reference (4)), can develop an over-the-head cooling fin root crack on the outer surface of fin roots Nos. 7 - 8, or 8 - 9, locations (counting from the R/H intake fins, as viewed from the rear). This type crack can propagate in fatigue fore and aft along the fin root and inward until a major portion of the head fails in tension and is liberated. It is the purpose of this bulletin to:

- B. Fluorescent penetrant inspect cylinder head Fins Nos. 7 - 8, and 8 - 9, along the outer surface of the fin roots over the cylinder head dome between the front and rear spark plug holes and including the partially formed cooling fin by the rear spark plug hole. See Figure 1. Carefully mark fins with pencil marks to enclose areas where defects are indicated. See Reference (1). The following inspection standards will apply;

A. For installed engines, visually inspect top of cylinder heads between Fins No. 7 and No. 9 (see Figure 1) as follows:

- (3) Using sufficient light, visually inspect between the central cooling fins (Fins No. 7 - No. 9) over the top of the cylinder head between front and rear spark plug openings. If crack over one inch in length is visible, or if black combustion leakage is found, replace cylinder assembly. Return rejected cylinder assembly to overhaul for inspection and salvage of usable parts.

- D. Rework Procedure;
  - (1) Using milling machine or a portable power tool and a 1/8 - 1/4 inch diameter end mill, machine over the top of cylinder head to remove the section of #8 or #9 fin containing a root crack or the section of #8 or #9 fin closest to root crack, between inspection marks. Machine fin down to root removing fin pedestal smoothly. Round edges of fin at cut out.

- (2) Using a milling machine or portable power tool and a 1/8 inch diameter end mill with a full radius end, rout out crack in root to 0.150 inch maximum depth. Scan defect area to assure complete crack removal. Remove all cylinder heads, with deeper cracks, from service. Blend ends and sides of crack cavity smoothly.
