# NATIONAL TRANSPORTATION SAFETY BOARD

MATERIALS LABORATORY FACTUAL REPORT

Report No. 17-079

Place : Carbondale, Illinois  
Date : August 28, 2017  
Vehicle : Grumman AA-5B, N28005  
NTSB No. : CEN17LA333  
Investigator : Aaron Sauer, AS-CEN

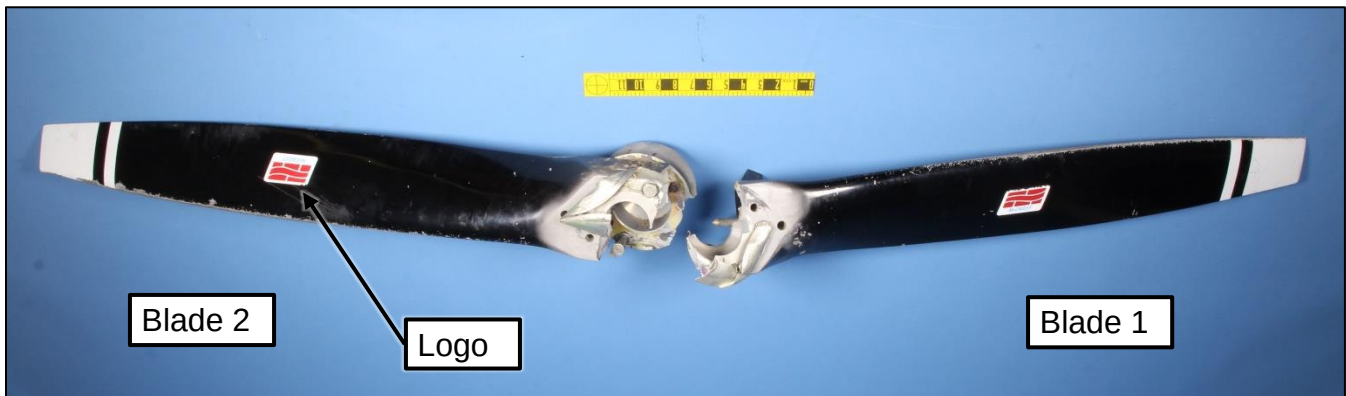
Figure 1. Overall view of the submitted components.

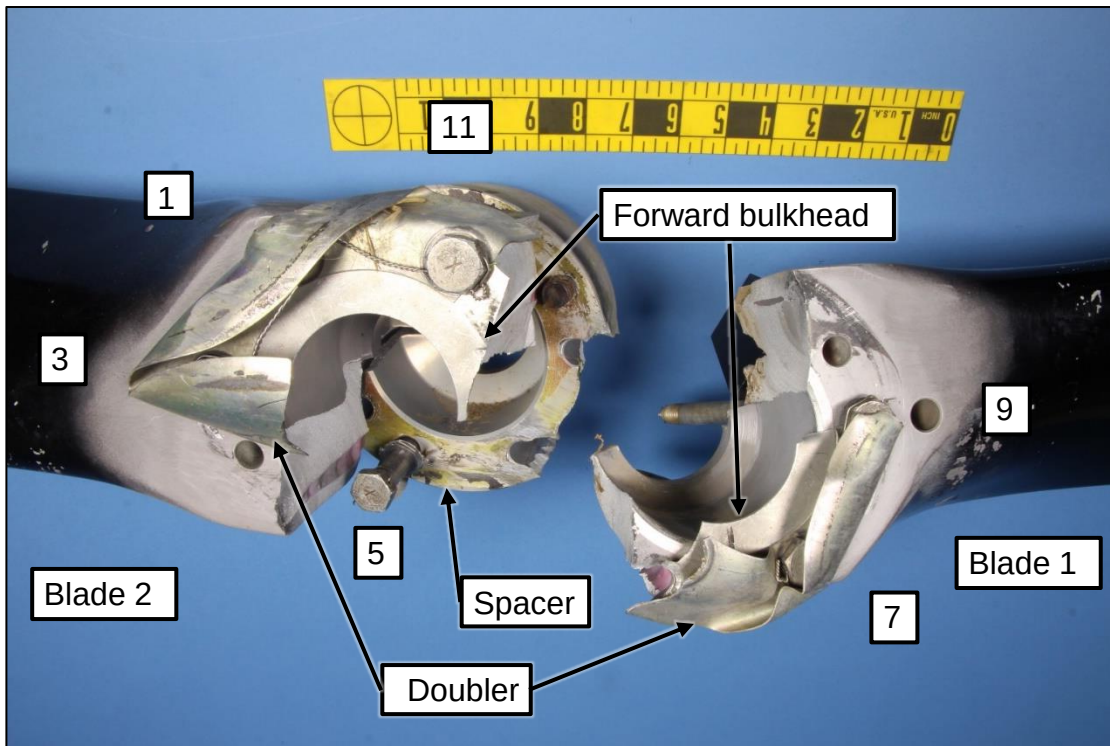
Figure 3. Closer view of the forward face of the propeller hub area.

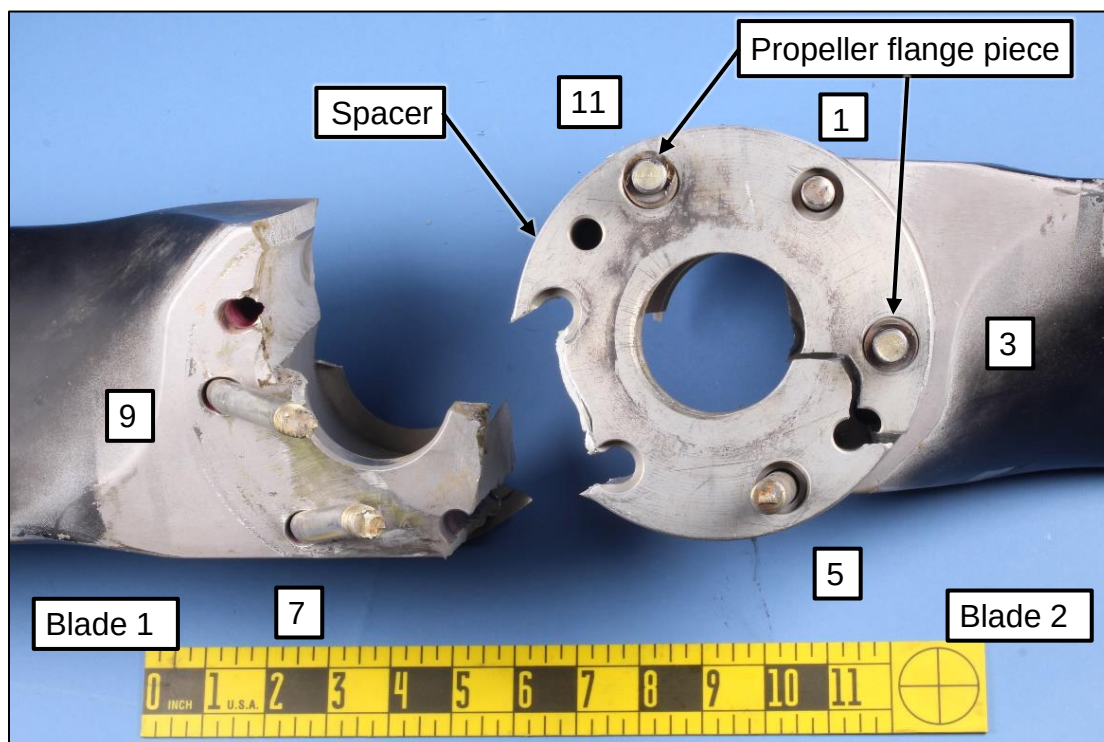
Figure 4. View of the aft faces of the propeller hub and spacer.

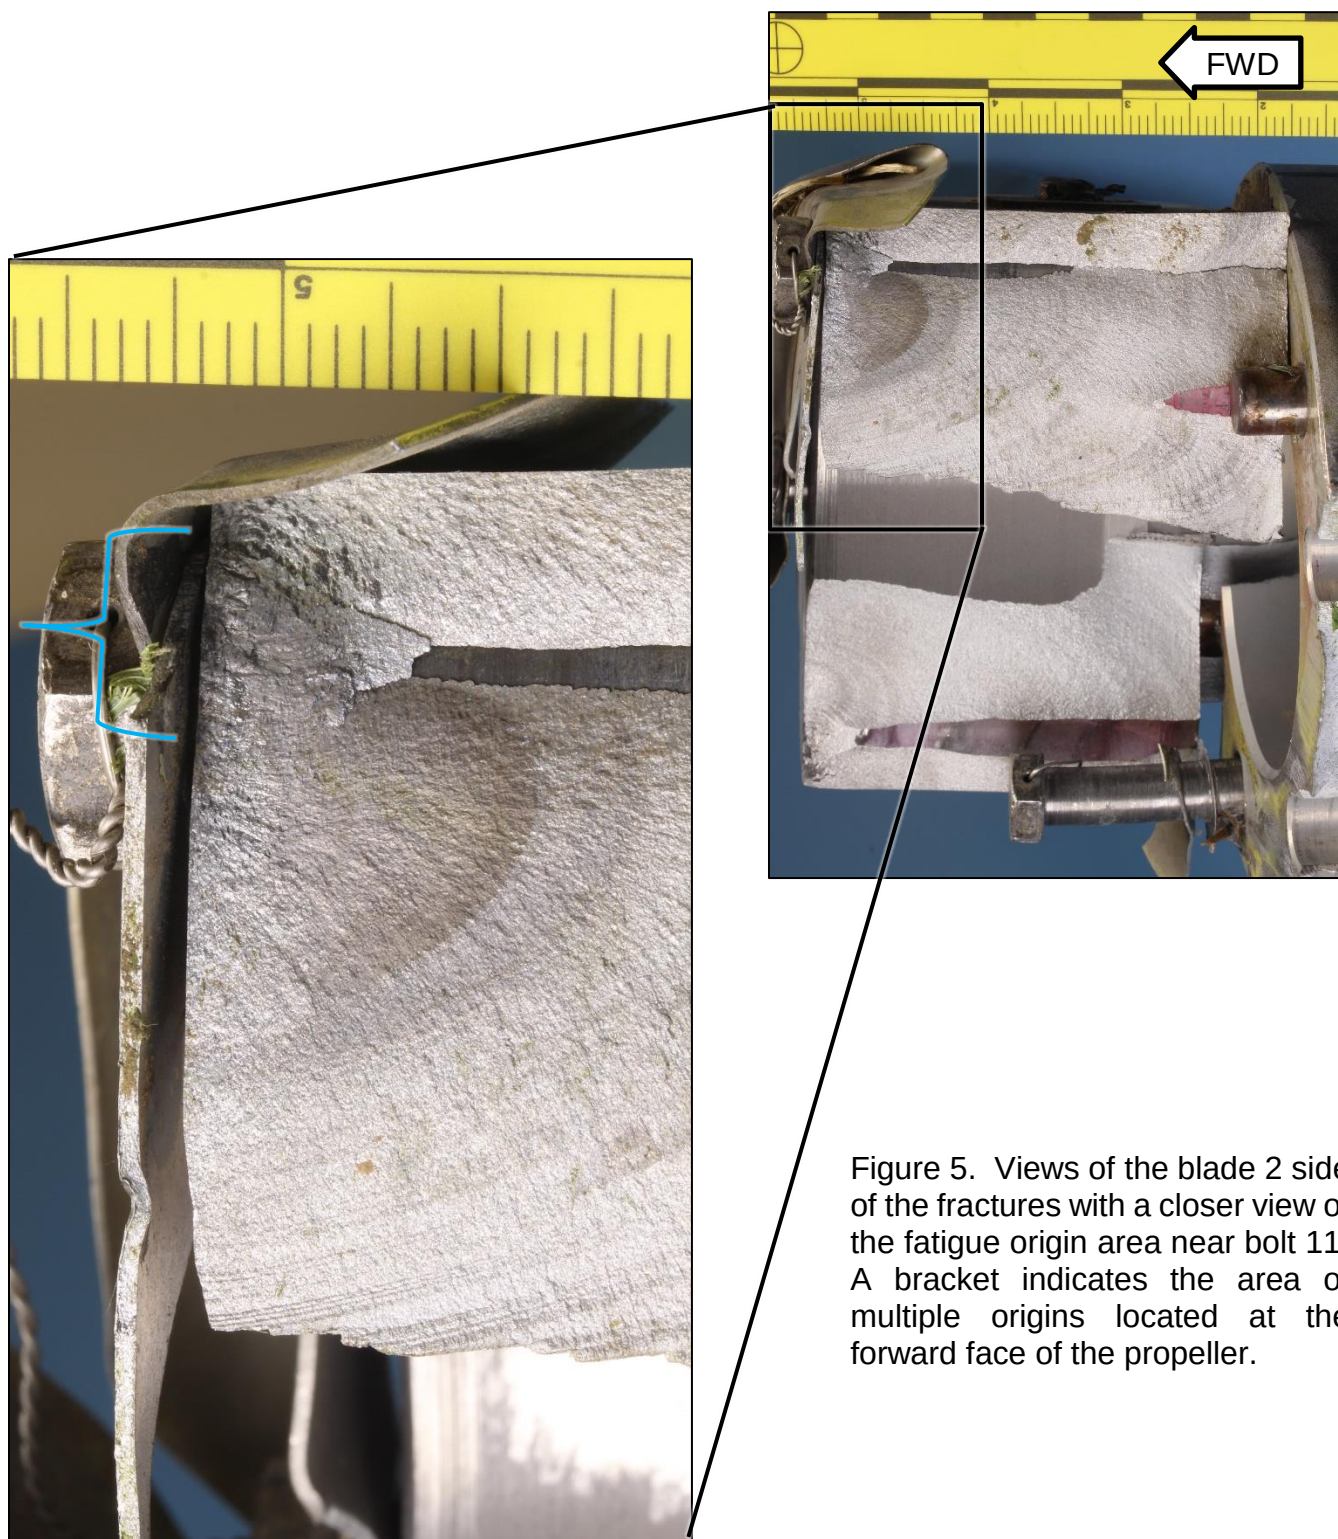
The propeller was fractured through the hub with fractures adjacent to and partially intersecting bolt holes 5 and 11. Photographs of the fracture surfaces on the piece labeled blade 2 are shown in figures 5 and 6. Both fractures were on relatively flat fracture planes with curving crack arrest marks, features consistent with fatigue. The fatigue features on each fracture surface emanated from multiple origins located at the forward face. Brackets in figures 5 and 6 indicate origin areas in each fracture.

Figure 5. Views of the blade 2 side of the fractures with a closer view of the fatigue origin area near bolt 11. A bracket indicates the area of multiple origins located at the forward face of the propeller.

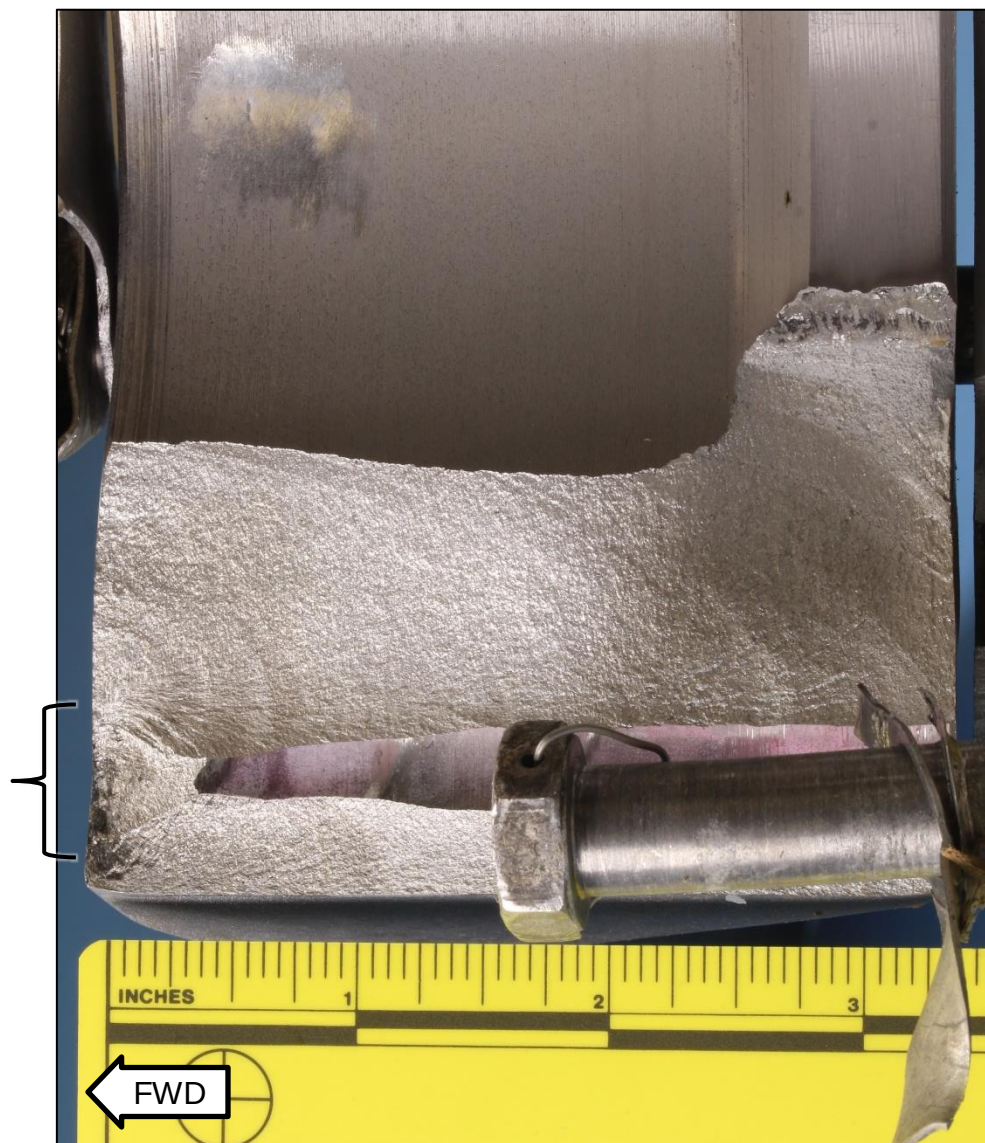
Figure 6. Blade 2 side of the fracture at bolt 5. A bracket indicates the area of multiple origins located at the forward face of the propeller.

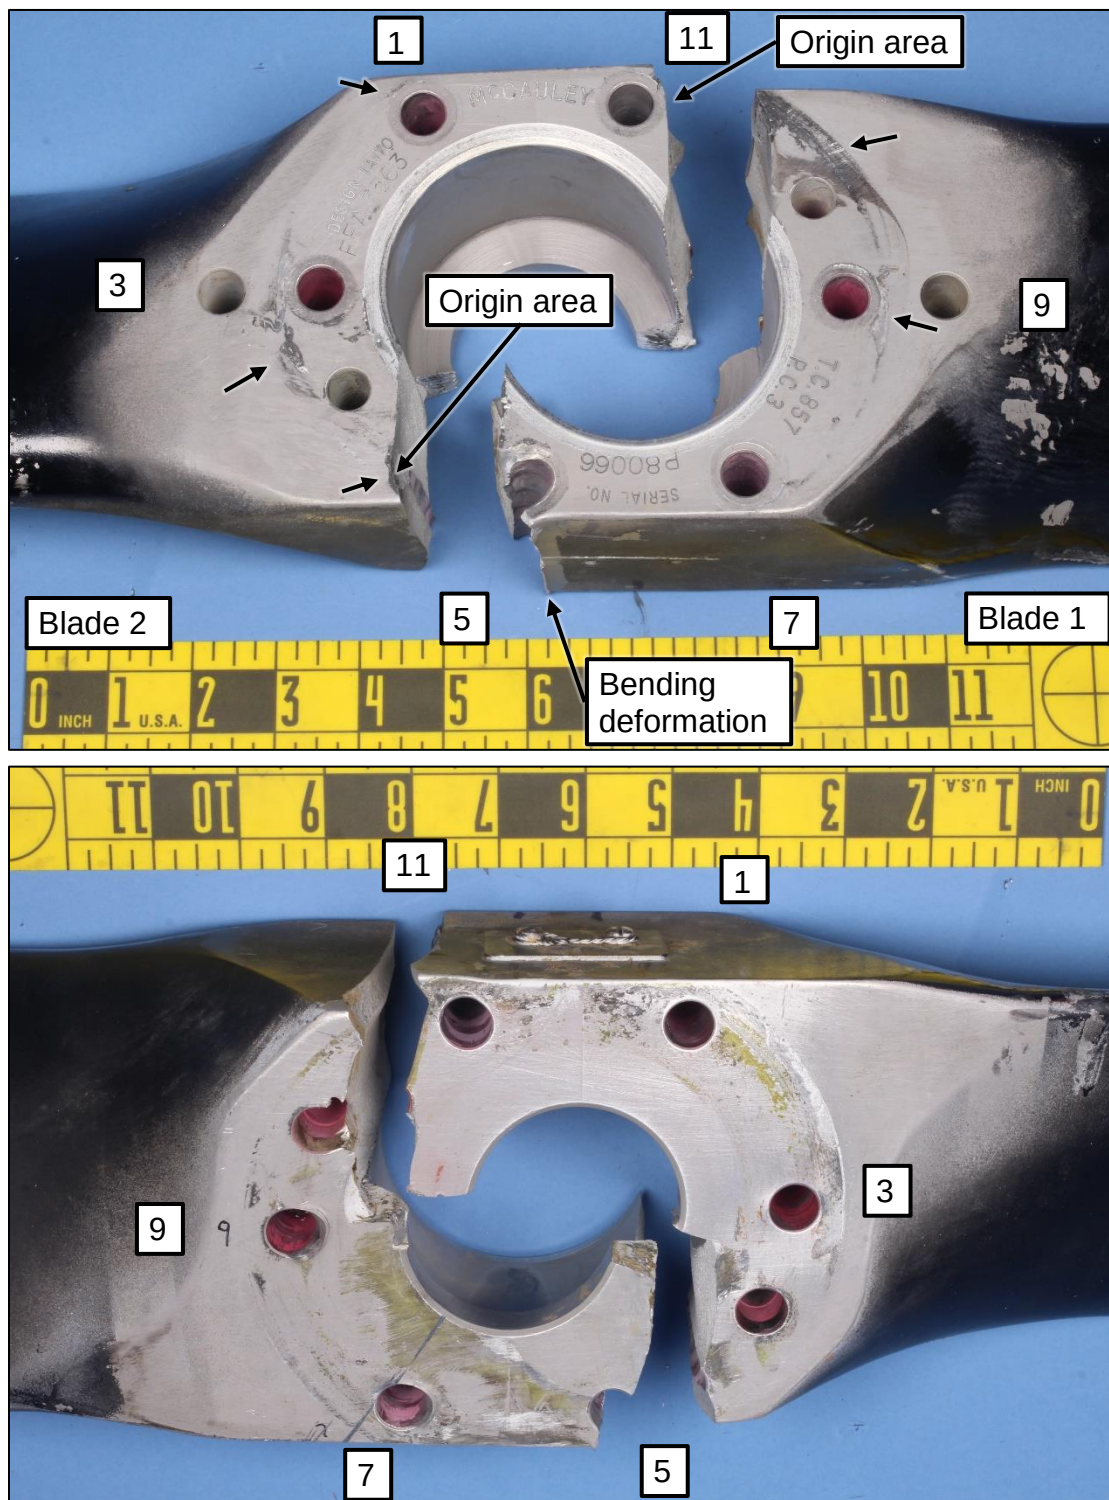
The locations of the origin areas for the two fatigue fractures in the hub are indicated in figure 7. The origins were located at the outer diameter of the annular rings associated with the underside of the attachment bolt heads at holes 5 and 11. At the number 5 attachment hole, a piece of the propeller adjacent to the hole was missing, and the missing piece included the blade 1 side of the origin area. The fracture at the blade 5 hole showed bending deformation as shown in figure 7, indicating the hub likely separated near hole 11 first. Fretting contact damage was also observed near many of the attachment holes as indicated with unlabeled arrows in figure 7. The area of fretting damage was largest adjacent to the fracture near hole 11.

Pink and red deposits were observed in the attachment and dowel holes for the propeller. The deposits can be seen clearly in figure 7 and on hole surfaces intersected by the fractures shown in figures 5 and 6. No pink or red deposits were observed on the surfaces of the holes in the spacer.

Figure 7. Overall views of the forward (upper image) and aft (lower image) faces of the propeller hub area after removing the attached components. Unlabeled arrows indicate areas of fretting contact damage. Note pink and red deposits in the holes.

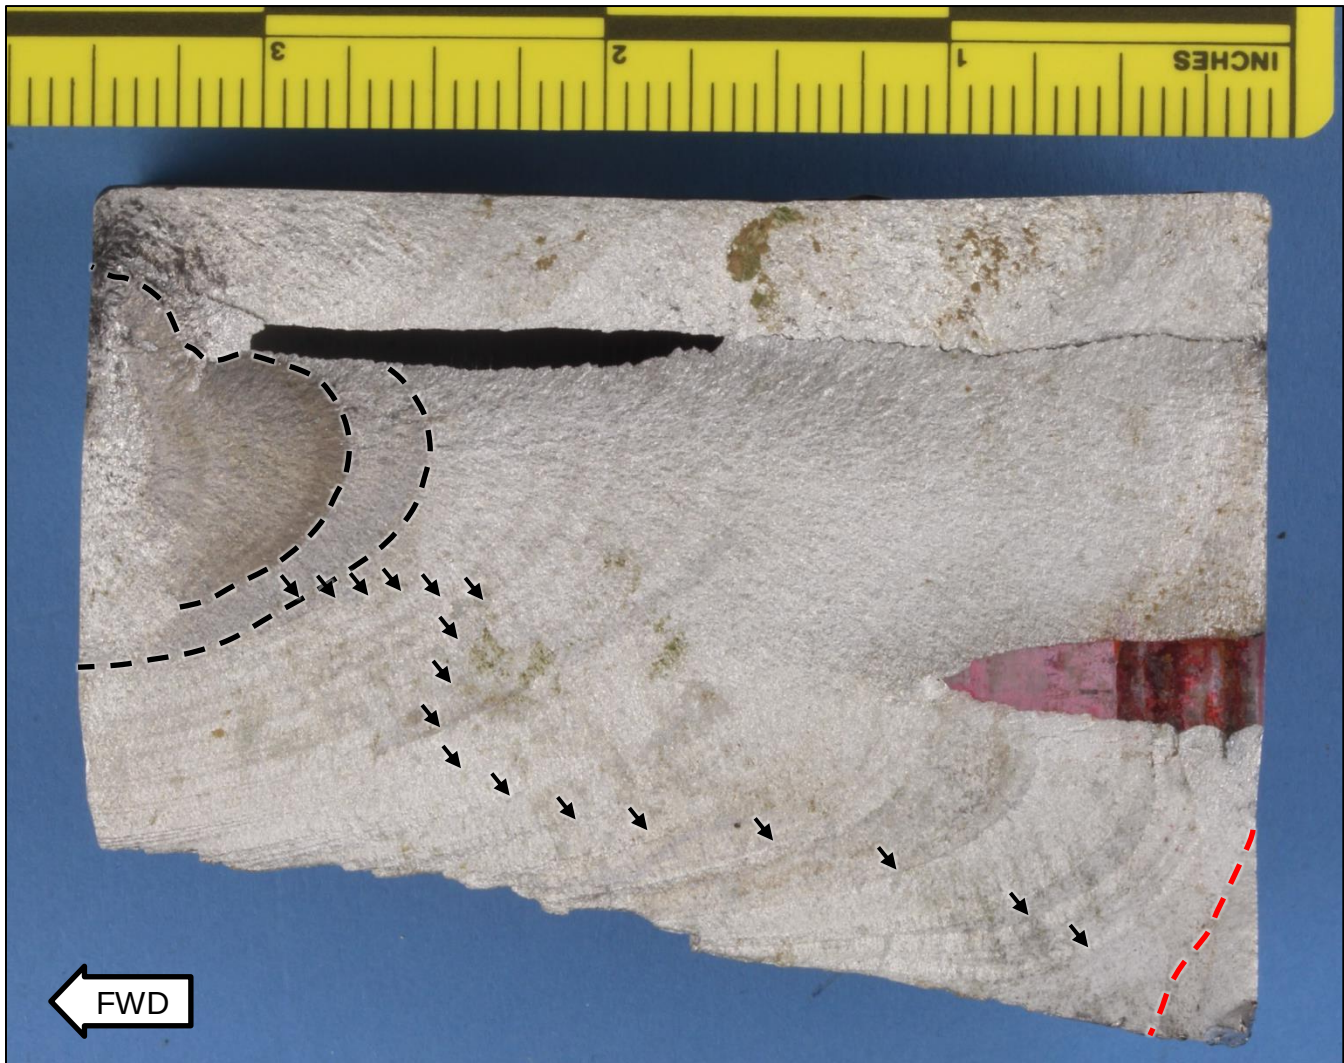
A portable bandsaw was used to cut through the hub at approximately the 12 o'clock position to separate the blade 2 side of the fracture near hole 11 for further examination. An overall view of the fracture surface after sectioning is shown in figure 8. The fatigue region extended across most of the fracture surface, ending near the inboard aft corner at the boundary indicated with a red dashed line. Near the origin, a portion of the fracture surface had a brown color, and the boundary of the brown region is indicated with a black dashed line. Adjacent to the brown region, a region with a bluish gray tint was observed, bounded by another black dashed line. A periodic pattern of crack arrest lines was observed between the bluish gray region and the fatigue boundary. Unlabeled

arrows in figure 8 indicate the locations of 17 crack arrest lines identified on the fracture surface between the bluish gray region and the fatigue boundary.

The fracture surface shown in figure 8 was initially examined under a stereo microscope using a black light. The fracture surface was prepared for examination by blowing away loose debris with compressed air. No evidence of fluorescing dye was observed on the fracture surface.

Figure 8. Overall view of the blade 2 side of the fracture near bolt hole 11 after disassembly and sectioning from the rest of the propeller. Black dashed lines indicate boundaries associated with surface oxidation near the origin area, and a red dashed line indicates the fatigue boundary. Arrows indicate 17 crack arrest lines identified on the fracture surface between the outermost oxidized region and the fatigue boundary.

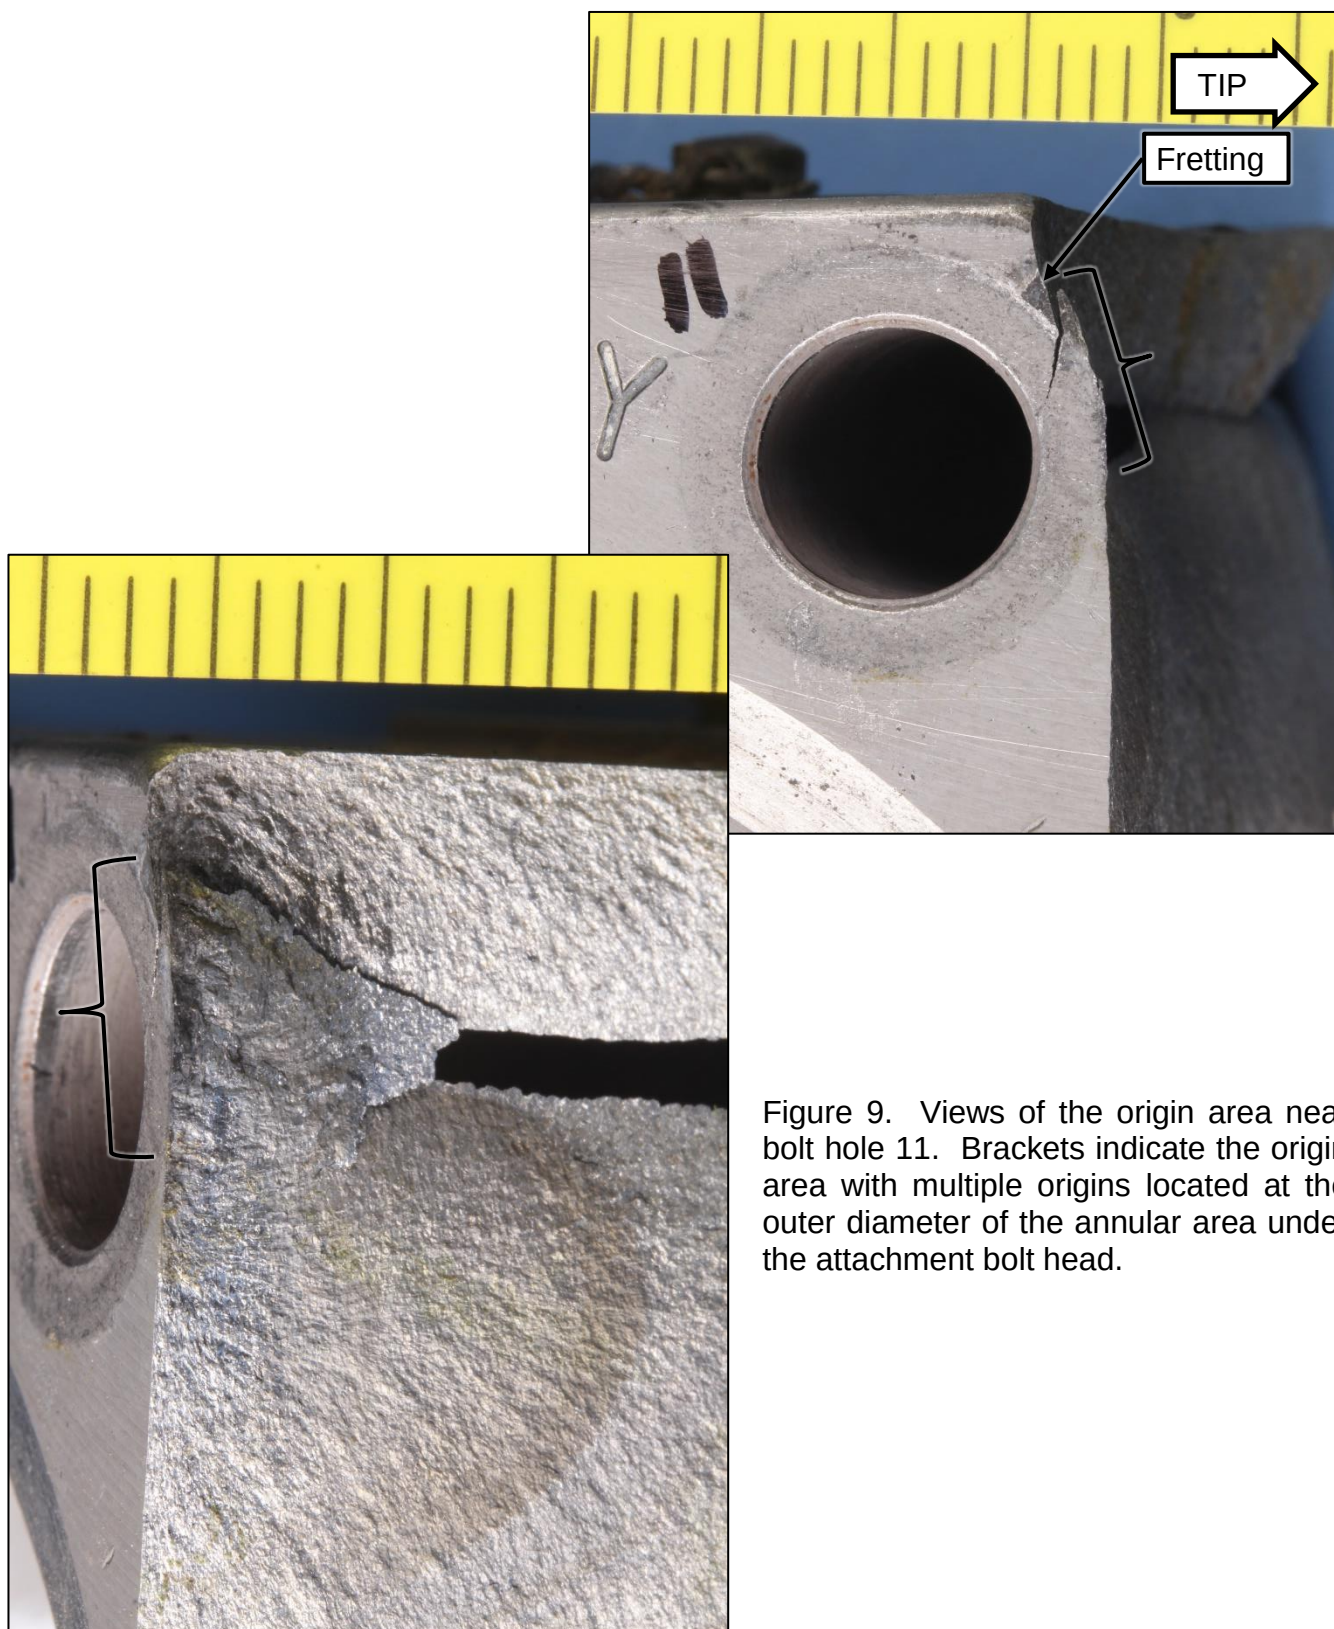
Views of the origin area and adjacent forward face of the blade are shown in figure 9. For reference, the forward bulkhead is shown in position at bolt hole 11 in figure 10. The fracture in the forward bulkhead curved around the outboard edge of the annular area of the bolt head, intersecting the propeller fracture near the middle of the origin area. Fretting contact damage was observed on the propeller surface along the line of fracture for the forward bulkhead and on the adjacent surface outboard of the bulkhead fracture.

Figure 9. Views of the origin area near bolt hole 11. Brackets indicate the origin area with multiple origins located at the outer diameter of the annular area under the attachment bolt head.

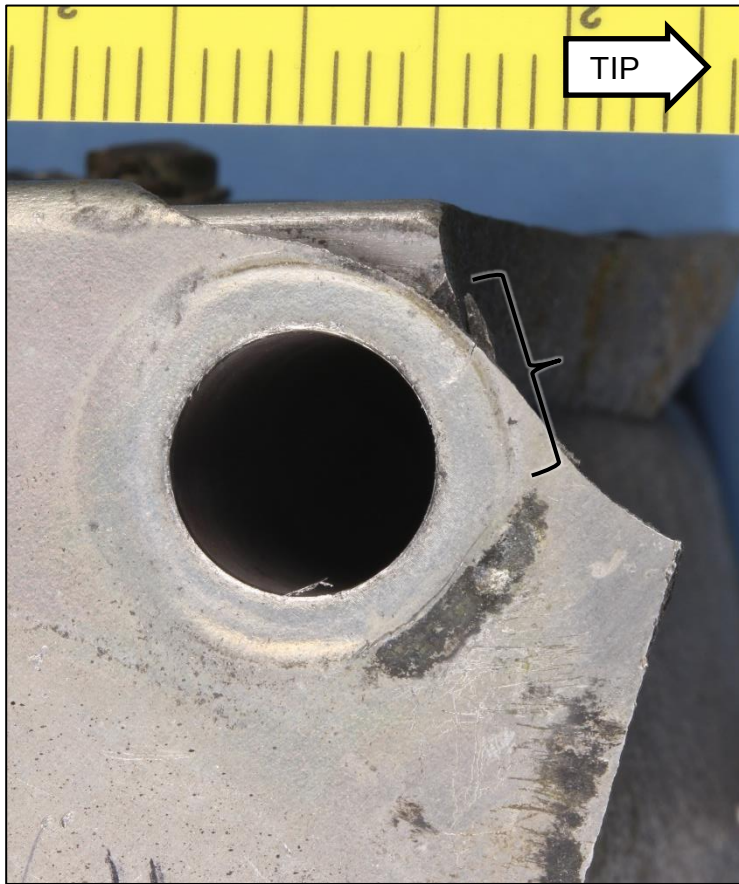
Figure 10. View of the origin area near bolt hole 11 with the forward bulkhead in position. The bracket indicates the location of the underlying origin area on the propeller.

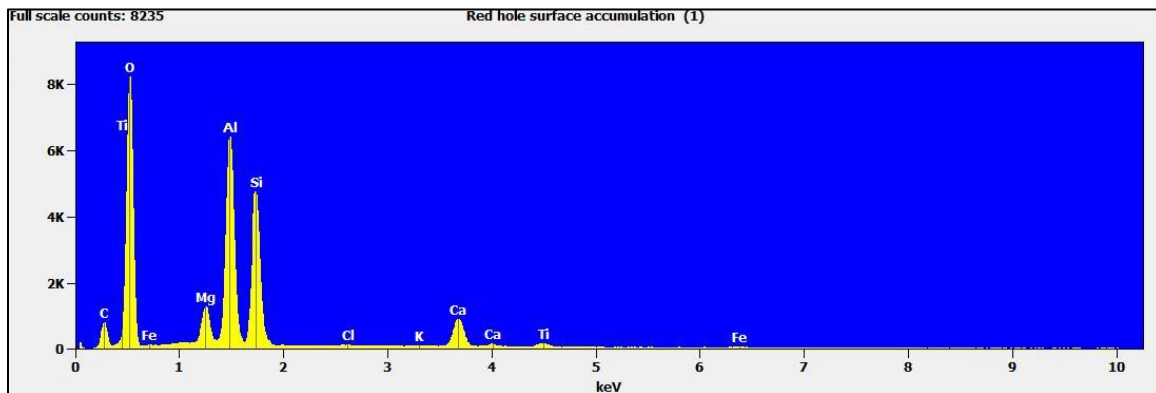
An accumulation of deposits in the dowel hole near the aft end of the fracture was analyzed using EDS, and the resulting spectrum is shown in figure 11. When viewed under an optical microscope, the deposits in the area analyzed appeared pink. For comparison, an EDS spectrum of the propeller fracture in an area relatively clean and free of deposits or oxidation is shown in figure 12 (lower spectrum). The pink deposits in the dowel hole had relatively higher peaks of carbon, oxygen, magnesium, silicon, chlorine, potassium, calcium, titanium, and iron compared to the spectrum from the relatively clean fracture surface.

Figure 11. EDS spectrum of an accumulation of deposits (appearing pink or red in optical images) in the dowel hole near the aft end of the fracture shown in figure 8.

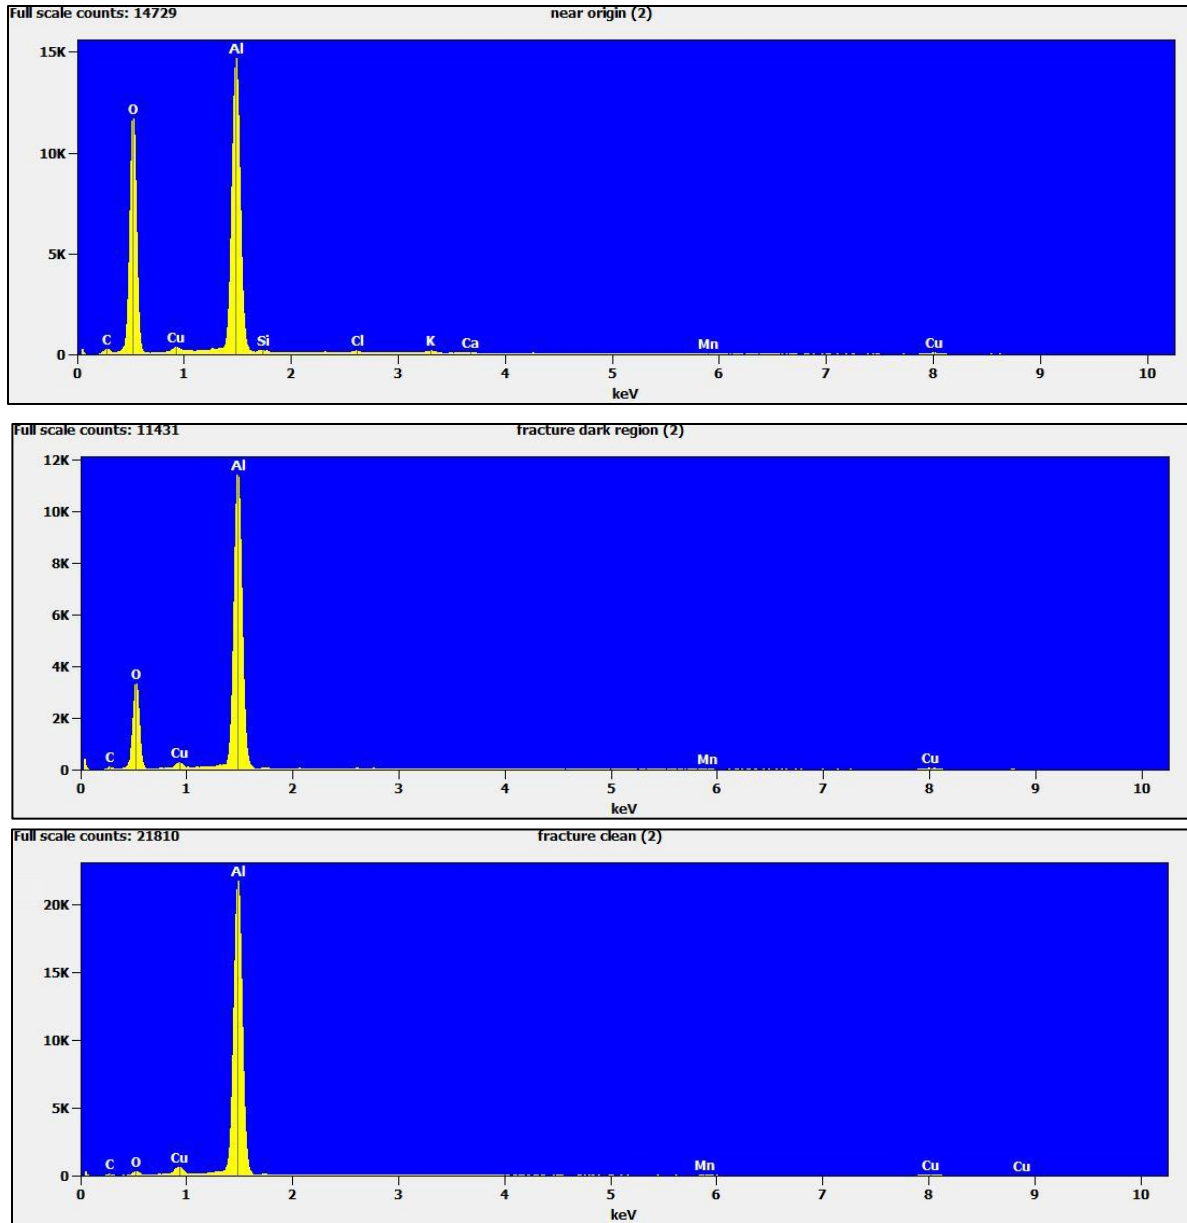
EDS spectra were obtained from areas near the origin and within the discolored areas indicated with black dashed lines in figure 8, and the EDS spectra are shown in figure 12 (upper and middle spectrum, respectively). Compared to the spectrum obtained from a relatively clean area of the fracture further from the origin (lower spectrum in figure 12), the spectra near the origin and within the discolored region showed relatively higher peaks of oxygen. Closer to the origin, small peaks of silicon, chlorine, potassium and calcium were also detected.

Figure 12. EDS spectra of areas of the fracture surface near the fatigue origin (upper spectrum), in the oxidized region near the boundary of the oxidized region (middle spectrum), and in an area outside of the oxidized region relatively free of surface deposits (lower spectrum). See figure 13 for an SEM image of the oxidized region boundary.

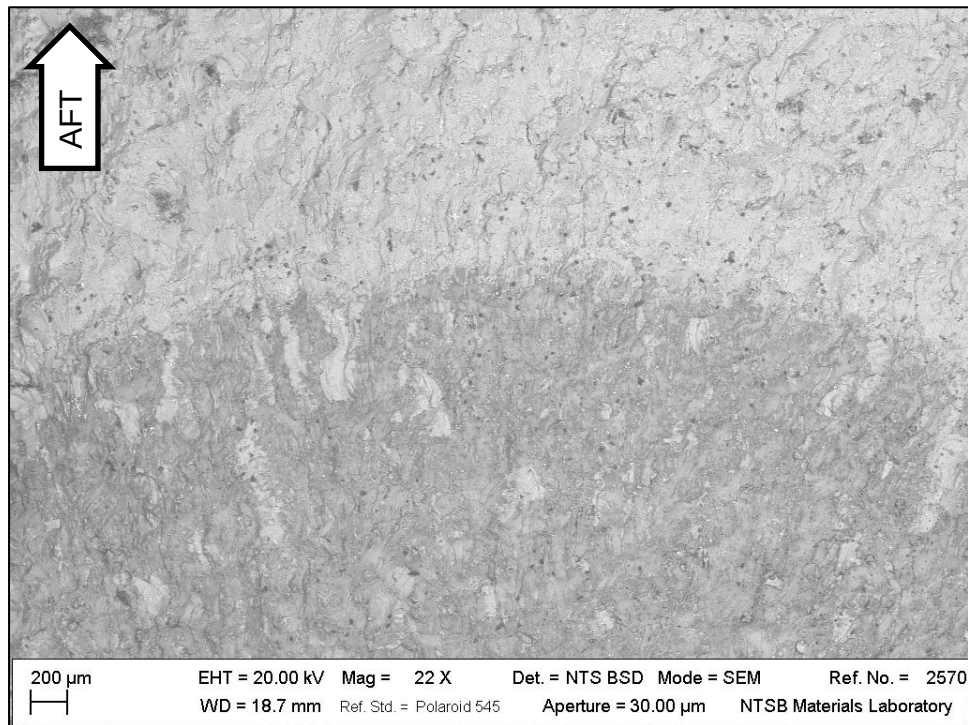
The boundary of the discolored (oxidized) region was imaged in the SEM using a backscattered electron detector in composition mode,<sup>2</sup> and the resulting image is shown in figure 13. The oxidized region appears darker relative to the fracture surface aft of the boundary.

Figure 13. SEM image using a backscatter detector showing the boundary of the oxidized region. The oxidized region appears darker due to the presence of oxygen, which has an atomic weight lower than that of aluminum.

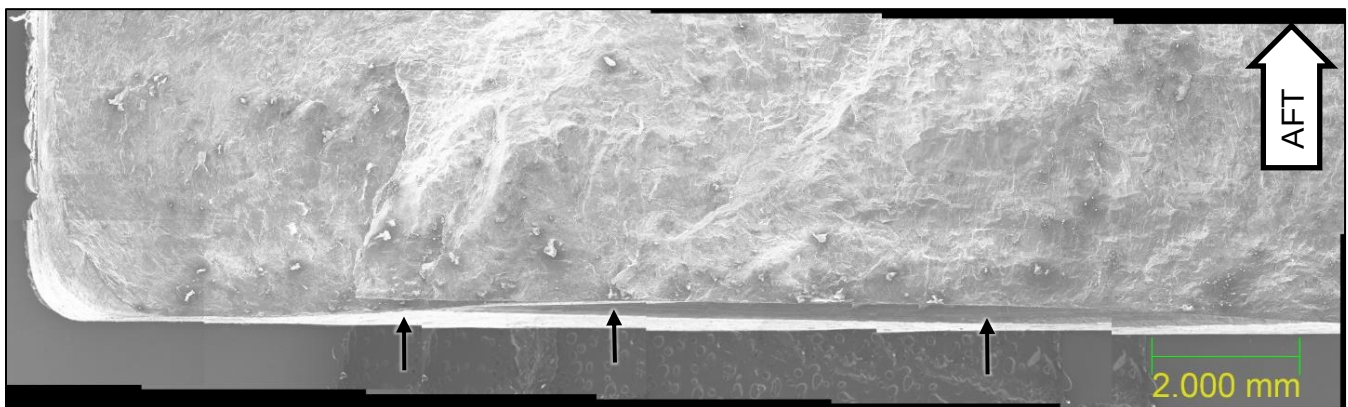
An overall view of the cleaned propeller fracture surface at the origin area near hole 11 is shown in figure 14. Several origins were noted as indicated with arrows in figure 14. Feathery fracture features with curving striations were observed emanating from the origin area, features consistent with fatigue. Figure 15 shows typical fracture features observed near the origin (upper image) and in an area outside the oxidized region (lower image).

Figure 14. SEM image of the origin area at hole 11 after cleaning with solvent. Arrows indicate locations of fatigue origins. stitched together into one image. The image was created from individual SEM images that were stitched together.

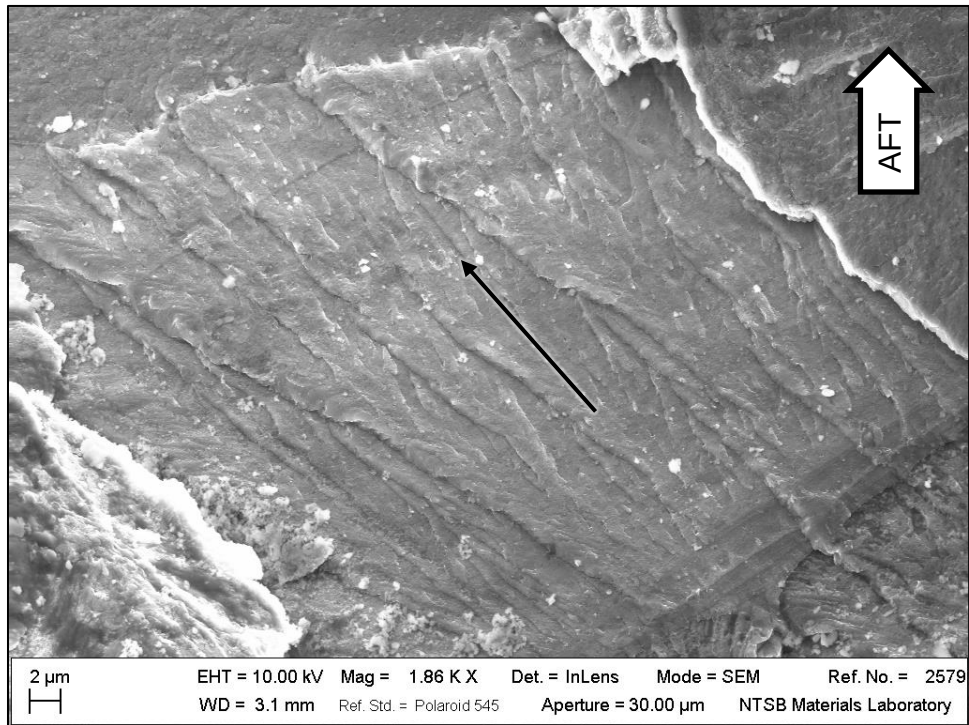
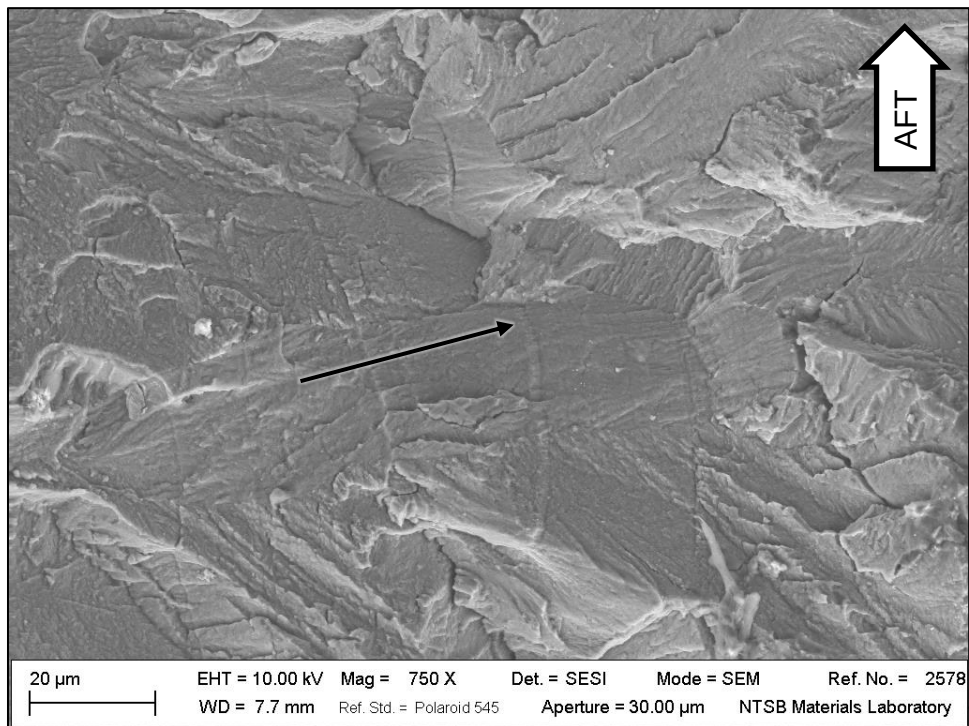
Figure 15. SEM images of typical fatigue fracture features near the origin (upper image) and at a location outside the oxidized region (lower image). Arrows indicate crack propagation directions.

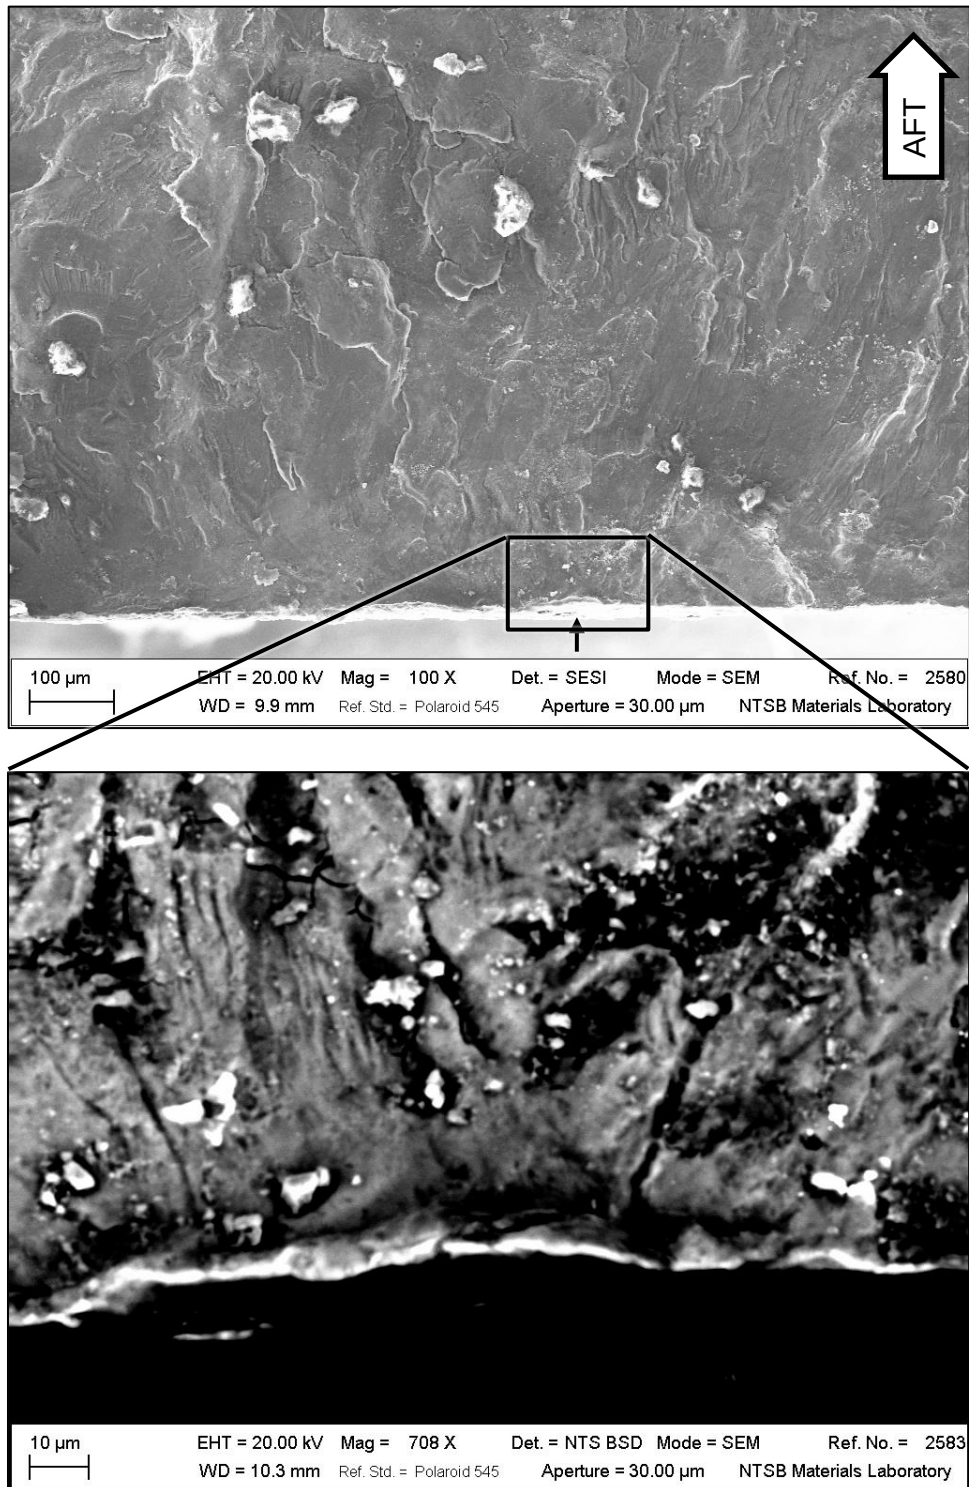
Most of the fracture features emanated directly from the origin at the right in figure 14, which will be referenced as the primary origin. Closer SEM images of the primary origin are shown in figure 16. A relatively shallow pit was observed at the origin as indicated with an arrow in the upper image in figure 16. No evidence of material anomalies were observed as shown in the lower image in figure 16 obtained using the backscattered electron detector.

Figure 16. SEM images of the origin area. The upper image shows the area as viewed using the secondary electron detector, and the lower image shows a closer view of the origin using a backscattered electron detector.

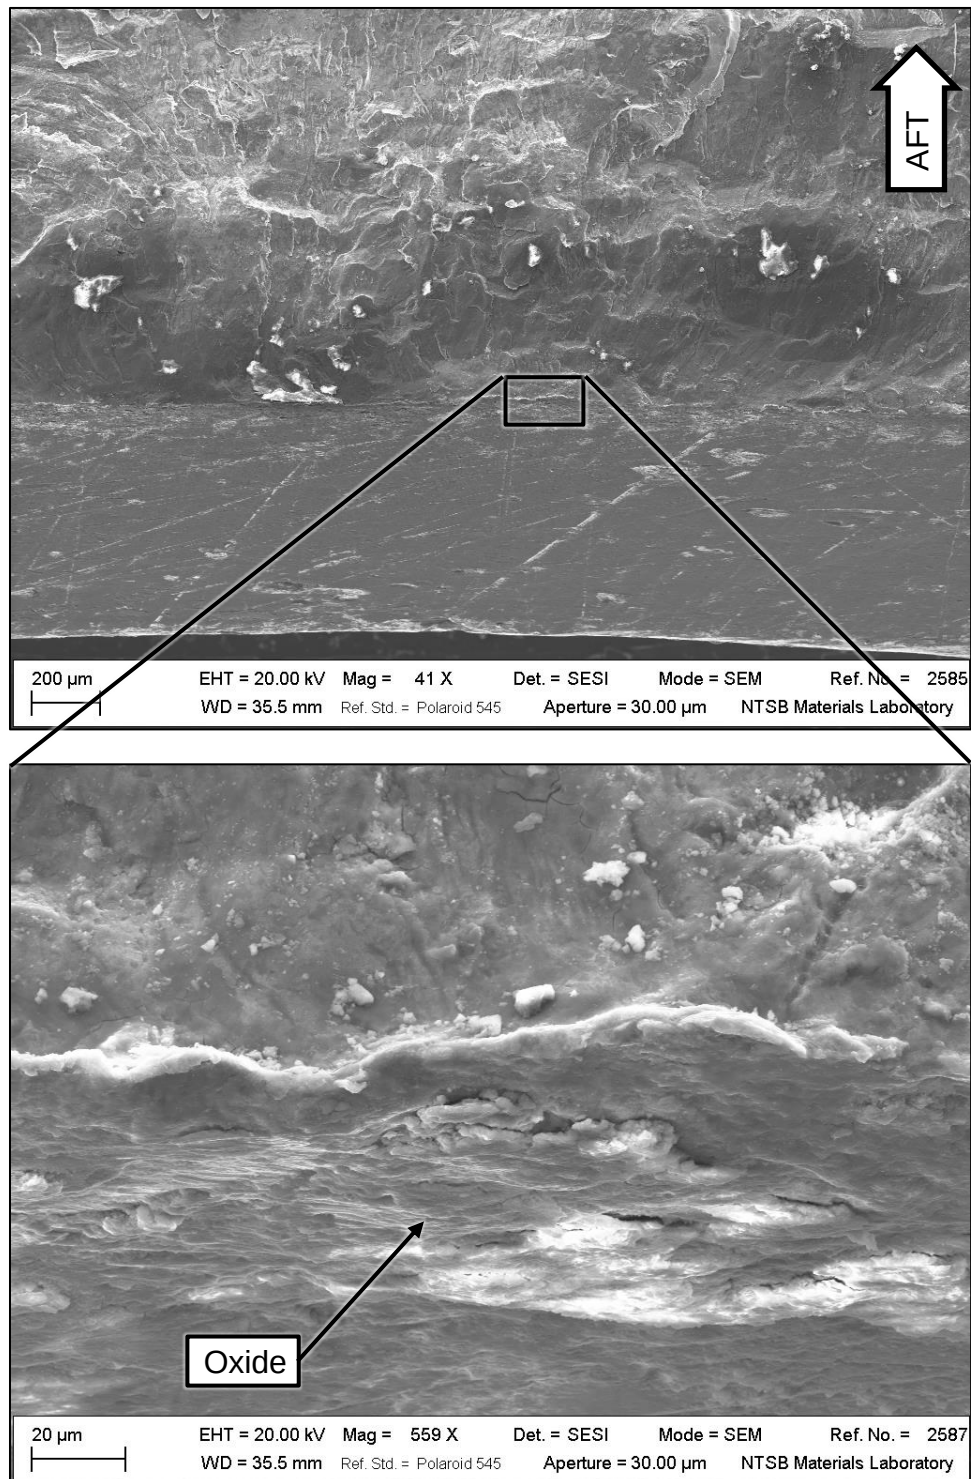
Oblique views of the primary origin are shown in figure 17. A relatively rough surface with oxide deposits were observed on the forward face of the propeller adjacent to the origin area. Additional views of the surface adjacent to the origin are shown in figure 18 as imaged using the secondary electron detector (upper image) and the backscattered electron detector (lower image). Scratches were observed on the surface mostly oriented at angles less than 45 degrees relative to the spanwise direction of propeller. Some scratches were also noted transverse to the spanwise direction such as those indicated in figure 18. However, the origin did not appear to coincide with any of the scratches. Particles of cadmium were observed scattered around the annular contact area around the bolt hole, and one of the particles is indicated in the lower image in figure 18. (The attachment bolts and doubler were coated with cadmium.) Accumulations of oxide particles were observed within approximately 0.008 inch (200 micrometers) of the fracture surface. No fretting contact damage was observed within the annular contact area located under the head of the attachment bolt.

Figure 17. SEM images of the origin area at an oblique angle showing both the fracture surface and the adjacent forward face of the propeller.
