# NATIONAL TRANSPORTATION SAFETY BOARD

MATERIALS LABORATORY FACTUAL REPORT

Report No. 17-079

Place : Carbondale, Illinois  
Date : August 28, 2017  
Vehicle : Grumman AA-5B, N28005  
NTSB No. : CEN17LA333  
Investigator : Aaron Sauer, AS-CEN

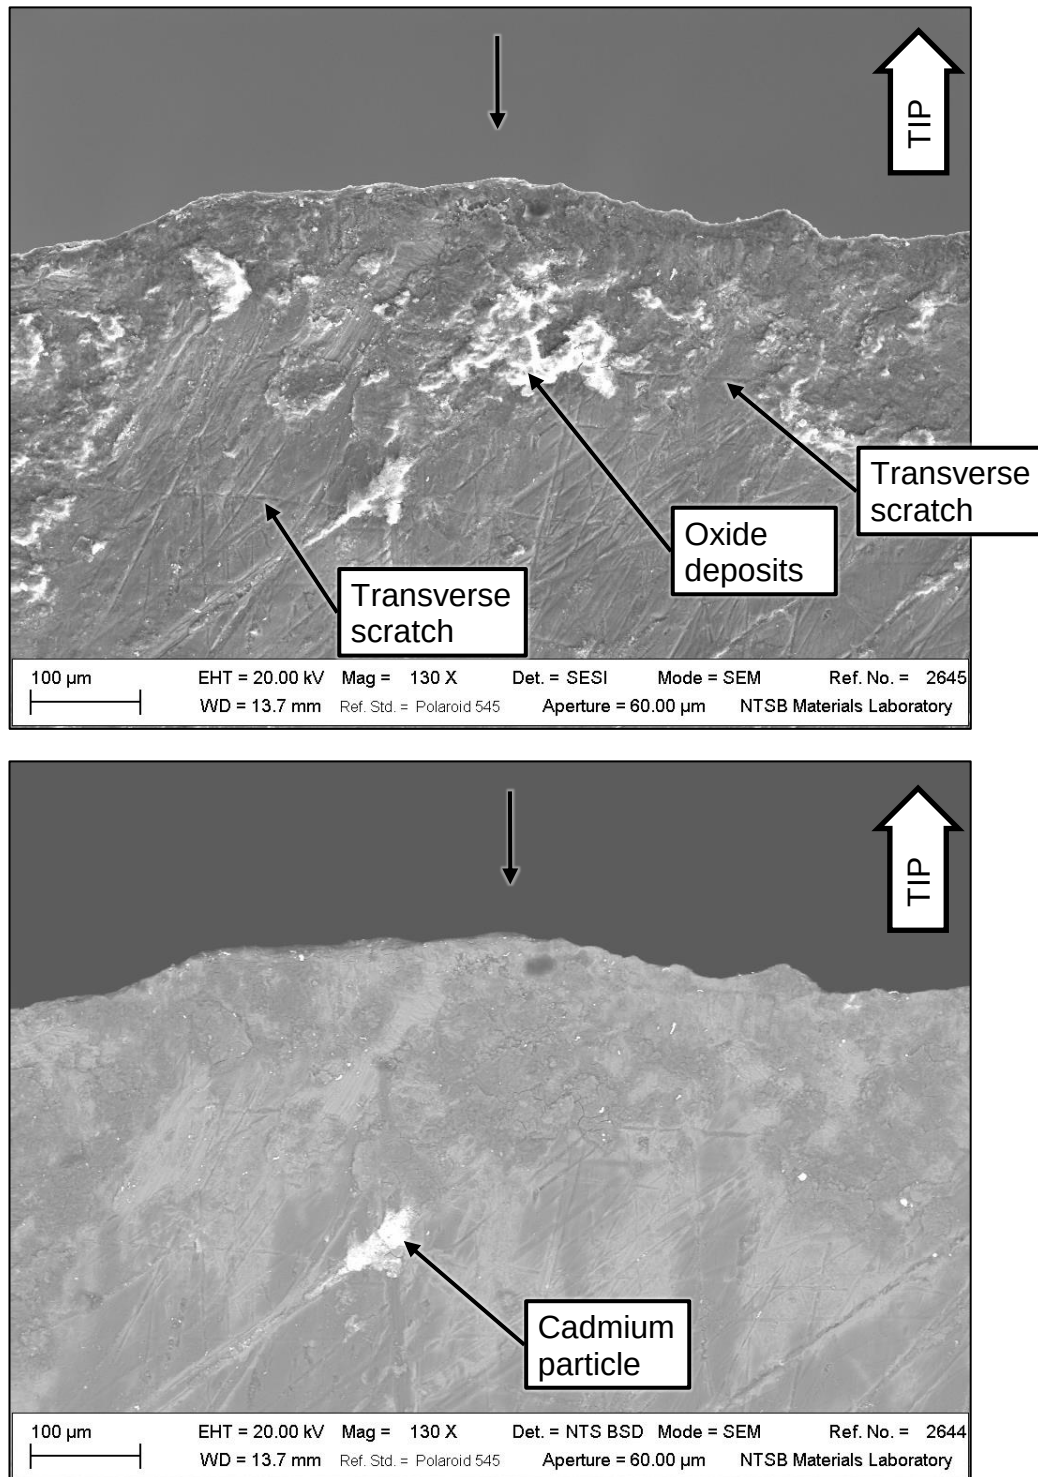
Figure 18. Forward face of the propeller adjacent to the fatigue origin as viewed in an SEM using the secondary electron detector (upper image) and the backscatter detector (lower image). An arrow in each image indicates the origin location.

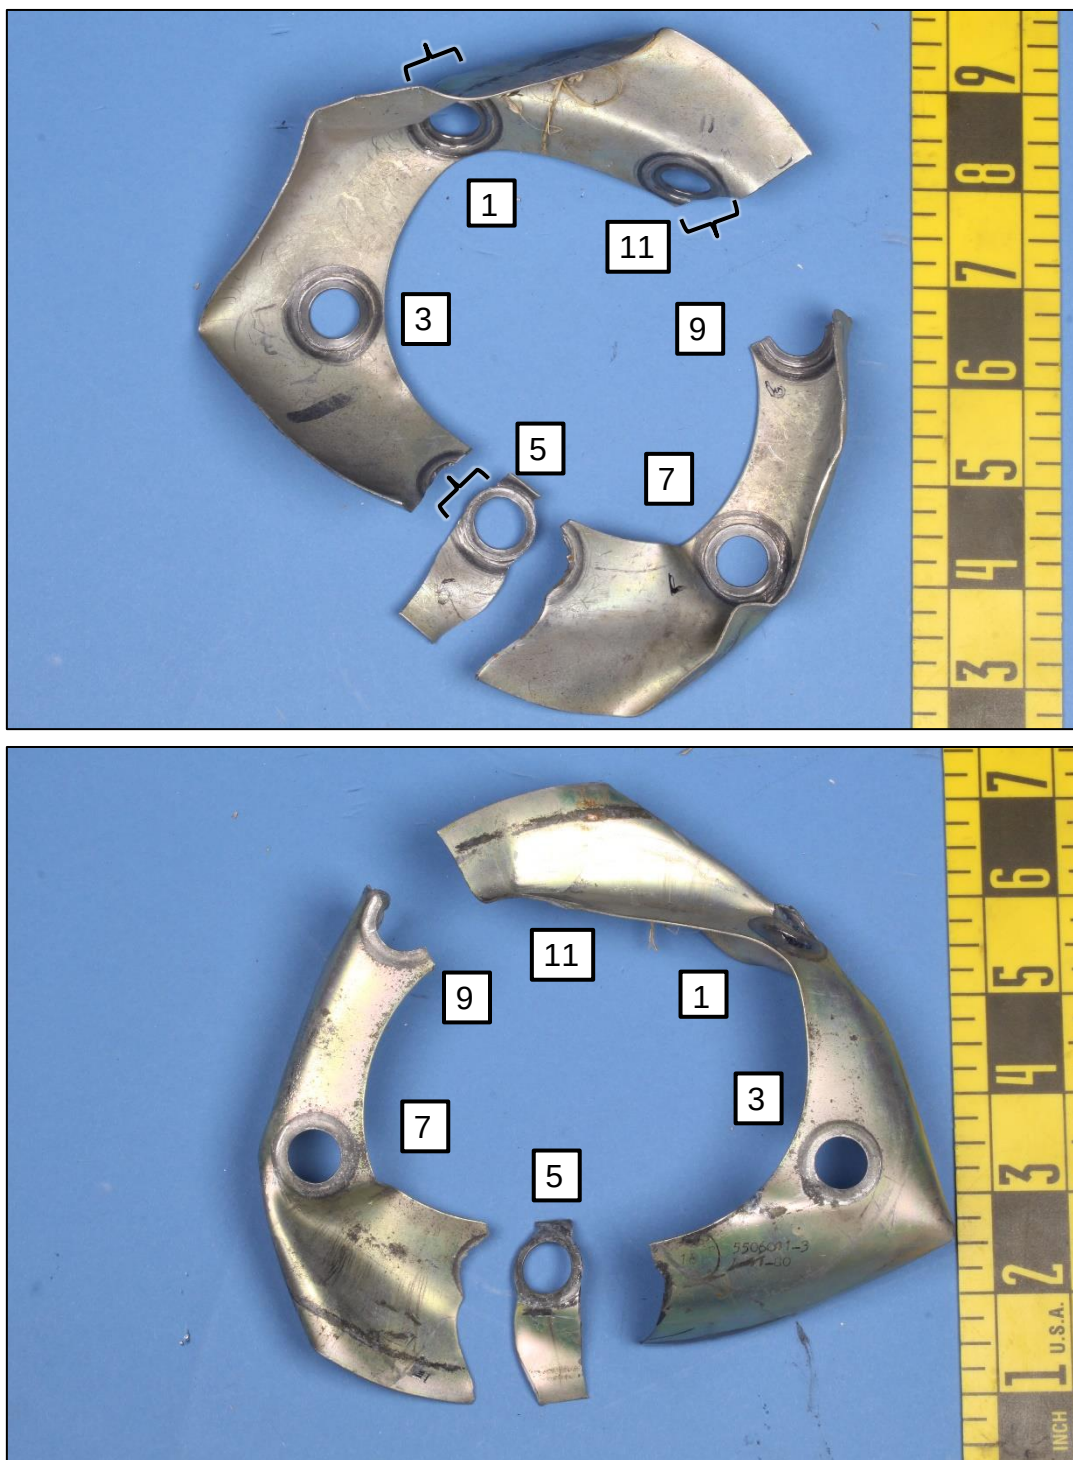
Overall views of the doubler are shown in figure 19. The doubler had approximately radial fractures adjacent to holes 5 and 11 and through hole 9. A crack

was present around the outboard edge of the attachment bolt contact face at hole 1. A piece of the doubler between holes 9 and 11 was missing.

Portions of the doubler fracture surfaces had flat fractures perpendicular to the surface with curving boundaries, features consistent with fatigue. The fatigue features were located at the edges of the attachment bolt contact faces in the areas indicated with brackets in the upper image in figure 19. The fatigue propagated through the thickness of the doubler, initiating at the forward face in the fractures near holes 5 and 11 and initiating at the aft face near hole 1. The remaining fracture faces had matte gray fractures on slant planes, features consistent with ductile overstress fracture.

Figure 19. Forward (upper image) and aft (lower image) faces of the doubler. Brackets in the upper image indicate locations with fatigue features.

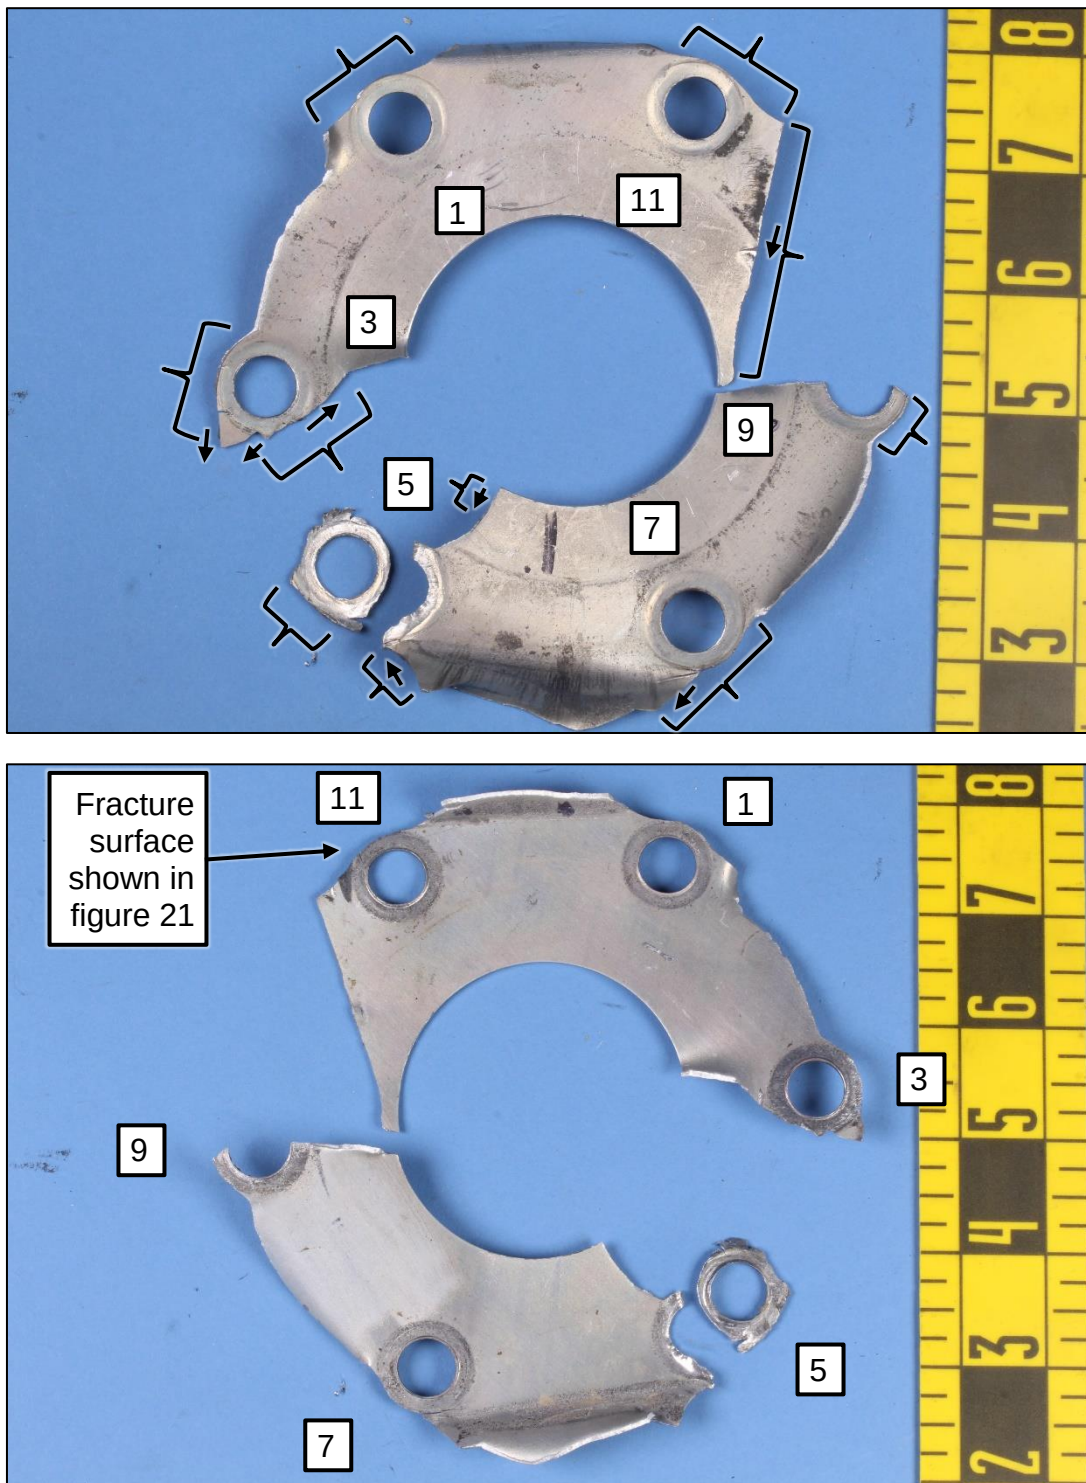
Overall views of the forward bulkhead pieces are shown in figure 20. The forward bulkhead was fractured circumferentially outboard of the propeller attachment holes and approximately radially near holes 3 and 5 and through hole 9. Another fracture was present near hole 11 oriented approximately transverse to the propeller span direction. Pieces were missing including the entire outer circumference and segments between holes 3 and 5 and between holes 9 and 11.

Portions of the fracture surfaces had flat fractures perpendicular to the surface with curving boundaries, features consistent with fatigue. Brackets in the upper image in figure 20 indicate locations with fatigue features. Unlabeled arrows indicate directions of fatigue propagation. Brackets without arrows or brackets with arrows near the end of the bracket had fatigue cracks that propagated through the thickness.

Fatigue regions were present outboard of each of the propeller attachment holes. The origins were located adjacent to the annular area associated with the attachment bolt heads, initiating at both the forward and aft sides of the bulkhead at each of the locations. The remaining fatigue regions had fracture features that generally propagated radially inboard or outboard as shown with arrows in figure 20 and were located between attachment holes that corresponded to the propeller fracture locations.

Figure 20. Forward (upper image) and aft (lower image) faces of the forward bulkhead. Brackets in the upper image indicate areas of fatigue fracture, and arrows indicate directions of crack propagation.

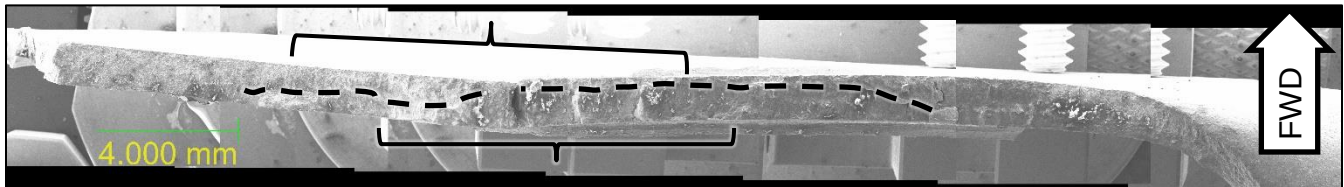
The forward bulkhead was cut between the 11 o'clock and 12 o'clock positions to facilitate a further examination of the fatigue region outboard of hole 11 and to examine the forward and aft surfaces adjacent to hole 11. An overall SEM image of the fatigue region at the outboard side of the hole is shown in figure 21. Brackets in figure 21 indicate approximate locations of fatigue origins at the forward and aft sides of the bulkhead, and a dashed line indicates the approximate boundary associated with the fatigue features emanating from each of the origin areas.

Figure 21. Fracture surface through the forward bulkhead at the outboard edge of the hole 11 annular area under the attachment bolt head (location indicated in figure 20). The image is a series of SEM images stitched together to produce a single image. Brackets indicate fatigue origin areas at the forward and aft sides of the fracture, and a dashed line indicates the boundary associated with fatigue features emanating from each origin area.

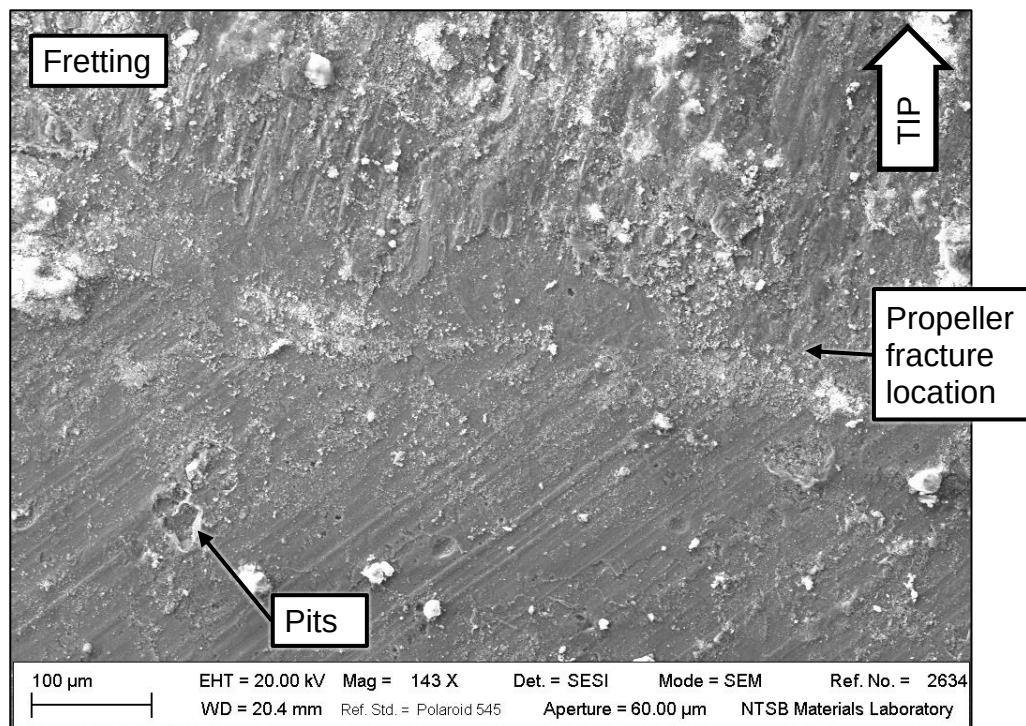
The aft surface of the forward bulkhead in the area mating to the primary fatigue origin for the propeller is shown in figure 22. A linear imprint corresponding to the propeller fracture was visible on the surface as indicated. Accumulations of oxides were present adjacent to the fracture line, and fretting contact damage was observed on the surface only to the tip side of the fracture line. Isolated shallow pits were observed inboard of the propeller fracture location.

Figure 22. SEM image of the aft surface of the forward bulkhead near the fatigue origin. Accumulations of oxides are present at the fracture location. Fretting damage is present on the surface outboard (toward the blade tip) of the fracture.

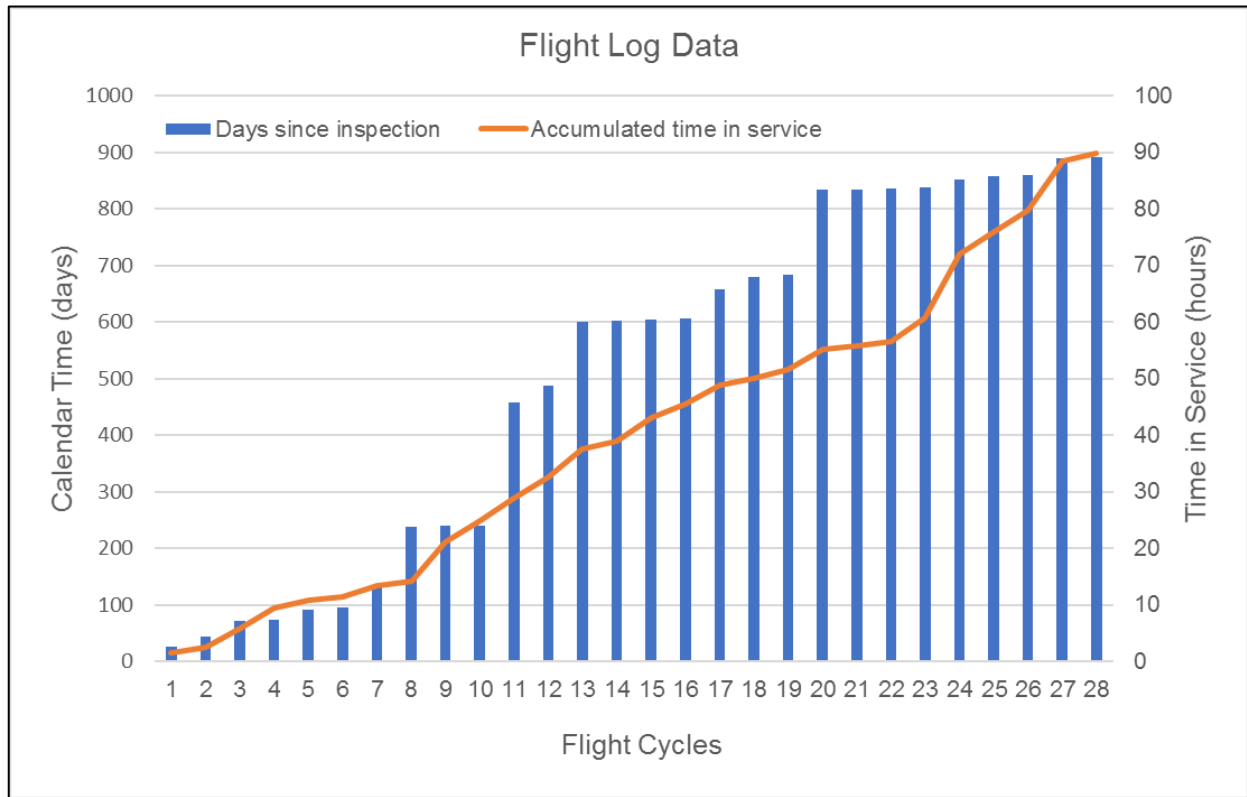
Data from the accident airplane flight log is shown plotted in figure 23. According to the flight log data, the airplane accumulated 28 flight cycles and 89.9 hours TIS since the last propeller inspection per AD 82-27-01. (The accumulated TIS includes a ground run engine cycle where the engine was run for 0.2 hours 13 calendar days before flight cycle 13.) According to the data, no flight cycles were accumulated for more than 100 calendar days on several occasions, including between cycles 7 and 8, cycles 10 and 11, cycles 12 and 13, and cycles 19 and 20. The longest calendar time between cycles occurred between cycles 10 and 11, which was 17 flight cycles prior to the accident.

Figure 23. Accumulated calendar days, flight cycles, and powerplant TIS since the last propeller inspection per AD 82-27-01 as reported in the flight log for the accident airplane. The accumulated TIS includes a ground run engine cycle where the engine was run for 0.2 hours 13 calendar days before flight cycle 13.
