CESSNA AIRCRAFT COMPANY  
**MODEL 340**  
SUPPLEMENTAL INSPECTION DOCUMENT

**SUPPLEMENTAL INSPECTION NUMBER: 32-30-00**

Main/Nose Landing Gear Retraction Systems Teardown and Inspection

Main Landing Gear Bell Crank Pivot Bolt

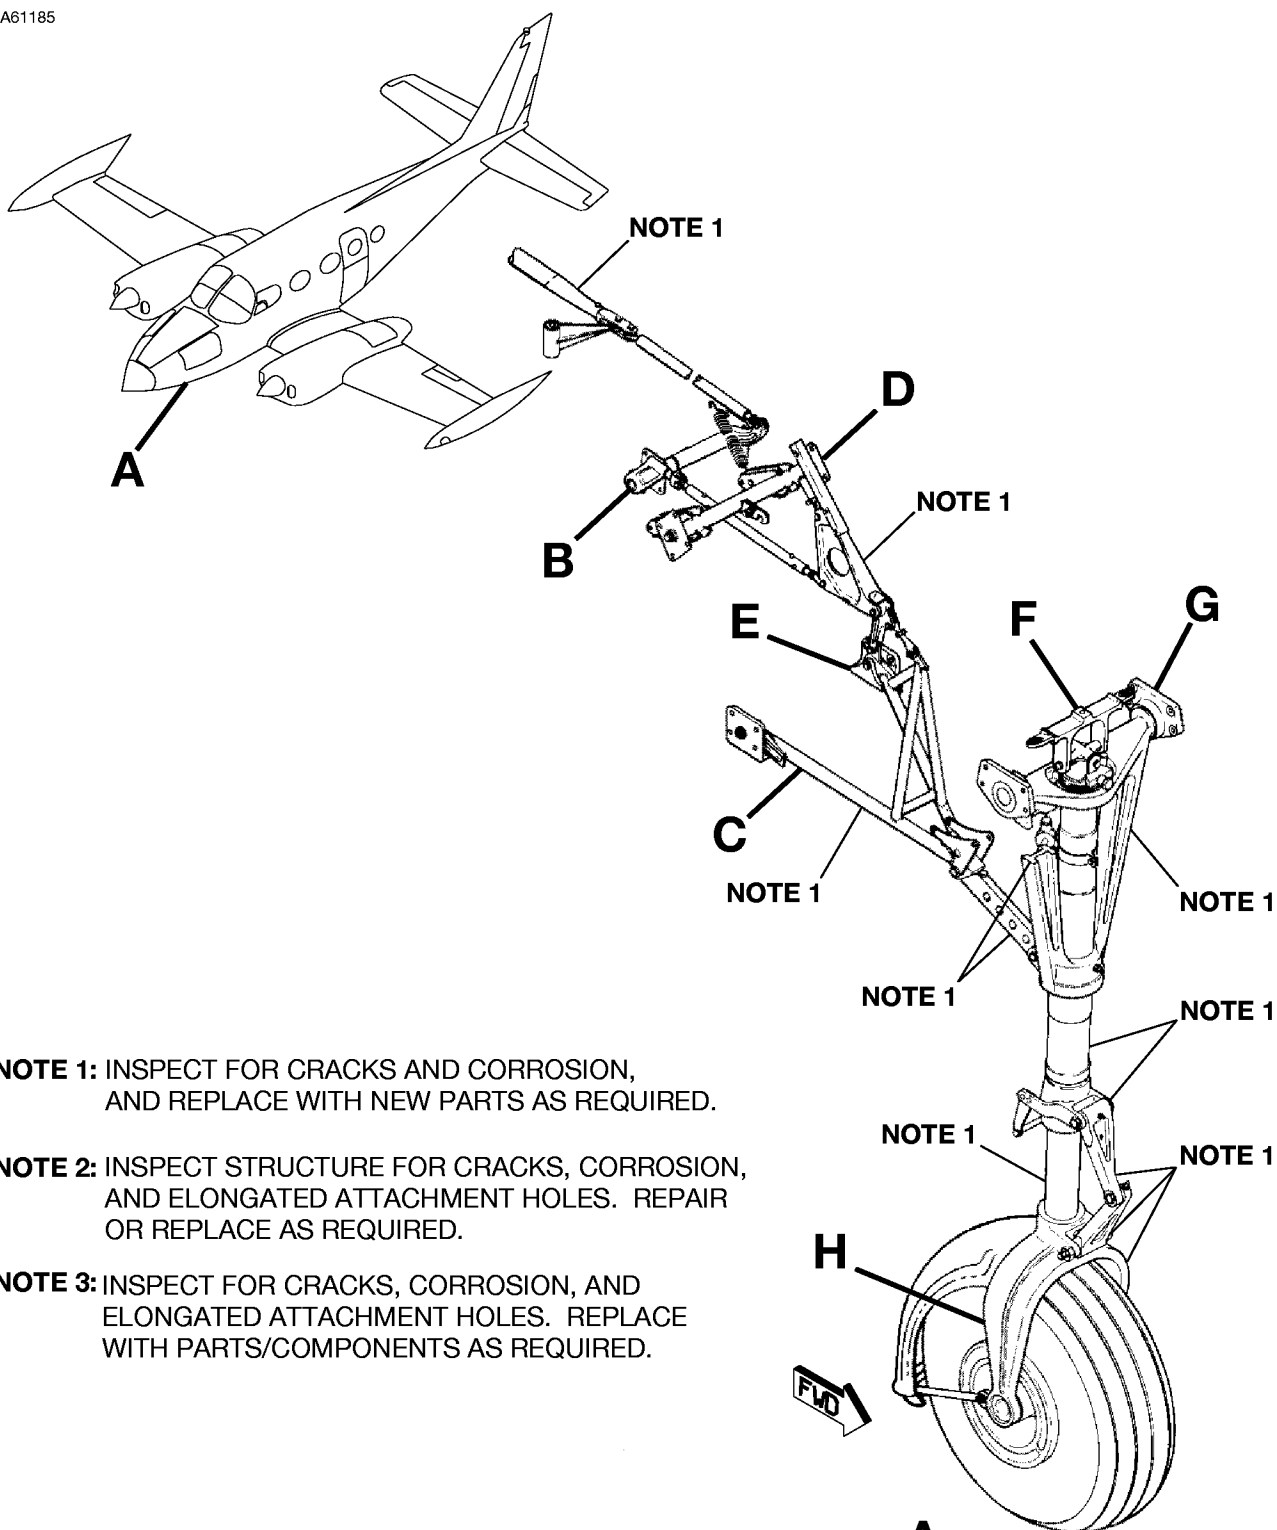
Electromechanical Landing Gear System (Nose Landing Gear)  
 Figure 2 (Sheet 1)

**NOTE 1:** INSPECT FOR CRACKS AND CORROSION, AND REPLACE WITH NEW PARTS AS REQUIRED.

**NOTE 2:** INSPECT STRUCTURE FOR CRACKS, CORROSION, AND ELONGATED ATTACHMENT HOLES. REPAIR OR REPLACE AS REQUIRED.

**NOTE 3:** INSPECT FOR CRACKS, CORROSION, AND ELONGATED ATTACHMENT HOLES. REPLACE WITH PARTS/COMPONENTS AS REQUIRED.

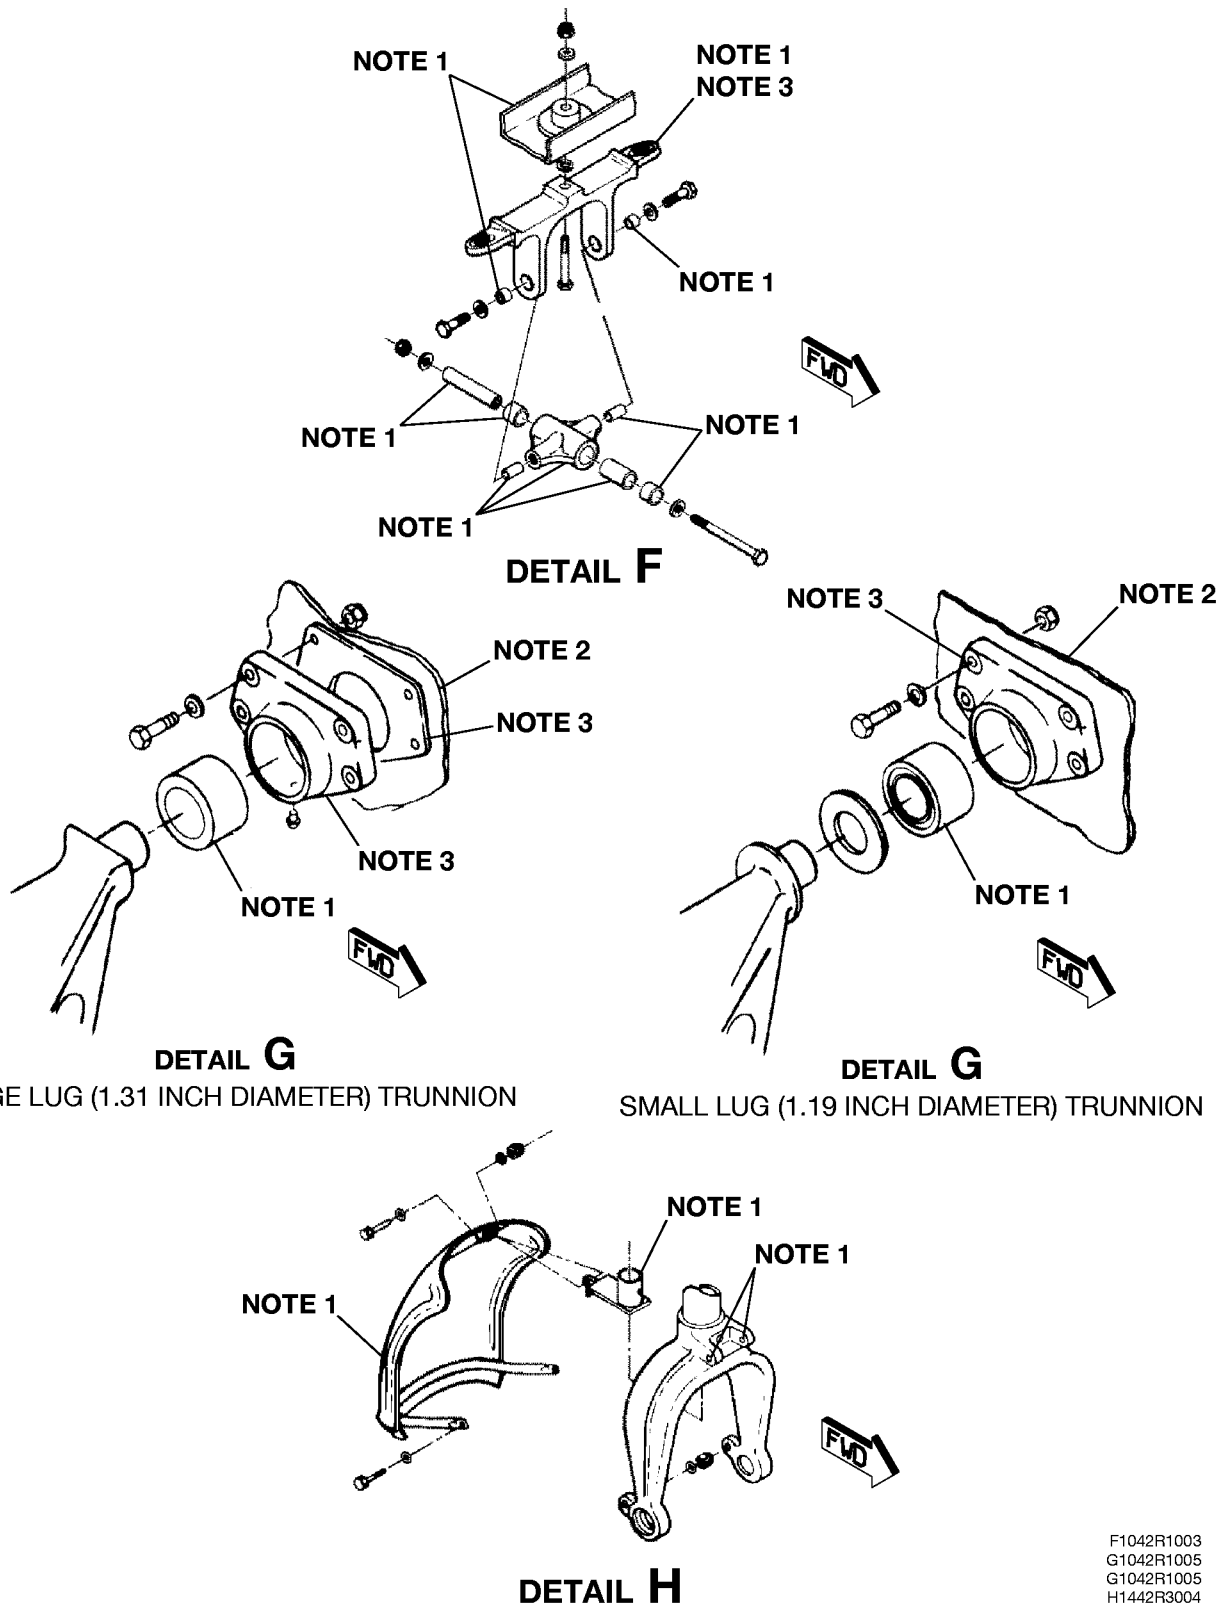
DETAIL H  
 Electromechanical Landing Gear System (Nose Landing Gear)  
 Figure 2 (Sheet 4)

DETAIL G  
 LARGE LUG (1.31 INCH DIAMETER) TRUNNION

DETAIL G  
 SMALL LUG (1.19 INCH DIAMETER) TRUNNION

This inspection is intended to assist in preventing gear and gear extension and retraction malfunctions. Refer to MEB88-5, Revision 2, for information on trunnion lug inspection.

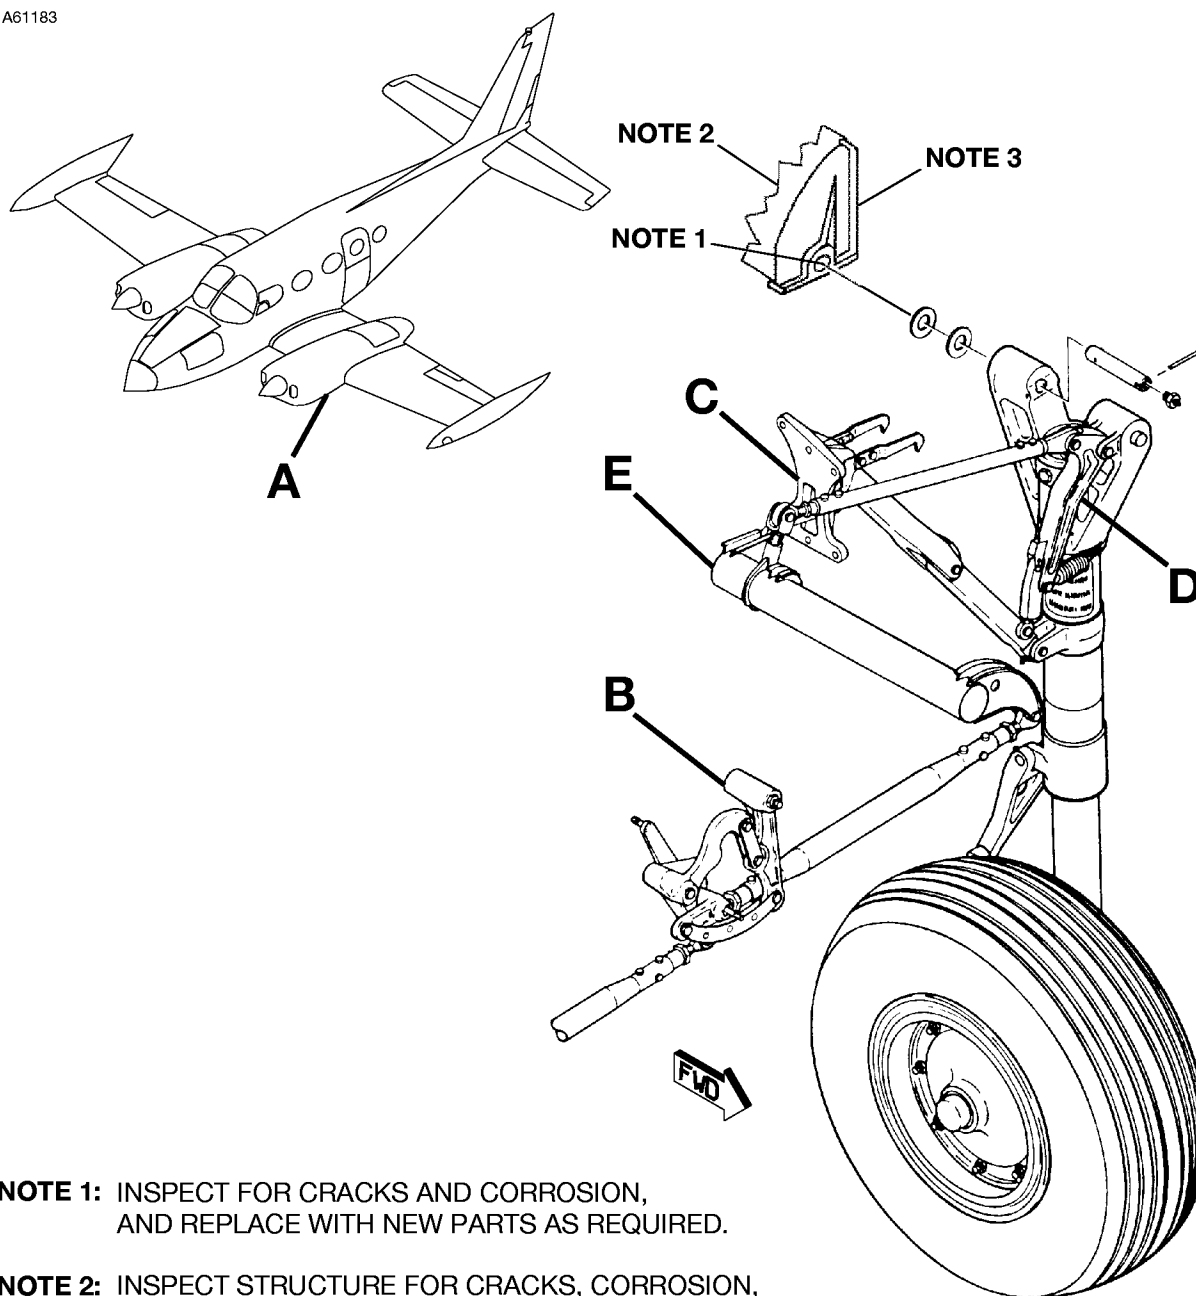
Electromechanical Landing Gear System (Main Landing Gear)  
Figure 3 (Sheet 1)

**NOTE 1:** INSPECT FOR CRACKS AND CORROSION, AND REPLACE WITH NEW PARTS AS REQUIRED.

**NOTE 2:** INSPECT STRUCTURE FOR CRACKS, CORROSION, AND ELONGATED ATTACHMENT HOLES. REPAIR OR REPLACE AS REQUIRED.

**NOTE 3:** INSPECT FOR CRACKS, CORROSION, AND ELONGATED ATTACHMENT HOLES. REPLACE WITH PARTS/COMPONENTS AS REQUIRED.

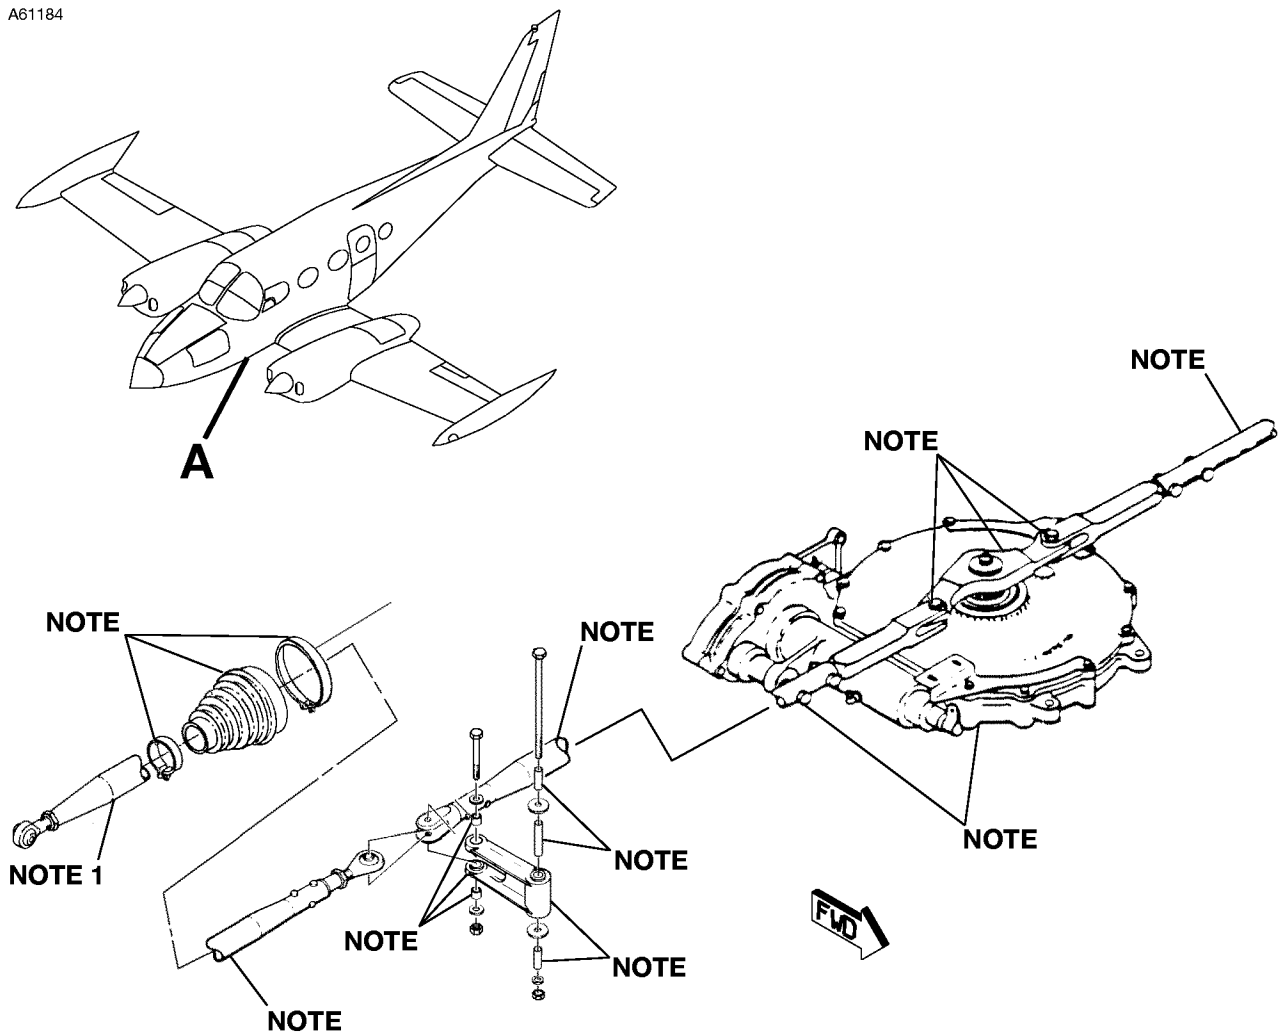
Electromechanical Landing Gear System (Actuator Assembly)  
Figure 4 (Sheet 1)

**NOTE :** INSPECT FOR CRACKS AND CORROSION,  
AND REPLACE WITH NEW PARTS AS REQUIRED.

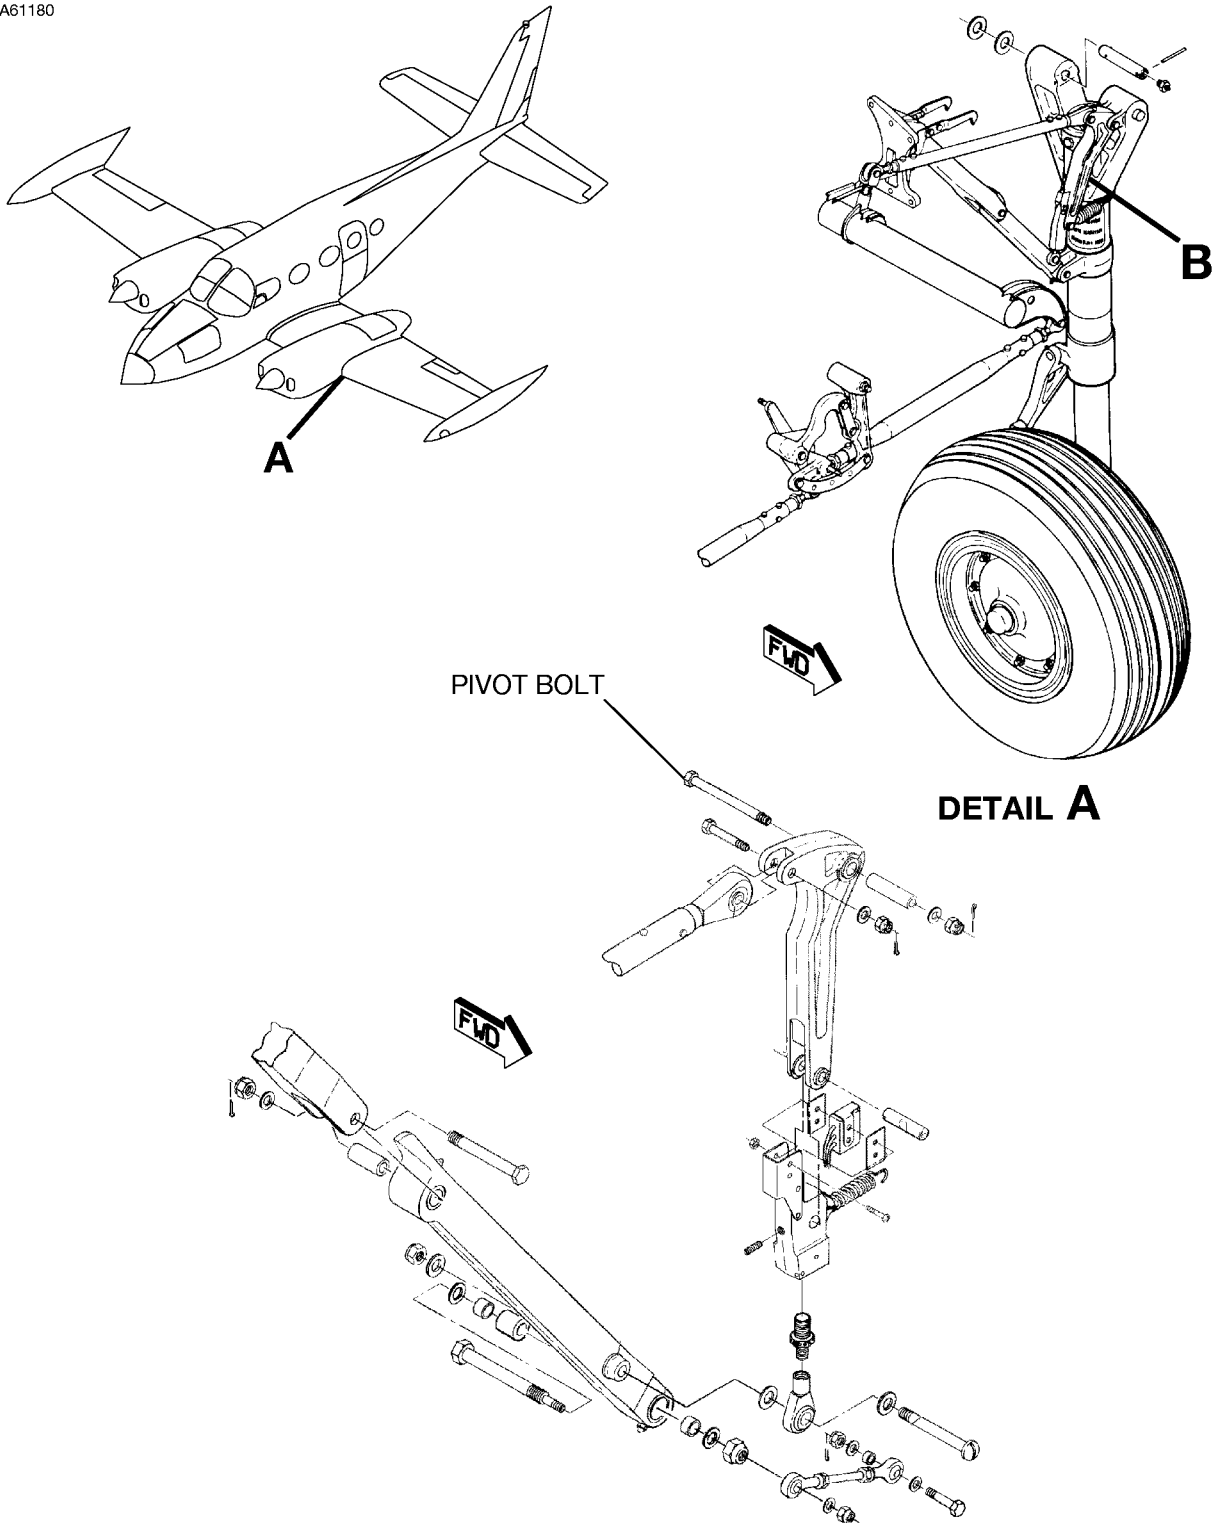
Main Landing Gear Bell Crank Pivot Bolt  
Figure 1 (Sheet 1)

- A. Remove the pivot bolt in accordance with the Service Manual. Refer to Figure 1.
- B. Inspect the bolt for evidence of shear failure.
- C. Reinstall the bolt if no evidence of shear failure is present. Replace bolt if shear failure is present.

Bolt failure will cause the main gear to collapse.

Replace bell crank pivot bolt in accordance with the Service Manual.
