# NATIONAL TRANSPORTATION SAFETY BOARD

## MATERIALS LABORATORY FACTUAL REPORT

Report No. 18-015

Place : Hallsville, MO  
Date : September 13, 2017  
Vehicle : Cessna 210G, N5960F  
NTSB No. : CEN17LA352  
Investigator : Mike Folkerts (AS-CEN)

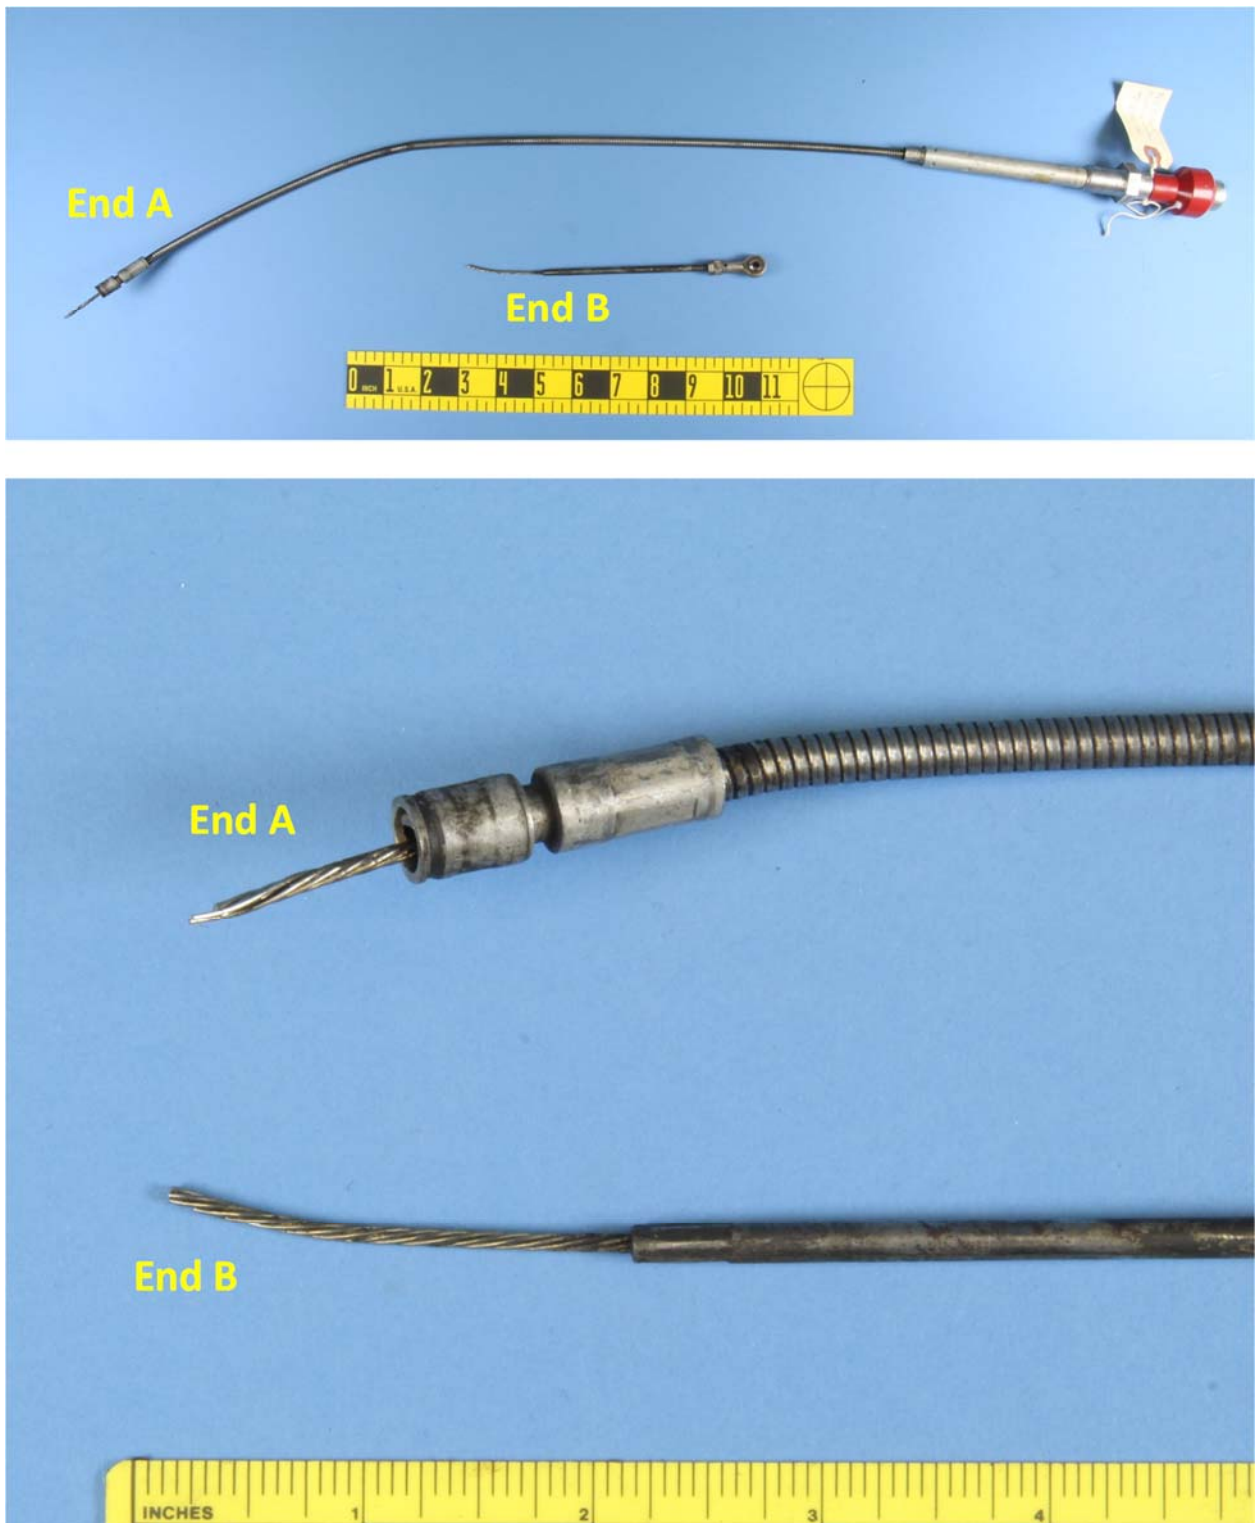
The engine mixture cable was submitted with the wire strands separated, as shown in Figure 1. The two cable halves were labeled End A and End B, with End A associated with the longer length of cable and End B associated with the cable attached to the rod end piece. The separation of the strands was between the end of the rod end piece and a fitting on the end of the external wire wrap.

Figure 1: Overall (top) and close-up (bottom) photos of the separated ends of the engine mixture cable.

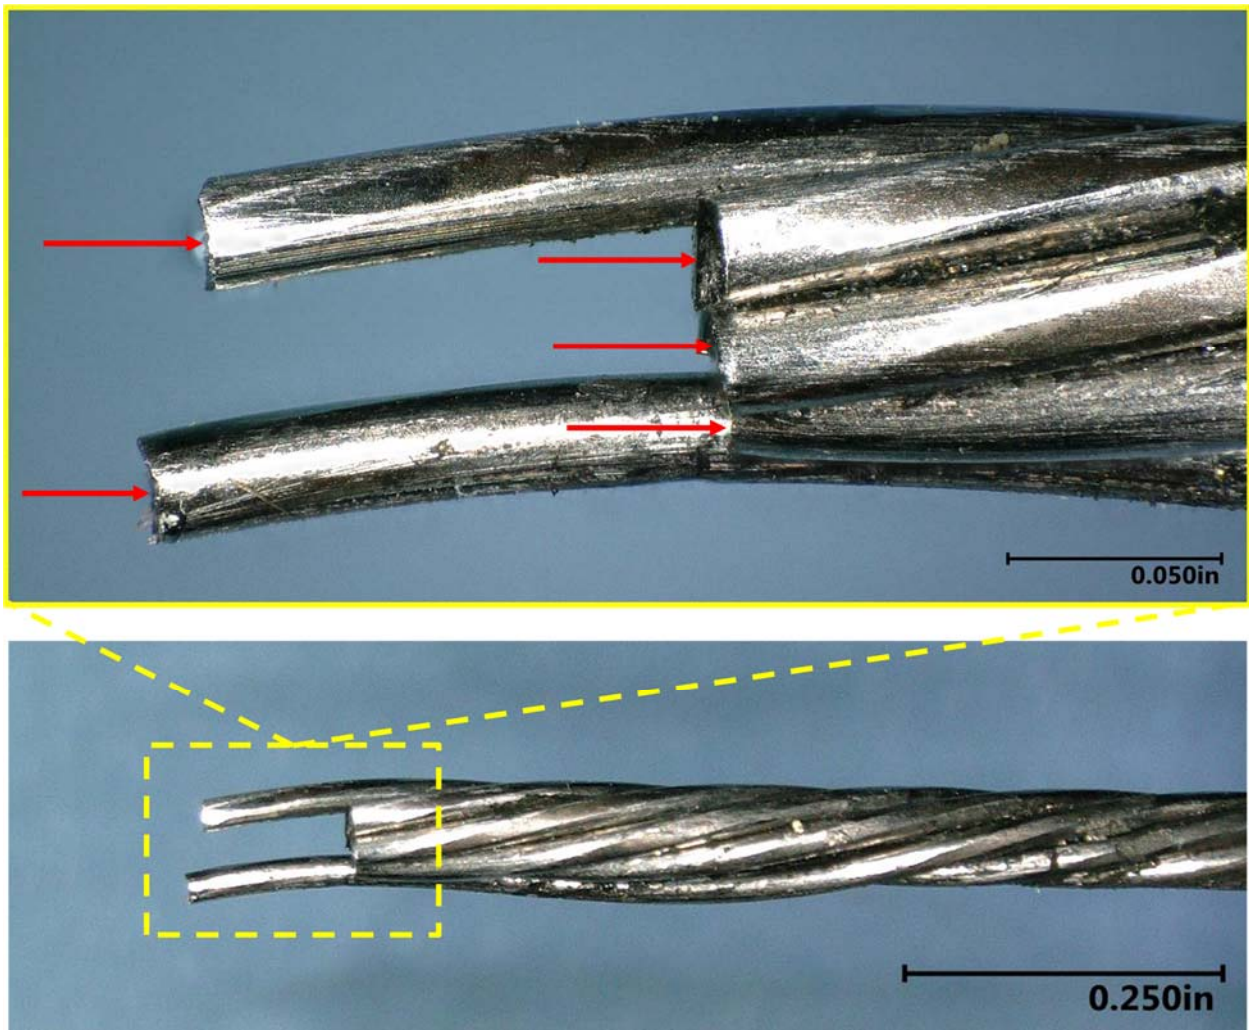
Digital microscope images of the wire strands of End A are shown in Figure 2 and Figure 3. Digital microscope images of the wire strands of End B are shown in Figure 4 and Figure 5. The fracture surfaces (red arrows) were flat and perpendicular to the axes of the strands. No necking or thinning of the individual strands consistent with overstress separation was observed.

Figure 2: Digital microscope images showing a perpendicular view of the separated wires on End A. The red arrows point to the flat fracture surfaces on the wires.

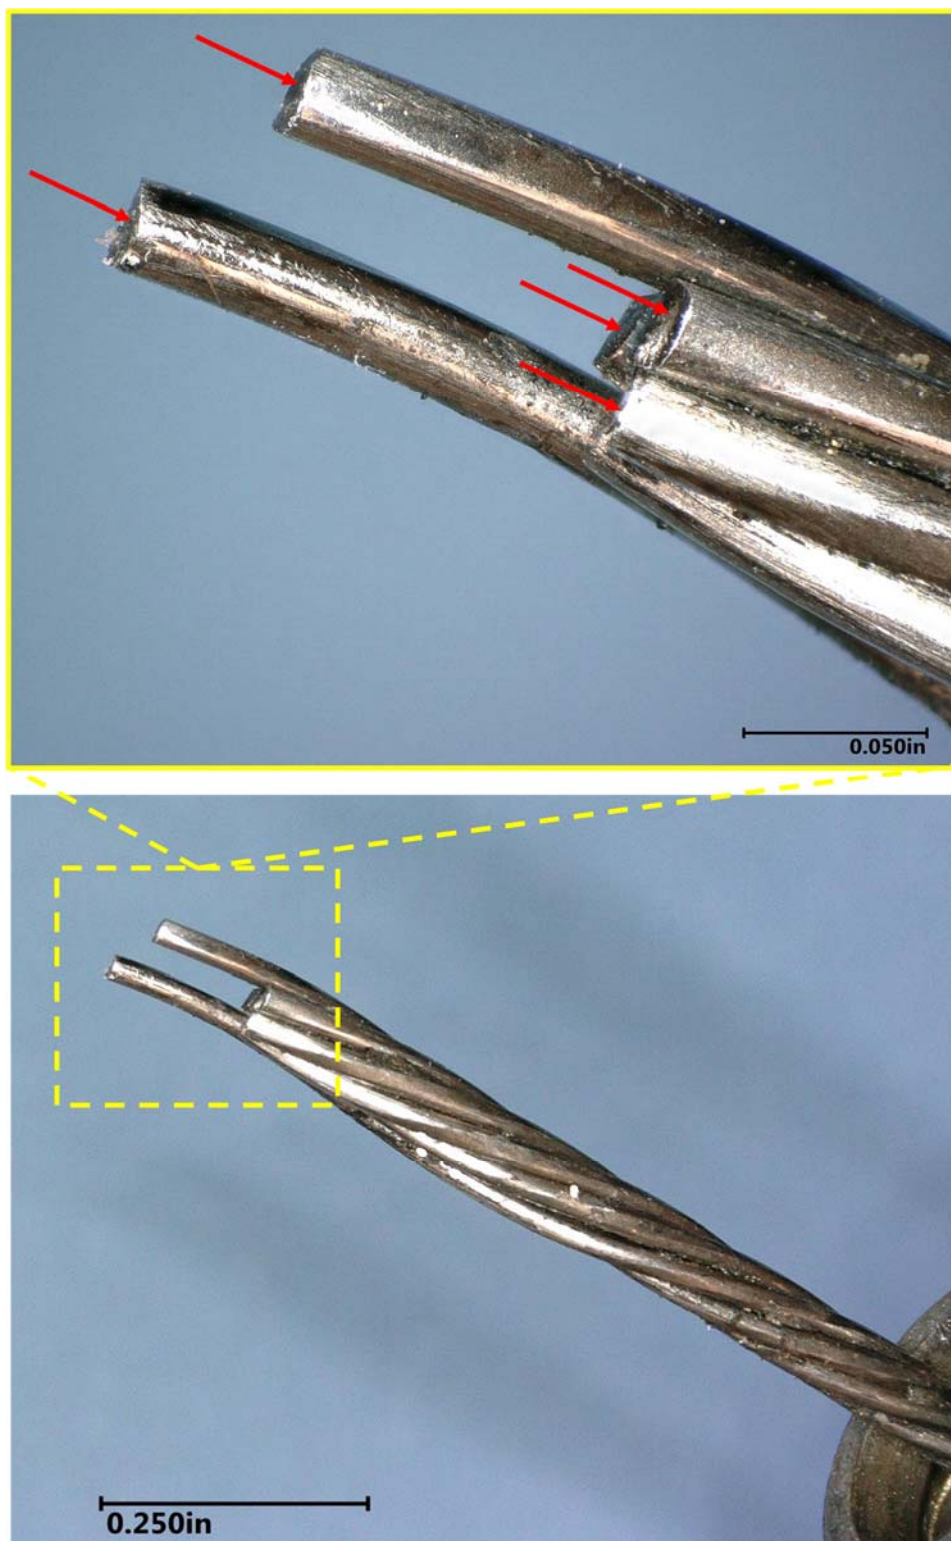
Figure 3: Digital microscope images showing an angled view of the separated wires on End A. The red arrows point to the flat fracture surfaces on the wires.

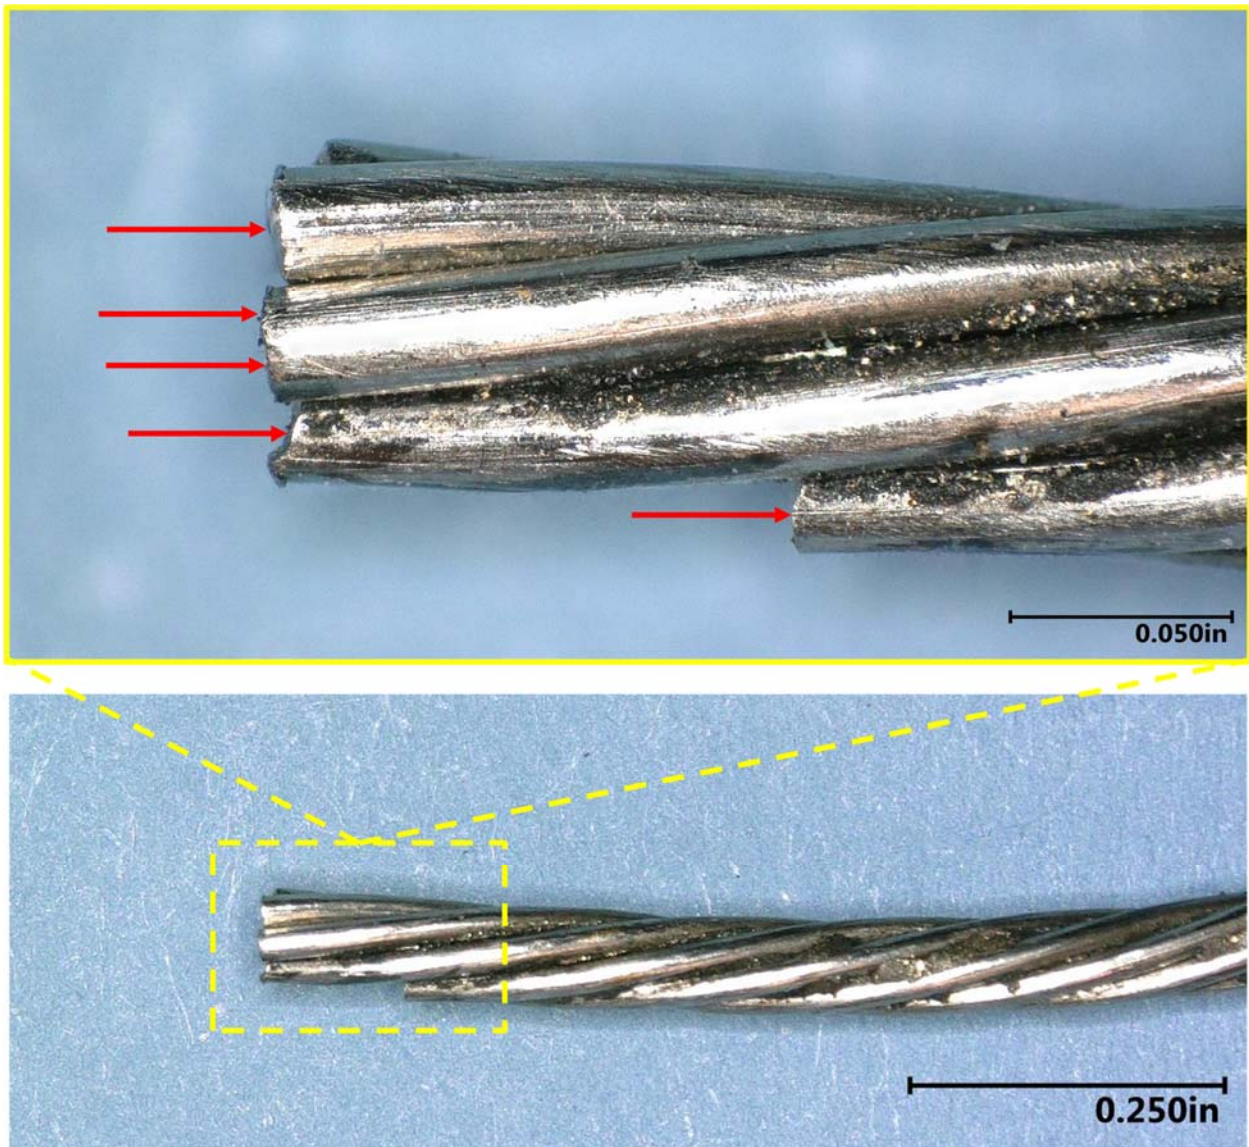
Figure 4: Digital microscope images showing a perpendicular view of the separated wires on End B. The red arrows point to the flat fracture surfaces on the wires.

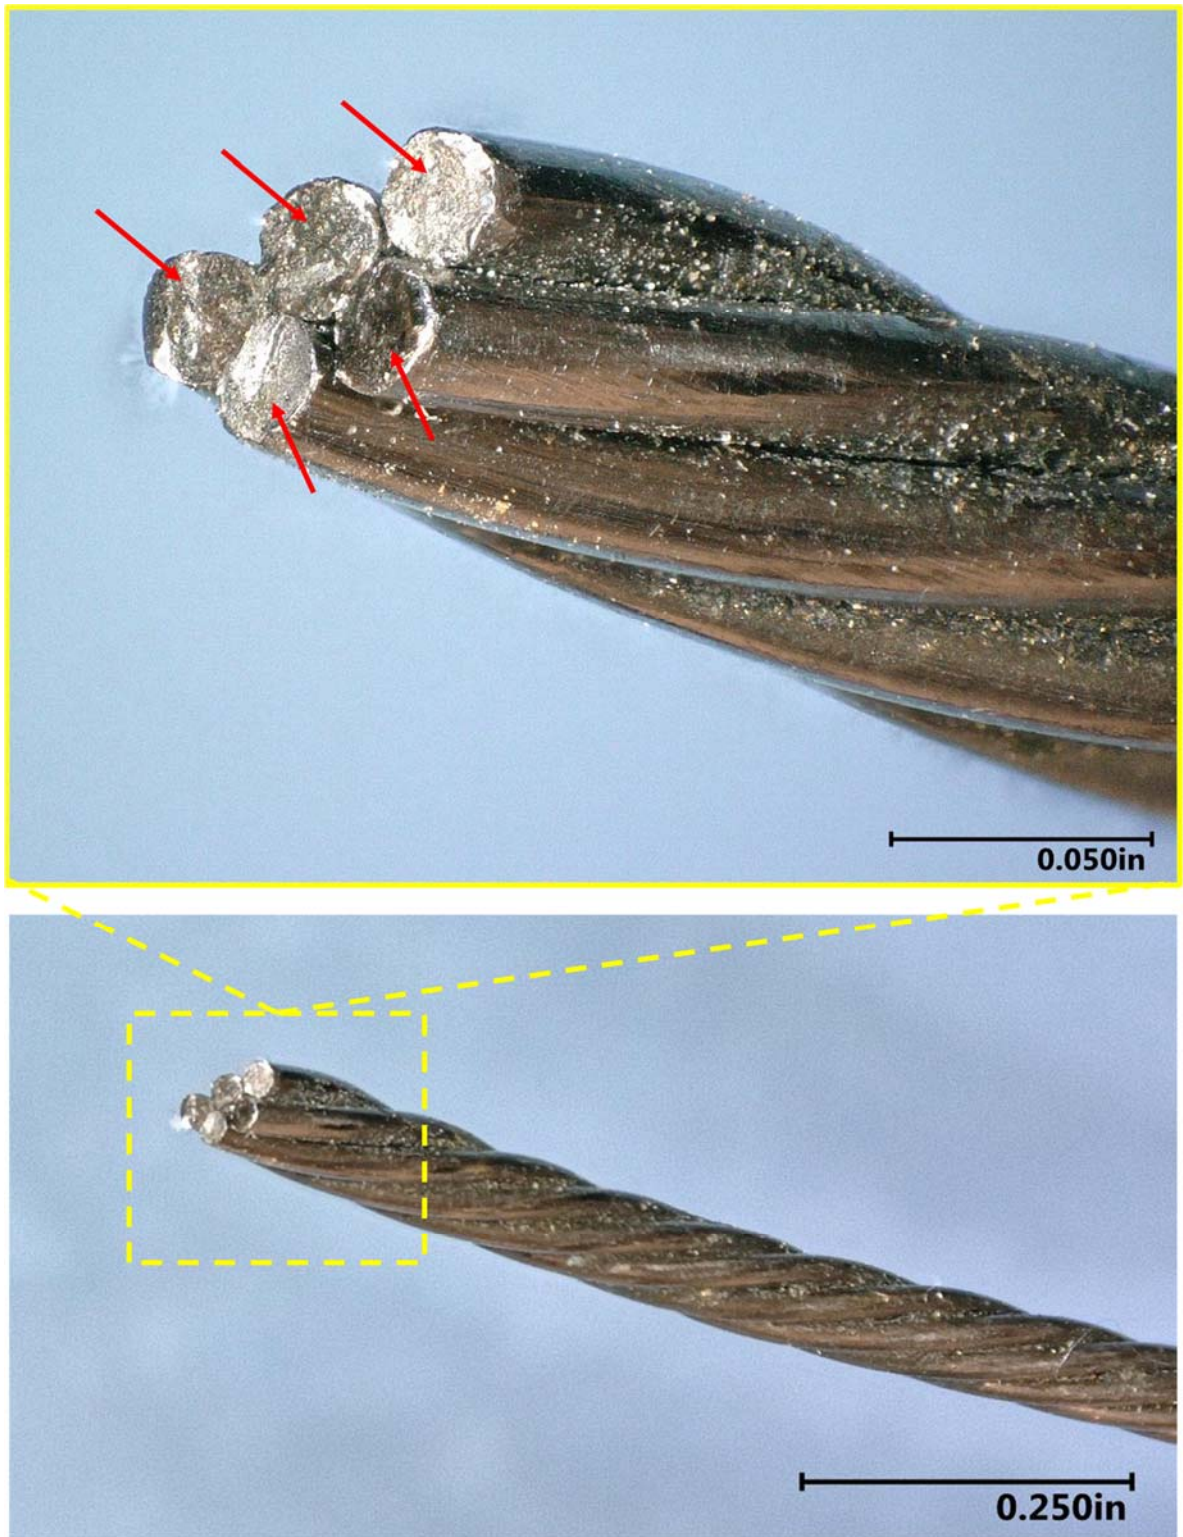
Figure 5: Digital microscope images showing an angled view of the separated wires on End B. The red arrows point to the flat fracture surfaces on the wires.

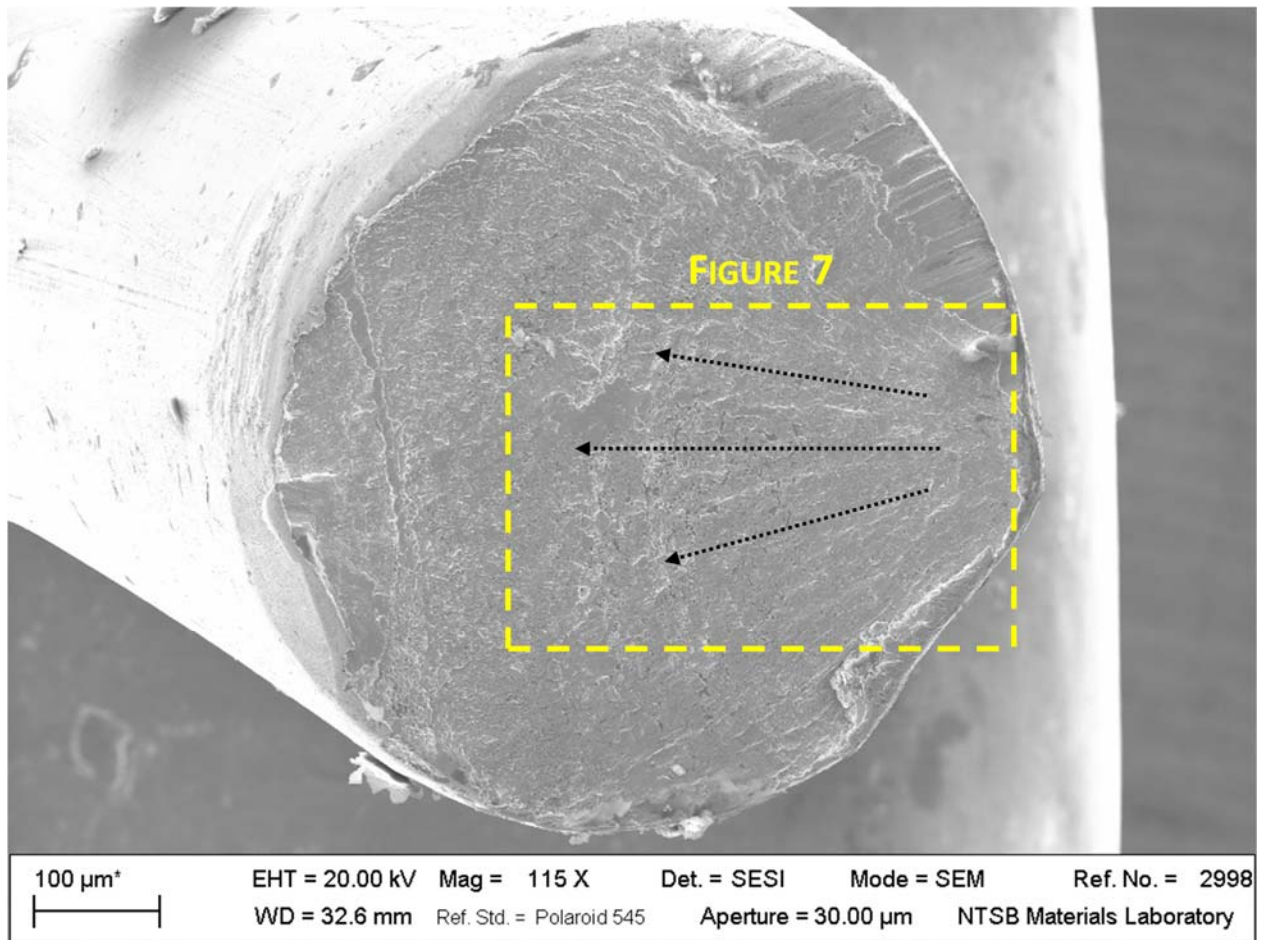
Several wires were sectioned from End B and examined using a Zeiss Auriga 40 field emission (FE) scanning electron microscope (SEM). Figure 6 and Figure 7 show the fracture surface on one representative wire. There was some post separation impact damage around the outer circumference of the fracture surface. Feathery features consistent with fatigue were observed on the fracture surface. The black dotted arrows in Figure 6 indicate the direction of fatigue propagation, which appeared to emanate from the outer diameter of the wire. Striations (yellow arrows, Figure 7) consistent with fatigue were observed at high magnification. Pitting consistent with corrosion overlaid the fatigue features on portions of the fracture surface.

The flat fracture surfaces on the wires and their perpendicular orientation to the wire axes, the lack of necking or other deformation, and the fracture surface features

consistent with fatigue observed in the SEM all indicate the engine mixture cable likely failed due to fatigue.

Figure 6: SEM image of the fracture surface of an exemplar wire sectioned from End B. The black dotted arrows indicate the direction of fatigue propagation.

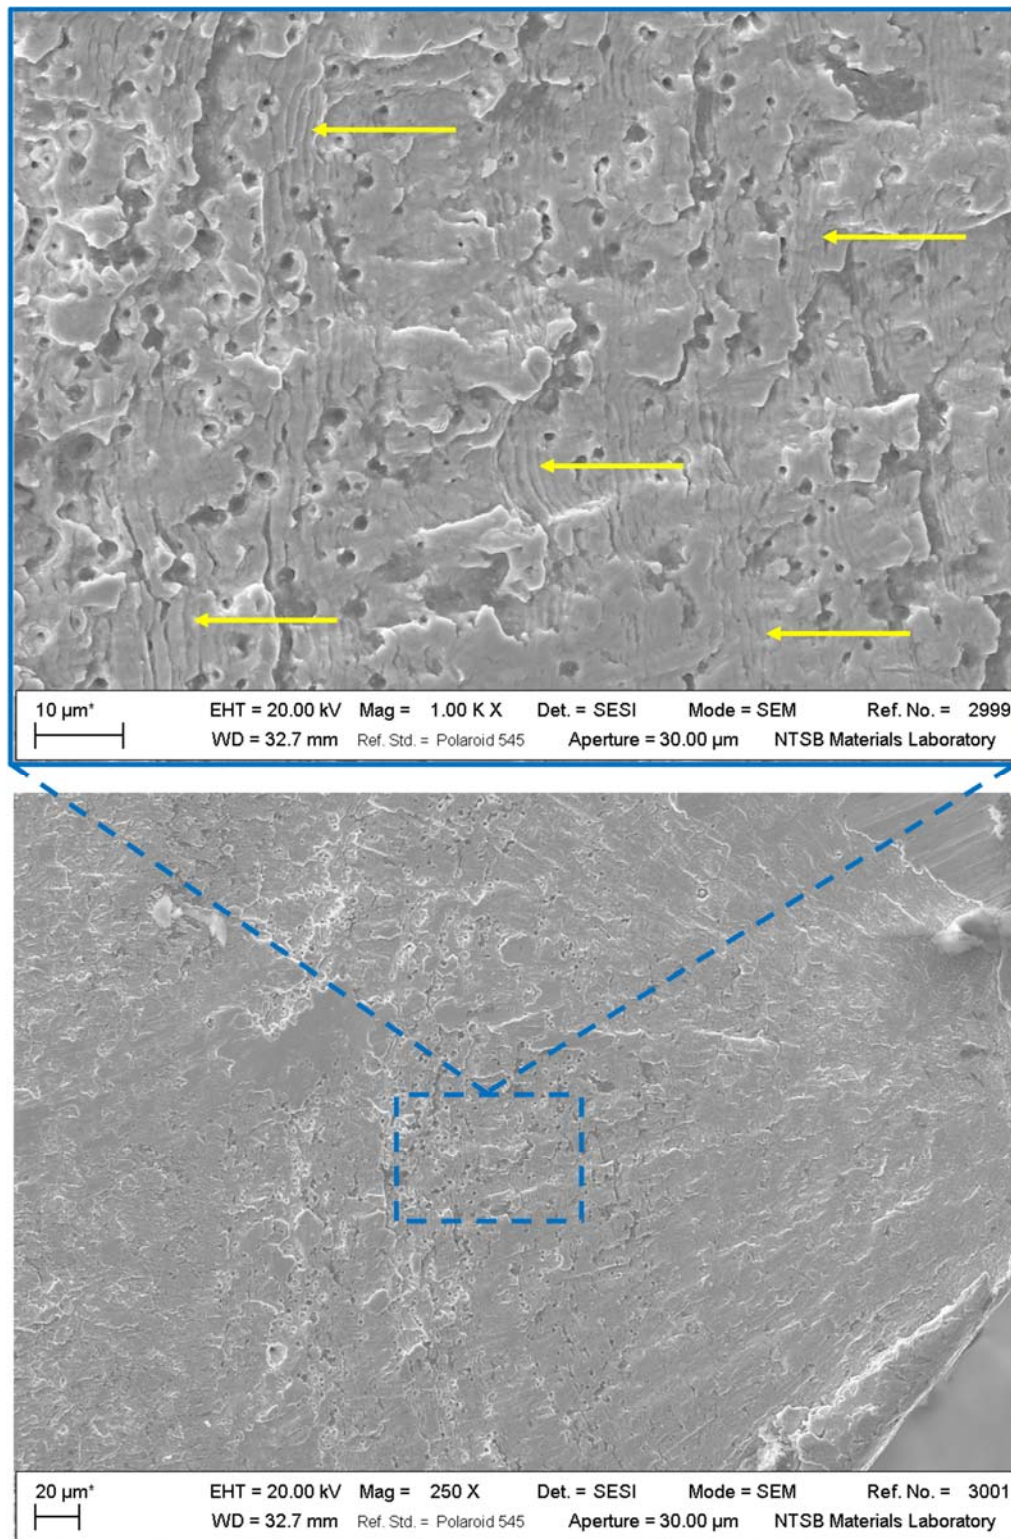
Figure 7: SEM images of the fracture surface of the exemplar wire sectioned from End B in the location indicated in Figure 6. The yellow arrows in the top image point to fatigue striations.
